# Article Impact of Chloride on the Environmentally-Assisted Crack Initiation Behaviour of Low-Alloy Steel under Boiling Water Reactor Conditions

Stefan Ritter \* D and Hans-Peter Seifert

Paul Scherrer Institute (PSI), 5232 Villigen, Switzerland; hans-peter.seifert@psi.ch \* Correspondence: stefan.ritter@psi.ch

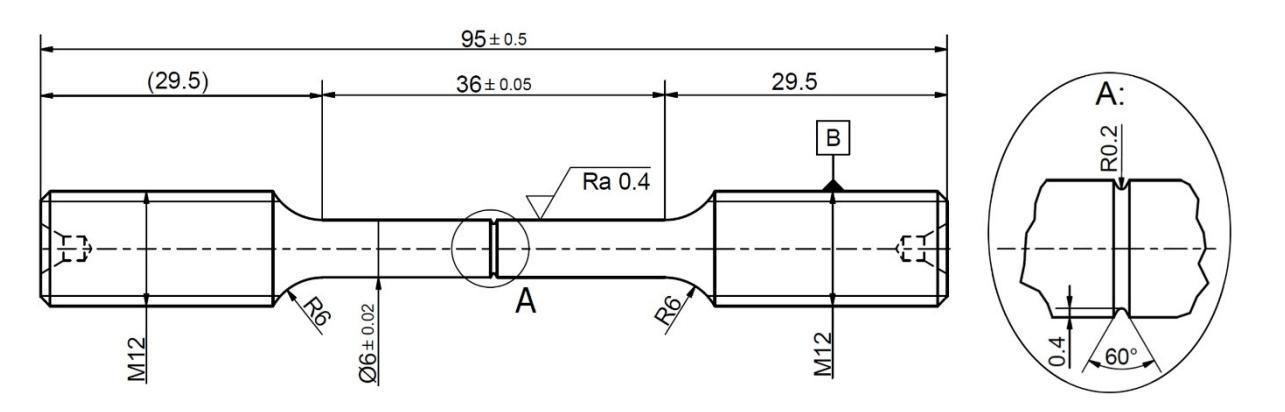
Figure 1. Schematic of the round bar tensile specimen with V-shaped notch (dimensions in mm).

For the EAC initiation tests, a reactor pressure vessel steel (hot-rolled plate) SA 533 B Cl.1 with a sulphur content of 0.018 wt.% was used. The material was guenched and tempered, stress relieved, and had a granular bainitic structure with an average former austenitic grain size of 10 to 20  $\mu$ m. The spatial distribution and morphology of the MnS inclusions was fairly homogeneous, covering the range from small, spherical, to large (up to a few 100 µm) elongated inclusions. The chemical composition and mechanical properties are shown in Tables 2 and 3. The tests were performed using round bar tensile specimens fabricated (lathed) in the L-orientation of the hot-rolled plate (a few tests were duplicated with specimens in S- and T-orientation revealing no influence of the orientation on the cracking behaviour) with a V-shaped notch in the centre of the gauge section (Figure 1). This notch was necessary to restrict the distance between the reference electrode and cracking site, which is necessary because the throwing power of the current is very limited in the low-conductivity electrolyte (high-purity water). The surface of the specimen was ground with SiC paper to a surface roughness of  $R_a \approx 0.4 \ \mu m$ , and the notch area was investigated in a scanning electron microscope (SEM) before testing it on any pre-existing surface defects. The specimen was electrically insulated from the test facility by ceramic washers.

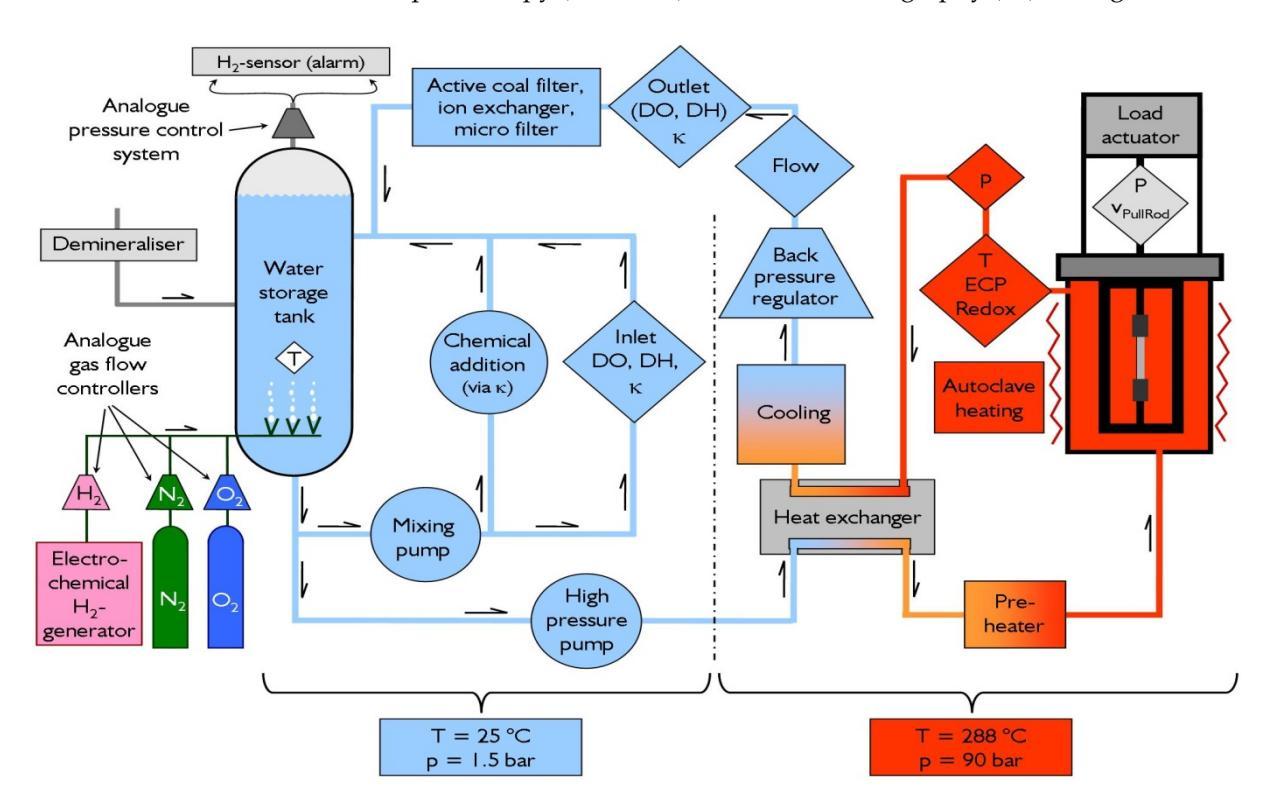
**Figure 2.** Schematic of the high-temperature water loop with autoclave and electro-mechanical tensile machine.

To study the EAC initiation behaviour, constant extension rate tensile (CERT) tests, as well as two tests under constant load, were performed in a sophisticated refreshing high-temperature water loop in an autoclave with an electromechanical tensile machine (Figure 2). During the experiments, all important mechanical loading (load, pull rod stroke) and environmental parameters at inlet and outlet (dissolved oxygen (DO), dissolved hydrogen (DH), conductivity, T, p, flow, etc.) were recorded continuously. The electrochemical corrosion potential (ECP) of the specimen and the redox potential (platinum probe) were monitored by use of a Cu/Cu<sub>2</sub>O ZrO<sub>2</sub>-membrane reference electrode. The ionic impurities of the water (inlet and outlet) were analysed by inductively coupled plasma–atomic emission spectroscopy (ICP–AES) and ion chromatography (IC) during each test.

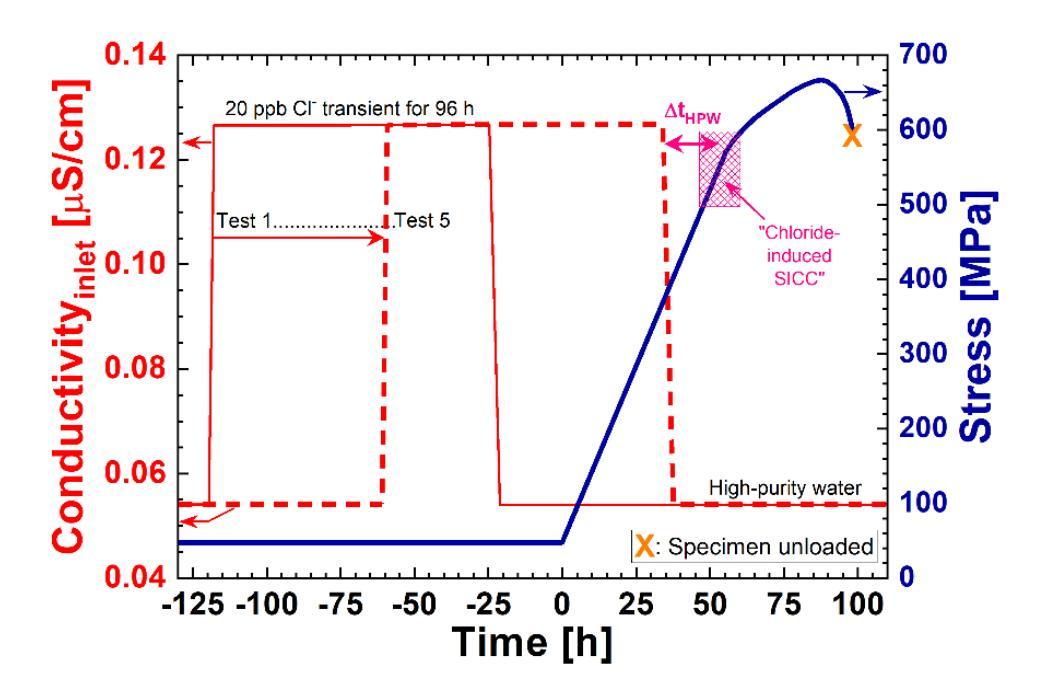
**Figure 3.** Schematic of the testing procedure of the five CERT tests with 20 ppb chloride transients (SICC = strain-induced corrosion cracking).

**Table 4.** Summary of the 20 ppb chloride transient tests;  $\Delta t_{HPW}$  = time between end of chloride transient (inlet conductivity < 0.066 µS/cm) and stress/strain regime where strain-induced corrosion crack initiation was usually observed in tests with continuous chloride addition, see Figure 3.

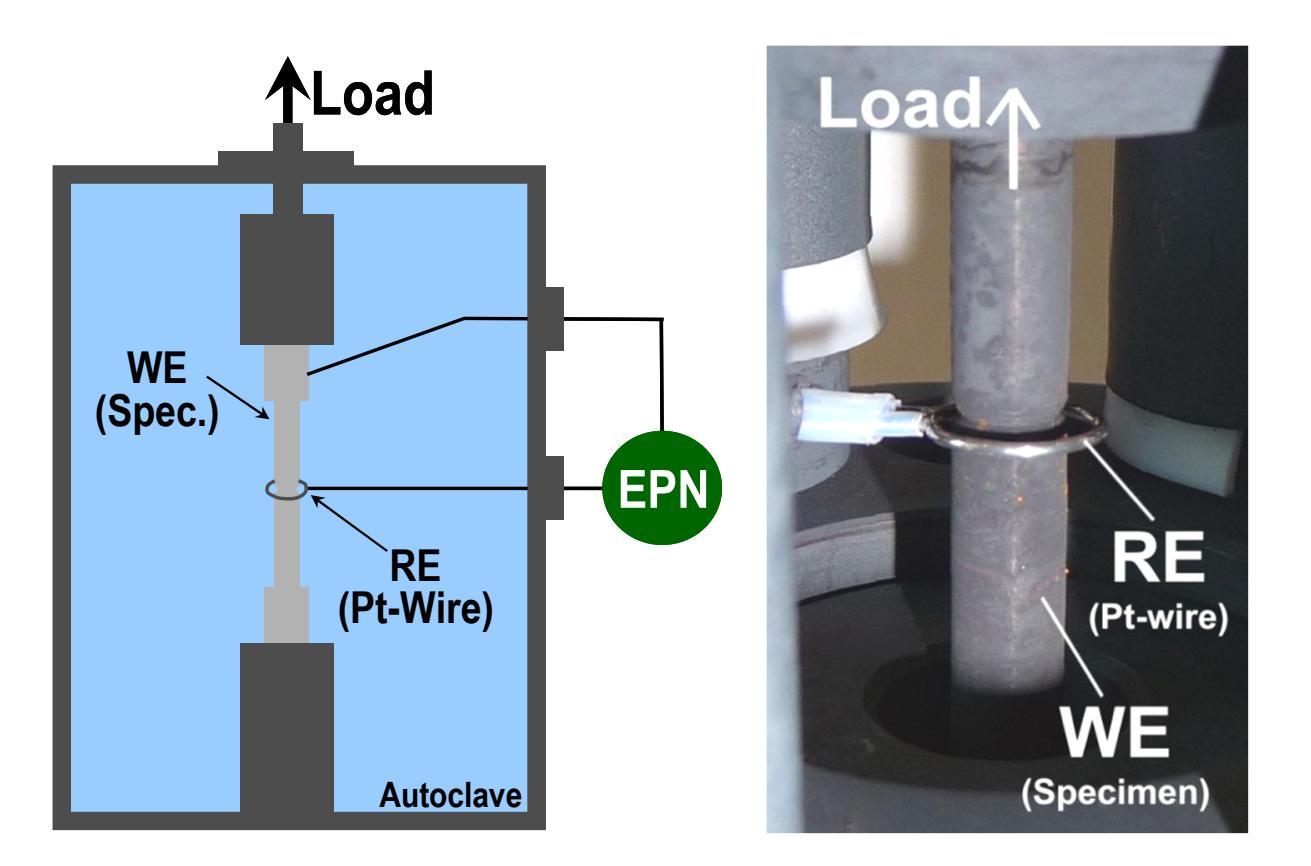
**Figure 4.** Simplified schematic (**left**) and photograph (**right**) of the setup for the EPN measurements, during CERT, and constant load tests with notched round bar tensile specimens.

The electrochemical potential noise (EPN) was recorded by a commercial electrochemical noise (EN) measurement device (EcmNoise, IPS, Muenster, Germany), developed in cooperation with PSI, with a sampling rate of 2 Hz. The EN measurement device was qualified and characterised by "round-robin" testing (within the European Cooperative Group on Corrosion Monitoring of Nuclear Materials, or ECG-COMON [20,21]) and by dummy cell testing according to a guideline for the assessment of EN measurement devices [22]. The EPN was measured via a Pt-wire (pseudo reference electrode) which was aligned around the V-notch of the specimen (Figure 4). This setup was developed, optimised, and verified during earlier research programmes [23,24].

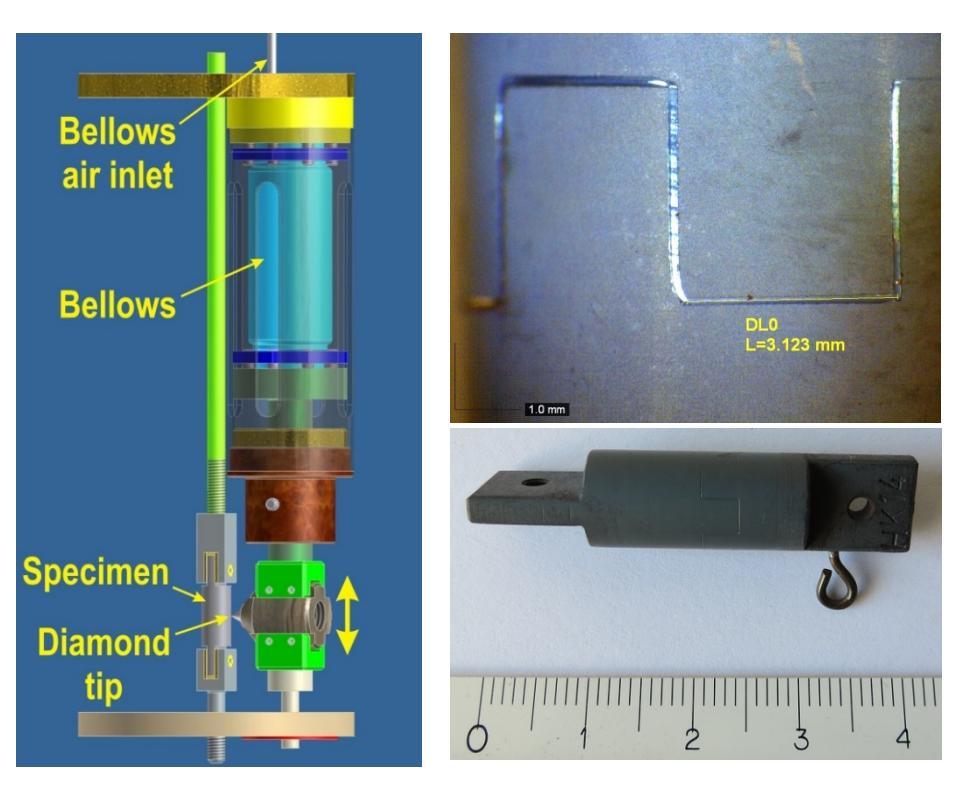
**Figure 5.** Schematic of the bellows-driven scratching device (**left**), photograph (**lower right**), and detail (**upper right**) of a specimen after a scratching test.

To obtain new insights into the mechanism behind the effect of chloride on crack initiation, the repassivation behaviour of the LAS in a simulated BWR/NWC environment was studied in an autoclave with a bellows-driven scratching device. A pneumatic metal bellow moved a diamond tip across a round LAS specimen (see Figure 5). By up and down movements of the diamond tip and by turning the specimens, up to 16 scratches (each with a length of approximately 3.2 mm) could be implemented on one specimen per experiment. During the test, the current between the specimen and a platinum sheet mounted very close to the specimen surface was recorded with the EN measurement instrument. The specimen, diamond tip, and platinum sheet were electrically insulated from the autoclave and from each other. Several tests were performed in, either, high-purity or 20 ppb chloride-containing high-temperature water.

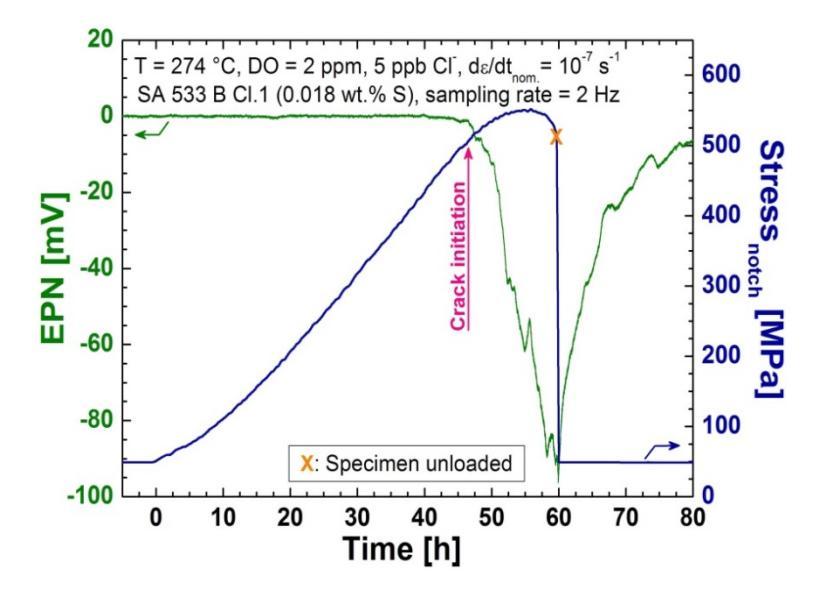
**Figure 6.** Typical course of the EPN signal and stress (at a smaller cross-sectional area in the notch) during a CERT test in high-temperature water containing 5 ppb of chloride; crack initiation was detected by the drop of the potential signal.

A series of 14 CERT tests with continuous chloride addition, or in high-purity water (as reference tests), were performed. In all tests in a BWR/NWC environment, crack initiation could be detected successfully by the EN measurements. Figure 6 shows the typical behaviour of the EPN signal (and stress) during a test where EAC, more precisely SICC, was initiated around the onset of plastic yielding at the notch root. This was shown by a clear drop of the baseline potential signal and by small potential transients in some cases. After the specimen was unloaded to the small pre-load, the EPN signal slowly returned to the original level. The fractographical post-test investigations showed transgranular SICC cracking with features typically observed in EAC tests with LAS in a high-temperature water environment Figure 7. [2,7]. This behaviour of the EPN signal was observed in many tests of previous studies [25] and could be clearly attributed to EAC initiation. The observed cathodic drift of the potential was probably related to oxide film rupture and anodic metal dissolution (sometimes interrupted or delayed by repassivation) during crack initiation at different surface locations, as well as to surface crack growth of previously formed microcracks. The initiation process of EAC, thus, involves local anodic metal dissolution, which is in line with the slip-dissolution mechanism [26]. The superposition of potential signals from the initiation events at different surface locations and the surface crack growth of microcracks under slow straining conditions with increasing plastic strain may result in this quasi-continuous drop in potential. Furthermore, superimposed crevice currents and the resulting potential changes to the differential aeration cell in the crack-mouth region, which vary with the crack-mouth opening, further contribute to these signal changes. Therefore, individual potential transients, as expected, cannot be resolved in every case and, in particular, for large distances between the specimen surface and reference electrode, due to the low throwing power of the current in the low-conductivity electrolyte.

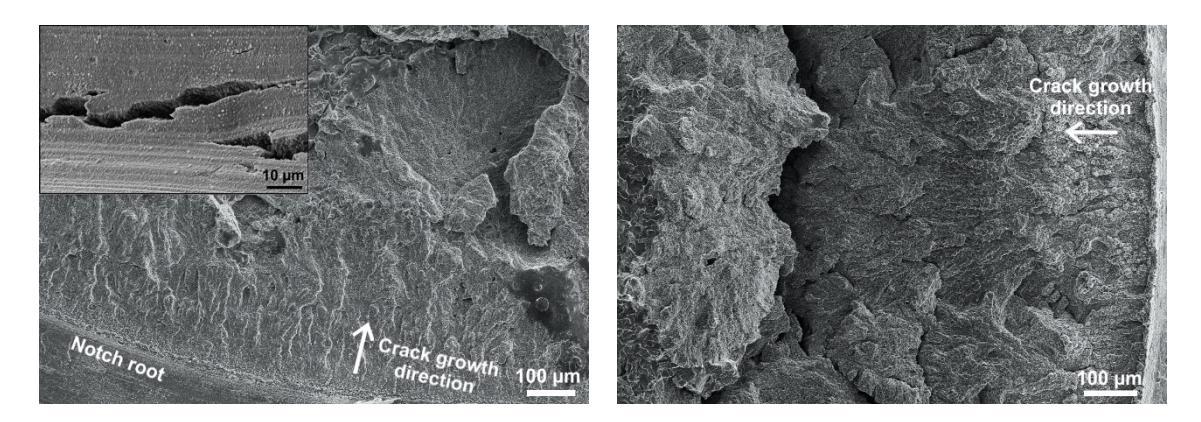
**Figure 7.** SEM secondary electron micrographs of crack flanks (specimen opened after the experiment) of the specimen from a test with addition of 5 ppb chloride (**left**) and with addition of 3 ppb chloride (**right**). Typical transgranular SICC with "fan-shaped" features and crack branching can be observed (surface covered with oxide film).

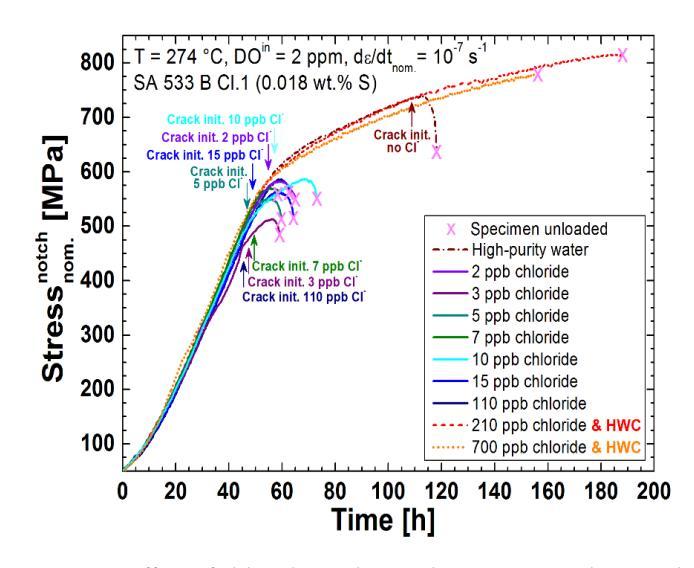
**Figure 8.** Effect of chloride on the crack initiation under simulated BWR conditions; EAC initiation was delayed in high-purity water or in reducing HWC environment.

The stress curves and crack initiation times of the most relevant tests are plotted in Figure 8 and all the results are summarised in Table 5 and Figure 9. In the chloridecontaining (2 to 110 ppb) BWR/NWC environment, EAC initiation occurred around the onset of plastic yielding and at much smaller nominal strains than in high-purity water. The initiation strains were similar for 2 to 15 ppb of chloride and only slightly higher than for 110 ppb chloride. To double check this behaviour, two further tests in high-purity water were performed, which confirmed the clearly higher initiation strain under these conditions. In the reducing HWC environment with 210 ppb or even 700 ppb of continuous chloride addition, on the other hand, no EAC was detected by EN up to very high strains (the tests were finished after 188 and 156 h, respectively). These results clearly show the tremendous effect of extremely small amounts of chloride on the EAC initiation process in LAS in a highly oxidising BWR/NWC environment. Due to the fact that it is very difficult to perform well-controlled experiments with less than 2 ppb chloride concentration, it is difficult to define a more precise critical chloride threshold value. More tests with  $\geq$ 700 ppb chloride in hydrogenated high-temperature water at low ECPs are needed to quantify the higher chloride tolerance in BWR/HWC environment.

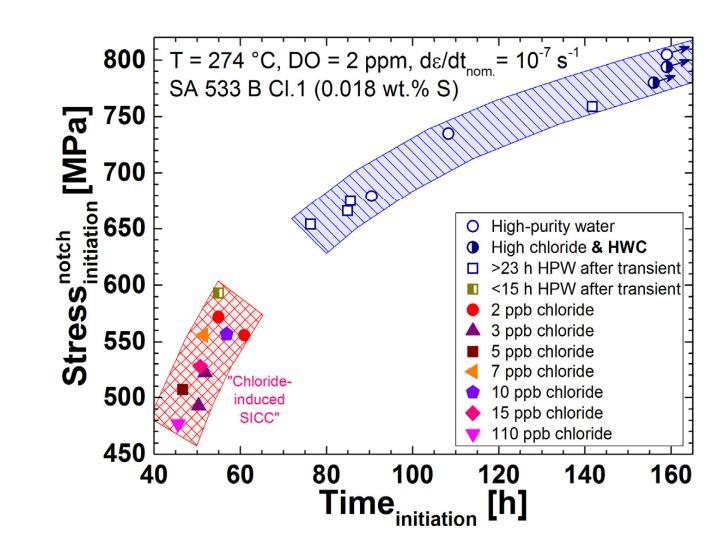
**Figure 9.** Summary of all CERT test results (points with arrows indicate that no clear signs of EAC initiation could be detected before the test was finished).

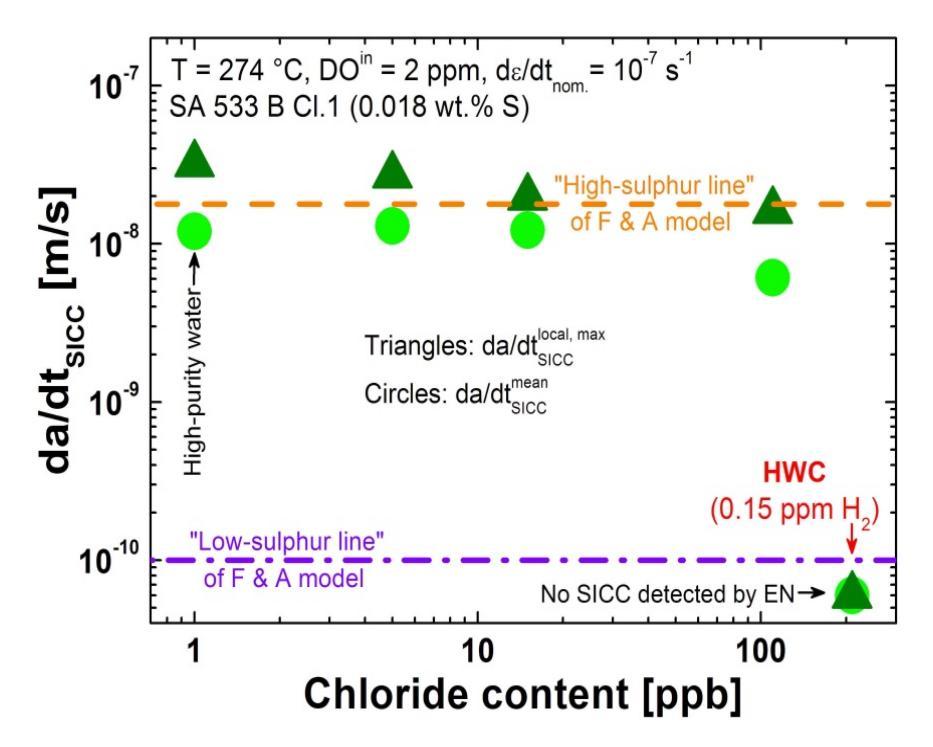
**Figure 10.** No effect of chloride on the subsequent SICC crack growth rate under simulated BWR conditions; the crack growth rates are in the range of the "high-sulphur line" of the Ford and Andresen crack growth model [5].

In contrast, the chloride had very little effect on the subsequent SICC crack growth rates under the slow straining loading conditions (Figure 10), which were all in the range of the "high-sulphur line" growth rates predicted by the Ford and Andresen model [5]. All these results are consistent with previous observations of slow-rising load experiments with pre-cracked compact tension specimens [10].

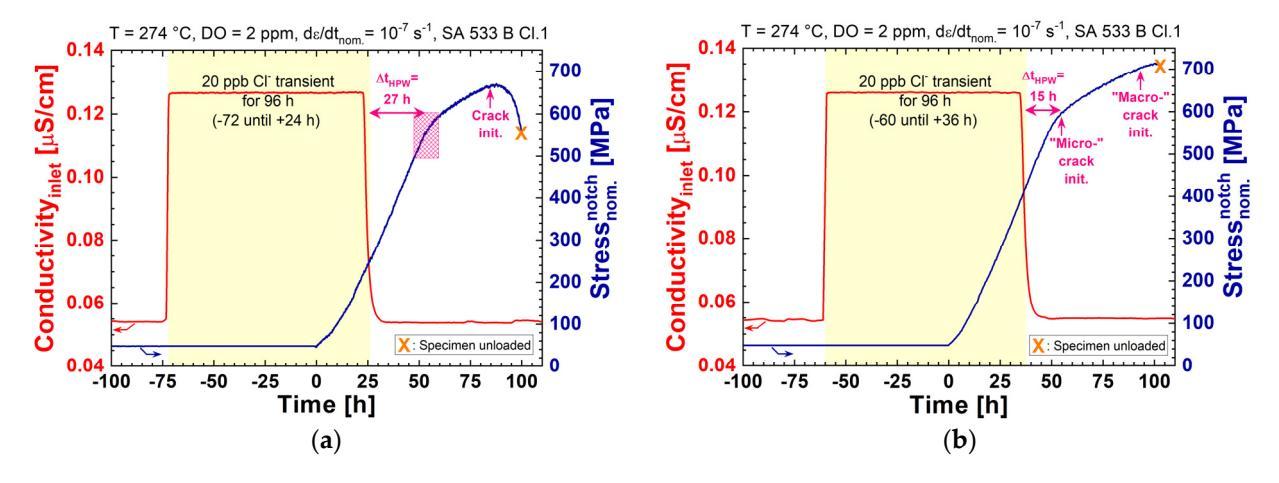
**Figure 11.** Effect of short-term chloride transients on the crack initiation under simulated BWR/NWC conditions. Crack initiation was delayed in test number 3 (**a**); during test number 5, first signs of crack initiation (="micro-" crack initiation) were detected in the EPN signal 15 h after returning to high-purity water (**b**).

The effect of temporary chloride transients on the crack initiation was investigated by five CERT tests. A 96 h-lasting 20 ppb chloride transient was applied either 120, 96, 72, 68, or 60 h before the loading phase started (see Table 4 and Figure 3), which means that the high-temperature water was chloride free 75, 51, 27, 23, or 15 h before reaching the load level where usually chloride-induced SICC was observed during the tests with continuous addition of chloride (see previous section). The specimens in the first four experiments (tests number 1 to 4 in Tables 4 and 6,  $\Delta t_{HPW} \ge 23$  h) showed no major influence of the temporary chloride transient, and behaved comparable to experiments in high-purity water. An example is shown in Figure 11a. In Figure 9, all crack initiation results are compared with the results of the CERT tests with continuous chloride addition. Only in the last experiment (test number 5 in Tables 4 and 6), "early" crack initiation was observed 15 h after returning to high-purity water (see Figures 9 and 11). According to these observations, it seems that, for the used LAS, the minimum time needed for a full recovery from a 96 h-long 20 ppb chloride transient is in the range of 16 to 23 h. With more severe chloride transients and existing cracks/flaws, the recovery time can be much longer and, therefore, the memory effects of the chloride cannot be excluded. Even though the material (high sulphur content) and loading parameters (continuous straining of the specimen) were chosen to be rather aggressive and, therefore, conservative, more tests with different LASs and different transients are needed to determine the possible memory effects of the chloride or a more precise minimum recovery time.

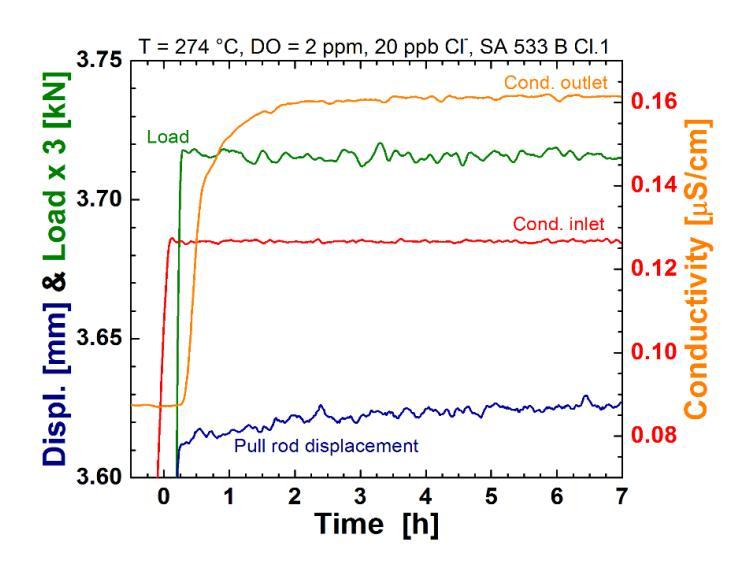
**Figure 12.** Detail of the initial loading of the specimen during the second constant load test showing the course of the load, pull rod displacement, and inlet/outlet water conductivity.

Finally, the influence of chloride impurities on the crack initiation under constant load was studied by two long-term experiments with the notched round bar tensile specimens. A nominal stress level of 540 MP, at the notch root (130% of YS), was chosen for the tests in order to be in the region where chloride-induced SICC initiation occurred in the CERT tests described before. To avoid crack initiation during the rising load phase, 20 ppb of chloride was added shortly after the final stress level was reached. After almost 1000 h, no cracks were detected by the EN technique and, also, careful fractographical examinations of the specimens, after the test by SEM, did not reveal any cracks. In the second test, the chloride was added slightly earlier when the significant low-temperature creep and, thus, moderate straining of the specimen surface was still present (see Figure 12); also here, no crack initiation occurred during the 10.4 weeks of constant load. Rather severe mechanical transients seem to be necessary to trigger chloride-induced crack initiation from surfaces without pre-existing cracks/flaws.

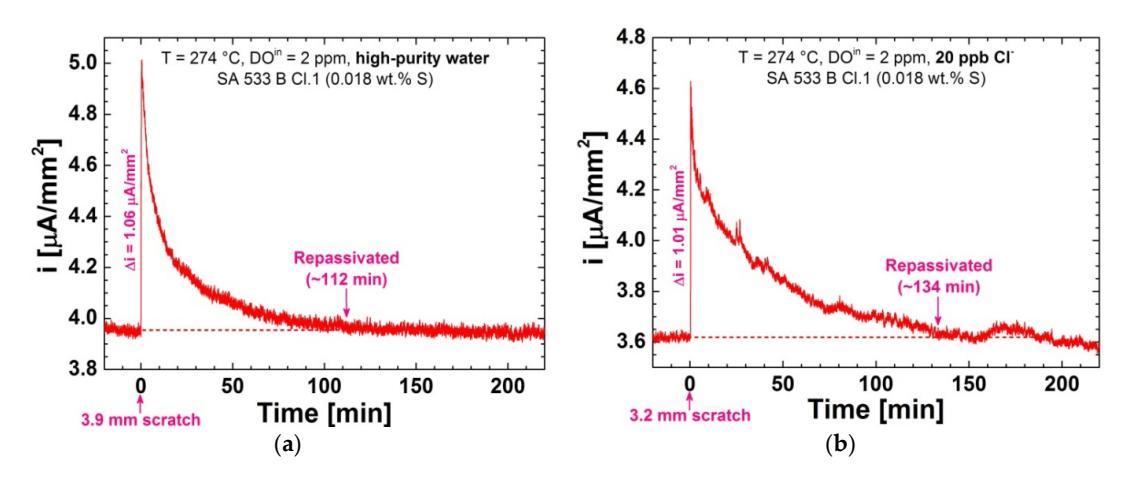
**Figure 13.** Examples of current (density) transients measured during scratching of a LAS specimen in high-purity (**a**) and 20 ppb chloride-containing (**b**) oxygenated high-temperature water.

To obtain at least some insights into the impact of chloride on the repassivation behaviour, a series of scratching tests with current measurements under simulated BWR/NWC conditions with and without chloride addition were performed. In Figure 13, examples of current transients, caused by removing the oxide film along a scratch, are shown for a chloride-free and 20 ppb chloride-containing oxygenated high-temperature water environment. In the case of chloride, the current needed more time to reach the baseline current and, therefore, to fully repassivate. Despite a rather large scatter in the repassivation times, a clear trend was revealed after evaluating 33 scratches, with an average repassivation period of 127 min in the case of the chloride-contaminated water vs. 99 min in high-purity water. Therefore, it seems that repassivation is slightly delayed by the chloride anions.
