# Article Developing a Sprayed-Glass Fiber-Reinforced Polymer Retrofitting System for Decommissioned Wooden Utility Poles

Abstract: Wooden utility poles are vulnerable to degradation and decay, which requires maintenance or replacement. The strengthening and retrofitting techniques for wooden poles are either prone to corrosion or encountering installation difficulties. However, the use of sprayed fiber-reinforced polymer (FRP) composites seems to be a viable solution as it has proven its efficiency and applicability for reinforced concrete members and connections. This study includes a comprehensive experimental program where the mechanical properties of the sprayed-glass FRP (GFRP) composite was evaluated in terms of tensile, compressive and shear strength, in addition to its bond strength to wood and confinement efficiency. Afterwards, the results of the material testing phase were implemented on full-scale old utility poles to evaluate their structural performance with varying composite thicknesses and sprayed zone lengths. The behavior of the retrofitted poles reflected remarkable effectiveness for the sprayed-GFRP composite and highlighted the need for a design model for the

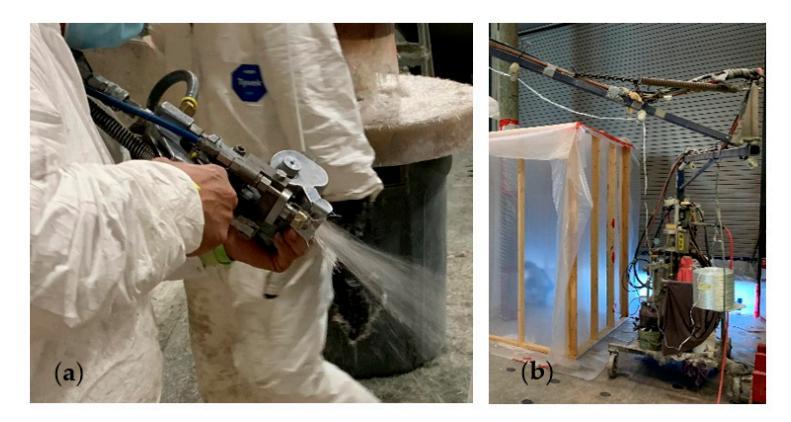
Figure 1. The spraying system: (a) spray gun, and (b) spray machine.

Glass fibers and unsaturated polyester resin, with percentages of 65 and 35%, respectively, comprised the GFRP composite utilized in this study. The mixing proportions of the sprayed composite were controlled through the settings of the spray gun, shown in Figure 1a, which has a fiber chopper that chopped the glass fibers to an approximate length of 15 mm. A mechanical arm is used to direct the spray gun, to which a pump is used to convey the resin from the resin tank shown in Figure 1b.

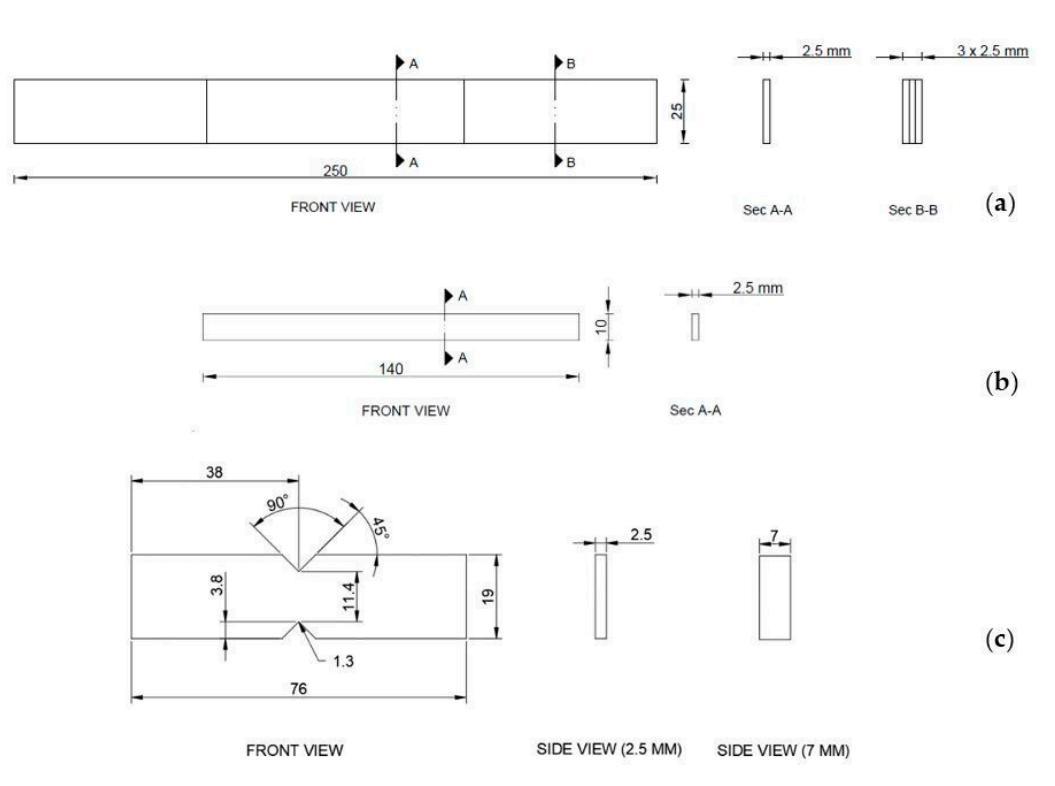
**Figure 2.** Details of the coupon specimens: (**a**) tension coupons, (**b**) compression coupons, and (**c**) shear coupons. (reproduced from ASTM D3039-17, ASTM D3410-16, and ASTM D5379-19 [33–35]– all dimension in mm).

Six sets of coupon specimens, with at least five coupons each, were prepared for the tensile [33], compressive [34] and shear strength [35] tests. Figure 2 shows the dimensions of the coupon specimen. The GFRP composite was sprayed on a relatively large surface inside a pre-set formwork to ensure the required thickness of the coupons is achieved. Then, the composite was left to cure. After curing, the coupons were cut out of the obtained composite sheet to the required sizes as shown in Figure 3.

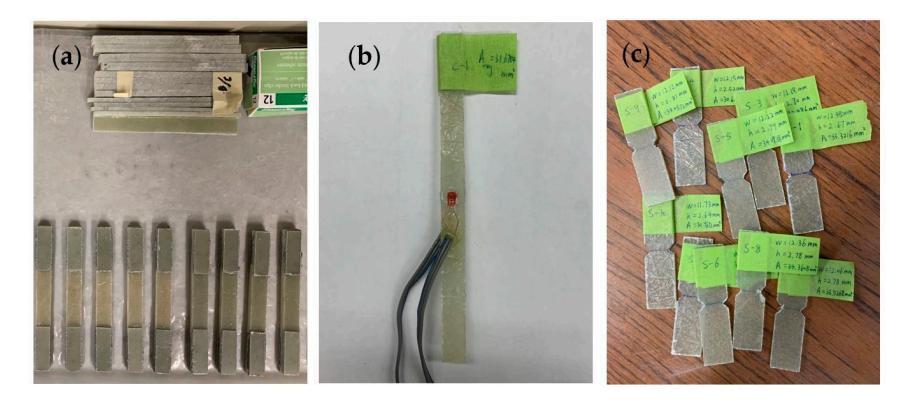
Figure 3. Coupon specimens: (a) tension coupons, (b) compression coupons, and (c) shear coupons.

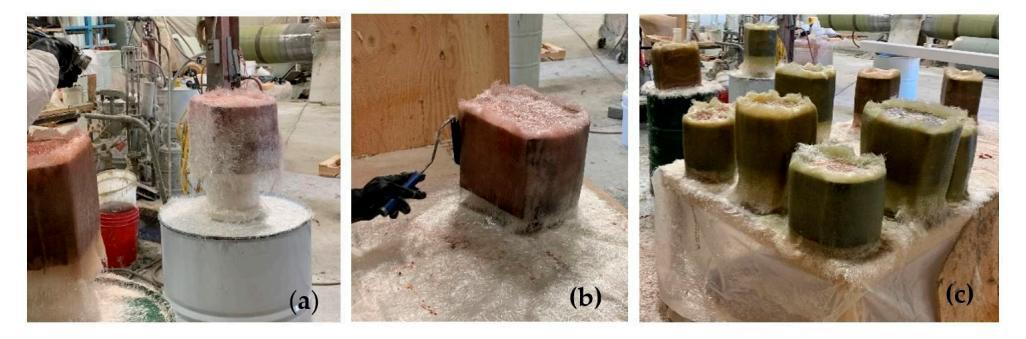
**Figure 4.** Spraying process for pull-off samples: (**a**) spraying the composites, (**b**) rolling the sprayed composites, and (**c**) sprayed composites curing.

The GFRP coating was sprayed on all the sides of the wood samples. Prior to that, a thin layer of resin was sprayed to enhance the bonding performance between the sprayed-composite and wood. Throughout the process, small hand rollers were used to maintain a uniform thickness for the sprayed composite and force the entrapped air out. In addition, rolling helped fill the small holes and cracks on the outer surface of the timber with the composite. Spraying and rolling were successively repeated until the required thickness was reached, which was checked against marked pins. Figure 4 shows the spraying process for the wood samples.

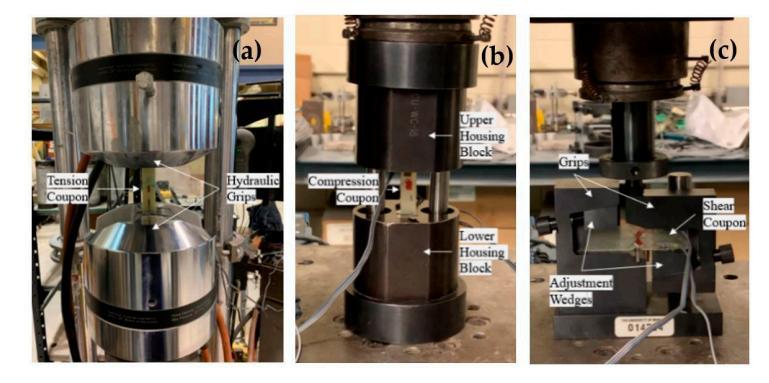
Figure 5. Test setups for coupon specimens: (a) tension, (b) compression, and (c) shear coupons.

The tests on the sprayed-GFRP tension, compressive and shear coupons were conducted as per ASTM D3039-17, ASTM D3410-16 2016, and ASTM D5379-19 2019 [33–35], respectively. A 100-kN capacity testing machine was used to conduct the tests, where a different fixture was used for each test, as appropriate (Figure 5). Since no standard is available to evaluate the bond strength for wood rehabilitation systems, pull-off tests in accordance with ASTM D7522-21 [36] for FRP laminates bonded to concrete or masonry were conducted (Figure 6). Therefore, it is recommended to evaluate this test method as an approved means to evaluate the bond strength of sprayed FRP composites on wooden members. On the other hand, the bond strength of the composites should be reassessed in case a new standard test method is introduced in the future.

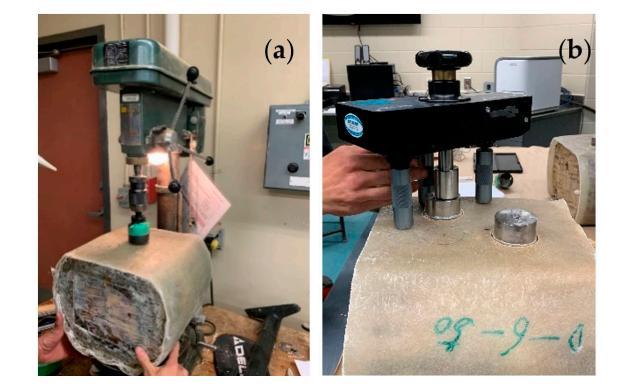
Figure 6. Pull-off tests: (a) preparation of test spots, and (b) test setup.

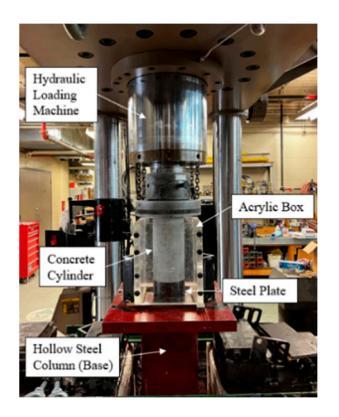
Figure 7. Confinement test setup.

For the confinement tests, each concrete cylinder was placed on top of a rigid steel base. A 5000-kN capacity hydraulic testing machine was utilized to apply the axial compressive loading on the concrete cylinders (Figure 7) as per ASTM C39-20 [37]. Multiple electrical

strain gauges were installed transversally on the surface of the composite to record the real-time hoop strains of the GFRP composite as the test proceeded. It should be noted that the conducted confinement tests involved uniform axial compression resulting in more uniform confinement, while utility poles are commonly subjected to flexure, resulting in compressive stress on a portion of the cross-section.

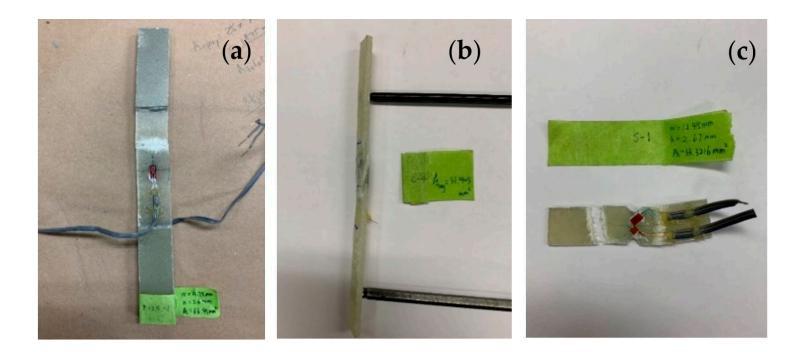
Figure 8. Examples of failure modes for: (a) tension, (b) compression, and (c) shear coupons.

As evident from Table 3, the ultimate tensile strength of the sprayed-GFRP coupons increased by only 8% when the coupon thickness increased by 180% (i.e., from 2.5 to 6 mm). Further increase of the coupon thickness from 6 mm to 10 mm (i.e., 40% increase) resulted in an increase of 15% for the tensile strength, which indicates a non-linear increase of the ultimate tensile strength of the sprayed-GFRP composite as its thickness increases. For the tensile chord elastic modulus, an increase was observed only when the composite thickness increased beyond 6 mm. The failure modes for the tensile coupons were mostly sudden and violent. Some examples of failed tensile coupons are shown in Figure 8a.

which was experimentally found to be about 50% the tensile strength [38,39], the results observed herein are highly promising for the sprayed GFRP composite. As shown in Figure 8b, all compressive coupons failed through the thickness near the instrumented region.

A significant increase (i.e., 58%) was observed for the ultimate shear strength as the coupon thickness increased from 2.5 mm to 6 mm (Table 5). As shown in Figure 8c, rupture of most coupons with the 2.5 mm thickness occurred away from the notched zone, which reflects an undesirable mode of failure. Poor fiber distribution of such small thickness as 2.5 mm could be the reason for this mode of failure. Such observations provide experimental evidence, from the material perspective, on the minimum sprayed composite thickness of 3–4 mm used by previous researchers [25,28,40,41]. Based on that, it was decided to use a minimum composite thickness of 4 mm, for the remainder of Phase I in addition to Phase II of this project to guarantee satisfactory fiber distribution within the sprayed-GFRP layer.

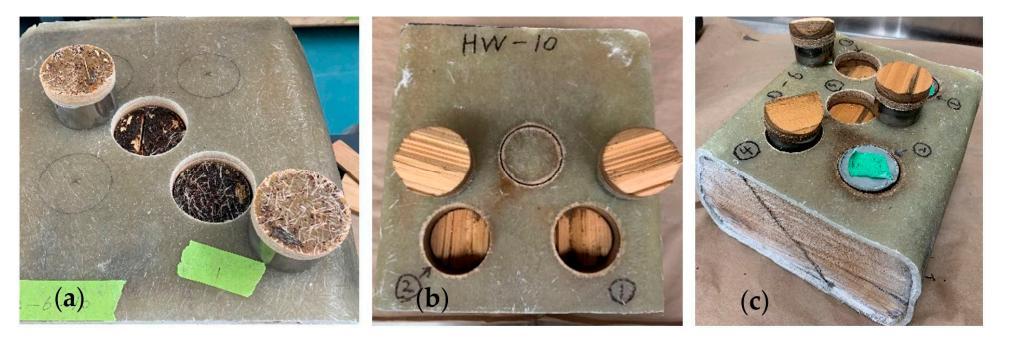
**Figure 9.** Examples of failure modes for: (a) PRF-primed, (b) n-HMR-primed, and (c) directly sprayed specimens.

For the sprayed samples pre-primed with n-HMR, a higher bond strength was also observed for the wetted wood specimens compared to that of the dry samples when sprayed with an 8- and 10 mm thick composite. While similar bond strengths can be noticed for PRF and n-HMR-primed specimens, the failure of the latter occurred through wood (Figure 9b), which proved the feasibility of using n-HMR as an adhesive for wooden poles prior to retrofitting with the sprayed-GFRP composite.

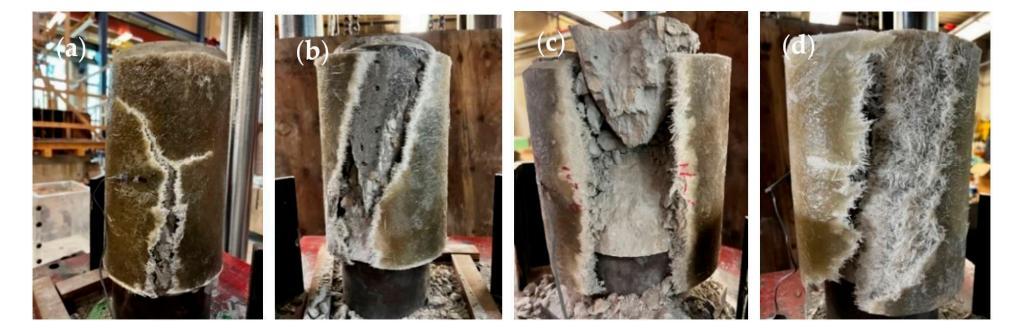
**Figure 10.** Examples of failure modes for retrofitted concrete cylinders: (**a**) N-4, (**b**) H-4, (**c**) N-6, and (**d**) H-10.

The test results of NSC and HSC cylinders are listed in Tables 6 and 7, respectively, where it can be observed that the improvements resulting from the utilized retrofitting technique were more pronounced for NSC cylinders. For instance, using a 4 mm thick layer of sprayed-GFRP resulted in increased compressive strength by approximately 37 and 13% for the NSC and HSC retrofitted cylinders, respectively, compared to the control set. In addition, further increase of the thickness of sprayed composite (i.e., 6, 8, 10 mm) resulted in higher compressive strength with the ranges of about 263–318% and 87–90% for NSC and HSC sprayed cylinders, respectively, over that of the control set. These results proved the efficiency of the confinement provided by the sprayed composite, which needs to be further verified through testing full-scale wooden poles sprayed with the proposed retrofitting system. The failure mode of the sprayed concrete cylinders incorporated rupture of the sprayed-GFRP layer in the hoop direction accompanied by concrete crushing. Examples of failed retrofitted cylinders are shown in Figure 10.

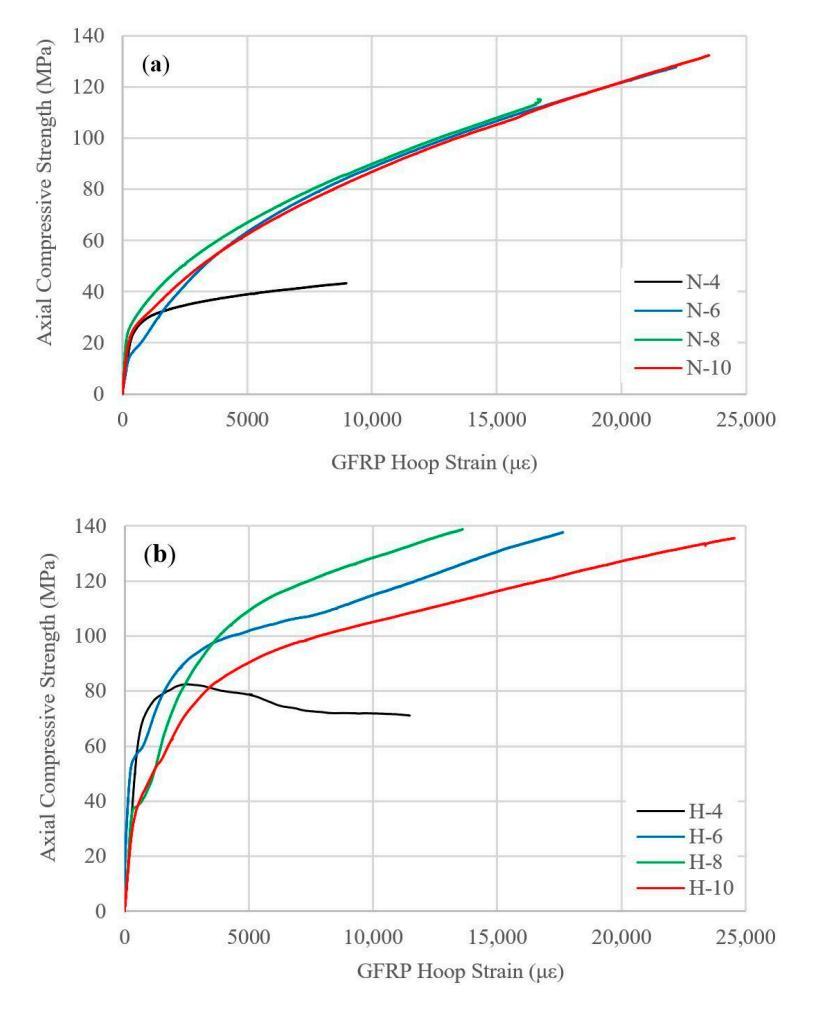
Figure 11. Stress-strain relationships for retrofitted concrete cylinders: (a) NSC, and (b) HSC.

The relationships of the axial stress versus the hoop strain of the sprayed composite for the retrofitted NSC and HSC cylinders are depicted by Figures 11a and 11b, respectively. It can be observed that the slope of the axial stress-hoop strain relationship exhibited a significant decrease following an axial stress value equal to the axial strength of the unconfined (i.e., control) cylinders, which can be attributed to triggering the confining effect of the sprayed-GFRP layer. The remainder of the axial stress-hoop strain relationships were mostly linear up to failure, which can be attributed to the elastic behavior of the GFRP composite. In addition, a substantial increase can be observed for the final ascending branches as the thickness of the sprayed composite increased from 4 to 6 mm, whereas insignificant changes were observed as the composite thickness increased beyond 6 mm. The inconsistencies that can be noticed in Figure 11a,b between the maximum hoop strain and the composite thickness can be justified by the fact that sometimes the rupture of the GFRP layer occurred away from the locations of the strain gauges, which might have made it more difficult to catch the actual strains experienced by the composite at such locations. It should be noted that these results indicate the efficiency of the confinement provided by the sprayed-GFRP composite, yet the actual confinement efficiency, within the context of retrofitting wooden utility poles, should be determined through a comprehensive experimental program, where an appropriate standard specimen is determined to represent the wooden poles.

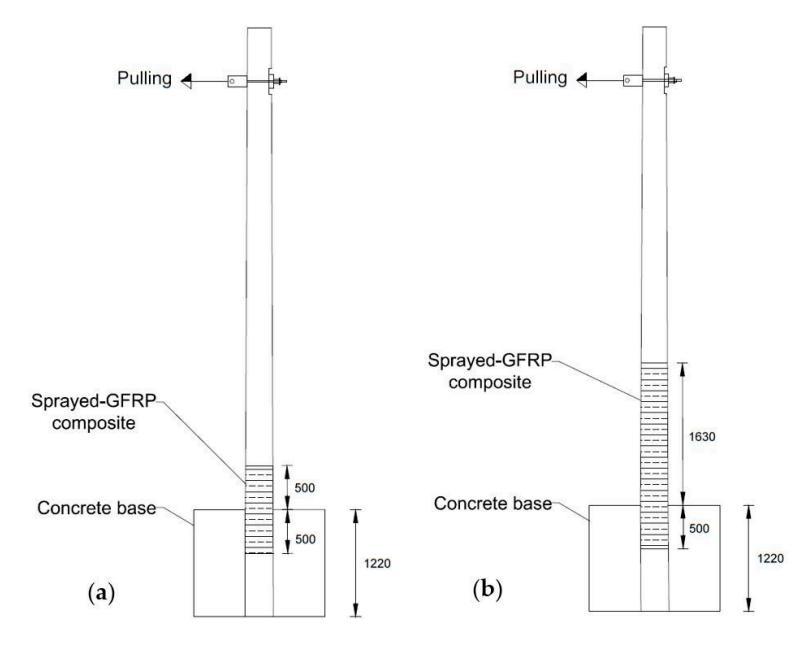
Figure 12. Details of retrofitted poles: (a) specimens LP4-6-1000 and LP4-8-1000, and (b) specimens LP3-4-2000 and LP3-6-2000.

It should be noted that the lower end of the sprayed region was about 500 mm below the ground line for all tested poles to avoid failure at the groundline section [24]. In practice, this can be accomplished by removing the soil around the pole to allow access to the spraying device. Consequently, the sprayed-GFRP composite is extended approximately 500 and 1500 mm above the groundline section for the poles, retrofitted using 1000- (i.e., LP4-6-1000 and LP4-8-1000) and 2000 mm (i.e., LP3-4-2000 and LP3-6-2000) sprayed layers, respectively, as depicted in Figure 12.

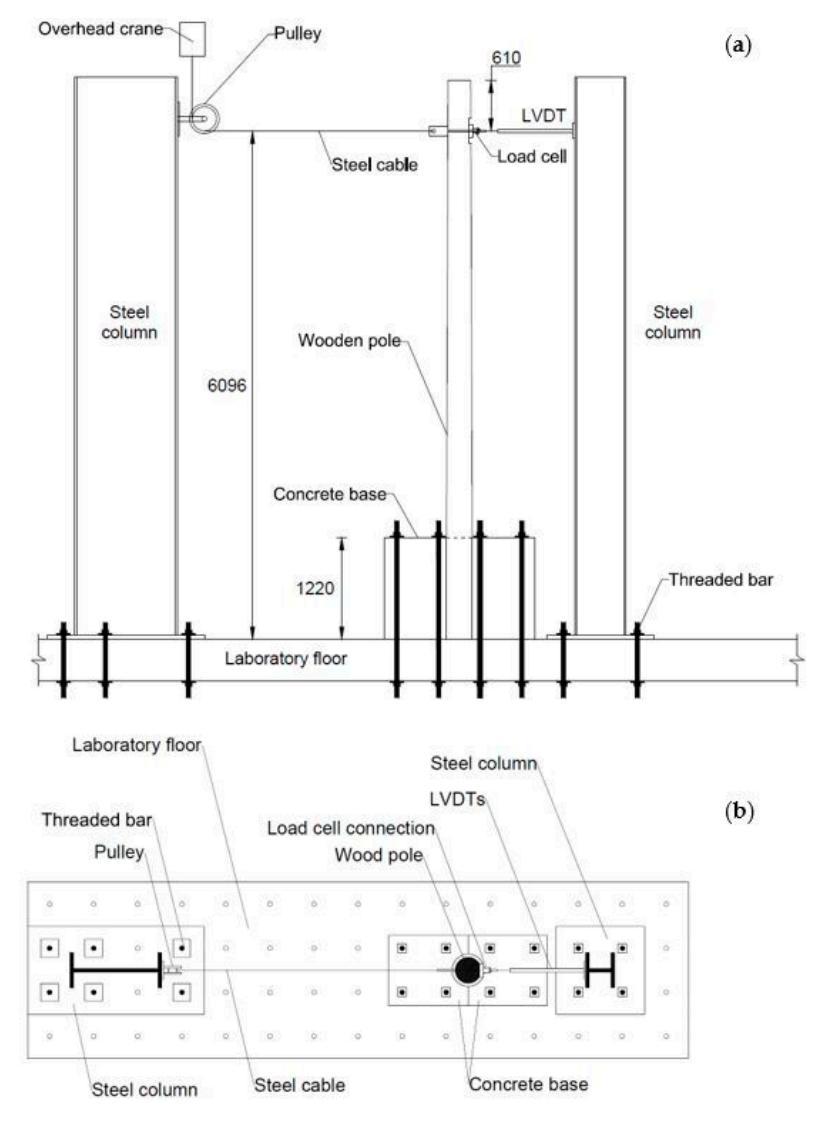
Figure 13. Test setup: (a) elevation view, and (b) plan view.

The cantilever test method, as per ASTM D1036–99 [30], was utilized to test all pole specimens in an upright position. The lateral load application device and a compression load cell were attached to the pole about 610 mm (2.0 ft) below the tip of the pole. A steel

cable was connected to the loading assembly from one end and passed through a set of pulleys to a 10-tonne capacity overhead crane on its other end, as shown in Figure 13, to transfer the lateral loading from the crane to the loading assembly attached to the pole. A 1.22 m (4.0-ft) high RC base, anchored to the laboratory floor, was used to simulate the confining effect of the soil in practice, where the top surface of the base represented the ground line. The RC base had a cylindrical void to house the wooden pole, where the gap between the pole and the inner face of the cylindrical void was filled with non-shrink grout for the bottom half of the height of the RC base, while the rest of that gap was filled with fine sand. The grout was used to compensate for the shorter embedment depth of the pole within the RC block (i.e., 1.22 m) compared to the actual depth in practice (i.e., 1.83 m) while avoiding significant rotation or uplift of the pole while testing. On the other hand, the fine sand was utilized to avoid excessive fixity of the pole and to simulate the effect of the soil around the pole in real life. Furthermore, a horizontally aligned linear variable displacement transducer (LVDT) was installed at the lateral loading point to plot the deflection of the wood pole against lateral loading. Despite the utilized approximations made to simulate the actual case of utility poles in practice while conforming to the lab constraints, the visual and experimental data of the tests indicated a proper response to the applied loading condition.

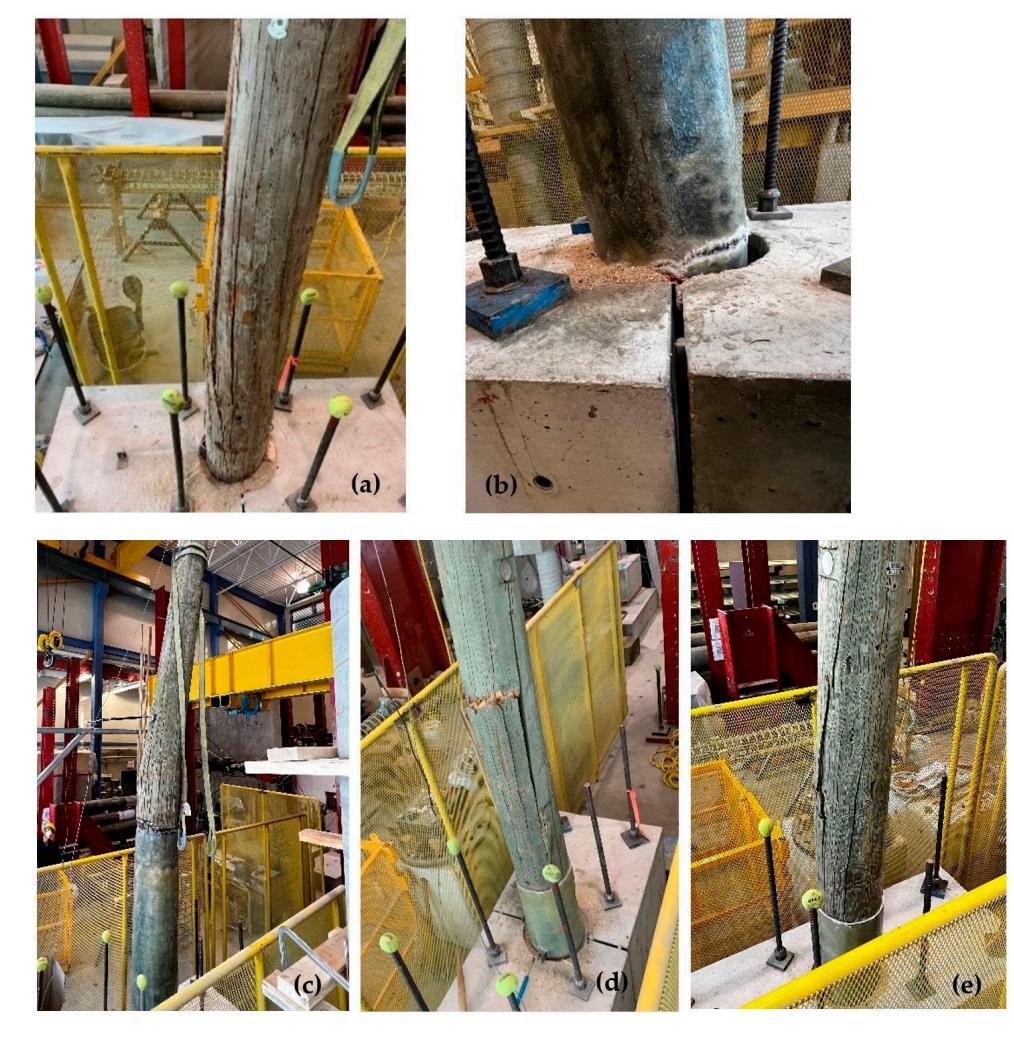
Figure 14. Failure modes of tested poles: (a) DF3-X-X, (b) LP3-4-2000, (c) LP3-6-2000, (d) LP4-6-1000, and (e) LP4-8-1000.

The failure of the control pole DF3-X-X was progressive where section by section was failing in tension, until the pole finally failed as shown in Figure 14a. In addition, all retrofitted poles, except for LP3-4-2000, exhibited a sudden tension failure of the wooden pole, which was located above the sprayed region for specimens LP4-6-1000, LP4-8-1000, and LP3-6-2000, as shown in Figure 14c–e, whereas no delamination or rupture was observed for the sprayed-GFRP layer. Similar observations were reported by Saafi and Asa [24] for some of their FRP-wrapped wooden poles. On the other hand, the retrofitted pole, LP3-4-2000, was the only pole to fail by rupture of the GFRP layer in the longitudinal direction at the ground line (Figure 14b). The failure manifestations exhibited by the other retrofitted poles, when compared to that of LP3-4-2000, indicate an excessively rigid sprayed region, accompanied by stress concentrations at the top of the sprayed zone, resulting in the poles failing right above the sprayed regions.

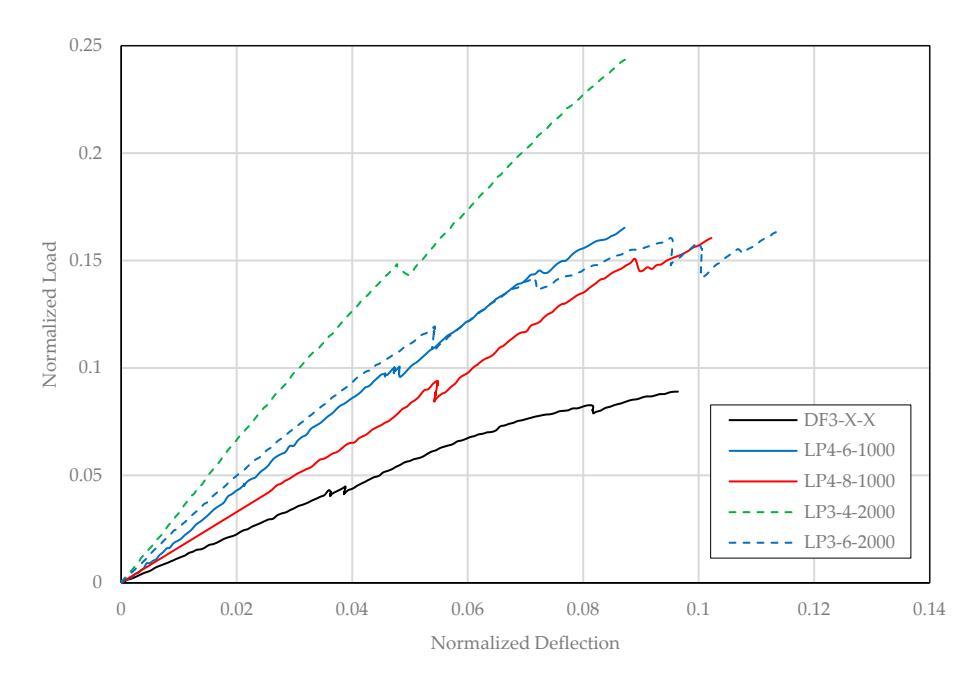
Figure 15. Normalized load-deflection response for the tested poles.

where  $\delta$  is the normalized deflection, p is the normalized load of the pole,  $\Delta$  is the deflection measured at the loading point of the pole during the test,  $E_w$  is the elastic modulus of the pole obtained from Table E.3 of CSA-O15-15 [3],  $I_w$  is the moment of inertia at the groundline section of the pole assuming uniform moment of inertia along the pole, while  $P_{exp}$ ,  $L_{lab}$ , 1220, and 610 are defined in the same manner as in Equation (1). Figure 15 depicts the normalized load-deflection responses of the tested poles in Phase II.

The normalized load-deflection response proceeded mostly in a linear manner for all tested poles, apart from a few drops near 50 and 90% the ultimate load value, before the pole restored its load resistance. It can be observed that retrofitting with sprayed-GFRP composite enhanced the load carrying capacity and stiffness of the poles. The lower stiffness exhibited by LP4-8-1000 compared to LP4-6-1000 could be attributed to the significant stress concentrations at the top of the sprayed composite layer, as explained earlier, or due to individual differences between the dismissed poles used for those specimens [23]. In addition, the similar normalized load capacity and stiffness noticed for LP4-6-1000 and LP3-6-2000 may align well with the fact that the sprayed composite in both conditions provided sufficient rigidity to the sprayed zone, which caused the failure to occur prematurely above the retrofitted region. On the other hand, the increased stiffness of LP3-4-2000 can be attributed to the rigid composite section formed at the ground line.
