# Proceeding Paper Effect of Matrix Modification on the Post-Impact Flexural Characteristics of Glass Fiber Laminated Composites <sup>†</sup>

Manoj K. Singh \* D and R. Kitey

Department of Aerospace Engineering, Indian Institute of Technology Kanpur, Kanpur 208016, Uttar Pradesh, India; kitey@iitk.ac.in

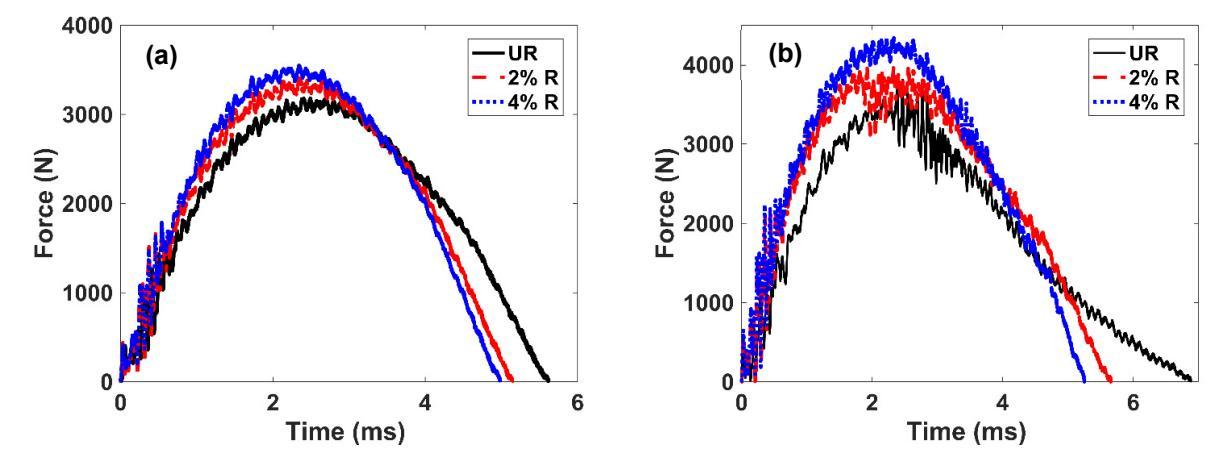
Representative force histories associated with 7.5 J and 12.5 J impact energies are shown in Figure 1a,b, respectively. The bell-shaped curves exhibit higher undulation when rising compared to when they fall. The prominent peaks at the start suggest damage initiation and/or damage propagation in the laminate. The force associated with the first peak is tabulated in Table 1 and was identified as the first failure in the laminate [8]. While the first failure load increased with increasing impact energy, the reinforcement appears to have had no influence on the failure initiation (see Figure 1). The impact force reduced to zero when the impactor rebounded and ceased to be in contact with the laminate. The plots show that the contact duration of the impactor decreased as the reinforcement in the laminate increased. In addition, the maximum force sensed by the laminate increased with increasing reinforcement. The force histories associated with the 12.5 J impact (Figure 1b) exhibit large oscillations around the peak force in the unreinforced and 2% R laminates.

This indicates delamination, with significant damage to the laminate. On the contrary, a relatively smoother transition from the ascending to the descending part of the curve suggests a higher resistance to damage in the case of the 4% R laminates.

Figure 1. Force time histories at (a) the 7.5 J loading and (b) the 12.5 J loading.

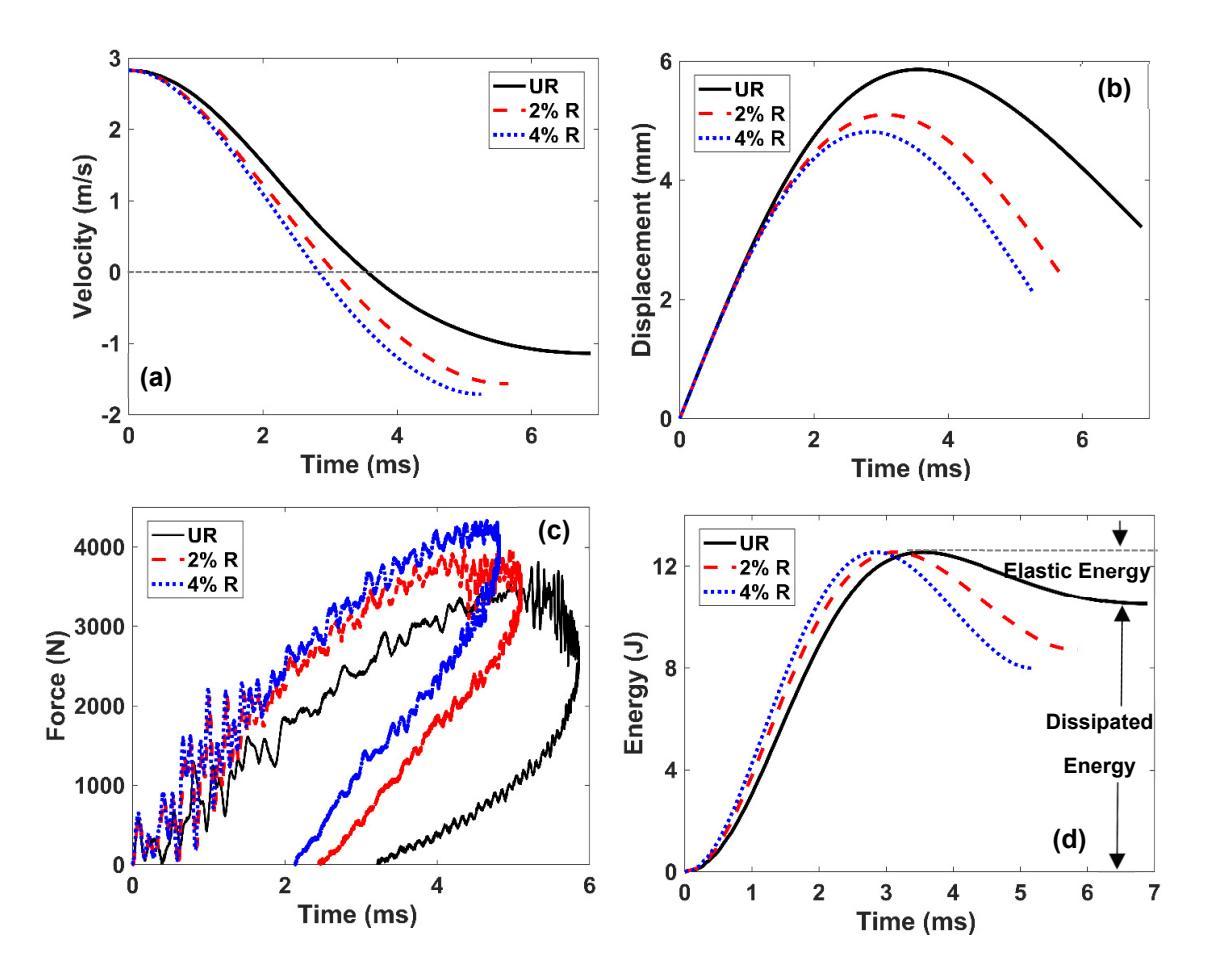
The velocity and displacement histories, determined by means of Equations (1) and (2), are shown in Figure 2a,b, respectively. The plots are associated with the 12.5 J impact energy. While the velocity at t = 0 represents initial impact velocity, the time instant associated with zero velocity corresponds to when the impactor begins to rebound. The velocity plots show that the rebound velocity consistently increased as the reinforcement in the laminate increased, which indicates an increasing elastic energy component during the impact events. The displacement histories (Figure 2b) exhibit skewed bell-shaped curves with increasing maximum displacement as the filler content in the laminate decreased. The force vs. displacement plots are illustrated in Figure 2c. The areas enclosed within the loading-unloading curves represent energy dissipated during impact. The plots show that the maximum force increased with increasing filler content, whereas the maximum displacement decreased with increasing filler volume fraction. The permanent displacement associated with zero force during unloading decreased with increasing filler content, which suggests an increase in the damage resistance of the laminates. The energy dissipated during impact, calculated by means of numerical integration, is reported in Table 1. While dissipated energy increased with increasing impact energy (Singh and Kitey [15]), it decreased with increase in the chopped fiber volume fractions.

**Figure 2.** Various impact performance parameter curves at 12.5 J impact: (**a**) force–displacement; (**b**) velocity–time; (**c**) displacement–time; (**d**) energy–time.

The energy absorbed by the laminates is plotted against time in Figure 2d. After attaining the maximum value, the curves monotonically decrease until a plateau value is attained. The plateau value signifies the energy dissipated in the failure process. The elastic energy stored in the laminate system was determined by the difference between the maximum energy and the dissipated energy (with an assumption of other frictional dissipation being negligible). For the 7.5 J impact, only a marginal increase in elastic energy was noted with increasing chopped fiber content. On the other hand, for the 12.5 J impact, the elastic energy stored in the laminates increased by 23% and 66% in the 2% R laminates and 4% R laminates, respectively.

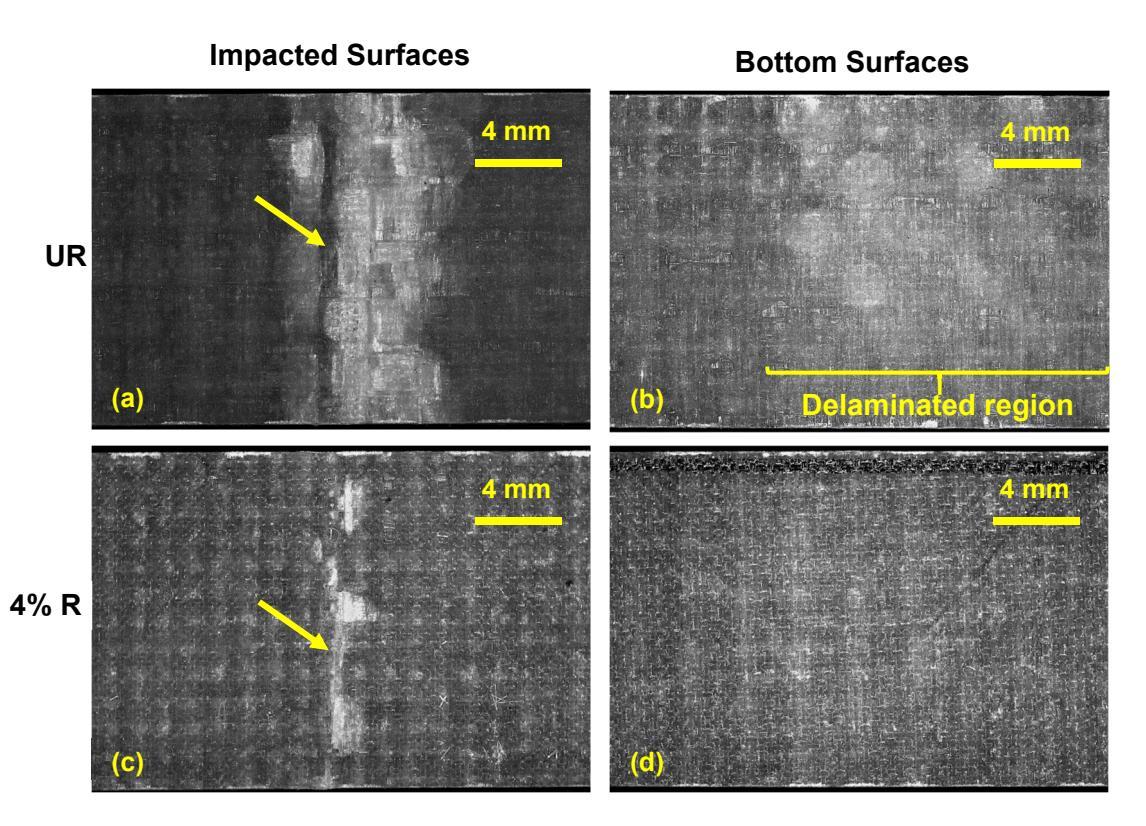
The surfaces of impacted beam samples were imaged using optical microscopy to analyze the extent of damage, as illustrated in Figure 3. The impact locations are marked by arrows. Figure 3a, b show the damage on the impacted surface and on the back surface, respectively, for the 12.5 J impact energy case. The bright area near the impacted site in Figure 3a suggests localized micro-buckling at the top lamina due to compressive stress. On the other hand, the bright area at the back face indicates delamination failure. A relatively smaller damage area was observed for the reinforced laminate at the impacted face as well as at the back face, as depicted in Figure 3c,d, respectively. At lower impact energies, less damage near the impact line, as well as on the back surface, was noticed.

**Figure 3.** Visible impact damage to the impacted and bottom surfaces of (**a**,**b**) the unreinforced specimen and (**c**,**d**) the 4% chopped fiber-reinforced specimen.

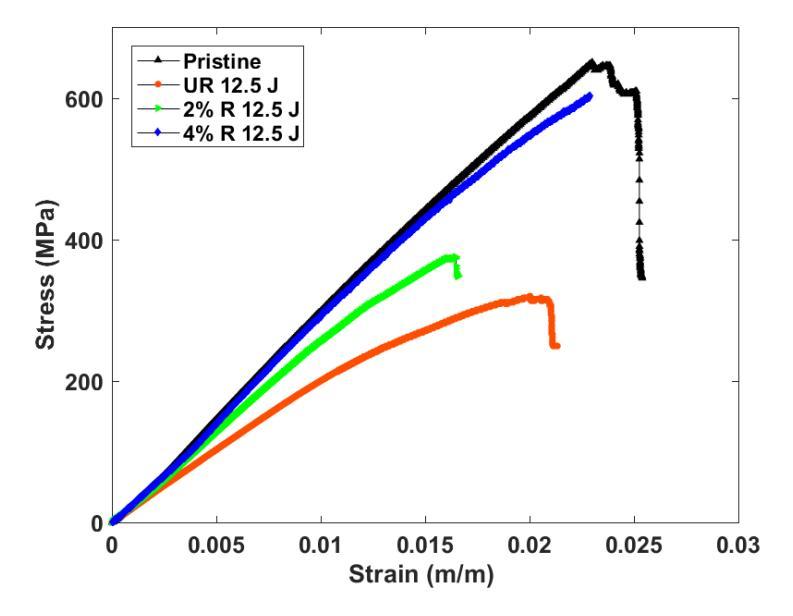
The flexural stress vs. strain curves associated with the specimens impacted with 12.5 J energy are shown in Figure 4. For comparison, the plot associated with the pristine UR specimen is also included in the figure. Flexural moduli and strengths were calculated for all the samples and they are tabulated in Table 1. In the case of the pristine samples, only a marginal increase in flexural strength was noted when the filler content was increased, whereas the associated flexural modulus remained nearly the same. The plots show that post-impact flexural modulus and strength decreased with increasing impact energy in all the laminates. Figure 4 and Table 1 suggest higher residual flexural moduli and strengths for the filler reinforced cases. While at 7.5 J impact energy, the increase in the residual properties was only marginal, a 32% and 68% rise in flexural modulus and strength, respectively, was observed for the 12.5 J loading case. Interestingly, the laminate prepared with 4% filler reinforcement exhibited nearly the same flexural strength and stiffness values as noted for the pristine UR specimens.

Figure 4. Stress-strain plot of various laminate samples, including an unimpacted neat epoxy sample.
