Article

Can Appropriate Thermal Post-Treatment Make Defect Content in as-Built Electron Beam Additively Manufactured Alloy 718 Irrelevant?

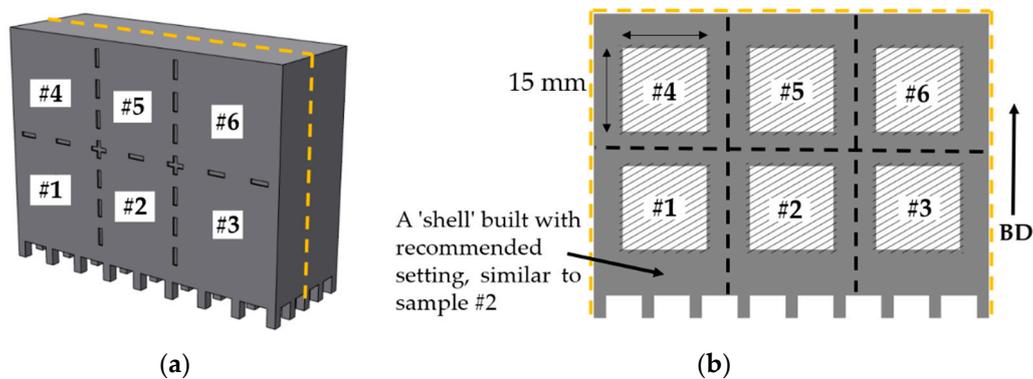
Figure 1. Schematic of the CAD model of one of multiple identical blocks comprising the electron beam melting (EBM) build (a), and cross-section view of the block revealing the cubes (marked by hatched lines) processed with different line spacing (b). The arrow on the right shows the build direction, BD.

Samples were EBM built with different defect contents by varying LS to assess their response to identical post-treatments, particularly HIPing. Plasma atomized Alloy 718 powder (AP&C, Québec, Canada) [5] recycled ~20 times was used. Six different samples (15 × 15 × 15 mm³) (Figure 1), henceforth referred to as AB#1 to AB#6, were built using EBM (Model A2X, Arcam AB, Gothenburg, Sweden) with varying LS corresponding to different processing speeds (expressed as relative melting time and relative melted area per unit time by normalizing with the “standard” values), as summarized in Table 1. All the samples were melted by a snake hatch method during which the electron beam was moved in a back-and-forth raster scan pattern [18]. All the other process parameters were kept constant as per the EBM process theme version 4.2.205, and some of the key process parameters associated with this theme are listed in Table 2. It is worth mentioning that the parameter speed function dynamically adjusts the electron beam scan speed depending on the scan length [22].

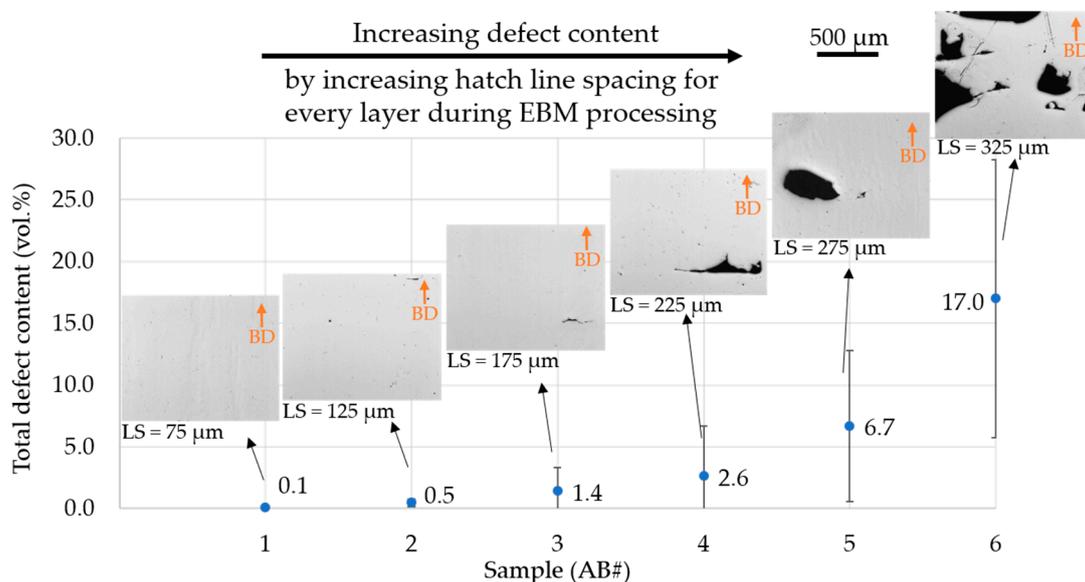
Figure 2. Defect content in as-built samples intentionally built with varied hatch line spacing (LS). The size and amount of defects are visualized in the insets. Arrows in the inset indicate build direction.

The as-built microstructures of samples processed with varying LS corresponding to different melting speeds (Table 1) are depicted in Figure 2. Increase in LS above the “recommended” value resulted in a rise in the defect content, as shown in Figure 2. The defect contents stated represent the sum of all types of defects observed in the as-built samples, i.e., gas and shrinkage porosity, and lack of fusion. Incidentally, these defects were also present in samples produced at the recommended LS = 125 μ m (AB#2) as well as at lower LS = 75 μ m (AB#1). Samples intentionally produced with higher LS exhibited defect contents up to 17%, as shown in Figure 2 and also visualized in accompanying micrographs. In a word, a systematic increase in line offset (processing speed) from 75 to 325 μ m resulted in an increased defect content ranging from 0.1% to 17% in the investigated samples. It is worth mentioning that large defects such as those observed in samples AB#5 (LS = 275 μ m) and AB#6 (LS = 325 μ m) are not typical of an EBM built even with not fully optimized processing conditions [23]. However, these samples were produced for the present ‘proof of concept’ investigation regarding the extent of defect closure enabled through HIPing.

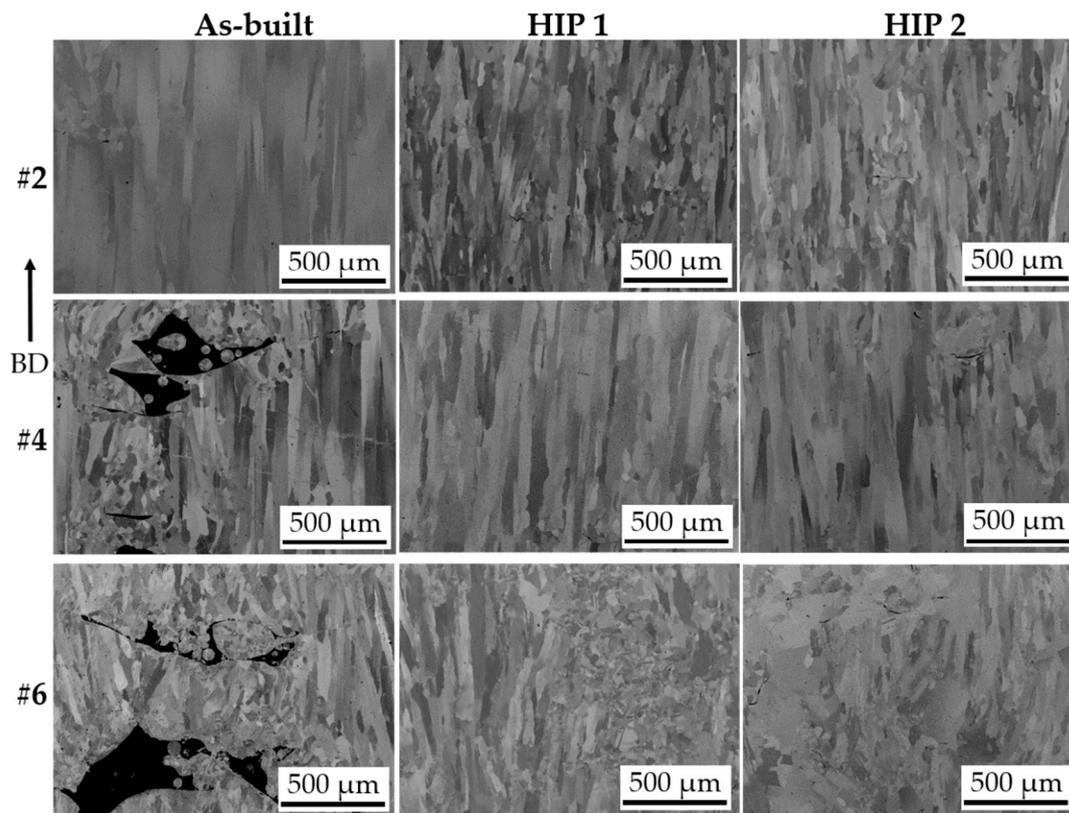
Figure 3. SEM micrographs showing defects in samples #2 (LS = 125 μm), #4 (LS = 225 μm), and #6 (LS = 325 μm) in as-built and HIP'ed conditions. The arrow indicates the build direction.

Samples with distinct defect contents, i.e., AB#2, AB#4, and AB#6 were subjected to two HIPing treatments to investigate the efficacy of defect closure. The defect contents in as-built samples AB#2, AB#4, and AB#6 (corresponding to LS = 125, 225, and 325 μm , respectively) were 0.5%, 2.6%, and 17%, respectively. After both the HIPing treatments, the defect content in all samples was significantly reduced, regardless of the original extent, as summarized in Table 4. Moreover, the difference in the extent of defect closure accomplished at 1120 $^{\circ}\text{C}$ (HIP1) and 1185 $^{\circ}\text{C}$ (HIP2) was not significant. The considerable densification of samples achieved by HIPing is also visualized from the microstructures in Figure 3. Furthermore, the small amount of remnant defects in all HIP'ed samples discussed were found to be typically associated with the presence of Al-rich oxide, which can inhibit complete defect closure. This is clearly evident from the representative EDS results given in Figure 4. It is worth mentioning that Al-rich oxides are thermodynamically very stable and not removed by HIPing, as previously observed in HIP'ed EBM Alloy 718 [24].

Such extensive and efficient reduction in the defect content by orders of magnitude (as evident from Table 4 and Figure 3) *prima facie* provides an opportunity to also potentially increase productivity—at least to some reasonable extent—during EBM processing. It is worth mentioning that the melting step typically comprises ~35% (the exact value depends on the build design [22]) of the layer heating time (preheat + melt + post-heat), which corresponds to 15% of the total layer processing time (also including lowering of build platform + powder raking) spent during the EBM process. Therefore, decreasing the melting time (by increasing the LS, as done in this study) would also have a corresponding effect on the overall EBM processing time.

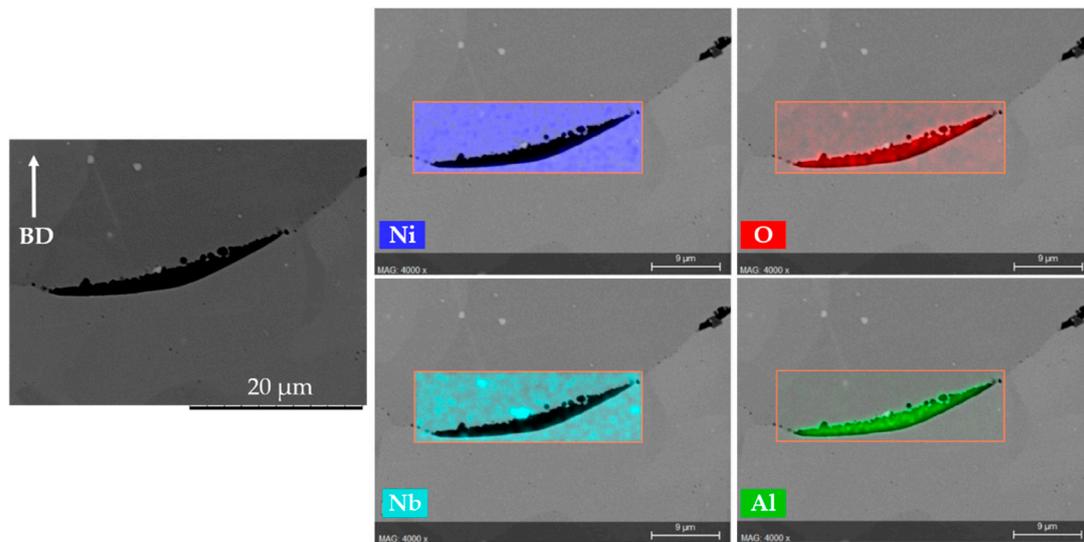
Figure 4. Representative EDS analysis showing inclusions typically associated with many remnant defects in sample #4 (LS = 225 μm) after HIP1. The arrow indicates the build direction.

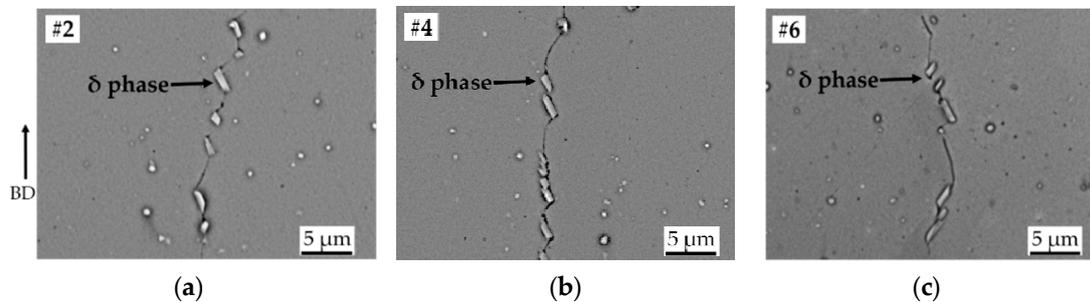
Figure 5. SEM micrographs of HIP1 + STA samples (a) LS = 125 μm , (b) LS = 225 μm , and (c) LS = 325 μm showing similar distribution of the δ phase. The arrow indicates the build direction.

Since the solution treatment was carried out at 954 °C, all the HIP1 + STA samples #2, #4, and #6 (corresponding to LS = 125, 225, and 325 μm , respectively) exhibited a virtually similar distribution of grain boundary δ phase, as shown in Figure 5a–c. This is in accordance with the reported time–temperature–transformation diagram of Alloy 718 [29], and has also been previously

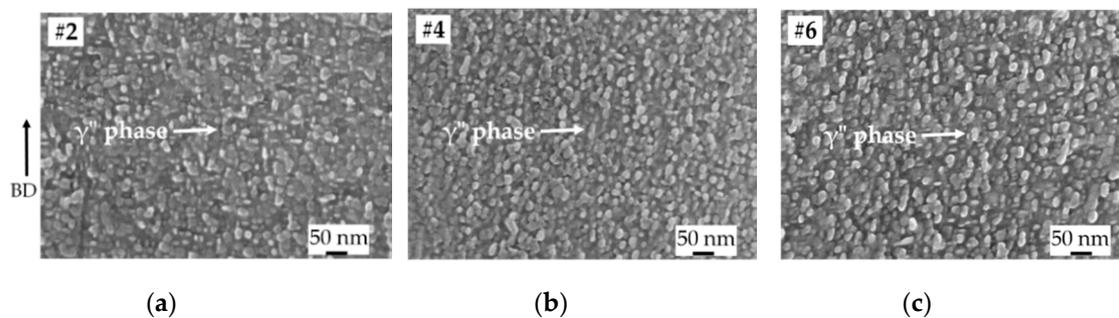
Figure 6. SEM micrographs of HIP1 + STA samples (a) LS = 125 μm , (b) LS = 225 μm , and (c) LS = 325 μm showing similar distribution of the γ'' phase. The arrow indicates the build direction.

observed in solution-treated EBM Alloy 718 that was not subjected to prior HIPing [10]. The effect of aging treatment can be readily seen from the similar distribution of γ'' phase as shown in Figure 6a–c. These microstructural similarities in the three samples (HIP1 + STA #2, #4, #6) were also reflected in the microhardness results, as described below.

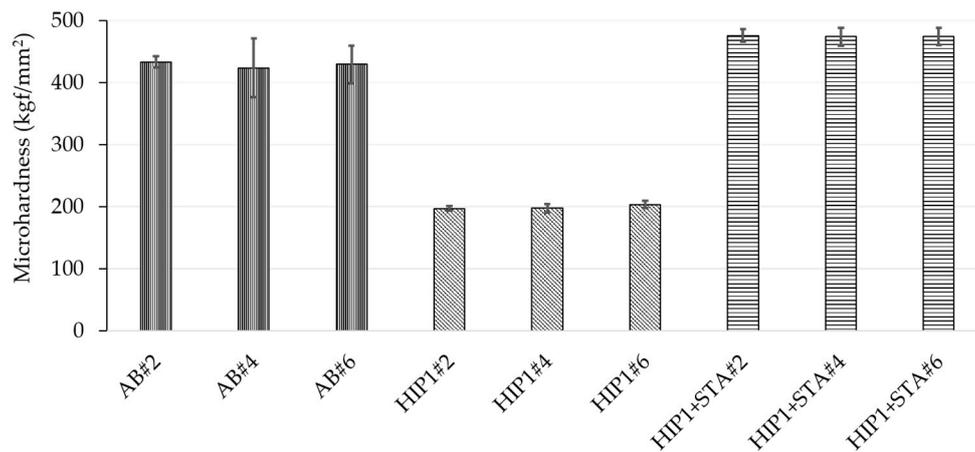
Figure 7. Microhardness values of the as-built and post-treated samples #2 (LS = 125 μm), #4 (LS = 225 μm), #6 (LS = 325 μm).

The average microhardness values of the as-built and post-treated samples, determined as previously described in the experimental procedure, are shown in Figure 7. It can be seen that, although the defect contents in the as-built samples were vastly different, they exhibit similar hardness values of ~ 430 kgf/mm². This can be explained by the similarity in local melting conditions for the three as-built specimens, as the electron beam parameters were unchanged, and only the line spacing was varied. This contrasts a previous reported study by Lee et al. [23], where hardness was observed to vary (405–450 kgf/mm²) with defect content (4.5%–0.5%) of the EBM Alloy 718 samples. In the study by Lee et al. the local melting conditions were varied between the different specimens by changing the focus offset, thereby influencing energy density. The HIP1 treatment caused a reduction in the hardness of all the samples to nearly identical values of ~ 200 kgf/mm². This is consistent with the previous observations on EBM and LPBF Alloy 718 [30,31]. After HIP1 + STA, all the samples exhibited similar hardness values (~ 475 kgf/mm²), which were higher than in the as-built condition. This value is close to the reported peak hardness (~ 490 kgf/mm²) of Alloy 718 [10]. Previous studies on EBM Alloy 718 have also reported an increase in hardness in the as-built condition from 410 kgf/mm² to 470 kgf/mm² after aging [32–34]. Thus, the foregoing results amply reveal that, regardless of the vastly different defect content in the as-built condition, the final post-treated condition exhibits a very similar density (Figure 3), phase constitution in terms of δ phase and γ'' phase distribution (Figures 5 and 6), as well as microhardness values (Figure 7).
