# Historical Geomorphological Research of a Ligurian Coastal Floodplain (Italy) and Its Value for Management of Flood Risk and Environmental Sustainability

**Abstract:** The alluvial plain of the Entella River (Eastern Liguria), historically affected by damaging flood events, has been heavily modified over the past 250 years by human activity and natural processes. A qualitative and quantitative analysis of the morphological and land use evolution of the Entella floodplain since the 18th century was carried out using base maps and aerial photos ranging from 1758 to 2016. These diverse sources were Geographical Information System (GIS) georeferenced. Additional information on land-use change was gathered from historical documents and recent research reports. The main transformations to the floodplain include morphological changes, e.g., narrowing, channelization, displacement of the river channel and the advance of the coastal line due to fills and embankments. In addition, there has been very significant urbanization with loss of vegetated and agricultural areas. Our results indicate the primary role of human disturbance on morphological changes and landscape modifications of the

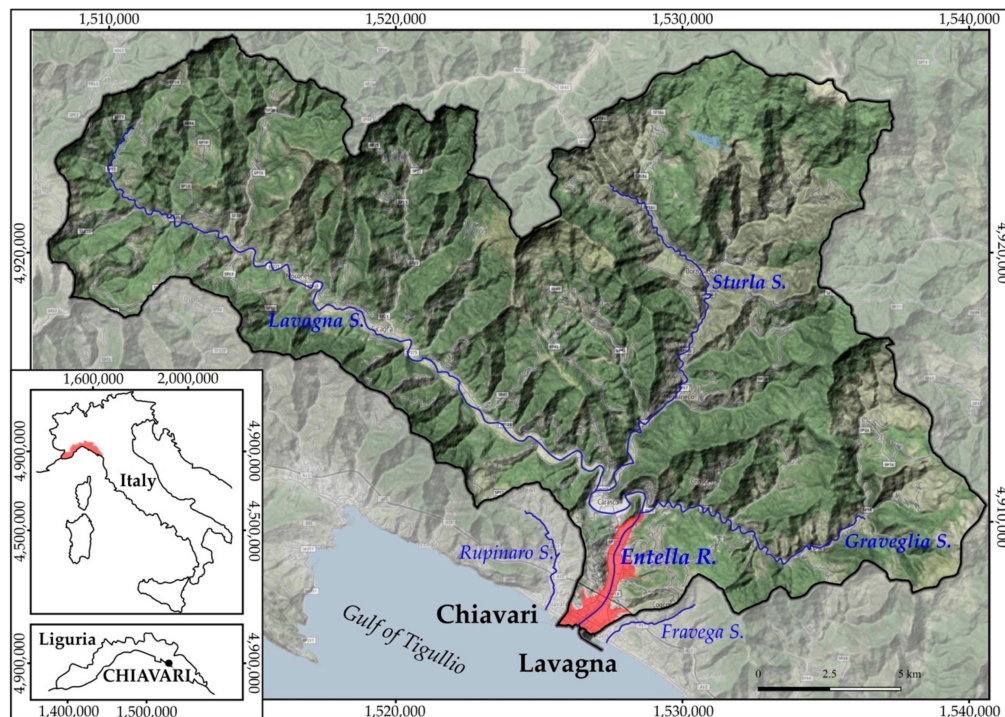
**Figure 1.** Relief map of the Entella River catchment. Lavagna, Sturla and Graveglia Streams, the three main tributaries, area indicated. Red area delimits the examined alluvial plain of the Entella River.

Figure 1 shows that the Entella starts at the confluence of the Lavagna and Graveglia streams; the Sturla joins 4 km below this confluence. The coastal floodplain results from combined and cyclical

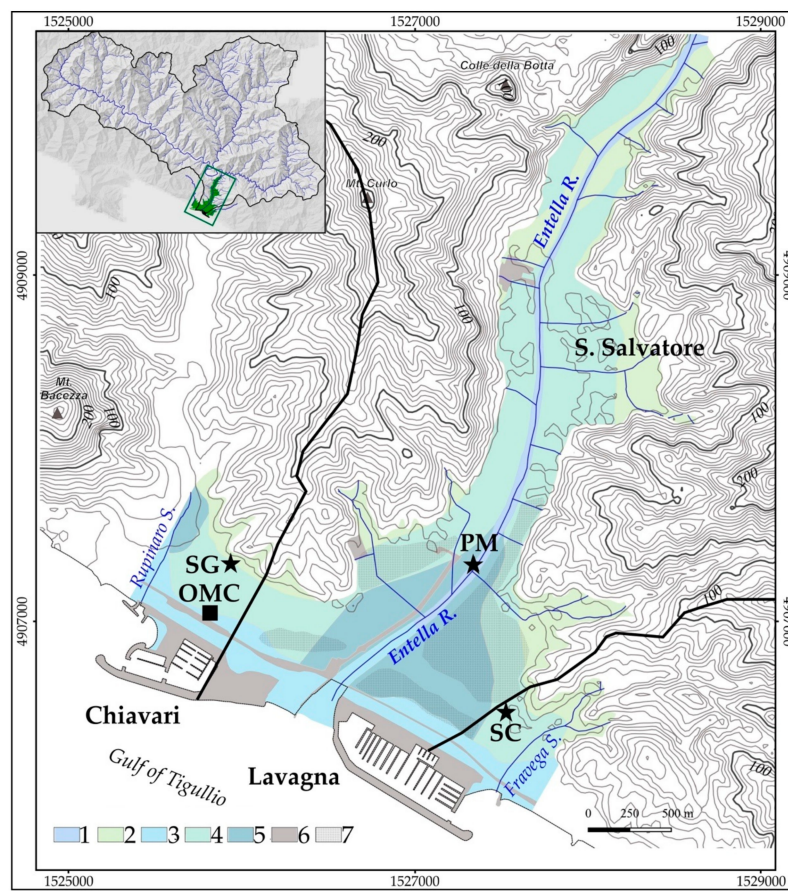
**Figure 2.** Engineering geological map of the Entella floodplain [34]. 1. Gravel, with subordinate sand and little or no fines; 2. Gravel and sands, with significant fines; 3. Sand, with subordinate gravel and little or no fines; 4. silty sand, gravelly silt and sandy silt; 5. clayey silt and inorganic silty clay, with a granular fraction (sand or gravel); 6. Man-made deposits, include coarse soil frequently mixed with heterogeneous material (pitch, bricks, etc.); 7. marshes, swamps. Black stars show reference points: SG, “San Giovanni Battista” Church; PM, “Ponte della Maddalena” bridge; SC, “Nostra Signora del Carmine” Church. Black square shows the Weather Station OMC, “Osservatorio Meteorologico di Chiavari”.

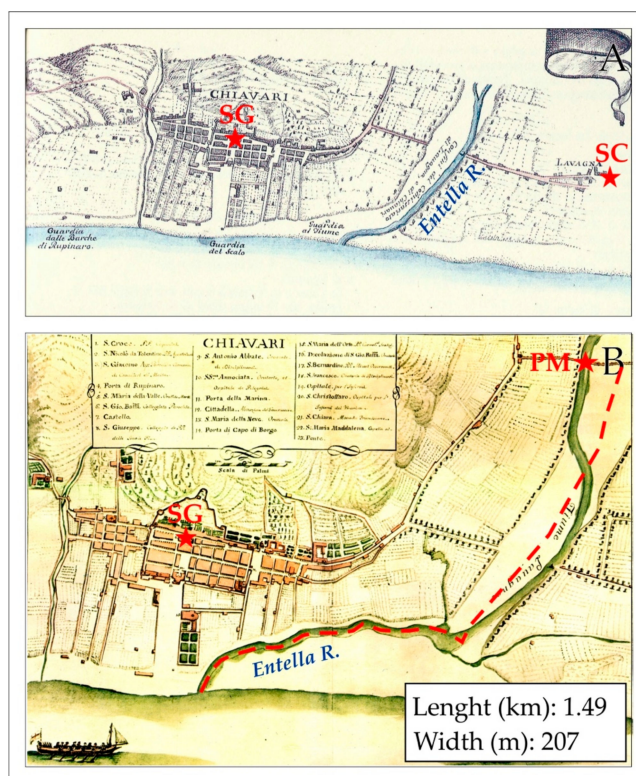
**Figure 3.** The Entella River floodplain in the 18th century: (A) “Pianta delle Due Riviere della Serenissima Repubblica di Genova divise ne’ i Commissariati di Sanità”, 1758; (B) “Il Dominio della Serenissima Repubblica di Genova in terraferma”, 1773. Red stars show reference points: SG, “San Giovanni Battista” Church; PM, “Ponte della Maddalena” bridge; SC, “Nostra Signora del Carmine” Church. (See also Figure 2). Red dotted line shows the axis of the channel. Values of the channel length and width are measured at the PM reference point.

Visual inspection of maps by Vinzoni dated 1758 and 1773 reveals the original geomorphological landscape of the Entella floodplain (Figure 3). The Entella was free to wander in its floodplain, characterized by a large channel and a mouth displaced westward, compared to the present river configuration. At the bridge “Ponte della Maddalena”, the riverbed reached 200 m across (Table 4).

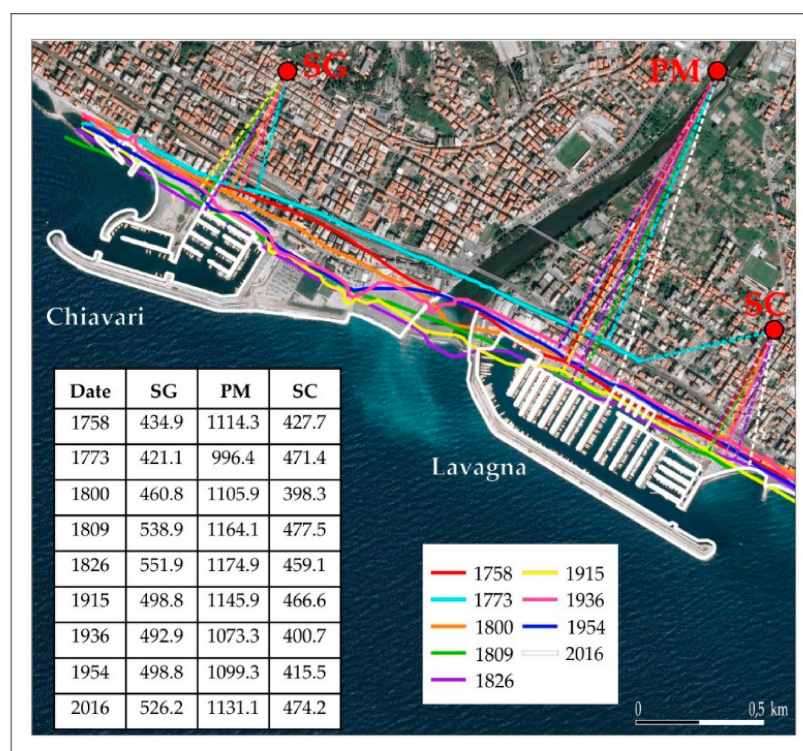
**Figure 4.** Evolution map of the shoreline from 1758 to 2016. Colored lines represent the different stages of coastal modification. Dotted colored lines show the distance measured from the reference point: SG, “San Giovanni Battista” church; PM, “Ponte della Maddalena” bridge; SC, “Nostra Signora del Carmine” church. Measured values (m) are reported in the table.**Table 5.** Distance of the sea from the Chiavari medieval walls reported in historical documents.

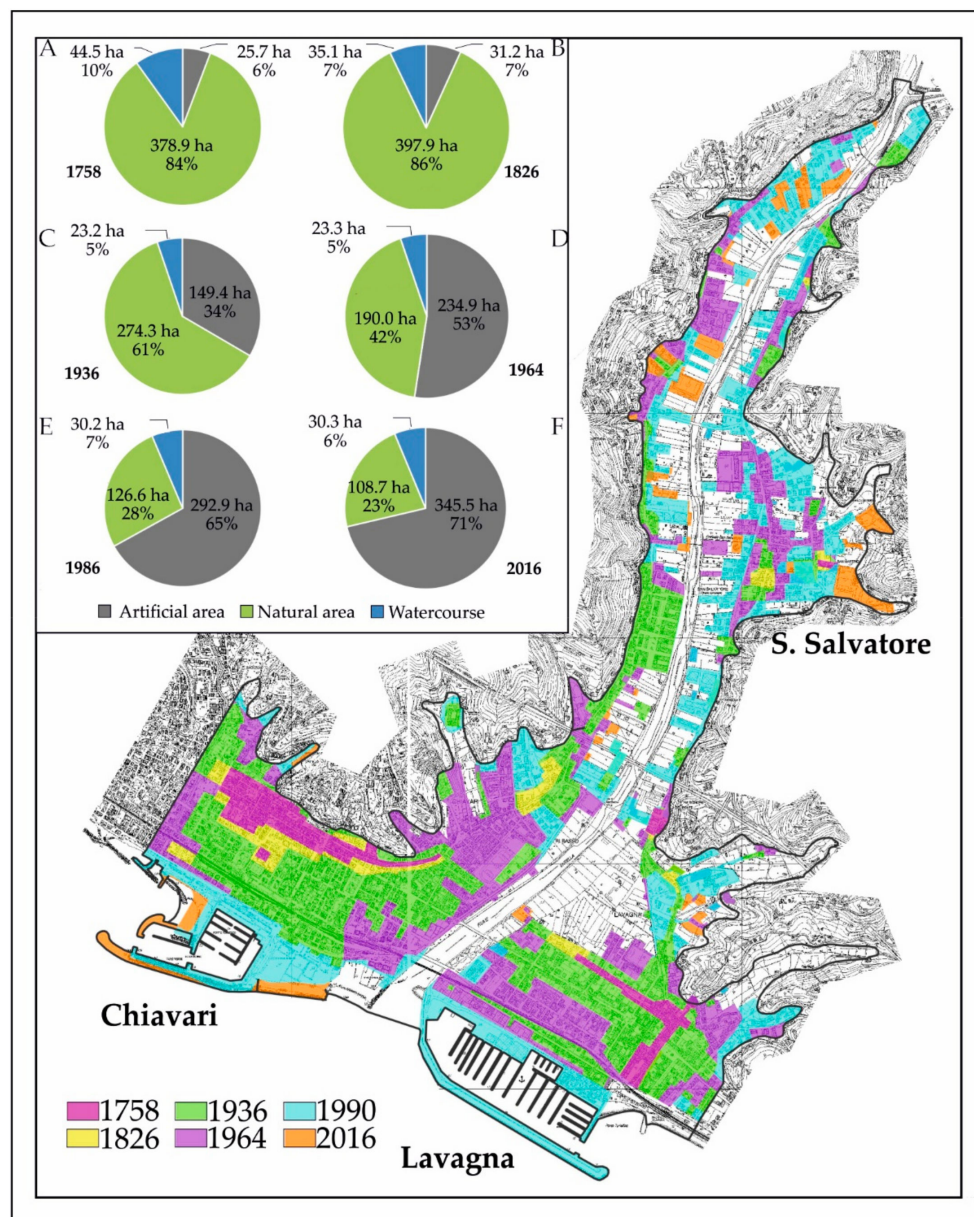
**Figure 5.** Urban evolution map of Chiavari and Lavagna from 1758 to 2016. Pie charts (A–F) show the relationship between artificial areas (continuous and discontinuous urban fabric, port areas and artificial, non-agricultural vegetated areas), natural areas (forested areas, olive groves and cultivated areas) and watercourse in the same period.

The interventions along the river favoured the sedimentation of alluvial deposits and shoreline advance, due to the continuous supply of materials to the plain and the beaches. Consequently, there was an increase in length of the distance between the coastline and the reference points, up to the maximum value in 1826 (Table 4). The urban development of Chiavari and Lavagna during the 19th century was moderate: only a limited and discontinuous expansion took place toward SW in the coastal strip between the mouths of the Entella and the Rupinaro, previously almost exclusively occupied by market gardens or marshland, whereas a small suburban district grew along the western riverside next to the "Ponte della Maddalena" bridge (Figure 5). Between 1868 and 1870,

The most important landscape modifications took place between the 1950s and the 1980s (Figure 5). Post-war population increase and economic growth caused rapid and massive urban sprawl in both Chiavari and Lavagna. By 1964, artificial spaces accounted for 53% of the floodplain (Table 6, Figure 5D), with most being discontinuous built-up areas (26%) (Table 7, Figure 6D). The residential area of Chiavari extended in the western sector of the floodplain and inwards along the western bank of the Entella; on the other riverside, the municipal areas of Lavagna extended as far as the river (Figure 5). Between the 1960s and the 1970s, the coastal sector of the floodplain was heavily urbanized with residential and tourist developments from the shoreline up to the foothills, with agricultural areas interspersed within the discontinuous urban fabric that characterized the inland suburban districts of Chiavari and Lavagna and the village of San Salvatore (Figure 5). The channelization of the lower stretch of the Entella was completed with the construction of the new bridge “Ponte della Pace” along the Aurelia Way, upstream the railway and downstream the existing bridge “Ponte della Libertà”. Since the 1950s–1960s, the flow section of the river in its lower stretch has stabilized: no substantial changes in channel width have been observed at the bridge “Ponte della Maddalena” (Table 3).

The rapid increase of the built-up area between the 1950s and 1980s caused the almost total saturation of the coastal sector of the floodplain (Figure 5). By 1986, artificial surfaces occupied more than 67% of the floodplain (Table 6, Figure 5E): continuous built-up areas are predominant (40%), whereas olives groves and agricultural land are strongly reduced (24%) and survive in the floodplain inland area and along the foothill, interspersed with a discontinuous urban fabric (21%) (Table 7, Figure 6E). The woodland at the mouth of the Entella River was also much reduced; at present a small pinewood (0.4 ha) survives in the municipal parks along the two riverbanks between the modern bridges.

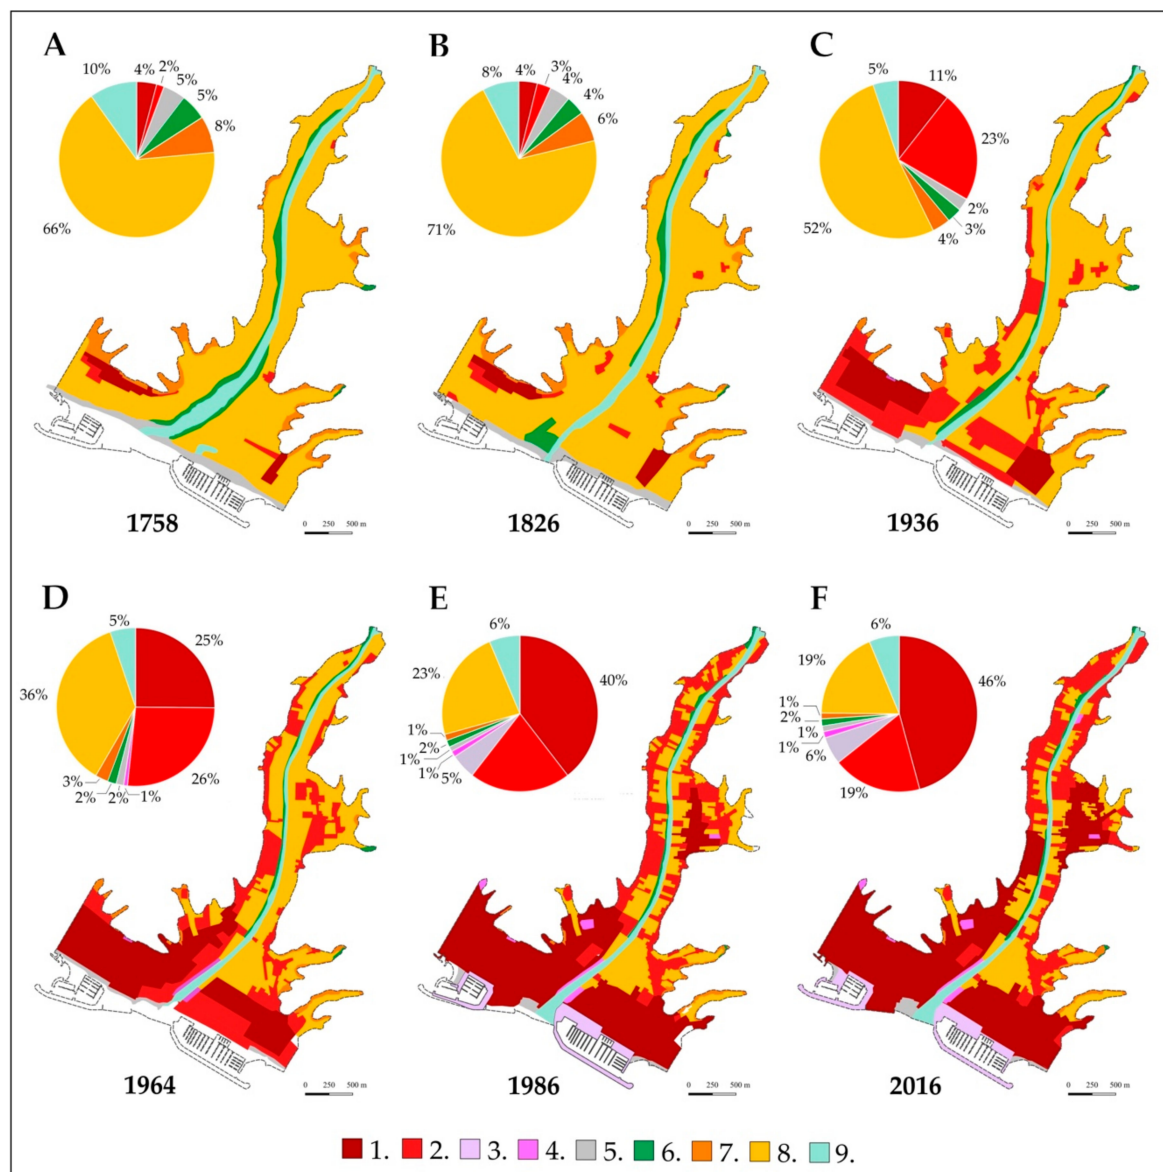
**Figure 6.** Land use changes from 1758 to 2016. Pie charts (A–F) show the relationship between different types of land use and land-cover categories provided by the CORINE project. Land use categories: 1, continuous urban fabric; 2, discontinuous urban fabric; 3, port area; 4, artificial, non-agricultural vegetated area; 5, shore; 6, forested area; 7, olive groves; 8, cultivated area; 9, watercourse.

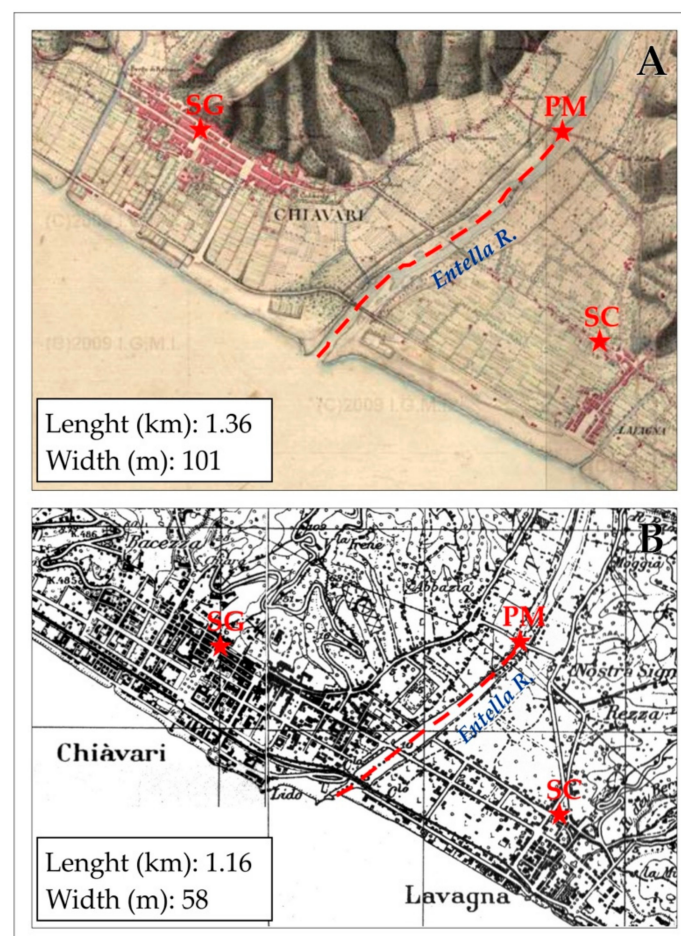
**Figure 7.** The Entella floodplain in the 19th and 20th centuries: (A) “Gran Carta degli Stati Sardi in Terraferma, Riviera di Levante”, Istituto Geografico Militare Italiano, 1816–1826; (B) “Carta Topografica d’Italia—serie 25, Foglio 94, Tavolette I-NO “Chiavari” e I-NE “Sestri Levante”, Istituto Geografico Militare Italiano, 1936. Red stars show reference points: SG, “San Giovanni Battista” Church; PM, “Ponte della Maddalena” bridge; SC, “Nostra Signora del Carmine” Church. (See also Figure 2). Red dotted lines show the axis of the channel. Values of the length and width channel are measured at the PM reference point.

In the early 19th century (Figure 7A), the artificial canals to the east of Chiavari were still in use. The main morphological effect of human impact was the eastward movement of the river mouth and the marked narrowing of the channel, to a minimum of 89 m in 1800 (Table 4). New cultivated areas replaced the old marshland next to the mouth, increasing the area of the plain covered with vegetation (84%); the moderate expansion of Chiavari slightly increased artificial surfaces, whose area accounted for less than 10% (Table 6, Figure 5B). Market gardens, olive groves and orchards were the dominant land uses (77%) (Table 7, Figure 6B). The wood at the mouth of the Entella, in a place called *Il Prato*, belonged to the noble Rivarola family who established a plantation of mulberry trees along the river [58]. The wood was composed of willows, alders and lime trees, all species that grow in wetlands and along rivers [59]. Visual evidence of this wood is provided by a pen drawing by William Strangways ("From above Chiavari on the road to Genoa", DocSAI Center, Topographical Collection, Genoa), which also shows the flat area, with a characteristic chessboard pattern of land plots.

During the 20th century (Figure 7B), there was very rapid urbanization of the coastal floodplain: new buildings, roads, bridges, commercial and production sites replaced many cultivated and vegetated areas. In the early 20th century, vegetated regions were reduced by 10% and the built-up areas increased fivefold over the century (Table 6; Figure 5C). The discontinuous urban fabric characterized the coastal sectors (23%), surrounding the continuous residential districts (11%) of the historical centers of Chiavari and Lavagna (Table 7; Figure 6C). The municipal development of the two seaside towns was rapid, with a marked expansion in the coastal sector of the plain and towards SW and the Entella riversides (Figure 4). In Chiavari entirely new exclusive neighbourhoods were built between the historical center and the railway, and secondarily in Lavagna, between the historical center and the Entella. Many were built for wealthy people who returned from North and South America, where they had migrated to seek fortunes at the end of the previous century. Cultivated land account for 52% of the total area and dominate the middle and inland sectors of the plain: olive groves survived at the foot of the hills, and woodland along the riversides (Table 6, Figure 5C). Around 1910, channelization interventions with concrete levees were carried out along the lower stretch of the Entella River [53,60] and next to its mouth due to the construction of the new bridge “Ponte della Libertà” about 250 m

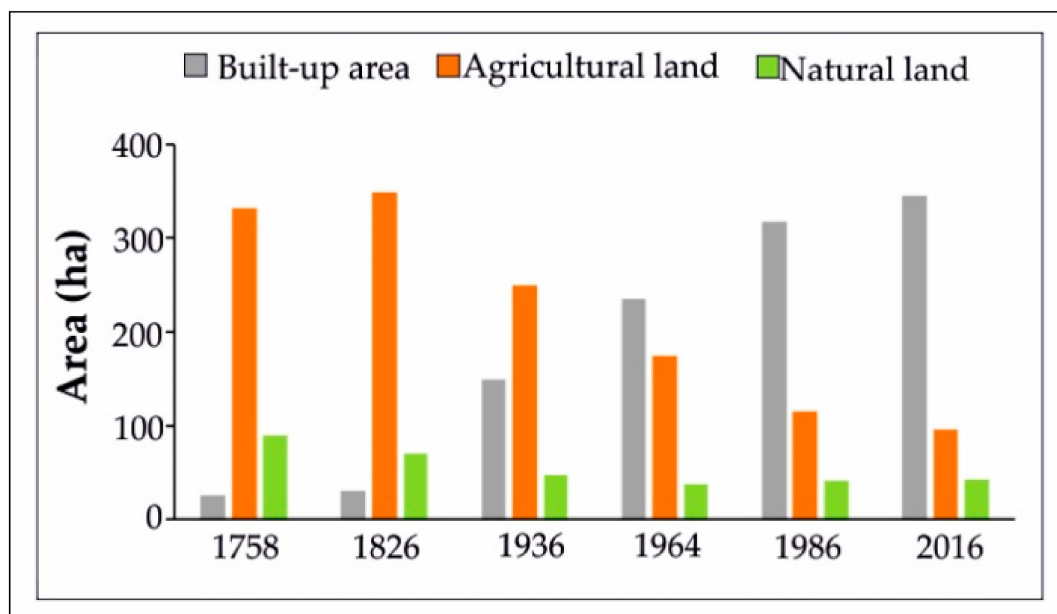
**Figure 8.** Land use modification over the last two centuries: built-up area includes urban fabric, port areas and artificial, non-agricultural vegetated areas; agricultural land includes complex cultivated land and olive groves; natural land includes forested areas, shores and watercourse.

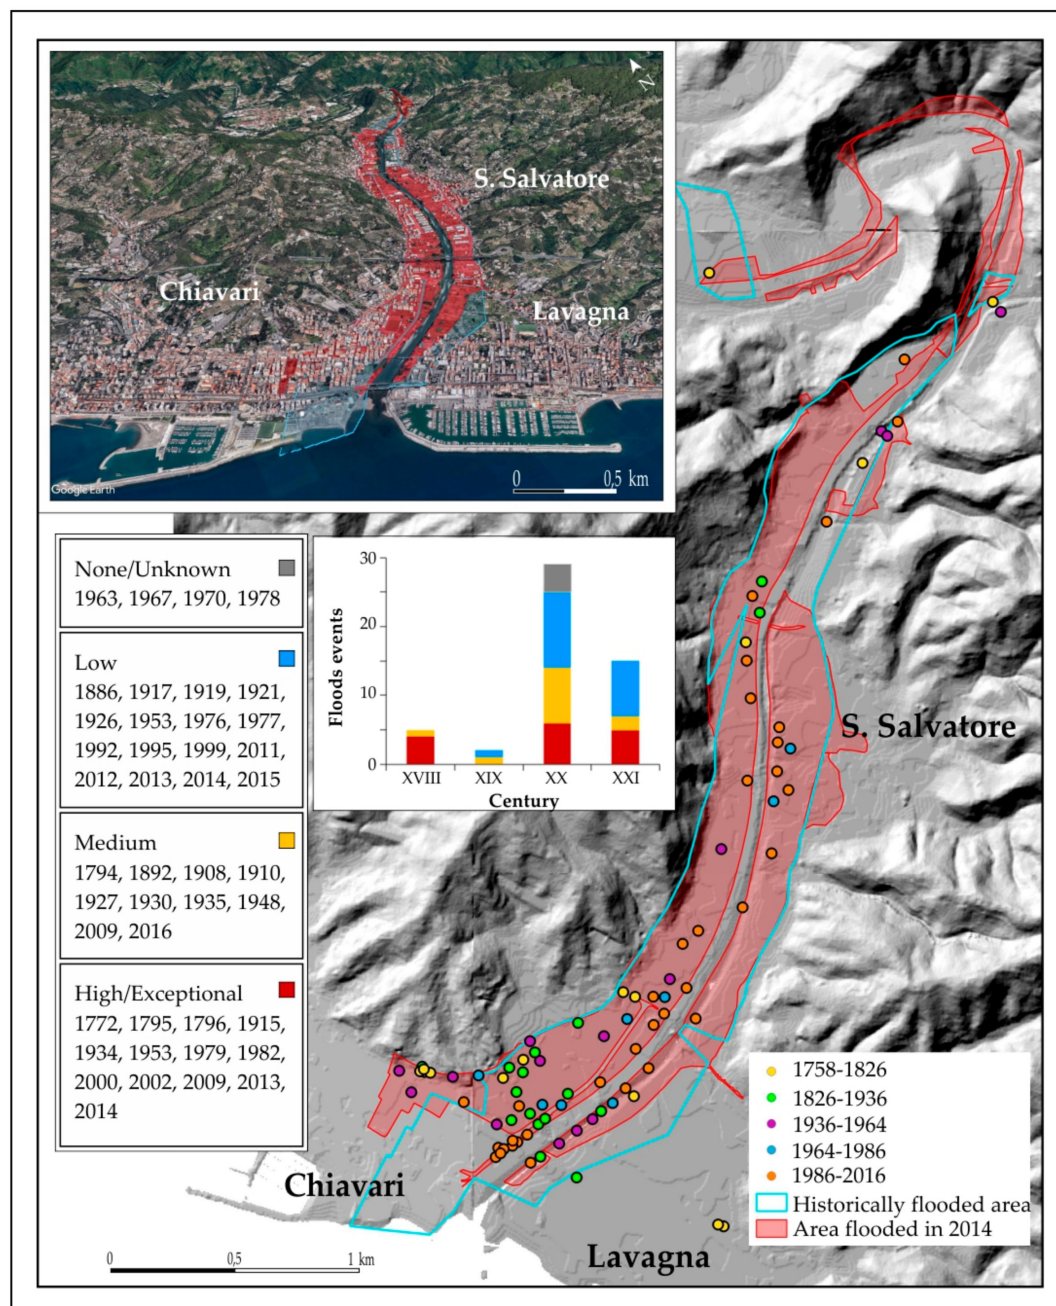
**Figure 9.** The main map shows the distribution of flood events (colored dots) that occurred in the Entella floodplain from 1758 to 2016. Events are classified into the five time breaks adopted in the historical analysis. Blue areas show the urban region historically flooded and red areas show the urban region that were inundated during the flood events of the year 2014. The table lists the years in which flood events occurred, classifying them according to the level of damage (none or unknown, low, medium and high or exceptional): years with exceptional floods are in bold, stars indicate years with events that caused fatalities. The graph shows the temporal distribution of the flood events.

sectors of the coastal plain at the mouth, including several present residential districts of Chiavari and Lavagna (Figure 9).

some of its tributaries (Lavagna stream) flooding large sectors of the floodplain and the Lavagna valley floor with significant damage to buildings, roads and industrial sites; (iii) 10 October 2013, when large portion of the plain and the Lavagna and Sturla valley floors were inundated and the flood wave caused two fatalities due to the collapse of a bridge in the inland of Chiavari; and (iv) 10–11 November 2014, when the town of Chiavari was largely occupied by waters due to the synchronous flash flood events in the Entella river and the Rupinaro stream, at the western boundary of the plain, caused by very short but intense rainfall events, with extensive damage to shops, basements, garages, roads and buildings in the urban area and to riverbanks, leisure and tourist facilities, industrial and commercial sites along the riversides (Figure 9).

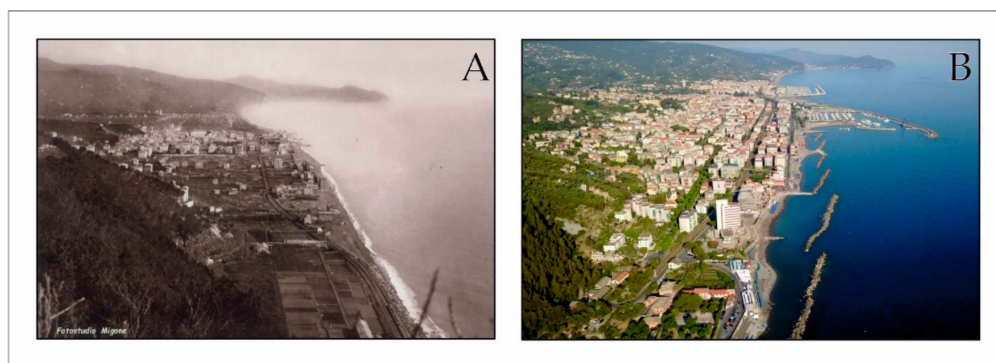
**Figure 10.** The Entella floodplain and its shoreline and land use modification over the last two centuries: (A) view of Chiavari and the western sector of the floodplain with market gardens, olive groves and vineyards in 1890 (“E. Migone”, photographer archive Chiavari); (B) recent view of Chiavari and its western urban districts and modified shoreline (Photo P. Giacomelli).

- The increase in built-up areas over the entire period 1758–2016, particularly in the late 19th century and after the Second World War, between the 1950s and the 1980s (Figure 5). Transformation from natural to artificial landscape is linked to the urban growth in the coastal and, later, in the inland sectors of the floodplain, with the gradual construction of residential urban and suburban districts and the consequent development of transportation and road networks, industrial sites, port areas and leisure, tourist and service facilities (Figure 10).

- The gradual loss of agricultural land since the 19th century. Human activity is the major factor in this land use change: in the 18th and the early 19th century, cultivations occupied large portions of the plain, and agricultural land was even increased at the end of 18th century as result of human intervention along the channel to reclaim marshy areas at the mouth. Since the late 19th century, the urban sprawl of Chiavari, Lavagna and the village of San Salvatore converted agricultural land into residential and technical areas (Figure 10).

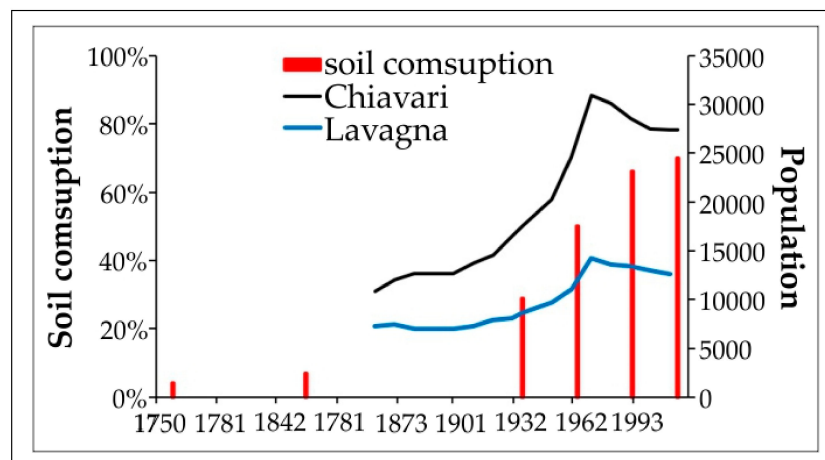
**Figure 11.** Soil consumption (%) correlated to the population increase (number of inhabitants) in Chiavari and Lavagna over the last 150 years (1861–2014). Red bars represent soil consumption, black and blue lines are the number of inhabitants registered in Chiavari and Lavagna, respectively, by population census from 1861 to 2014.

- The increasing density of built-up area in the urban area, with a continuous urban fabric between the shoreline and the foothills (Chiavari and Lavagna) and along both the riversides in the inland sector of the plain (sub-urban districts of Chiavari and San Salvatore). Figure 11 shows the soil consumption in the floodplain (i.e., the conversion of natural land, with healthy soils and intact habitats, into technical areas for industrial, agricultural and mainly urban human settlement, with concomitant negative effects upon landscape and its resources) and population increase in

Chiavari and Lavagna over the last 150 years (1861–2014): most intensive urbanization and land use change phases are closely correlated to the higher economic and population rate of growth.

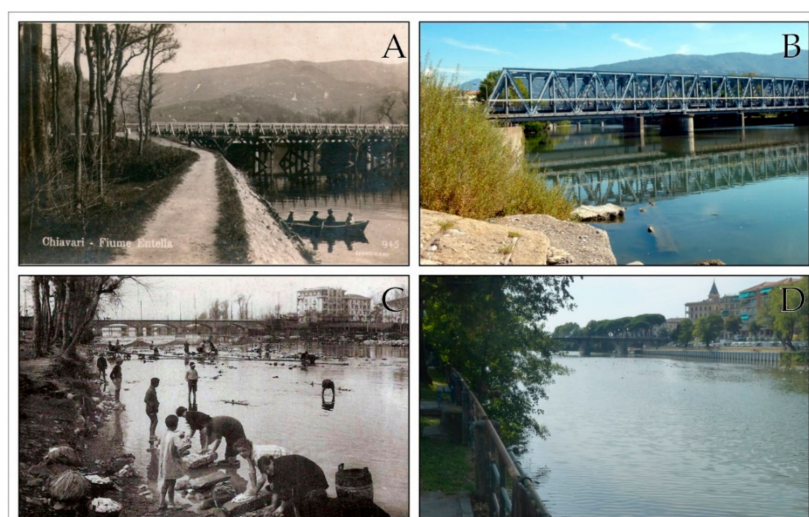
**Figure 12.** View of the Entella banks over the last two centuries: (A) concrete levees and fences at the beginning of the 20th century (Photographer’s Archives “E. Migone”, Chiavari) and (B) embankment at present day (Photo E. Roccati) along the western riverside, Chiavari; (C) levees at the beginning of the 20th century (Photo Web) and (D) bank and Cycle path at the present day (Photo E. Roccati) along the eastern riverside, Lavagna.

- A reduction in the channel width, particularly in the final stretch, linked to the construction of fences and rudimentary levees at the end of 18th century to protect the plain from the recurrent floods, and later to the gradual construction of concrete levees, required for the building of new bridges at the mouth and the Genoa–Pisa railway line since the late 19th century (Figure 12).

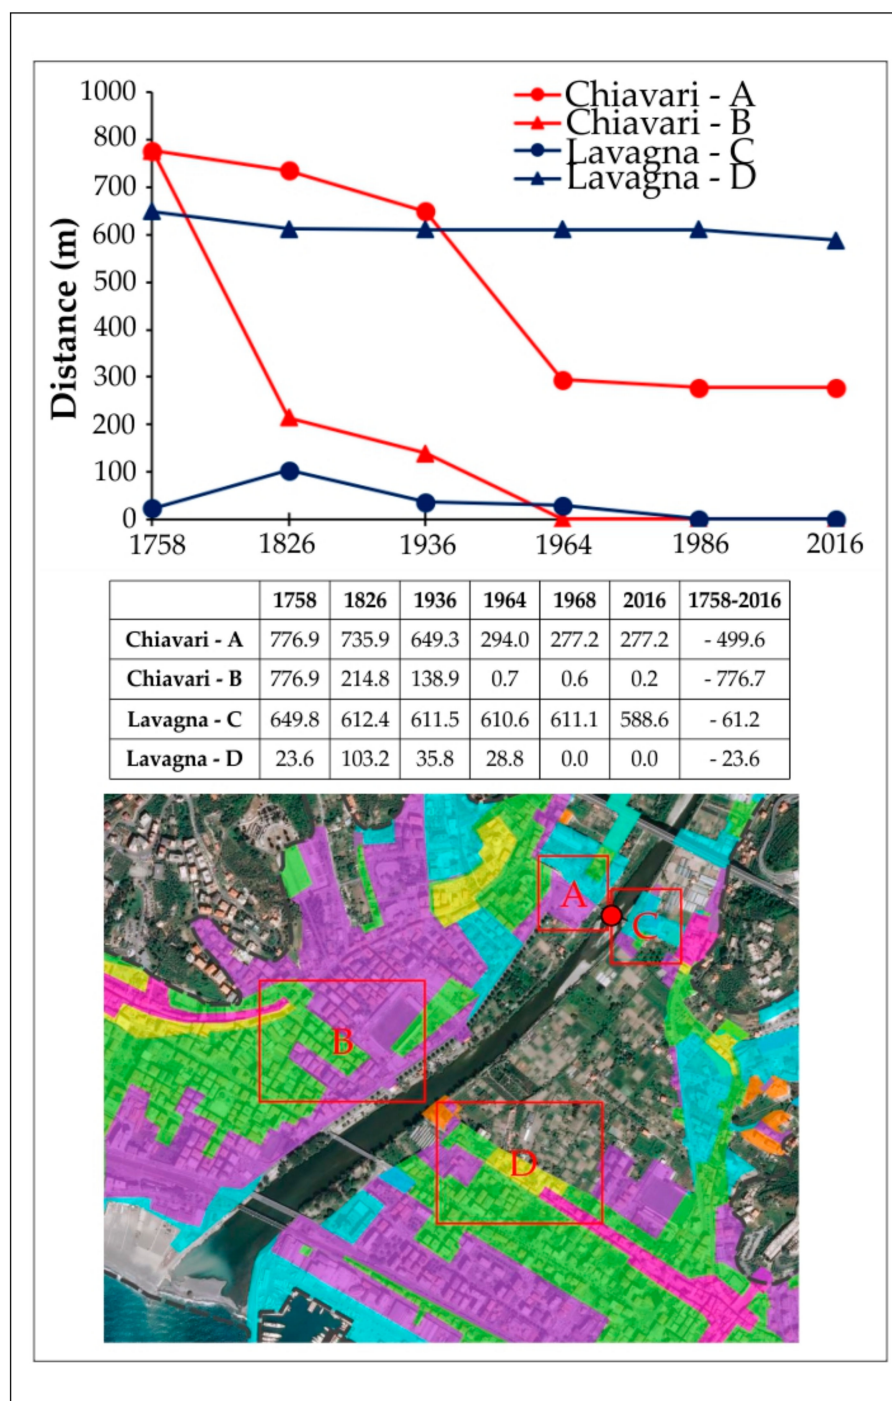
**Figure 13.** Variations in the distance of the river channel from the built-up area 1758–2016. A, B, C, D are the floodplain sectors (red rectangles in the map) where the distances of built-up area have been measured from the channel riversides at the “Ponte della Maddalena” bridge (red dot on map).

- A decrease in distance between the river channel and the built-up area: the residential and industrial development of the plain has caused the gradual reduction of the distances between the watercourse and the built-up area, particularly on the western riverside (Chiavari), where the ancient flood bed was obliterated in the 20th century by the gradual construction of roads, buildings, craft warehouses and small business next the riverbank (Figure 13). We observed that the largest reduction of distance from the channel is closely correlated to the most intensive urbanization phase and rate of population growth.
