The Importance of Checking Indoor Air Quality in Underground Historic Buildings Intended for Tourist Use

Department of Building Construction, University of Alicante, Carretera San Vicente del Raspeig, s/n, San Vicente del Raspeig 03690, Spain; victor.echarri@ua.es

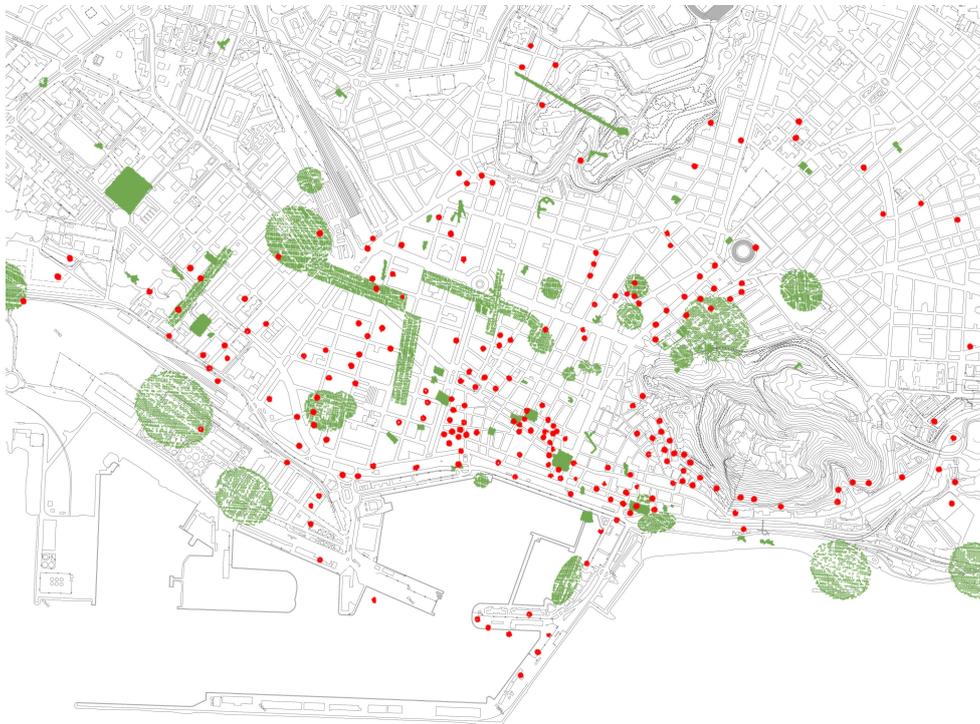
Figure 1. Image showing in red, the impact of the bombs dropped in Alicante during the Spanish Civil War and in green, the bomb shelters.

When the means of war came from one side or the other, the participation of aviation grew and Alicante began to be a key strategic point; Figure 1 shows the impacts of aerial bombs on the city of which there is evidence. Among the areas bombed, is the Rabasa airfield, which currently houses the Campus of the University of Alicante with at least five confirmed bombardments, being one of the most important objectives for rebellious aviation. The city was equipped with anti-aircraft defenses during the first bombardments, in addition to four observation posts that had a phonolocator to determine the course of the planes by means of their sound, located in Cabo de las Huertas. The active defense of the city was completed with both fixed and mobile cannons to defend certain areas according to the needs of the conflict [4].

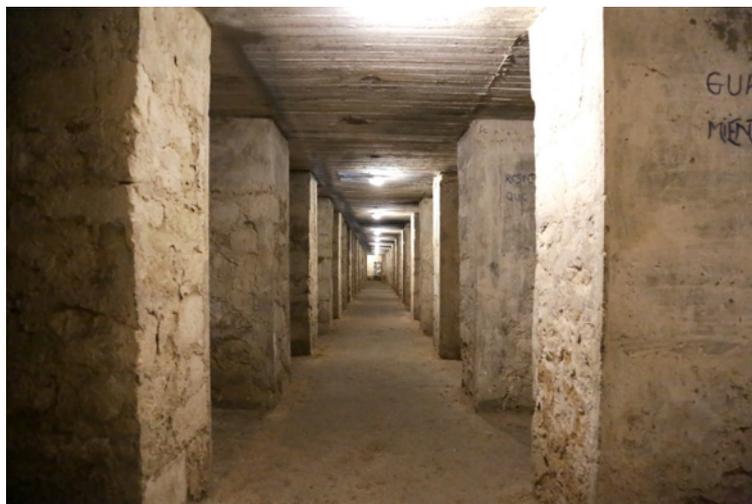
Figure 2. The inner corridor of the Seneca Square shelter.

The maximum capacity of the shelter at Seneca Square (Figure 2), according to the Partial Plan (Spanish regulations) of shelters in the city, raised a capacity for 1200 people, although sources close to users at the time, assert that, in moments of alarm, about 2500 people sought shelter inside. During the

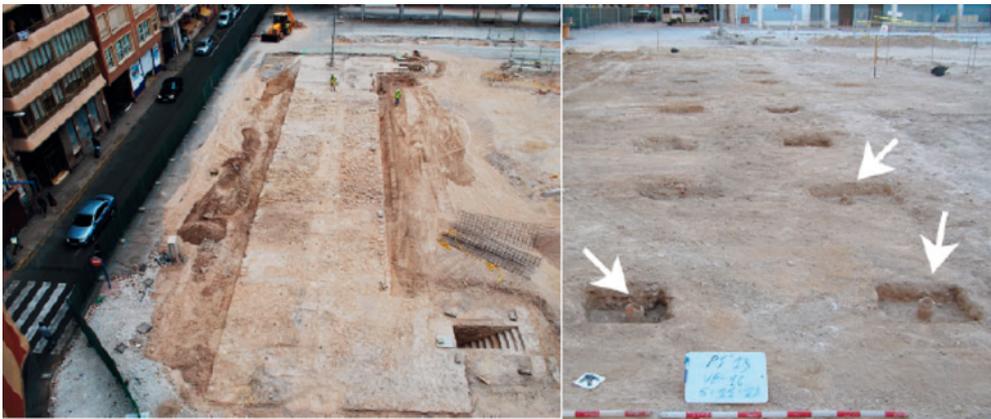
Figure 3. (left) View of the entire shelter from a neighbouring building in the aftermath of the demolition of the buildings that were built on top of it in the post-war years. (right) View showing the inlaid vents in the concrete slab.

The shelter volume is composed of a single body 51 m long by 12 m wide, not counting the two lateral arms of the 9 meter entrances, as shown in Figure 3. The concrete slab varies depending on the structural needs of each zone, between 60 cm and 180 cm at the accesses.

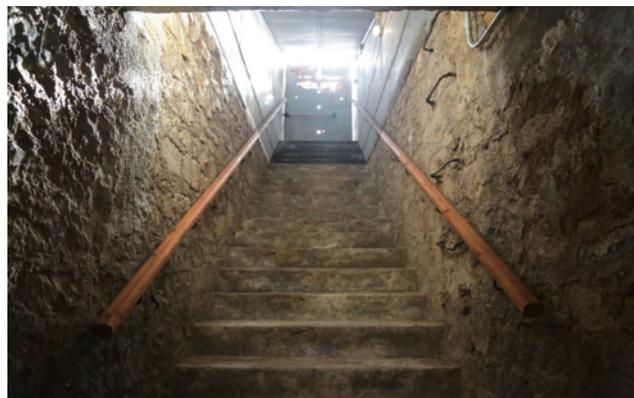
Figure 6. South Access.

The original construction had two zigzag-shaped entrances to mitigate the damage to a possible direct bombardment on the shelter and, in this way, to facilitate the evacuation of people as indicated by the recommendations of the city architect of the day. The accesses save the 3 m of drop with some steps, of reinforced concrete, of 16 steps in 4.9 m of floor (Figures 6 and 7).

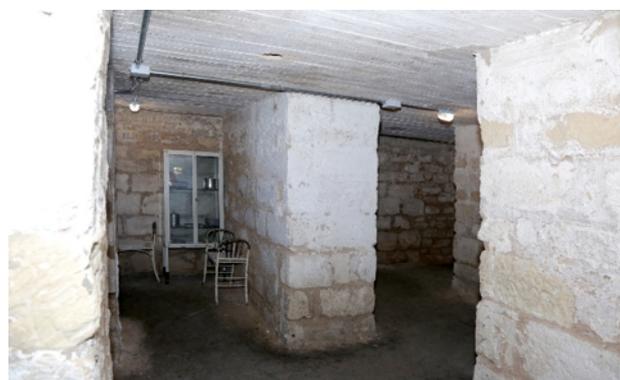
Figure 7. North access in zigzag form and rebuilt cubicle with period furniture.

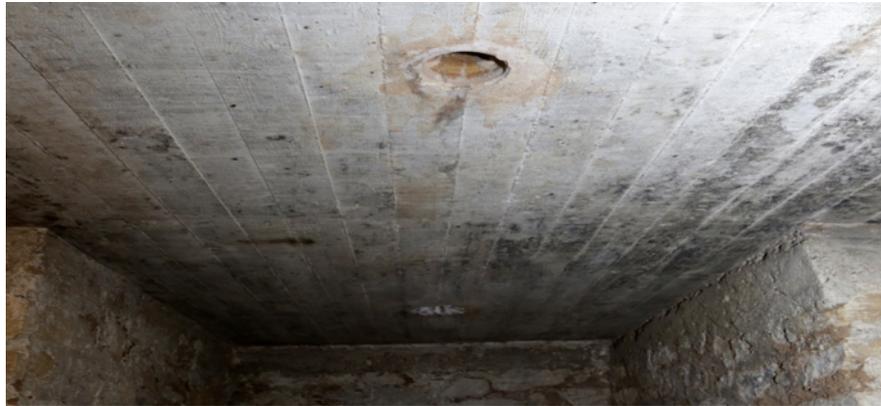
Figure 9. Interior view of the old vents.

The shelter had 65 ceramic vents (Figure 9), measuring between 7 and 140 cm, which crossed the concrete slab and ventilated the interior along the central corridor connecting the cubicles. The layer behind the concrete slab consisted of compacted earth to cushion the effect of the bombs.

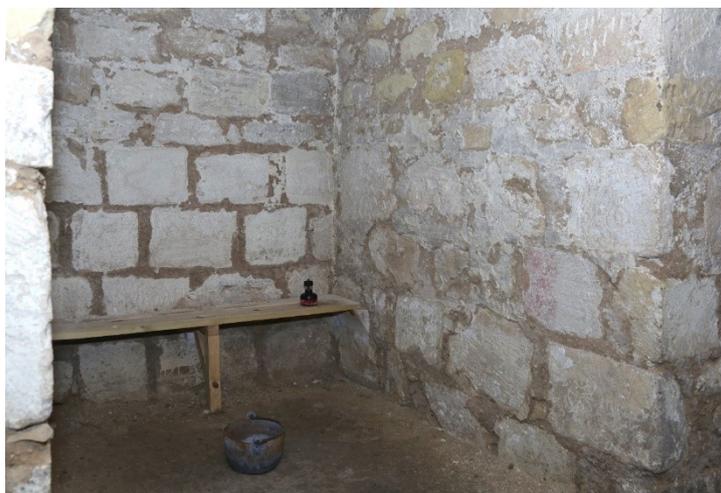
Figure 15. Image of the chamber in a cubicle.

For the data collection phase of the study carried out at the Seneca Square shelter, the measurements were made between 18 and 28 January 2016. This process included the entire length of the shelter, separating the chambers into the previously mentioned cubicles in order to measure the amount of radon generated in the different areas within the same room. The measurement zones of the study correspond to the cubicles, as shown in the Table 1 and the positions of the cameras are shown in Figures 14 and 15.
