Article

# **Combining Unmanned Aircraft Systems and Image Processing for Wastewater Treatment Plant Asset Inspection**

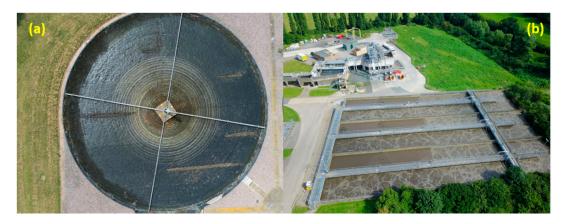
**Figure 1.** (a) Example of trickling filter and (b) example of activated sludge within two independent wastewater treatment plants.

TFs and ASs (Figure 1) are the most common biological processes in WWTPs in England [7]. TFs deal with organics and nitrogen in the wastewater [8], whereas AS also treat the organics and nitrogen, but can also be easily adapted to treat phosphorous [9]. TFs are most likely to be installed in small and remotely located WWTPs which operators visit but are not based at permanently. Remote WWTPs are considered to be those with a capacity below 10,000 p.e [10]. In UK, approximately 54% (986) of the WWTPs have a lower capacity than this [11]. AS consists of aerated tanks containing suspended biomass followed by settling tanks to allow for the separation of the biological flocs from the treated water. It requires a high level of maintenance [9], as any changes in pollutant levels in the wastewater require a manual adjustment to key parameters, such as the Sludge Retention Time, Return Activated Sludge rates, and the Oxygen Supply Rate. The use of AS is not feasible for small plants and remote sites, because it requires a high level of operator oversight [9].

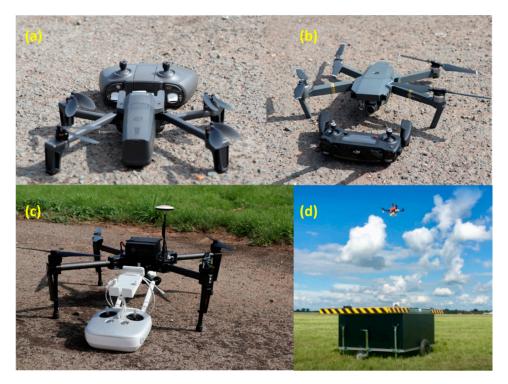
**Figure 3.** Unmanned aircraft systems compared for image quality acquisition at the Cranfield WWTP study site. (a) Parrot Anafi (Parrot, France); (b) DJI Mavic 2 Pro (DJI Technology Co, China); and (c) DJI Matrice 100 (DJI Technology Co, China). (d) Autonomous docking station (Herotech8, UK).

Three different quadcopters were used for image acquisition during an initial pilot study that was carried out at Cranfield WWTP (Figure 3): the Parrot Anafi (Parrot, France), the DJI MAVIC 2 Pro (DJI Technology Co, China), and the DJI Matrice 100 (DJI Technology Co, China) (Figure 3). The Parrot Anafi (Parrot, France) is one of the smallest (0.17 m  $\times$  0.24 m  $\times$  0.06 m) and lightest (0.32 kg) UASs currently available in the market. The platform has a 4K and 21 megapixel (35 mm focal length, 1/2.4" CMOS sensor) camera with High Dynamic Range (HDR) video and digital zoom capabilities. The camera can tilt up and down through 180 degrees. The Parrot Anafi has a high-density Li-Po battery that provides 25 min flight time and a GPS and GLONASS geo-positioning system that enables the smart return to home and accuracy of  $\pm 0.5$  m in the vertical and  $\pm 1.5$  m in the horizontal axes. The UAS legs contain a dual-band antenna to optimize the video transmission up to 4 km. It is able to operate in wind speeds up to 50 km h<sup>-1</sup> and speed of up to 55 km h<sup>-1</sup> in the sport mode. The DJI Mavic 2 Pro (DJI Technology Co, China) with a dimension of  $0.32 \text{ m} \times 0.24 \text{ m} \times 0.08 \text{ m}$ , weighs 0.90 kg. The platform has omnidirectional obstacle sensing and a 20 megapixel (28 mm focal length, 1" CMOS sensor) Hasselblad L1D-20c camera that can be tilted up and down through 180 degrees. The Li-Po 4S battery provides up to 31 min of flight time. The DJI Mavic 2 Pro is equipped with the same GPS as the Parrot Anafi. The UAS legs contain a dual-band antenna for optimizing the video transmission up to

The Herotech8 (Herotech8, UK) UAS docking station (Figure 3) was used to autonomously deploy the UASs. The docking station enables autonomous take-off, landing, flight plan implementation, and image capture at selected waypoints. The docking station is  $1.6 \text{ m} \times 1.6 \text{ m} \times 1.1 \text{ m}$ , weighs 80 kgs,

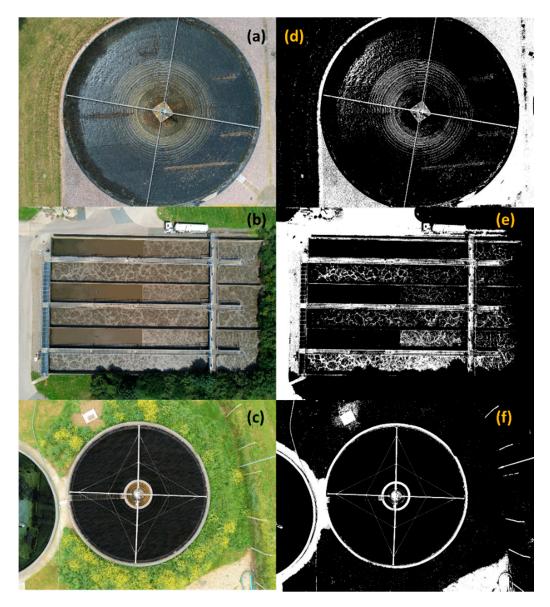
**Figure 4.** Examples of identification of asset failure. (a–c) Red, Green, and Blue (RGB) images taken with the Parrot Anafi (Parrot, France) Unmanned Aircraft Systems representing "working" conditions (a) and "failure" conditions (b–c); (d–f) white and black transformation of the RGB image. The white pixel to total pixel ratio is 7.85% for (d), 10.76% for (e), and 3.23% for (f).

The variation in the TF ratios of white pixels over total number of pixels differed, depending on the site and TF inspected, with values that range from 1.3% to 2.7% for Cranfield and 8.6% to 7.7% for Worcester. Figure 4 shows typical values and image outcomes obtained for the TFs and ASs algorithms. The threshold values for the classification of an asset as failing or working correctly are not reported, due the confidentiality aspects of the research carried out.
