# Evaluating the Infiltration Performance of Eight Dutch Permeable Pavements Using a New Full-Scale Infiltration Testing Method

Floris Boogaard <sup>1,2,3,\*</sup>, Terry Lucke <sup>4</sup>, Nick van de Giesen <sup>1</sup> and Frans van de Ven <sup>1,5</sup>

**Keywords:** permeable pavements; infiltration rate; clogging; SUDS; full-scale test method

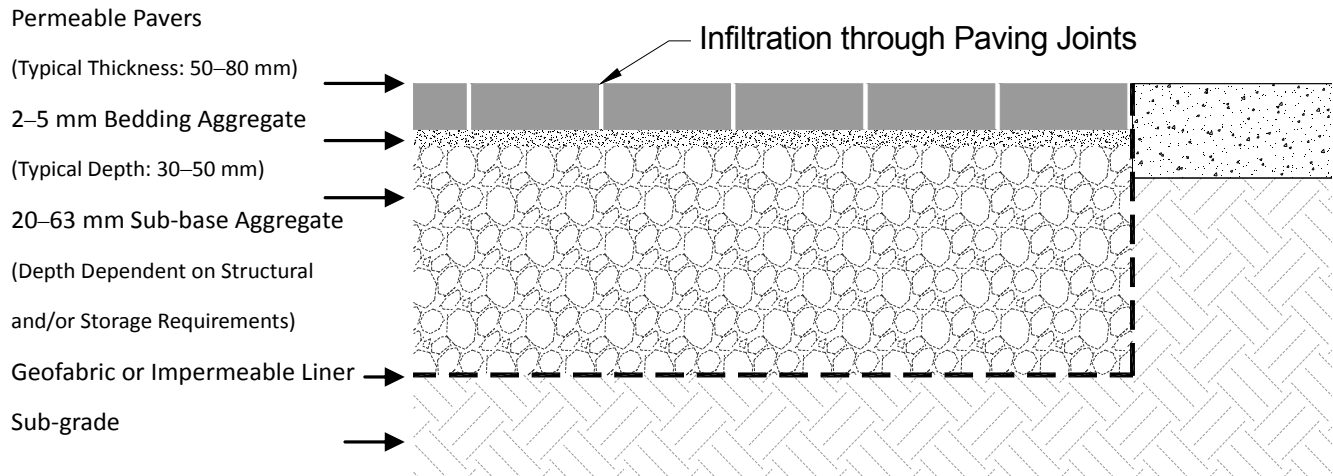
**Figure 1.** Typical permeable pavement structure.

- Construction: While the construction of the test pavements were generally similar to that shown in Figure 1, there were slight differences between the sites. These included the size of the paving joints, different types of bedding aggregates and different pavement laying processes.

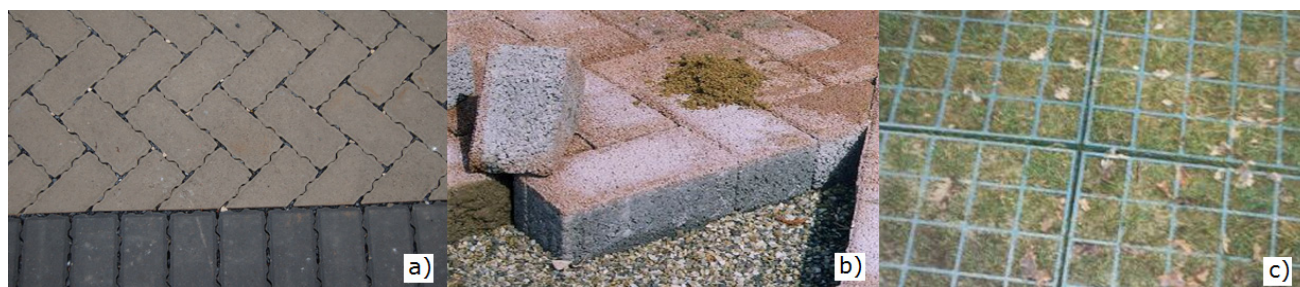
There are several types of permeable pavements typically used in Europe, including concrete pavers with wide joints or apertures (Figure 2a) and porous concrete pavers, either with or without wide joints (Figure 2b). These are usually manufactured as blocks and are generally referred to as permeable concrete interlocking pavers (PCIP). Concrete and plastic grid pavers (CGP and PGP) are also often used in Europe. The design and function of CGPs and PGPs are similar to PCIP; however, the areas of the individual pavers are generally much larger than those used for PCIP systems. They also have more open void spaces to promote infiltration. Stormwater is able to infiltrate through the large gaps in these pavers, which are usually filled with gravel, or topsoil planted with grass (Figure 2c).

**Figure 2.** (a) Impermeable concrete PCIP (permeable concrete interlocking pavers); (b) porous concrete PCIPs; (c) grass-filled plastic grid pavers (PGPs).

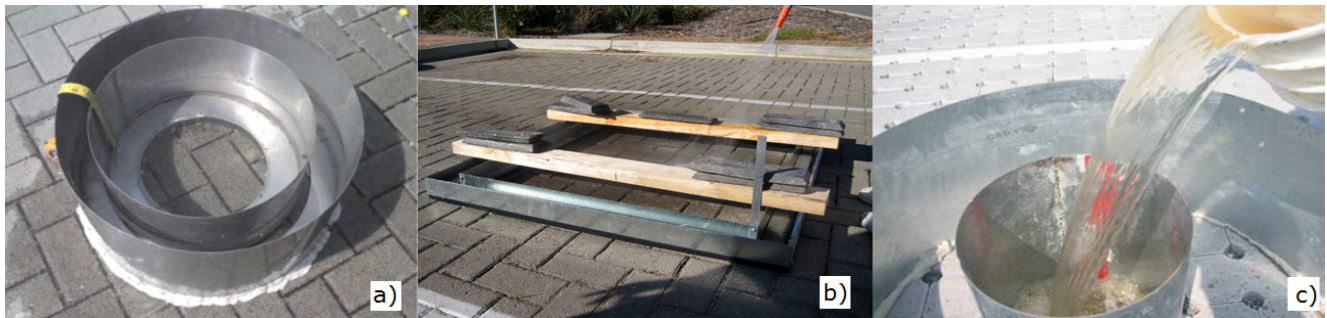
A number of previous permeable pavement infiltration studies [4,10,13,15] have been based on results using a modified version of either the single- or double-ring infiltrometer test (ASTM D3385-09) [17]. In these tests, rings are sealed to the pavement surface and filled with water. The time taken for the water to infiltrate through the permeable surface area is used to estimate an average infiltration rate (usually in mm/h) for the test location. Both the constant head and the falling head methods can be utilised in these testing procedures. Double-ring infiltrometer tests (DRIT) have generally been the preferred method in the past. This is because the outer ring is thought to reduce measurement errors and to prevent lateral flow from occurring beneath the rings. However, on pavements where the infiltration rate is so high that it is difficult to supply enough water to both rings, the single-ring surface infiltration test [4] has been used (Figure 3c).

Three variations of ring infiltrometers used in past permeable pavement studies are shown in Figure 3. Other permeable pavement infiltration research has been undertaken using specially fabricated rainfall simulation infiltrometers [6,9]. A new Standard Test Method for the Surface Infiltration Rate of Permeable Unit pavement Systems (ATSM C1781M-13) [18] has recently been published. However, to date, there have been no studies published using this method.

**Figure 3.** Modified ring infiltrometers used for permeable pavement testing: (a) double-ring infiltrometer tests (DRIT) [15]; (b) square, double-ring [13]; (c) single-ring surface inundation test [4].

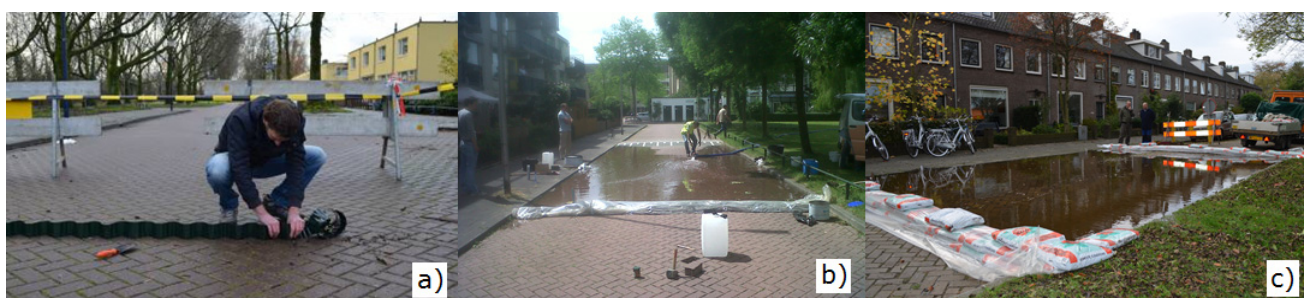
To accurately define the infiltration testing area and to contain the water used to infiltrate the pavement, it was necessary to construct small, temporary dams at the ends of the pavement test sections. The roadway kerb and gutter system retained the water on the sides of the pavement test sections. A number of dam variations were trialled at the eight different test locations (Figure 4). These included:

1. Soil core wrapped in plastic sheeting;
2. Sand core wrapped in geotextile;
3. Soil- or sand-filled plastic bags;
4. Impermeable barriers inserted into paving gaps; and
5. Use of existing traffic calming devices (speed-humps).

**Figure 4.** Various dam variations used at the different test locations; (a) impermeable barriers; (b) plastic wrapped soil core; (c) soil-filled plastic bags.

leaking from the test area and entering the underground stormwater drainage system. This can be both difficult to accomplish and time consuming. Of all the methods trialled to create temporary dams, the soil-filled were found to be the most effective. This was due to their ability to properly seal the test sections, the rapid filling and emptying characteristics of the bags, the ability to reuse the material and the ease of construction by hand without the need for heavy machinery.

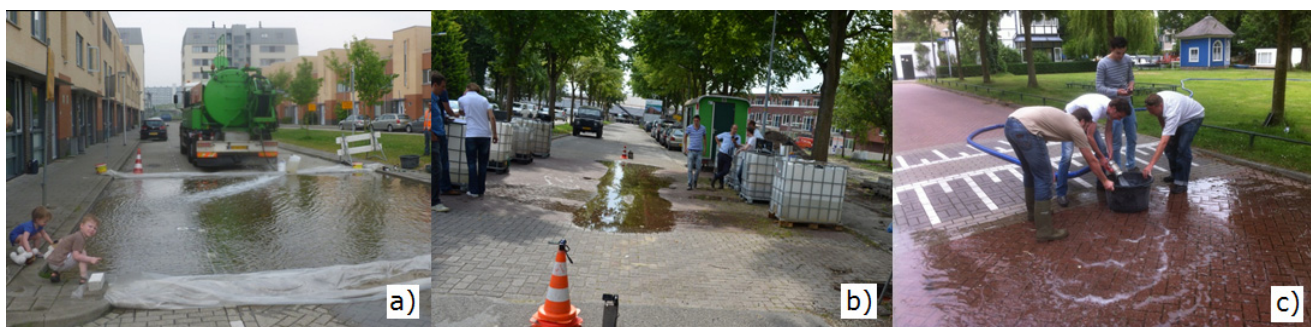
The new infiltration test requires large volumes of water to be discharged onto the test paving section in order to inundate the pavement surface. Depending on the site location, a number of different water supply options were trialled in this study, including transporting water directly to the site with water trucks (Figure 5a) or water tanks (Figure 5b) and pumping water directly from nearby canals (Figure 5c).

**Figure 5.** (a) Water truck supply; (b) water tank supply; (c) pumping from canal.

Of the three water supply methods trialled, it was found that pumping the water from a nearby canal was the easiest option, where this option was available. This method offered total flexibility with types of testing and also offered an unlimited availability of water. It is recommended to include a flowmeter in the water supply line to allow accurate monitoring of water inflow rates. Water trucks were the second easiest option. However, these had the disadvantages of being expensive and difficult to arrange, manoeuvre and park, and they generally had only limited water supply capacity. When a water truck must be used, it is advisable to ensure that the outlet is fitted with a flowmeter to measure flow rate into the test pavement area.

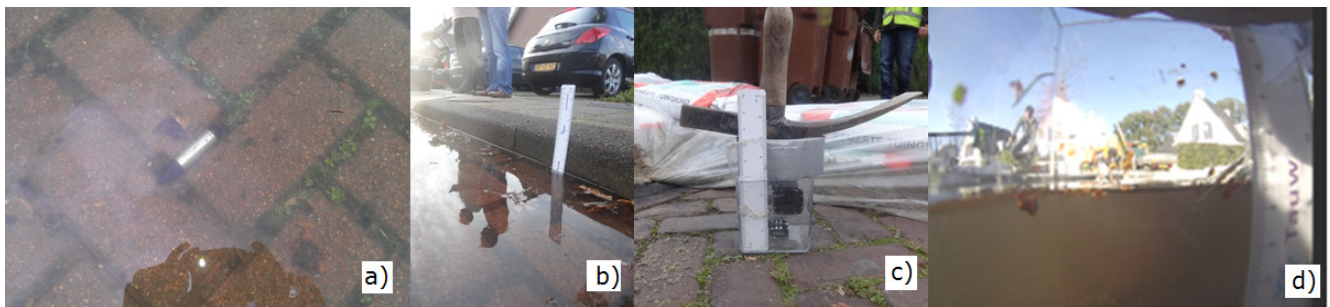
Three different measurement methods (Figure 6) were used in conjunction with the pressure transducers in order to calibrate and verify the transducer readings. The three methods were:

1. Hand measurements;
2. Calibrated underwater camera;
3. Time-lapse photography.

**Figure 6.** (a) Minidiver installed at lowest point of pavement; (b) hand measurement point; (c) underwater camera set-up; (d) underwater camera view.

Water level measurements were taken using a simple 300-mm hand ruler (Figure 6b) at strategic locations on the pavement surface throughout the duration of the testing. These measurements were used to verify the functionality and accuracy of the self-logging pressure transducers, as described above. Photographs of each hand measurement were also taken for documentation and verification purposes.

A high-definition video camera was also used at a number of strategic locations to record the decrease in pavement water levels over the duration of the tests. The camera was placed inside a waterproof, calibrated, transparent box, so that it could capture the entire infiltration process (Figure 6c). This system allowed real-time monitoring of the entire infiltration process and also facilitated precise verification of the pressure transducer measurements.

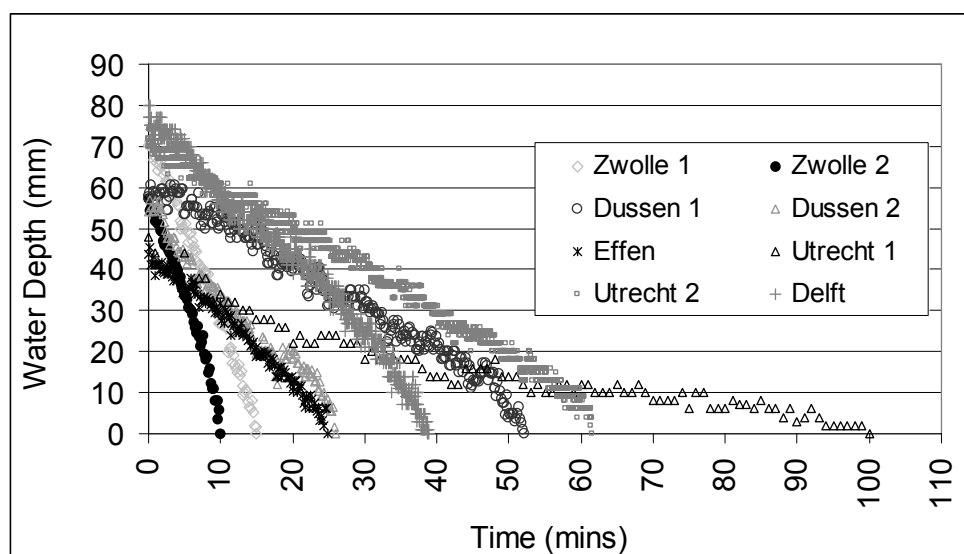
All eight test pavements (Table 1) were sealed, inundated and monitored as described above. The pressure transducer readings were then plotted against time to generate precise infiltration curves for each of the test sites (Figure 7). Simple linear regression analysis was used to generate lines of best fit for the transducer readings from each site. The equations of the linear regression lines were then used to calculate the average infiltration rate in mm/h for each test site (Table 1).

**Figure 7.** Infiltration curve results for the eight permeable pavements tested in the study.

The surface infiltration rates recorded for each of eight test pavements using the new experimental test procedure are shown in Figure 7.

Although the eight permeable pavements tested in this study were of a similar construction type and of similar age, Table 2 shows a large variation in the calculated infiltration rates between the eight study pavements. This variation in results is similar to the findings of a number of previous studies that have attempted to quantify the infiltration rates of permeable pavements [4,13,16,21–23]. The infiltration rates of the eight test pavements differed from between 29 and 342 mm/h.
