Article

The Experimental Verification of Direct-Write Silver Conductive Grid and ARIMA Time Series Analysis for Crack Propagation

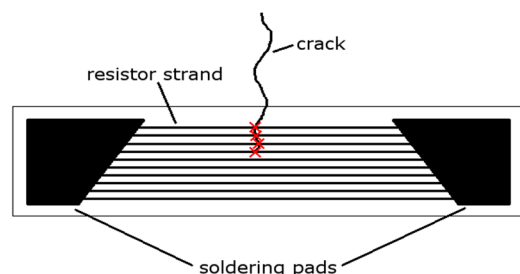
Figure 1. An example of a commercially available crack gauge.

The customized resistive crack propagation sensors proposed in this article could become a good alternative method for crack detection and monitoring, due to their economic and functional features, which will be discussed further. Fatigue crack detection and its size determination are the basic aims of the SHM system. One of the approaches to fatigue crack monitoring is the use of commercially available crack gauges, as shown in Figure 1.

The sensor is composed of a series of conductive strands connected in parallel. When a crack propagates underneath the sensor bonded to the structure, subsequent strands of the sensor break down. This results in a stepwise increase in the sensor's resistance. Therefore, by tracking the resistance of the sensor, the condition of the structure can be inferred. Investigation of this technique was performed for both coupons, realistic structures [25], and during a full-scale fatigue test [26] of an aircraft structure. The method can provide a convenient, straightforward, and economically effective solution to indicate the presence of a crack and to quantify its linear size in a predetermined location on a test part or structure. The method of integrating the sensor into the structure is similar to that for regular foil strain gauges, so the surface needs to be mechanically and chemically prepared before bonding to ensure good and reliable results.

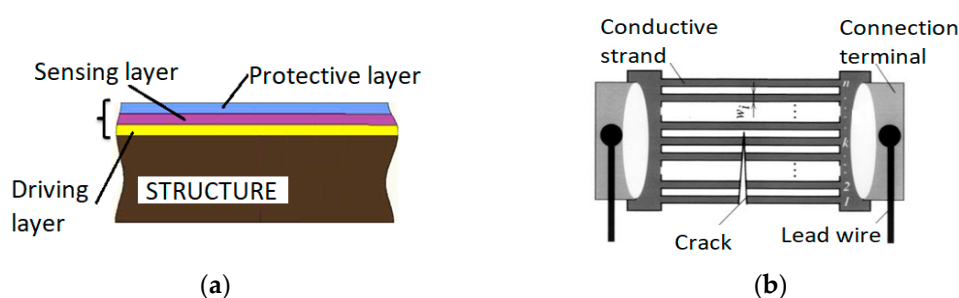
Figure 2. The crack propagation sensor: (a) cross-section; (b) top view.

the tailoring of the shape of the sensor's measuring grid to the specific structure. The feature of adapting the measuring grid shape translates directly into the ability to detect even relatively short cracks (sensor installed closer to the "hot spot") and damage size quantification. Additionally, the overall dimensions of the sensor itself can be adjusted to fit the specific location or structural element. Customized resistive crack propagation sensors are fabricated using flexible insulating materials for the driving and protective layers and conductive paint with silver microparticles for the sensing layer (Figure 2). Compared to most methods mentioned in the previous subchapter, the sensor's conductive layer is not continuous, which allows for the discrete but precise evaluation of the crack length, even in the presence of external factors (e.g., temperature, load).

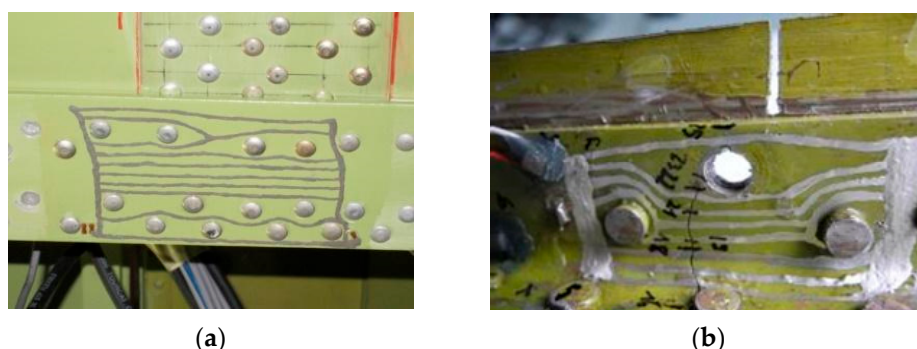
Figure 3. The customized crack propagation sensors, fabricated directly on the structure: (a) the bottom central wing section during full-scale fatigue test, (b) a fragment of a wing spar during lab test.

The experimental verification of direct-write customized resistive crack propagation sensors for the detection and quantification of fatigue cracks was investigated by performing a laboratory fatigue test. During the test, a compact tension specimen (CT coupon) was used, with 2 simply shaped sensors installed on both sides of the specimen, as shown in Figure 4. The simple shape of the sensing layer was chosen for this test as a proof-of-concept and a direct analogy to commercially available crack gauges, although a more complex grid can be achieved, as shown in Figure 3.

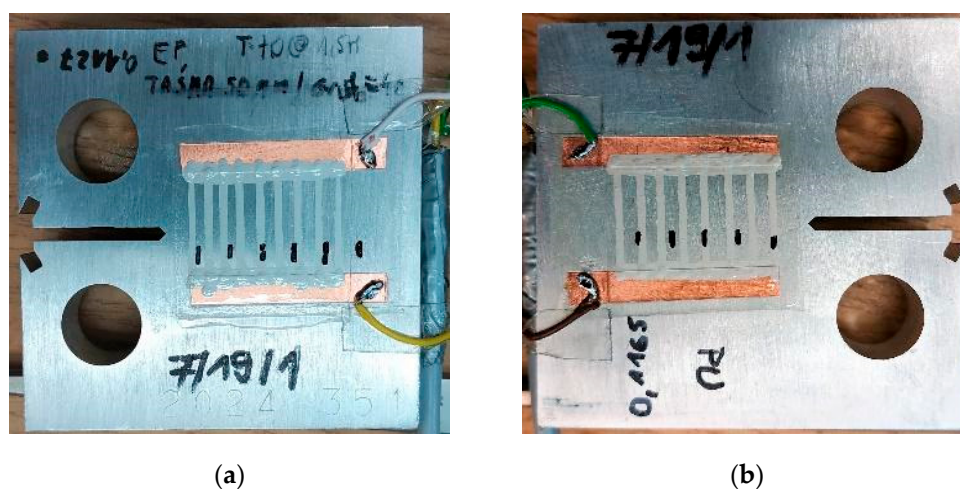
Figure 4. A view of two sides of CT coupon specimen with customized crack propagation sensors: (a) epoxy (EP), (b) polyurethane (PU) driving layer.

Sensors were fabricated layer-by-layer on the specimen, using translucent two-part epoxy (832C, MG Chemicals, Ontario, Canada) on one side and 1-part polyurethane coating (M-Coat A, Vishay Precision Group, Malvern, PA, USA) on the other side of the CT coupon as a driving and top layer (Figure 4). Tape masking and a doctor blade were used to prepare and smooth the driving layers, which were cured for 1.5 h at 70 degrees Celsius in the oven. As a sensing grid layer material, Pelco® 16031 Colloidal Silver Paint (Ted Pella, Inc., Redding, CA, USA) was applied on the driving layer with a rapidograph drawing pen and left to cure at ambient temperature for more than 24 h. Side terminals for wire connections were produced using thin copper adhesive tape.

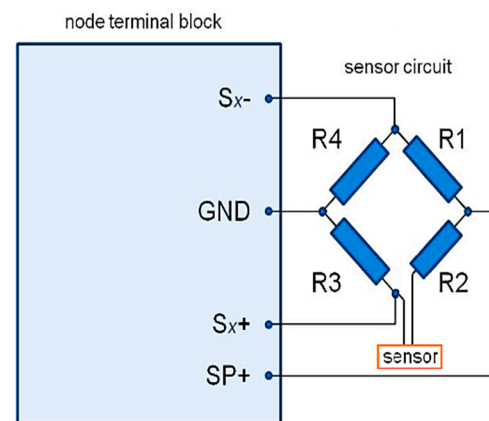
Figure 5. The measurement circuit for crack propagation sensors.

During the execution of the fatigue test, the sensors were connected to the differential voltage input of the wireless V-Link-200 sensor node (Lord MicroStrain® Sensing, Williston, VT, USA) through a Wheatstone bridge as a basic electrical circuit. The bridge was completed with 350 ohm resistors, one in each arm, and the additional resistance (crack propagation sensor) was placed in one arm (Figure 5). Raw data from the sensors were pre-processed for further analysis using the DIAdem data management software (NI, Austin, Texas), and this included resampling from 64 Hz to 60 Hz (for synchronization with data from the fatigue machine) and smooth filtering (3 point width median filter).

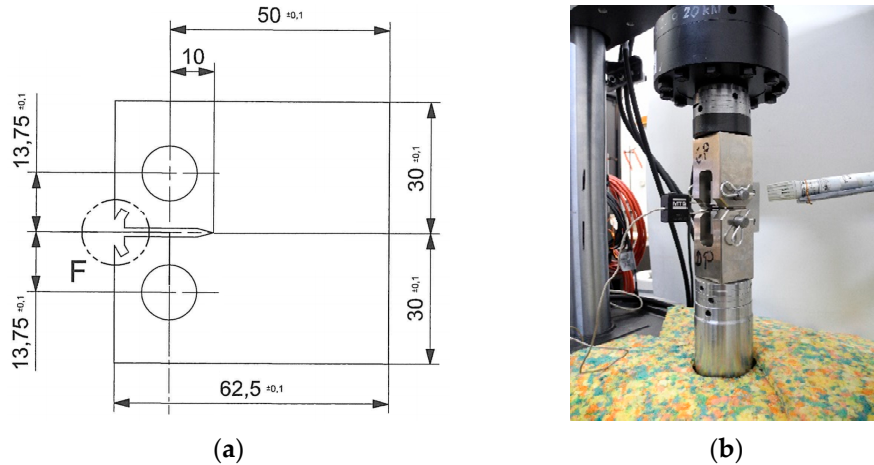
Figure 6. The CT coupon specimen for fatigue test: (a) dimensions; (b) installed in test machine with COD mounted at front.

The specimen was cut from a 13 mm thick sheet of EN AW-2024 T351 alloy ($R_m = 461$ MPa, $Re_{0.2} = 317$ MPa) and its geometry is shown in Figure 6a.

Displacement (v) refers to displacement between the measurement points in front of the specimen, marked in Figure 6a with dashed circles. The specimen fitted in the fatigue machine and mounted on the COD gauge for displacement measurement is depicted in Figure 6b.

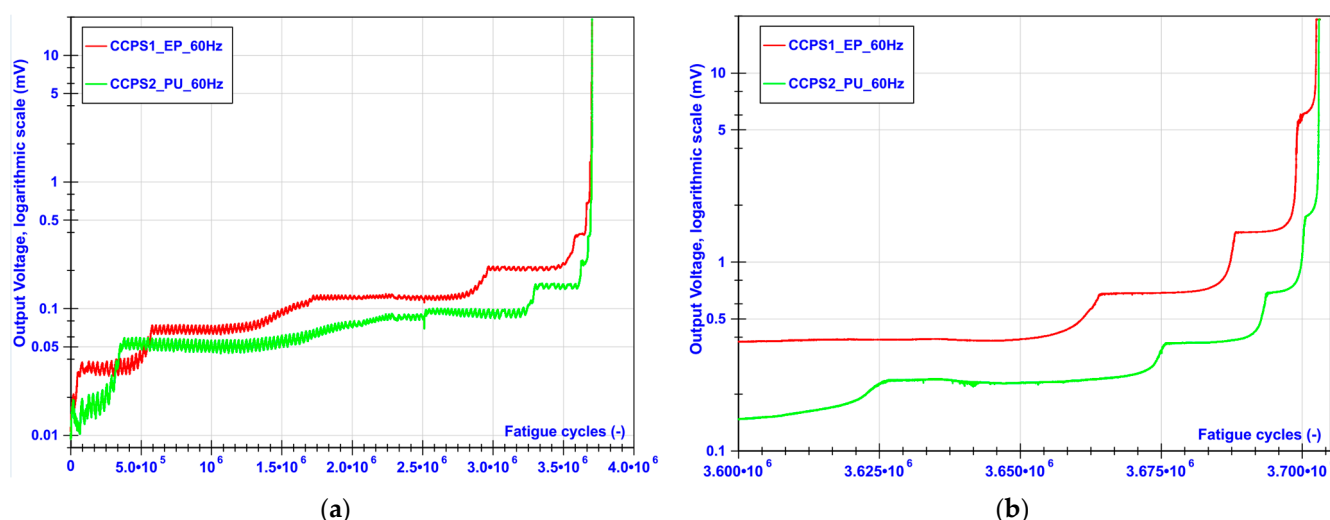
Figure 7. The output voltage from customized crack propagation sensors during CT coupon fatigue test: (a) the whole test, (b) last 100,000 cycles with high crack growth rate.

The measured output voltage from sensors on both sides of the CT coupon are illustrated in Figure 7. The CCPS1_EP conductive grid was fabricated on the epoxy resin, and CCPS2_PU on the polyurethane coating. Due to high value of the crack growth rate at the end of the test, the data from last 100,000 cycles are magnified in Figure 7b to reveal the sensors' performance in this region.

Similarly to classical crack gauges, the stepwise output characteristic could be seen as the crack was propagated during the test. Signal steps at the beginning of the crack evolution were small but stable. Signal fluctuations, mainly seen at the initial stage of the test, were caused by temperature drifts around the test stand. Then, the signal steps became evident, when the number of broken strands was increased. Both driving layer materials—epoxy (EP) as well as polyurethane (PU)—showed good insulation between the conductive grids and the specimen and also the adhesion to its structure during the fatigue test. Slightly higher signal fluctuations could be observed for the PU layer. This can be explained by the incompatibility of the thermal expansion coefficient of the PU driving layer and the specimen or the elasto-plastic deformation of this type of driving layer. The PU was found to be more flexible than EP, and its hardness was within the Shore A range, while epoxy was considered Shore D. Nevertheless, for both sensors, the crack was transferred from the specimen to the sensor layers equally. The monotonic increase in the signals between stable step values confirms that the single conductive strand tore apart gradually with the coupon.

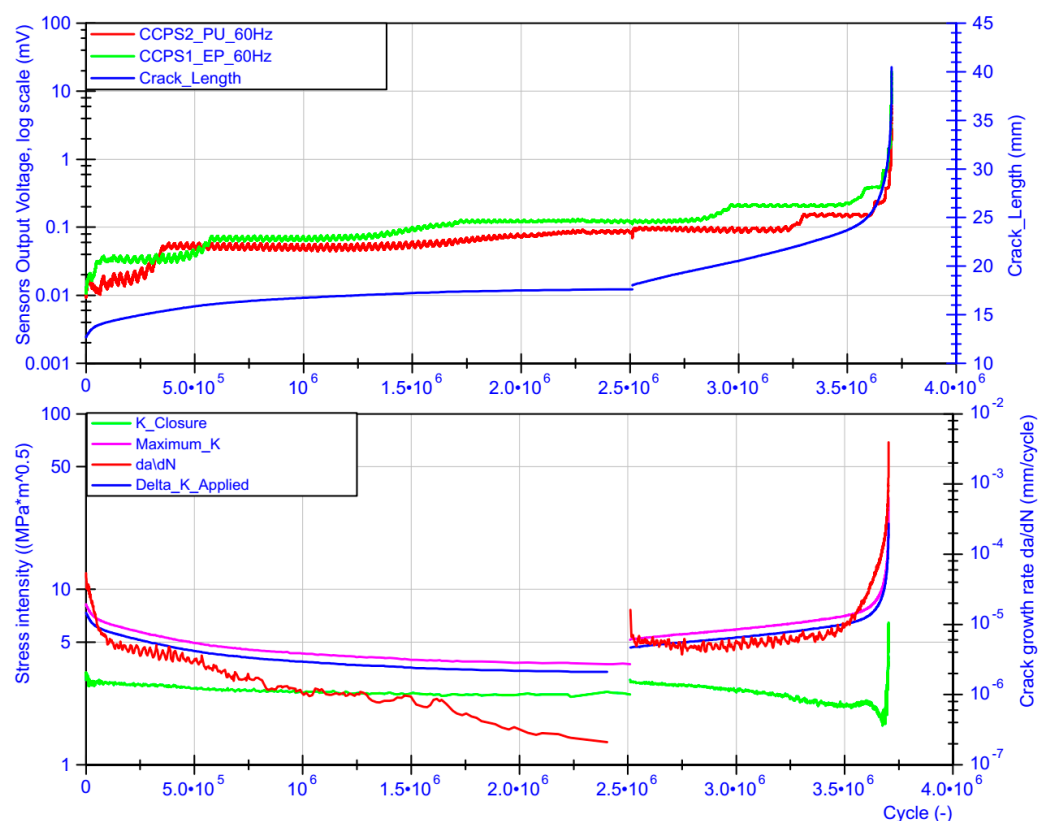
Figure 8. Performance of conductive grids due to change in fatigue test parameters.

Figure 8 collectively presents data from the conductive grids as well as from the fatigue machine controller. The crack length from the upper chart was measured by the COD gauge, with the reference at the fitting points of the CT specimen. As shown in Figure 6a, it was 10 mm. The starting value included approx. 2.6 mm of the pre-crack. During the first part of the test, the decreasing stress intensity factor $\Delta K_{Applied}$ (named Delta_K_Applied in Figure 8) from 7.3 to 3.4 $\text{MPa}\sqrt{\text{m}}$ caused the same trend in the crack growth rate da/dN . For this reason, longer periods of maintaining the stable voltage level from the conductive grids were observed, as well as a wider range of the transient state while the strand of the conductive grid was torn apart. In the constant amplitude force part of the test, a linear increase in crack length as well as the stress intensity factor could be observed for the COD gauge measurements from 18 to 24 mm. The crack growth rate decreased its value from 1.61×10^{-5} mm/cycle and reached a valley at 4.40×10^{-6} around approx. 2,900,000 cycles. After this, both parameters da/dN and $\Delta K_{Applied}$ increased linearly, reaching 1.61×10^{-5} mm/cycle around 3,500,000 cycles of the test. Further rapid acceleration of crack propagation could be noticed for all parameters in Figure 8 until the CT specimen became permanently damaged. Immediately before the end of the test, the crack growth rate as well as stress intensity factor reached their maximum values of 3.92×10^{-3} mm/cycle and 23.6 $\text{MPa}\sqrt{\text{m}}$, respectively. In the region of the high value of $\Delta K_{Applied}$, the effect of plasticity started to influence the crack growth rate because the plastic zone size became large before the crack tip. As can be observed in Figure 7b, even in this region, signals from the silver conductive grids showed a highly stable stepping characteristic between transient states due to the tearing of the silver strand.

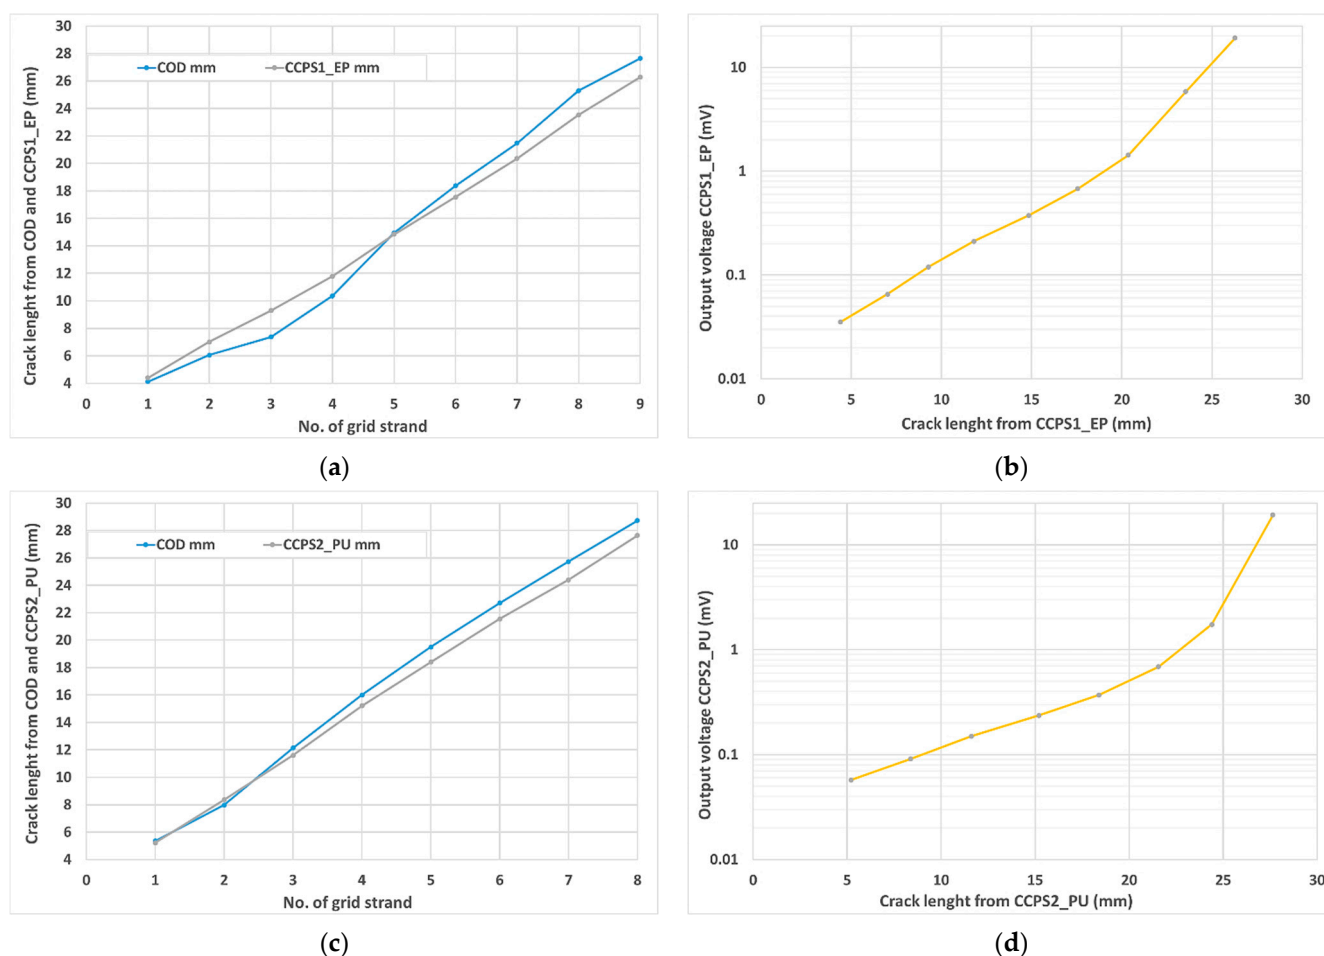
Figure 9. (a) The crack length measurement comparison from COD and sensor CCPS1_EP; (b) crack length versus output voltage for sensor CCPS1_EP; (c) crack length measurement comparison from COD and sensor CCPS2_PU; (d) crack length versus output voltage for sensor CCPS2_PU.

The comparison of crack lengths measured by the COD gauge and predefined conductive grid shapes (strand separation) is presented in Figure 9a for CCPS_EP and in Figure 9c. The shape of both sensors' grids, the single strand distances from the specimen notch, and their widths were measured before conducting the test by the optical microscope. The corresponding crack length from the COD was captured when the sensor voltage signal stabilized (reached the next stable step value) after the transient state (Figure 8—top). Additionally, for both sensors, CCPS1_EP and CCPS2_PU, the characteristics of output voltage as a function of the crack length are shown in Figure 9b,d, respectively.

It can be observed that for sensor CCPS2_PU with the polyurethane driving layer, the crack length measured by the COD gauge and optical image were similar for the first three strands. After this, the crack length from the COD gauge was approx. 1–1.5 mm longer than measured by the conductive grid. The same can be seen for the CCPS1_EP sensor on the epoxy driving layer after the sixth strand was torn apart. The reason for the decreased crack length value for both sensors compared to COD will be considered in a further investigation. There could be several potential causes, e.g., the thickness of the driving layer, a delay in strain transfer from the specimen surface to the sensing layer, or local delamination of the sensor near the crack plastic zone, or, on the other hand, slight overestimation of the COD indication in the higher $\Delta K_{Applied}$ region. Nonetheless, the offset between the COD and crack propagation sensors seems to be stable and acceptable in operational application.

However, some differences in the measured crack length were also seen for the CCPS1_EP sensor for the first four strands of the conductive grid. While, for the first strand, this offset was negligible (0.27 mm), for the second, third, and fourth strand, the conductive grid showed, respectively, 0.96 mm, 1.90 mm, and 1.42 mm higher crack lengths than the COD gauge. There could be at least two main causes that explain this phenomenon. The first is the false positive indication of the crack propagation from the sensor due to the low fatigue strength of the EP layer. As a consequence, the sensor could have suffered from adhesive failure and become delaminated from the host structure of the CT specimen. It is less likely that the force acting on the specimen was higher than the cohesion force of the EP layer, because, during this stage of the fatigue test, the stress intensity factor as well as the excitation force were constantly decreasing. The second explanation could be uneven crack propagation in relation to the CT coupon thickness (which was 13 mm). In other words, the front of the crack was not parallel to the line of the notch. If so, the surface cracks on the sidewalls of the specimen would not have had equal length. The microscope images of the specimen taken after test are shown in Figure 10 to verify the fracture surface through the thickness of the CT coupon. As revealed by Figure 10a, the darker shade of the fracture seems to start and finish lower on the left (side of the CCSP2_PU) than on the right (side of the CCSP1_EP). The difference is at least 1 mm. The same can be confirmed by the fracture surface height profile in Figure 10b, indicated by the dark red area at the bottom of the image (marked by blue frame). The uneven crack propagation through the specimen thickness could be caused by, e.g., the movement of the test article in the clamps, the machining of the notch while preparing the specimen,

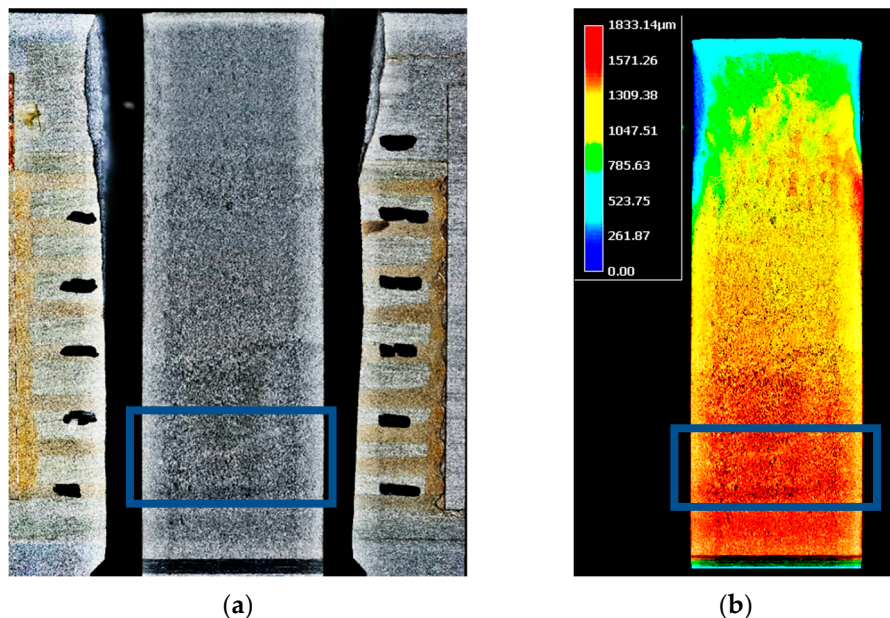
Figure 10. The microscope images of the specimen after test: (a) combined images of sensor CCPS2_PU (left), fracture surface (center), sensor CCPS1_EP (right); (b) fracture surface height profile from 3D optical scan mode.

or fatigue machine piston misalignment. However, one of the main indicators of the correctness of the compliance test is the crack propagation in the center of the specimen. The height profile scan shows that the change in height along the direction of crack propagation in the fatigue fracture range was less than 0.8 mm. Thus, it can be concluded that the differences in the crack length measured by the COD gauge and the sensor CCPS1_EP grid were due to uneven propagation in the specimen thickness.

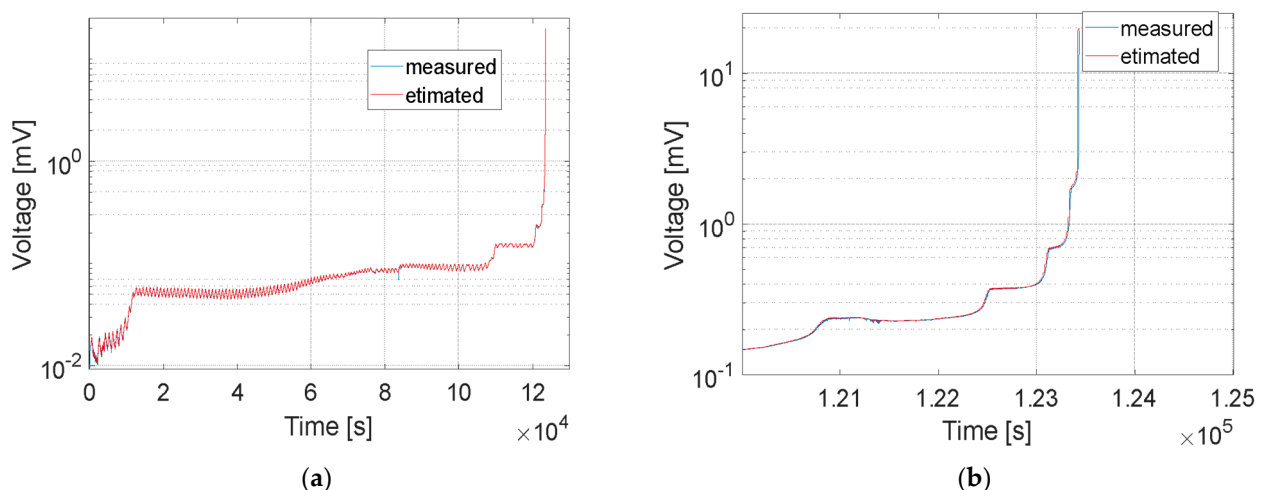
Figure 11. Measured and estimated data of (PU) sensor: (a) all registered samples, (b) high crack growth area.

Crack predictions with ARIMA modeling were performed. Calculation results of the designed algorithm are presented in Figures 11 and 12, respectively, for the CCPS2_PU and CCPS1_EP sensors. Measured and estimated data are marked with blue and red lines, respectively.

The crack prediction was conducted with use of the ARIMA model, based on the output voltage time series registered during the research. A simple model with all parameters (p , d , q) equal to 1 was used. Slight discrepancies between the recorded and forecasted values of the time series were obtained. The estimated standard error was very small and had a value of less than 0.03 in the case of the MA and AR components.

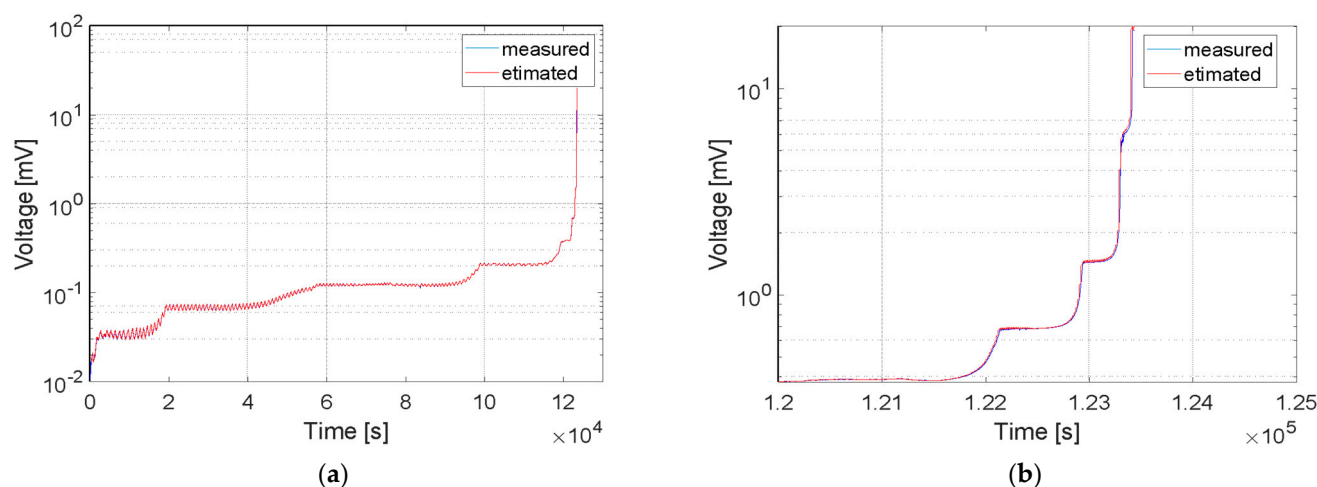
**Figure 12.** Measured and estimated data of (EP) sensor: (a) all registered samples, (b) high crack growth area.

The presented results show that the size of the crack could be predicted with the use of ARIMA modeling. During the analysis, 7000 iterations were made for more than 7 million samples of time series voltage. In each iteration, the ARIMA model parameters were estimated and 1000 future series values were predicted based on almost 20,000 samples. In our future work, we plan to use the estimated ARIMA model parameters as damage indicators, which would allow us to minimize the amount of archived data. In the case of the presented experiment, registered data were reduced by almost 99%. We also plan future studies of ARIMA modeling with different values of the p , d , and q parameters in order to verify the effectiveness of the algorithm and increase the estimation possibilities.
