# Application of Distributed Optical Fiber Sensing Technology to the Detection and Monitoring of Internal Swelling Pathologies in Massive Concrete Blocks

**Abstract:** This paper presents an experimental application of Distributed Optical Fiber Sensors (DOFS) for the Structural Health Monitoring (SHM) of concrete structures affected by internal swelling pathologies. In the framework of a large research project aiming to assess the possible extension of the operating lifetime of nuclear power plants from 40 to 60 years, massive blocks were cast from reactive concrete mixtures intended to develop delayed ettringite formation and alkali-silica reaction. These blocks were subjected to specific ageing conditions to initiate and accelerate the concrete pathologies. Some of the blocks were instrumented with DOFS bonded to the surface and embedded in the concrete. Using an interrogator device based on Rayleigh backscattering and a suitable procedure to eliminate temperature effects, distributed strain measurements were then performed at different time intervals. The first results of this ongoing study made it possible to demonstrate the feasibility and effectiveness of this sensing techno

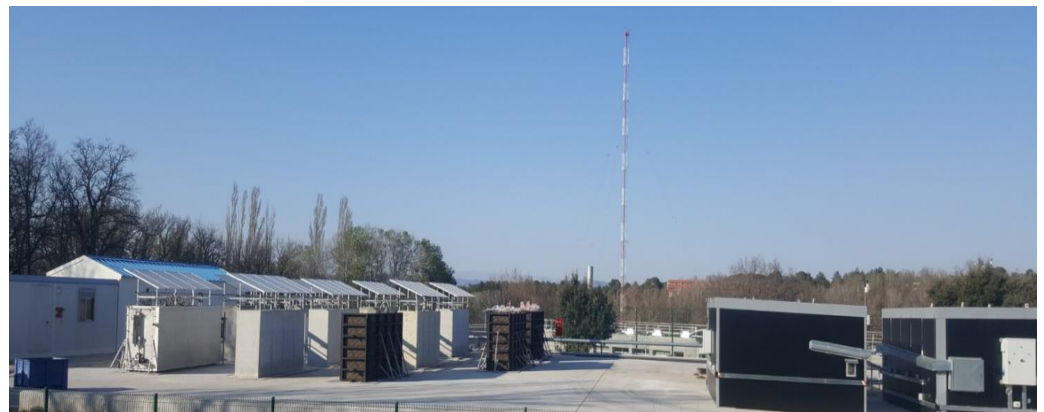
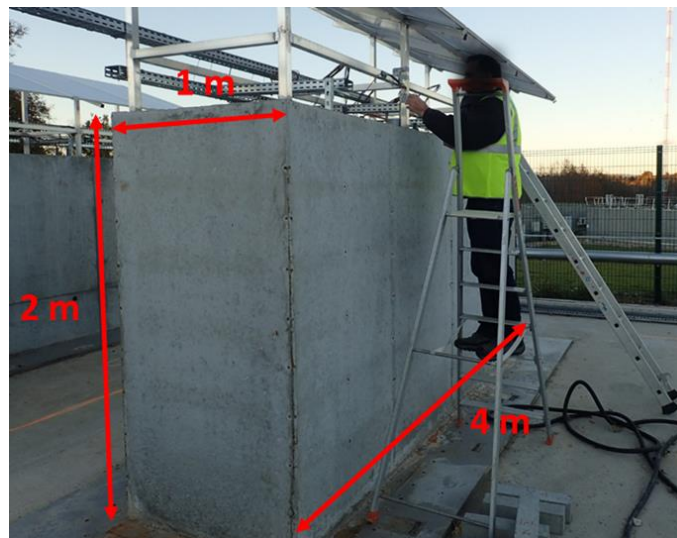
**Figure 1.** (a) Exposure platform for ODOBA blocks, and (b) dimensions of the blocks.

The concrete blocks of the ODOBA project are stored on a dedicated outdoor platform in Cadarache (south of France) and arranged in rows (Figure 1a). Each block measures  $1 \times 2 \times 4 \text{ m}^3$  (Figure 1b) and weighs about 20 tons. These massive blocks are divided into three categories: Reference blocks which are not expected to develop pathologies, potentially pathological blocks subjected to external weather conditions (referred to as “natural ageing” conditions), and potentially pathological blocks subjected to experimental protocols aimed at accelerating the development of pathologies (referred to as “accelerated ageing” conditions).

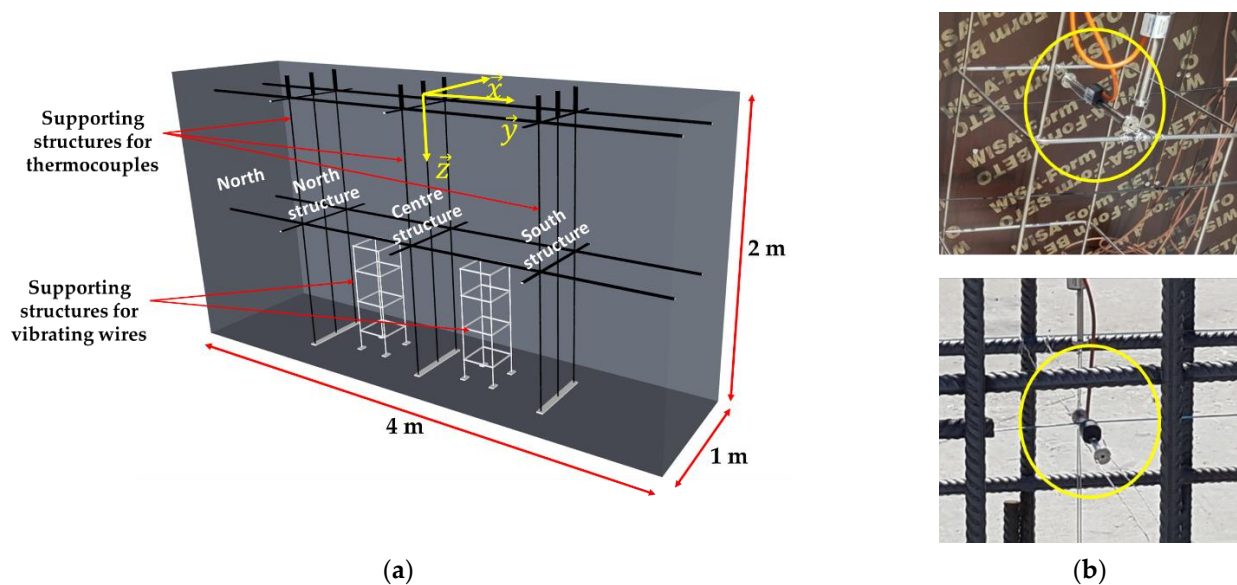
**Figure 2.** (a) Supporting structures for conventional sensors in NRC concrete block; (b) Installation of vibrating wires in an NRC block (top) and in an RC block (bottom).

Regarding NRC blocks, metallic frames supporting the VWs are installed at two specific locations (Figure 2a). Three VWs are attached to each frame (one VW along each direction  $\vec{x}$ ,  $\vec{y}$ , and  $\vec{z}$ —see reference coordinate system in Figure 2a), allowing for strain measurements along the three directions of space at each support location.

For the RC blocks (without supporting structures), the VWs are arranged according to the same geometrical configuration but using the steel reinforcement of the block as a supporting frame (Figure 2b bottom).

In the case of NRC blocks, these thermocouples are attached to three vertical structures, which are represented in black in Figure 2a. The thermocouples are thus arranged on three vertical ( $\vec{x}$ ,  $\vec{z}$ ) planes: one plane close to the north side of the block, another at the mid-width of the block, and the last plane near the south side of the block. This arrangement provides a global overview of the temperature gradients within the block. The locations of the various thermocouples on the three vertical structures are detailed in the scheme of Figure 3. The coordinates shown in Figure 3 are relative to the reference coordinate system drawn in Figure 2a (origin at the center of the upper face of the block).

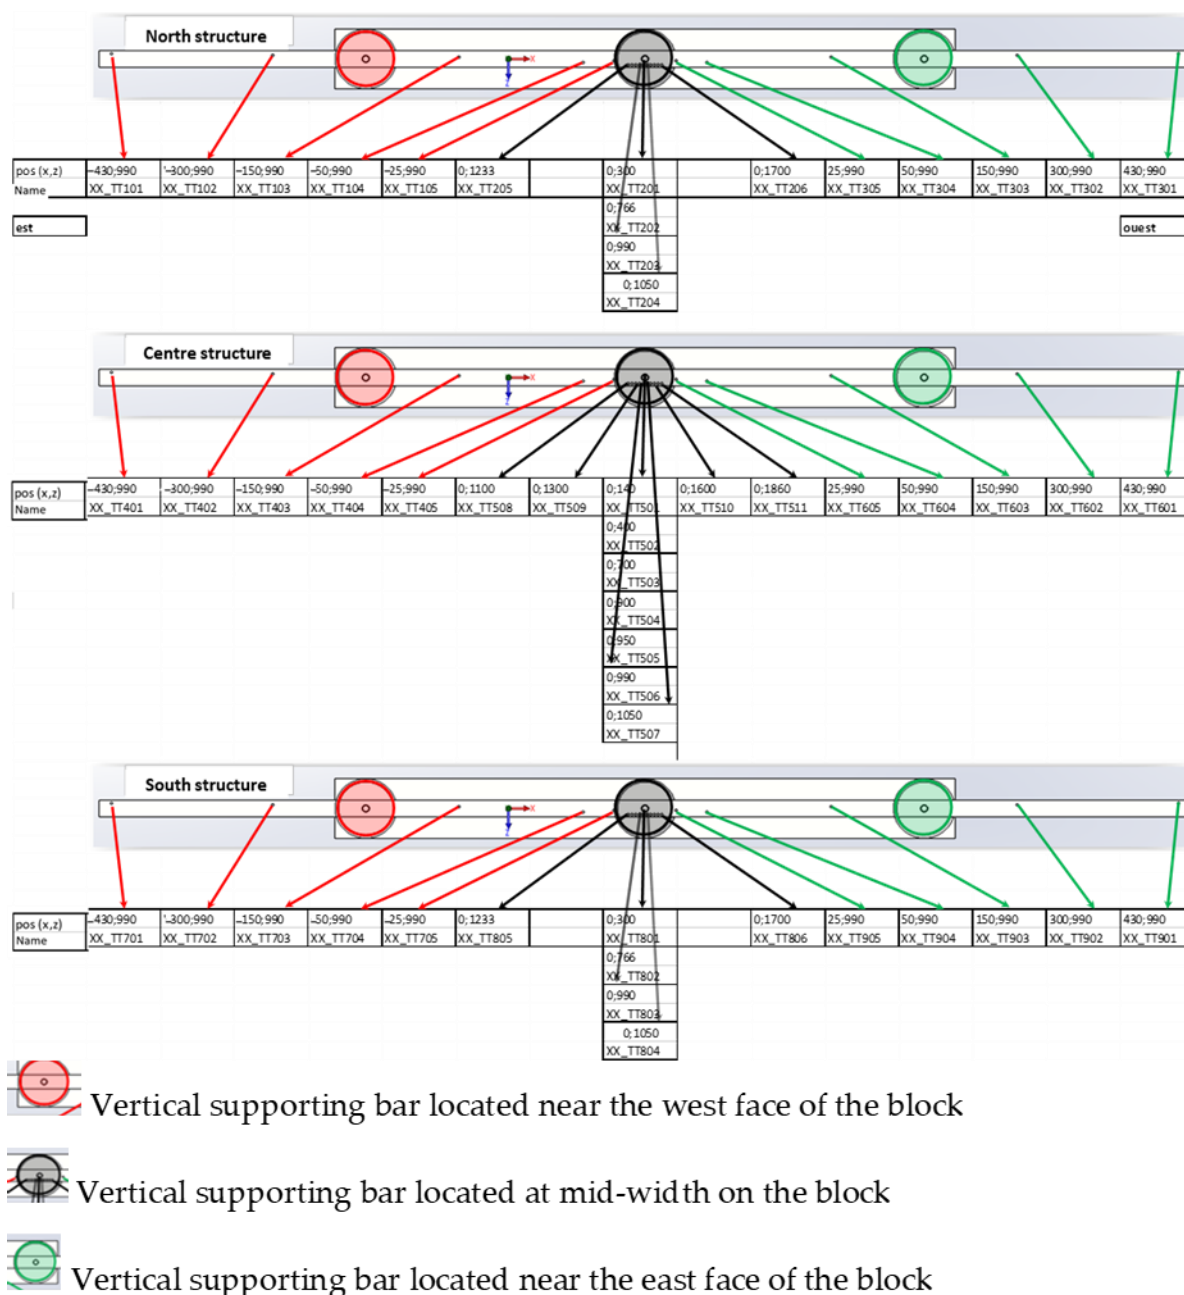
**Figure 3.** Coordinates (in mm) of the thermocouples in an NRC concrete block considering the origin of the coordinate system at the center of the upper face of the block.

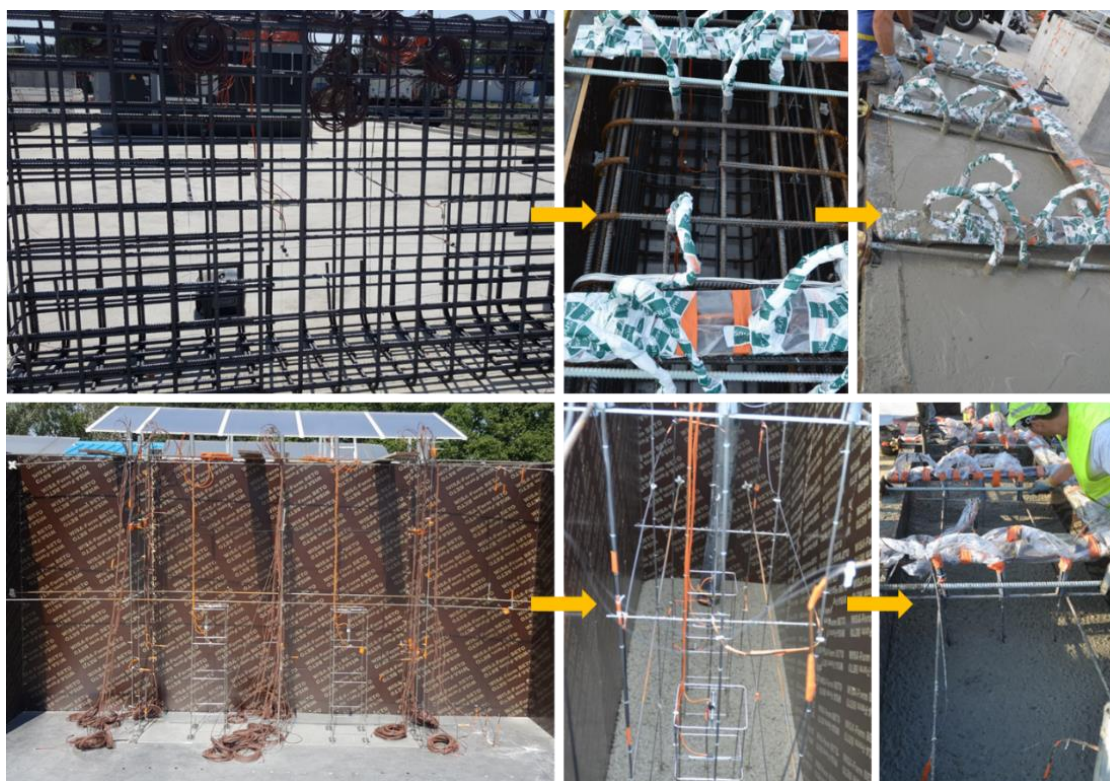
**Figure 4.** Construction steps of the two types of ODOBA blocks: RC blocks (top pictures) and NRC blocks (bottom pictures).

Figure 4 illustrates the manufacturing steps for RC blocks (top pictures) and NRC blocks (bottom pictures).

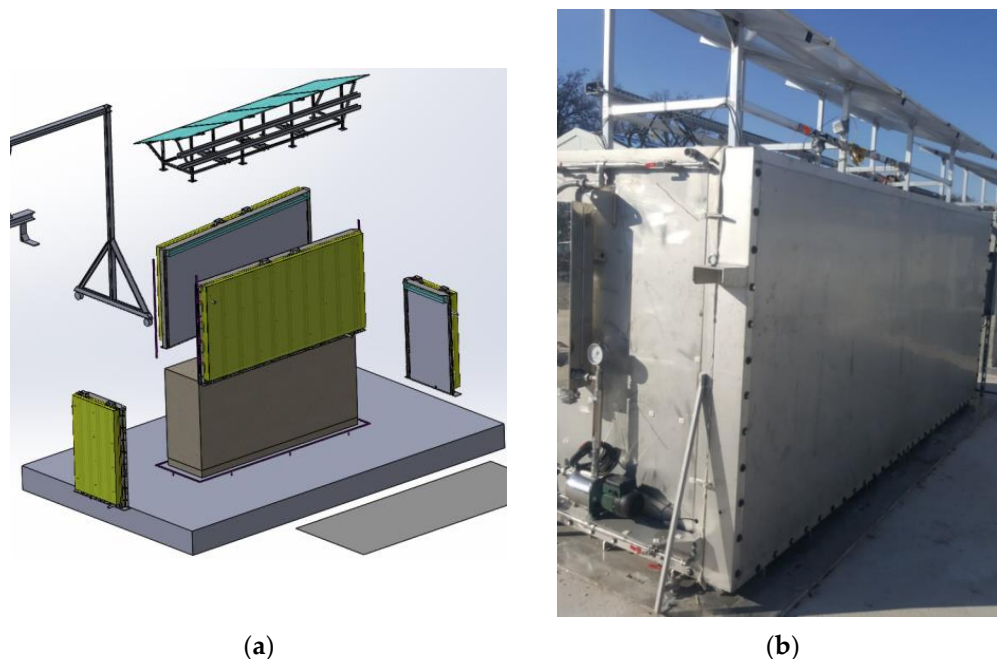
**Figure 5.** (a) Scheme of the pool setup used for the immersion of ODOBA blocks; (b) Picture of a pool in operation.

order to achieve this alternation of immersion/drying, the pool can be dismantled and reassembled. Indeed, as shown in Figure 5a, the four sides of the pool are easily put in place to form a watertight structure. Once filled, the pool provides a homogeneously heated water layer around the block, thanks to an integrated water circulation system (Figure 5b). In addition, an effluent treatment station allows for monitoring the quality of the water used in the pools (pH, chemical composition).

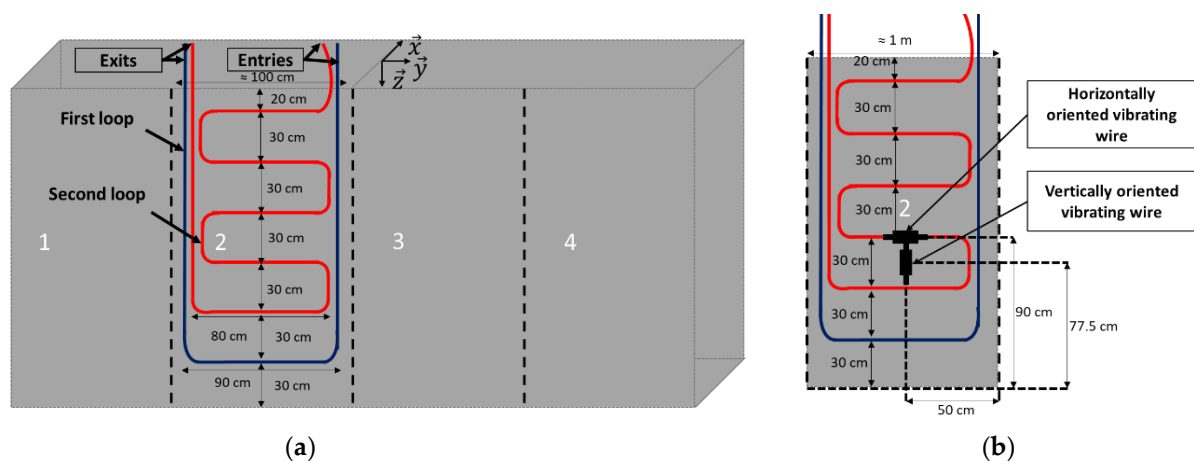
**Figure 6.** (a) Instrumentation scheme with bonded DOFS (b) Detail of the instrumented zone showing the two DOFS loops, and projection view of the embedded vibrating wires used for comparison.

One of the two larger sides of the block, with a surface area of  $4 \times 2 \text{ m}^2$ , is first divided into four identical zones (zones 1–4, see Figure 6a). Zone 2 is dedicated to receiving the bonded DOFS. The instrumentation scheme consists of two loops of DOFS cable.

The first loop (represented in blue color in Figure 6) follows the two vertical borders of zone 2 and has a horizontal portion about 30 cm above the ground level. This loop allows for the collection of the strain profiles at the two vertical borders of the instrumented zone 2, which can then be compared with the local measurements of the vertically oriented vibrating wire (VW) located halfway between the two vertical paths of the DOFS (see Figure 6b).

A second loop (red color in Figure 6) includes several horizontal paths at different heights of the block, the lowest being about 30 cm above the ground and the highest 20 cm from the top of the block. This second loop allows for the collection of the horizontal strain profiles over the whole instrumented zone and a comparison of the recorded values with the strain measurements from the horizontally oriented VW located in the same region of the block (see Figure 6b).

The concerned VWs are embedded 50 cm away from the surface of the block. Their locations in the  $(\vec{y}, \vec{z})$  plane are shown in Figure 6b.

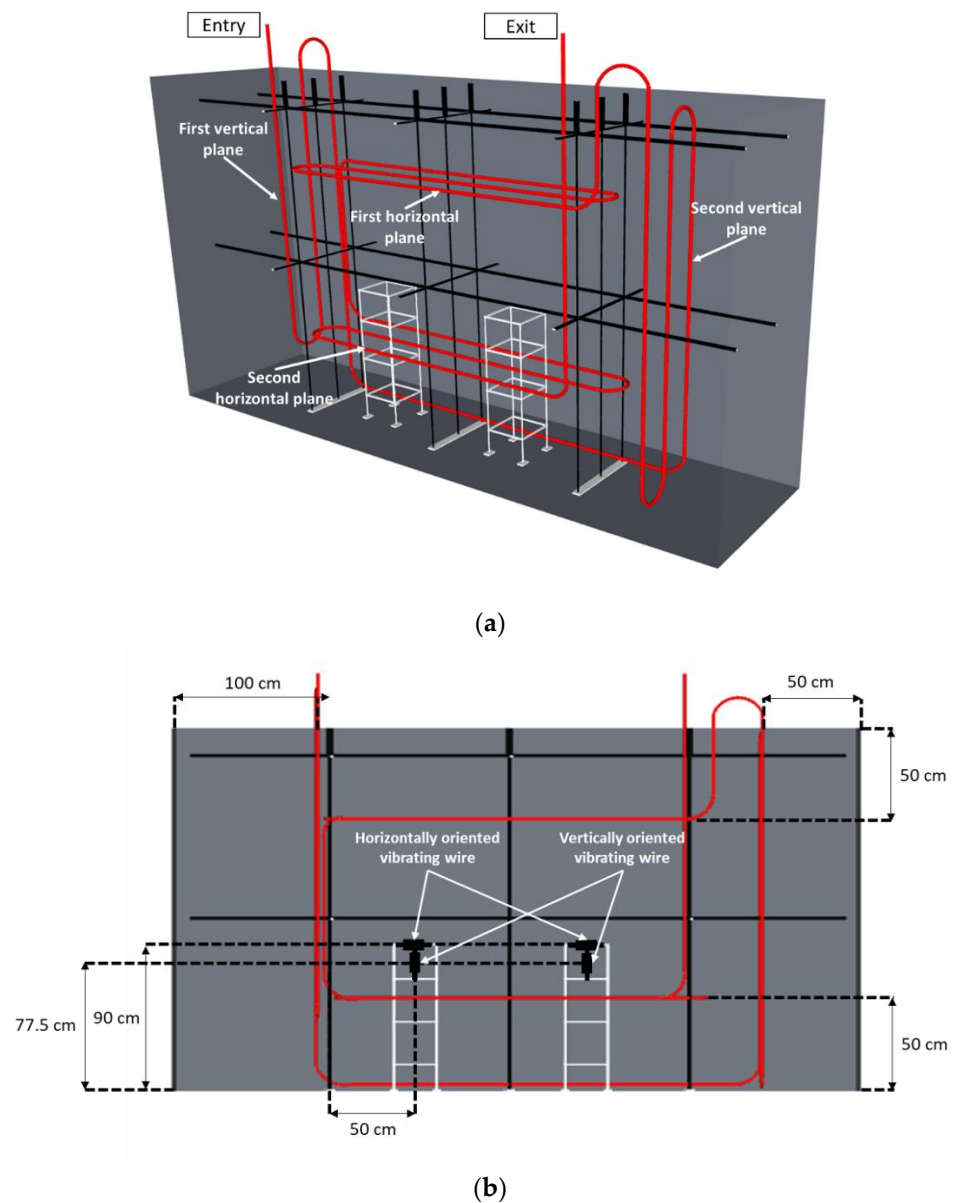
**Figure 7.** (a) Instrumentation scheme of NRC blocks with embedded DOFS; (b) Projection view showing the horizontal/vertical positions of the embedded DOFS and vibrating wire sensors.

As for the installation of thermocouples and VWs, the instrumentation of the NRC block with embedded DOFS was carried out prior to concrete pouring. In the first step, only three sides of the formwork were put in place to allow easy access to the operators. The fourth side of the formwork was only put in place after all the sensors were installed in their final locations. The internal loop of the DOFS follows a complex scheme presented in Figure 7a. As for the bonded configuration, and for the same reasons, the entry and exit of the DOFS cable are located on the upper side of the block. The DOFS path meanders first across a vertical plane perpendicular to the large faces of the block. In this plane, the DOFS cable is fixed to the metallic structure supporting the thermocouples. This first path allows for monitoring the vertical strain at several depths within the block, very close to the thin metal bars supporting the thermocouples. Such strain measurements will provide an overview of concrete swelling at various depths inside the block. In addition, the path of the DOFS cable also meanders across a second vertical plane (near the south face of the block), but here relatively far from the metallic structure bearing the thermocouples. Therefore, a comparison of the strain measurements carried out in these two vertical planes will allow for the detection of any influence of the metallic structures on the concrete swelling (possible restraining effect). It will also be interesting to compare DOFS data with local strain measurements from the two vertically oriented VWs (Figure 7b).

Two horizontal planes perpendicular to the large faces of the block are also instrumented with the embedded DOFS cable. The first horizontal plane (see Figure 7) is located at three-quarters of the block height. This horizontal DOFS path allows the strain to be measured in the upper part of the block where there is no VW. The second horizontal plane is located at a quarter of the block height, and hence the corresponding DOFS path provides horizontal strain profiles in the lower part of the block. A comparison can therefore be made

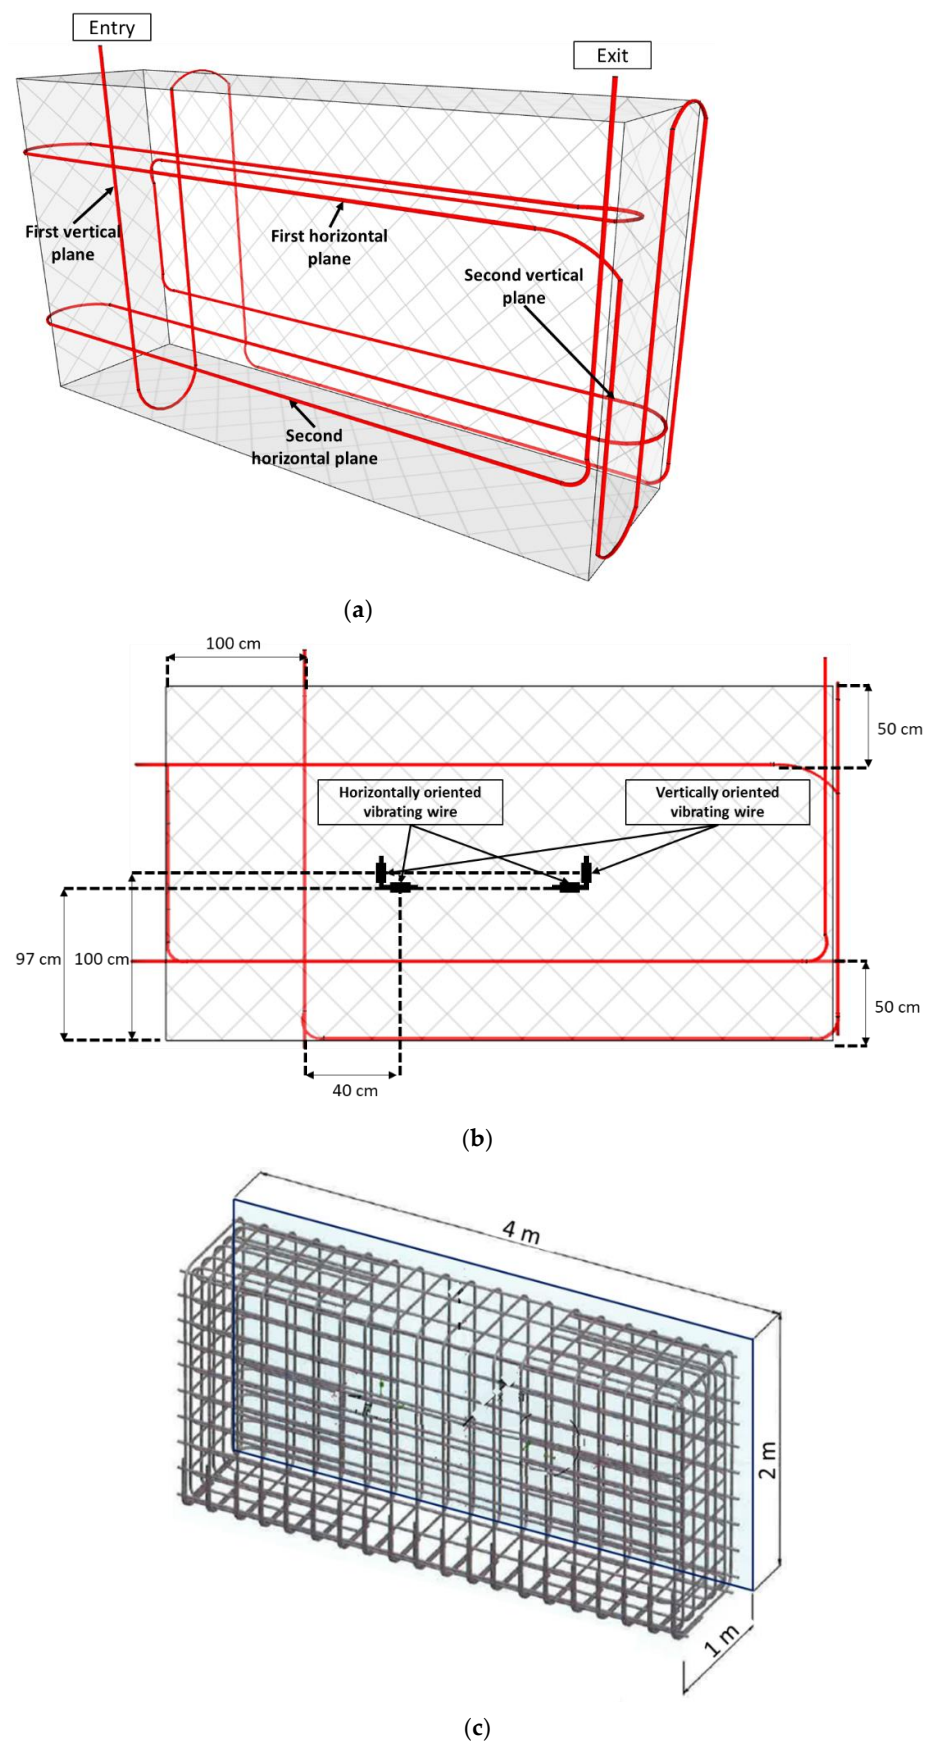
**Figure 8.** (a) Instrumentation scheme of RC blocks with embedded DOFS; (b) Projection view showing the horizontal/vertical positions of the embedded DOFS and vibrating wire sensors; (c) detail of the steel stirrup in RC blocks.

Unlike the previous case, the RC blocks do not contain specific metallic supports for VWs and thermocouples that could serve to fix the DOFS instrumentation. It was thus necessary to attach the DOFS cable directly to the steel stirrups and hence to adapt the internal path of the cable inside the blocks. However, the DOFS loop was still designed to pass through two vertical and two horizontal planes, as depicted in Figure 8.

Just after entering into the RC block, the DOFS cable meanders across the first vertical plane (Figure 8a). In this plane, the two descending branches of the DOFS cable are close to the steel reinforcement (see the detail of the stirrup in Figure 8c), whereas the ascending branch is distant from the steel rebars. A comparison of the strain profiles collected in these branches will thus provide relevant information about the influence of the steel reinforcement on the concrete expansion (for blocks exposed to the ageing conditions).

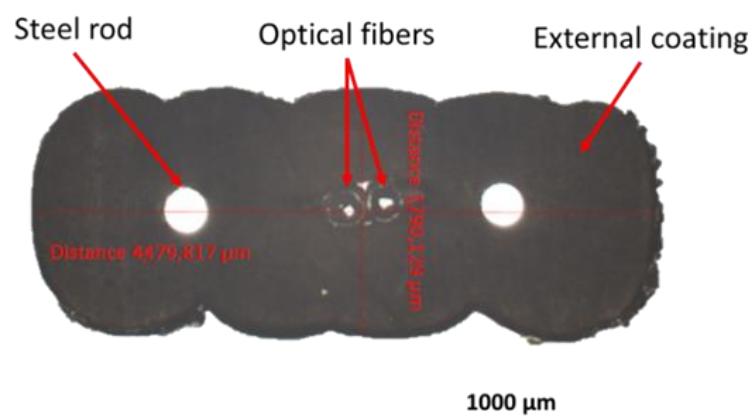
**Figure 9.** Cross-section of the DOFS cable, as observed by optical microscopy.

The DOFS cable considered in this study is the FutureNeuro™ FN-SILL-3 cable manufactured by Neubrex Co. Ltd. (Kobe, Japan) [26]. As illustrated in Figure 9, this cable is composed of two single-mode optical fibers (OFs) with an acrylate primary coating, two steel wires of diameter 0.3 mm, which ensure the mechanical reinforcement of the cable, and an external coating made of a soft elastomer.

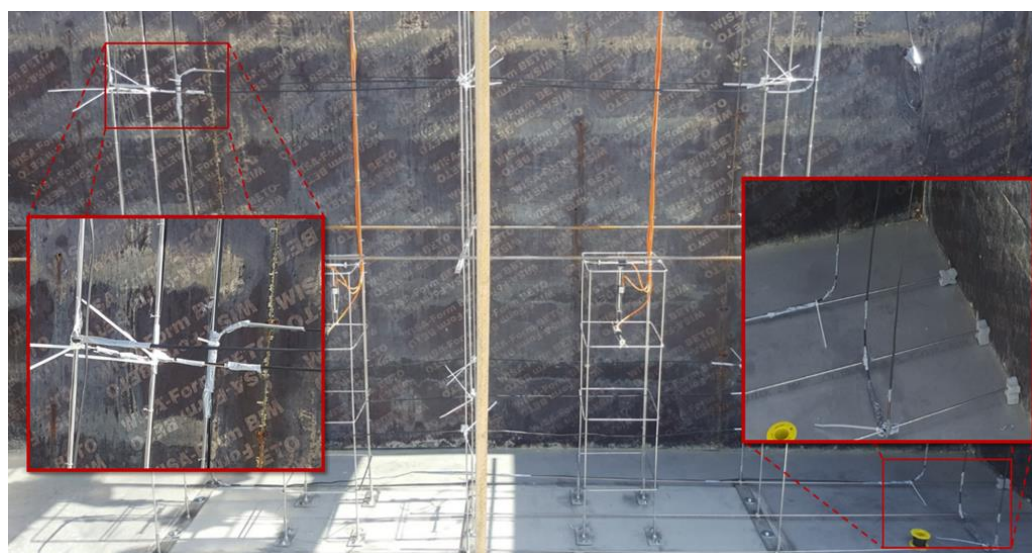
**Figure 10.** Instrumentation of block IA with embedded DOFS, and details of a metallic guide for curved parts (enclosed picture on the left side) and of the three metallic rods supporting the second vertical plane (enclosed picture on the right side).

The IA block was instrumented according to the scheme of NRC blocks presented in Section 3.2. In order to prevent displacements of the DOFS cable during concrete pouring, three horizontal metallic rods were added at the bottom of the formwork to support the second vertical plane of instrumentation (Cf. Figure 7). Metallic guides were also added to support the curved parts of the DOFS path in order to prevent the pinching of the cable and subsequent optical loss during interrogation. Pictures of the block instrumentation are presented in Figure 10.

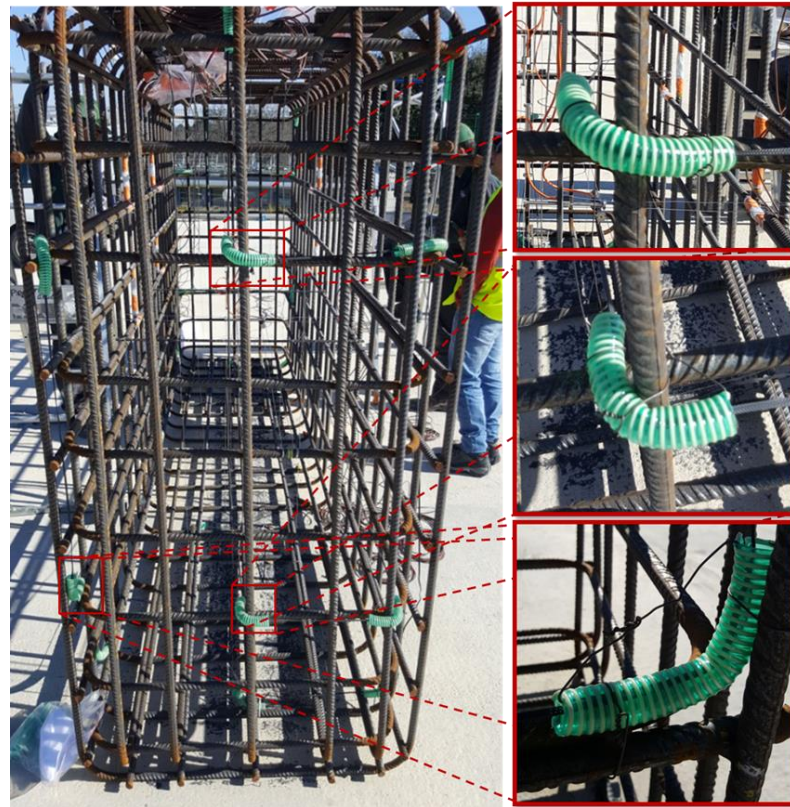
**Figure 11.** Instrumentation of block KB with embedded DOFS and details of cable bends around the stirrup (pictures on the right side).

of the DOFS cable around the stirrup and to avoid optical losses due to pinching, guides were again used. However, for this block, the guides consisted of plastic sheaths that ensured a bending radius greater than 4 cm. Figure 11 shows some pictures taken during the instrumentation of the KB block, including details of the cable bends (on the right side).

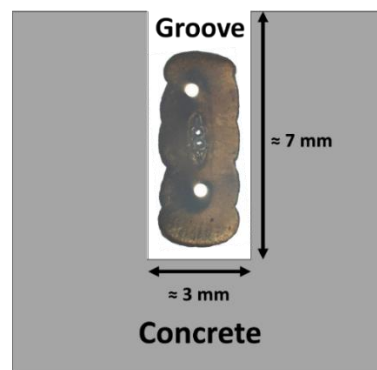
**Figure 12.** Positioning of the DOFS cable into the groove.

The positioning of the DOFS cable into the groove, as illustrated in Figure 12, allows for the maximization of the contact surface area between the cable and concrete and hence the adhesion at the cable/concrete interface [28,29].

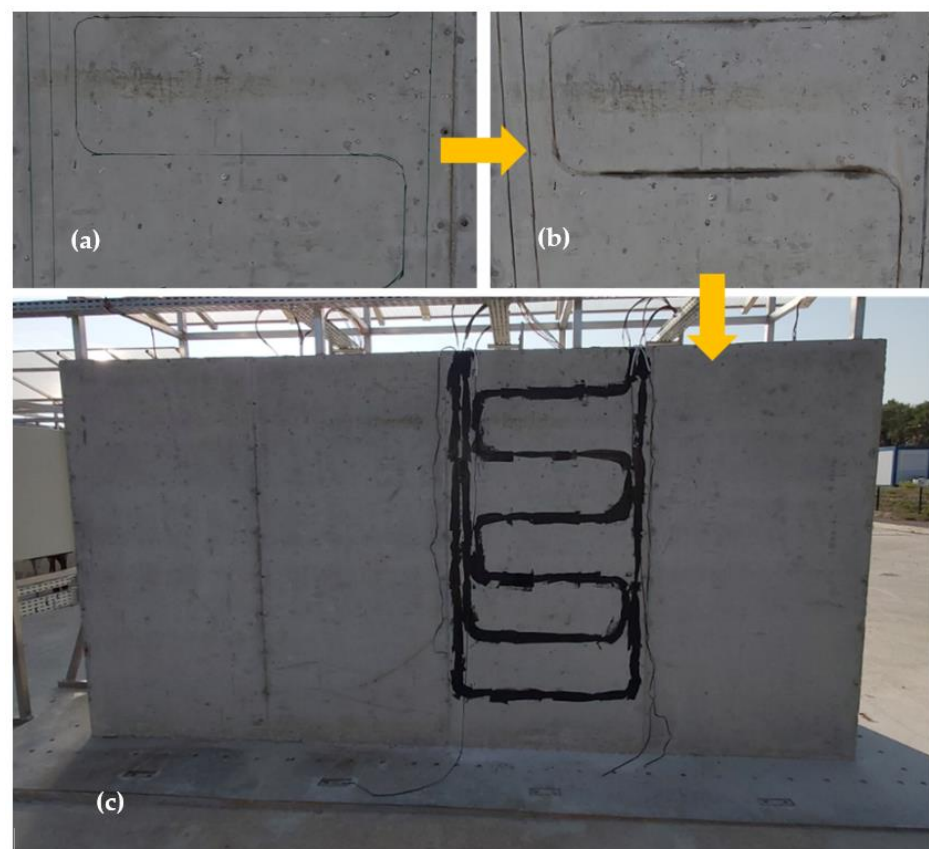
**Figure 13.** Installation steps of the DOFS cable at the surface of block KB. (a) Marking of the cable path at the surface of concrete (b) engraving of the groove along the path (c) insertion of the DOFS cable into the groove and application of the closing layer of X120 adhesive.

The installation steps and the final aspect of the instrumented zone are illustrated in Figure 13.

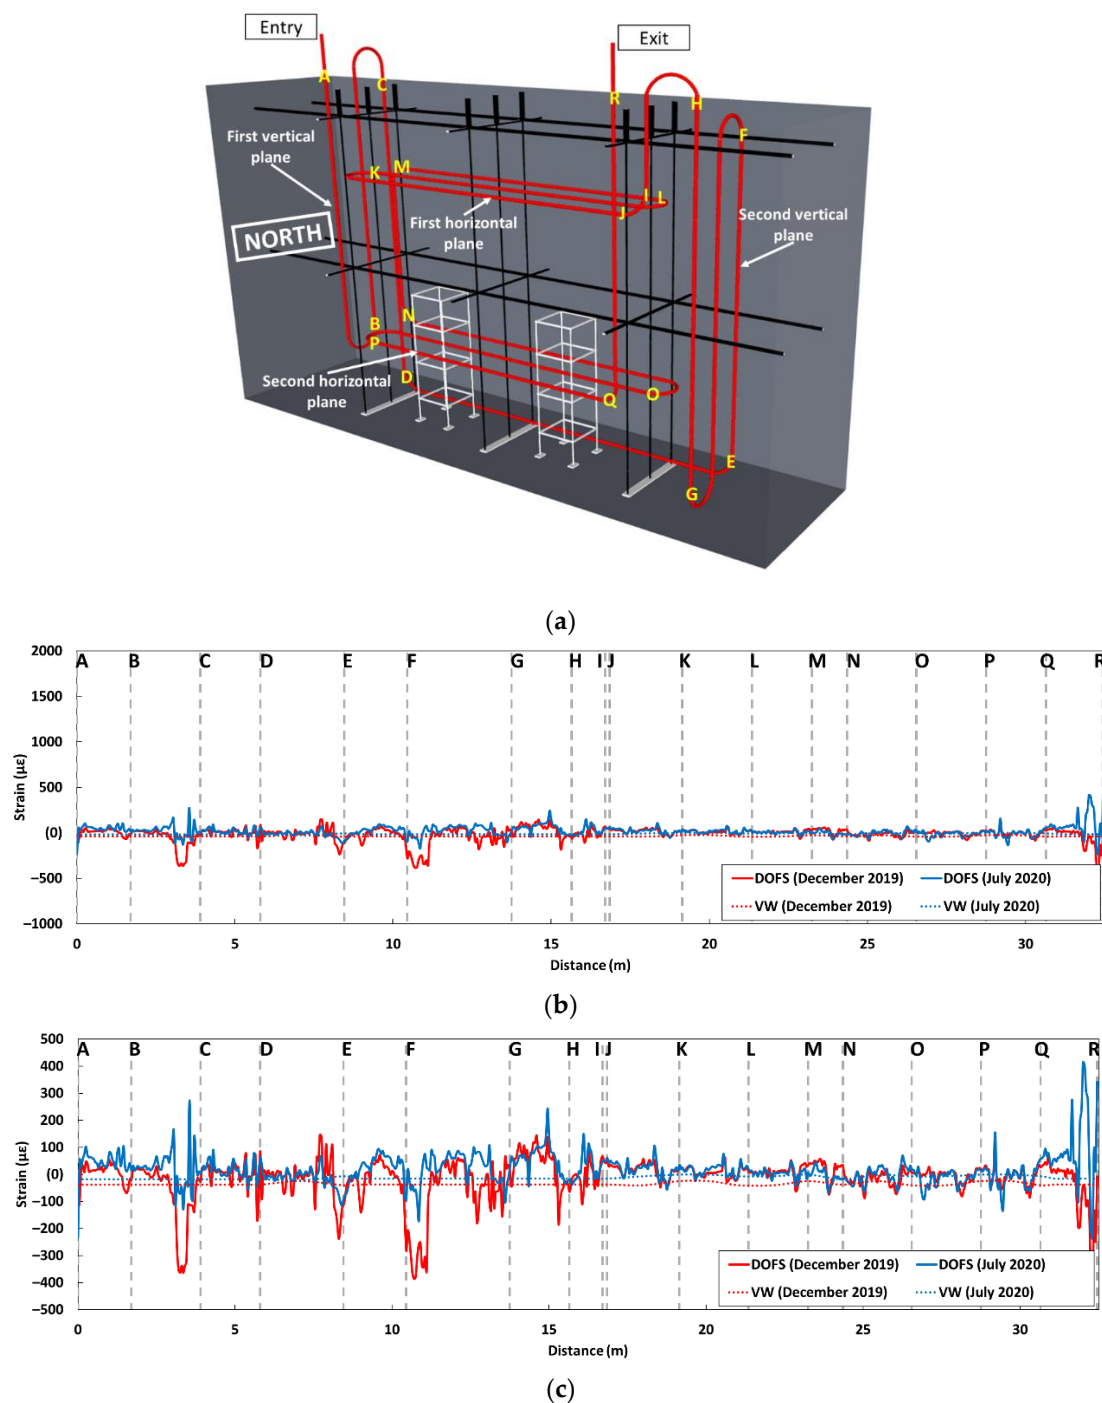
**Figure 14.** (a) Instrumentation scheme of the block IA with embedded DOFS, in which segments of the DOFS path are identified with alphabet letters; (b) Strain profiles along the DOFS (in solid lines) together with VW measurements (dotted lines); (c) Strain profiles at magnified y-scale.

Figure 14b displays the strain profiles using a large y-scale ( $\epsilon$ -scale) that can be used in the following to compare the profiles of the two blocks IA and KB. In Figure 14c, the same profiles are displayed using a magnified scale that is more adapted to the low strain values recorded on block IA. The segments of the DOFS cable identified with letters on these profiles correspond to those previously defined in Figure 14a.

The strain profiles at both measurement times (December 2019 and July 2020) provided continuous signals along the entire length of the embedded DOFS and included the data collected from the two vertical and the two horizontal instrumentation planes (Cf. Figure 14a). The strain values recorded by the DOFS are found to be consistent with those recorded by VWs (on each considered segment of the DOFS cable, the strain values are compared to those of the nearest VW).

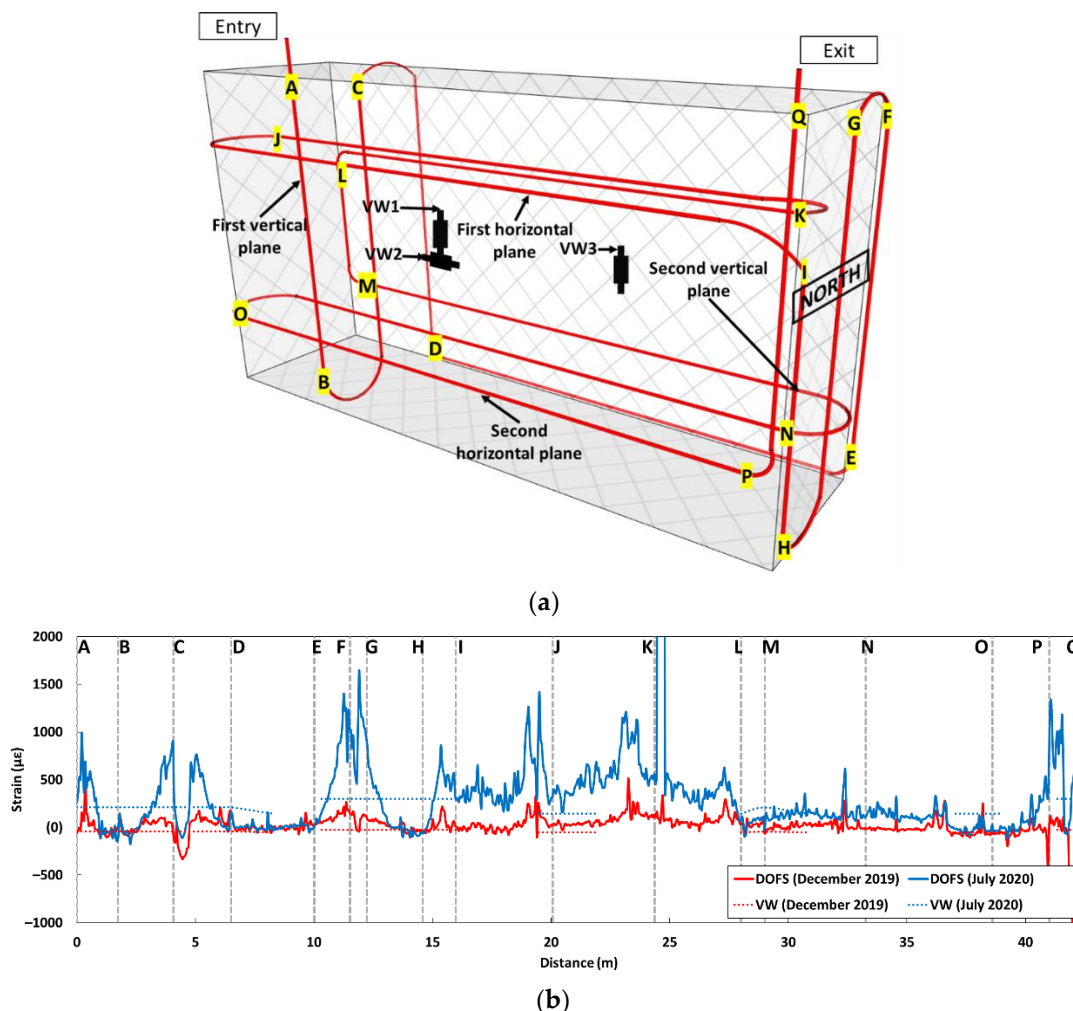
**Figure 15.** (a) Instrumentation scheme of the block KB with embedded DOFS, in which segments of the DOFS path are identified with alphabet letters; (b) Strain profiles along the DOFS (in solid lines) together with VW measurements (dotted lines).

Figure 15 displays the strain profiles recorded by the DOFS embedded in block KB, together with the strain values recorded by the three vibrating wires (VW1, VW2, and VW3, see Figure 15a) operational at the time of the measurements and located near the DOFS.

Here, again, the instrumentation scheme of this RC block is recalled in Figure 15a, and the different segments of the DOFS loop are identified using alphabet letters. Figure 15b displays the strain profiles using a large y-scale ( $\epsilon$ -scale) similar to that of Figure 14b.

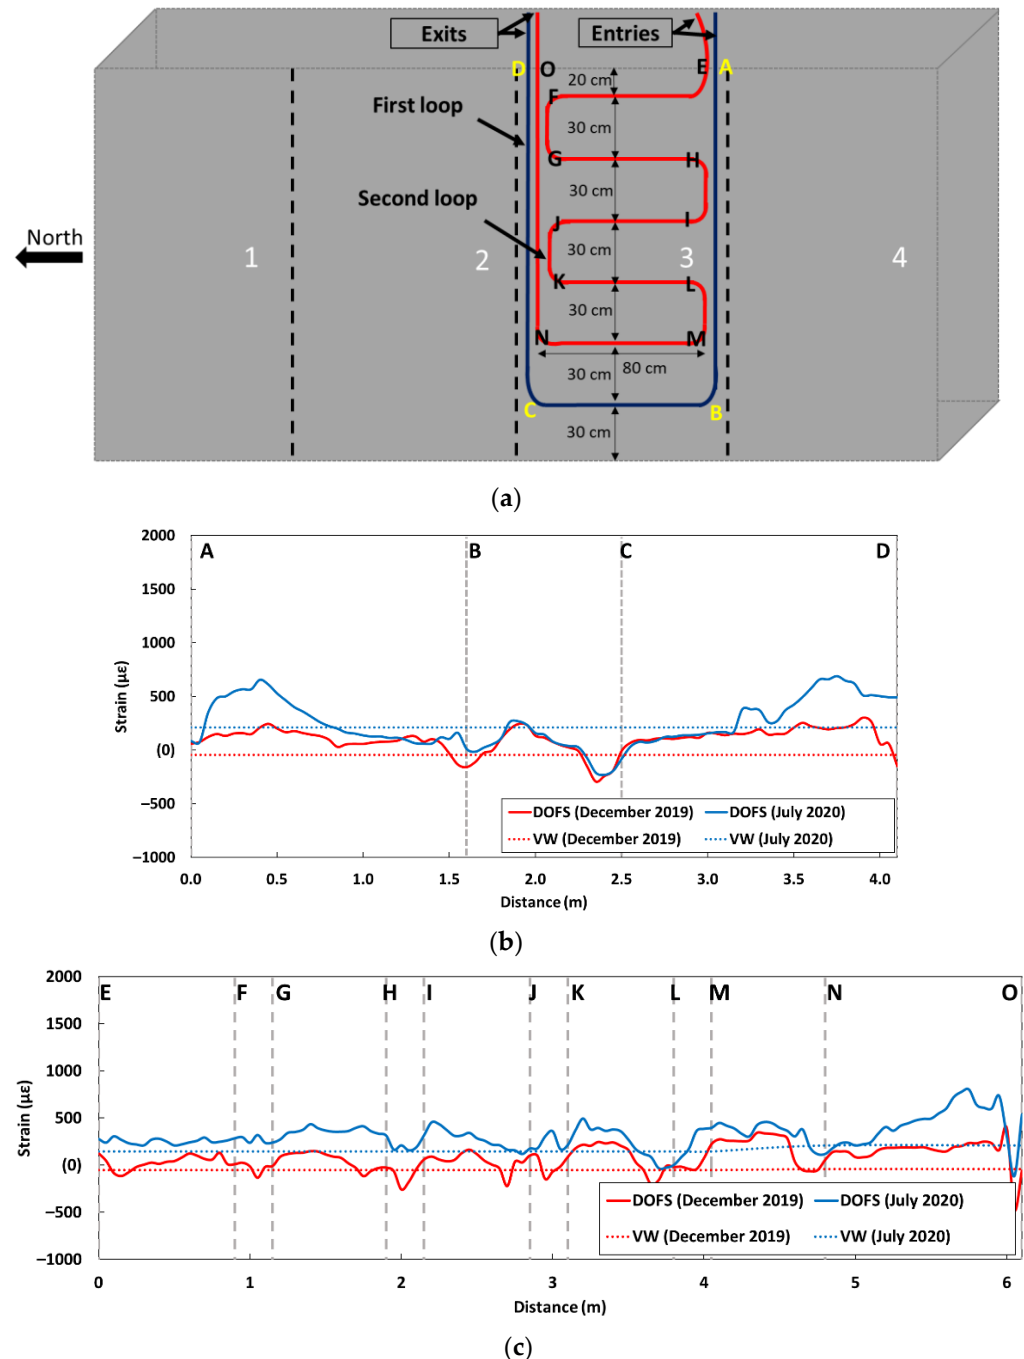
**Figure 16.** (a) Instrumentation scheme of the block KB with bonded DOFS, in which segments of the two DOFS loops are identified with alphabet letters; Strain profiles along the first loop (b) and the second loop (c) of the bonded DOFS cable (solid lines), together with the strain data from the nearest VWs (dotted lines).

Moreover, the profile along the second loop (see Figure 16) shows that the intensity of the strain is globally constant over the horizontal parts of the instrumented area and for all height levels.

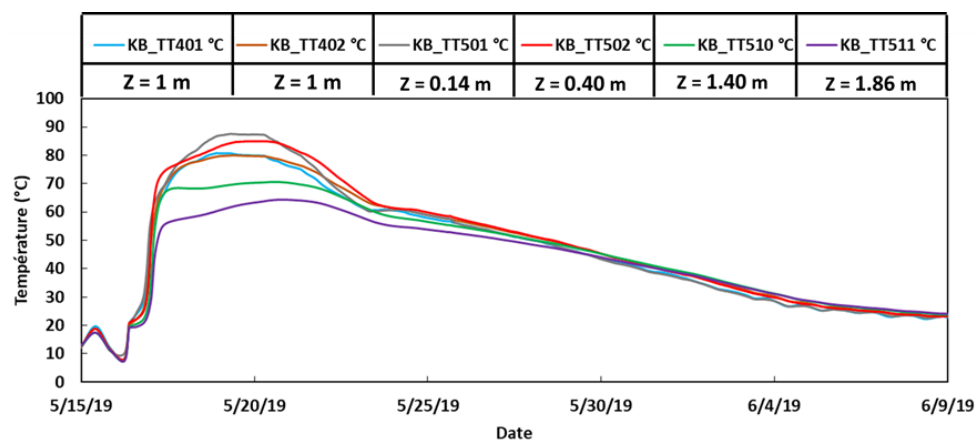
**Figure 17.** Temperatures recorded by selected thermocouples inside the block KB during the initial thermal treatment (z refers to the vertical position of the thermocouple, the origin of the  $\vec{z}$  axis is located at the center of the top face of the block).

In order to analyze further the previous results provided by the DOFS instrumentation, it is interesting to examine the temperatures that were recorded within the KB block during the initial thermal treatment intended to initiate the DEF. Figure 17 shows the temperature evolutions provided by several thermocouples located at different heights of the block during the 3-week thermal treatment from 15 May to 9 June 2019. From this graph, it is found that the maximum temperature reached during the heat treatment was around 80–85 °C in the upper part of the block, whereas it was much lower (around 65–70 °C) in the bottom part of the block. Considering this vertical temperature gradient at an early age, and hence the effective thermal energy gradient created [34], it could be expected that the DEF pathology would develop first in the upper part of the KB block. This is very consistent with the strain measurements provided by the embedded DOFS in July 2020, which revealed a significantly higher expansion of concrete in the upper part of the KB block, suggesting the higher kinetics of DEF in this region of the block.
