Article

Laboratory Results of a Real-Time SHM Integrated System on a P180 Full-Scale Wing-Box Section

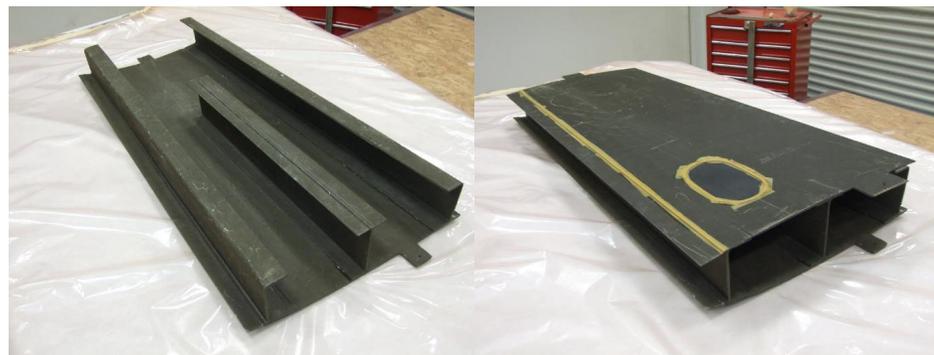
In Figure 1, a view of the naked box is reported, before the imposition of the artificial de-bonding between the bottom panel and the spar caps, the deployment of the fibers, and the gluing of the two parts and the bottom panel.

Figure 1. General view of a small composite wing-box demonstrator.

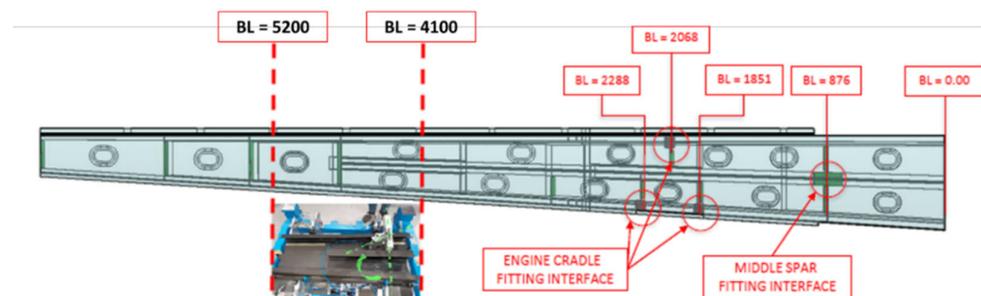
The small composite wing-box demonstrator is figuratively extracted from a complete wing-box, as detailed in Figure 2. In particular, the test article is representative of a wing segment between the stations (approximately), BL = 4100 and BL = 5200. The overall dimensions of the test article follow, as reported in Table 1, and shown in Figure 2, for a better understanding:

Figure 2. Wing-box section from which the test article has been taken.

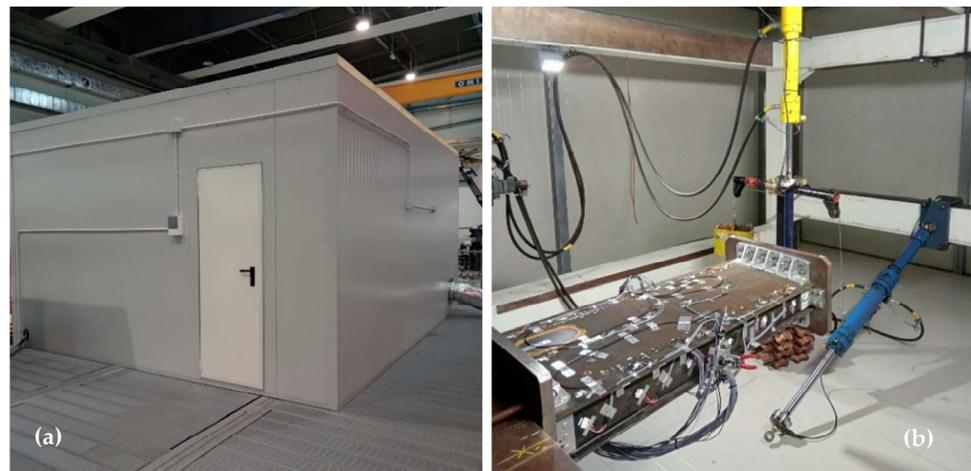
For the test execution, the test article (TA) is installed on the load rig in a laboratory environment, see Figure 3, with the lower skin facing up. This choice renders the installation and handling of the sensors easier. The TA is subjected to static tests in two different load conditions, namely, compression and bending, at different temperatures (room temperature and around 70 °C). To that aim, it is installed within a walk-in climatic chamber, specifically exploring the heating effect over the data processing. In this first investigation outside the environment temperature, it was chosen to select the most affordable high-temperature range (in terms of costs and complexity of the necessary facility), with the aim to move afterwards to the more challenging interval of the cold conditions.

Figure 3. Actual test configuration: (a) left picture reports the climatic chamber specifically designed to host the test rig; and (b) right picture reports the bending actuator installed on the test article, while the compression actuator is detached.

Loads are applied by means of two different hydraulic actuators, each for the two configurations prescribed, see Figure 4 (schematic) and Figure 3 (lab picture). The hydraulic actuators are controlled by means of a cyber servo controller, regulating the hydraulic oil pressure in the cylinders, based on the actual force acquired through a load cell. The main characteristics of the two actuators are reported below, see Table 2. The root of the small composite wing-box is fixed on a rig beam by means of a set of machined plates and bolts, properly sized, while the hydraulic jacks are constrained to a rig beam positioned above the rig for the bending test and to another lateral rig beam for the compression test. The test article is, therefore, in two configurations:

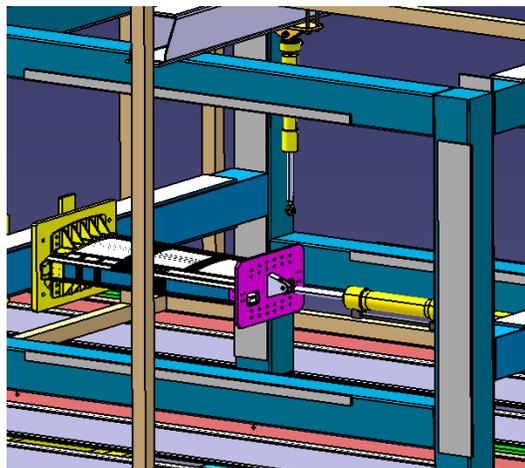
- bending: the load FB, applied along the opposite direction of the Z axis (aircraft axis);
- compression: the load FC, applied along the opposite direction of the Y axis (aircraft axis).

Figure 4. Load direction in compression and bending configuration.

The reference limit load for both conditions is $FC = FB = 20,000$ N. At the end of the limit load cycles, it is decided to go up to the jack full scale in bending condition at room temperature, with steps of a 10% LL (approaching ultimate load (UL)). For the bending test, the hydraulic jack pulled while the jack pushed for the compression test.

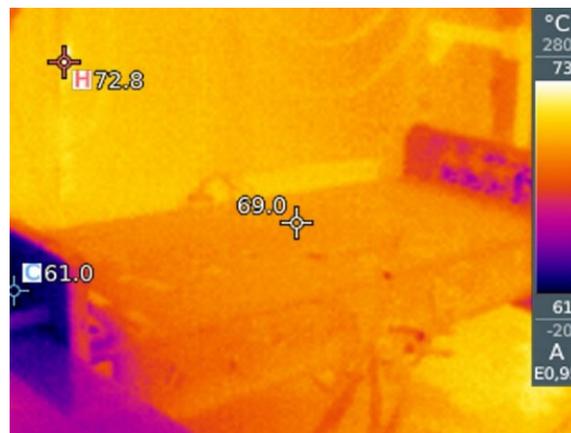
To show that the temperature distribution is constant over the entire surface of the test article, pictures were taken with a Testo thermal imager and reported below, see Figure 5.

Figure 5. Thermal scan of the wing-box under thermal conditioning—test @ 70 °C.

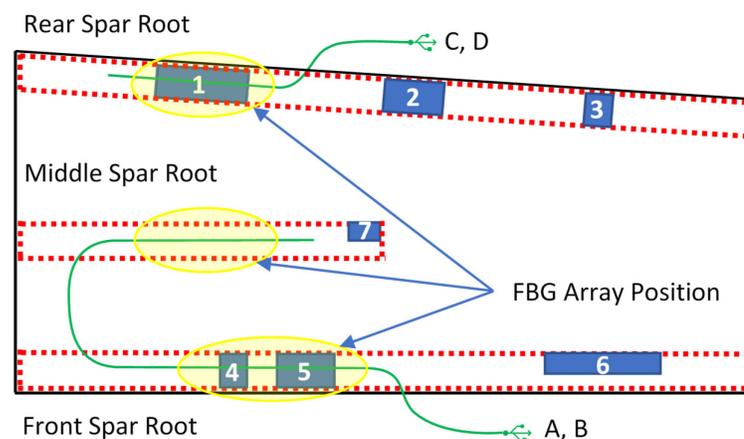
The test article is supplied for test laboratory with four embedded optical fibers (OF), and seven de-bonds, applied as reported in Figure 6. Flaws and inner OF are, therefore, placed between the wing-box main body and the bottom panel. Inner OF and flaws positions are listed in Table 3. The spar print (i.e., the shape of the caps bonded to its internal surfaces) are shown in red dotted lines. The embedded fibers were placed in pairs for redundancy, to minimize the possibility of breakage during the manufacturing process that could have prevented strain acquisitions. In any case, all four fibers survived.

Figure 6. Optical fibers and damage locations—sketch. Embedded optical fibers are shown in light green and coded according the letters A, B, C, and D, while the qualitative positions of the FBG arrays are reported in the tallow oval. Damage locations are presented as blue parallelograms, and their numbering is reported in white digits.

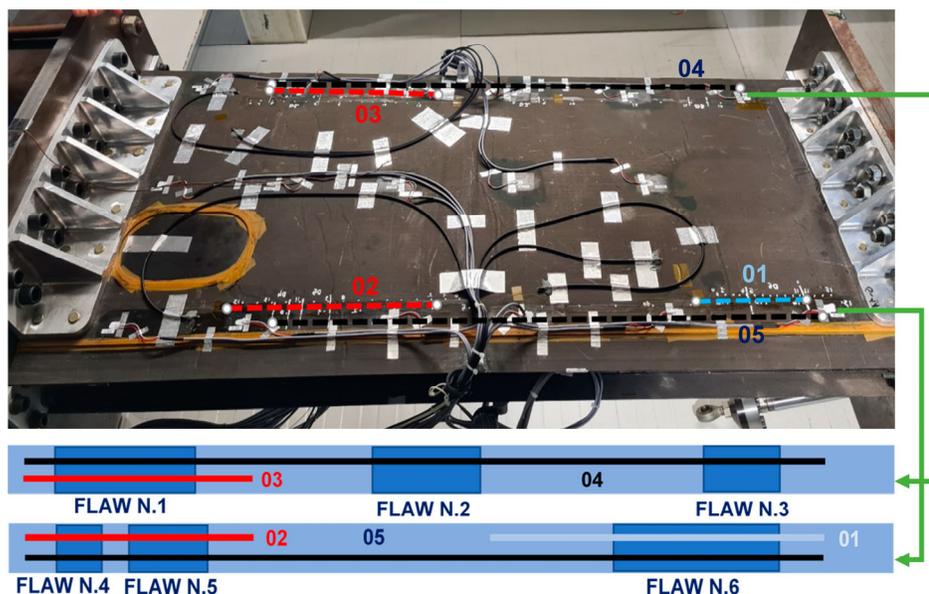
The bonded FO are arrays of 16 FBG but the space resolution is not the same for all fibers. For the sake of simplicity, the fibers are colored in red, black, and blue. The red and blue fibers are used to monitor a single region of interest, 80 mm long, with a 20 or 10 mm space resolution for the red and blue fibers, respectively (Figure 7). The black fiber is 1000 mm long and is used to monitor the whole length of the spar. In this case, the space resolution is 50 mm.

Figure 7. Schematic layout of the additional fibers installed on the wing-box, bottom panel, with the associated code; namely, 03 and 04 for the rear spar; and 01, 02, and 05 for the front spar. For the sake of clarity, a synthetic scheme of the flaws and fiber positions is reported, for both the spars, top and bottom. These same schematics are used to describe the results, in the last part of the paper.

Then, the bending effects are detected by fibers 01, 02, and 05, deployed on the surface skin in the region of the front spar, see Figure 7, at RT and at HT. The figures below, Figures 19 and 20, report the data processing for RT, on the left, and for HT, on the right. Figure 19 represents the strain logged during the incremental loading up to LL, along a generic fiber. Figure 20 represents the CDI derived from the four features. Fibers 01, 02, and 05 were each equipped with 15 FBGs sensing points.

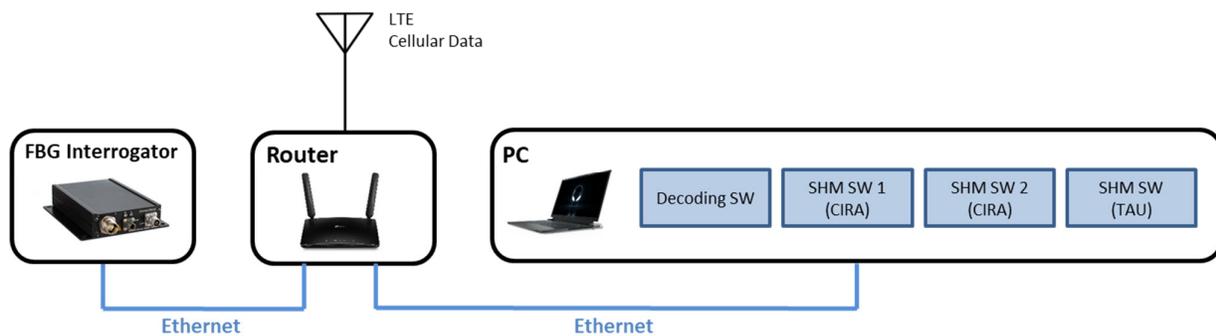
The hardware used to run all the real-time software and the SHM algorithms is a single consumer-grade personal computer (PC)—an Alienware X17 laptop with an i7 11,800 H processor, 32 GB of RAM, and a gigabit ethernet port. The PC is running Windows 11 as the operating system (OS). The interrogator (SmartScan2) is connected to the laptop through a TP-Link Archer MR600 modem/router and all devices are configured to be on the same local address network (10.0.0.X). The TP-Link modem/router has an LTE cellular data connection providing Internet access for the PC, including remote desktop access, during the tests. A sketch of the HW setup is shown in Figure 8.

Figure 8. Hardware setup.

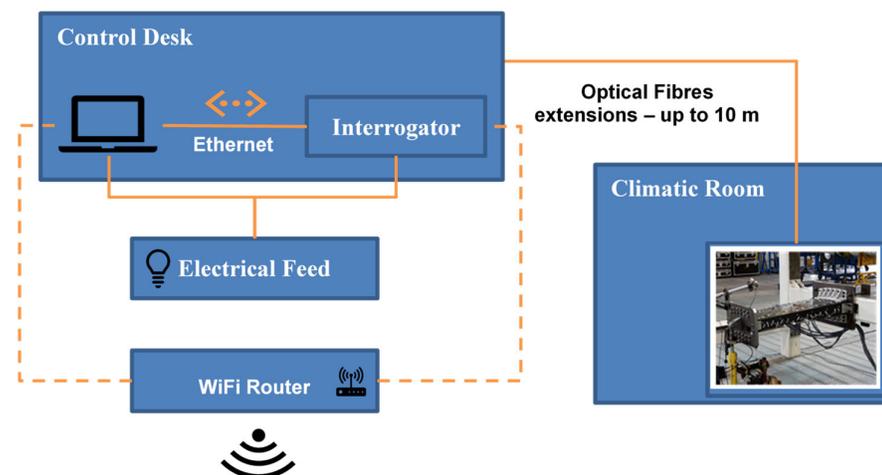
The equipment listed below is strictly necessary to run the experiment. A logic schematic of the test set-up is reported in Figure 9. In detail:

- optical fibers;
- optical fiber stand-off cables;
- optical interrogators;
- PC equipped, with;
- optical interrogator SW;
 - CIRA SHM SW;
 - TAU SHM SW;
 - real-time decoding SW;
- Wi-Fi router for driving the PC and the interrogator.

Figure 9. Block diagram of the experimental set-up.

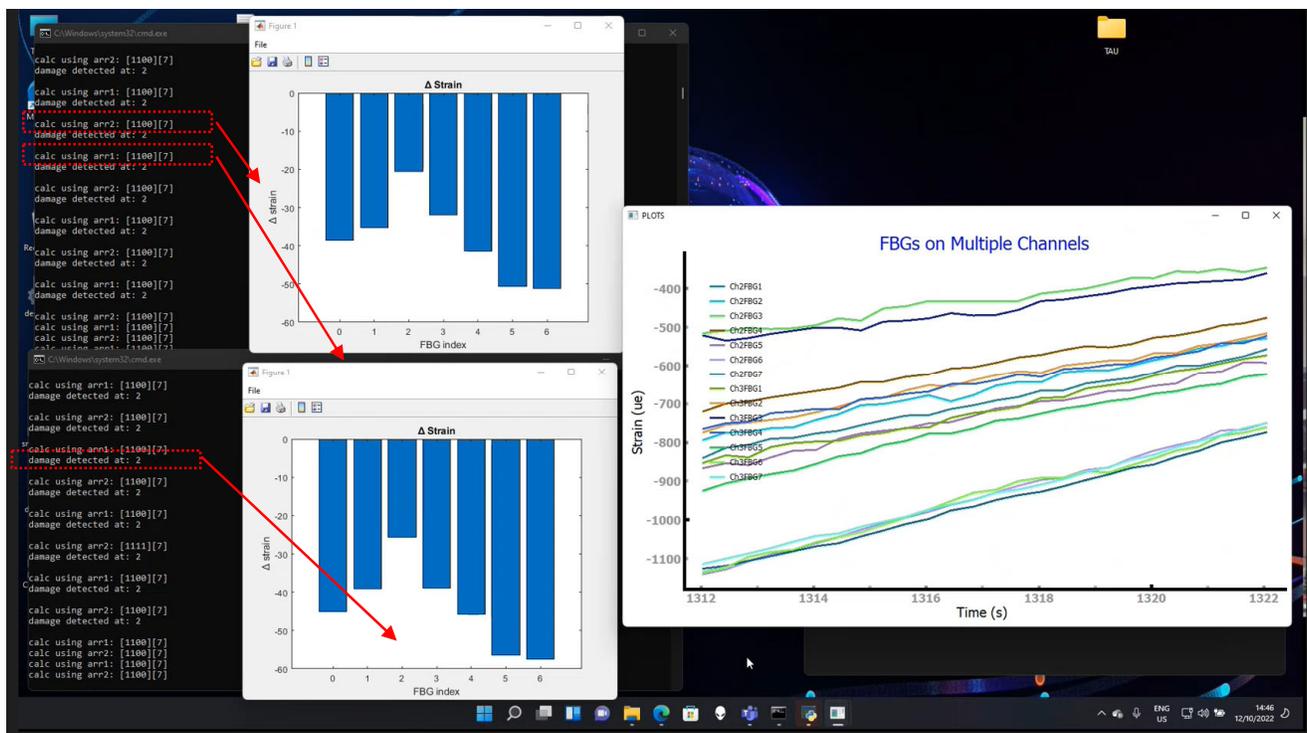
The figure below, Figure 10, depicts screen captures of the computers' desktop with ongoing real-time tests performed at Piaggio Aerospace. The image depicts the prompt DOS with the current data streaming and the corresponding strain graphs. Three contemporary SHM instances, two instances of CIRA's SHM and one instance of TAU/IAI SHM code, are elaborating the same data in real time. The incoming data-streamed package is indicated by bracket reporting the line quantity (in this case, (1100)), and the number of sensors (in this case, (7)) for two arrays ("calc using arr1 and arr2"). For each package, the SHM outcomes provide information about the sensor number indicating a damage occurrence ("damage detected at: 2"). The reported image is aimed at illustrating the simultaneous working of the three SWs, managing two bar plots (one for each array) and one data plot of the strain vs. time for the two arrays (Ch2 and Ch3) comprised of seven FBG each (as reported in the legend).

Figure 10. Screenshot of the SHM module running in real-time mode. Red box indicates the channel (arr1 and arr2) with the corresponding bar plot and the readout (damage detected at sensor number 2).

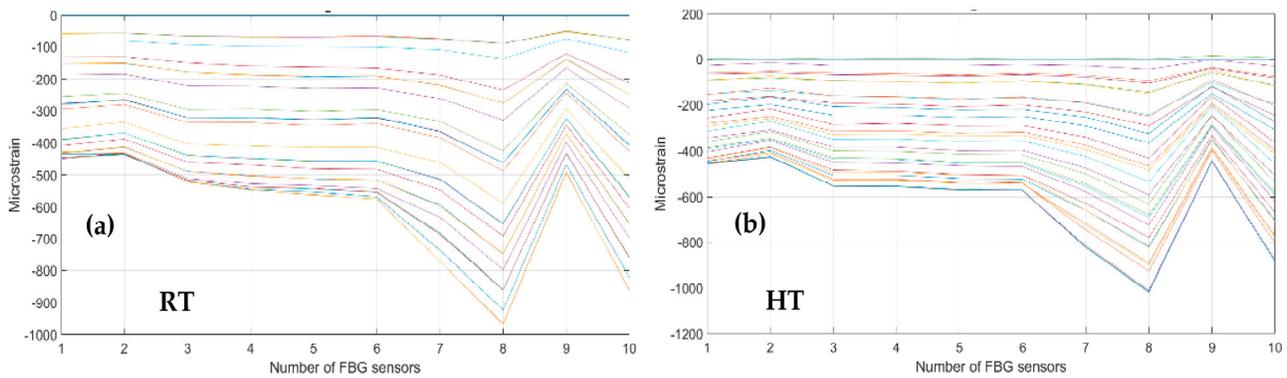
As a first step, bending effects are recorded by the front spar fibers, A and B, at RT and HT. The figure below, Figures 11 and 12, report the data-processing for a single fiber at RT (right) and HT (left), respectively, for quick comparison of the temperature variation effects over the strain. Specifically, Figure 11 reports the strain magnitude along the y-axis during the incremental loading up to LL, while the x-axis represents the index of the FBG sensors from 1 to 10. Figure 12 represents the cumulative damage index (CDI) for each sensor (x-axis) estimated from Equation (2).

Figure 11. Strain distribution in the function of the increasing bending load each curve characterized by a different color. For an embedded FBG sensors array, along the front spar; (a) the incremental strain at room temperature; and (b) the incremental strain at high temperature.

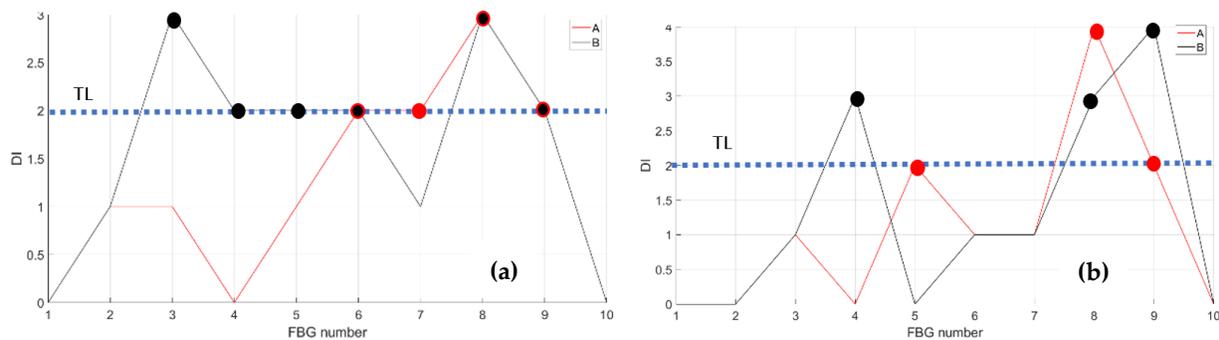
Figure 12. Cumulative damage index under bending; red line sensor A; black line sensor B; TL as the dashed blue line; (a) the cumulative damage index at room temperature; (b) the cumulative damage index at high temperature.

The threshold level (TL), set at the value 2, is estimated as the mean value of the CDI distribution for the current data-streamed package. The SHM system indicates the occurrences of edge onset each time the sensor value exceeds the TL, hence, at sensors 6, 7, 8, and 9 at RT for fiber A and at sensors 5, 8, and 9 at HT for the same fiber A (red dots indicating the eligible sensors); similarly, at sensors 3, 4, 5, 6, 8, and 9 at RT and at sensors 4, 8, and 9 at HT for fiber B (black dots indicating the eligible sensors).

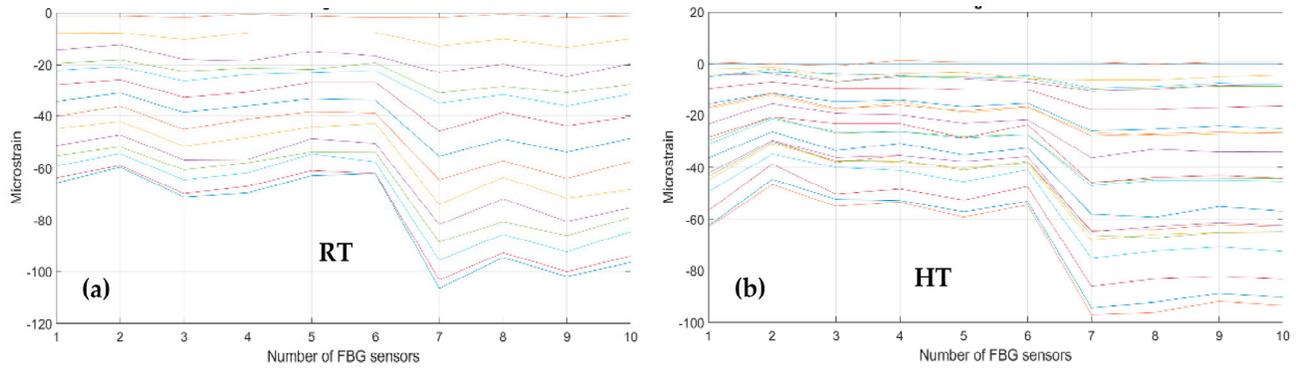
The compression effect is retrieved by the same fibers above, A and B, at RT and HT. The figure below, Figure 13, reports the strain magnitude along the y-axis during the incremental loading up to LL, while the x-axis reports the index of the FBG sensors from

Figure 13. Strain distribution in the function of the increasing compression load each curve characterized by a different color. For FBG sensors embedded array, along the front spar; (a) the incremental strain at room temperature; (b) the incremental strain at high temperature.

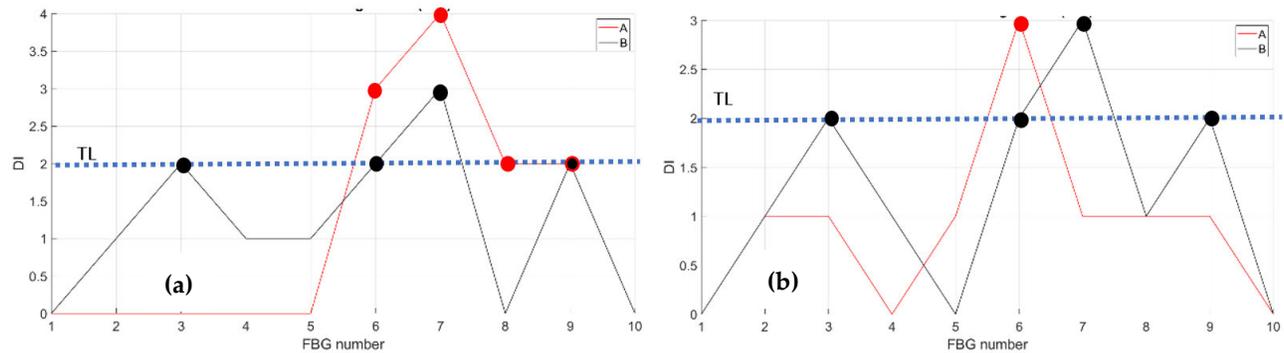
1 to 10. The Figure 14 represents the cumulative damage index for each sensor (x-axis) estimated from Equation (2).

Figure 14. Cumulative damage index under compression: red line sensor A; black line sensor B; TL as the dashed blue line; (a) the cumulative damage index at room temperature; (b) the cumulative damage index at high temperature.

As the threshold level (TL) is fixed at 2, estimated as the mean value of the full dataset logged during the streaming, the CDI indicates the occurrences of edge onset each time the value exceeds the TL, hence at sensors 6, 7, 8, and 9 at RT and at sensor 6 at HT for fiber A; similarly, edge onset occurs at sensors 3, 6, 7, and 9 at RT and at sensors 3, 6, 7, and 9 at HT for fiber B.

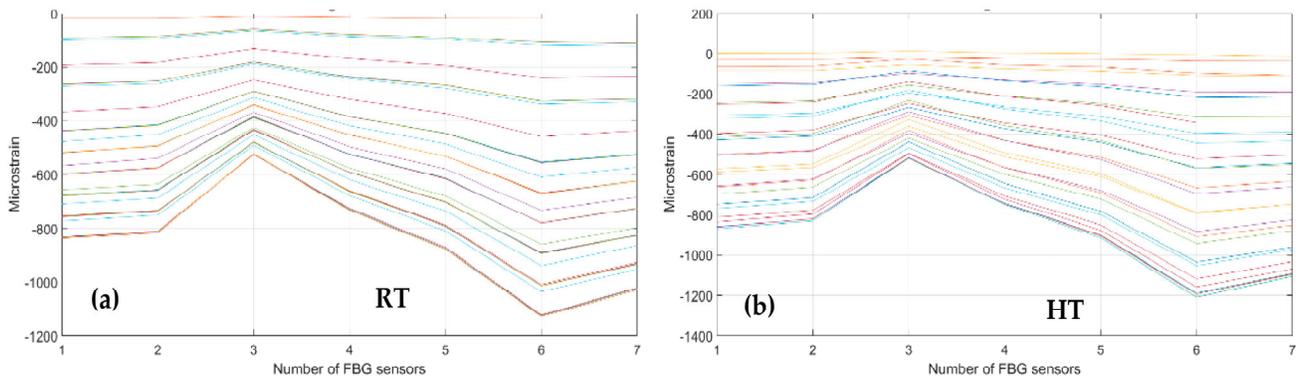
Again, the same description is provided for the seven FBG array fibers C and D along the rear spar, at RT and HT. Figures 15 and 16 report data processing for RT (left) and for HT (right).

Figure 15. Strain distribution in the function of the increasing bending load each curve characterized by a different color. For FBG sensors embedded array, along the rear spar; (a) the incremental strain at room temperature; (b) the incremental strain at high temperature.

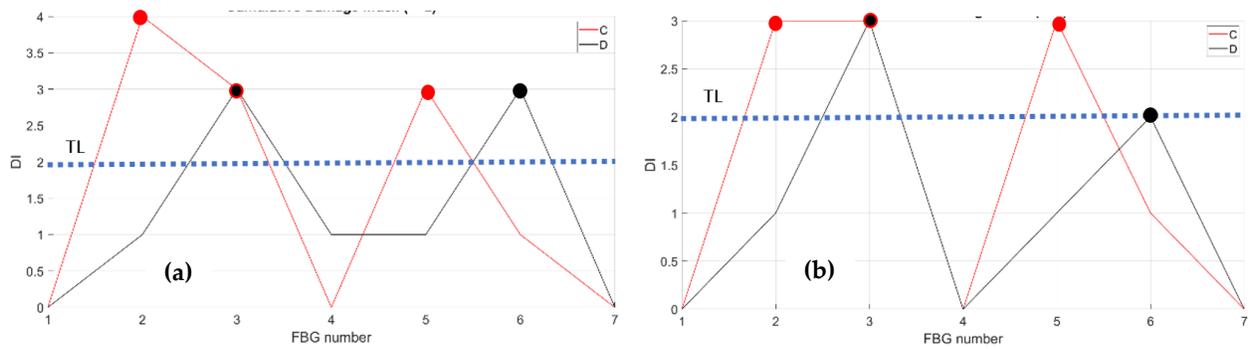
Figure 16. Cumulative damage index under bending; red line sensor C; black line sensor D; TL as the dashed blue line; (a) the cumulative damage index at room temperature; (b) the cumulative damage index at high temperature.

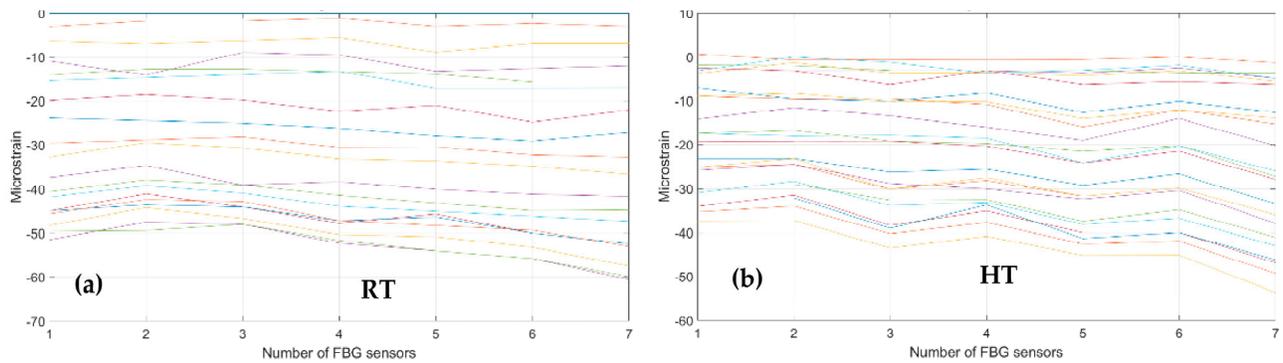
The compression effects are then investigated, as retrieved by the fibers C and D at RT and HT. The figures below, Figures 17 and 18, report the data processing for RT (left) and for HT (right).

Figure 17. Strain distribution in the function of the increasing compression load each curve characterized by a different color. For FBG sensors embedded array, along the rear spar; (a) the incremental strain at room temperature; (b) the incremental strain at high temperature.

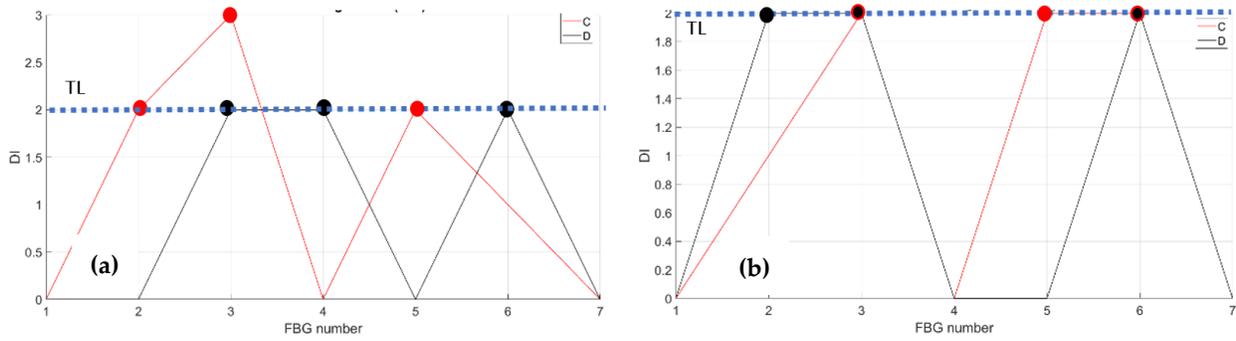
Figure 18. Cumulative damage index under compression: red line sensor C; black line sensor D; TL as the dashed blue line; (a) the cumulative damage index at room temperature; (b) the cumulative damage index at high temperature.

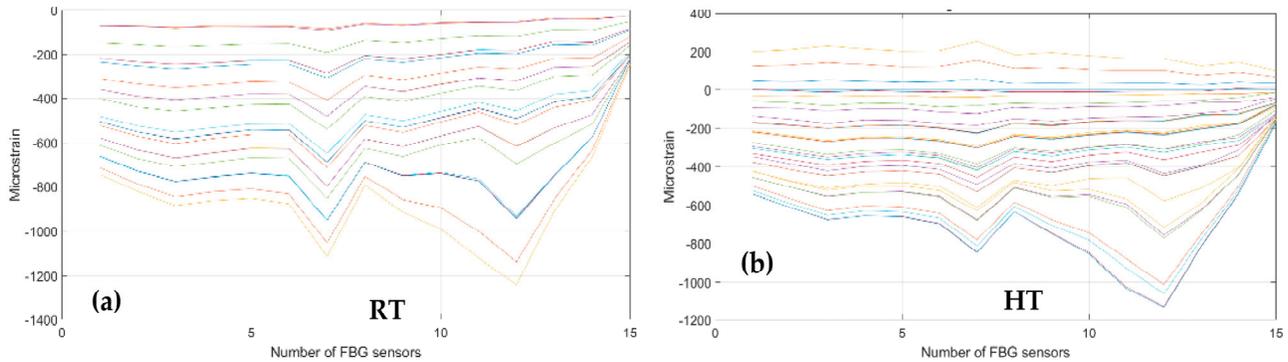
Figure 19. Strain distribution in the function of the increasing bending load each curve characterized by a different color. For FBG sensors bonded array, along the front spar; (a) the incremental strain at room temperature; (b) the incremental strain at high temperature.

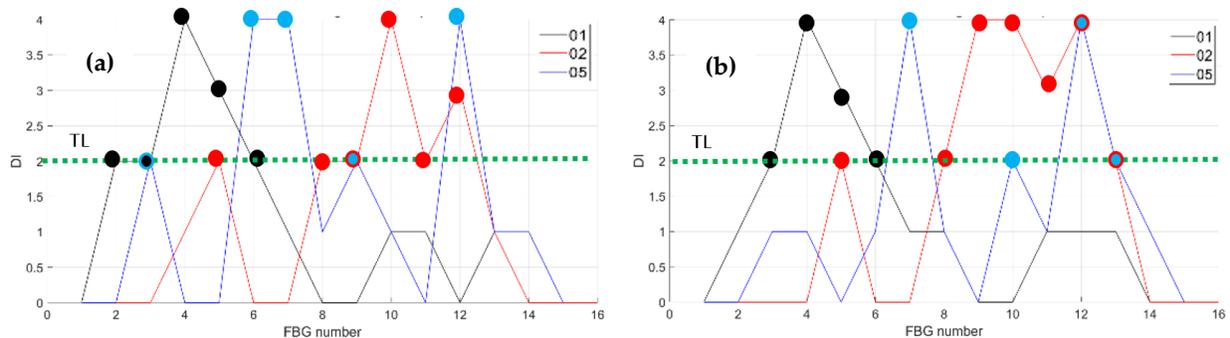
Having fixed the TL at a value of 2, as before, the CDI indicates the occurrences of an edge onset at sensors 2, 3, 4, 5, and 6 at RT and at HT for fiber 01. Such an occurrence verifies at sensors 5 and 8–12 at RT and the same plus 13 HT for fiber 02. For fiber 05, the sensors are 3, 6, 7, 9, and 12 at RT and 7, 10, 12, and 13 at HT.

Figure 20. Cumulative damage index under bending; black line fiber 01; red line fiber 02; blue line fiber 05; TL as the dashed green line; (a) the cumulative damage index at room temperature; (b) the cumulative damage index at high temperature.

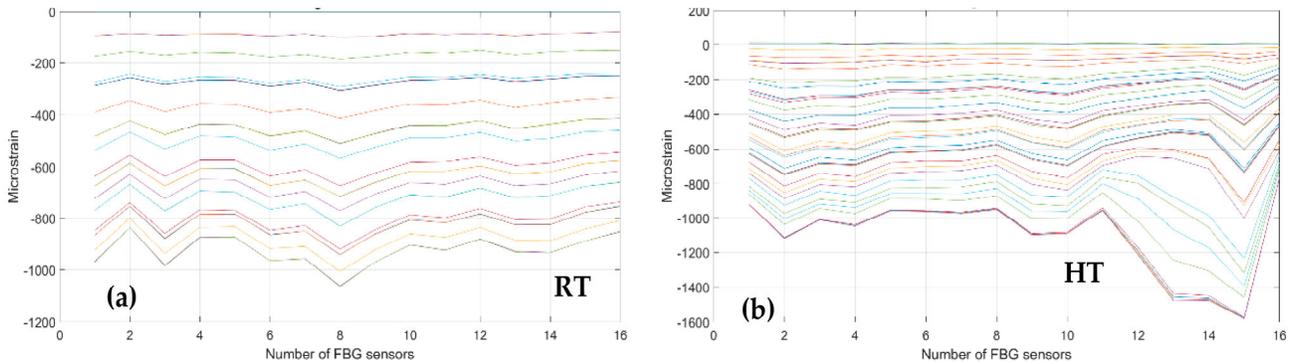
In this case, the bending effects are retrieved as represented below where Figures 21 and 22 report the data processing for RT along the left column, and for HT along the right column, for quick comparison. Fibers 03 and 04 were carried on 15 FBGs sensing points.

Figure 21. Strain distribution in the function of the increasing bending load each curve characterized by a different color. For FBG sensors bonded array, along the rear spar; (a) the incremental strain at room temperature; (b) the incremental strain at high temperature.

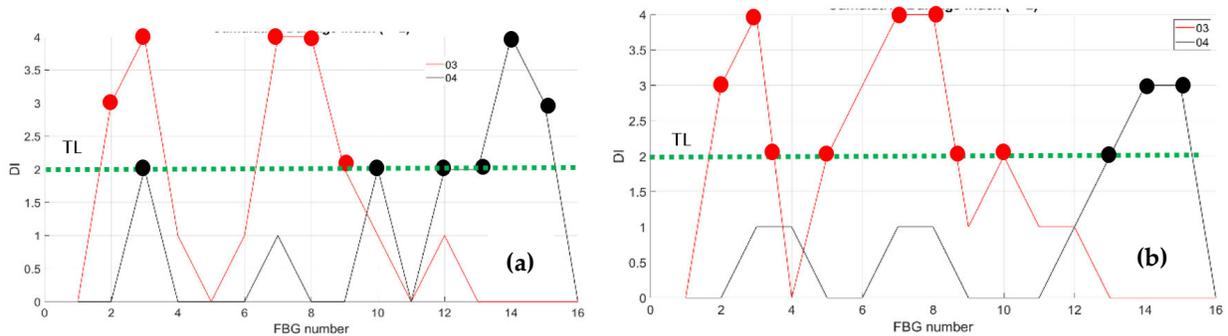
Figure 22. Damage index under bending; red line fiber 03; black line fiber 04, TL as the dashed green line; (a) the cumulative damage index at room temperature; (b) the cumulative damage index at high temperature.
