Article

Modelling the Small Throw Fault Effect on the Stability of a Mining Roadway and Its Verification by In Situ Investigation

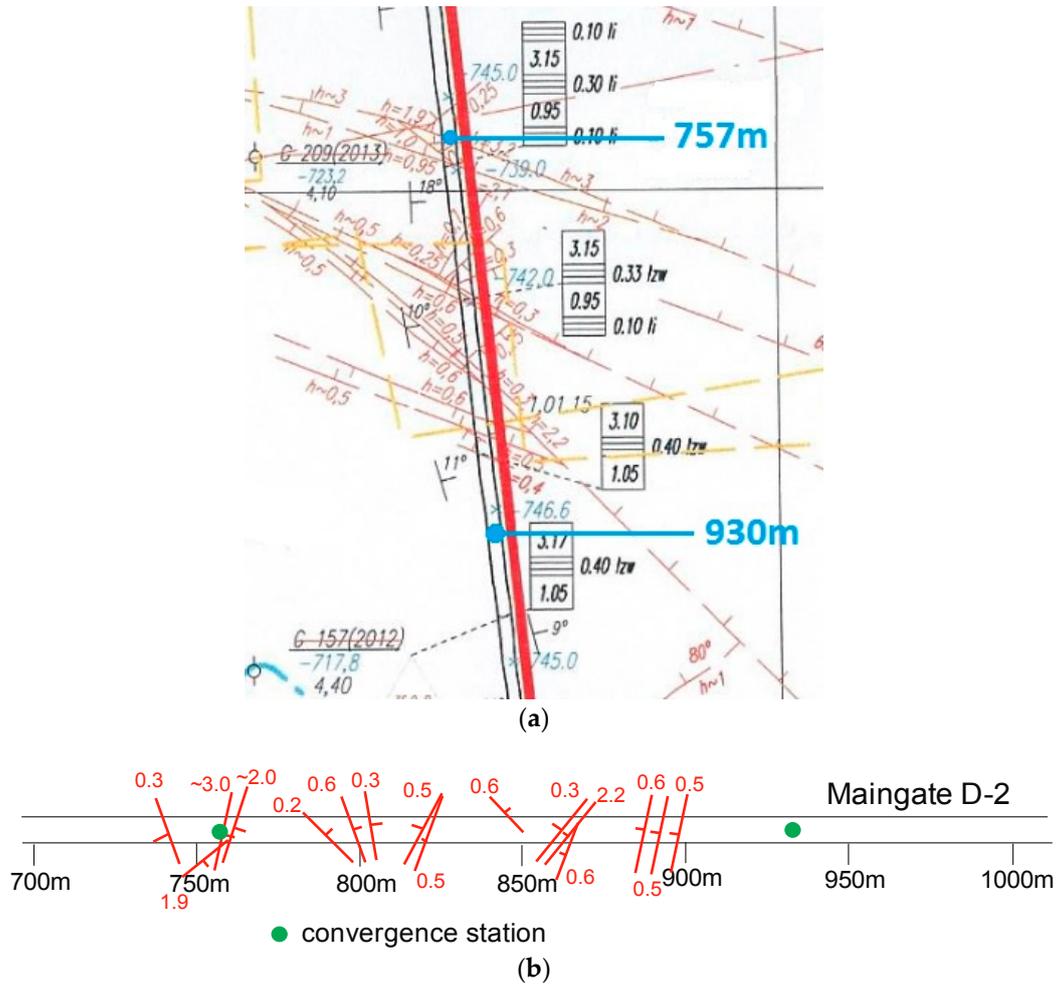
Figure 1. Faults position and the convergence stations in Maingate D-2; (a) The map of Maingate D-2 (b) The convergence stations layout.

In this paper are presented the convergence measurement results from two monitoring stations (Figure 1): at chainage ch. 930 m where there were no faults found or mining related effects, and at chainage ch. 757 m where the roadway intersected a series of faults of a relatively small throw ranging from 0.3 to 3 m over 12 m section (Figure 1). Convergence measurements were carried out until July 2016 i.e., until the closing longwall excavation started showing up in the results.

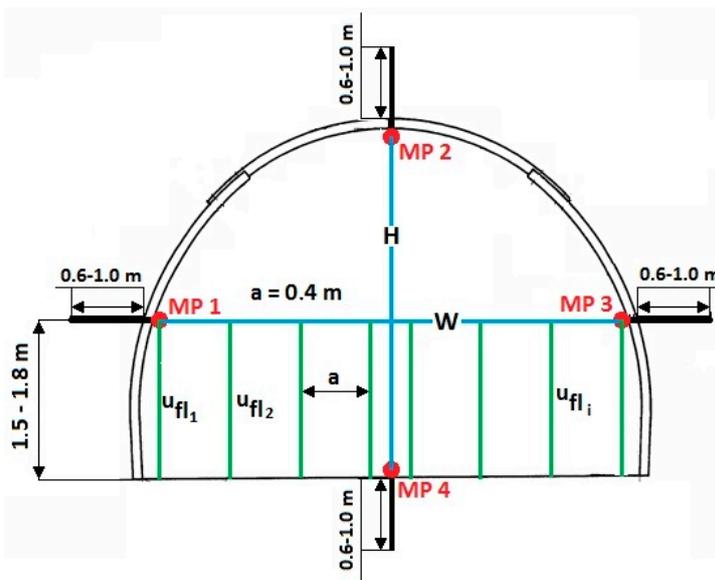
Figure 2. Scheme of convergence measurement station and the measurement methodology in D-2 Maingate.

The convergence of the maingate D-2 was investigated by a series of in situ measurements to determine: change of the height of the opening H , change of the width W , and change of the floor heave u_H (Figure 2). The values were calculated with reference to the design dimensions of the opening.

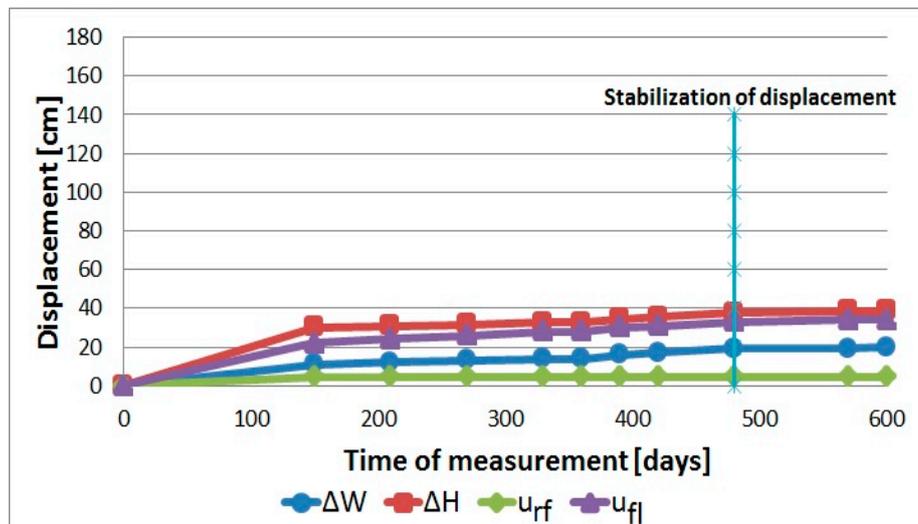
Figure 3. Maingate D-2 convergence—station at chainage 930 m (ΔW —roadway width change, ΔH —roadway height change, u_{rf} —roof displacement, u_{fl} —floor heaving).

Analysis of the convergence monitoring shows that in the 19 months since the completion of the roadway D-2, at the ch. 930 m station, the height of the opening decreased 38.5 cm (ΔH —Figure 3) and measured 3.84 m, which is 91% of the initial (nominal) dimension. Apparently, the heave of the floor was the cause of the change of the opening height. The width of the roadway within the same period decreased 20 cm (ΔW) and measured 5.9 m i.e., 96.7% of the initial (nominal) width 6.10 m. The cross-sectional area of the roadway decreased by 2.9 m² i.e., 13% of the initial figure [10]. The convergence development versus time is presented on Figure 3.

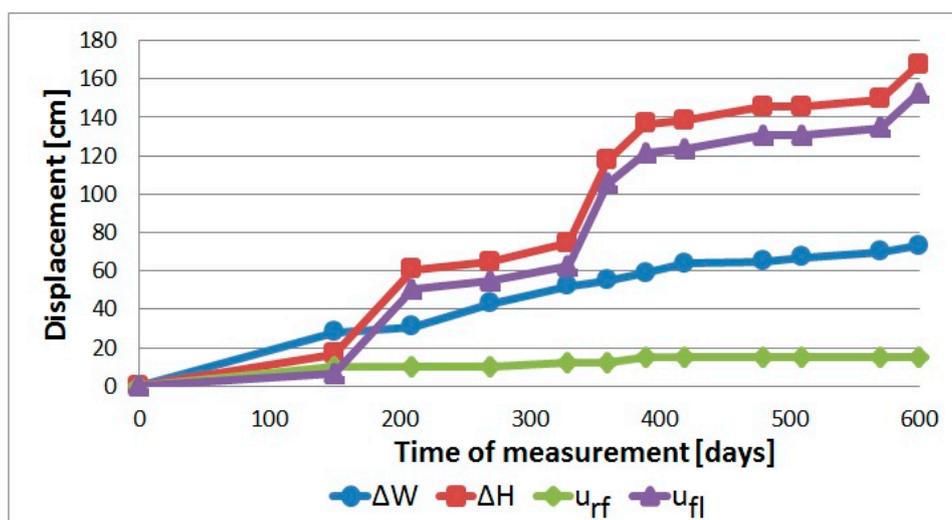
Figure 4. Maingate D-2 convergence—station at chainage 757 m (ΔW —roadway width change, ΔH —roadway height change, u_{rf} —roof displacement, u_{fl} —floor heaving).

In contrast, the convergence of the roadway at station ch. 757 m located within fault zone shows much higher magnitudes. The height of the opening within 19 months decreased 1.7 m mainly due to the floor heave. Horizontal, inward movement of the sidewalls amounted to 0.73 m, i.e., 12% of the initial width of the roadway (Figure 4). Based on the measured convergence, the reduction of the cross-sectional area could be calculated as 46% of the initial value [10]. To maintain the maingate D-2 operational the floor had to be brushed three times: by 80, 60, and 70 cm which is included in the record and the convergence results corrected accordingly (Figure 4).

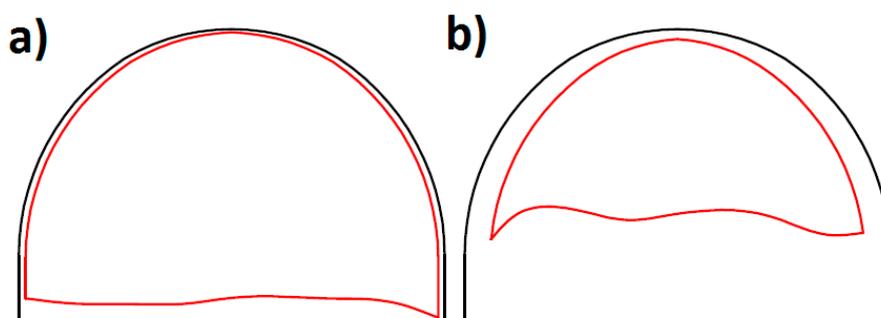
Figure 5. Maingate D-2 convergence: (a) station at ch. 930 m; (b) station at ch. 757 m.

Figure 5 graphically depicts changes of cross sectional areas at both monitoring stations. It demonstrates that in the tectonically undisturbed section as well as in fault affected section the floor heave contributed mainly to the vertical convergence of the roadway D-2. This kind of behavior of the rock mass around openings is regarded typical for Carboniferous formation [18], particularly where the underlying rock is closely stratified and of a low strength [2,19].

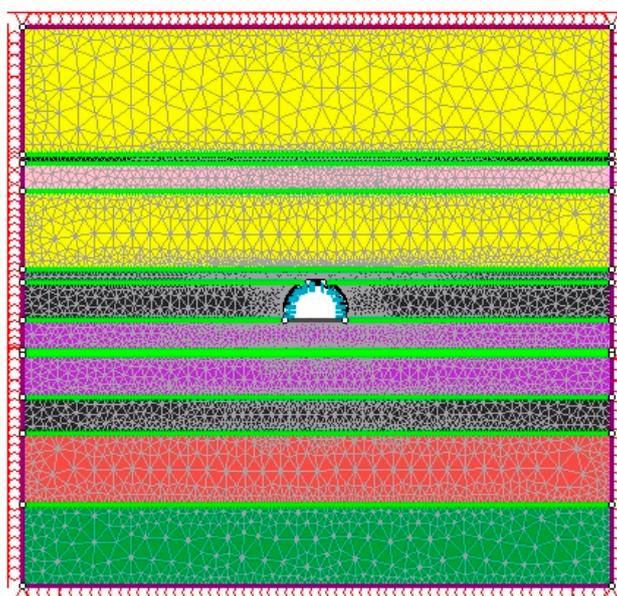
Figure 6. Model plane of the roadway beyond the fault effect.

A model of rock mass for the section of the roadway tectonically unaffected was outlined within 60 × 60 m plane (Figure 6). The total number of nodes and elements for the model amounted to 6785 and 13,122. The computation was carried out on 13 different numerical models to produce a series of strain-stress characteristics in the surrounding of the roadway, as well as the extent of rock failure zones (Table 4). Nine of the models represented rock mass of elasto-plastic properties, strengthened or weakened, or perfect elasto-plastic properties, while four of the models assumed elastic behavior of the rock. In the elasto-plastic model no. 3, and in elastic model no. 12, Young modulus of the rock strata was empirically estimated assuming that Geological Strength Index is equal to Rock Mass Rating - GSI = RMR [20], whereas for other models it was determined through laboratory testing. The *joint* type interbed contact has been used in three models no. 7, 8 and 9 (Table 4). In the model no. 7 the contact between all beds was assumed as Phase 2 default setting for normal and shear stiffness, i.e., $k_n = 100,000$ MPa/m and $k_s = 50,000$ MPa/m (case 1). In the model no. 8 the contact type joint was applied to the contact between coal, sandstone and shale where $k_n = 220,000$ MPa/m and $k_s = 110,000$ MPa/m, while for other gangue rocks $k_n = 880,000$ MPa/m and $k_s = 440,000$ MPa/m (case 2).

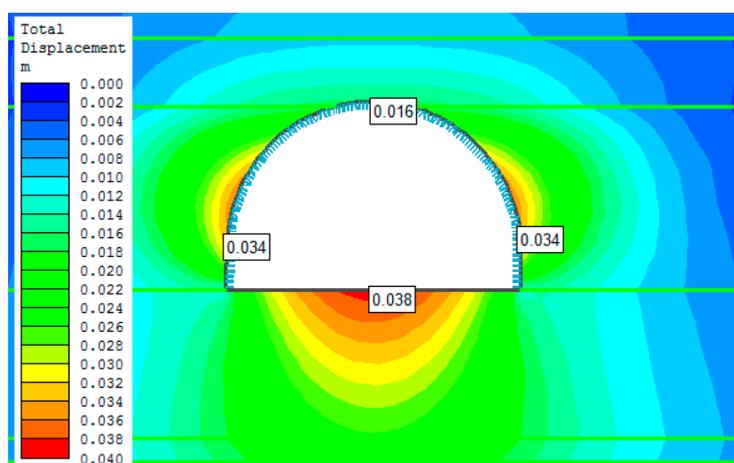
Figure 7. Elastic model no. 10—map of total displacements.

Analysis of the obtained results shows that in all elastic models the coefficient of conformity between modelled and measured values appears significantly lower than in the elasto-plastic models. Generated displacements are generally very low (Figure 7), and even decreasing Young modulus and increasing deformability of the rocks did not change the output values towards closer to the deformations measured in the maingate D-2.

7), whereas the decreasing of post-failure parameters does not affect the zone of yield above the roof and beyond the sidewalls. Directly at the contour of the opening the destruction of the rock is due to tension, where the depth of the tension zone is from approx. 80 cm in the crown and sidewalls to approx. 1.5 m below the floor.

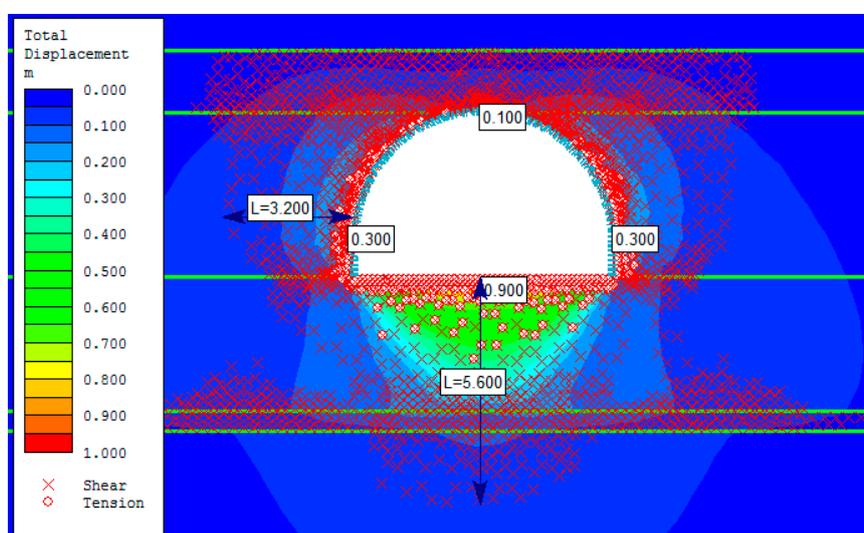
Figure 8. Model elasto-plastic with interpreted Young modulus—map of total displacement and failure mechanism around the opening.

An interesting conclusion was suggested by the analysis of the models where Young modulus for the rock mass was empirically estimated. Despite the evident difference between the behavior of a rock sample and rock mass it is commonly recommended a reduction of mechanical parameters for rock mass [20–22], researches prove such a reduction for sedimentary rock, that are typically low anyway, is not well substantiated. In the case of maingate D-2, both models where estimated Young modulus for a rock mass was applied, the results were largely discrepant from the in situ measurements. The elastic model (no. 12) generated results even lower than for the model based on laboratory derived Young modulus and on yielding support. The elasto-plastic model (model no. 3) showed results certainly too high, exceeding twice the underground measurements on average, that can be expressed as coefficient of conformity 38% between predicted and measured values. The chart of total displacements and mechanism of failure is presented on Figure 8. The zone of failure is formed in the floor of the opening due to tension and shearing. Its extent is 5.6 m. In the sidewalls the failure is caused by shear stress and reaches 3.2 m deep. In the crown, the yielded elements zone appears in the entire 1.5 m thick layer of coaly shale. However, such an extensive failure zone does not exist in reality.

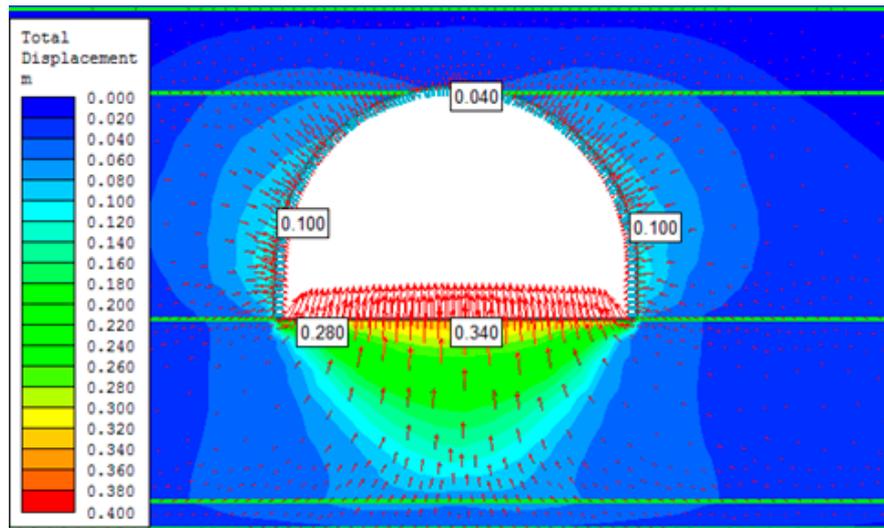
Figure 9. Model no. 1—elasto-plastic—map of total displacements.

Almost entire conformity between generated and measured values was achieved for elasto-plastic model no. 1 (coefficient of conformity 96.9%—Table 4). The chart of total displacement generated from this model is presented on Figure 9. Movement of the floor appears nearly uniform on the full width of the opening and reaches approx. 34 cm, which is consistent with in situ measurements in the mine. The chart of yielded elements around the opening is shown on Figure 10. It is worth pointing out that it is almost identical with the one generated from model no. 3 (compare with Figure 7) in which the Young’s modulus of the rock mass was estimated empirically. The downward extent of the yield zone appears, reaching 5.8 m from the floor, whereas in the crown it spreads over the overlying layer of coaly shale and shows a clear boundary on the above layer of the strong sandstone. Towards the sidewalls the yield zone is 3 m deep. Therefore, it can be concluded that change of the Young’s modulus, which indicates the ratio between stress and strain, strongly affects total displacements. However, it does not significantly affect the extent of yield zone around the opening.

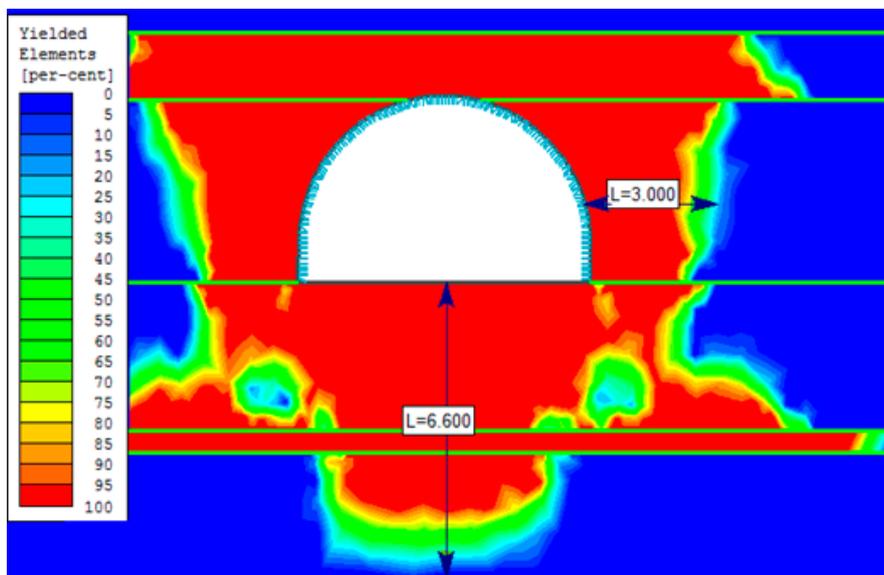
Figure 10. Model no. 1—elasto plastic—yielded rock mass elements.

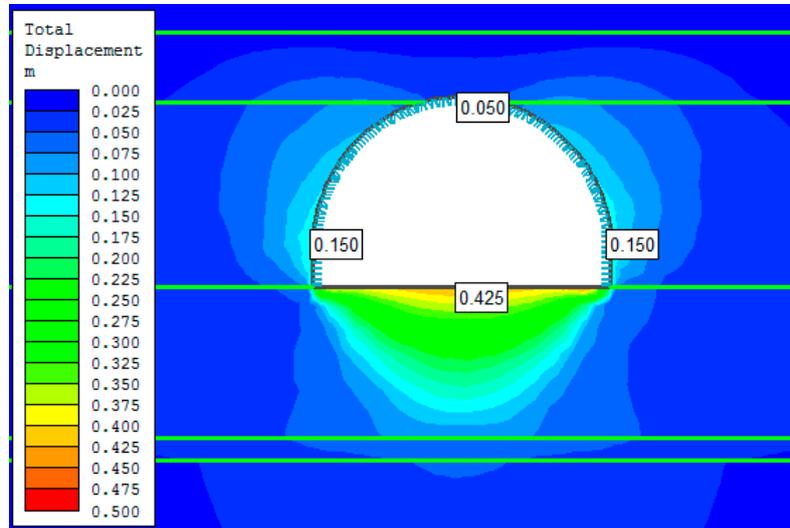
Figure 11. Model no. 6 elasto-plastic with 20% post-failure strength weakening of the rock mass—map of total displacements around the opening.

The most satisfactory results were obtained from model no. 6 with 20% post-failure strength weakening of the rock mass. Considering that the roadway needs to be maintained and used over a period of time, model no. 6 may prove to be the most one suitable for predicting the behavior of the opening under given conditions. It has been demonstrated that even after 450 days from completion of the opening the deformation of the rock mass may continue. The chart of total displacement is shown on Figure 11, and the chart of stress distribution around the opening on Figure 12. Due to weakening of post-failure parameters of about 20% the yield zone below the floor increases from 5.8 to 6.6 m comparing to equivalent model yet without weakening of the rock mass (compare to Figure

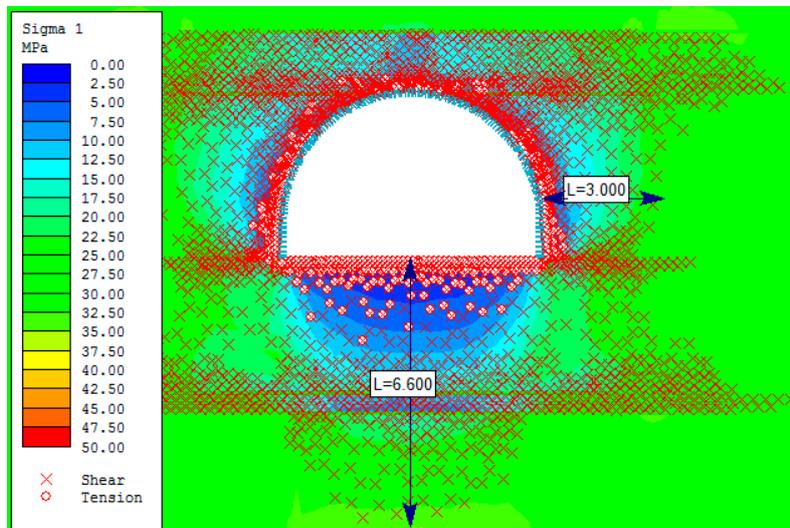
Figure 12. Model no. 6 elasto-plastic with 20% post-failure strength weakening of the rock mass—map of stress distribution around the opening.

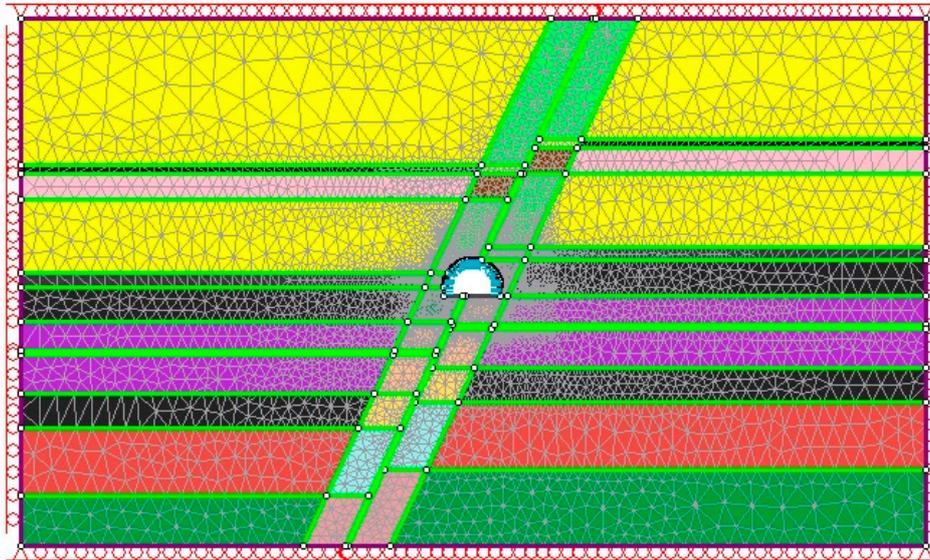
Figure 13. Model planes of the roadway intersecting fault zone.

For the section intersecting fault zone dimensions of the rock mass model were: height 60 m, width 100 m (Figure 13). The total number of nodes and elements for the model in this case amounted to 7042 and 13,803, but the mesh density and the size of elements next to the roadway were the same, so the discretization didn't influence the results of the calculations. The fault is represented in the model as a zone of lower mechanical parameters. The extent of the zone is assumed to be 5 m on both: the footwall and hanging wall side, based on experience discussed in Chapter 2 [2,3,5,9]. For all models, it is assumed also that the compressive strength UCS within tectonically disturbed zone is 50% smaller compared to the unaffected section. The fault plane is

modelled as a 30 cm thick band of tectonic breccia, as observed in the Maingate D-2, and featuring ca. 10 times lower mechanical parameters than intact rocks in this area.

The 2-D geological model depicts dislocation of the strata consistently with 3 m throw of the fault, its slip direction and magnitude. The fault plane dip is assumed to be 65° after geological documentation of the area (Figure 13). The change of the fault angle parallel to the roadway axis hasn't been considered in 2-D model.

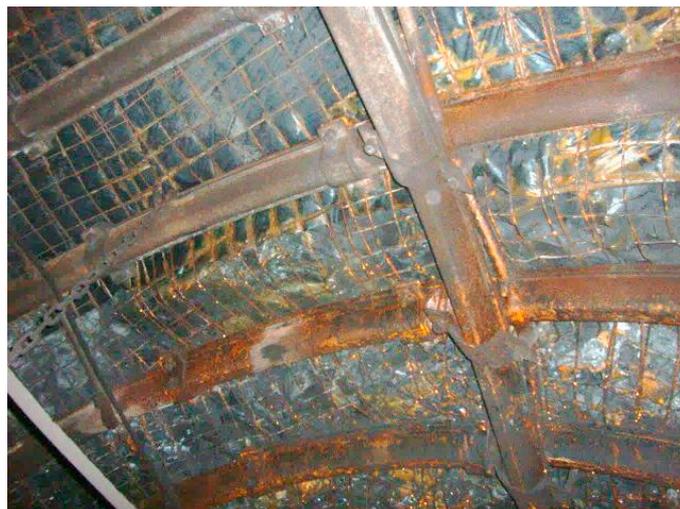
Figure 14. View on the roof of the roadway at the monitoring station at chainage 757 m.

When modelling the fault effect on the stability of the roadway the authors utilized the experience from modelling of the section beyond the fault zone. For this purpose, eight numerical models were elaborated excluding elastic models. In all models, the elasto-plastic rock mass was assumed. A minor leakage was found during site visits from the fault fracture in the maingate D-2. The leakage causes corrosion of many roof arches of the support (Figure 14).

On that section, the observed movements on roof arches joints and roof-sidewall arches clamps were not bigger than several millimeters. Based on these observations it was specified, that for the stiffened support structure, half of the models did not feature the ability of clamp movement, whereas in the second half this option is enabled and is set as 0.5% of the support cross section contour, i.e., movement approx. 7 cm along the joint (models no. 1, 4, 6 and 8).

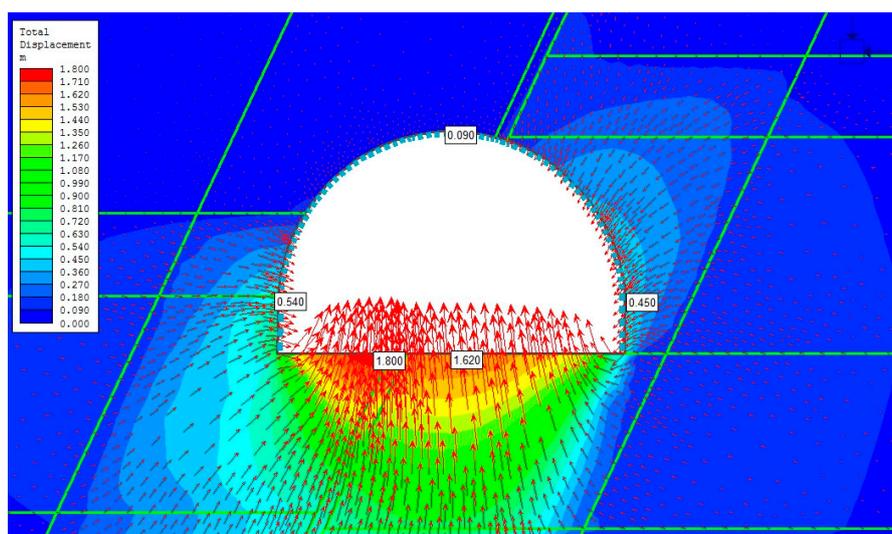
Figure 15. Model no 3—Maingate D-2 in the fault zone—map of total displacement.

Charts of total displacements of the opening contour generated from model no. 3 and model no. 4 are presented on Figures 15 and 16 respectively. The charts show qualitatively very similar deformation around maingate D-2 and characteristic asymmetrical movement of the contour in relation to the fault plane. Quantitatively, the deformation of the rock mass is better reproduced by model no. 3.

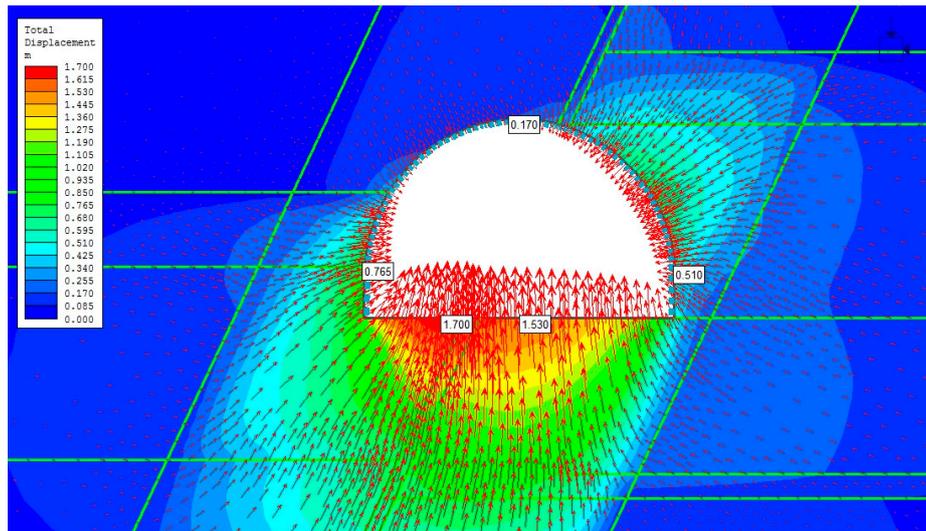
Figure 16. Model no 4—Maingate D-2 in the fault zone—map of total displacement.

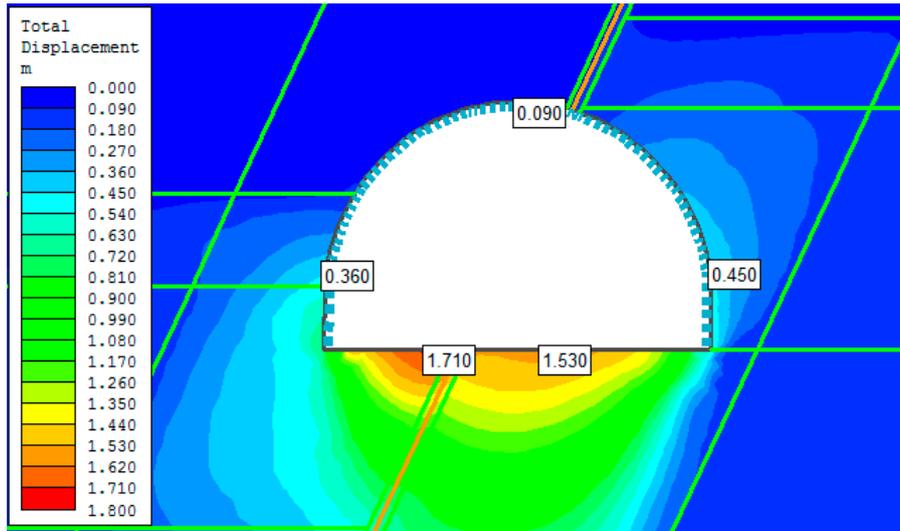
Figure 17. Model no. 7—Maingate D-2 in the fault zone—*joint* type rock mass and rigid arch support—the map of total displacement.

Figures 17 and 18 depict the distribution of displacements around the opening generated from models no. 7 and 8. A significant difference (yet small in terms of absolute value—around 8 cm) can be noted in displacement of hanging wall of the fault that is bigger in model no. 8, in which the support was set with option of arch sliding (Figure 17). Qualitatively, the deformation around maingate D-2 in both models does not differ, except for the above detail. However, in terms of magnitude, it needs to be pointed out that in the model no. 8, the increase of deformation in the roof of 8 cm resulted in a decrease of the floor upheaval by 9 cm.

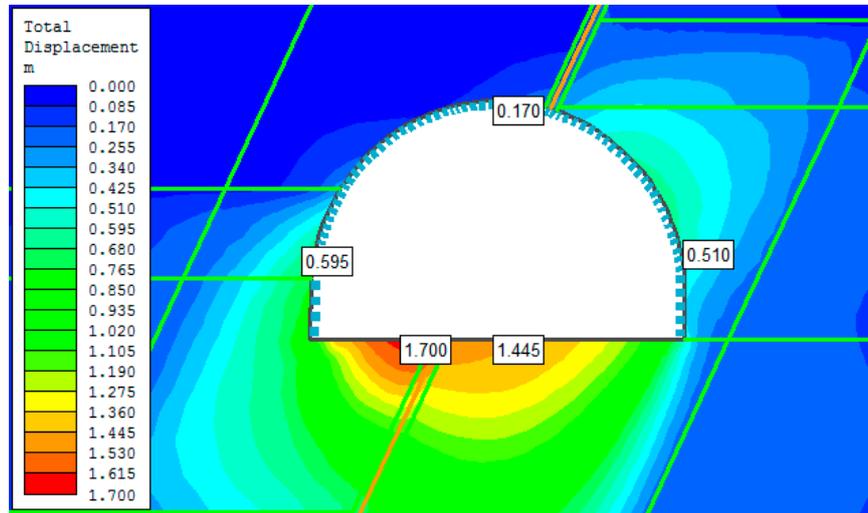
Figure 18. Model no. 8—Maingate D-2 in the fault zone—*joint* type rock mass and yielding arch support—the map of total displacement.

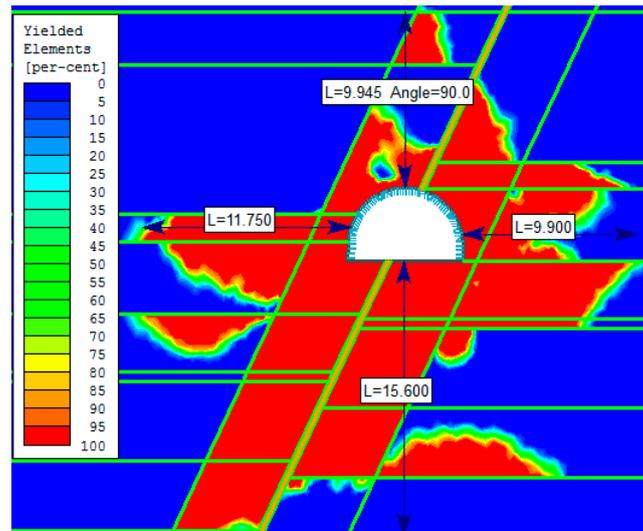
Figure 19. Model no. 7—Fault zone, *joint* type contact, rigid support—map of yielded rock mass elements around the roadway.

In the applied numerical models, the destruction zone mainly coincides with the area of strength parameters reduced to reflect fracturing caused by the fault. Introduction of *joint* type contact into the model (Figure 19) affects the extent of the zone only in the roof of the roadway i.e., reduces its downward movement approx. by 10% comparing to model without *joint* contact (Figure 20).

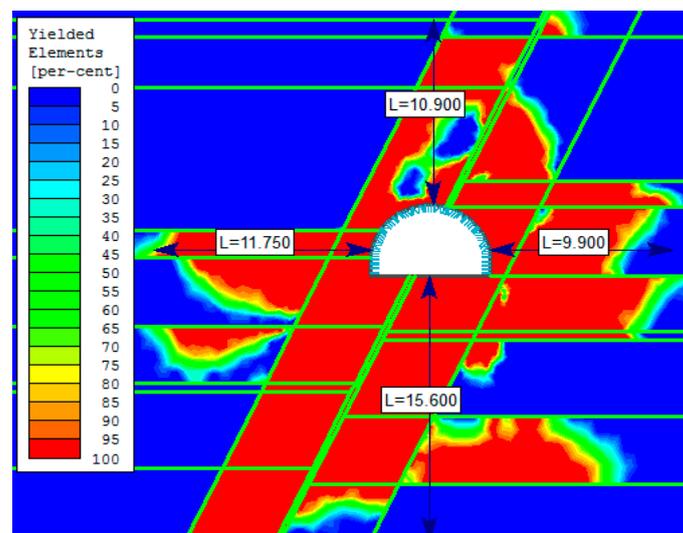
Figure 20. Model no. 3—Fault zone, yielding support—map of yielded rock mass elements around the roadway
