Article

Efficiency of Different Balcony Slab Modernization Method in Retrofitted Multi-Family Buildings

Keywords: balcony slab; thermal bridges; THERM simulations; building envelopes; large panel residential building; internal surface temperature; energy analysis

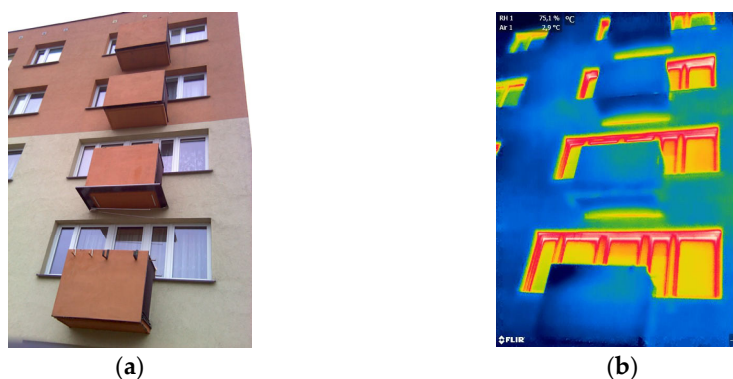
Figure 2. Fragment of the balcony facade of one of the analyzed large-panel residential buildings (OWT-67 system): (a) Photography; (b) Thermal image taken of the external wall surfaces of the building.

The connections of non-insulated precast cantilevered balcony with the wall were areas with undoubtedly worse thermal parameters than the rest of the building envelope. This is proven by the temperature difference between the main surface of construction and the area of balcony connection. The same situation occurred in all 40 tested buildings. Similar research results were obtained by the second author of this paper for a building erected in a different location in Poland. In the study on non-invasive tests of precast cantilever balcony in the OWT-67 system [39], the average temperature difference was found within the interactions and outside the thermal impact area of the thermal bridge equal to 4K. In the aspect of the internal surface of the external wall, the difference was, on average,

8K on the longitudinal wall in the level of the floor and 3K within the prefabricated “Z” lintel beam.

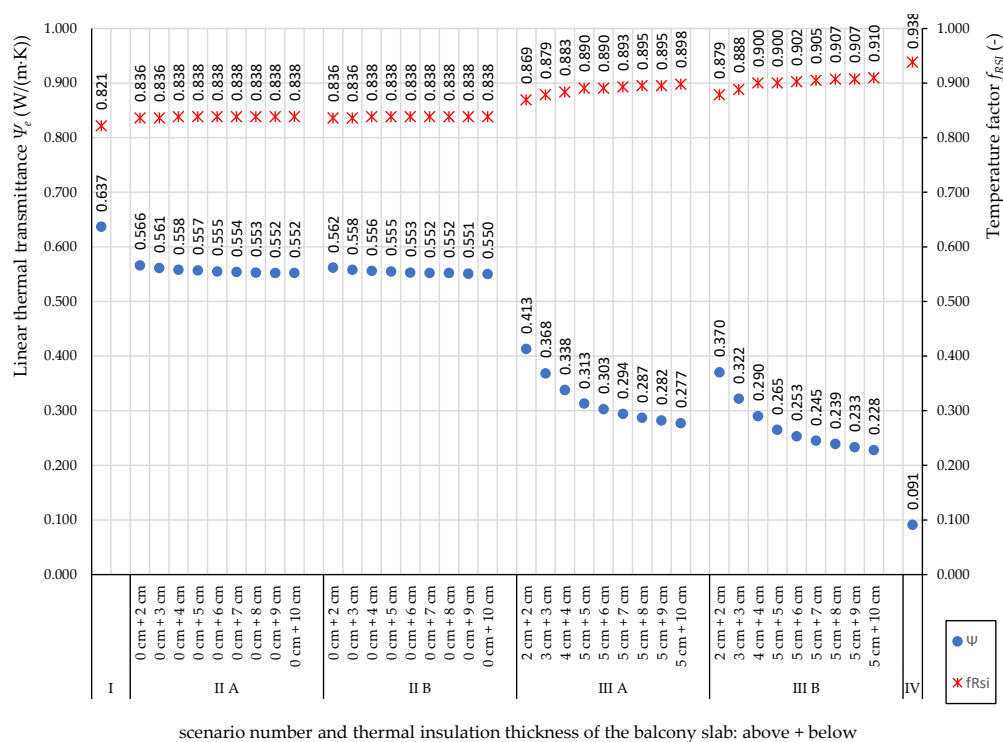
Figure 5. The linear thermal transmittance and temperature factor for the location of the building in Białystok, when the walls of a large-panel building have been insulated with an additional 15 cm thick thermal insulation.

ized in recent years. Figure 5 concerns a wall with additional 15 cm thick thermal insulation, which meets the current requirements in Poland ($U_{wall} = 0.196 \text{ W}/(\text{m}^2\cdot\text{K}) < U_{wall,max} = 0.20 \text{ W}/(\text{m}^2\cdot\text{K})$ [30]).

Figures 4 and 5 present not only the Ψ value for each scenario, but also the f_{Rsi} . The determined values of the temperature factor, according to Equation (5), correspond to the minimum temperatures in the connections between the balcony slab and the wall. Sample THERM models generated using the solutions presented in Figure 3 are shown in Figures 6–9.

Analyzing the results presented in Figures 4 and 5 (for the location in Bialystok), it was proven that in the case of using both a balcony slab without insulation (scenario I) and an insulated balcony slab on the bottom (scenario II), the code condition to avoid surface condensation of water vapor is not met. In the case of thermal insulation of the balcony slab from below and from above using XPS (scenario IIIA), the obtained value of the temperature coefficient is higher than the critical value from 2.08–5.76% (for a wall with 12 cm thick insulation) and 3.21–6.61% (for walls with 15 cm insulation). In the case of using resol foam around the balcony slab (scenario IIIB), the obtained differences amounted between 3.21 and 7.17% and 4.34 and 8.02%, respectively, while using the LKBD system (scenario IV) was between 10.61% and 11.43%. Scenario IV achieves the lowest Ψ -value so is deemed to be the most successful. The application of the LKBD system also allows for avoiding the risk of surface condensation of water vapor in the joints of the balcony slabs with the walls (the obtained f_{Rsi} is higher than the critical value) under appropriate operating conditions (adequate air humidity and efficient ventilation). While in air-tight, higher-humidity buildings, with insufficient ventilation (which is often observed in retrofitted buildings), it can form condensation on “cold” indoor surfaces, causing mould to grow.

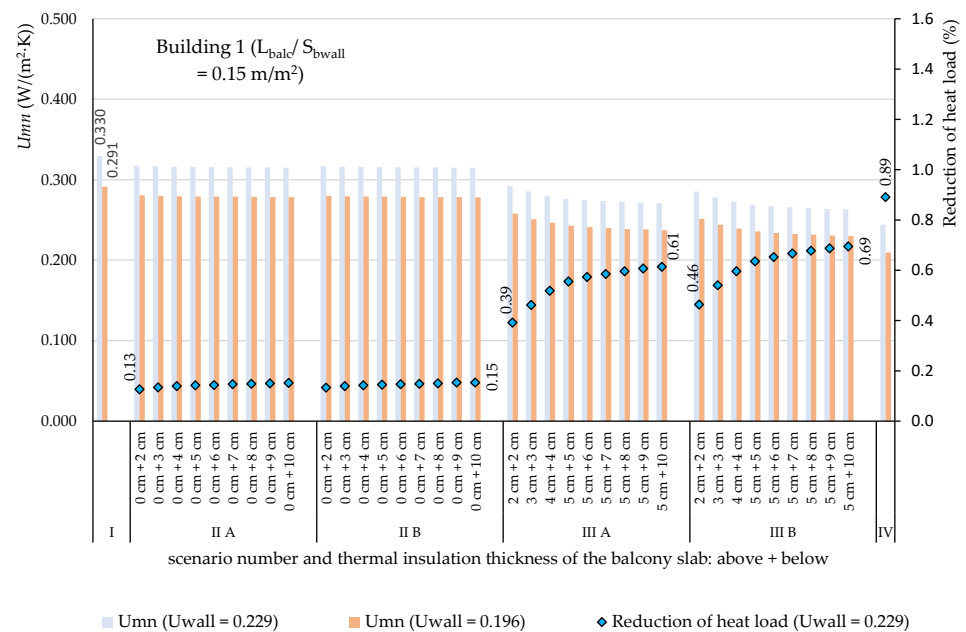
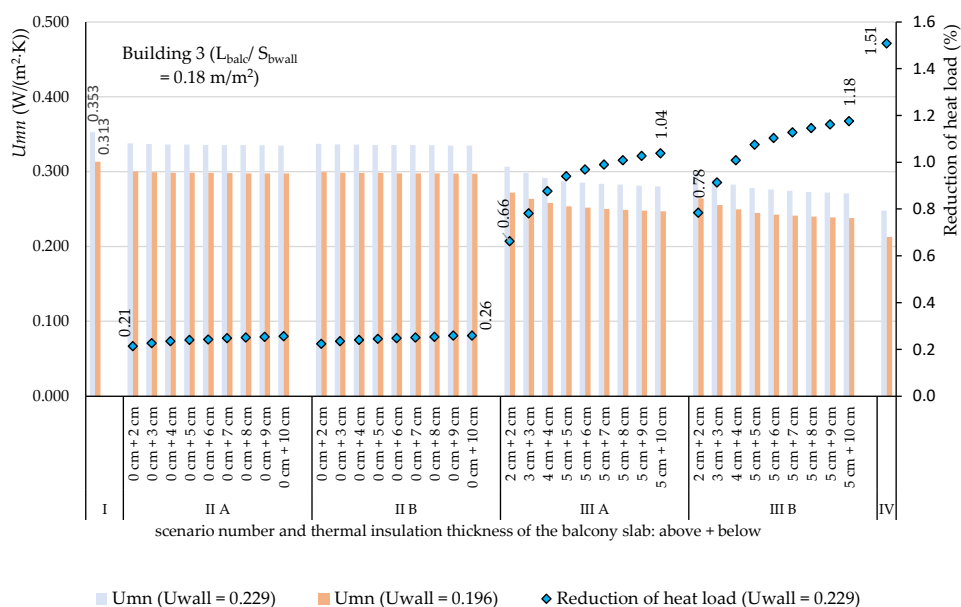
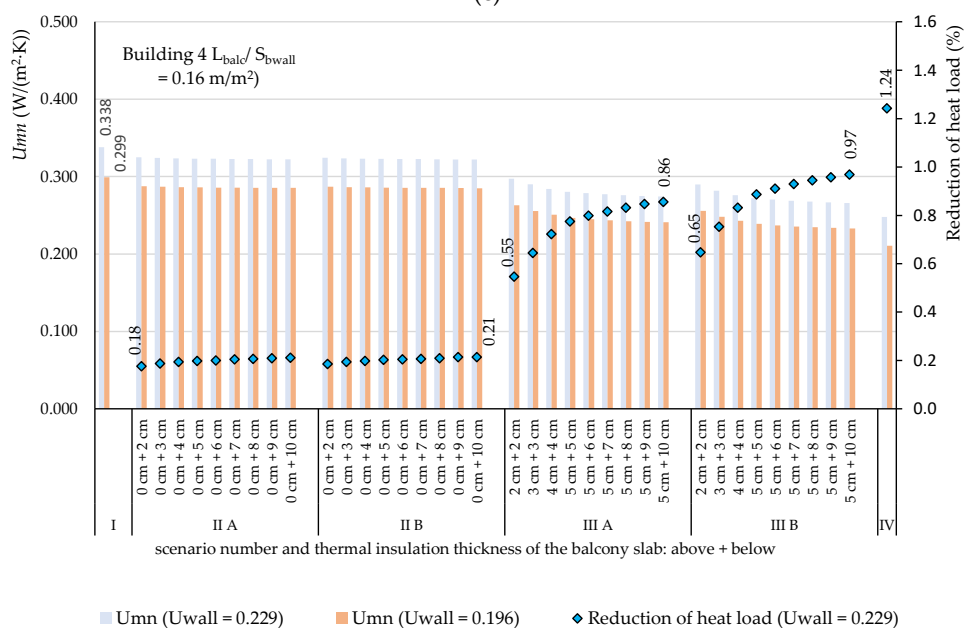
Figure 10. The influence of thermal bridges of balconies in different scenarios and reduction of the heat load of individual analyzed buildings: (a) building no. 1; (b) building no. 2; (c) building no. 3; (d) building no. 4.

The linear thermal transmittance coefficients determined in Subsection 3.1 were used to test the effectiveness of individual balcony modernization methods on the scale of the entire building. As a case study, four multi-family apartment blocks were analyzed, described in 2.1. The nature of the impact of thermal bridges on the thermal transmittance of building walls, determined based on formula 3, is shown in Figure 10.

Uninsulated balcony slabs had the greatest impact on the deterioration of the wall insulation. The increase in the U -value of the walls in the analyzed buildings amounted to between 44 and 54% (in the case of a 12 cm thick EPS insulated wall) and between 49 and 60% (in the case of a 15 cm thick EPS insulated wall). In scenario II, the increase was slightly lower and amounted to approximately between 38 and 48% and between 43 and 53%, respectively. Insulating the balcony slabs from above and below was a much better solution. Here, the increase in the U coefficient of the walls reached between 18 and 33% and between 21 and 39% (with the use of XPS) and between 15 and 30% and between 17

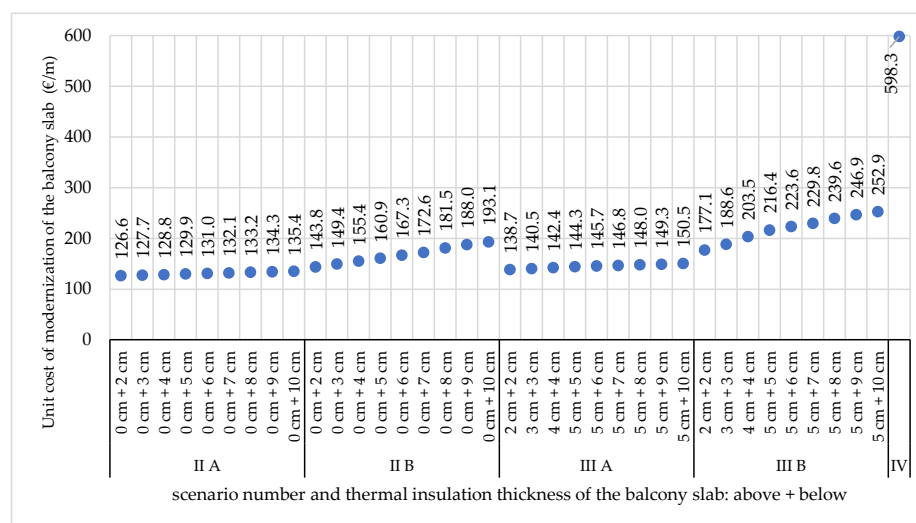
Figure 11. Unit cost of considered individual methods of modernization of balcony slabs.

High investment costs may be a barrier to the use of modern materials and solutions in construction practice. Figure 11 shows the cost of individual methods of modernization of balcony slabs in relation to the 1 m length of balconies. Such information may be useful for energy audits, architects, or civil engineers. It is worth emphasizing that the correct solution from the point of view of humidity scenario IIIA is cheaper by between 5.1 and 42.6% than scenario IIB, which may cause surface condensation.

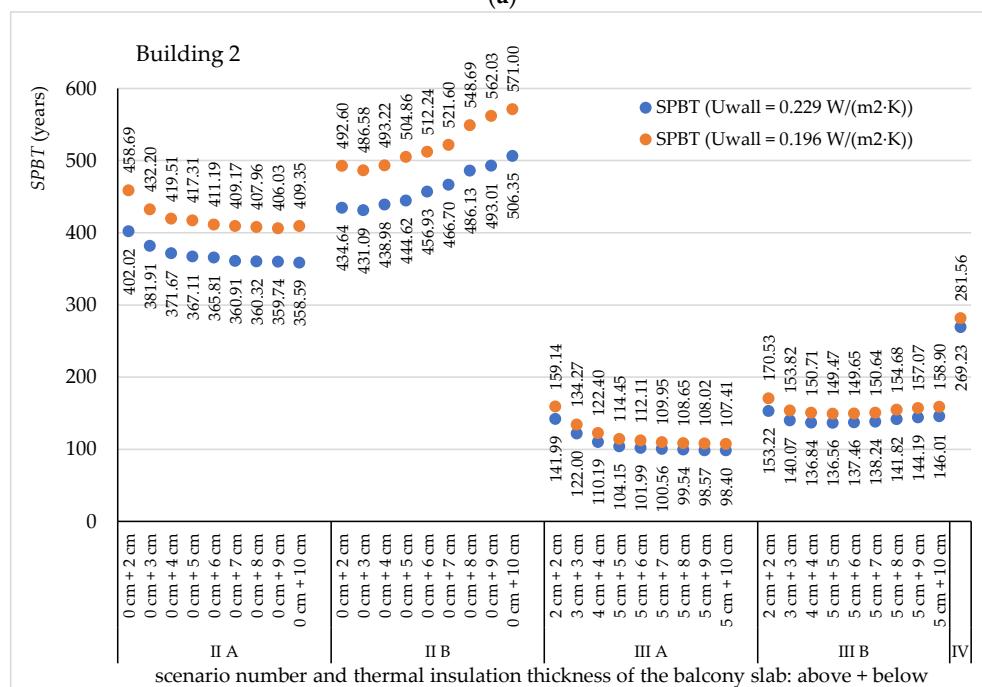
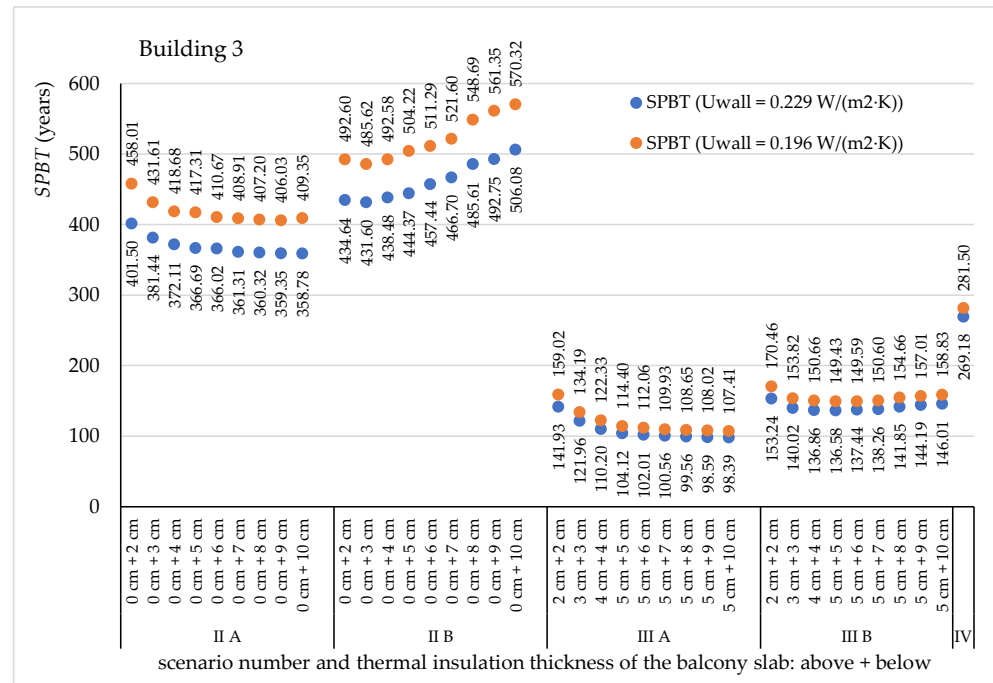
Figure 12. The Simple Payback Time for investment costs in different scenarios: (a) in building no. 1; (b) in building no. 2; (c) in building no. 3; (d) in building no. 4.

To evaluate the cost effectiveness of the investment according to the adopted method (SPBT), the average price of a unit of energy was assumed at the level of 11 €/GJ [51]. The Simple Payback Time, calculated according to formula 6, is shown in Figure 12.
