Article

Microstructural Analysis and Wear Performance of Carbon-Fiber-Reinforced SiC Composite for Brake Pads

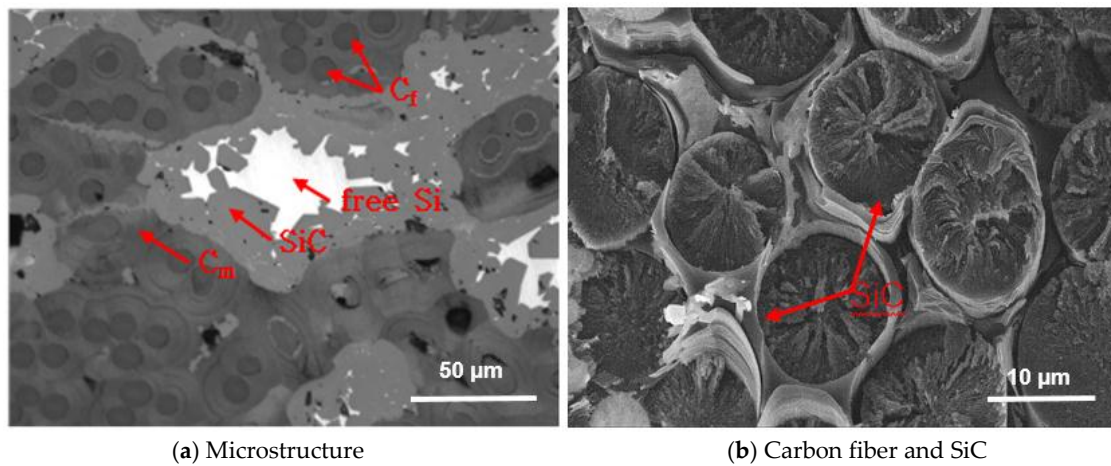
Figure 1. Microstructure of C/C-SiC composite showing the presence of SiC areas in the material. Note: C_f is the C fiber, C_m is the matrix.

The specimens with dimensions of $10 \times 10 \times 3$ mm³ were cut from a C/C-SiC composite. To produce the C/C-SiC composites, carbon fibers coated with phenolic resin were chopped and mixed with phenol resin powder. A preform was produced by hot-forming the mixture at 170 °C for 30 min under pressure. The measured density of the preforms was found to be 1.7 g/cm³. The preforms were pyrolyzed in an inert gas ambience by a heating temperature speed of 10 °C/min up to 1000 °C. The volatile ingredients in the phenol resin began to evaporate at about 200 °C. The final heat treatment of the composite was carried out at 2000 °C. Finally, the C/C composite was infiltrated with molten Si at 1550 °C. The manufacturing process for the C/C-SiC composites was described in more detail in the previous study [14]. The SiC fiber volume fraction in the C/C-SiC composite was about 31%, as shown in Figure 1. The density of C/C-SiC composite was about 2.2 g/cm³. The elastic modulus and tensile strength of the specimens were 15 GPa and 60 MPa, respectively. For microstructural characterization, the specimens were polished using an alumina suspension down to a particle size of 1 μm.

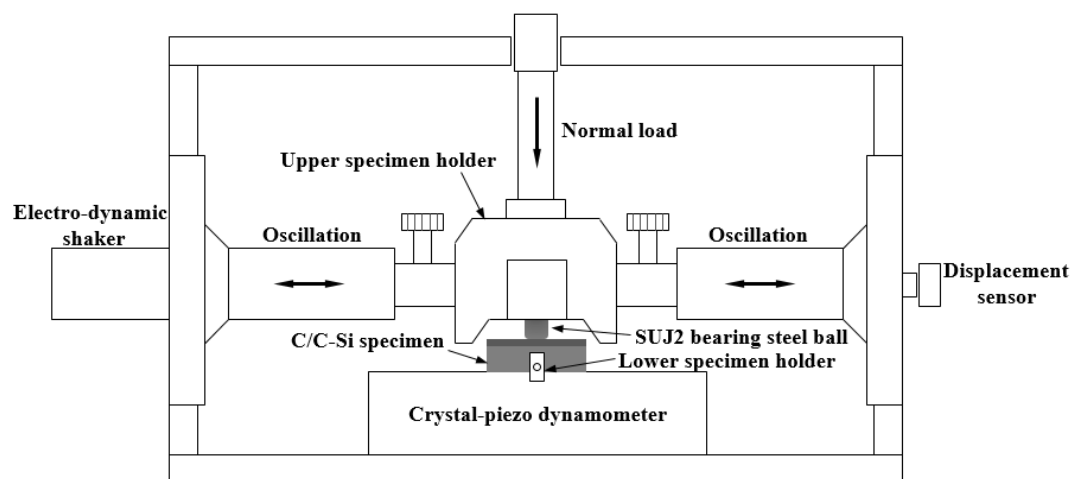
Figure 2. Schematic diagram of the ball-on-disk tribometer.

The friction and wear tests of the specimens were carried out using a ball-on-disk tribometer (Optimol SRV4, Munich, Germany) under dry conditions at different temperatures of 25, 100 and 200 °C. Figure 2 shows a schematic diagram of the tribometer. Table 1 presents the friction and wear test conditions. The calculated Hertzian pressure and circular contact area diameter were found to be in the range of 56–451 MPa and 0.230–0.654 mm, respectively. The lower disk specimen was fixed, while the upper ball oscillated by an electro-dynamic shaker. A bearing steel SAE52100 similar to the brake discs was used as a counter surface with a diameter of 10 mm [15]. All the friction and wear tests were performed three times, and the average values are presented hereafter. Prior to tribological tests, the specimens were cleaned up in deionized water for 10 min to eliminate dust and solid contamination.

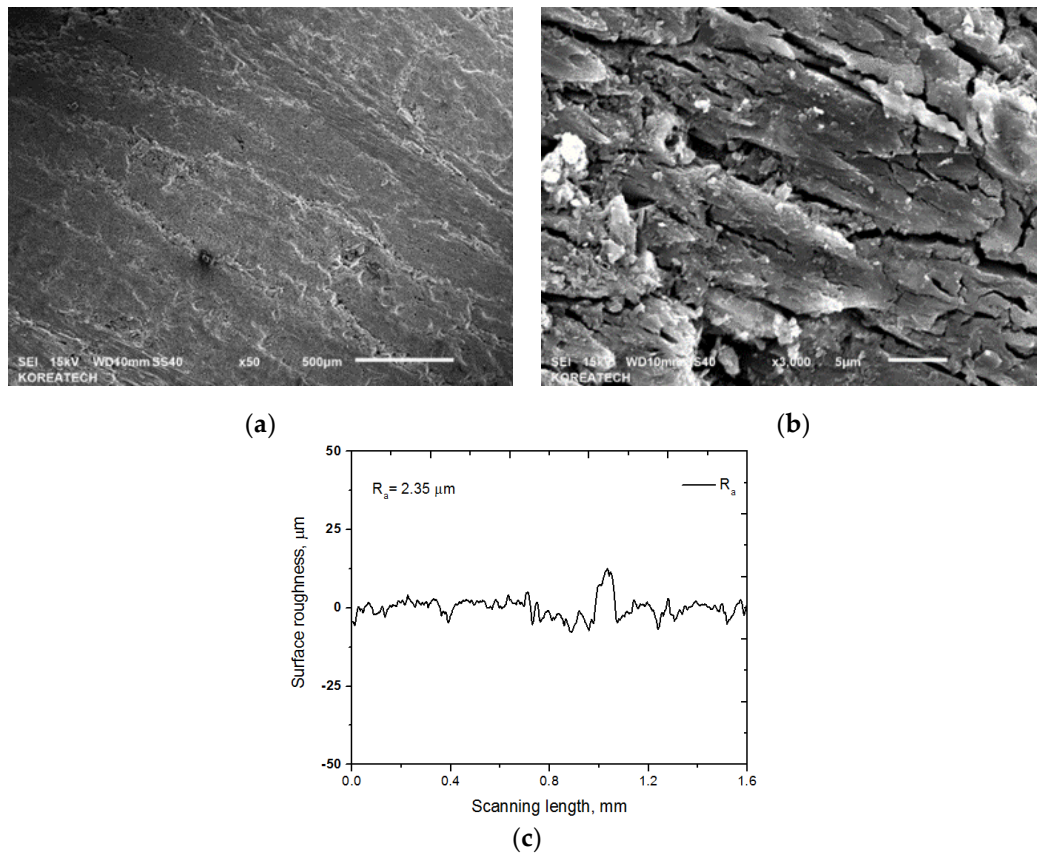
Figure 3. SEM images at low (a) and high (b) magnification, and cross-sectional surface roughness profile (c) of the C/C-SiC composite.

The hardness of material is an important factor in terms of wear resistance. The average surface hardness of the specimens was about 156 HV. The surface microstructure at low and high magnifications along with the cross-sectional surface roughness profile of the specimen is presented in Figure 3. Figure 3a shows that some defects exist on the surface, and the microstructure of the specimen is not homogeneous. Irregular cracks and surface damage in micro-scale are observed, as shown in Figure 3b. These surface defects, cracks or pores deteriorate the mechanical properties, such as strength, hardness, and also the friction and wear behavior of C/C-SiC composites [16]. The most important factor that determines the physical properties of C fiber is the degree of carbonization (C content usually more than 92 in wt %). The average surface roughness of the specimen was

2.35 μm , as shown in Figure 3c. The surface roughness of the specimen is very high, which has the advantage of providing a high friction coefficient during braking. A car needs a rapid dissipation of kinetic energy in the form of heat. Sticking due to heat generation between the pad and disc leads to rapidly accelerated wear and oxidation at the interface.

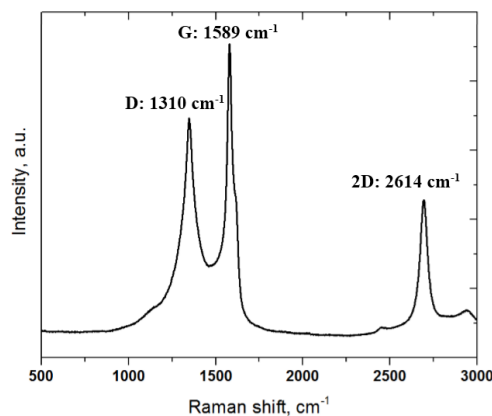
Figure 4. Raman spectrum taken from the C/C-SiC composite.

The Raman spectrum of the specimen is shown in Figure 4. Typical carbon fiber peaks were present in the Raman spectrum of the C/C composite, as shown in Figure 4 [17]. The peak at around 1590 cm^{-1} (G band) with a shoulder around 1604 cm^{-1} was assigned to the in-plane vibration of the C-C bond (G band), which is typical of defective graphite-like materials, and the peak at around 1310 cm^{-1} (D band) was activated by the presence of disorder in the carbon systems. The Raman spectrum showed another peak at around 2610 cm^{-1} (2D band), which was attributed to the overtone of the D band [17].

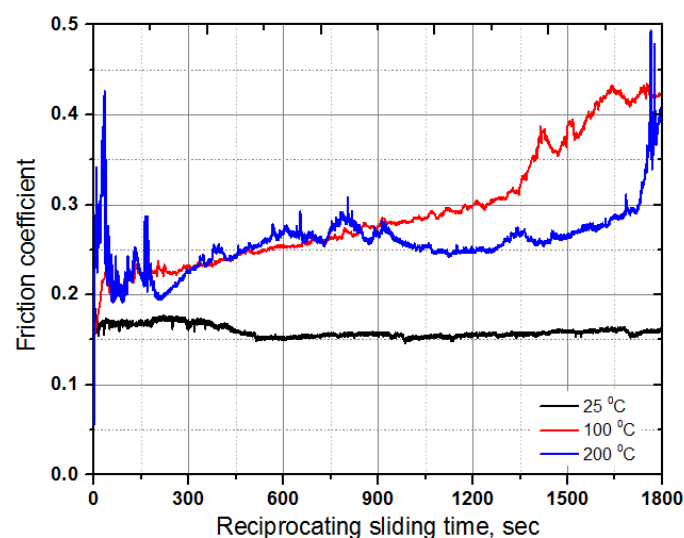
Figure 5. Variation in friction coefficient of the C/C-SiC composite with respect to time at temperatures of 25, 100 and 200 °C.

Friction brakes decelerate a car by dissipating the kinetic energy of a running car into frictional heat, which has a significant influence on the behavior of the brake disc and pads. Figure 5 shows the variation in friction coefficients for the specimen at temperatures 25, 100 and 200 °C. At a temperature of 25 °C, a very stable frictional behavior with a value of 0.16–0.17 was observed. However, the friction coefficient increased gradually with the sliding distance, and reached about 0.42 after a sliding time of 30 min at a temperature of 100 °C. Interestingly, the friction coefficient was very high at the initial stage of the test, and then the friction coefficient decreased drastically and increased gradually at a temperature of 200 °C. After a sliding time of about 15 min, the friction coefficient stabilized and decreased a bit, and then it started to increase and reached a very high friction coefficient value of about 0.48–0.50 at the end of the test. Sudden reduction and increase with sliding time in friction coefficient value, which was lower than the friction coefficient at a temperature of 100 °C, may be attributed to the smoothing phenomenon at the contact interface and to the presence of wear-induced particles and debris at the contact interface during reciprocating sliding under dry conditions. This study clearly demonstrated that the friction coefficient of the specimens increased with temperatures from about 0.18 to 0.48. The main reason for the increase in friction coefficient with an increasing temperature may be the decomposition of the composite. Similar results were reported in a previous study where the friction coefficient increased as the friction temperature rose from 100 to 300 °C [18]. The friction and wear behavior can be explained in terms of plasticity of the composite at different temperatures [19] because C/C-SiC composites soften with increasing temperature under dry conditions where hard phase SiC cannot be cut by shearing and easily break. SEM was employed to observe the surface of worn out specimens as shown in Figure 6. It can be seen that after sliding under dry conditions at temperatures of 25, 100 and 200 °C, the specimens were severely worn out. The specimen tested at a temperature of 25 °C showed relatively minor wear compared to the specimens that were tested at temperatures 100 and 200 °C. This kind of wear behavior is in a good agreement with the friction coefficient presented in Figure 5. It signifies that the resistance to wear of the composite was weakened with a temperature increase. Surface damage after friction and wear tests at different temperatures are presented in Figure 7. All the surface specimens were broken up with cracks. The wear mechanism for all the specimens was found to be abrasive mode, where the surface layers were peeled off gradually layer-by-layer as shown in Figure 8. Abrasive wear is usually considered as a primary wear mechanism for composite materials [4]. An oxidative wear mode was also observed and was determined from the SEM images and EDX patterns of the worn out surfaces.

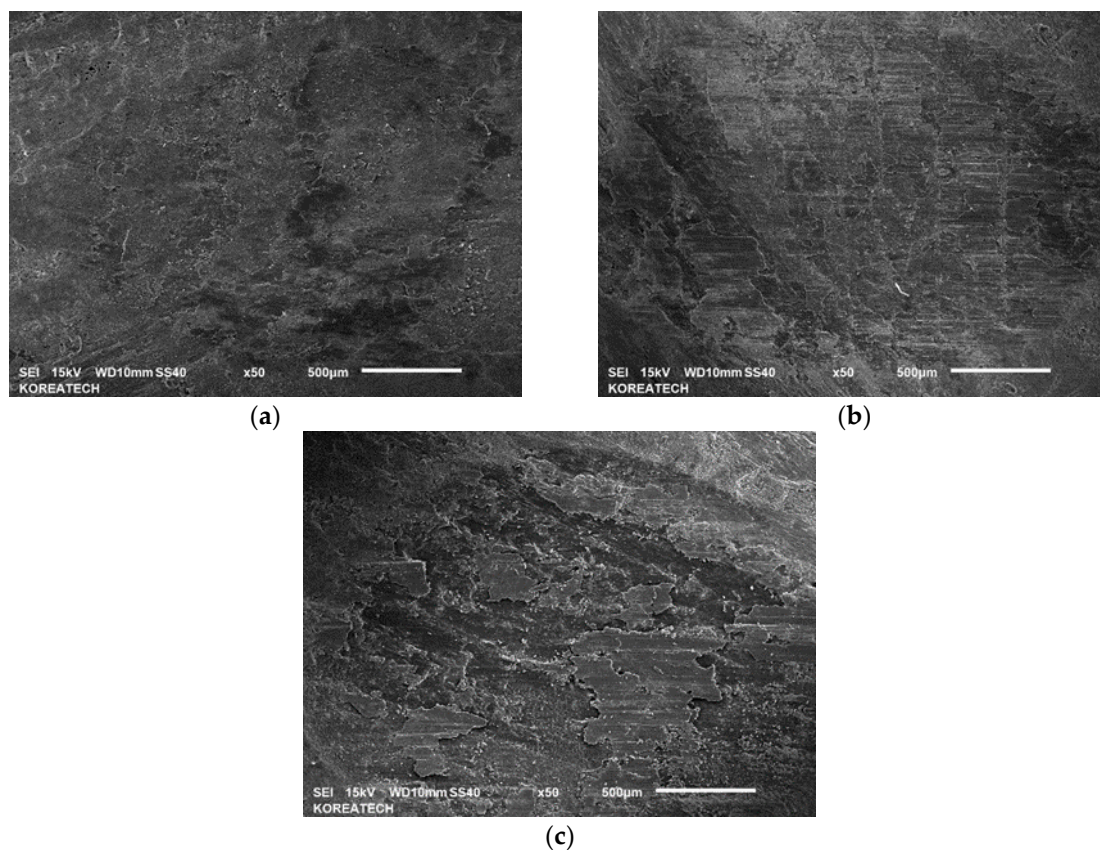
Figure 6. SEM images of wear track formed on the C/C-SiC composite at temperatures of 25 °C (a); 100 °C (b) and 200 °C (c).

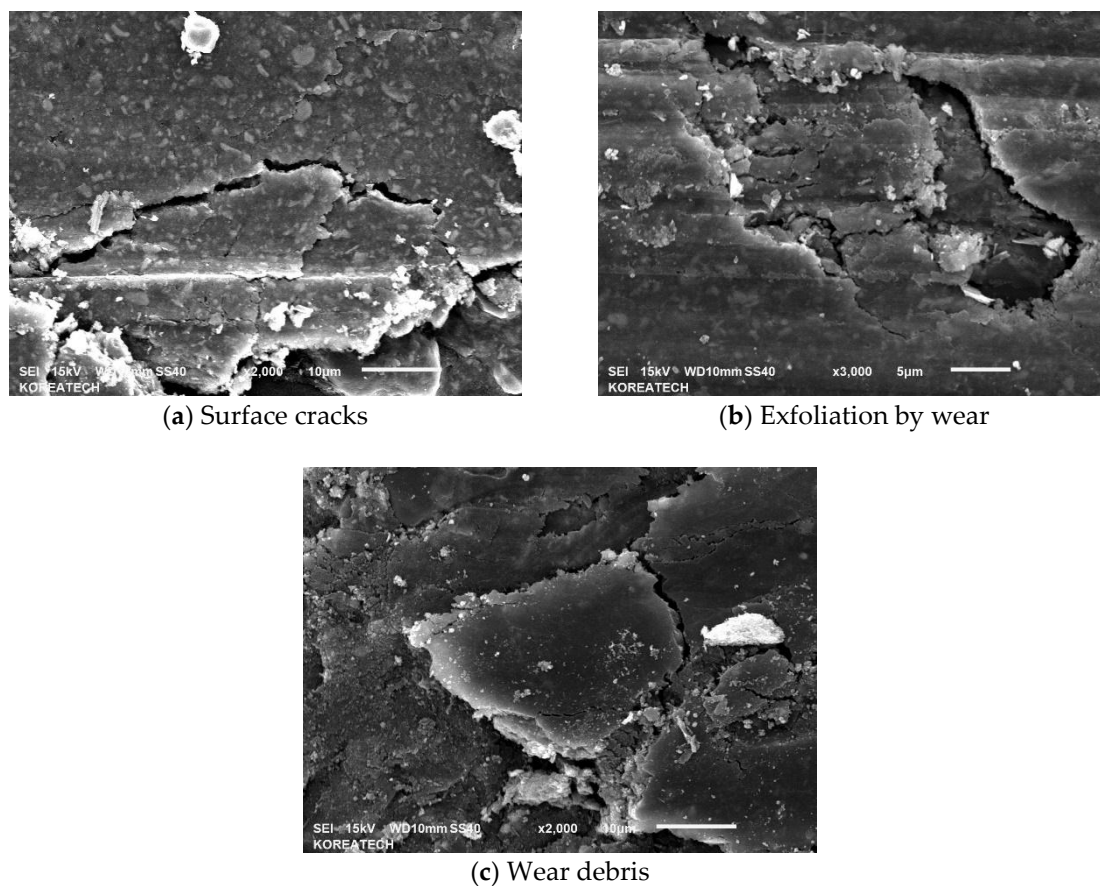
Figure 7. SEM images of wear tracks of the C/C-SiC composite showing the cracks on the surface.

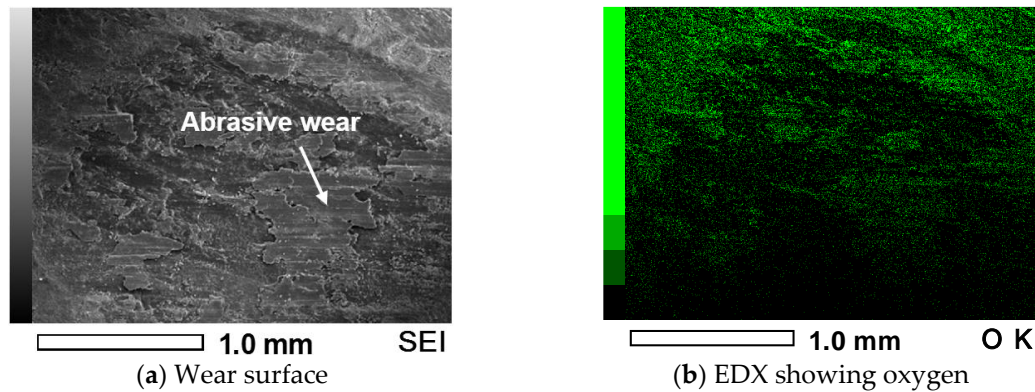
Figure 8. SEM image of wear track formed on the C/C-SiC composite at temperature 200 °C showing the wear mechanism along with oxidation state.

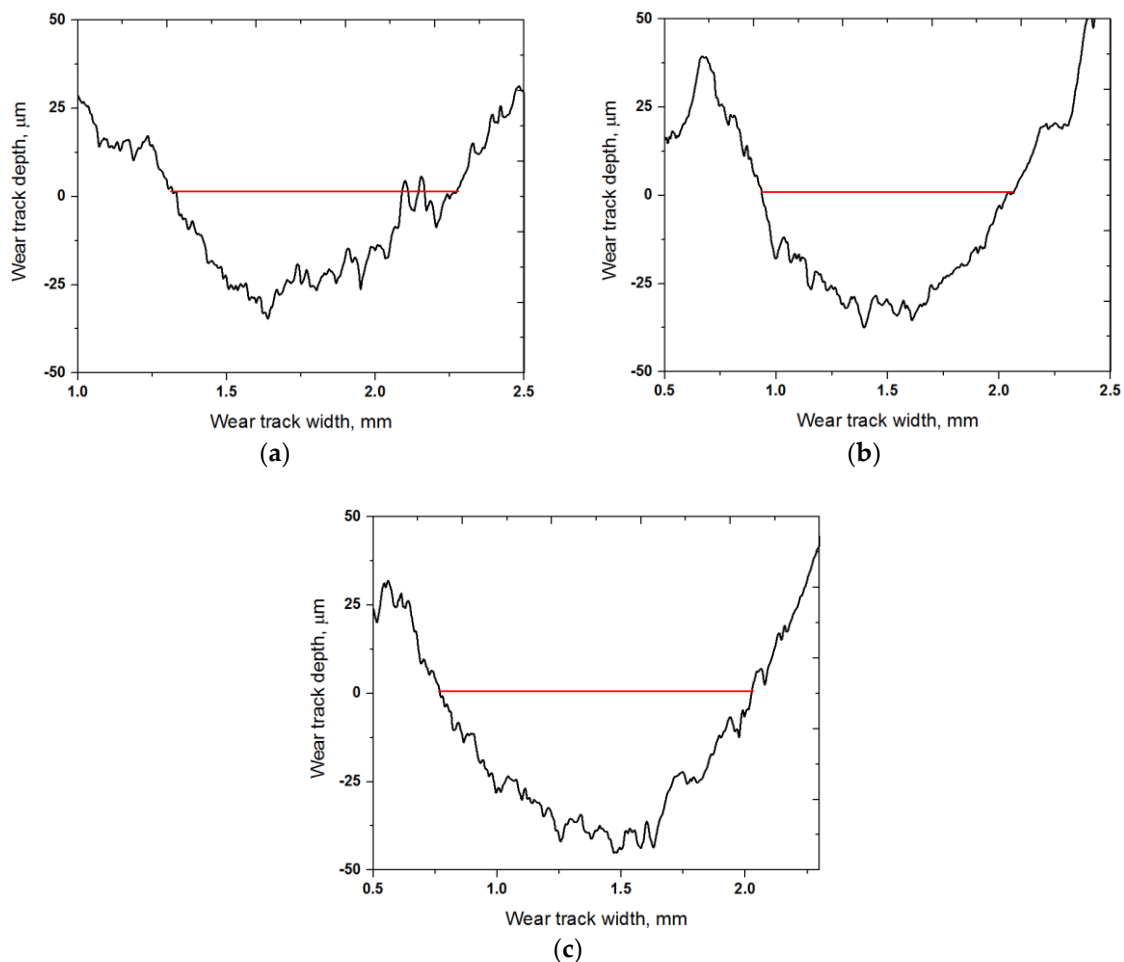
Figure 9. Cross-sectional profiles of wear track formed on the C/C-SiC composite slid against AISI52100 steel at temperatures of 25 °C (a); 100 °C (b) and 200 °C (c).

Figure 9 presents the cross-sectional wear track profiles of the specimens tested at temperatures 25, 100, and 200 °C. The friction and wear results revealed that the specimen tested at a temperature of 25 °C exhibited a shallower and narrower wear track. The depth of the wear track of the specimens tested at temperatures 25, 100, and 200 °C was about 31, 38 and 46 μm , respectively. The depth and diameter of the wear track increased with an increasing temperature, as shown in Figure 9b, c. These cross-sectional profiles allowed us to calculate the wear rate of the specimens. Figure 10 shows the wear rates at temperatures 25, 100, and 200 °C. The wear rate increased with an increasing temperature.

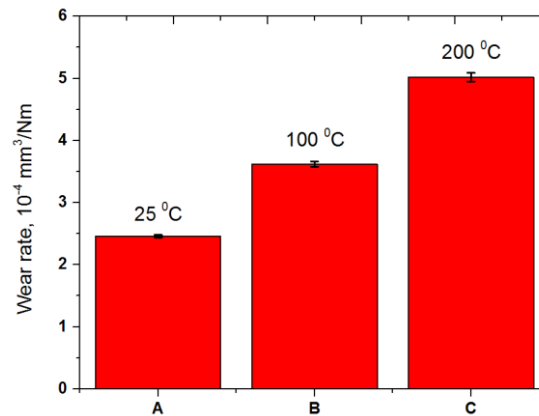
Figure 10. Wear rate of the C/C-SiC composite slid against AISI52100 steel at temperatures of 25, 100, and 200 °C.

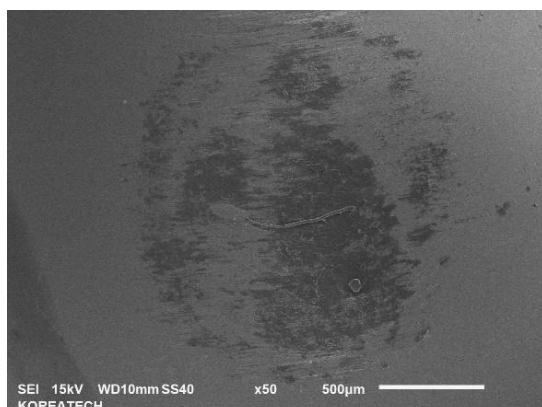
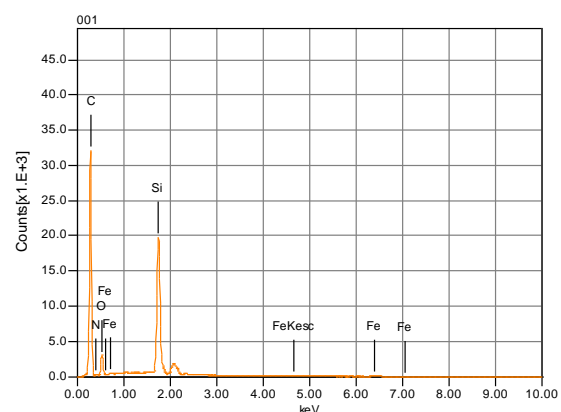
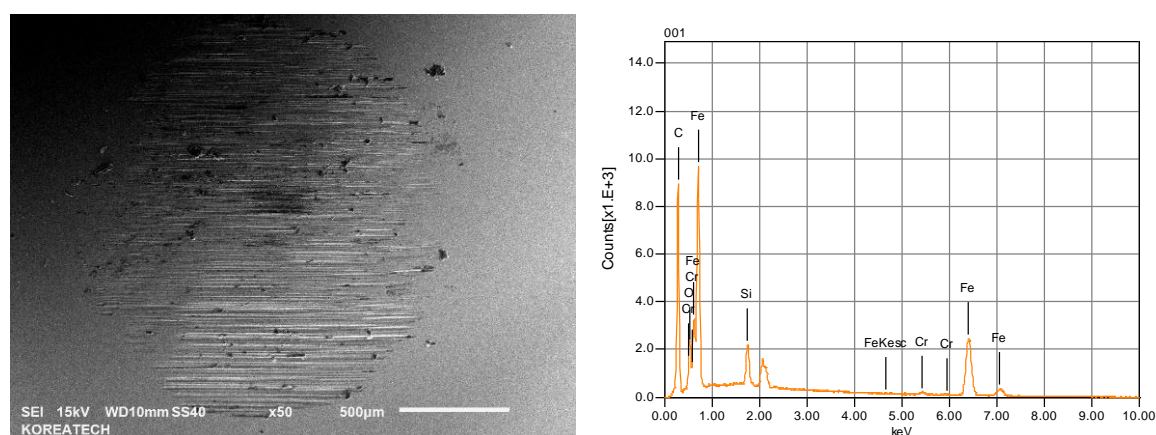
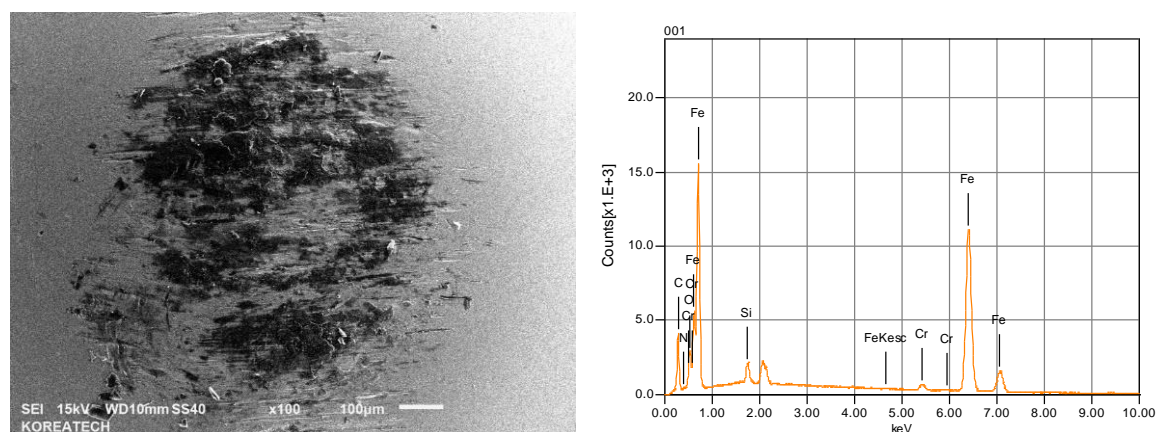
Figure 11. SEM images and EDS patterns of wear scars formed on the AISI52100 steel ball slid against the C/C-SiC composite at temperatures of 25, 100 and 200 °C.

Figure 11 presents the wear scar formed on the counter ball surfaces and its chemical composition when the balls slid against the disc specimens at temperatures of 25, 100, and 200 °C. No significant difference in wear scar was found for the balls tested at temperatures of 25 and 100 °C. However, the counter ball surface tested at 200 °C demonstrated a much larger wear scar diameter and rougher surface with a high amount of Fe and Cr elements, which were transferred from the counter surface, than the specimen tested at a temperature of 25 °C. This means that the contact area of the specimen tested at a temperature of 25 °C with the corresponding ball was smaller than that of the specimens tested at a temperatures of 200 °C with the corresponding ball. Figure 12 shows the wear volume of the balls. The wear volume was quantified using the equation presented above. It is obvious that the ball tested at a temperature of 25 °C exhibited a higher resistance to wear than the specimens tested at a temperature of 200 °C. A similar result was reported in [20]. The presence of SiC in a C/C composite increases the friction coefficient during braking, but the wear resistance can also be mitigated because of the abrasive character of SiC. With an increasing temperature, the friction coefficient and wear rate deteriorated due to the flexion by debonding of SiC grains where the C fiber loosened. Braking increases the temperature of the disc and the pads, and the friction coefficient. The wear rate also increases simultaneously. In addition, the friction coefficient of a C/C-SiC composite during braking depends on the surface hardness, which increases the friction coefficient due to the ploughing effect [21]. Softening occurs in the friction surface due to heat generation during braking, and relatively hard SiC particles in the C/C composite come into hard contact with the counter surface. Either the material of the disc or the pad has an influence on the friction coefficient of a frictional brake. A number of factors affect the friction coefficient and wear rate of a C/C-SiC composite. For example, the pyrolytic C amount, porosity and SiC content as well as braking pressure and speed play an important role in controlling the friction and wear behavior of a C/C-SiC composite.

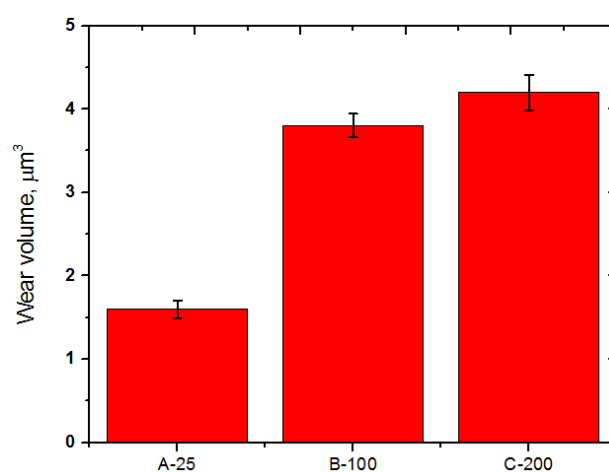
Figure 12. Wear volume of AISI52100 steel ball slid against the C/C-SiC composite at temperatures of 25, 100 and 200 °C.

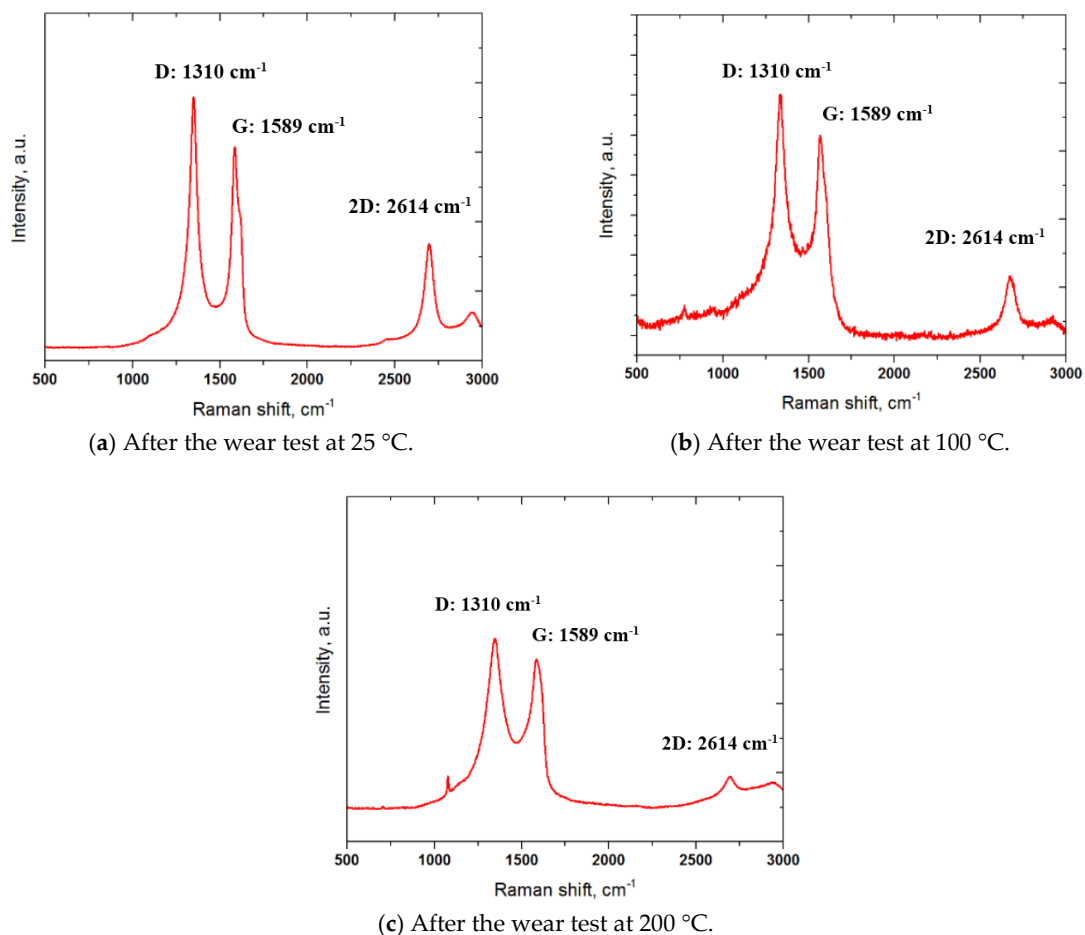
Figure 13. Raman spectra obtained from wear track formed on the surface of the C/C-SiC composite slid against AISI52100 steel at temperatures 25, 100 and 200 °C.

influence on the friction and wear behavior of a C/C-SiC composite at the initial stage of braking. In this regard, the microstructure of the C/C-SiC composite after friction and wear test was characterized by Raman spectroscopy. Figure 13 shows the Raman spectroscopy results taken from the worn surfaces at temperatures of 25, 100, and 200 °C. The intensity of C-C bonds (G band) that was tetrahedral (sp^3) was found to be lower than the *D band* after friction tests at temperatures of 25, 100, and 200 °C. These changes may be due to the C concentration after wear tests, and account for the oxidation as detected by EDS in Figure 11. It can be seen that the intensity of the *2D band* decreased with an increasing temperature, which was also due to the role of C concentration [22]. At temperatures of 100 and 200 °C, the friction and wear increased and the C concentration started to increase due to the high wear of the bearing steel, which resulted in a reduction in Raman intensity due to the increase in C concentration. Moreover, some new peaks appeared at about 750 and 1100 cm^{-1} at temperatures of 100 and 200 °C (see Figure 12b, c), respectively. These peaks may be attributed to the presence of SiC and Si elements formed at the contact interface and graphitization during sliding under dry conditions. It has been reported that the friction coefficient of C/C-SiC composites with no graphitization is higher than the friction coefficient of C/C-SiC composites with graphitization. It is also observed that graphite can act as a solid lubricant to reduce the friction coefficient at the initial stage of braking and normalize the fluctuation in the friction coefficient in the final stage of braking. Moreover, graphitization may increase the content of SiC in C/C-SiC composites, where graphite crystallite can be formed [23], which can lead to softening of C/C-SiC composites. A precise description of the evaluation of graphite spectrum with consideration of amorphization or graphitization of the structure was reported earlier [24,25]. In particular, the G band intensity is used as a normalized intensity to study the evolution of the G band by the calculation of the ratio ID/IG .
