Article

Degradation of Glaukonite Sandstone as a Result of Alkali-Silica Reactions in Cement Mortar

Przemysław Czapik

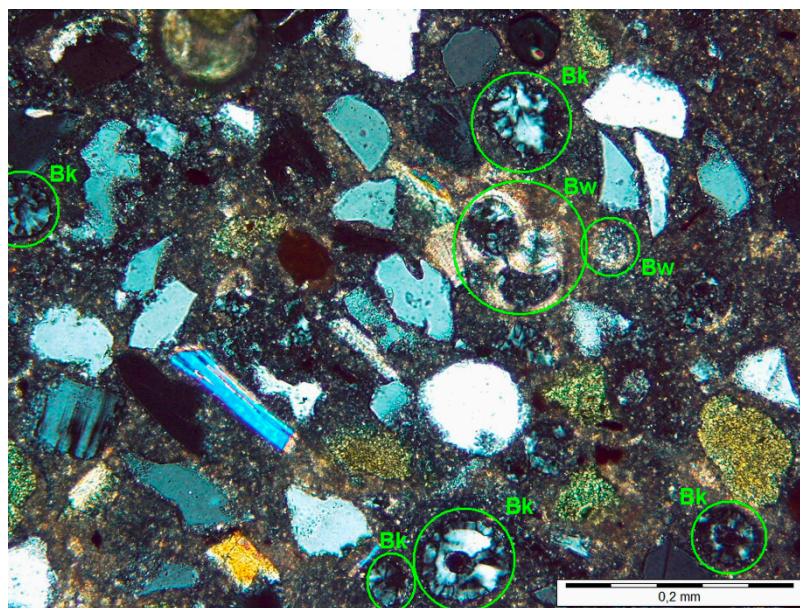
Quartz-glaukonitic sandstone surface with clay-carbonate cementing substance obtained during the observations under the light microscope is shown in Figure 1. This surface has the form of loose particle framework built from quartz grains, glaukonite aggregates, as well as silicate (Bk) and carbonate (Bw) bioclasts. These grains of size 15–100 μm are embedded in cementing substance build from clay minerals, microcrystalline silica, microsparitic calcite and organic material.

Figure 1. Texture of quartz-glaukonitic sandstone with clay-carbonate cement at 120 \times magnification. Marked silicate (Bk) and carbonate (Bw) bioclasts.

Silicate bioclasts in the form of sponge needles are built from fibrous chalcedony. They occur in two cross sections: longitudinal and transverse, and their maximum dimension reaches 280 μm . In both cases, the empty central channel is often visible. The needles length reaches 0.4 mm with diameter not exceeding 0.1 mm.

Fibrous chalcedony sometimes occurs also inside the carbonate bioclasts represented by shells of multichamber calcareous foraminifera. Size of this type of bioclasts varies from 0.1 to 0.2 mm.

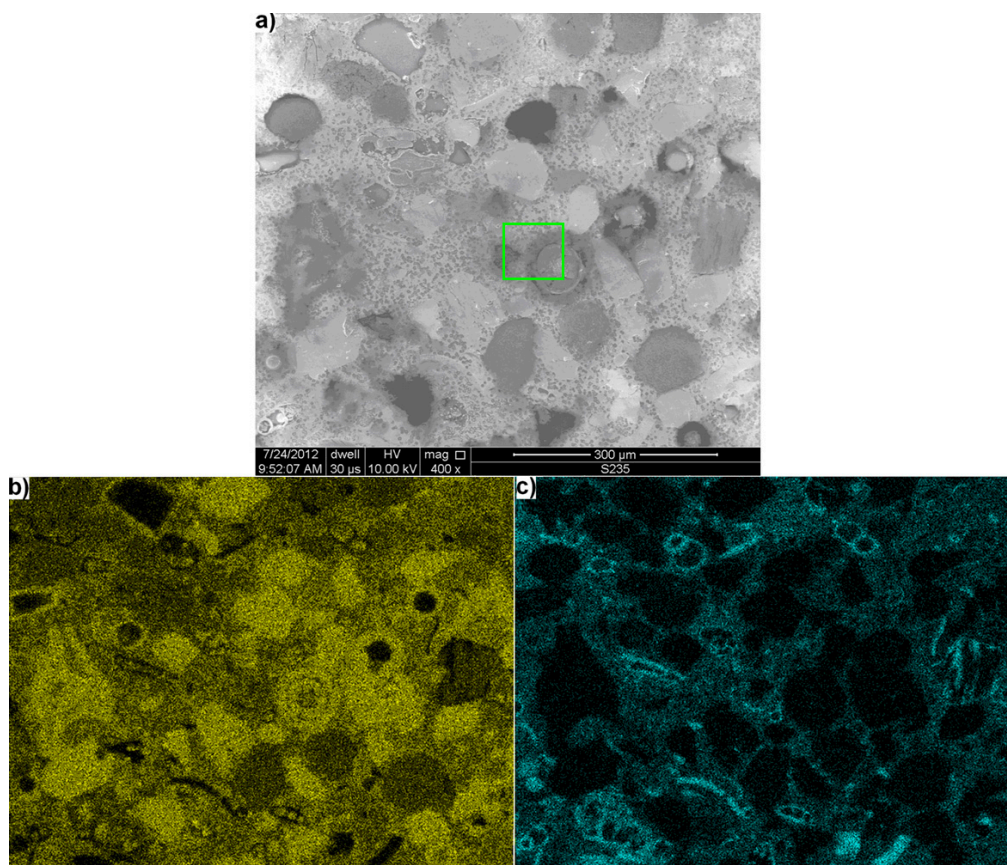
The image of polished section surface of quartz-glaukonite sandstone obtained under the scanning electron microscope is shown in Figure 2a. The psammite microstructure of sandstone, in which numerous grains with size about 100 μm are bonded by inhomogeneous cementing substance, is shown in this figure too.

Figure 2. Microstructure of quartz-glaukonitic sandstone with clay-carbonate cement: (a) an image at 400 \times magnification and distribution on its surface (In the green rectangle, is marked the area selected for further analysis on Figure 3), (b) Si; and (c) Ca.

Figure 2b,c show the distribution of silicon and calcium in the form of mapping obtained using the X-ray microanalyzer. It was found that silicon (Figure 2b), besides its mainly occurrence in quartz grains composition, is also present in significant amount in the binder bonding aggregate grains. Silica shown in Figure 4b can also occur in a form similar to amorphous silica fume, forming the spherical grains with diameter from 25 to 70 μm . They can be silicate bioclasts from the analysis under the light microscope.

Calcium (Figure 2c) occurs almost exclusively in cement, forming the envelopes with higher concentration around some grains rich in silicon. They can be carbonate bioclots. On the image taken with the SE (Secondary Electron) detector (Figure 2a), these bioclots are not as clearly visible as the silicate bioclots. It also forms the individual concentrations in these grains, in which the presence of silicon is not detected. Part of them can be identified as residues of living organisms—foraminifera.

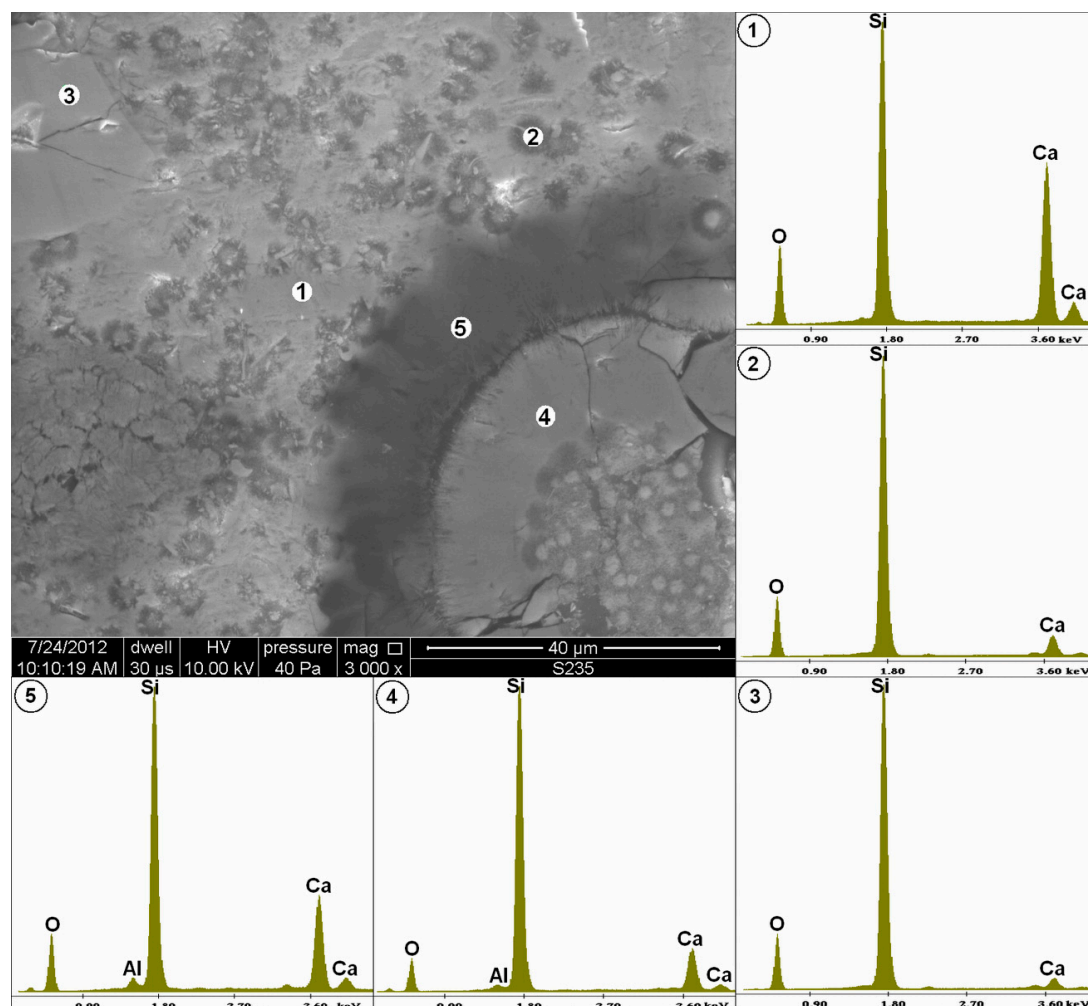
While analyzing bonding substance in sandstone, one can detect that it is inhomogeneous (Figure 3). The point X-ray microanalysis, in point ①, reveals that this material is mainly composed of silicon and calcium. It is built of numerous small grains with size not exceeding 5 μm . They are mainly composed of silicon ②, which occur in the form of large quartz grains ③ bonded by “cement”. Thus, they can be regarded as micro and cryptocrystalline quartz and chalcedony, classified as reactive components.

Figure 3. Microstructure of quartz-glauconitic sandstone with clay-carbonate cement (area marked in Figure 2a), the image at 3000 \times magnification and with X-ray microanalysis.

In the bottom right corner of Figure 3, one of the aforementioned spherical grains of bioclast is visible. The X-ray microanalysis of its surface ④ shows that it is mainly composed of silicon with a small addition of calcium. Its external surface has a visibly cracked and defected layer.

The occurrence of the modified bonding material zone with lower calcium content was identified around the studied spherical silicon rich agglomeration ⑤.

layer, it cannot be proven that the silica agglomerations are chalcedony filling the carbonate bioclasts, observed during the petrographic analysis of sandstone (Figure 3).

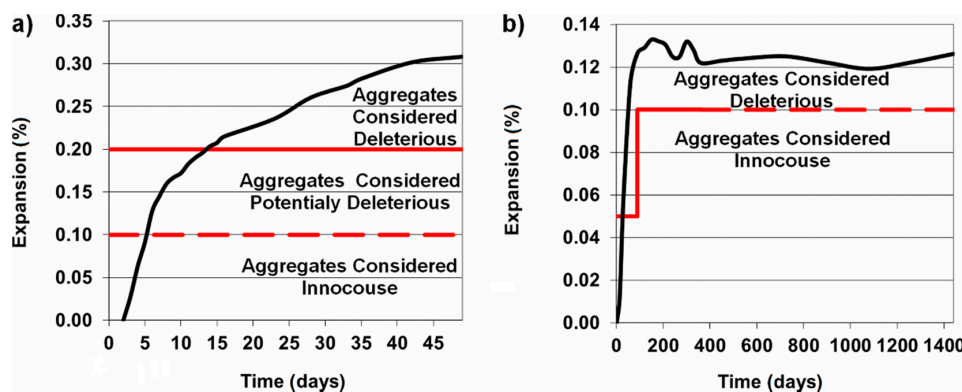
Figure 4 shows the results of the mortar expansion caused by the alkali-silica reaction. In both tests, the achieved expansion indicates that the used aggregate has reactivity that can result the concrete degradation.

Figure 4. Expansion of mortar with gravel aggregate according to (a) ASTM C 1260, (b) ASTM C 227.

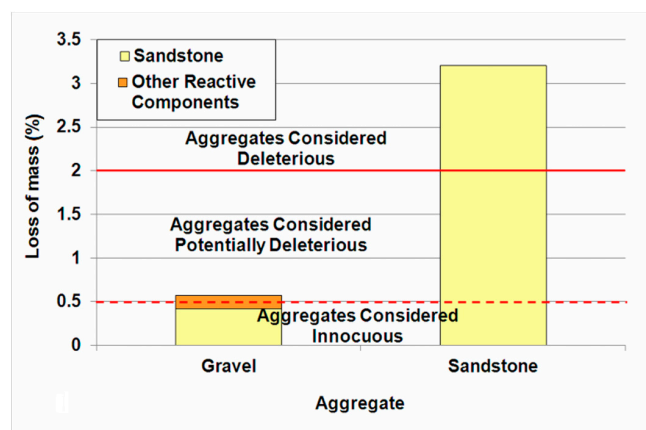
Chemical testing of the post-glacial gravel aggregate confirmed its potential reactivity (Figure 5, left column). The quartz-glaukonitic sandstone is mainly responsible for this effect. The sandstone in 8–16 mm gravel, stored in NaOH solution causes the loss of mass lower than 0.5%, and is thus insufficient to classify this natural aggregate as potentially reactive. However, it can be classified as reactive because of the other reactive components [33].

Figure 5. Loss of mass for particular aggregate fractions in NaOH solution.

The loss of mass determined during measurement of sandstone particles, selected from the gravel (Figure 5, right column) was 3.21%, so it exceeded the standard limit of 2%, thus it can be stated that it is a reactive rock.

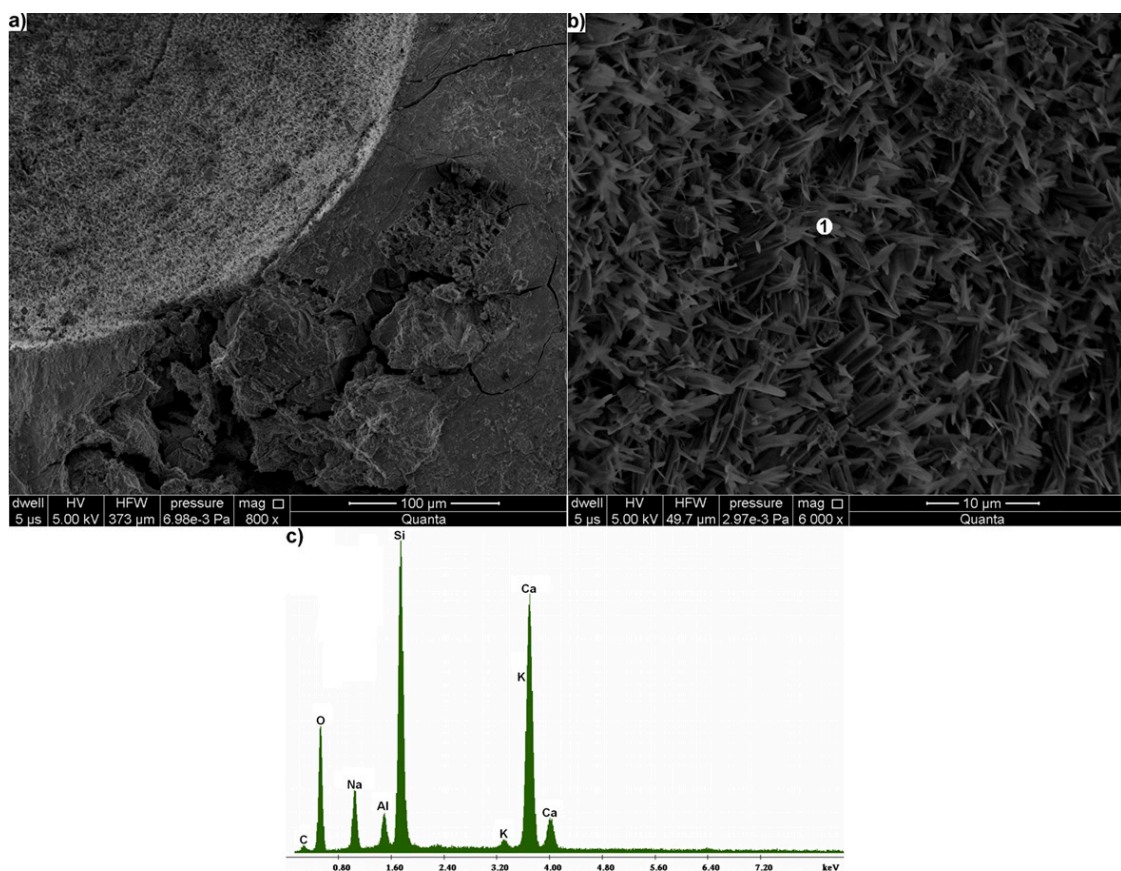
Products of alkali-aggregate reaction often occurred in pores. Having a place that can be filled, the gel in the pores takes the crystalline form (Figure 6a,b) [42]. Besides high content of silica and calcium, it is also characterized by increased sodium content (Figure 6c).

Figure 6. Microstructure of mortar: (a) pore in mortar at 800 \times magnification; (b) products of alkali-silica reaction, filling it; (c) X-ray microanalysis in point 1.

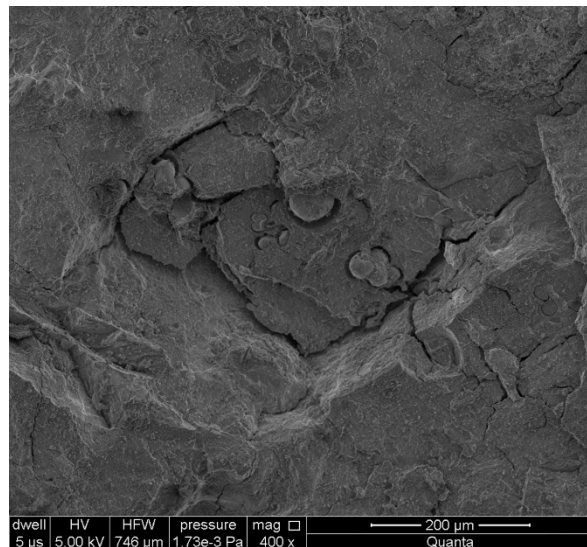
There is also the occurrence of damaged aggregate particles, for whose degradation the alkali-silica reaction can also be considered (Figures 7 and 8a). These particles were partly separated from paste by crack propagating along the paste-aggregate interface. The other cracks propagation was observed from this crack into the paste. The additional cracks also occurred in aggregate. They had an oval shape, which caused the separation of some spherical forms from the aggregate cement material. These forms have size from 6 to 60 μm .

Figure 7. The cracked aggregate (in the central part of the figure) in the cement matrix.

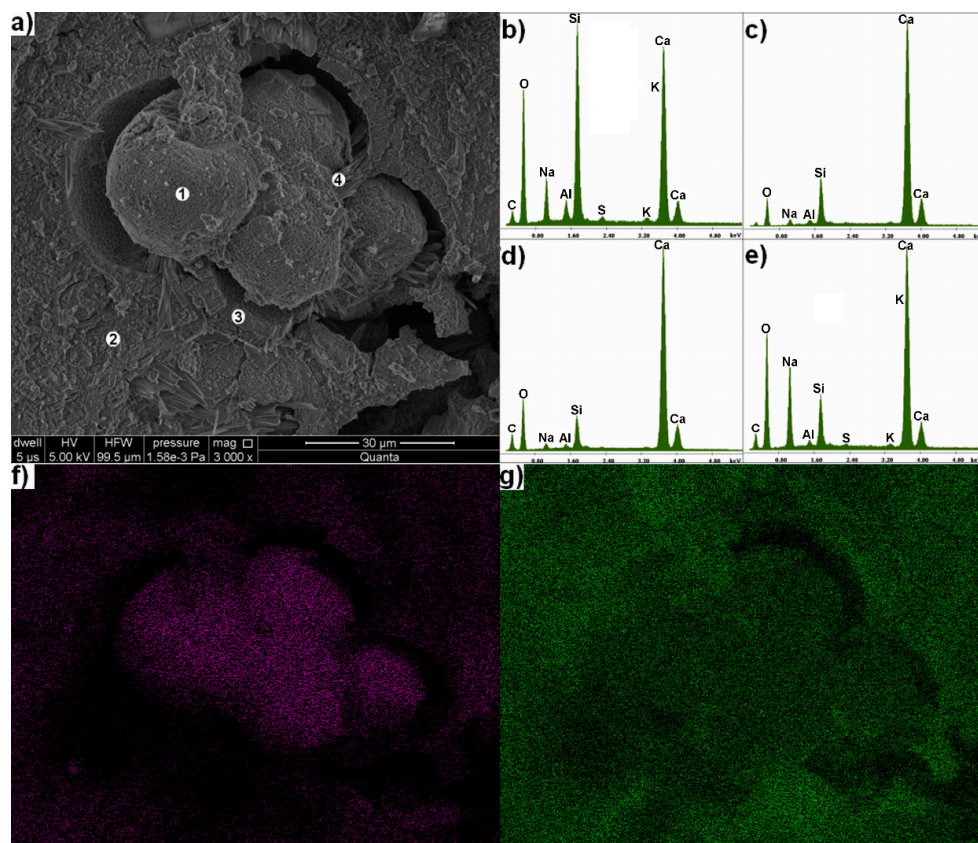
The X-ray microanalysis reveal that separating spheres are mainly composed of silicon and calcium, with significant sodium content (Figure 8b). It was also found that they contain much less calcium compared to the surrounding aggregate cement (Figure 8c). Besides calcium, small silicon content was found in the cement.

Figure 8. (a) a cracked grain of carbonate aggregate in mortar at 3000× magnification and X-ray microanalysis of elemental composition in point; (b) 1; (c) 2; (d) 3; (e) 4, and distribution maps of (f) Si; and (g) Ca.

The occurrence of a layer built of columns, perpendicularly growing out from cementing material and crack was found between this cement and spherical silicon agglomerations. The elemental composition of this layer is similar to cement composition (Figure 8d).

Acicular forms rich in calcium and sodium occur in the crack between spherical silicon agglomerations and layer rich in calcium (Figure 8d). This is the same phase, which, as a product of alkali-silica reaction, fills the pores of this mortar (Figure 5).

The mapping of silicon and calcium distribution using the X-ray microanalyzer was carried out because of variable contents of these elements in damaged aggregate particle. These data confirmed the results of point X-ray microanalysis. Silicon content is significantly greater in separating spherical forms (Figure 7f). However, calcium is accumulated in cementing material, and increase of its concentration occurs in layer surrounding silica agglomerations (Figure 8g). This layer is also poorer in silicon compared to the rest of the material.

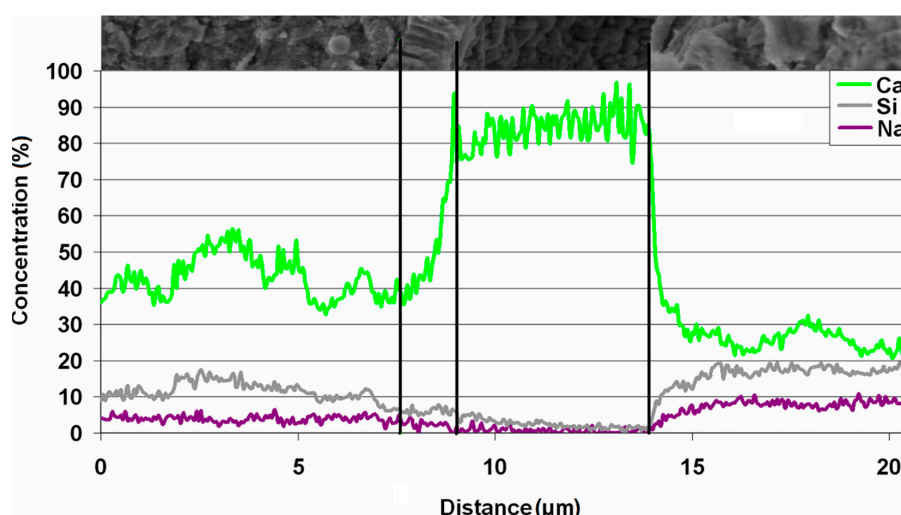
The elements distribution in the contact zone between cement and spherical silicon agglomeration was additionally determined using linear mapping shown on Figure 9. It presents the change of elements contents, on the way from aggregate cementing material to the center of the separating spherical form. In its consequence, it was stated that changes in element concentrations primarily concern calcium, silicon and sodium. Some fluctuations of their concentrations occur in the inhomogeneous cementing material. However, the role of calcium is dominant. Its content significantly increases in the layer formed on cementing material, separated from spherical silicon agglomeration by the 5 μm crack. This envelope thickness is 1.5 μm . Its surface is mainly composed of calcium. Silicon and sodium are almost undetectable in this envelope and they can occur only in trace amounts. Silicon and sodium amounts are significantly higher on the surface of separating spherical form, compared to aggregate cementing material, and calcium content is lower.

Figure 9. Changes of elements concentrations between carbonate cement and spherical silicon agglomeration from Figure 8a.
