Article

Comparative Analysis of the Corrosion Resistance of Titanium Alloys Intended to Come into Direct or Prolonged Contact with Live Tissues

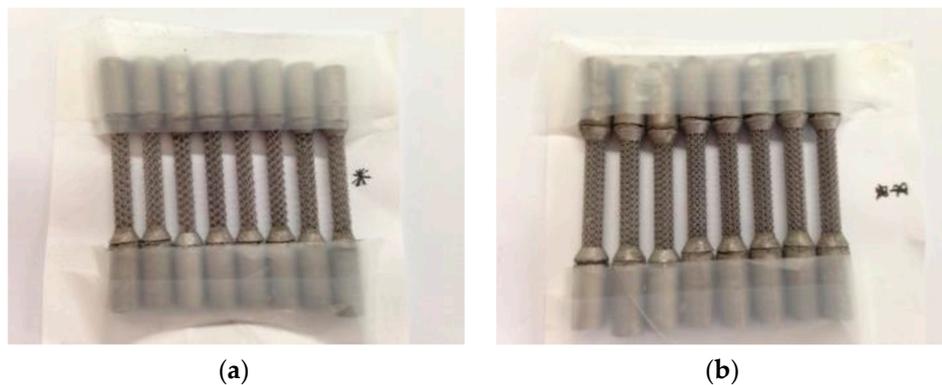
Complementary tests were carried out on Ti6Al4V alloy scaffold structures [18] and Ti13Nb13Zr nanostructured alloy. University KUL Leuven, Belgium provided us with Ti6Al4V alloy scaffold samples in cylindrical shapes (Figure 1). From UniVie Vienna, Austria, we received two nanostructured Ti13Nb13Zr alloy samples that were previously deformed by HPT (high pressure torsion) process, under 5 GPa and 10 rotations (Figure 2).

Figure 1. Alloy scaffolds' structures samples: cylinders (a) 1000 µm and (b) 750 µm received from KUL Leuven, Belgium.

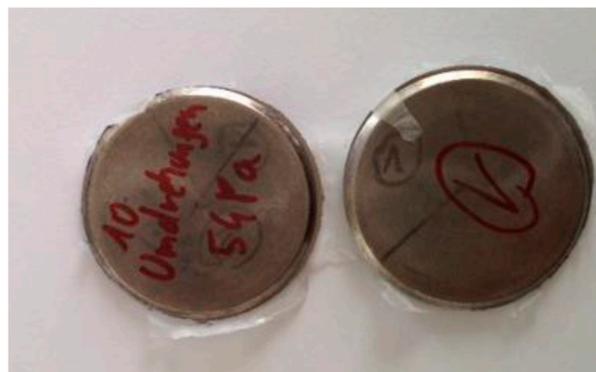
Figure 2. Alloy nanostructured samples: discs (1000 µm and 750 µm) received from UniVieVienna, Austria.

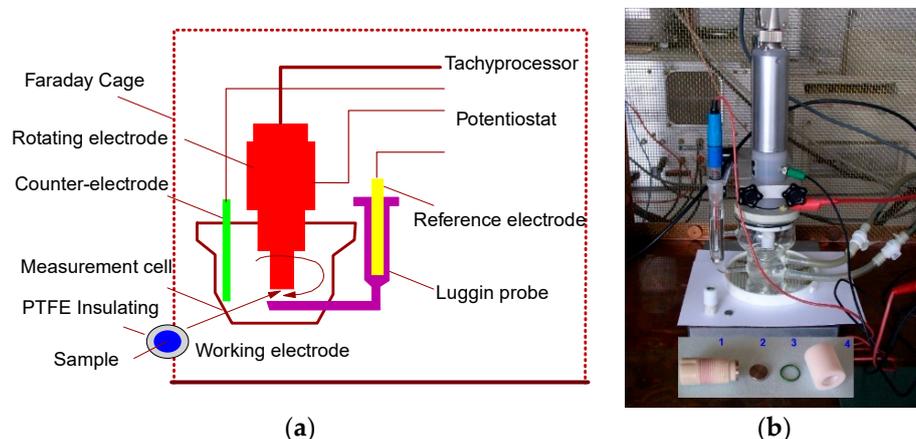
The electrochemical measurements were carried out with a potentiostat model PAR 273A EG&G, Princeton Applied Research (Figure 3a), with a breakdown noise of 5×10^{-12} A. The electrochemical measurements were conducted in a three-electrode cell with a saturated calomel electrode (SCE) as the reference electrode and a platinum band as the counter electrode. The electrochemical cell was provided with a Luggin capillary for the reference electrode (Figure 3b). The test's specimens (cylinders with 35 mm height and 4.5 mm diameter) served as a working electrode. To assure an accurate determination of the degradation rates, a 3.72 cm² surface area was exposed to the electrolyte. The surface conditions of an alloy may affect its electrochemical behavior; consequently, in order to assess this, the samples were polished and cleaned with ethanol and acetone, and then dried with fresh air before each experiment. Afterwards, the samples were introduced into a special PTFE (polytetrafluoroethylene) port designed for rotating electrode tests.

Figure 3. (a) Rotating electrode technique; (b) electrochemical cell used for the electrochemical tests.

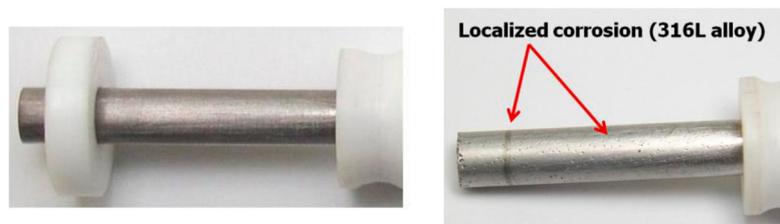
The crevice/pitting corrosion for the Ti-based alloys was evaluated using the method presented in ASTM F746-87 standard [25]. A cylindrical sample was fitted with an inert tapered collar (PTFE) and immersed for 1 h in the electrolyte (9 g/L NaCl), in order to establish the corrosion potential (Figure 4). The crevice corrosion is then stimulated by potentiostatic polarization of the specimen to a potential much more noble than the corrosion potential (800 mV for 10 s). Immediately, the potential is decreased as rapidly as possible to one of the several preselected potentials (-300 mV, -250 mV ... 750 mV) at, or more noble than, the corrosion potential. If the alloy is susceptible to pitting or crevice corrosion at the preselected potential, the polarizing current will remain at relatively high anodic values and will fluctuate or increase with time. The parameter of interest is the critical potential for crevice corrosion, E_{crev} .

Figure 4. Sample used for the crevice corrosion tests.

At the end of the test, a microscopic analysis was used to establish if the localized corrosion has occurred by pitting of the exposed surface or by preferential attack at the crevice formed by the tapered collar, or both.

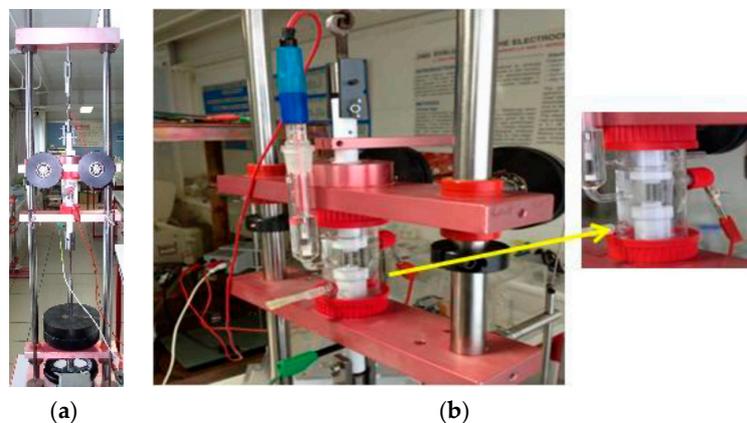
A prototype device was adapted for the fatigue corrosion tests (Figure 5). The test was carried out under static and dynamic mechanical cycles and was coupled with electrochemical cycles. For the first type, a static traction strength of 10 kg was applied and the electrochemical measurement cycles were recorded. The dynamic mechanical cycles consisted in applying the same traction strength accompanied by a 20° vertical rotation (right/left movements). The frequency of these rotations is 24 Hz and its amplitude is 1.3 cm. Figure 6 presents the schematic image of the two types of movements used for the fatigue corrosion tests.

Figure 5. (a) The fatigue corrosion device; (b) detail of the electrochemical cell.

A male female screw system is used to fix the sample into the device. The internal screw thread (female), made of copper, to ensure the electrical contact, was introduced in a Teflon holder to avoid any transfer of electrical charge. The extremities of the tested specimen were the external screws threads. Another type of protection was made using a silicone rubber coating at the interface sample/Teflon holder to avoid a possible infiltration of the electrolyte and, therefore, a galvanic couple between the copper and the tested specimen. The electrolyte was a physiological solution of NaCl at a concentration of 9 g/L in ultra-pure water, and the tests were conducted at the ambient temperature.

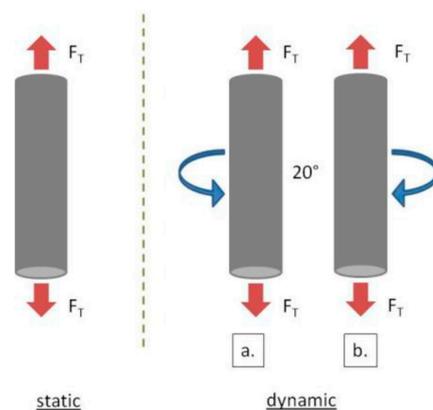
Figure 6. Schematic image of the two types of mechanical movements (F_T —traction strength).

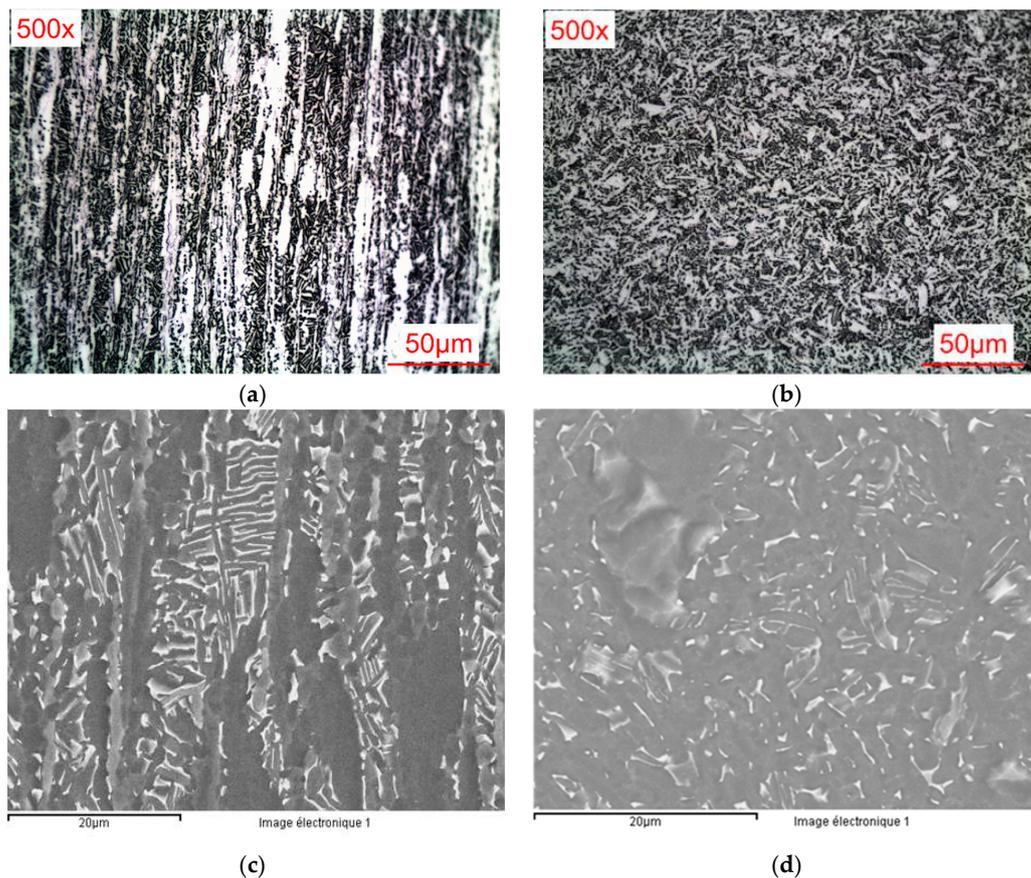
Figure 7 shows the optical and SEM images of the Ti6Al4V alloy's microstructure (#1), after etching. Ti6Al4V alloy has small-sized grains with clear and dark areas, which refer to the α and β phases, respectively (Figure 7b,d). The addition of alloying elements to titanium leads to a refinement of the grain sizes, thus conferring better mechanical resistance to the material. The grains were subject to deformation, and were elongated along the deformation direction (Figure 7a,c).

Figure 7. Alloy microstructure (#1): longitudinal section (a) optical microscopy (OM) and (b) scanning electron microscope (SEM) images; transversal section (c) OM and (d) SEM images.

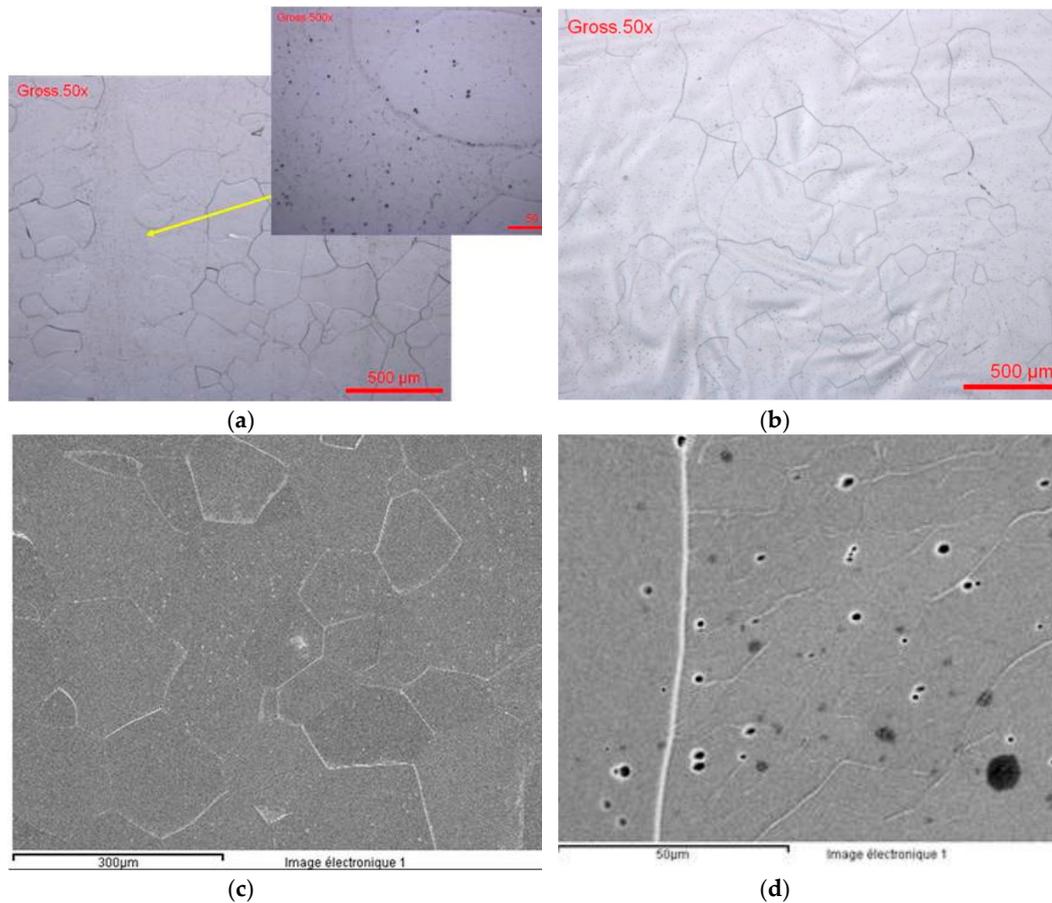
The Ti45Nb alloy's microstructure is presented in Figure 8. The microstructure is heterogeneous. Threadlike inclusions of niobium are observed in the niobium–titanium matrix (ripple effect or snake skin). Two different areas are noted: one with coarse polygonal grains and the other one with small

grains. From the energy-dispersive X-ray spectroscopy (EDX) analysis, no difference of composition between the two areas was noted.

Figure 8. Ti45Nb alloy microstructure (#3): longitudinal section (a) OM and (b) SEM images; (#4): transversal section (c) OM and (d) SEM images.

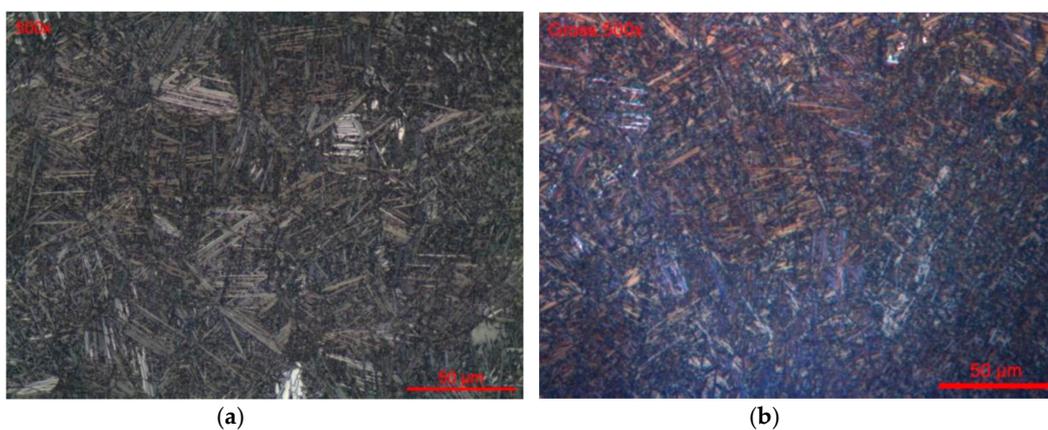
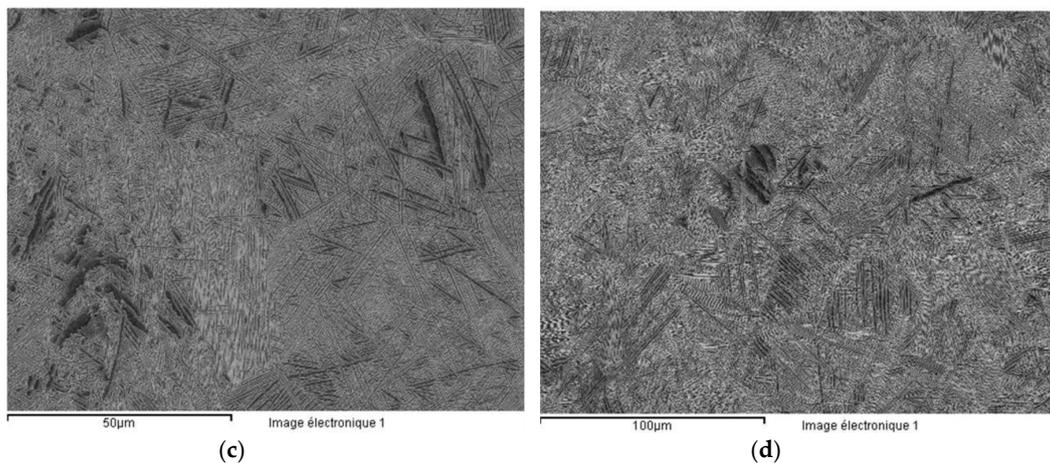
Figure 9. Cont.

The bulk Ti13Nb13Zr alloy was dominated by a fine acicular α martensite in β matrix morphology (Figure 9). The presence of two phases was verified through X-ray diffraction (XRD) studies (Figure 10).

Figure 9. Ti13Nb13Zr alloy microstructure: longitudinal section (a) OM and (b) SEM images; transversal section (c) OM and (d) SEM images.

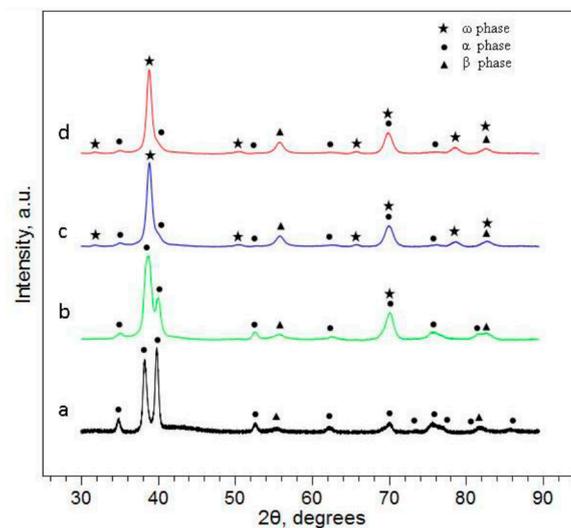
Figure 10. X-ray diffraction (XRD) patterns of the #2 (a) and #7 (b) 0 mm [$\gamma = 0$], (c) 7mm [$\gamma = 220$], and (d) 13 mm [$\gamma = 408$] from the center of the sample. Shear strain due to high pressure torsion (HPT) deformation was calculated using the following equation: $\gamma = 2\pi rN/t$, where r = distance from center to point of interest, N = number of rotations, and t = final thickness.

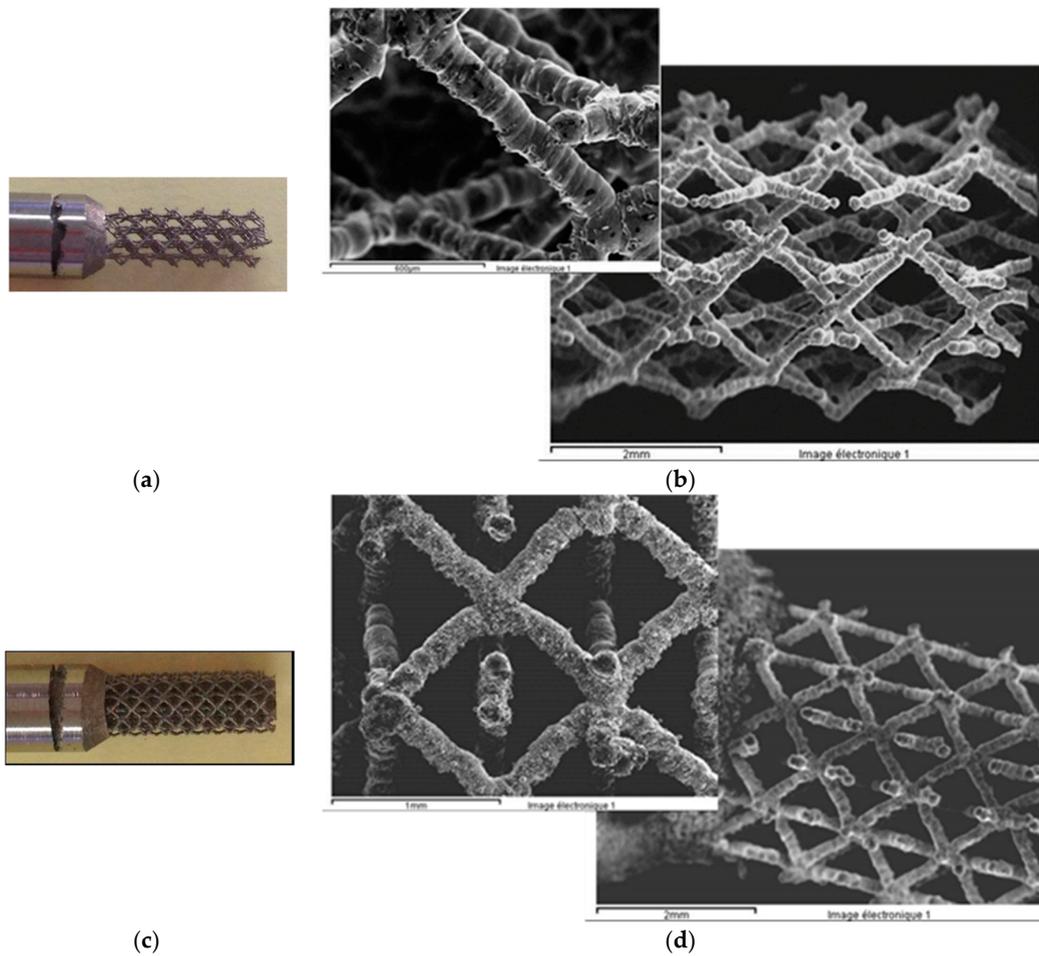
The Ti6Al4V alloy scaffold structures were prepared by the selective laser melting (SLM) technique. This is a layer-wise material addition technique that allows generating complex 3D parts by selectively consolidating successive layers of powder material on top of each other, using thermal energy supplied by a focused and computer controlled laser beam [35,36]. The surfaces of the Ti6Al4V alloy scaffold structures were analyzed by SEM (Figure 11). The scaffolds have two different pores sizes: 1000 μm (Figure 11a,b) and 750 μm (Figure 11c,d). The strut size is 100 μm . It can be observed that the strut surface presents numerous irregularities (wholes from the removed particles). The chemical etching used at KUL Leuven on these samples does not seem to be the optimum one. According to their previous studies, a chemical and an electrochemical etching were used and the surface was smoothed with a nano-scale level roughness [37].

Figure 11. Ti6Al4V alloy scaffold structures with 1000 μm (a,b) and 750 μm (c,d) pore size.

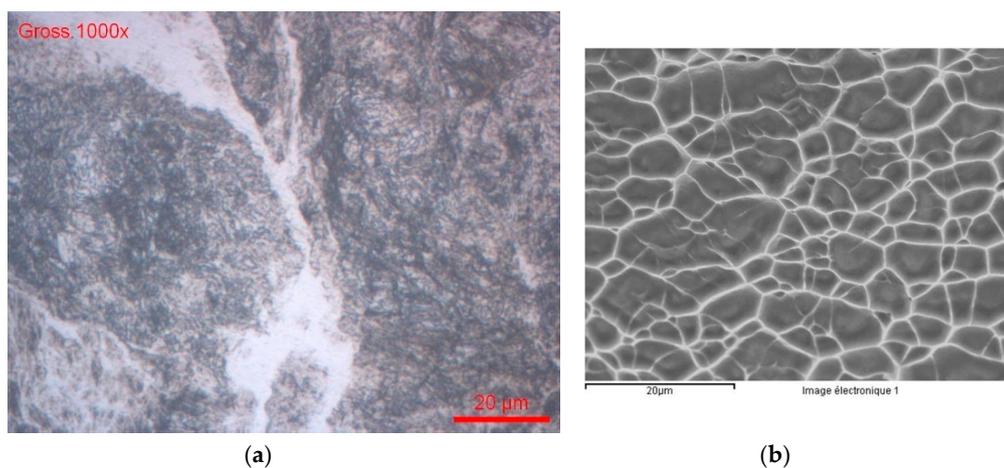
microstructure. During the HPT process, the α and β of the initial Ti13Nb13Zr alloys were transformed in α , β , and ω ; Figure 12 (XRD analysis).

Figure 12. Ti13Nb13Zr nanostructured alloy (a) OM and (b) SEM images.

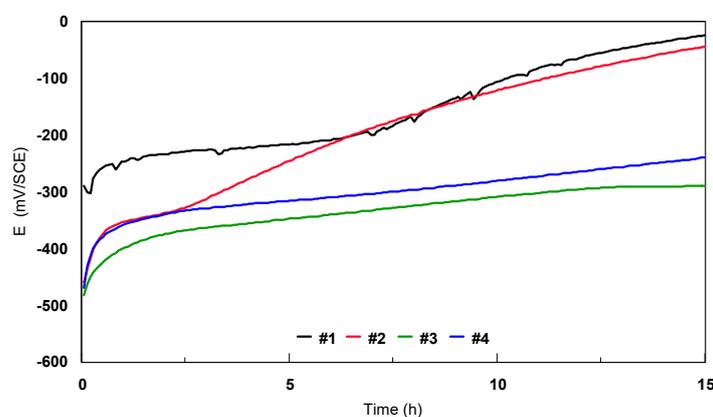
The open circuit potential is the only electrochemical technique that does not cause any disturbance to the state of the studied system. It is measured versus a reference potential, in our case, the SCE electrode. From the open circuit potential plots, it is possible to extract the first information about the electrochemical behavior of a material in contact with an aqueous corrosive environment (the preliminary transformations at the metal/electrolyte interface: corrosion, passivation). It allows to find out the required immersion time to establish the pseudo-stationary state necessary for the potentiodynamic polarization or electrochemical spectroscopy impedance (ESI) measurements. An example of this curve, E_{oc} versus the immersion time, recorded for bulk Ti-based alloys in 9 g/L sodium chloride electrolyte, is presented in Figure 13.

Figure 13. Open circuit potential vs. immersion time curves for bulk Ti-based alloys in 9 g/L NaCl electrolyte. SCE: saturated calomel electrode.

The rising and steady plots (#3 alloy) show the behavior of Ti-based alloys covered with films that thicken in time and maintain their integrity in this environment. Hoar and Fraker demonstrated that the passivation of titanium is an aging process and the latter depends strongly on the immersion period [39,40]. The oxide film formed on Ti-based alloys mainly consists of TiO_2 and Ti_2O_3 . The latter is a thinner and stronger film [40,41].

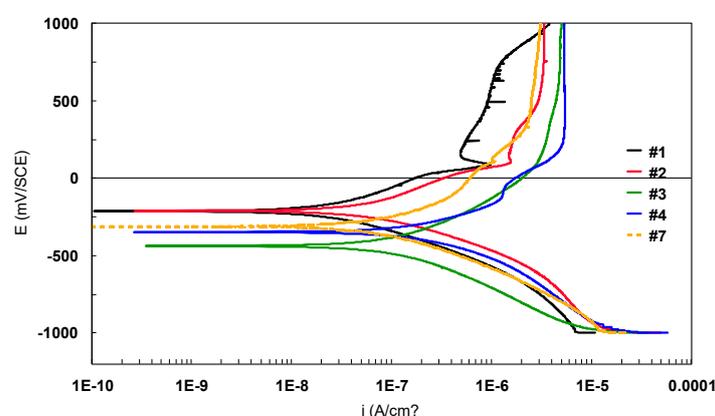
The potentiodynamic polarization curves in semi-logarithmic scale for Ti-based alloys (bulk materials), immersed in 9 g/L NaCl electrolyte, are presented in Figure 14. The potentiodynamic plots were recorded between -1000 mV and 1000 mV/SCE with a scan rate of 0.5 mV/s.

Figure 14. Potentiodynamic polarization curves recorded in 9 g/L NaCl electrolyte for the Ti-based alloys (semi-logarithmic scale).

According to Figure 14, a small difference between the anodic current densities of the three Ti-based alloys (a few hundreds of nanoamps) was noticed. Sample #1 is characterized by the lowest anodic current density, followed by #2 and #3. For all the alloys, an important domain of passivation (approximately 800 mV) was observed. Samples #1 and #2 presented a peak that could correspond to the degradation of a component. After that, the current densities decrease, meaning that a passive oxide layer is formed on the metallic surface.

The two sections of the Ti45Nb alloy present similar corrosion behavior. The anodic current densities are in the same range of values, only the potential is shifted in the anodic direction for #4 compared with #3. The same observation is noted for the Ti13Nb13Zr alloys (the potential of the bulk Ti13Nb13Zr alloy is shifted in the anodic direction).

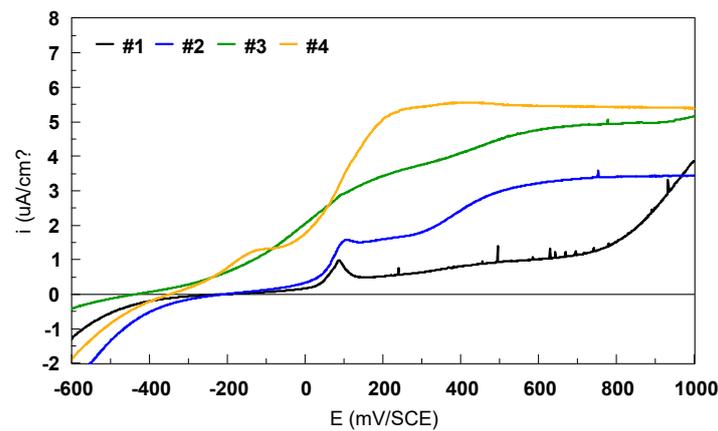
From the current–potential curves in linear scale (Figure 15), the breakdown potential, E_{break} , can be also identified. The breakdown potential, E_{break} , is the potential for which the anodic current increases strongly. The range of the potential situated between the corrosion potential (E_{corr} or $E_{(i=0)}$) and E_{break} represents the immunity zone in which the corrosion is weak, even insignificant. The more this zone is extended, the less the alloy is likely to be found in a situation where, by polarization or by galvanic effect resulting from the presence of another alloy, it can be led to being strongly corroded. In the case of Ti-based alloys, it was very difficult to determinate the E_{break} for all the samples.

Figure 15. Potentiodynamic polarization curves recorded in 9 g/L NaCl electrolyte for the bulk Ti-based alloys (linear scale).

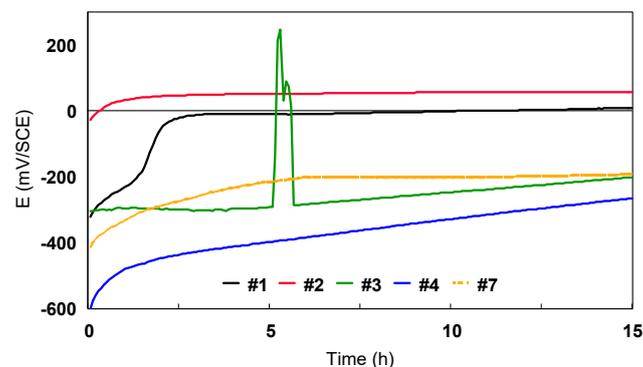
The curves for all the Ti-based alloys in artificial plasma bone are presented in Figure 16. The values of the E_{oc} recorded after 15h of immersion in artificial plasma bone are presented in Table 6. Same as in the sodium chloride solution, almost all the samples maintained a stable and negative E_{oc} . The #1 and #2 samples recorded positive potential values.

Figure 16. Open circuit potential vs. immersion time curves for bulk Ti-based alloys in artificial plasma bone.

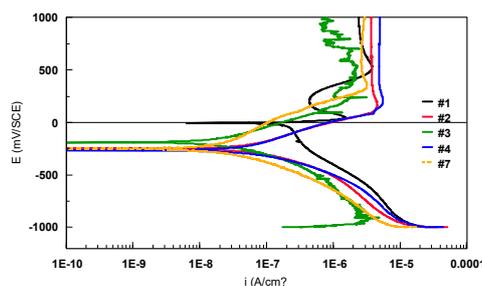
The potentiodynamic polarization curves in semi-logarithmic scale for Ti-based alloys (bulk) in artificial plasma bone are presented in Figure 17. As in the case of the first type of electrolyte, the potentiodynamic plots were recorded between −1000 mV and 1000 mV/SCE with a scan rate of 0.5 mV/s. The curves shapes are very different from one alloy to another. Sample #1 (Ti6Al4V alloy) presented a similar curve with the one recorded in 9 g/L NaCl electrolyte, with a peak that could correspond to a degradation component, followed by a passivation domain. Sample #2 has recorded the largest passivation domain, but the anodic corrosion densities are a little bit more important than those of the other alloys. Strong variations of anodic current densities were observed in the plot recorded for #3 (Ti45Nb longitudinal section), associated with pitting corrosion. The fluctuations of the cathodic current densities are related to the cathodic reaction—hydrogen evolution—during the test.

Figure 17. Potentiodynamic polarization curves recorded in artificial plasma bone for bulk Ti-based alloys (semi-logarithmic scale).

The transversal section of the Ti45Nb alloy does not present the same corrosion behavior as the longitudinal section; on the contrary, the recorded plot presents a very large passivation plateau (Figure 17).

A small difference was observed between the two curves recorded for the Ti13Nb13Zr alloys. The nanostructured samples presented lower anodic current densities values than the bulk alloy. This could be associated to the microstructure modifications generated by the HPT process, namely the morphology and the appearance of the new ω phase.

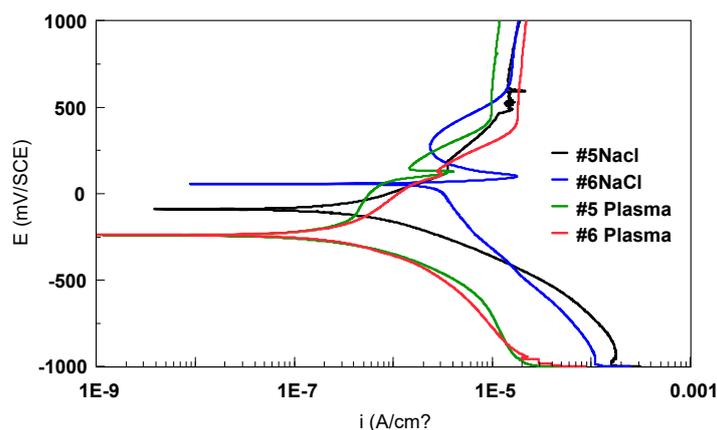
The curves presented a peak (more or less important) that could correspond to a component degradation (Figure 18). Afterwards, the anodic current densities increased, forming an important passivation domain (~500 mV).

Figure 18. Potentiodynamic polarization curves recorded for the Ti6Al4V scaffold samples in 9 g/L NaCl and artificial plasma bone (semi-logarithmic scale).

This behavior is related to the metallic surface preparation after the SLM process. It was noted that, after etching, the Ti6Al4V alloy particles were not totally removed from the sample's surface.

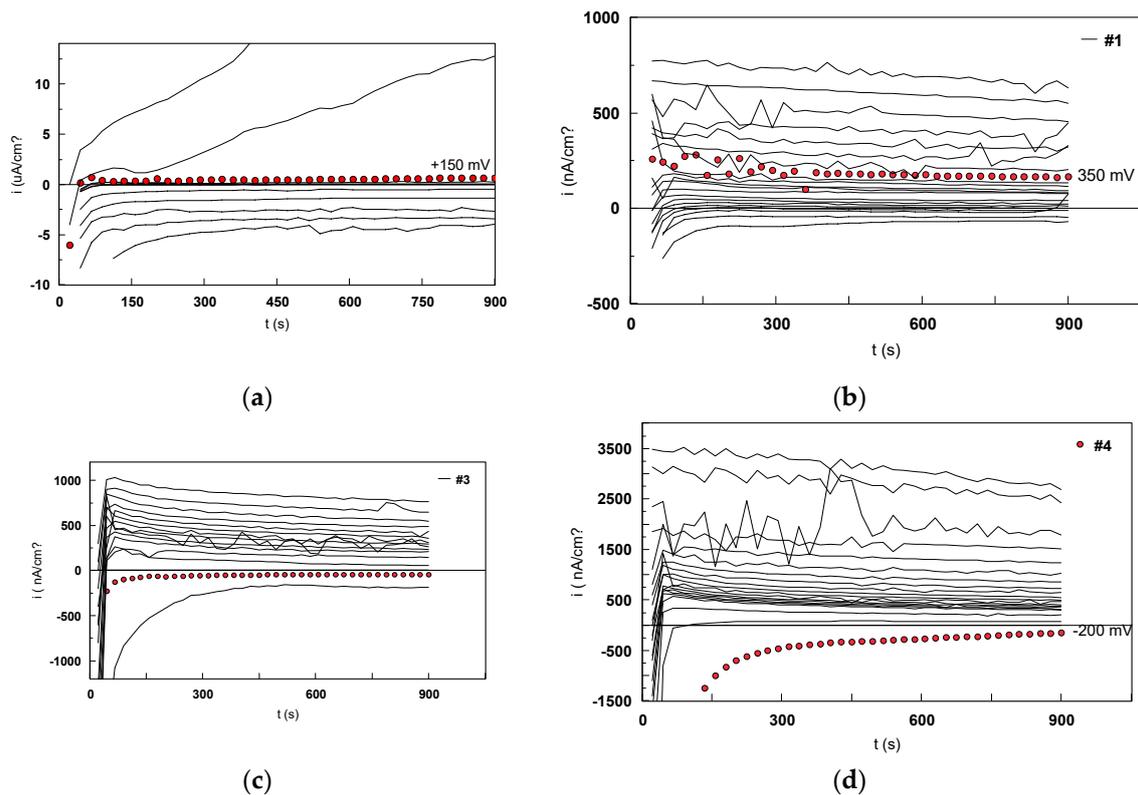
Figure 19. Polarization current densities recorded for different alloys, during 15 min, at preselected potentials and above E_{oc} , in a solution of 9 g/L NaCl: (a) 316L alloy [43] and Ti-based alloys: (b) #1, (c) #3 and (d) #4.

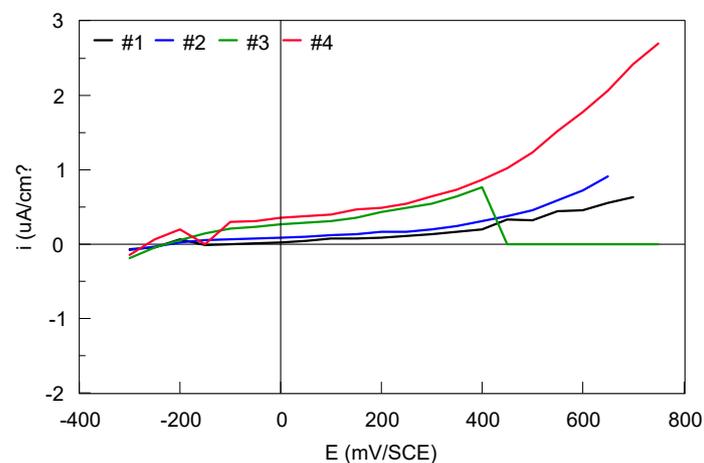
The new "polarization curves" are obtained if the final value of the current recorded at the end of each plot of the potentiostatic curve is plotted as a function of the preselected potential (Figure 20) [17]. These new plots are specific for the localized corrosion behavior of Ti-based alloys.

Figure 20. Potentiostatic polarization plots, current value recorded after 15 min, versus the preselected potentials for bulk Ti-based alloys.

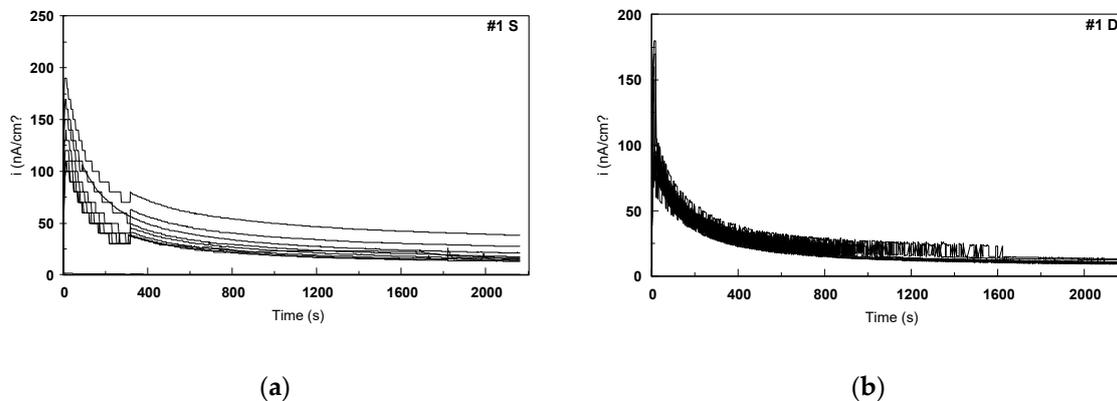
potentiostatic curves recorded at 600 mV level for #1 (Ti6Al4V alloy) during the ten electrochemical cycles for both the static and dynamic mechanical cycles.

Figure 21. Potentiostatic curves recorded for the level of 600 mV/SCE for #1 in 9 g/L NaCl corresponding to (a) static and (b) dynamic mechanical cycles.

It should be noted that the quantities of current densities recorded during the potentiostatic scan were in the order of nano-amperes. The quantities of current recorded during the dynamic mechanical cycles were inferior to those recorded during the static ones.

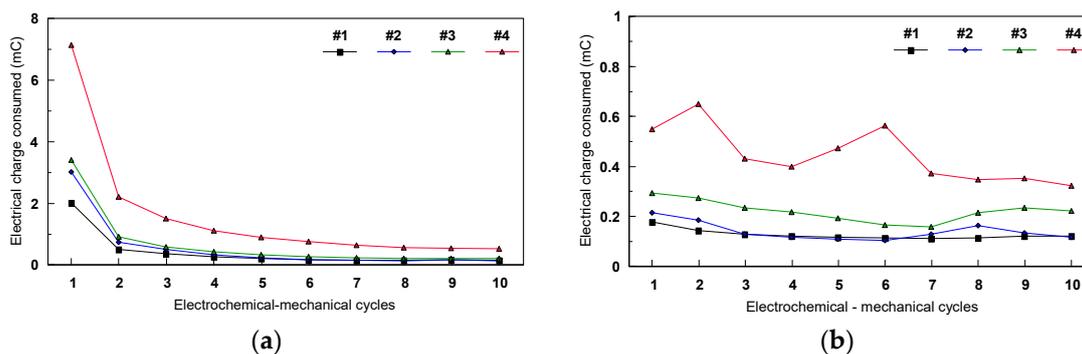
All the values of consumed electrical charge (mC) were determined for both types of mechanical cycles. Figure 22 presents the evolution of the consumed electrical charge during the two types of mechanical cycles (static and dynamic). In the case of the static cycles, a decrease of the electrical charge during the first four cycles was observed for all the Ti-based alloys, then it remains almost constant while increasing the mechanical cycle's number. The values of the electrical charge recorded during the static mechanical tests for #4 (Ti45Nb alloy in transversal section) were more important than those of the others samples (Figure 23).

Figure 22. The fatigue corrosion behavior of Ti-based alloys in 9g/L NaCl during the mechanical cycles: (a) static and (b) dynamic cycles.

During the dynamic cycles, the values of the consumed electrical charge were between 150 and 700 mC, much smaller than those determined for the static tests. For each tested specimen, the dynamic test followed the static one. Therefore, their specific evolution of the consumed electrical charge and the difference between their values could be explained by the fact that during the static cycles, a passive film (generally the TiO₂-anatase) is being formed and reformed, after the depassivation step at -700 mV, on the metallic surfaces. Also, when the dynamic mechanical cycles were performed, the surfaces were already covered with a thin and adherent oxide film.

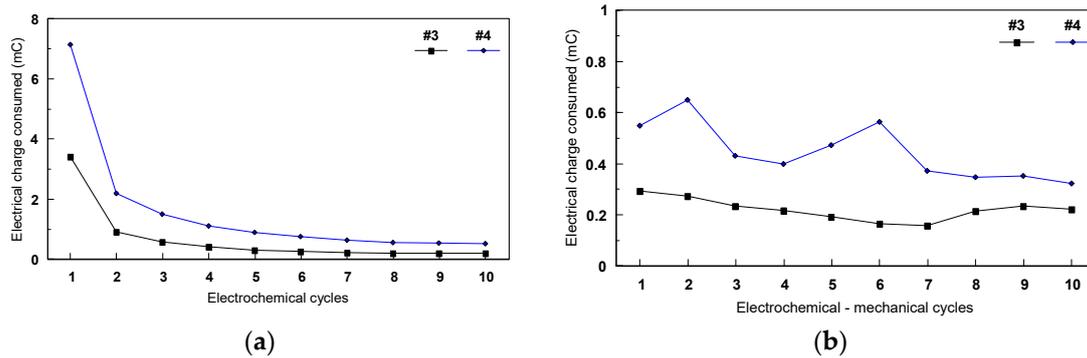
Figure 23. The fatiguecorrosion behavior of Ti45Nb alloy (longitudinal and transversal sections) in 9 g/L NaCl during the mechanical cycles: (a) static and (b) dynamic.

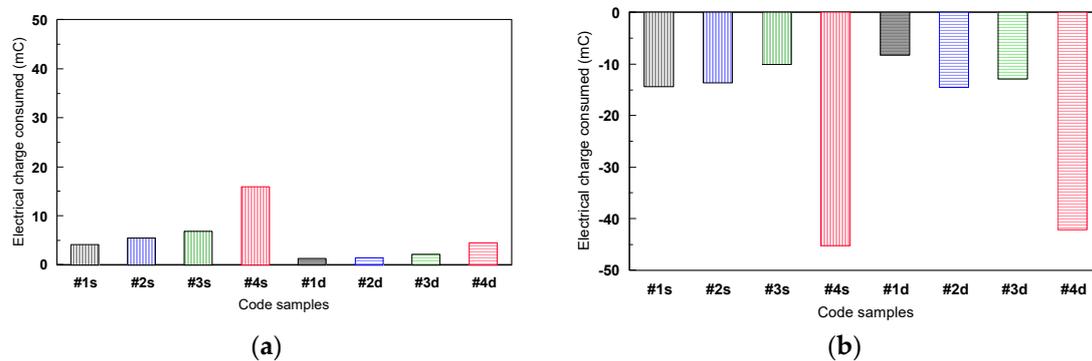
Figure 24 shows the results obtained in the mechanical-electrochemical tests during the passivation steps (potentiostatic levels: 600, 650, 700, and 750 mV) and the depassivation step at -750 mV. It was noted that the total electrical charge consumed during the passivation steps was smaller compared with the one consumed during the depassivation step, meaning that the TiO_2 film formed on Ti alloy’s surface during the passivation steps is strongly adherent, and that it is necessary to double the electrical charge to remove it.

Figure 24. The total electrical charge consumed for the fatigue corrosion tests in 9 g/L NaCl during (a) the passivation and (b) the depassivation steps (s: static and d: dynamic mechanical cycles).

Analyzing the sum of electrical charges consumed during the entire test period, it was observed that the #1 (Ti6Al4V alloy) presents the best corrosion behavior and #4 (Ti45Nb alloy transversal section) presents the worst corrosion behavior.

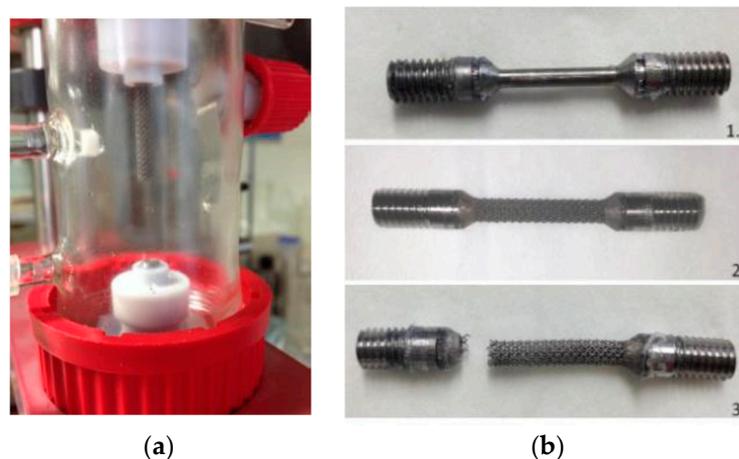
The Ti6Al4V alloy scaffold structures were machined and prepared for the fatigue corrosion tests in the same way as the bulk alloys. Unfortunately, the fatigue corrosion tests were not conducted on these samples because they broke before starting the tests (Figure 25a). The failure was localized at the interface bulk /scaffold structure (Figure 25b).

Figure 25. (a) Failure of the Ti6Al4V alloy scaffold specimen before fatigue corrosion tests; (b) Ti-based alloys samples before and after test.

Two factors could contribute to the failure of the samples before the fatigue corrosion tests:

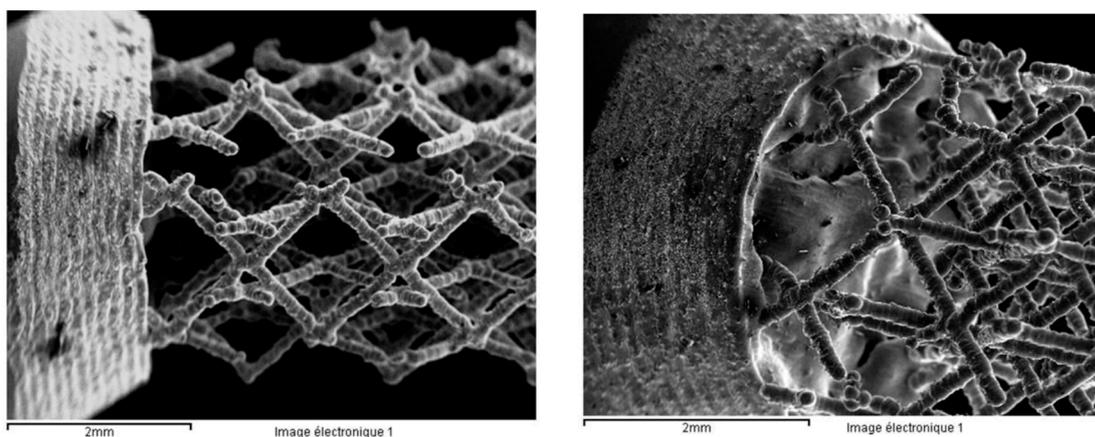
- The sample was not well melted on the bulk parts during the SLM process because of the specific design. Figure 26 presents the SEM images of the scaffold structure before testing.
- The structure was also weakened during etching, the machining process, and cleaning in the ultra sound bath.

Figure 26. SEM images of the Ti6Al4V alloy scaffold structure taken before any machining or cleaning process.

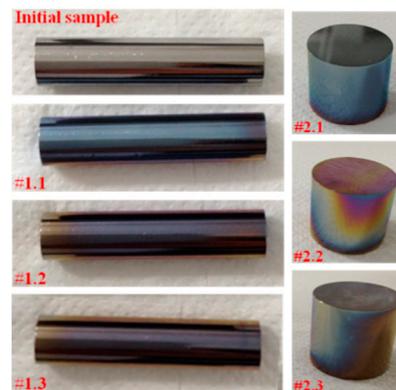
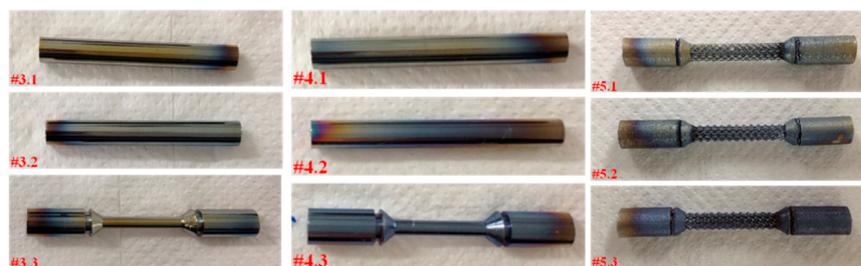
Figure 27. Titanium alloys after the extraction test.

A more detailed analysis of an oxide film formed on each metal surface seems to be necessary to verify its chemical composition and to validate the hypothesis of tarnish films.
