# Microscopic Analysis of Steel Corrosion Products in Seawater and Sea-Sand Concrete

**Abstract:** In this paper, the types, formation time, structural morphology, and influence of steel corrosion products in seawater and sea-sand concrete were studied, and the intermediate and final products of steel corrosion under different conditions were determined. The corrosion products of steel in these concrete specimens under two curing methods were studied separately by X-ray powder diffraction (XRD) and scanning electron microscopy (SEM). Due to the presence of a large amount of chloride ions in the concrete, the rust layer on the surface of a steel bar contained many intermediates, such as lepidocrocite ( $\gamma$ -FeOOH) and aka-ganeite ( $\beta$ -FeOOH). Under wet/dry cycles, with the addition and loss of moisture in concrete, various corrosion products were also dynamically converted into each other. In the specimens immersed in seawater for a long time, the intermediates of corrosion were lepidocrocite ( $\gamma$ -FeOOH) and aka-ganeite ( $\beta$ -FeOOH), which were substituted for oxygen as the new depolarizers of cathode reduction reaction, and consumed themselves to ensure smoo

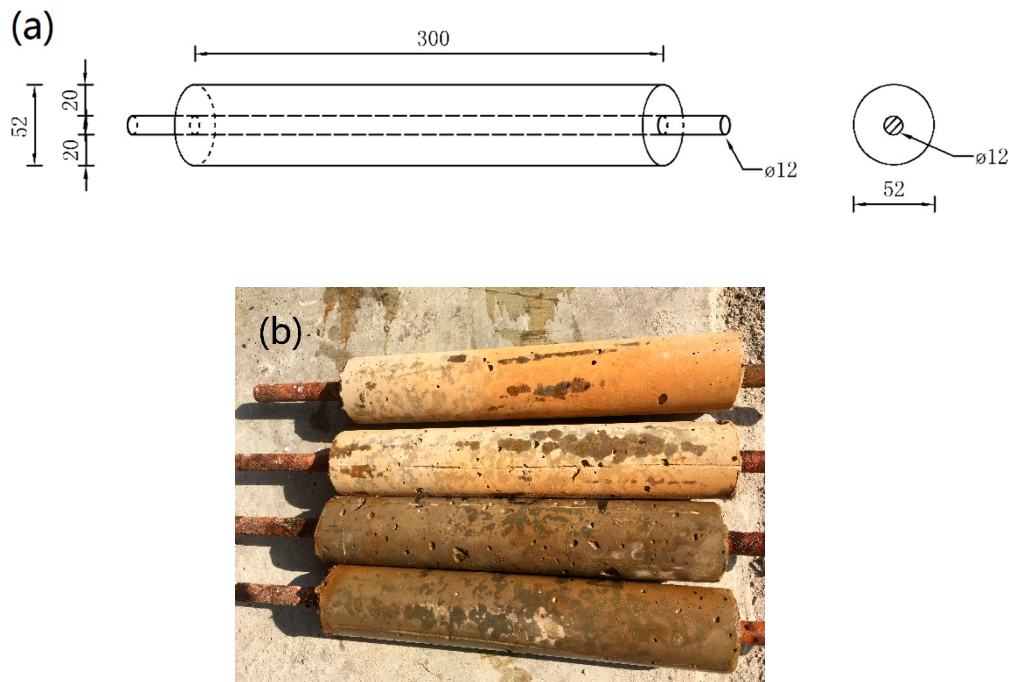
**Figure 1.** Details of test specimen; (a) Schematic diagram, (b) Photograph.

The steel bars used in the specimens were all made of the same batch of HPB235 ordinary low carbon steel with a diameter of 12 mm. The composition of the steel bars is shown in Table 1. Each steel bar was  $320 (\pm 1) \text{ mm}$  in length, and there were no rust pits and other major defects on the surface. The steel bar was immersed in 12% hydrochloric acid solution, rinsed with clean water, neutralized with lime water, rinsed with clean water, and placed in the dryer for 4 h. The bare part of the steel bar was coated with anti-rust paint to ensure its non-corrosion. The schematic and physical drawings of the specimens are shown in Figure 1.

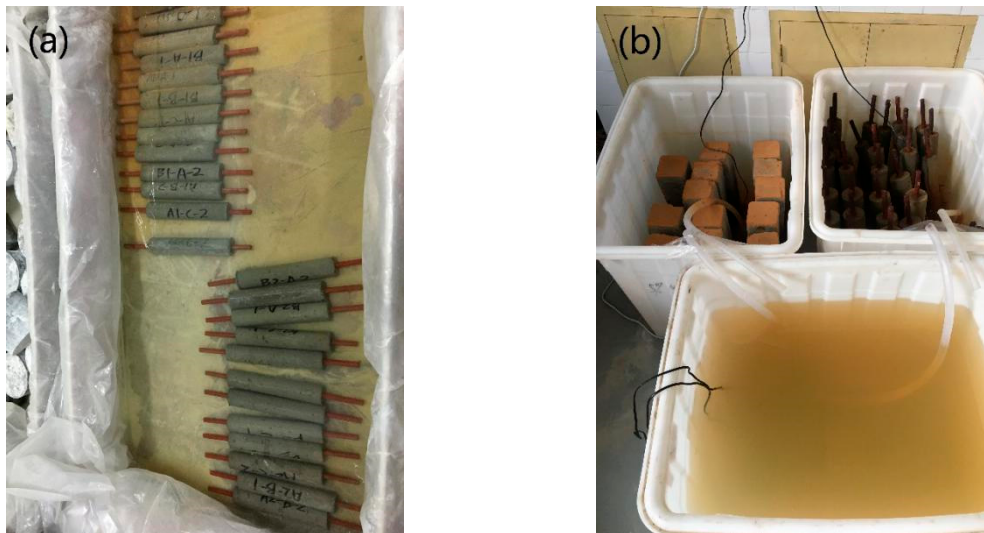
**Figure 2.** Images of curing setup for test specimens; (a) Setup of the immersion process, (b) Setup of the wet/dry cycles.

After the specimens were made, they were placed in the curing room in different groups. One group was immersed continuously in artificial seawater to simulate the underwater environment of the ocean. The other group used a wet/dry cycles device to simulate the tidal environment of the ocean. The specimens were immersed for two days and dried for two days. The water temperature was  $20 \pm 5$  °C (Figure 2). The grouping of specimens is shown in Table 2.

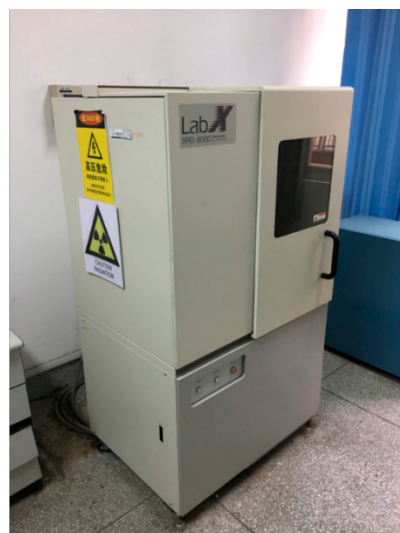
**Figure 3.** XRD-6000 model X-ray powder diffractometer.

First, the corroded steel bars in concrete were taken out. The corrosion layers can be divided into internal rust layer and external rust layer according to the structure. The external rust layer was loose and could be easily exfoliated. The internal rust layer with compact structure was closely connected with the reinforced bar matrix. The rust powder was grinded separately in grinding bowls until it passed through 330 mesh sieves. As shown in Figure 3, the test process involved first placing the proper amount of rust powder (about 2 g) on the supporting slide, smoothing the surface, and then placing the sample into the X-ray powder diffractometer (XRD-6000, Shimadzu Company, Kyoto, Japan). After XRD analysis, the test results were output from the computer and analyzed by software MDI Jade 6.5

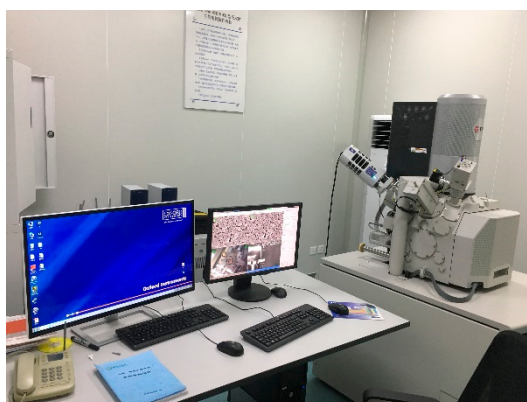
**Figure 4.** Nova NanoSEM450 scanning electron microscope.

vacuum to prevent the corrosion products from continuing to oxidize in contact with air. The prepared samples were analyzed by Nova NanoSEM450 field emission scanning electron microscope (Waltham, MA, USA) (Figure 4). Corrosion products were observed three times at the same location. The magnification was 2000, 5000 and 10,000 times, respectively.

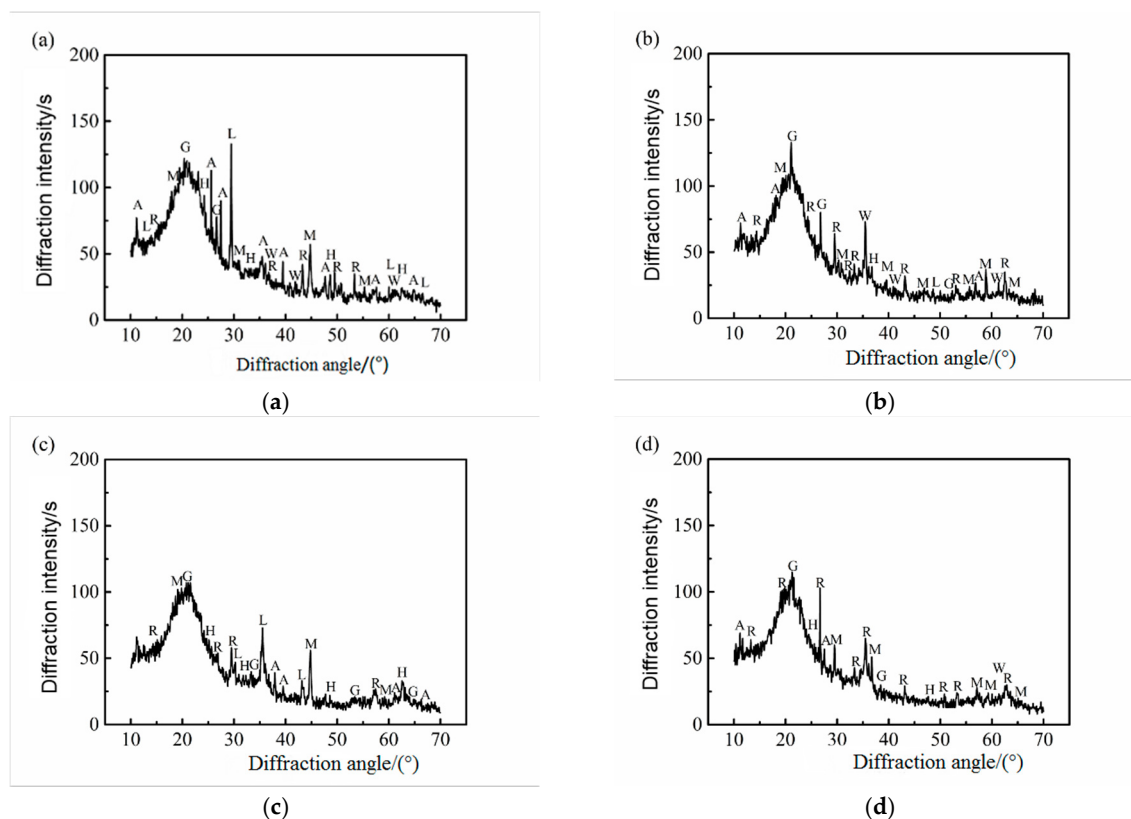
**Figure 5.** XRD patterns of rust sample of steel bar in seawater sea-sand concrete; (a) Inner rust layer of A1, (b) Outer rust layer of A1, (c) Inner rust layer of A2, (d) Outer rust layer of A2.

X-ray diffraction spectra of powder samples of the inner rust layer and the outer rust layer of carbon steel rust products in the two concretes are shown in Figures 5 and 6. It can be seen from the two graphs that the corrosion products of carbon steel were a mixture of wustite ( $\text{FeO}$ ), aka-ganeite ( $\beta\text{-FeOOH}$ ), lepidocrocite ( $\gamma\text{-FeOOH}$ ), goethite ( $\alpha\text{-FeOOH}$ ), magnetite ( $\text{Fe}_3\text{O}_4$ ), maghemite ( $\gamma\text{-Fe}_2\text{O}_3$ ), and hematite ( $\alpha\text{-Fe}_2\text{O}_3$ ). Among them, the diffraction peaks of maghemite ( $\gamma\text{-Fe}_2\text{O}_3$ ), hematite ( $\alpha\text{-Fe}_2\text{O}_3$ ), lepidocrocite ( $\gamma\text{-FeOOH}$ ), and goethite ( $\alpha\text{-FeOOH}$ ) were higher, indicating that the content of these rust products was higher, or their crystallinity was higher. In addition, some impurities of cement hydration products such as orthoclase, calcium silicate hydrate, calcium aluminate hydrate, and iron were also present in the samples, possibly due to the mutual infiltration of rust products and cement paste.

From Figure 5, it can be seen that the outer rust layer of steel bars in seawater and sea-sand concrete was mainly composed of wustite ( $\text{FeO}$ ), magnetite ( $\text{Fe}_3\text{O}_4$ ), and maghemite ( $\gamma\text{-Fe}_2\text{O}_3$ ), while the inner rust layer was mainly composed of a mixture of goethite ( $\alpha\text{-FeOOH}$ ), magnetite ( $\text{Fe}_3\text{O}_4$ ), and lepidocrocite ( $\gamma\text{-FeOOH}$ ). Correspondingly, it can be seen from Figure 6 that under the condition of chloride corrosion, the outer rust layer of steel bar was mainly composed of magnetite ( $\text{Fe}_3\text{O}_4$ ), hematite ( $\alpha\text{-Fe}_2\text{O}_3$ ), wustite ( $\text{FeO}$ ) and lepidocrocite ( $\gamma\text{-FeOOH}$ ), while the inner rust layer was mainly composed of a mixture of lepidocrocite ( $\gamma\text{-FeOOH}$ ), goethite ( $\alpha\text{-FeOOH}$ ) and maghemite ( $\gamma\text{-Fe}_2\text{O}_3$ ). At the same time, under the same sample treatment, sample quality, and sample conditions, the diffraction peak intensity of the outer rust layer was obviously lower than that of the inner rust layer, which indicates that the crystallinity of the corrosion products of the inner rust layer was better and the protection of the reinforced bar was stronger. On the other hand, the reason the corrosion rate of the steel bar decreases gradually in the later period was explained. The structural model of steel bar corrosion caused by sea water in seawater and sea-sand concrete is shown in Figure 7a and that of steel bar corrosion caused by sea water in ordinary concrete is shown in Figure 7b.

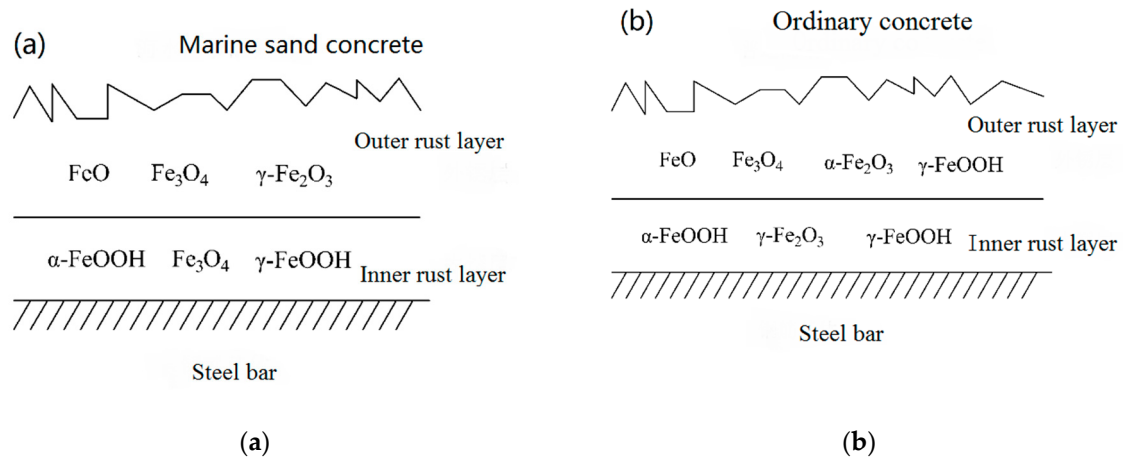
**Figure 7.** Schematic illustration of layered structure of rebar rust in different concrete; (a) Seawater and sea-sand concrete, (b) Ordinary concrete.

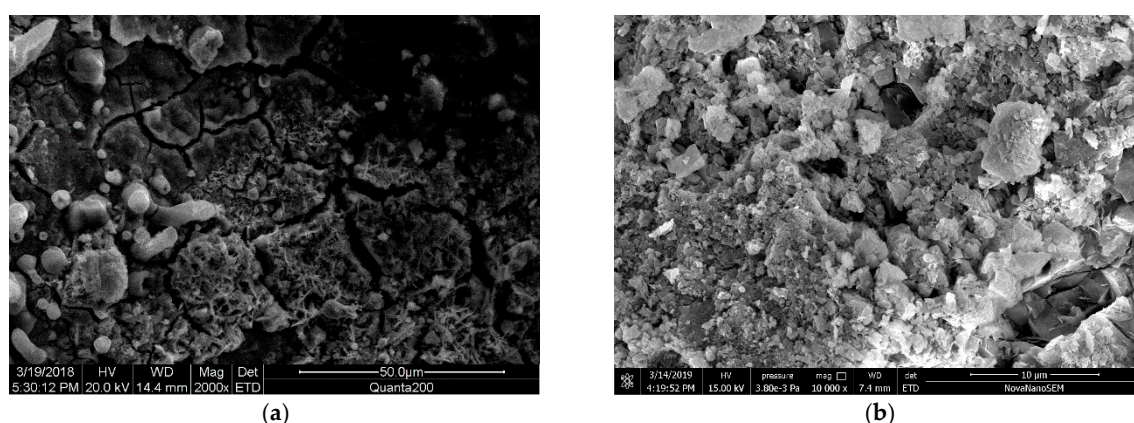
**Figure 8.** SEM images of rust layer in seawater and sea-sand concrete under continuous immersion; (a) Initial rust layer morphology of A1, (b) Later rust layer morphology of A1.

From Figure 8, it can be seen that the corrosion products of steel bars in seawater sand concrete specimens exhibited massive and granular morphology at the initial and later stages, but the structure was relatively loose. Moreover, the corrosion products formed in seawater sand concrete specimens under immersion conditions were mostly black and some were brown-red in color. Combined with the XRD results, it can be inferred that the corrosion product was mainly composed of wustite  $\text{FeO}$ , magnetite ( $\text{Fe}_3\text{O}_4$ ) and lepidocrocite ( $\gamma\text{-FeOOH}$ ), where wustite  $\text{FeO}$  was the major component and was formed by the reaction of rust intermediates. The related reaction is as follows:

Due to the long-term immersion of the specimens, it was difficult for oxygen to reach the surface of steel bars during the corrosion process. Thus, the other part of the specimens was oxidized incompletely and became black magnetite ( $\text{Fe}_3\text{O}_4$ ). The reaction formula is as follows:

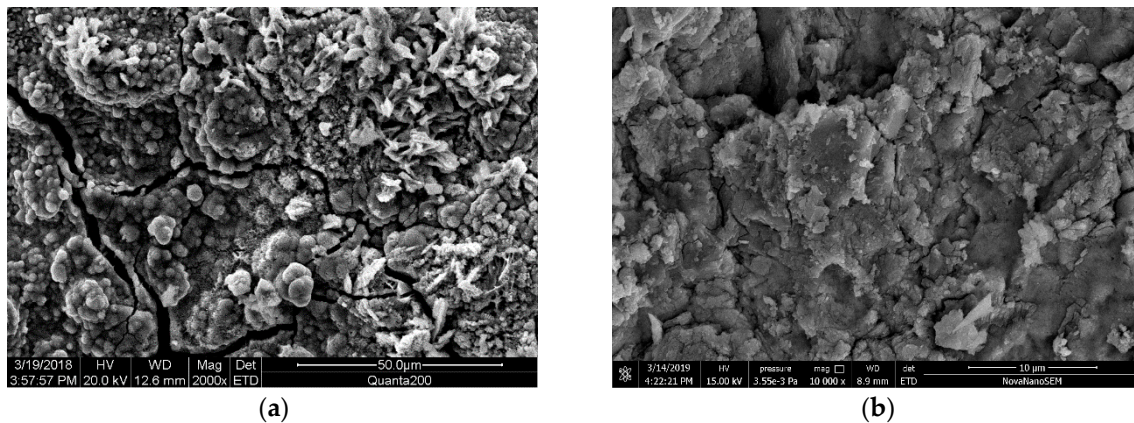
**Figure 9.** SEM images of rust layer in seawater and sea-sand concrete under dry-wet cycle; (a) Initial rust layer morphology of A2, (b) Later rust layer morphology of A2.

Figure 9 shows the SEM morphology of the early and later corrosion products of carbon steel in seawater sand concrete specimens under dry-wet cycling. It can be seen from the images that the initial corrosion products were mostly granular aggregates with compact texture, including some acicular and flaky products, which are typical maghemite ( $\gamma\text{-Fe}_2\text{O}_3$ ). Later, the corrosion products of

steel bars were similar to those of Figure 8a, both massive and granular, but the structure of corrosion products in this image was more compact. Moreover, the corrosion products of seawater sand concrete specimens under dry-wet cycling conditions were mainly ferrous black and brown in color. Combined with the XRD results, it was inferred that the content of magnetite ( $\text{Fe}_3\text{O}_4$ ) and maghemite ( $\gamma\text{-Fe}_2\text{O}_3$ ) was higher in the corrosion product. According to Legrand's theory, because seawater contains a large amount of sulfate, it reacts with  $\text{Fe}(\text{OH})_2$  to produce green rust hydrochloride  $\text{GRCl}^-([\text{Fe}_3^{2+}\text{Fe}^{3+}(\text{OH})_8]^{+} \cdot [\text{Cl}^- \cdot n\text{H}_2\text{O}]^{-})$  first, and green rust hydrochloride  $\text{GRCl}^-([\text{Fe}_3^{2+}\text{Fe}^{3+}(\text{OH})_8]^{+} \cdot [\text{Cl}^- \cdot n\text{H}_2\text{O}]^{-})$  continues to oxidize to produce orange-yellow lepidocrocite ( $\gamma\text{-FeOOH}$ ). Due to the frequent dry-wet cycles in this experiment, the environment of the sample was wet. Thus, lepidocrocite ( $\gamma\text{-FeOOH}$ ) was transformed into magnetite ( $\text{Fe}_3\text{O}_4$ ), and magnetite ( $\text{Fe}_3\text{O}_4$ ) finally formed maghemite ( $\gamma\text{-Fe}_2\text{O}_3$ ) through secondary changes under sufficient oxygen conditions. The related reaction equations are as follows:

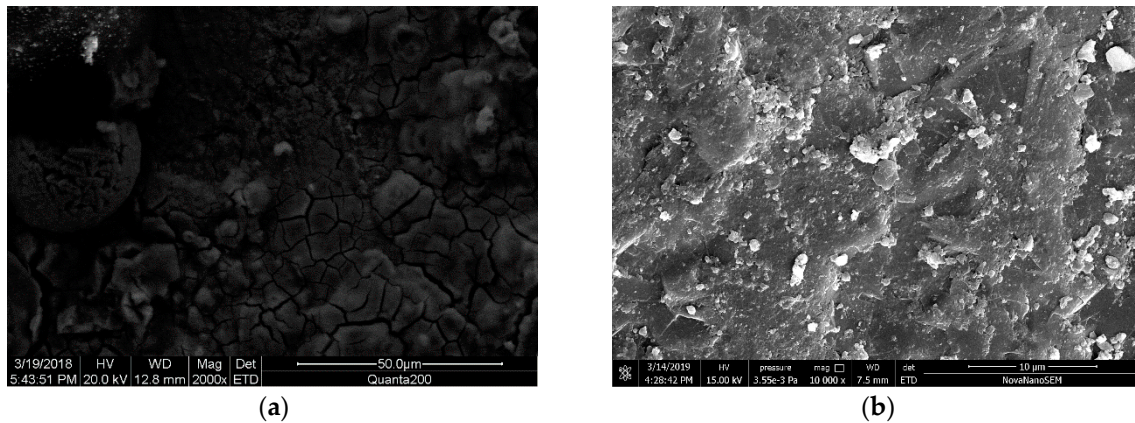
**Figure 10.** SEM images of rust layer in ordinary concrete under continuous immersion; (a) Initial rust layer morphology of B1, (b) Later rust layer morphology of B1.

Figure 10 presents the SEM images of the corrosion products of carbon steel in ordinary concrete specimens under immersion conditions. It can be seen from the images that the corrosion products of steel bar in the early stage were block magnetite ( $\text{Fe}_3\text{O}_4$ ) and spherical hematite ( $\alpha\text{-Fe}_2\text{O}_3$ ). Goethite ( $\alpha\text{-FeOOH}$ ) was strongly adhered to the surface of steel bar, which reduced the dissolution rate of anodic iron. This is also the reason the corrosion rate of steel bar decreased gradually with the development of corrosion. In the later stage, the morphology of corrosion products was similar to that in Figure 10a, but the texture was more compact, and the granular material was less. Moreover, the corrosion products of ordinary concrete specimens under immersion conditions were mostly black in color. Combined with the XRD results, it was inferred that magnetite ( $\text{Fe}_3\text{O}_4$ ) was the main product, which contained some partially powdered wustite ( $\text{FeO}$ ) from incomplete oxidation.

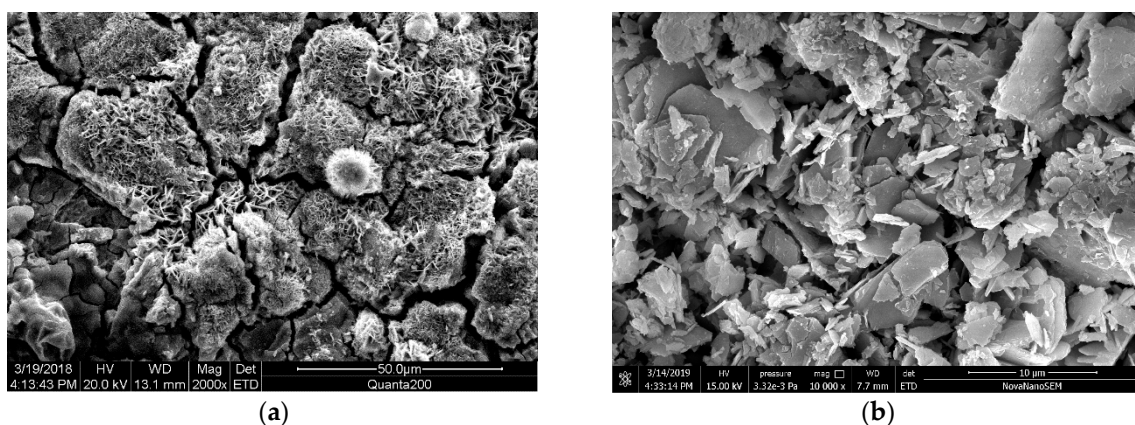
**Figure 11.** SEM images of rust layer in ordinary concrete under dry-wet cycle; (a) Initial rust layer morphology of B2, (b) Later rust layer morphology of B2.

Figure 11 presents the SEM morphology of the corrosion products of carbon steel in common concrete specimens under dry-wet cycling conditions. It can be seen that in the early stage, the corrosion products contained many needle-spherical aggregates, which were adhered to the surface of lepidocrocite ( $\gamma$ -FeOOH) and goethite ( $\alpha$ -FeOOH). In the later stage, the corrosion products of reinforcing bars were mostly scaly, fibrous and granular, and the structure of the products was loose. Comparing the color of the corrosion products, the corrosion products of ordinary concrete specimens under wet/dry cycling conditions were mainly brown-red and some of them were orange-yellow, indicating typical hematite ( $\alpha$ -Fe<sub>2</sub>O<sub>3</sub>) and lepidocrocite ( $\gamma$ -FeOOH) mixed products. In the wet-dry cycle, the oxygen supply was enough, so the Fe element was fully oxidized into trivalent iron ions. Lepidocrocite ( $\gamma$ -FeOOH) was converted to maghemite ( $\gamma$ -Fe<sub>2</sub>O<sub>3</sub>) under dehydration condition, and maghemite ( $\gamma$ -Fe<sub>2</sub>O<sub>3</sub>) was converted to hematite ( $\alpha$ -Fe<sub>2</sub>O<sub>3</sub>). At the same time, some lepidocrocite ( $\gamma$ -FeOOH) was converted to goethite ( $\alpha$ -FeOOH) under certain conditions, and goethite ( $\alpha$ -FeOOH) was converted to final product hematite ( $\alpha$ -Fe<sub>2</sub>O<sub>3</sub>) under dehydration condition. The related reactions are as follows:
