Article

Detection and Imaging of Debonding in Adhesive Joints of Concrete Beams Strengthened with Steel Plates Using Guided Waves and Weighted Root Mean Square

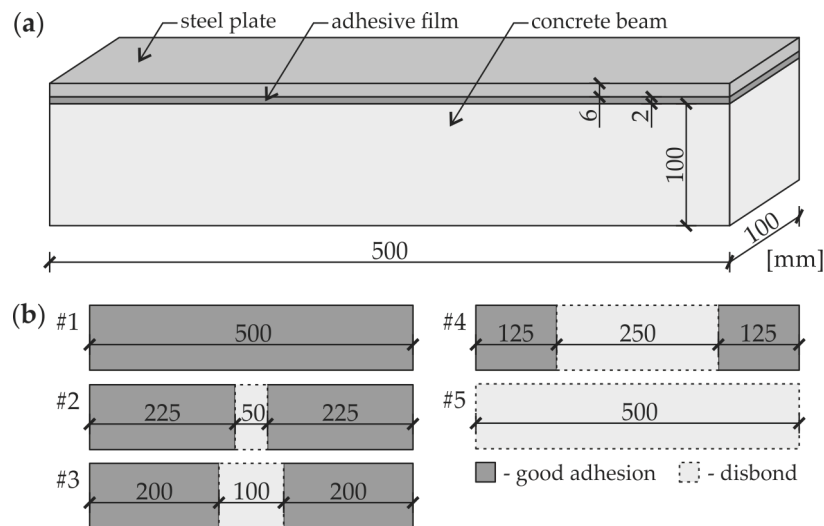
The object of investigations (Figure 1a) was a beam with a square cross section of 100 mm × 100 mm and a length of 500 mm. The beam was made of concrete class C30/37 and strengthened with a steel plate of dimensions 100 mm × 6 mm × 500 mm fixed to the upper surface of the beam by an adhesive film. Five specimens were analyzed (Figure 1b). The first specimen was an intact composite beam (#1) with a full connection between both elements. Three partially damaged beams (#2, #3, and #4) had defects in the form of a debonding, covering a different area of the joint (relative defect surface was 10%, 20%, and 50%, respectively). The last sample was a steel plate (#5), which was laid freely on the beam to simulate a fully debonded joint. The defects were obtained by sticking a Teflon (PTFE) tape

Figure 1. Analyzed specimens: (a) geometry of beams and (b) variants of defects.

onto the appropriate area of the steel plate. To prevent any unintentional defects, the treatment of each bonded elements was performed. The surface of the concrete beam was dedusted and degreased with Loctite-7063 cleaner (Henkel, Düsseldorf, Germany). The steel plate was treated with a fine abrasive paper (grit size 120) and then degreased. The connection between concrete and steel was provided by the two-component epoxy-based structural adhesive Sikadur 30 Normal (Sika, Baar, Switzerland). The specimens were conditioned in room temperature for seven days after gluing. The photograph of prepared specimens with close-ups for selected defects is presented in Figure 2. The thickness of the adhesive film for specimens (#1–#4) was equal to about 2 mm. It was determined after conditioning as the difference between the overall specimen thickness and the sum of beam and plate thicknesses.

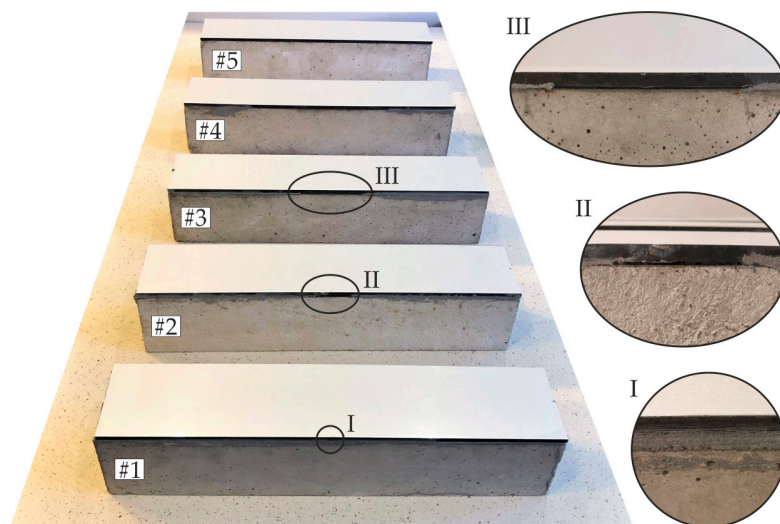
Figure 2. Photograph of prepared specimens (#1–#5) with close-up views of adhesive films in beams #1, #2, and #3.

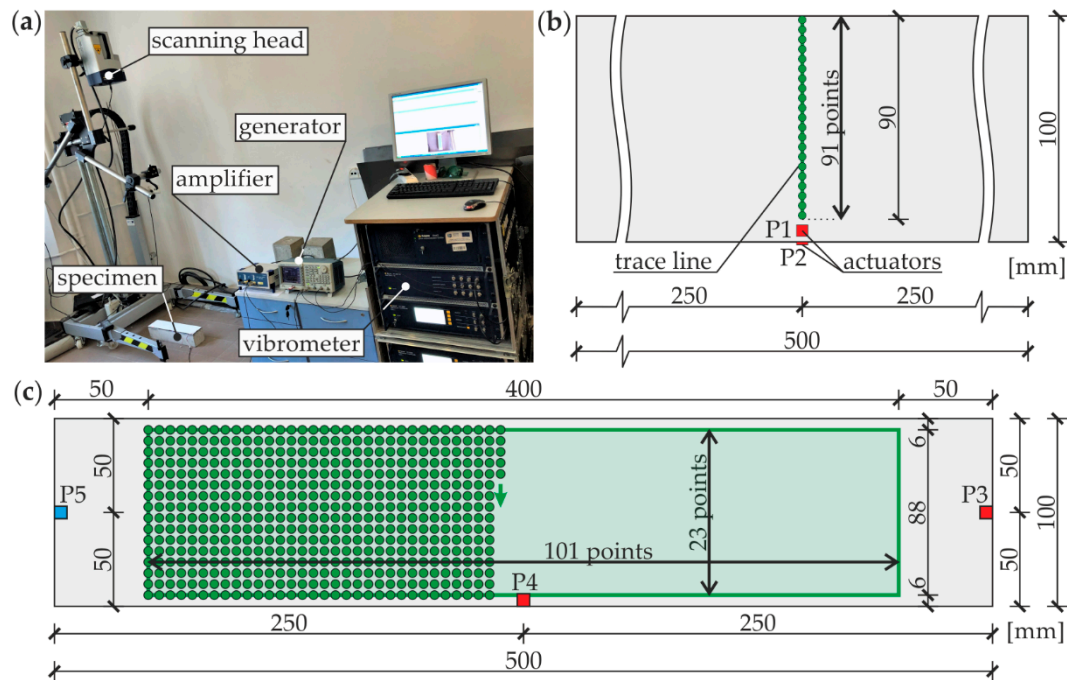
The experimental measurements of guided waves were carried out by the scanning laser Doppler vibrometry (SLDV) method using the set-up presented in Figure 3a. The input wave signal was generated by the arbitrary function generator AFG 3022C (Tektronix, Inc., Beaverton, OR, USA) and magnified with the use of the high-voltage amplifier PPA 2000 (EC Electronics, Krakow, Poland). The excitation of the guided wave field was provided by the plate piezoelectric actuators NAC2024

Figure 3. Experimental investigations: (a) setup for scanning laser Doppler vibrometry (SLDV) measurements; (b) scheme of measurements for dispersion curves determination; and (c) scheme for damage identification and visualization measurements.

The samples #1 and #5 were firstly tested to determine dispersion curves in a single-layer and three-layer medium, according to the scheme presented in Figure 3b. For this purpose, the propagation of antisymmetric and symmetric modes was induced by actuators P1 and P2, respectively, both attached to the steel plate. The input signal had the form of a wave packet obtained by the Hanning window modulation of the single-cycle sine function. To obtain a wide frequency spectrum for both excitation types, measurements were conducted five times with the different carrier frequency, equal to 50, 100, 150, 200, and 250 kHz, consecutively. The time-domain wave signals were acquired in 91 points spaced evenly over a straight line with a length of 90 mm, resulting with a resolution equal to 1 mm. The influence of potential reflections of propagating waves at the boundaries, induced by the short path length in relation with beam thickness, was further eliminated by analyzing only the initial part of the collected signals. The main investigations aimed at damage imaging in all beams #1–#5 were conducted with respect to the scheme shown in Figure 3c. Each specimen was tested twice, changing the location of the excitation point (P3 and P4). Excitation signal was a five-peak wave packet obtained from a sinusoidal burst with a central frequency equal to 100 kHz. The signals of propagating waves were collected in 2323 points distributed on the top surface of the steel plate, covering the area of $440 \times 88 \text{ mm}^2$. The scanning was conducted point by point in the regular mesh of 23 rows and 101 columns with a resolution of 4 mm in both directions.

Additional measurements with a contact method were performed to identify the damaged specimens. The input signal was identical to the one used for damage imaging with SLDV (five-cycle sine wave packet with a central frequency of 100 kHz). The piezoelectric actuators were attached at the

ends of each beam to excite and acquire wave signals in points P3 and P5, respectively (Figure 3c). The excitation signal was created by the arbitrary waveform generator AFG 3022C (Tektronix, Inc., Beaverton, OR, USA) and then amplified by the high-voltage amplifier A400DI (FLC Electronics AB, Partille, Sweden). The collection of signals was provided by the digital oscilloscope PicoScope 4824 (Pico Technology, St Neots, Great Britain) with a sampling frequency of 20 MHz.

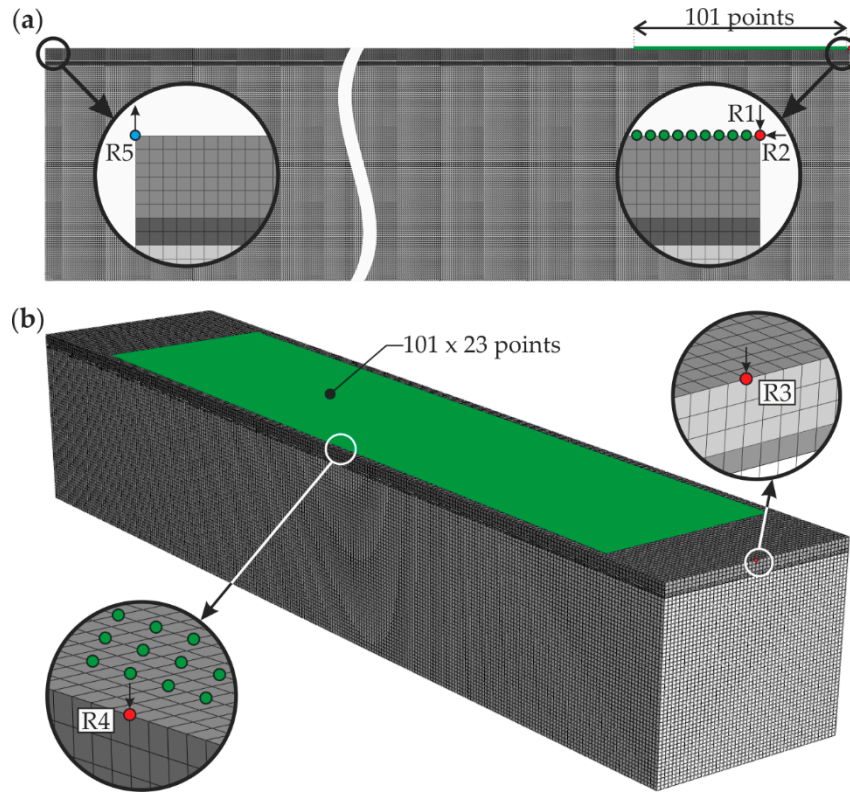
Two kinds of models were prepared for different purposes, plane (2-D) and spatial (3-D). Two-dimensional models (example in Figure 4a) were prepared for specimens #1 and #5 to analyze the differences between guided wave fields in a single-layer plate and a three-layer medium. Two-dimensional four-node plane strain elements with reduced integration (CPE4R) were used. The element size was constant and equal to 1×1 mm² throughout the whole model. This value satisfies the requirement of the appropriate mapping of wave behavior (at least 10 nodes for the length of the shortest considered wave) presented in [48]. The calculations were conducted with a fixed time step with a value of 10^{-7} s that meets the recommendation of at least 20 integration points per cycle of the wave with the highest frequency of interest [49]. For initial analysis, the wave was excited at one end of the plate (point R1) and its signal was collected at another end (point R5) to determine the time-of-flight (TOF) of the wave through the length of the specimen. In the same simulation, guided wave field was saved for the whole model. The excitation had the form of a concentrated force varying in time in accordance with a 5-cycle tone burst with a center frequency of 10, 23, and 100 kHz (three different simulations). The plane models were also used to determine the numerical dispersion curves, similarly as in the experimental investigations (cf. Figure 3b). The input signal was applied in points R1 and R2 (independently) as a wave packet modulated from a single-cycle sine function with a different frequency (50, 100, 150, 200, and 250 kHz), resulting with ten consecutive simulations. The guided wave responses were obtained at 101 points distributed along the line with a length of 100 mm, giving 1 mm spacing between each point. It is worth noting that the measurement path was oriented perpendicularly to the one in experimental investigations. However, the results of both approaches could be compared, as long the materials used were modeled as isotropic and only the initial parts of signals were further analyzed. Three-dimensional models (example in Figure 4b) were prepared for specimens #1–#5 to verify the results of experimental measurements. Eight-node linear brick elements

Figure 4. Numerical models for specimen #1: (a) 2-D plane model and (b) 3-D spatial model.

with reduced integration (C3D8R) and a global size of 2 mm were applied. The integration step was 2×10^{-7} s. Both element size and time step met the requirements from [48,49], described above. The scheme of excitation and collection of signals was identical with the experimental measurements (cf. Figure 3c). The wave (Hanning windowed five-cycle sine function with a carrier frequency of 100 kHz) was excited in point R3 or R4 and collected in 2323 points covering the area of 88×400 mm².

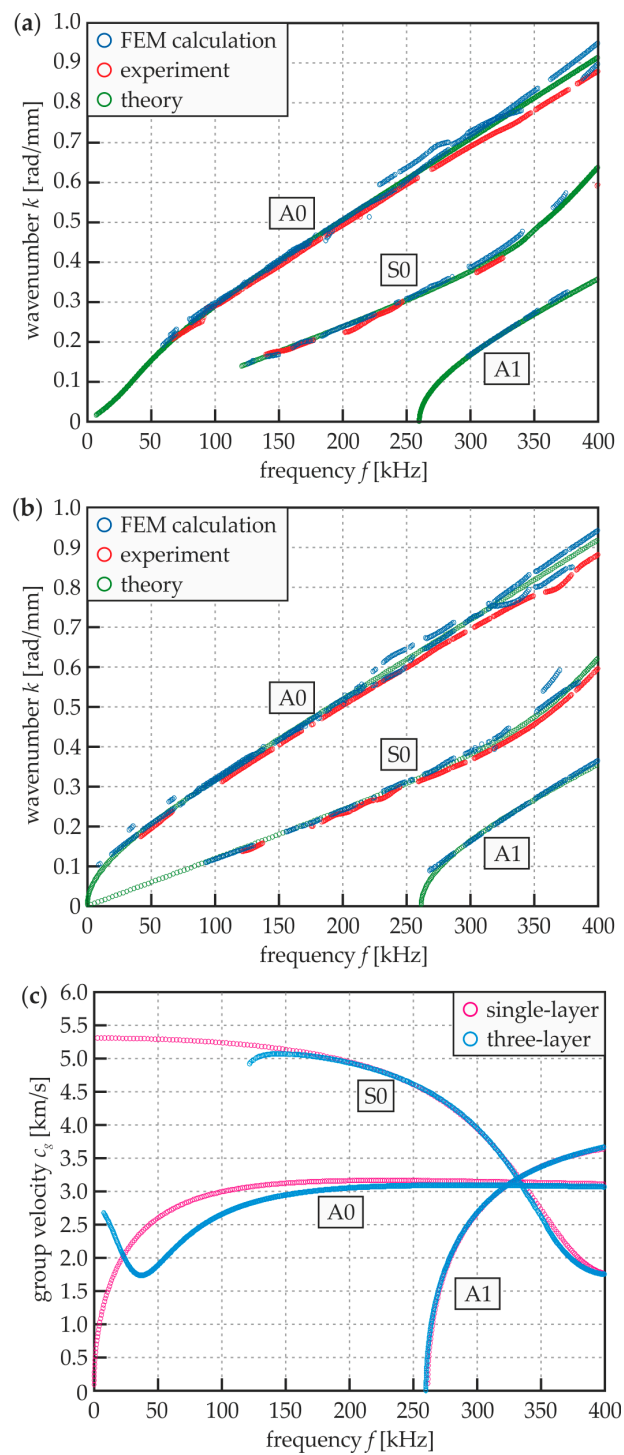
The dispersion curves obtained from the three approaches are presented in Figure 5. The wavenumber–frequency relations for specimen #1 (Figure 5a) reveal the fact, that two flexural (A_0 , A_1) and one longitudinal (S_0) modes can propagate in the frequency range up to 400 kHz. It is essential to note, that the fundamental S_0 mode does not appear in the range up to 122 kHz and the A_1 mode is present for the frequencies above 260 kHz, thus only one mode can propagate for the assumed excitation frequency equal to 100 kHz. The comparison of the three approaches allowed concluding that the overall agreement between the numerical, experimental and theoretical results was very good. However, the higher mode A_1 was not identified in the experimental approach, probably due to the setup limitations. It is also important to note that neither experimental nor numerical calculations detected A_0 in the range up to 60 kHz, what could have been caused by the strict tolerance level. However, the increase of l would significantly decrease the legibility of the curves obtained. The analysis of dispersion curves for specimen #5 (Figure 5b) leads to similar conclusions. Compared with the results for beam #1, the S_0 mode can propagate in the whole assumed frequency range, such as A_0 . The dispersion relations for both specimens for the frequencies above 150 kHz are comparable. The important differences are observable in the lower frequency range. To expose these dissimilarities, the theoretical dispersion curves for group velocity were prepared for both #1 and #5 specimens (Figure 5c). No significant difference can be seen for the A_1 curve. The shapes of A_0 and S_0 curves are also very similar for the higher frequency range. As mentioned above, S_0 mode is not present in the lower frequency range. To be noticed, it is important to analyze the shape of the A_0 mode, because for the damage imaging, measurements the waves were excited perpendicularly to the plate surface and the out-of-plane velocity signals were collected. It is interesting that in the frequency range up to about 23 kHz it propagates with higher velocity in the specimen #1, whereas above this limit, the velocity of propagation is higher in specimen #5.

Figure 5. Dispersion curves for analyzed specimens: (a) wavenumber vs. frequency for three-layer plate #1; (b) wavenumber vs. frequency for single-layer steel plate #5; and (c) theoretical group velocity vs. frequency for three-layer plate #1 and single-layer plate #5.

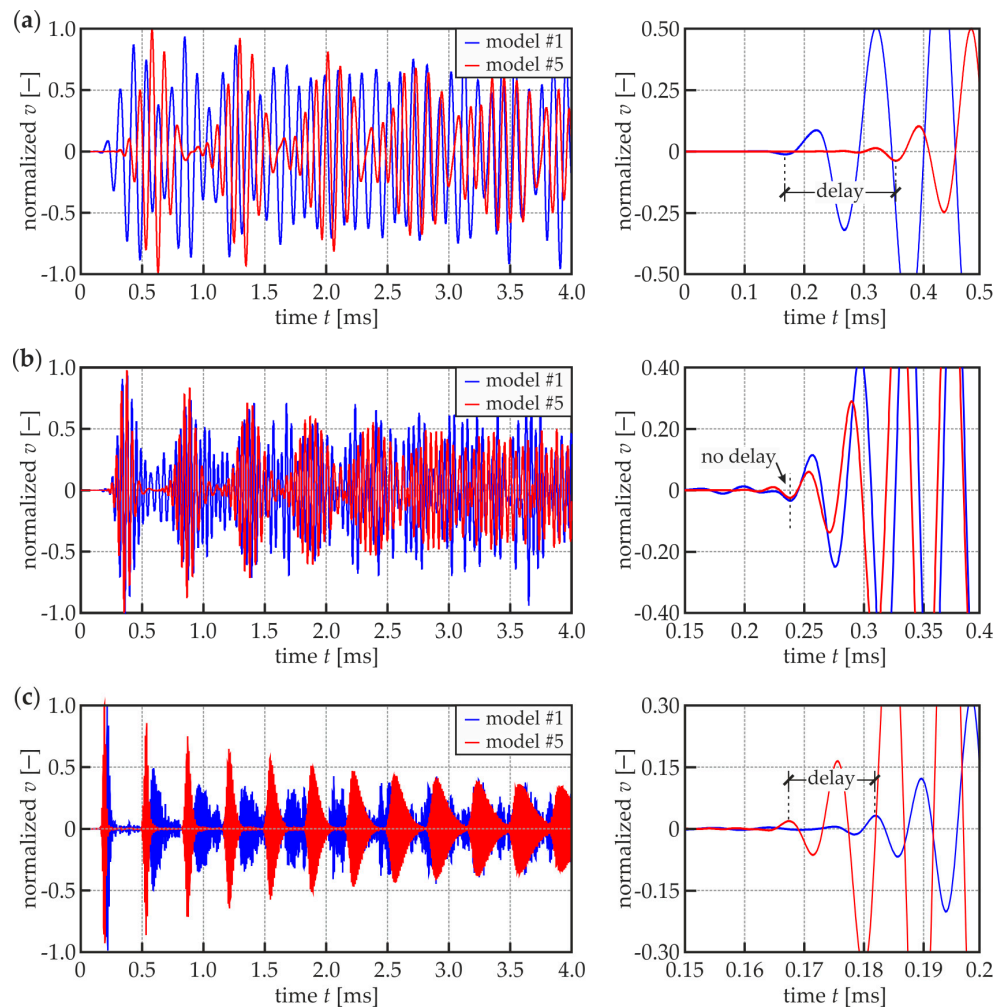
The simple FEM numerical simulations were performed to check whether this dispersion relationship is actually observable. Figure 6 shows the time signals of propagating waves in specimens #1 and #5 obtained from the numerical models in point R5 as the results of R1 excitation (cf. Figure 4a). It is clearly visible, (especially in close-ups) that the wave packet related to the A_0 mode appears earlier in the signal from specimen #1 for the excitation frequency equal to 10 kHz (Figure 6a). If the excitation frequency is equal to 23 kHz, no difference in time of flight (TOF) of the first wave packet is

observable (Figure 6b). The further increasing of the frequency value leads to the situation when the wave propagates faster in specimen #5 (Figure 6c). The TOF values for both models were calculated based on the dispersion curves (theoretical TOF) and are presented in Table 2, together with the values got from signals recorded. The relative differences between theoretical and numerical TOFs do not exceed a few percent, which indicates on the good compliance between dispersion curves and FEM simulations.

Figure 6. Normalized velocity signals (whole signals and zoom) registered at point R5 in numerical models of specimens #1 and #5 for different excitation frequencies: (a) 10 kHz; (b) 23 kHz; and (c) 100 kHz.

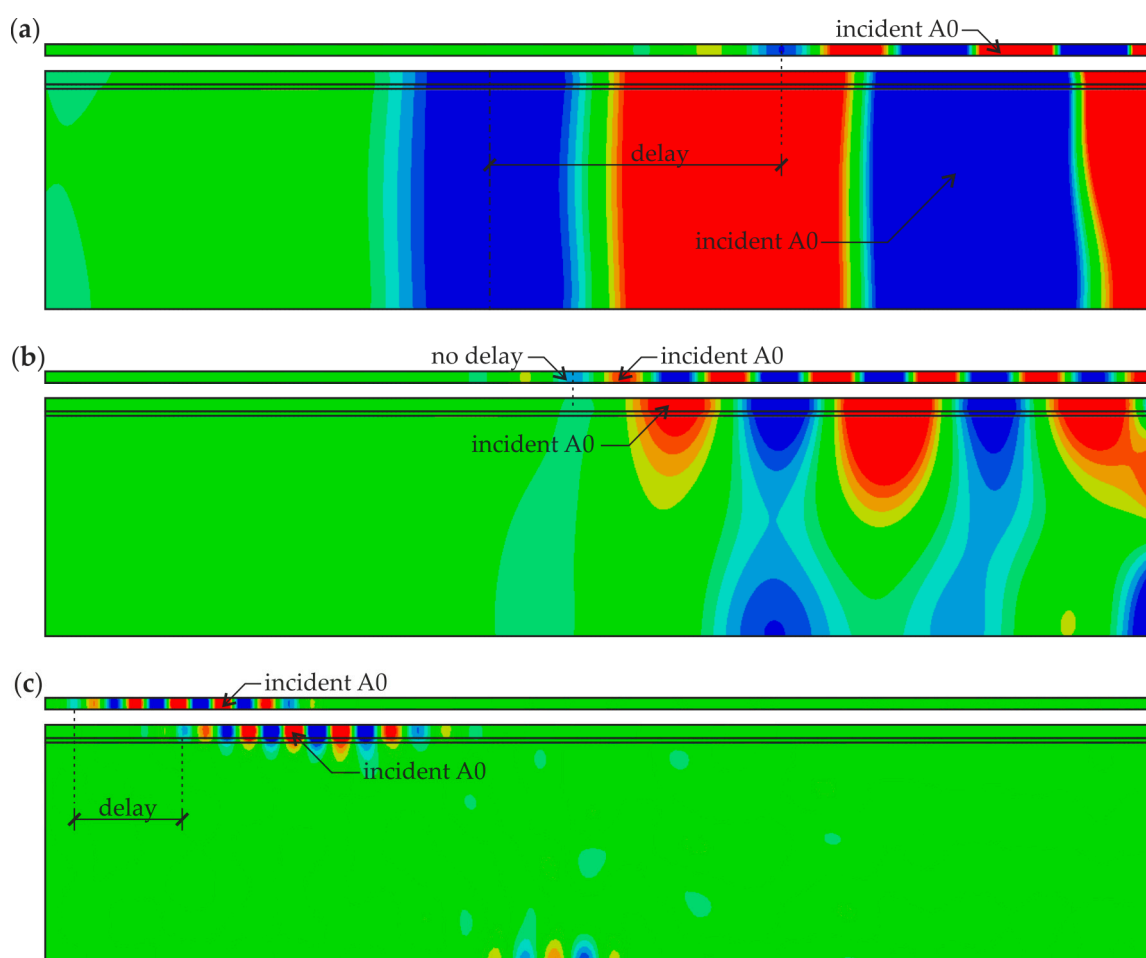
In addition to the analysis of the time signals, the guided wave fields representing the propagation of A_0 mode for specimens #1 and #5 for a specific time instance 0.17 ms are shown in Figure 7. It is visible that the incident wave with the frequency of 10 kHz propagates faster in beam #1 compared with plate #5 (Figure 7a), what stays in the agreement with the comparison of dispersion curves. What is also important, the wave propagates through the three-layer medium as a single waveguide,

although the wave was excited only in the steel plate. It is possible because the A_0 wavelength is large enough (271 mm), compared to the overall sample thickness (108 mm). The length of the A_0 mode in beam #1 is significantly smaller (74 mm), but much greater than the thickness of the plate (6 mm). For the frequency equal to 23 kHz (Figure 7b) the wave packets in both specimens propagate with similar velocity. The distribution of the wave field through the thickness of specimen #1 is not uniform, the amplitude decreases with the depth because the wavelength (107 mm) is slightly smaller than the specimen thickness. The interesting situation takes place when the excitation frequency increases to 100 kHz (Figure 7c). The wave propagation velocity in specimen #1 is smaller compared with specimen #5 (what is confirmed by the dispersion curves), but the wave propagates mainly in the steel plate and adhesive film. The reason is that the wavelength is now much smaller (22 mm) than the overall specimen thickness. For the concrete part, only the Rayleigh waves can be observed propagating at the interface between concrete and adhesive and the bottom boundary. The length of the wave propagating in plate #5 is comparable with the one present in the beam #1 and equal to 20 mm, which is also clearly visible in the snapshot. The analysis of the FEM simulations illustrating in Figure 7 allows concluding that the differences in the dispersion curves for both, three-layer and single-layer media are less pronounced for the higher frequency range (above about 120 kHz), because in this case, the wave propagates mainly in the steel plate, passing by the influence of the concrete part. Thus, the damage visualization in analyzed specimens would not be successful in this case. On the other hand, lower frequencies result in poorer image resolution. As the compromise, the excitation frequency equal to 100 kHz was chosen for further investigations aimed at damage detection and imaging.

Figure 7. Numerical wave fields in 2-D finite element method (FEM) models of specimens #1 and #5 ($t = 0.17$ ms) for different excitation frequencies: (a) 10 kHz; (b) 23 kHz; and (c) 100 kHz.

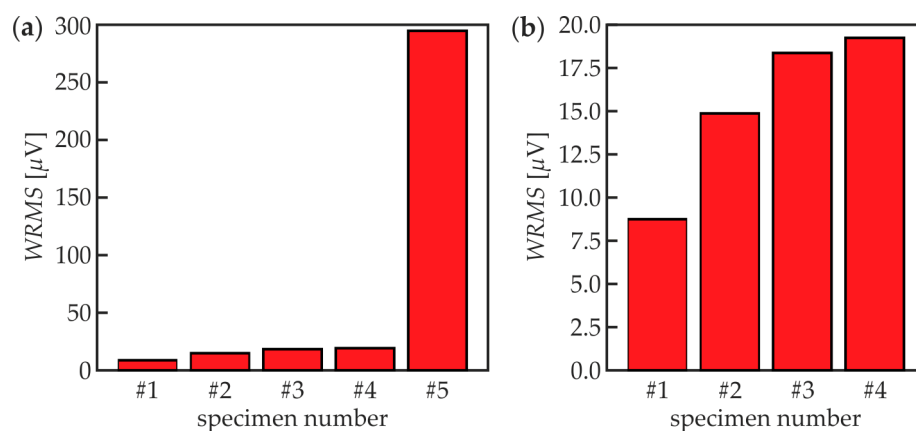
The non-destructive diagnostics of specimens #1–#5 was conducted in two stages: identification and imaging. The aim of the damage identification was to detect, whether there are any defects in the adhesive joint between the concrete beam and the steel plate. The root mean squares values were calculated for the time signals excited by the actuator located in point P5 and measured by the sensor located in point P3 (see Figure 3c). This means that the wave propagated through the whole length of the specimen. The calculations were performed for the time of averaging assumed as $t_a = 1$ ms, with a linear weighting factor ($m = 1$, $w_r = r$). The results for all specimens are presented in Figure 8a. It is clearly visible that the WRMS value for specimen #5 (single-layer steel plate) is significantly higher than in others. In the case of specimen #5, the point of excitation was located on the free steel plate, characterized by the relatively small material damping. For specimens #1–#4, the wave was excited on the area where the steel plate had a good connection with the adhesive layer and concrete part (i.e., materials with higher damping) what resulted in the instantaneous leak and dissipation of energy in the bottom part of the specimen. For this reason, a close-up of the chart for the specimens #1–#4 is shown in Figure 8b. The correlation between WRMS value and the size of the defect is clearly visible, with the greater the damaged area, the higher WRMS value. This relationship occurs because the wave energy is magnified by the multiple reflections of propagating waves at the boundaries of defects. It is also worth noticing that the WRMS increased significantly between intact #1 and damaged #2 specimen (71%) but the further growth of defect surface did not result in the significant growth of WRMS. The damaged area of specimen #4 was 2.5 times bigger than in specimen #3 but the growths in comparison with #1 were equal to 116% and 129%, respectively. Concluding, the comparative analysis of WRMS values gave the answer about the presence of the defect, however, it did not provide the information about the size and location of damaged areas.

Figure 8. Weighted root mean square (WRMS) values of experimental signals collected in P5 point: (a) specimens #1–#5 and (b) specimens #1–#4.

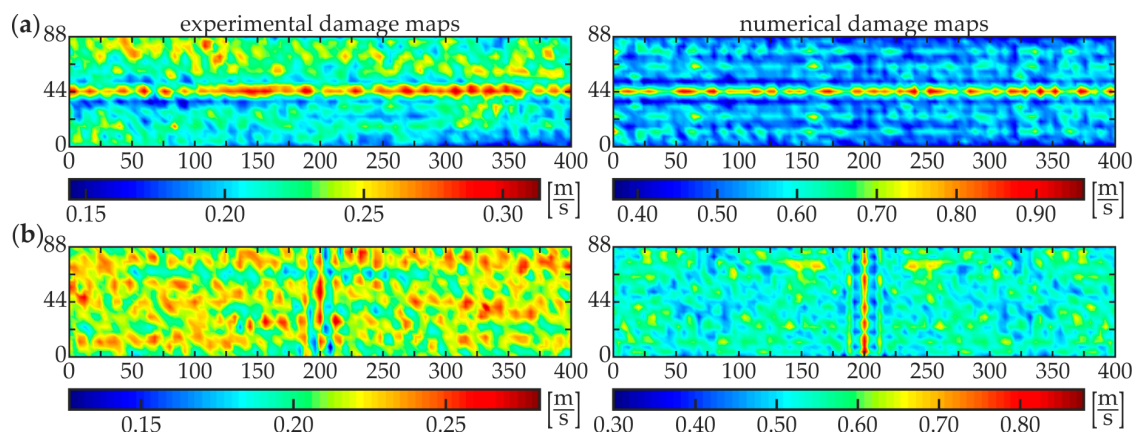
The second stage, i.e., damage imaging, was performed to identify the exact position and size of the damaged area of each specimen. The WRMS map in the form of the two-dimensional defect representation over the scanned area was prepared based on the experimental investigations and numerical simulations on 3-D FEM models (see Figures 3c and 4b). The parameters of the calculations were assumed to be the same as for damage identification stage ($t_a = 1$ ms, $w_r = r$). The results for specimens #1–#5 are presented below. Figure 9 shows the WRMS maps for the intact composite beam (specimen #1). Regardless of the location of the excitation point, the visualizations reveal that no internal defects were detected inside the analyzed adhesive joint. The values in each experimental and numerical map are concentrated over a certain value. The horizontal lines with magnified values in images for excitation P3 (Figure 9a), such as the vertical lines for excitation P4 (Figure 9b) are the effects of the specimen and the load symmetry. Some interesting conclusions can be derived from the

Figure 9. Experimental and numerical WRMS damage maps for specimen #1: (a) Excitation P3 and (b) Excitation P4.

A good agreement of experimental and numerical results is observed, however, the quality of the numerical visualization for the excitation in point R3 is richer compared with the experimental one. This may be caused by the noise present in the experimental signals. Similar conclusions can be derived from the analysis of damage maps of scanning for the two other partially damaged beams: #3 (Figure 11) and #4 (Figure 12). The WRMS maps for the fully debonded joint #5 (Figure 13) are similar to the ones obtained for the intact composite beam #1 (cf. Figure 9). This convergence allows stating that the damage visualization is possible only when the area of scanning covers both areas of good

adhesion and debonding. The only difference between both specimens is that the value of WRMS is significantly higher for the steel plate (see color bars in Figures 9 and 13).

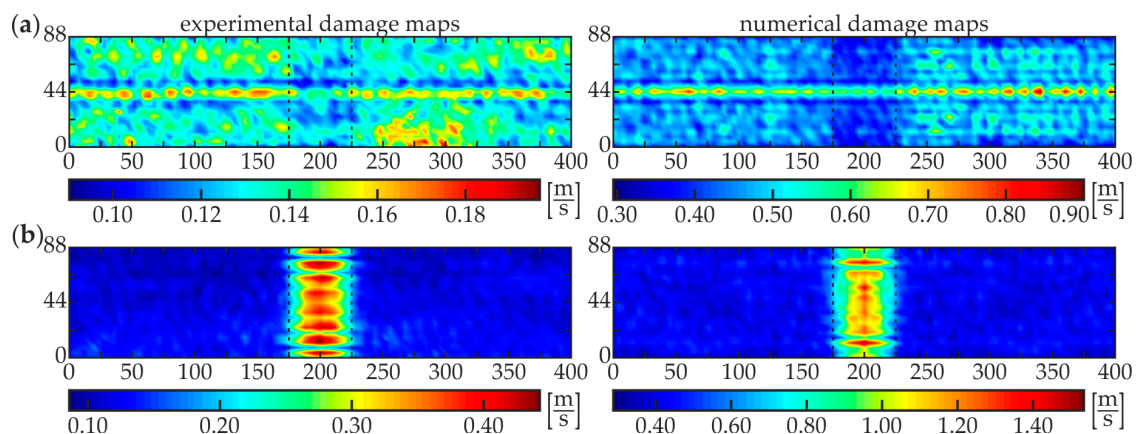
analysis of the results for specimen #2 with a partial debonding (Figure 10). It is clearly visible that the map obtained for the excitation applied in point P3 (Figure 10a) results in the moderate defect imaging when compared with the excitation in point P4 (Figure 10b). The reason is that the wave excited in point P3 (in the area of good adhesion) strongly leaks into concrete, so the wave energy is damped significantly before meeting the boundaries of the defect, thus it has no possibility to be clearly visualized. It was already possible to conclude in the stage of damage identification (the high WRMS value for specimen #5 indicated on this effect, see Figure 8a). However, the damaged area is somehow detectable and it is characterized by slightly smaller WRMS values than the remaining part of the sample. The energy of the wave excited by the actuator P4 is concentrated in the damaged area and the damage map has a high quality. The properly boded areas have much lower WRMS values because the waves transmitted to the three-layer medium are highly damped.

Figure 10. Experimental and numerical WRMS damage maps for specimen #2: (a) excitation P3 and (b) excitation P4.

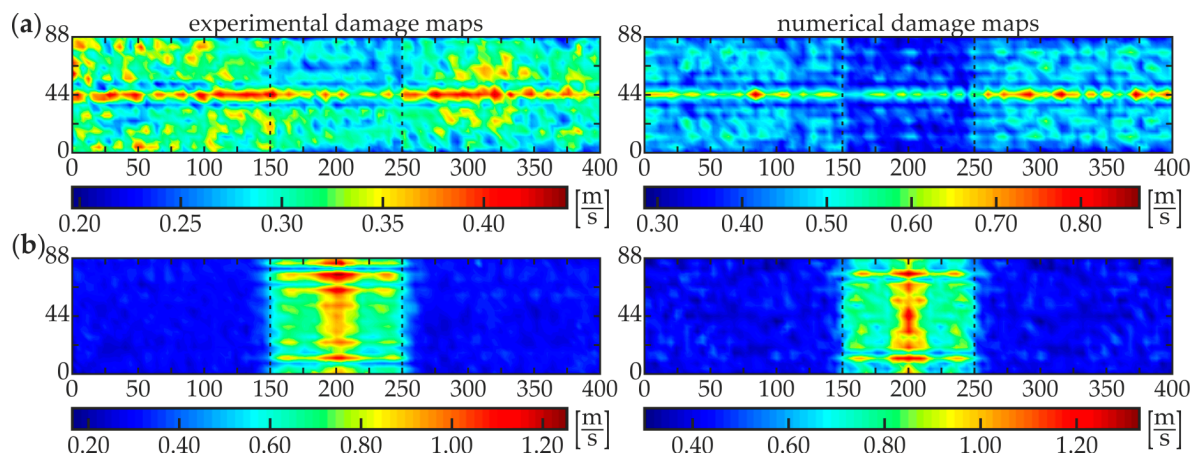
Figure 11. Experimental and numerical WRMS damage maps for specimen #3: (a) excitation P3 and (b) excitation P4.

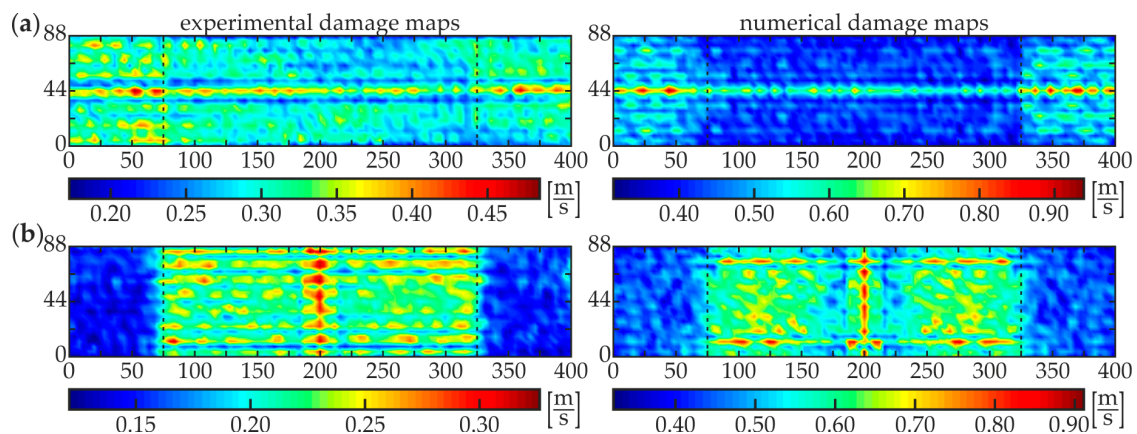
Figure 12. Experimental and numerical WRMS damage maps for specimen #4: (a) excitation P3 and (b) excitation P4.

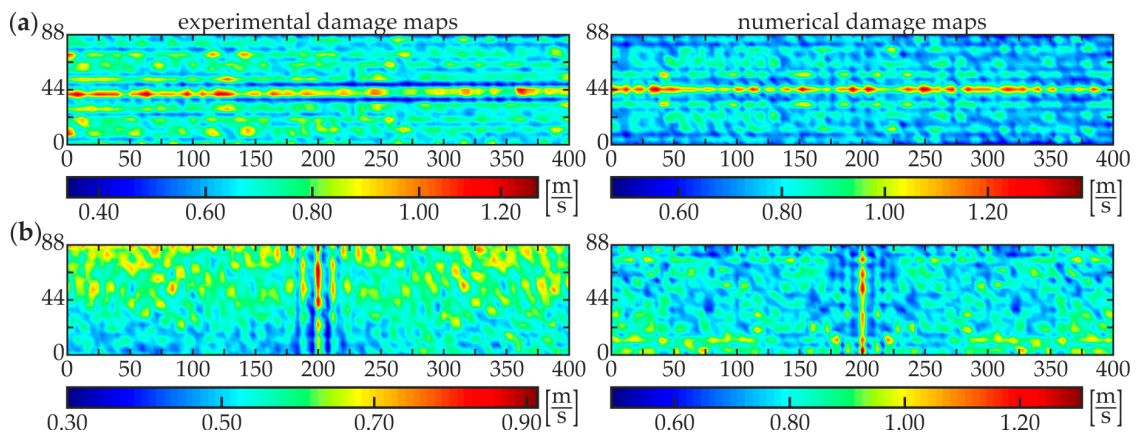
Figure 13. Experimental and numerical WRMS damage maps for specimen #5: (a) excitation P3 and (b) excitation P4.
