## Article

# The Influence of the Environment for Glass-Reinforced Plastic Composite Material Used for Ground Water Transport Pipes

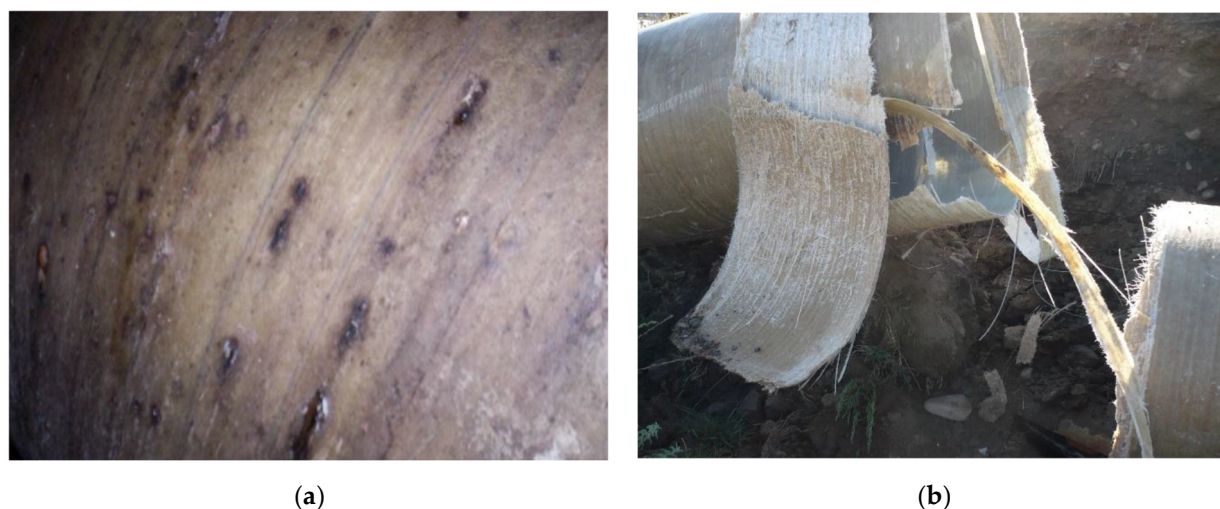
**Figure 1.** Damage to the glass-reinforced plastic pipeline in (a) basic soil and (b) acidic soil.

Figure 1 shows two photos taken at different locations along the pipeline: basic ground and acidic ground. In the case of the pipe buried in basic soil, exfiltration phenomena can be observed visually through the points of rust that appear at the level of the pipe, indicating the complete destruction of the pipe in the case of acidic ground.

In the case of acidic soil, the damage was manifested in a remarkable way. By changing the mechanical characteristics of acid-contaminated soils, their bearing capacity decreases. There is also a drastic alteration of the pipe material due to the significant effects on the glass fibre.

In the case of basic ground, leaks and colour changes could be observed in the pipe, without significant damage to the fibreglass.

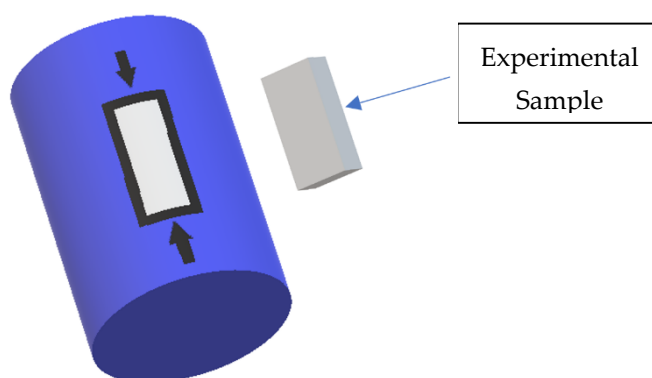
**Figure 2.** Sampling area for structural analysis.

For structural analysis using scanning electron microscopy, samples were taken according to Figure 2, and the specific analytical areas are highlighted by section in the longitudinal area of the pipe.

From the point of view of the morphological structure of the material (Figure 2), it can be observed that it is more affected in the case of acidic soil than basic soil.

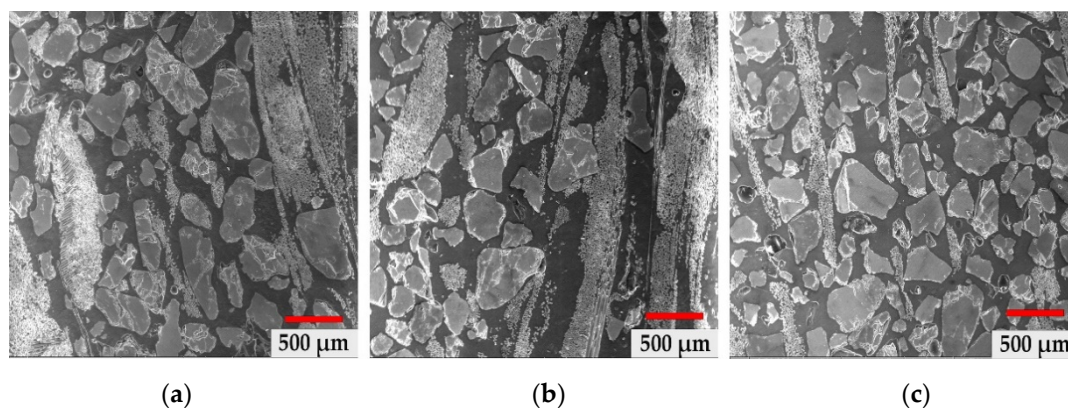
**Figure 3.** Morphological structure of the material core: (a) neutral soil, (b) basic soil, (c) acidic soil.

In Figure 3a–c, we have highlighted the structures in the core area of the GRP material at a magnification power of 100× for all three types of material samples collected from the three types of terrain. There is a structure with granulation and uneven distribution of glass particles and fibres, which is similar to the samples collected from neutral and basic terrain. In the acid field test, the structurally highlighted fibres were much smaller

and thinner, which confirms the degradation of the glass fibres in the composite mass and thus the plasticization of the core structure in the acidic environment.

Figure 3 shows the morphology of the component particles in the pipe in the specific medium (neutral, acidic and basic). There is a more accentuated fragmentation for samples a and c, respectively, in neutral and acidic environments, and a lower fragmentation for sample b, due to the presence of continuous fibres arranged in the longitudinal direction. The average dimensions of the particles have the following values (Figure 4): (a) neutral:  $339.50 \mu\text{m} \pm 146.63 \mu\text{m}$ , (b) basic:  $321.58 \mu\text{m} \pm 124.15 \mu\text{m}$  and (c) acid:  $295.78 \mu\text{m} \pm 111.58 \mu\text{m}$ .

Scanning electron analysis presents a structure with granulation and uneven distribution of glass particles and fibres, a problem that is similar to the structures obtained from neutral and basic terrain. In the acid field test, fibres were found to be much smaller and thinner, which confirms the degradation of the glass fibres in the composite mass and thus the plasticization of the core structure in the acidic environment.

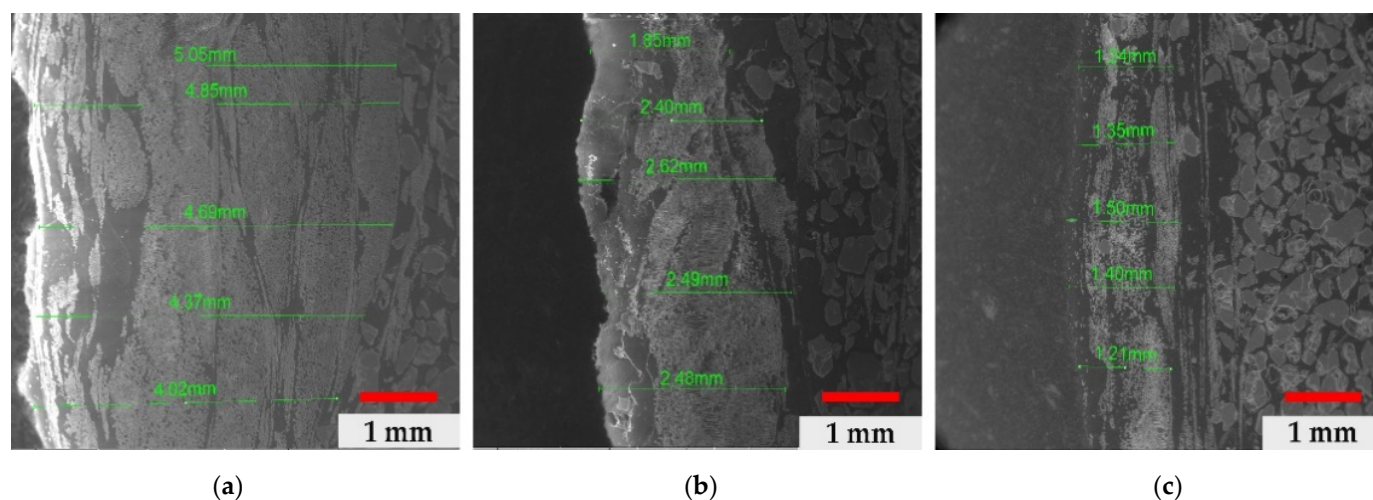
**Figure 5.** Dimensional variation in the outer layer: (a) neutral soil, (b) basic soil, (c) acidic soil.

From the analysis of the outer layer for the three cases—shown in Figure 5a–c—the fibrous structure obtained through the arrangement of glass fibres with different thicknesses is highlighted, with an average value of 4.608 mm for the neutral ground sample; an average value for 2.368 mm for the primary field sample and an average value of 1.34 mm for the acidic field sample. There is a reactive activity of the environment on the thickness of the outer layer, with a significant reduction in thickness by 50% in the case of basic soil and by 70% in the case of acidic soil.

The mechanism of degradation of the pipe material differs from acidic soils with respect to neutral basic soils. In particular, in acid soils, there is a degradation of the outer layer by 70% as a result of increasing roughness, aging of the material, exfoliation, cracks and damage to the pipe.

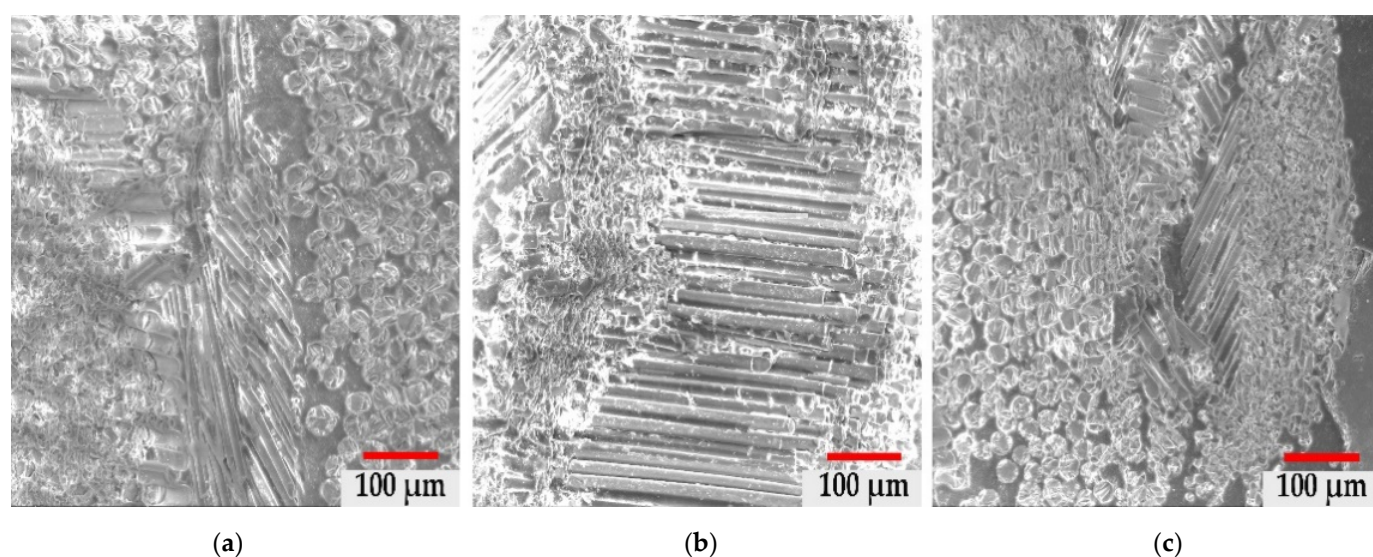
**Figure 6.** Morphological structure of the outer layer: (a) neutral soil, (b) basic soil, (c) acidic soil.

Structural analysis of external areas—as shown in Figure 6a–c—highlights fibrous structures with different orientations with the same calcium aluminosilicate morphology.

Figure 6 confirms the continuity of the fibres in the structure of the pipes used in a neutral environment, having a parallel and substantially equal fibre structure in different areas of the material and with different orientations, without a preferential orientation. We also highlighted the size of the component particles by extending the SEM analysis (Figure 4).

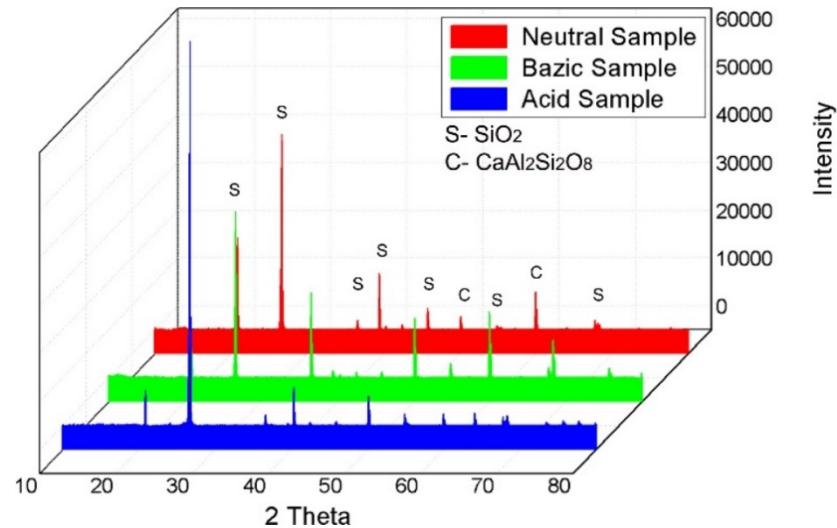
**Figure 7.** XRD analysis of 3 experimental samples.

Figure 7 shows the X-ray diffraction analysis results for the core of each of the three samples. The figure highlights the specific diffraction peaks of the two main components ( $\text{SiO}_2$  and  $\text{CaAl}_2\text{Si}_2\text{O}_8$ ).

Figure 7 shows the diffraction peaks for the component phases of the pipes used in the three different media. The figure presents the three cases in different colours and provides the related explanations.

From the XRD point of view, the predominant peak is identified at the  $2\theta$  angle of  $26.64^\circ$  and is formed of silicon dioxide (COD: 96-710-3015) and has a crystalline structure of the hexagonal type. Secondary peaks consist of silicon dioxide and calcium aluminosilicate (COD: 96-154-0253), identified at various  $2\theta$  angles of  $51.42^\circ$  and  $60.31^\circ$ , having a crystalline structure of the tetragonal type. These results are in accordance with the structural and morphological analysis obtained by SEM analysis.

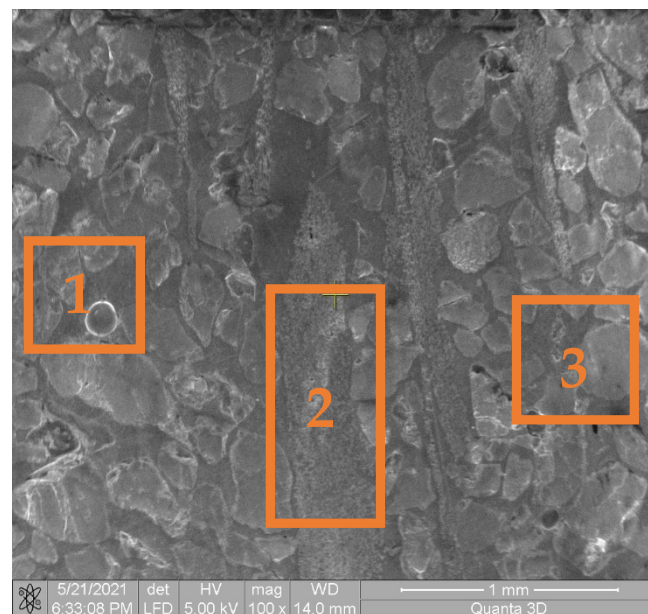
**Figure 8.** SEM images for different areas used for EDS chemical analysis. (1) SEM images for General aspect area, (2) SEM images for Continuous Fibres area, (3) SEM images for Particles area.

EDS analysis of the component particles and base material was an important aspect of this study. The results are justified by the XRD analysis, in terms of the identified compounds. The diffraction peaks did not show displacements in terms of the  $2\theta$  angle, but there were clear differences in intensity for the acidic sample, which explains the higher crystallinity, Figure 8. The EDS results collected in three different areas are presented in Table 5.
