# Corrosion Behavior and Susceptibility to Stress Corrosion Cracking of Leaded and Lead-Free Brasses in Simulated Drinking Water

**Abstract:** Duplex  $\alpha + \beta'$  brasses are widely used in drinking water distribution systems for tube fittings, valves, and ancillaries because they are low cost, easy to fabricate, and exhibit high mechanical strength. However, depending on application conditions and alloy composition, they may undergo dealloying and stress corrosion cracking. In this research, three different brass types, two leaded (CW617N and CW602N) alloys and one lead-free brass (CW724R), were investigated to assess their corrosion behavior and susceptibility to stress corrosion cracking (SCC) in simulated drinking water (SDW) solutions containing different chloride concentrations, compatible with drinking water composition requirements according to Moroccan standard NM 03.7.001. The corrosion behavior was assessed by electrochemical tests such as polarization curve recording and electrochemical impedance spectroscopy (EIS) monitoring, coupled to SEM-EDS surface observations. The susceptibility to SCC was investigated by slow strain rate tests (SSRT). The tests showed th

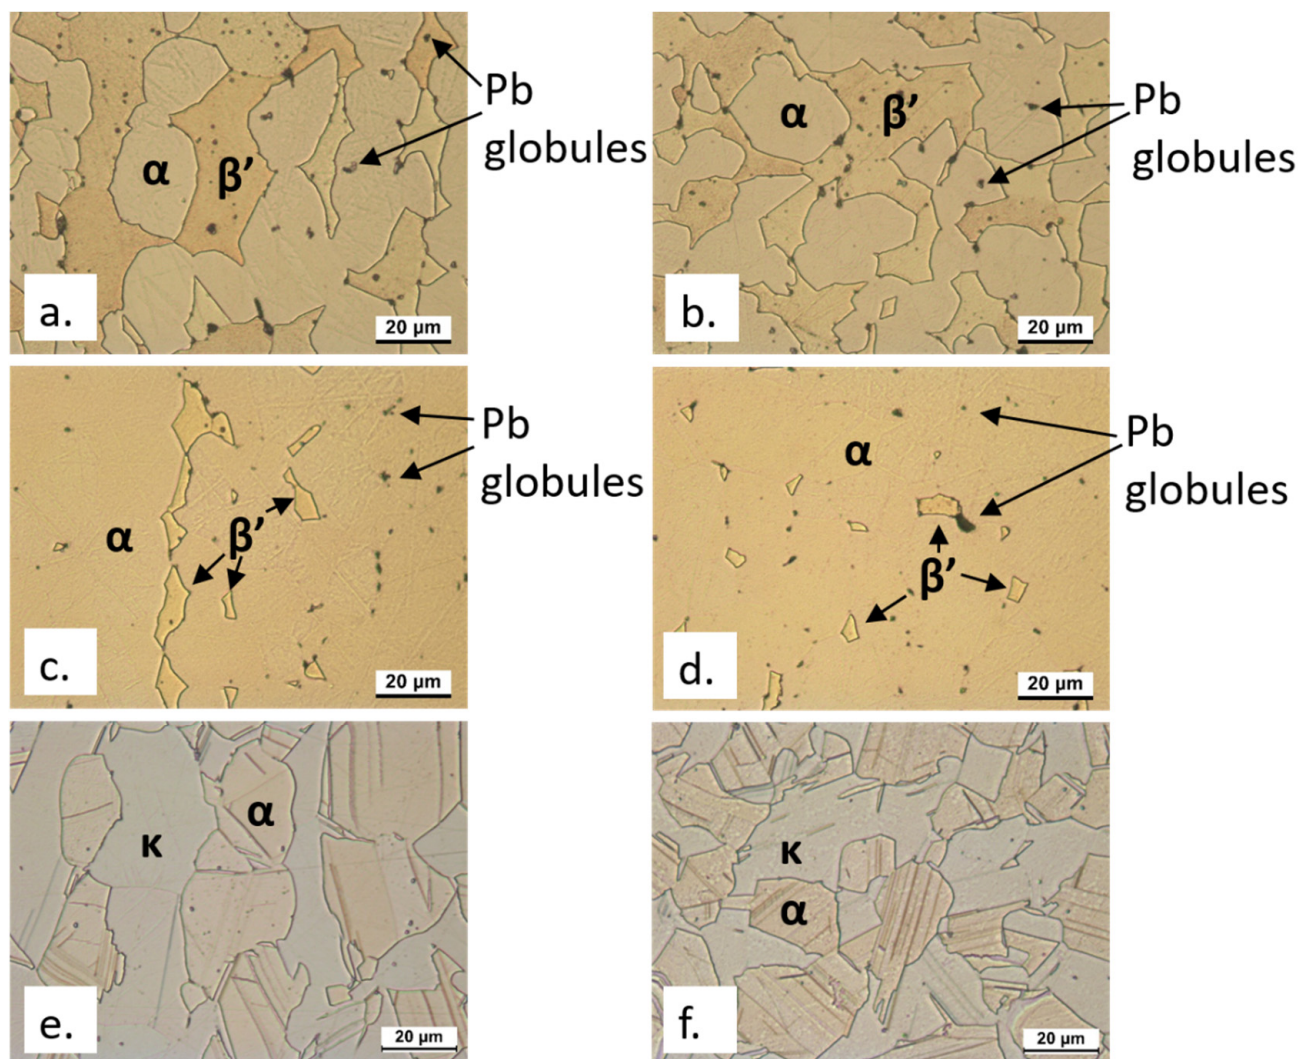
**Figure 1.** OM microstructures of etched longitudinal (a,c,e) and transverse (b,d,f) sections of CW617N (CuZn40Pb2: (a,b)), CW602N (CuZn36Pb2As: (c,d)), and CW724R (CuZn21Si3P: (e,f)) samples. The longitudinal direction in (a,c,e) is the vertical one.

The composition of the investigated alloys, as evaluated by glow discharge optical emission spectrometry (GDOES), is shown in Table 1, while Figure 1 exhibits the alloy microstructures both in transverse (T) and longitudinal (L) sections.

The alloy CW617N and the dezincification-resistant CW602N evidenced  $\alpha + \beta'$  microstructures (that is mixed face-centered cubic, fcc, and body-centered cubic, bcc) with dispersed Pb globules, but the amounts of  $\beta'$  were quite different, that is  $62 \pm 3\%$  in the former and  $10 \pm 2\%$  in the latter alloy (as calculated by image analysis software). CW724R exhibited about  $40 \pm 2\%$   $\kappa$  phase (grey in color in Figure 1) and balance  $\alpha$  phase (pale pink in Figure 1).  $\kappa$  is a hard Si-rich phase, with close-packed hexagonal (cph) lattice and atomic composition close to the stoichiometry  $\text{Cu}_8\text{Zn}_2\text{Si}$  [8]. In CW724R, SEM-EDS

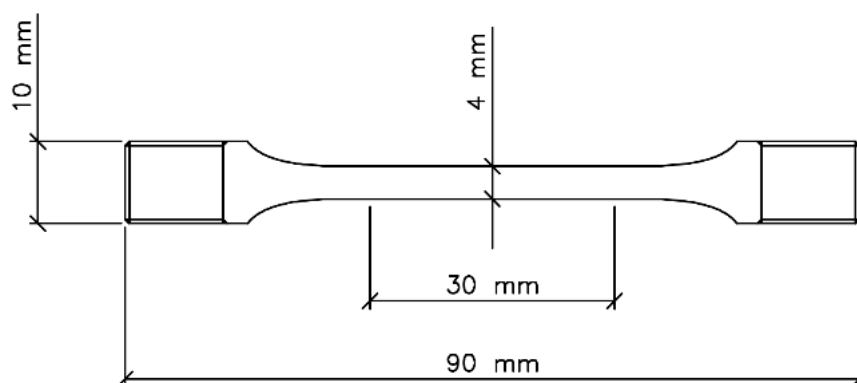
**Figure 2.** Scheme of the tensile specimens adopted in slow strain rate tests (SSRT).

For slow strain rate tests (SSRT), tensile specimens were prepared with an overall length of 90 mm and diameter of the grip sections of 10 mm, while the gauge portion had length and diameter of 30 mm and 4 mm, respectively (Figure 2). The gauge portion of the tensile specimens was ground parallel to the tensile direction down to 1200 grit emery paper, degreased with acetone, and covered by a two-component epoxy varnish leaving an exposed central region of about 3 cm<sup>2</sup>. In these tests, the solution volume was 500 cm<sup>3</sup> and again no stirring was applied.

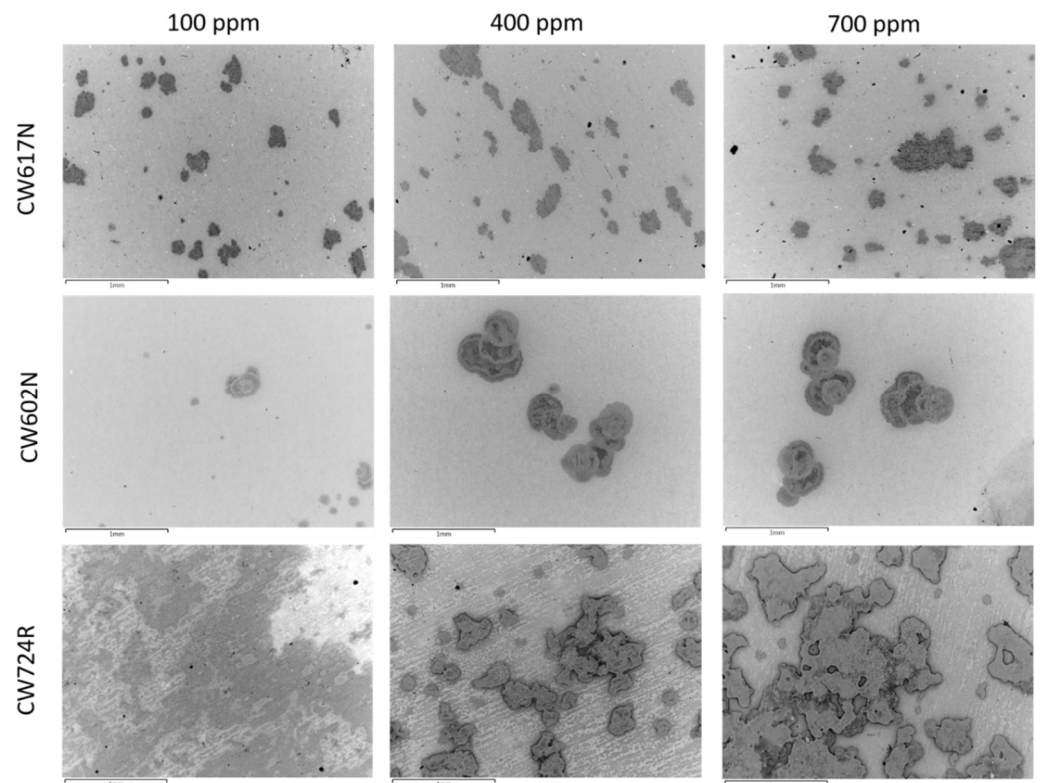
**Figure 3.** BS-SEM images of brass specimens after 24 h immersions in SDW solutions containing different chloride concentrations.

The Figure clearly shows the onset of dealligation spots under all exposure conditions and particularly at high chloride concentrations. This is confirmed in Figure 4 which reports, as an example, the SEM-EDS analyses carried out in correspondence of the dark spots obtained at 700 ppm chlorides. In these regions, a strong zinc (for all alloys) and silicon (in the case of CW724R) depletion is detected.

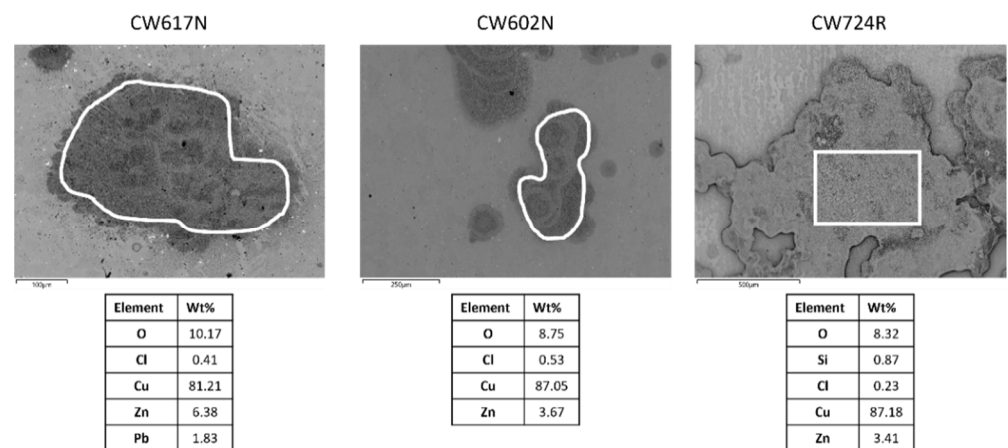
**Figure 4.** SEM-EDS analyses carried out in correspondence of dark spots formed on brasses after 24 h immersions in SDW solutions at 700 ppm chlorides.

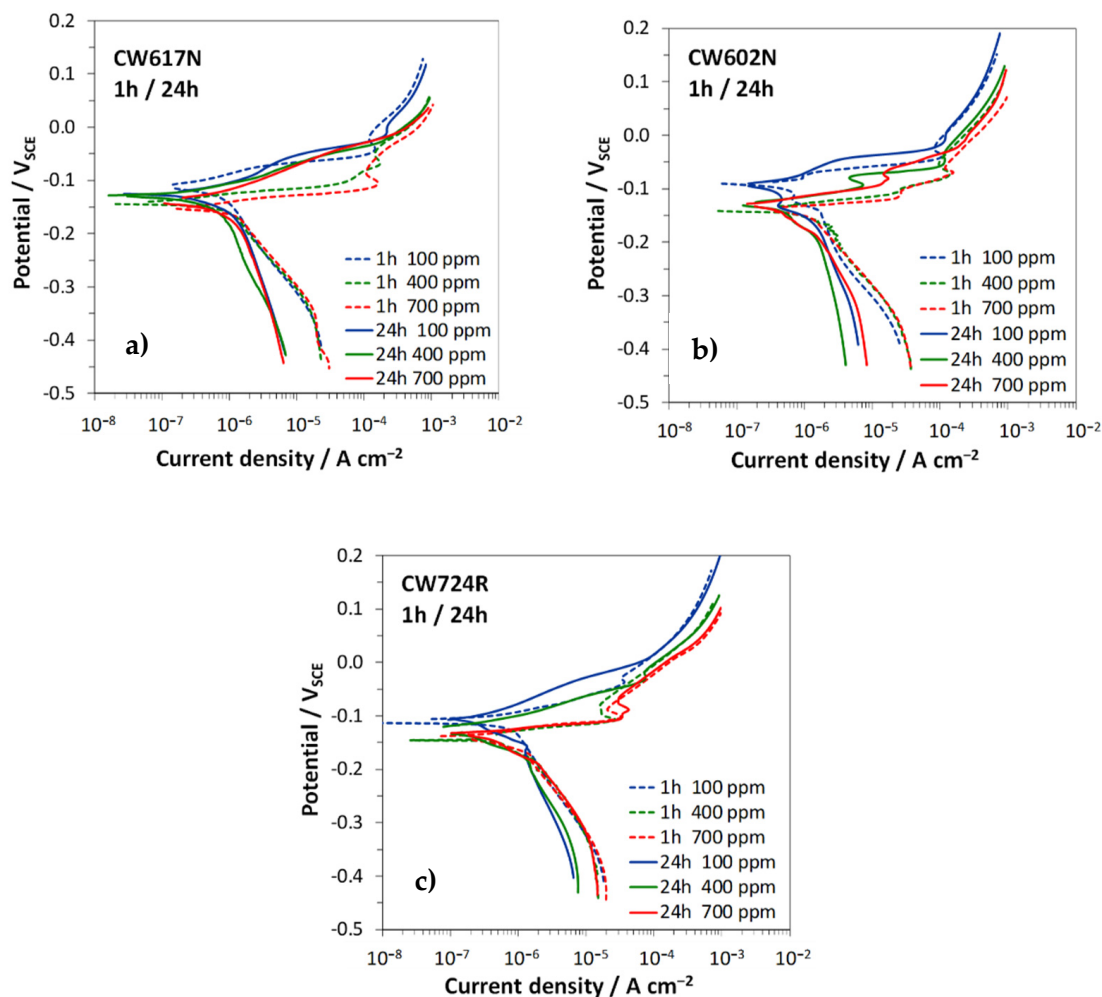
**Figure 5.** Polarization curves recorded on CW617N (a), CW602N (b), and CW724R (c) after 1 h (dashed lines) and 24 h (solid lines) immersion in the SDW solutions, at the three different chloride concentrations.

Figure 5 collects the polarization curves recorded after 1 h and 24 h in SDW with different chloride contents on the investigated brass alloys, while Table 2 collects  $E_{cor}$  and corrosion currents ( $i_{cor}$ ) values, together with the anodic ( $\beta_a$ ) and cathodic ( $\beta_c$ ) Tafel slopes.

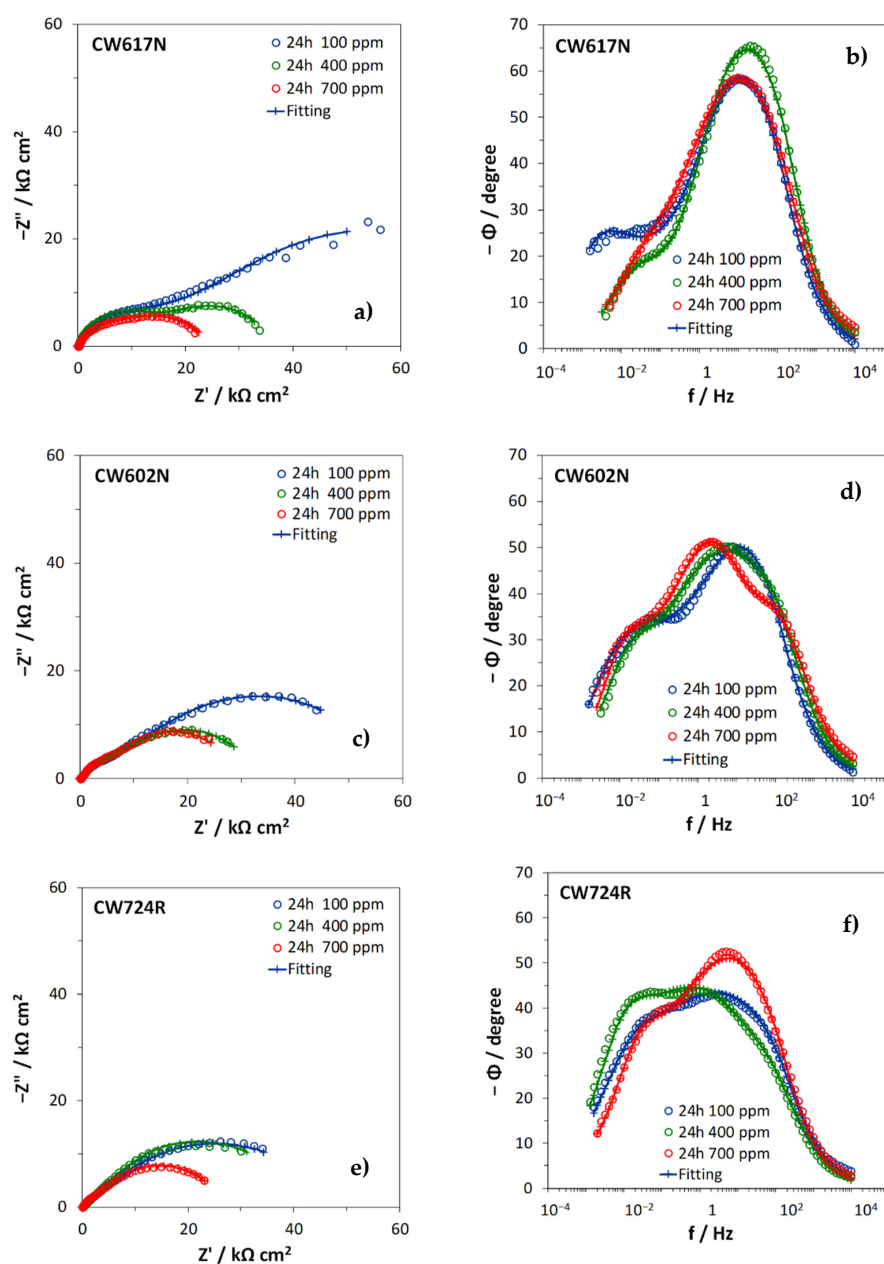
**Figure 6.** EIS spectra recorded on CW617N (a,b), CW602N (c,d), and CW724R (e,f) after 24 h immersion in SDW solutions, at the three different chloride concentrations.

Figure 6 collects the Nyquist and Bode (phase angle) plots of the impedance spectra recorded after 24 h immersion in the different SDW solutions.

The spectra recorded on CW617N at all chloride concentrations and on CW602N at 100 ppm chlorides clearly exhibited two arcs in the Nyquist plots and, in accordance, two peaks in the Bode plots of the phase angle, centered respectively at frequencies of 0.01 Hz or lower (low frequency, LF, time constant) and 1–30 Hz (medium frequency, MF, time constant). One more time constant centered at about 100–150 Hz (high frequency, HF, time constant) occurred in the other spectra (although not always very evident) and was particularly evident on CW602N at 700 ppm.

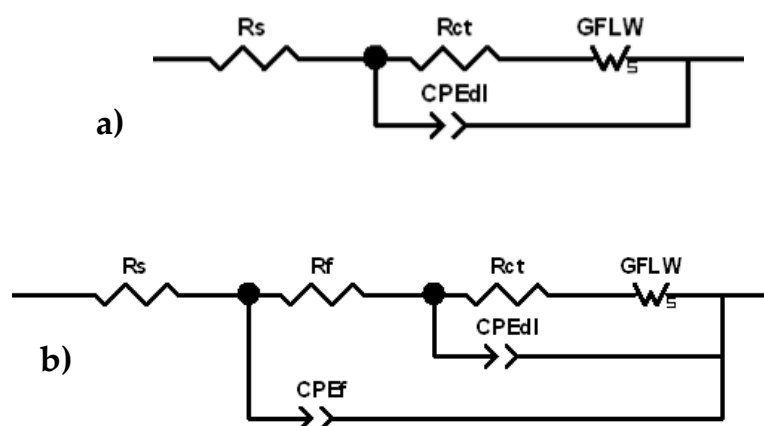
**Figure 7.** Equivalent circuits (EC) used to fit the electrochemical impedance spectroscopy (EIS) spectra: (a) two-time-constant EC; (b) three-time-constant EC.

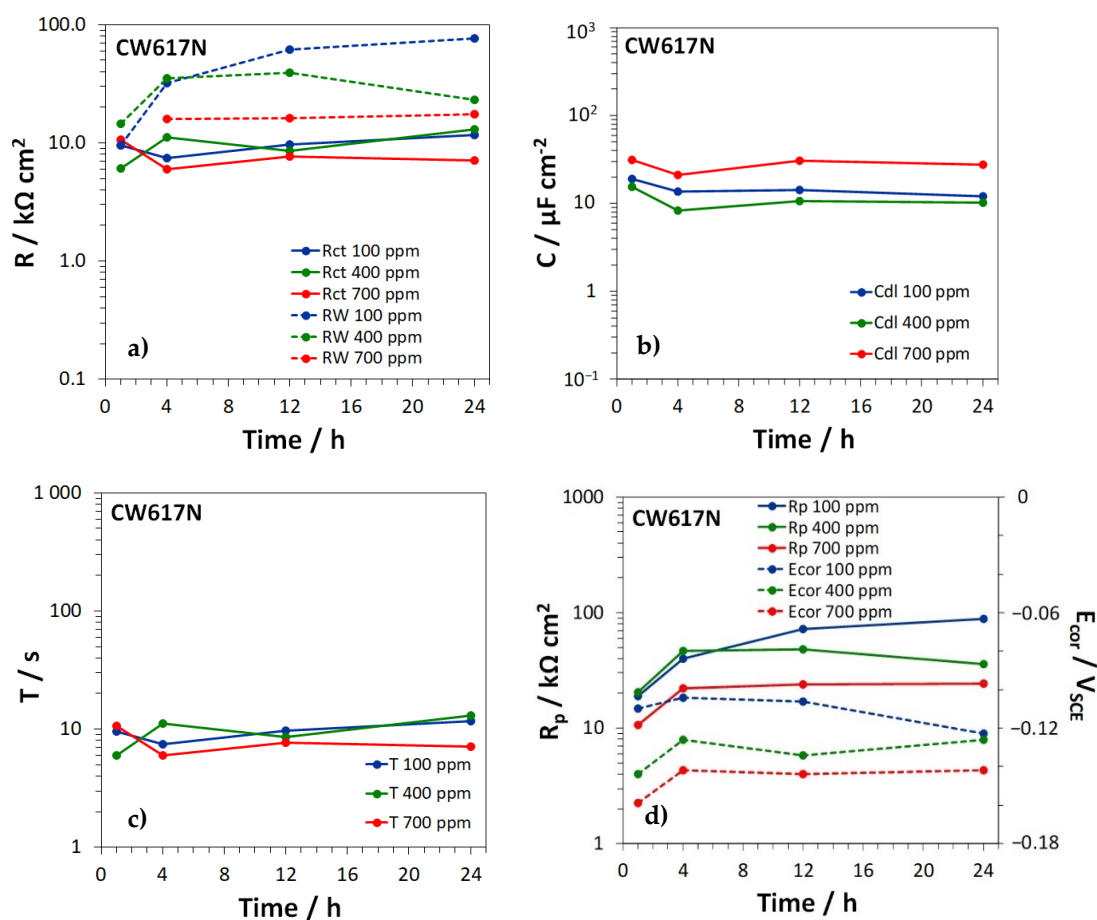
**Figure 8.** Time dependence of (a) the charge transfer and diffusion resistances ( $R_{ct}$  and  $R_W$ ); (b) the double layer capacitance ( $C_{dl}$ ); (c) the  $T$  parameter of the GFLW element; and (d) the polarization resistance ( $R_p$ ) and corrosion potential values ( $E_{cor}$ ), measured on CW617N during the immersion in SDW with three different chloride concentrations.

According to the EIS spectra, no film formed on CW617N (Figure 8a), even if SEM-EDS analyses detected the presence of a surface oxide film on all brass types at all chloride concentrations. This discrepancy was likely due to the relatively high conductivity and thickness of the film on CW617N, which make the film characteristic frequencies higher than those accessible by EIS tests [39]. On the other brasses, oxide films with more or less constant  $R_f$  values of about 1  $\text{k}\Omega \text{ cm}^2$  or lower were detected (Figures 9a and 10a). The corresponding  $C_f$  values were around 10–12  $\mu\text{F cm}^{-2}$  (Figures 9b and 10b), in good agreement with literature information under similar conditions [14,31].

Even  $R_{ct}$  values remained rather constant within the observed time interval (around 10  $\text{k}\Omega \text{ cm}^2$  or slightly lower) and resulted scarcely affected by the chloride concentrations (Figures 8a, 9a and 10a). The corresponding  $C_{dl}$  values (Figures 8b, 9b and 10b) assumed values of 10–100  $\mu\text{F cm}^{-2}$ , again similar to previously achieved ones [14,31]. They were scarcely dependent upon time and often assumed the highest values at the highest chloride concentration, likely due to a more significant chloride adsorption at the metal/solution interface at the bottom of film pores [39].

Figures 8d, 9d and 10d clearly indicate that the  $R_p$  values, which measure the brass corrosion resistance, increased with time and by moving to lower chloride concentrations. These Figures also evidence that the corresponding  $E_{cor}$  values always remained in the range  $-0.160 \div -0.090$  V, with a tendency to ennoblement at decreasing chloride concentration.

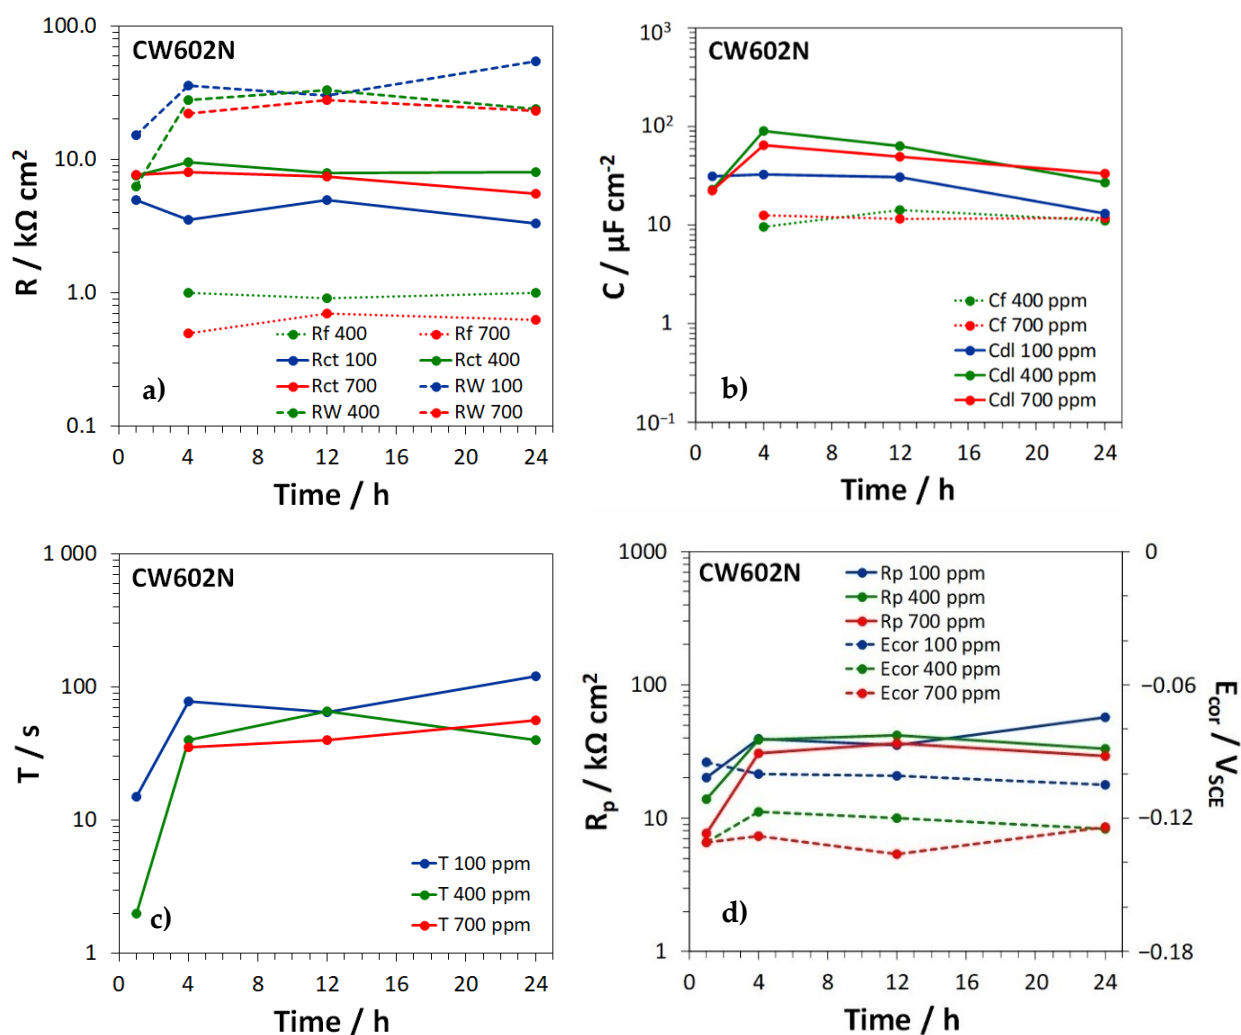
**Figure 9.** Time dependence of (a) the film, charge transfer, and diffusion resistances, ( $R_f$ ,  $R_{ct}$ , and  $R_w$ ); (b) the film and double layer capacitances ( $C_f$  and  $C_{dl}$ ); (c) the  $T$  parameter of the GFLW element; and (d) the polarization resistances ( $R_p$ ) and the corrosion potentials ( $E_{cor}$ ), measured on CW 602N during the immersion in SDW with three different chloride concentrations.

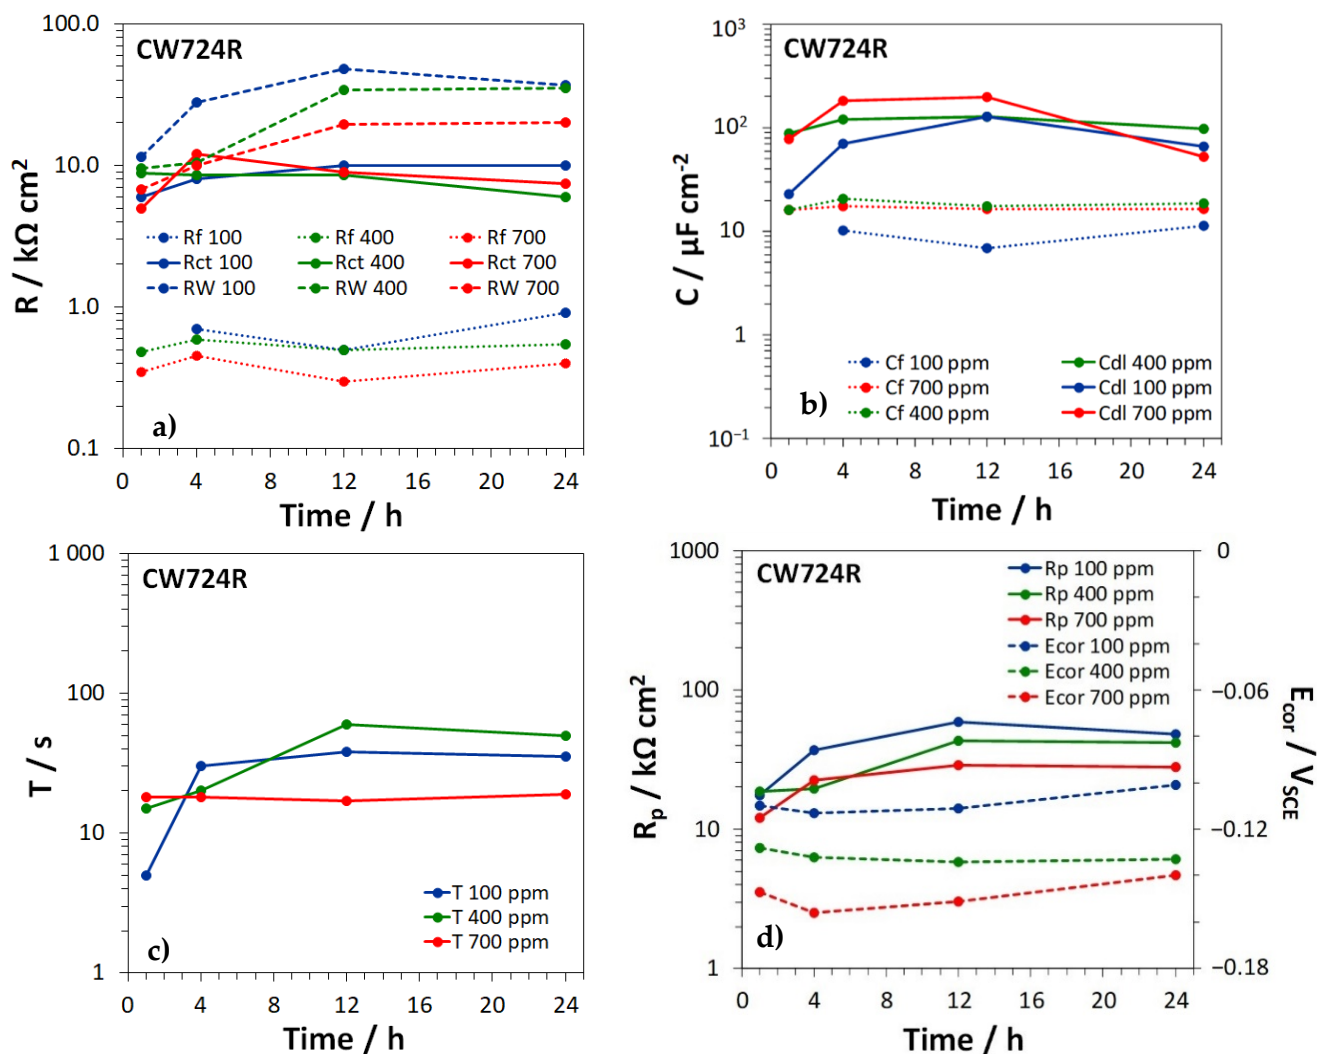
**Figure 10.** Time dependence of (a) the film, charge transfer, and diffusion resistances ( $R_f$ ,  $R_{ct}$ , and  $R_W$ ); (b) the film and double layer capacitances ( $C_f$  and  $C_{dl}$ ); (c) the  $T$  parameter of the GFLW element; and (d) the polarization resistance ( $R_p$ ) and corrosion potential values ( $E_{cor}$ ), measured on CW724R during the immersion in SDW with three different chloride concentrations.

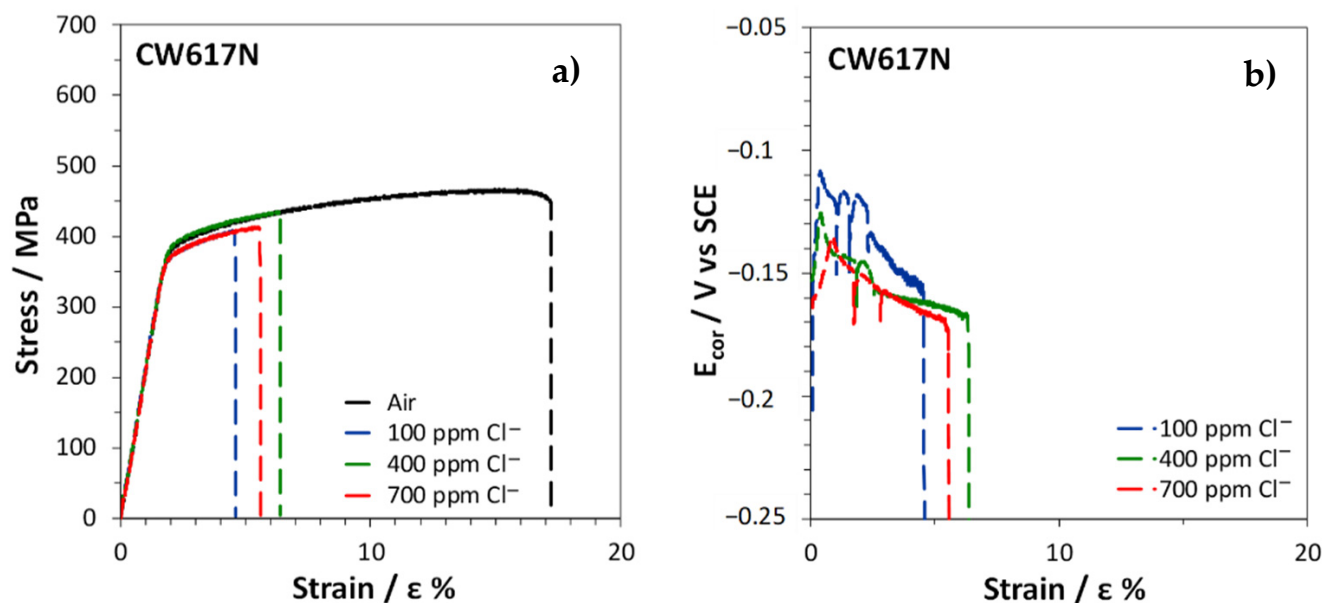
**Figure 11.** SSRT on CW617N: (a) stress vs. strain curves obtained in air and in SDW solutions and (b)  $E_{\text{cor}}$  values recorded in SDW solutions.

The stress–strain curves obtained by SSRT on CW617N exposed to air or immersed in SDW solutions with different chloride concentrations are reported in Figure 11a.

In air, the fracture strain was about 17% (Table 3), suggesting a scarce alloy ductility, due to the high volume fraction of the brittle  $\beta'$  phase. In solutions, an even lower ductility was obtained with fracture strains ranging within  $4 \div 6\%$  (Table 3). The R index, corresponding to the ratio of the fracture strain in solution ( $\epsilon_{\text{fs}}$ ) to that in air ( $\epsilon_{\text{fa}}$ ) was in the range  $0.27 \div 0.37$  (Table 3), indicating a high susceptibility to SCC in these environments. The lowest R value was obtained at the lowest chloride concentration.

The  $E_{\text{cor}}$  values measured on CW617N during the SSRT in SDW solutions decreased with increasing strain (Figure 11b), reaching about  $-0.150 \div -0.170$  V, depending on the chloride concentration in the test solution. The noblest potential values were obtained at the lowest chloride concentration. The progressive  $E_{\text{cor}}$  reactivation suggests a faster anodic dissolution at increasing alloy deformation.

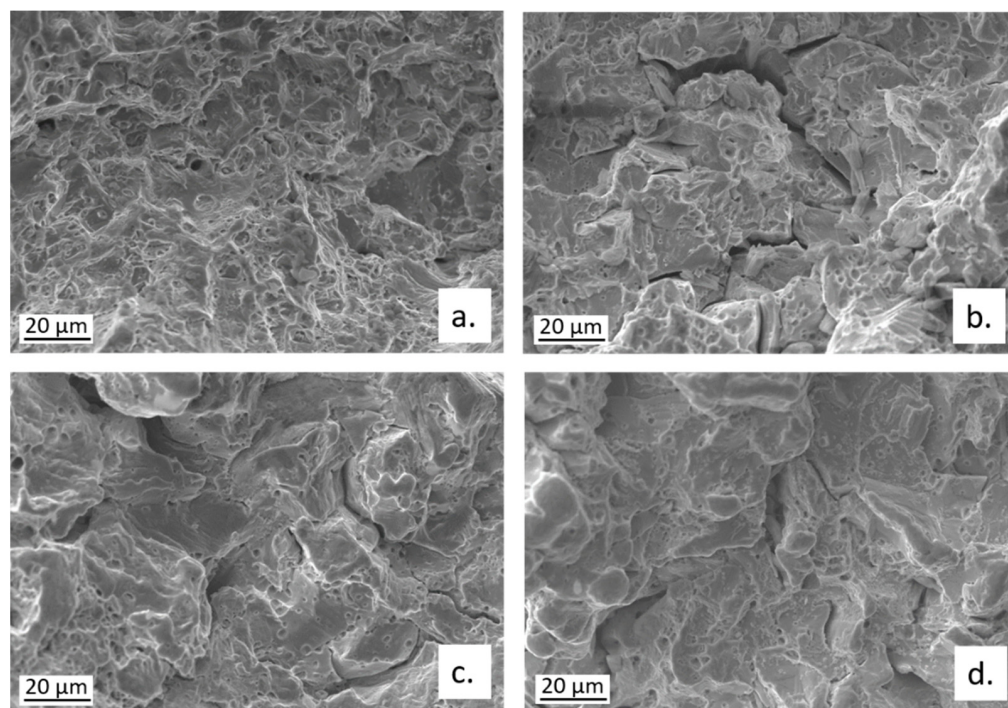
**Figure 12.** Fractographic analysis of CW617N tensile samples after SSRT carried out in (a) air or in SDW solutions containing (b) 100 ppm; (c) 400 ppm; and (d) 700 ppm chlorides.

The fractographic analysis (Figure 12) revealed that the failure occurred through cracks that mainly followed transgranular (TG) paths, even if some intergranular (IG) cracks were also visible.

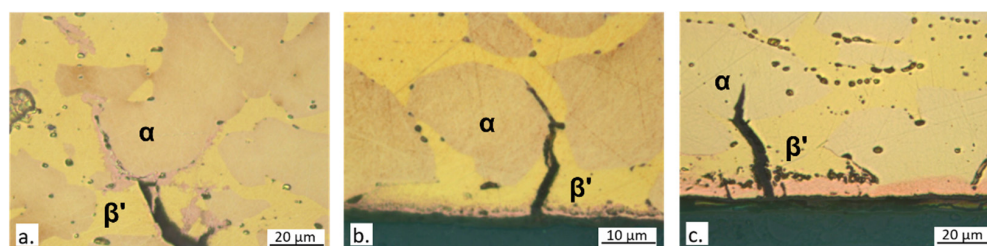
**Figure 13.** Optical micrographs of sections of CW617N specimens after SSRT in SDW solutions containing (a) 100 ppm; (b) 400 ppm; and (c) 700 ppm chlorides.

Figure 13 shows typical secondary cracks observed in longitudinal sections of specimen gauges. Dezincification was always observed suggesting an interaction between SCC and dezincification. At 400 and particularly at 700 ppm chlorides, large macroscopic surface dezincification spots formed and favored crack formation (Figure 13b,c). At 100 ppm chlorides, where SCC susceptibility was highest (Table 3), surface dezincification was less intense, while it was clearly visible inside the cracks and at the crack tips (Figure 13a), producing a brittle film where the stress intensity was maximum. This could have favored crack propagation. Figure 13b also evidences that in CW617N cracks started on the  $\beta'$  phase (more easily dezincified), while  $\alpha$  caused crack deflection and meandering (Figure 13a).

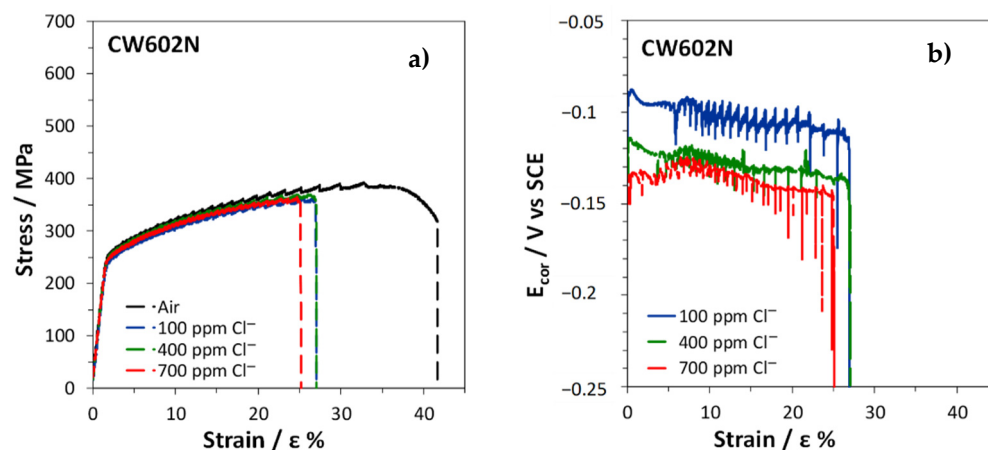
**Figure 14.** SSRT on CW602N: (a) stress vs. strain curves obtained in air and in SDW solutions and (b)  $E_{\text{cor}}$  values recorded in SDW solutions.

Figure 14 shows the stress–strain curves and, in SDW solutions, even the  $E_{cor}$  trends obtained on CW602N tensile specimens during the SSRT. This brass was more ductile than CW617N because in air  $\epsilon_f\%$  reached 47% (Table 3). The significant reduction of  $\epsilon_f\%$  in solutions and the consequently low measured R ratios of  $0.60 \div 0.65$  (Table 3) evidenced that this alloy too is susceptible to SCC, although less than the previous one. The lowest R ratio and therefore the highest SCC susceptibility was achieved in 700 ppm chloride solution.

It is interesting to observe that in both air and solution, jagged stress–strain curves were recorded. This is a mechanical phenomenon known as dynamic strain aging or DSA [40–42]. In the case of  $\alpha$  and  $\alpha + \beta'$  brasses it was attributed to the interaction of mobile dislocations with Zn solute atoms. In fact, Zn atoms are slightly larger than Cu atoms and are attracted by the regions around edge dislocations loaded by tensile stresses, allowing a reduction in the overall alloy elastic energy.

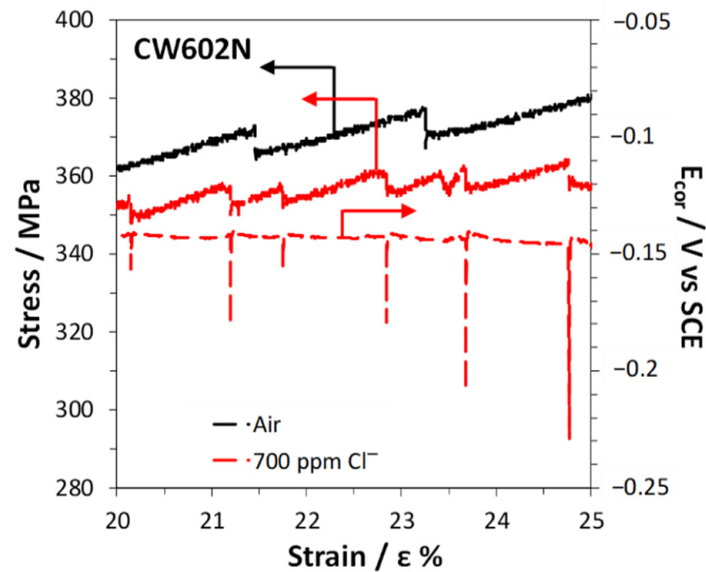
**Figure 15.** Enlarged view of portions of both the stress vs. strain curves obtained in air and in SDW with 700 ppm chlorides on CW602N and the  $E_{cor}$  vs. strain curve of the alloy in the same solution.

In solutions, two observations can be done: (1) the stress drops are concomitant to  $E_{\text{cor}}$  drops and (2) these drops are more frequent than in air (Figure 15). The first observation suggests that in this alloy mechanical slip determines surface film rupture on the alloy, followed by accelerated dissolution at new active sites and, consequently,  $E_{\text{cor}}$  reactivation. Then, fast film healing and  $E_{\text{cor}}$  ennobling occur. The other observation involves a corrosion stimulation of mechanical slip events. This latter phenomenon is not new and was attributed by some authors [20,44] to the formation of pits which can produce stress concentration and can consequently stimulate mechanical slip. Other authors found that dealloying stimulated SCC due to the additive stress produced at the dealloyed brittle film/substrate interface. An additive stress could justify easier mechanical slips [17,21,26], the consequent formation of cracks in the brittle film, and more frequent stress and  $E_{\text{cor}}$  transients.

In solutions, all brasses suffered from SCC in the environments considered and corrosion clearly stimulated mechanical slip events on CW602N (Figure 15) and CW724R. This latter phenomenon can be reasonably interpreted by the dealloying-induced additive tensile stress model, which is compatible with the discontinuity of crack propagation, well evidenced by the presence of concomitant stress and  $E_{\text{cor}}$  drops (Figures 14, 15 and 18). In fact, the alternative enhanced surface diffusivity model of SCC would involve a continuous crack growth due to dealloying, progressive accumulation of surface vacancies, and vacancy diffusion at the crack tips.

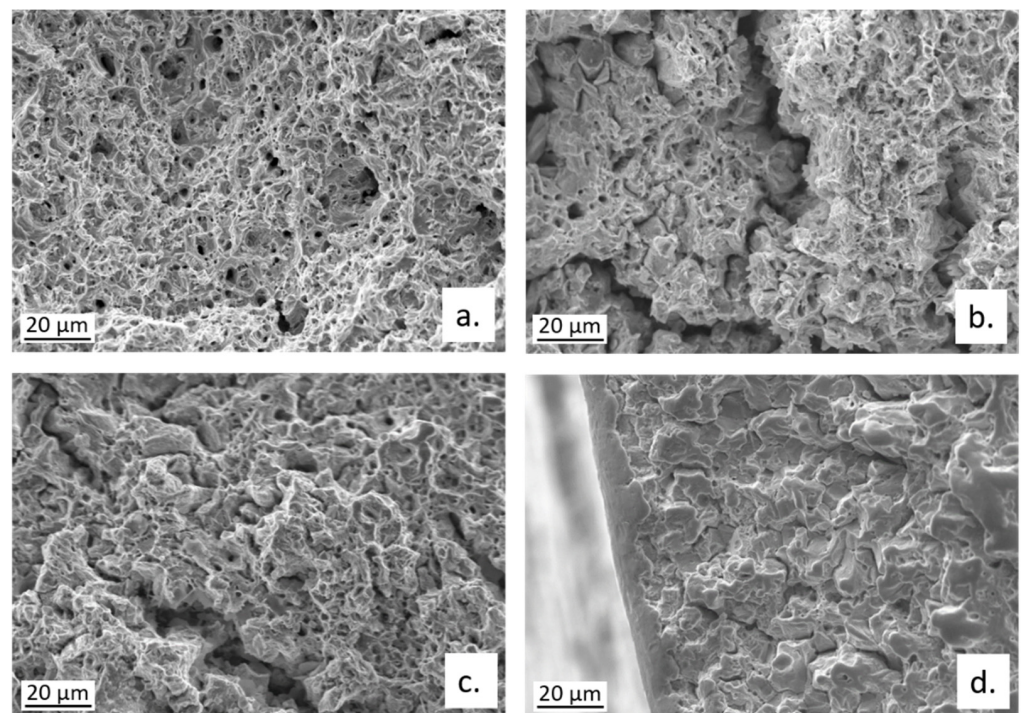
**Figure 16.** Fractographic analysis of CW602N tensile samples after SSRT carried out in (a) air or in SDW solutions containing (b) 100 ppm; (c) 400 ppm; and (d) 700 ppm chlorides.

The fractographic analysis on broken CW602N tensile specimens revealed that the fracture mode moved from ductile to mixed ductile/brittle, on changing the environment for SSRT from air to SDW solutions. In fact, a transition from a ductile dimpled fracture, to fracture surfaces with shallower dimples, associated with some cleavage fracture areas and multiple cracks is documented in Figure 16. The cracks occurred along both TG and IG paths, as also evident in Figure 16a, showing an optical micrograph of a secondary crack section, after microstructural etching.

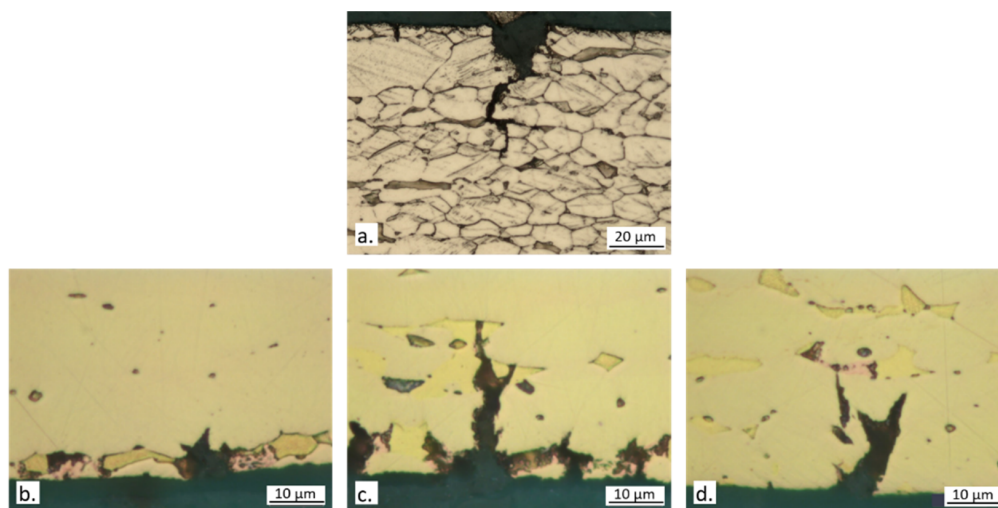
**Figure 17.** Optical micrographs of secondary cracks on CW602N section surfaces after SSRT in SDW solutions containing (a) 400 ppm (surface etching by acid  $\text{FeCl}_3$  solution to evidence grain boundaries); (b) 100 ppm; (c) 400 ppm; and (d) 700 ppm chlorides.

Figure 17a–d collecting optical microscope pictures of secondary cracks appear to support both hypotheses concerning the stimulation of mechanical slip due to corrosion. In fact, cracks often originated from dezincified regions localized on the emerging  $\beta'$  phase (Figure 17b,c) and these localized attacks can lead to the formation of craters (Figure 17a) which can produce stress intensification.

It is interesting to observe that when the cracks cross the  $\beta'$  phase, which is elongated in the longitudinal specimen direction, dezincification and subsequent oxidation of the  $\beta'$  phase ensue, thus determining crack tip blunting and crack deviation (Figure 17c,d). This delays the fracture to higher strains and explains the lower SCC susceptibility of the alloy, in comparison with CW617N. At increasing chloride concentration, dezincification propagated more deeply into the material, causing higher SCC susceptibility.

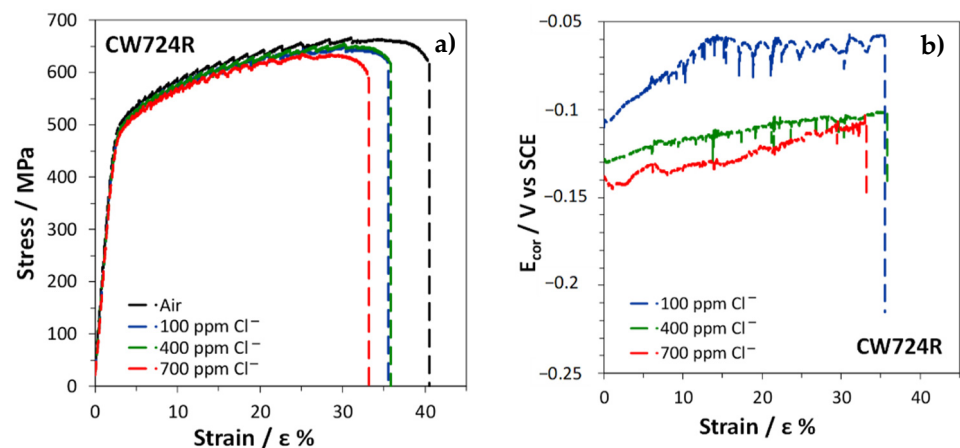
**Figure 18.** SSRT on CW724R: (a) stress vs. strain curves obtained in air and in SDW solutions and (b)  $E_{\text{cor}}$  values recorded in SDW solutions.

Figure 18 collects the stress–strain curves and  $E_{\text{cor}}$  trends obtained on CW724R. It shows that even on this alloy a serrated plastic flow occurs in both air and solutions, although this alloy, like CW617N, contains a high fraction of hard phase ( $\kappa$  in this case) which should reduce or annul the stress drops. Silicon brass actually contains silicon, besides zinc, as a solute atom. The size of silicon atoms is slightly bigger than that of zinc atoms, so it is reasonable that this element produces stronger interactions with dislocations, with consequent increase in stress drops after dislocation unpinning. This could oppose the effect of the high hard phase fraction. The DSA phenomenon has already been observed in fcc, bcc, as well as in hcp structures [45].

The curves in Figure 18a show that CW724R is ductile ( $\epsilon_f\% = 46$  in air) and undergoes limited reductions of  $\epsilon_f\%$  in solution, so that high R values of  $0.82 \div 0.88$  were obtained (Table 3). The lowest value was obtained in 700 ppm chloride solution. In spite of these high R ratios, the presence of multiple secondary cracks on the tensile specimens after SSRT (Figure 19) evidenced that even this alloy underwent SCC at all chloride concentrations and particularly at the highest one.

In contrast to the other investigated brasses,  $E_{\text{cor}}$  values recorded during SSRT (Figure 18b) tended to ennobel at increasing strain. According to some authors [46], this could be due to a noble copper layer redeposited after dezincification. However, it is also possible that on this alloy, where surface silicon tends to form electrically insulating silicates [47], the formation of multiple cracks on the surface film predominantly speeds up the cathodic activity and consequently ennobles  $E_{\text{cor}}$ .

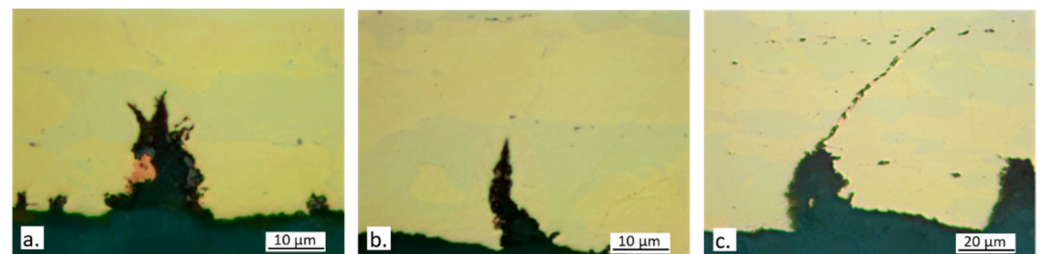
**Figure 19.** Optical micrographs of sections of CW724R specimens after SSRT in SDW solutions containing (a) 100 ppm; (b) 400 ppm; and (c) 700 ppm chlorides.

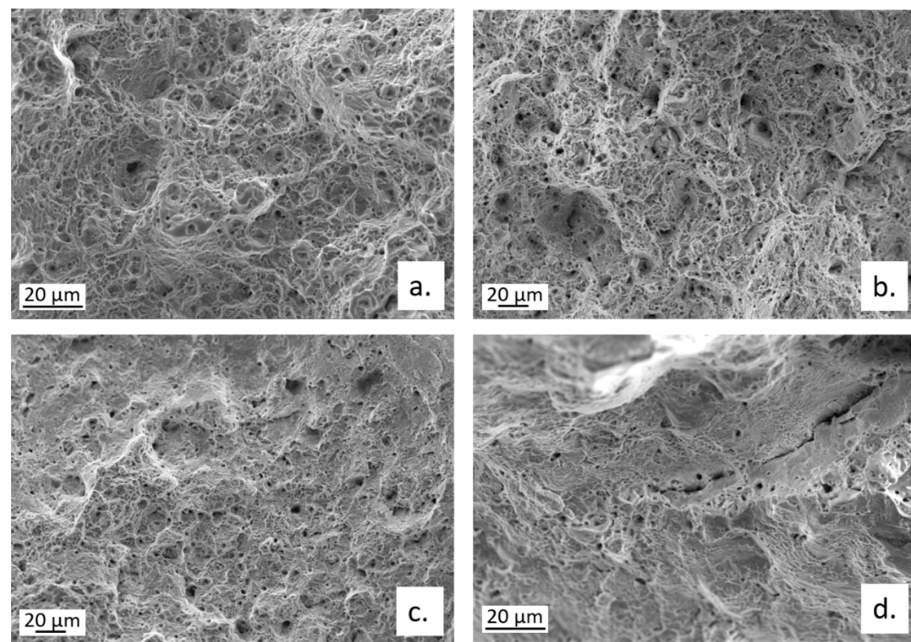
**Figure 20.** Fractographic analysis of CW724R tensile samples after SSRT carried out in (a) air or in SDW solutions containing (b) 100 ppm; (c) 400 ppm; and (d) 700 ppm chlorides.

The fractographic analysis of CW724R specimens revealed the presence of a ductile fracture on the alloy tested in air and a mixed ductile/cleavage fracture in solutions (Figure 20). No evidence of IG cracking was observed.

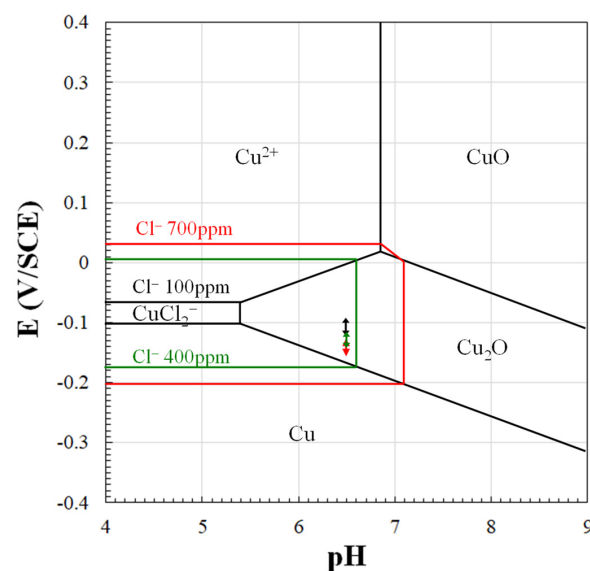
**Figure 21.** Potential-pH diagram for the system  $\text{Cu}-\text{Cl}^--\text{H}_2\text{O}$  at 25 °C for the three different chloride concentrations. The black, green, and red lines delimit the  $\text{CuCl}_2^-$  stability region at 100, 400, and 700 ppm, respectively. The double arrow lines at pH 6.5 show the range of  $E_{\text{cor}}$  variability for the alloys during the 24 h immersion in 100 (black double arrow line), 400 (green double arrow line), or 700 ppm chlorides (black double arrow line). Figure constructed for a total dissolved Cu species activity of  $10^{-6}$  M.

Figure 21 shows the potential-pH diagram for the system  $\text{Cu}/\text{Cl}^-/\text{H}_2\text{O}$ —at 25 °C at the three chloride concentrations of the SDW solutions. In particular, black, green, and red lines respectively delimit the  $\text{CuCl}_2^-$  stability region at the chloride concentration of 100 ppm, 400 ppm, and 700 ppm. In the graph, the black, green, and red double arrow lines evidence the variability ranges of  $E_{\text{cor}}$  for the alloys during the 24 h immersion in SDW solutions (from Figures 8d, 9d and 10d).

The figure evidences that at 100 ppm chlorides on all alloys the formation of a  $\text{Cu}_2\text{O}$  surface film is predicted, due to the reaction:
