# The Biocompatibility and Self-Healing Effect of a Biopolymer's Coating on Zn Alloy for Biomedical Applications

**Abstract:** The objective of this study was to formulate dip coatings, incorporating casein, NaOH, and nanocrystalline hydroxyapatite (nanoHAp), with self-healing properties for application on ZnMg3.2 wt.% alloy in the field of biomedical applications. This study hypothesizes that the self-healing mechanism within the layer will impede substrate degradation by progressively filling defects where chlorides from simulated body fluids intervene. Furthermore, it aims to mitigate potential damage effects during the implantation process by the layer's self-healing capabilities. The research focused on the dip-coating process parameters and chemical composition of baths for producing casein coatings on Zn alloy surfaces. This study investigated the impact of casein and NaOH concentration, along with the immersion time of ZnMg3.2 wt.% samples in the coating bath, on the self-healing capability of the coating under simulated human body fluid conditions (Ringer's solution, temperature: 37 °C). Effective technology was developed by selecting specific chemical compositions and im

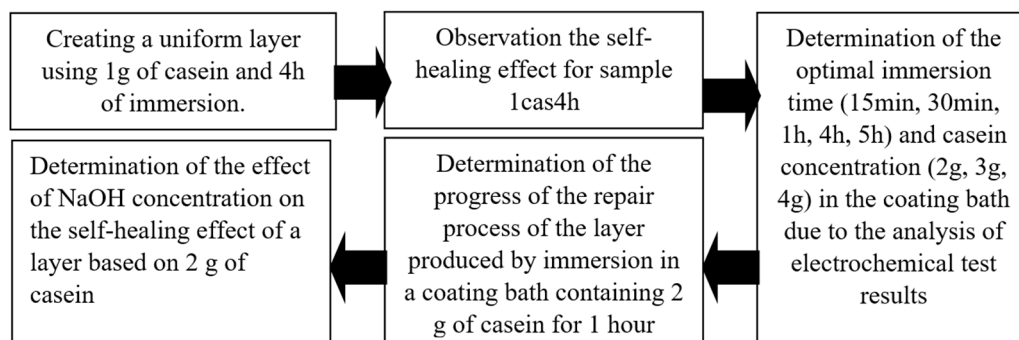
**Figure 1.** The concept and main goals implemented in this study.

In order to determine the most favorable technological conditions to obtain self-healing coatings, the following research plan was devised (Figure 1).

As outlined in the established research plan (Figure 1), protective coatings were generated on the ZnMg3.2 alloy surface using the dip-coating method. This process involved immersing the alloy in solutions with varying concentrations of casein and NaOH (Table 1). In the first stage, the coating was evaluated following a 4 h immersion in a dip-coating batch containing 1 g of casein, denoted as 1cas4h (Figure 3). Morphologically, the coating appears quite uniform, showcasing distinct star-shaped elements dispersed across the entire sample surface.

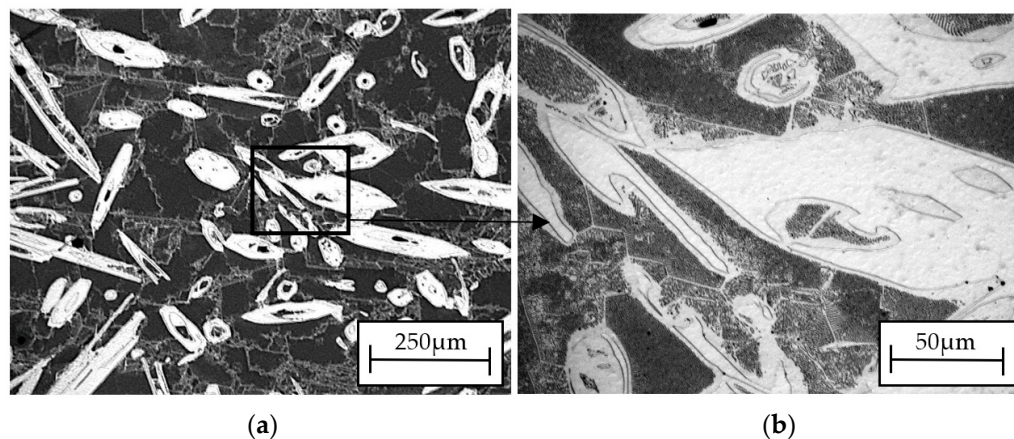
Analysis of the ZnMg3.2 wt.% alloy (shown in Figure 2) revealed a multi-phase composition. As per the Zn-Mg phase system, this composition encompasses MgZn<sub>2</sub> polyhedrons (light) and a Zn + Mg<sub>2</sub>Zn<sub>11</sub> eutectic structure.

**Figure 2.** Structure of ZnMg3.2 wt.% alloy at 25 $\times$  (a) and 100 $\times$  (b) magnification.

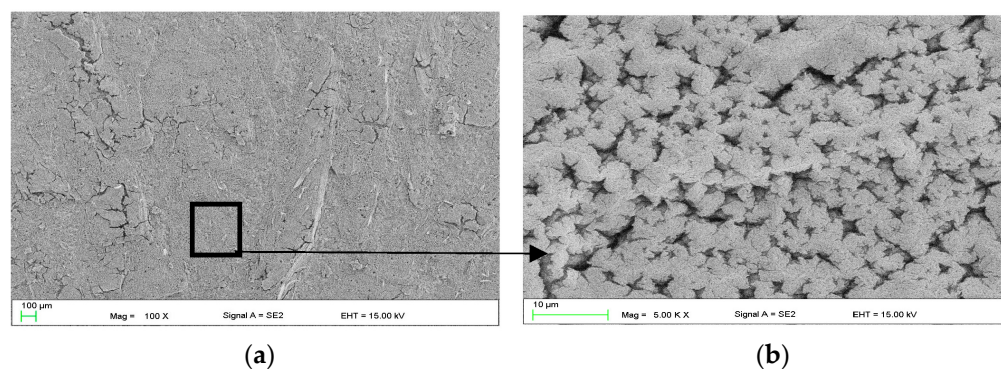
**Figure 3.** SEM images of casein 1cas4h coating with NanoHAp addition showing surface morphology (a) where star-shaped elements may be distinguished at higher magnification (b).

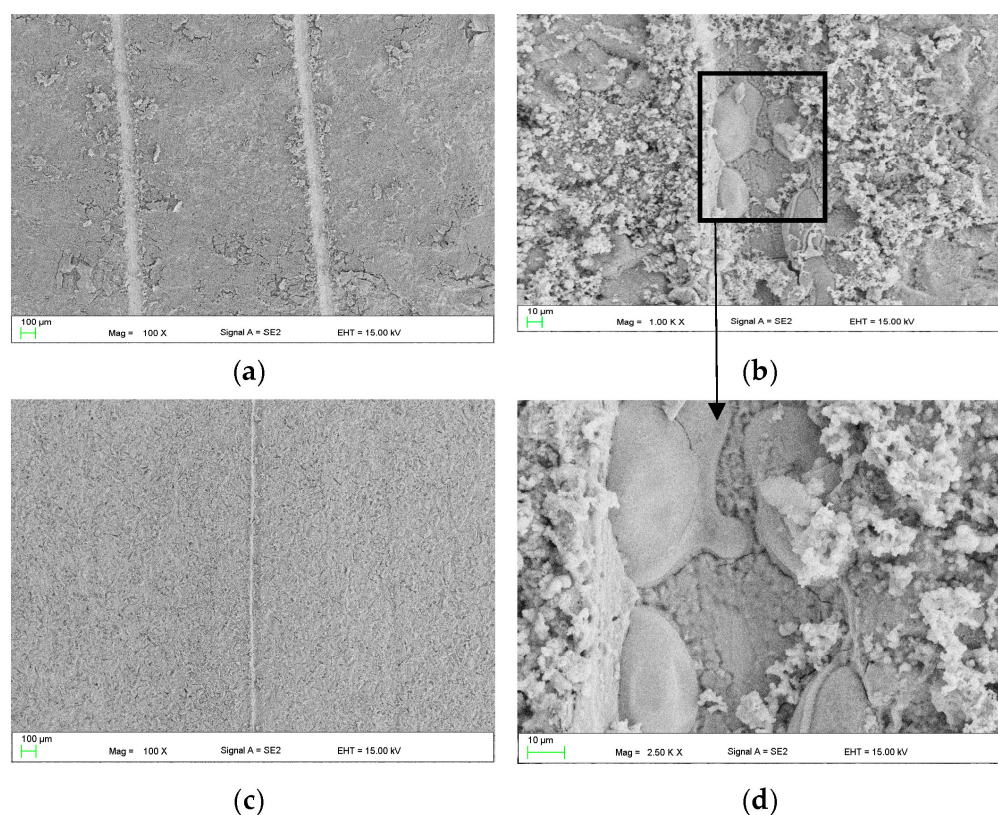
Then, the self-healing effect of the coating was assessed. A scratch was made on the 1cas4h sample (Figure 4a). At the edges of the scratch, deformation of the coating and traces of the blade in the middle part of the scratch are visible. A sample with a 1cas4h coating with a scratch was immersed in Ringer's solution for 1 h, shown in Figure 4b. In order to determine the degree of “repair” of the coating, morphological changes in the area of the intentionally made scratch were examined. SEM observations revealed that the morphology of the scratch surface has changed. The blade traces in the central part of the scratch are invisible. In addition, conglomerates similar to fragments of the shell morphology were observed (Figure 4b). The area with a round-like element is marked in the black frame, suggesting the beginning of the “repair” process of coating.

**Figure 4.** SEM images casein coating with scratch before (a) and after (b–d) immersion in Ringer's solution at 37 °C of 1cas4h.

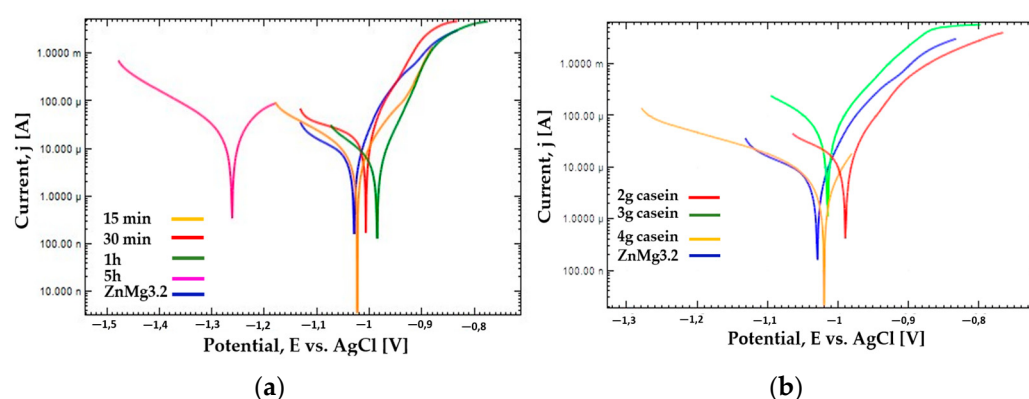
Next, the potentiodynamic corrosion test in Ringer's solution at 37 °C was performed in order to determine favorable immersion time and casein concentration in the dip-coating baths. Varied concentrations of casein in the coating bath were tested (2 g, 3 g, and 4 g), according to Table 1. The best results were obtained for coatings deposited in bath containing 2 g of casein and 6 g NaOH. For such a concentration of casein (2 g) in the bath, coatings were made for different immersion times in the dip-coating process, i.e., 15 min, 30 min, 1 h and 5 h (samples 2cas15, 2cas30, 2cas1h, 2cas5h). Figure 4 presents the potentiodynamic polarization curves for coatings with 2 g casein addition and varied dip coating immersion time (Figure 5a), and coatings obtained with varied casein addition for the process lasting 1 h (Figure 5b). The potentiodynamic curves of the samples immersed in the coating bath for 15 min, 30 min, and 1 h (Figure 5a) in comparison to the uncoated substrate shift towards positive potentials. Increasing the immersion time to 5 h is unfavorable because the potentiodynamic curve has shifted towards negative potentials compared to the uncoated substrate. Therefore, the optimal immersion time was 1 h of immersion in the coating bath, because the determined potentiodynamic curve shifted most significantly to positive potential values among the tested samples. The potentiodynamic curves of samples submerged in a coating bath containing casein concentrations of 3 g and 4 g (Figure 5b) exhibit a higher potential position to that of the uncoated substrate. Reducing the casein concentration to 2 g is the most favorable because the potentiodynamic curve has shifted toward positive potentials compared to the uncoated substrate.

**Figure 5.** Potentiodynamic curves in Ringer's Solution at 37 °C for uncoated substrate and samples coated with different immersion times (a) and different concentrations of casein (b) in the coating bath.

The  $V_{corr}$ ,  $j_{corr}$  determined from the Tafel analysis is the lowest for samples immersed in a bath with a concentration of 2 g of casein and immersion time in the bath for 1 h. Immersing a Zn alloy sample in a coating bath for 5 h and 30 min is the least advantageous because the values of corrosion current density, polarization resistance and corrosion rate are closest to those values corresponding to the uncoated substrate. The position of the potentiodynamic curves for 5 h and 30 min also indicates low corrosion resistance because they are in a high current range on both the anode and cathode sides compared to the rest of the curves. Similarly, the curves determined for samples immersed for 1 h in a bath with a concentration of 3 g of casein are characterized by the lowest value of polarization resistance and the highest values of corrosion rate and corrosion current density among coated samples, which indicates low corrosion resistance. The position of the potentiodynamic curve determined for the sample coated in a bath with a concentration of 3 g of casein indicates the highest current values on both the anodic and cathodic sides among the tested samples.

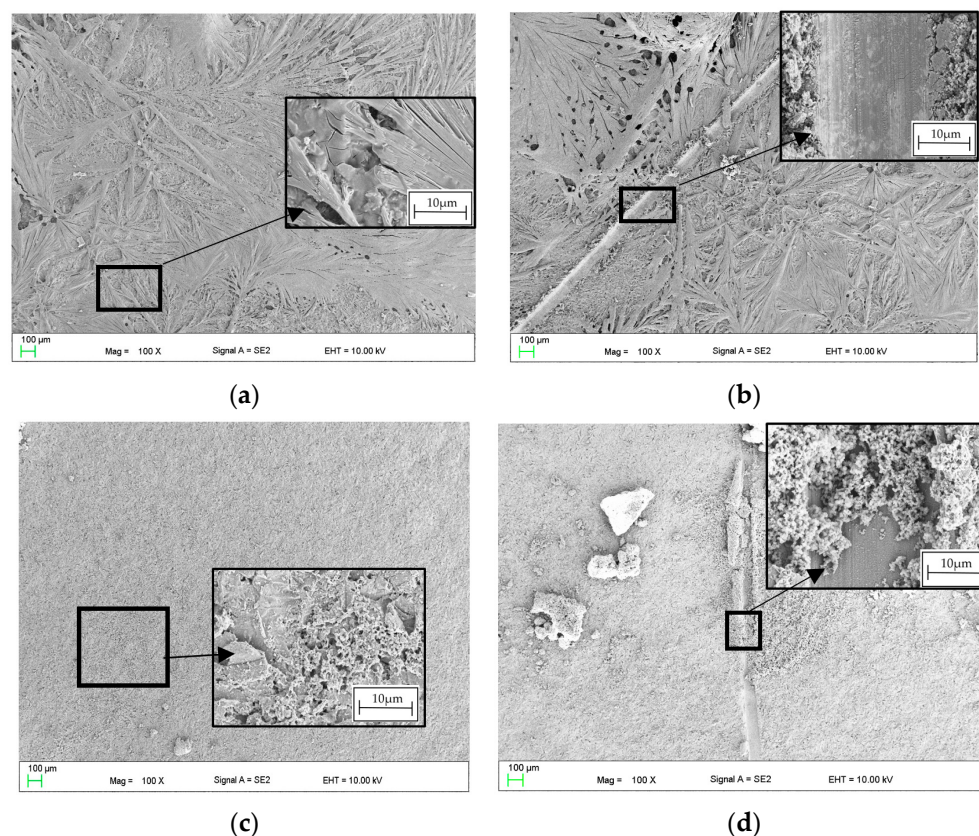
**Figure 6.** SEM images of casein coating marked as 2cas1h: (a,b) before and (c,d) after immersion for 1 h in Ringer's solution at 37 °C.

The coating's morphology is defined by crystal-like branches that create a cohesive layer on the surface of the substrate (Figure 6a). The scratch evident in Figure 6b displays blade traces in the center and coating deformation at the edges. After an hour-long im-

mersion in Ringer's solution at 37 °C, the casein layer in Figure 6c exhibits enhanced surface development. Notably, within the scratch area in Figure 6d, there is an almost “repaired” appearance, featuring elements resembling the structure of the coating found outside the scratched region. To assess the impact of NaOH concentration on the self-healing capabilities of the 2 g casein-based layer, coating baths were formulated with 2 g NaOH (2naoh2cas) and 4 g NaOH (4noah2cas). Subsequently, samples were immersed in these baths for 1 h. Following drying, the coated samples underwent a 1 h immersion in Ringer's solution at 37 °C. The observed outcomes regarding the self-healing effect of the layer after this hour-long immersion in Ringer's solution are presented in Figure 7. Lowering the concentration to 2 g of NaOH (Figure 7a,b) in the coating bath does not produce the self-healing effect. No notable indications suggestive of the layer self-repairing were observed. Conversely, a layer formed in a bath with 4 g of NaOH exhibits significantly improved self-healing effects. Distinctive overhangs and even “ribs” connecting both edges of the crack (Figure 7c,d) are visible, likely resulting from material sourced from the coating and subsequent reaction with the solution.

Therefore, microscopic examinations were conducted to observe morphological alterations in the region where the intentionally scratched coating made with 2 g of casein addition (2cas1h) was submerged in Ringer's solution (Figure 6).

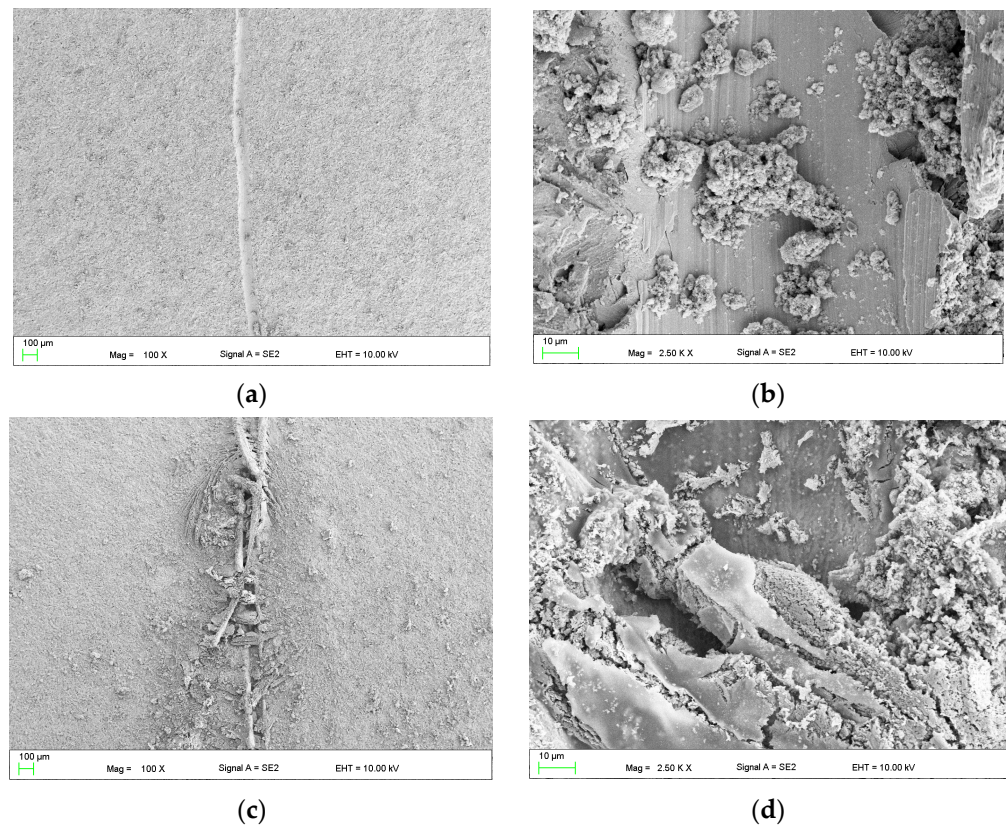
**Figure 7.** SEM images of casein coating marked as 2naoh2cas (a,b) and 4naoh2cas (c,d) after 1 h of immersion in Ringer's solution at 37 °C.

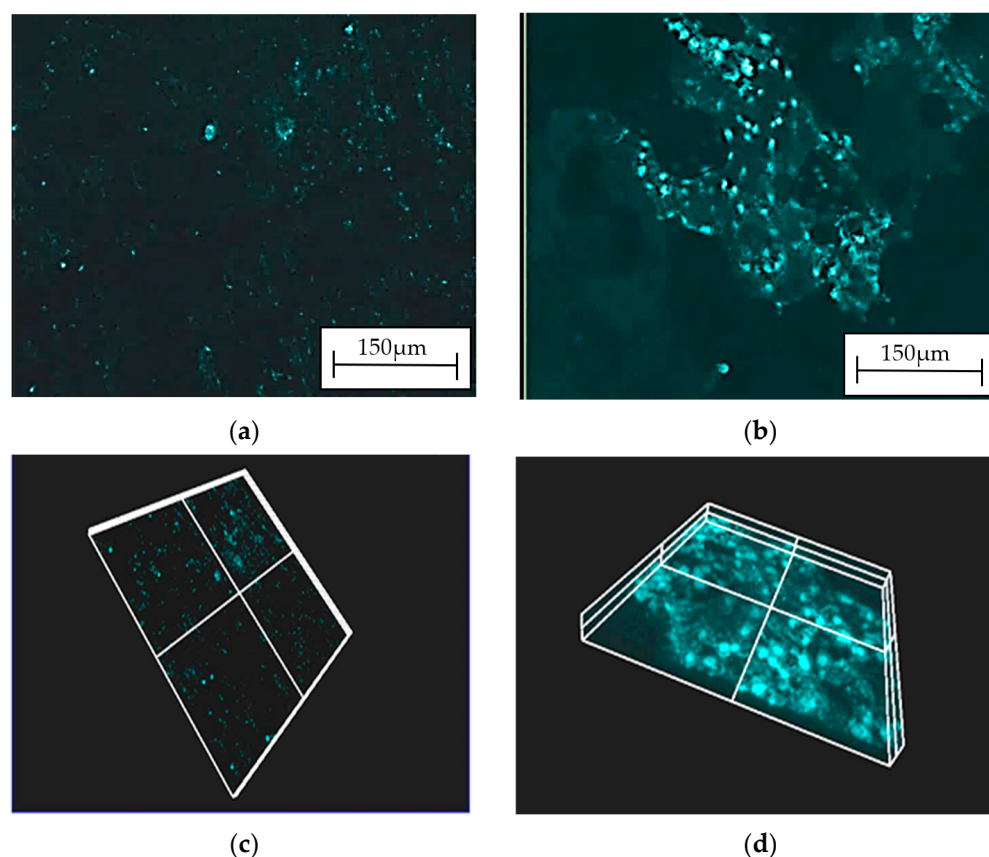
**Figure 8.** Confocal images of U2OS cells with DAPI-stained nucleus after 7 days of incubation on casein-based layer (2cas1h) on tested materials: ZnMg3.2 alloy (a); casein coating (2cas1h) (b). Additional 3D visualization from Immaris software (Bitplane Scientific Software; version 10.0.0; Olympus, Zurich, Switzerland) for ZnMg3.2 alloy (c), casein coating (2cas1h) (d).

Optimal cellular adhesion and proliferation for U2OS osteosarcoma cells were observed after 7 days of incubation on a casein coating (2cas1h) (Figure 8b,d). This signifies that the alloy surface, when covered by the casein layer, significantly enhances cell adhesion. In contrast, uncoated ZnMg3.2 alloy exhibits notably poor cell survival (Figure 8a,c). Cells struggled to proliferate on this substrate due to its surface, which does not support optimal adhesion for this specific cell line (U2OS being an adherent cell type).

The biocompatibility of the produced casein-based coatings was evaluated through a biocompatibility assay conducted with osteosarcoma cells (Figure 8).

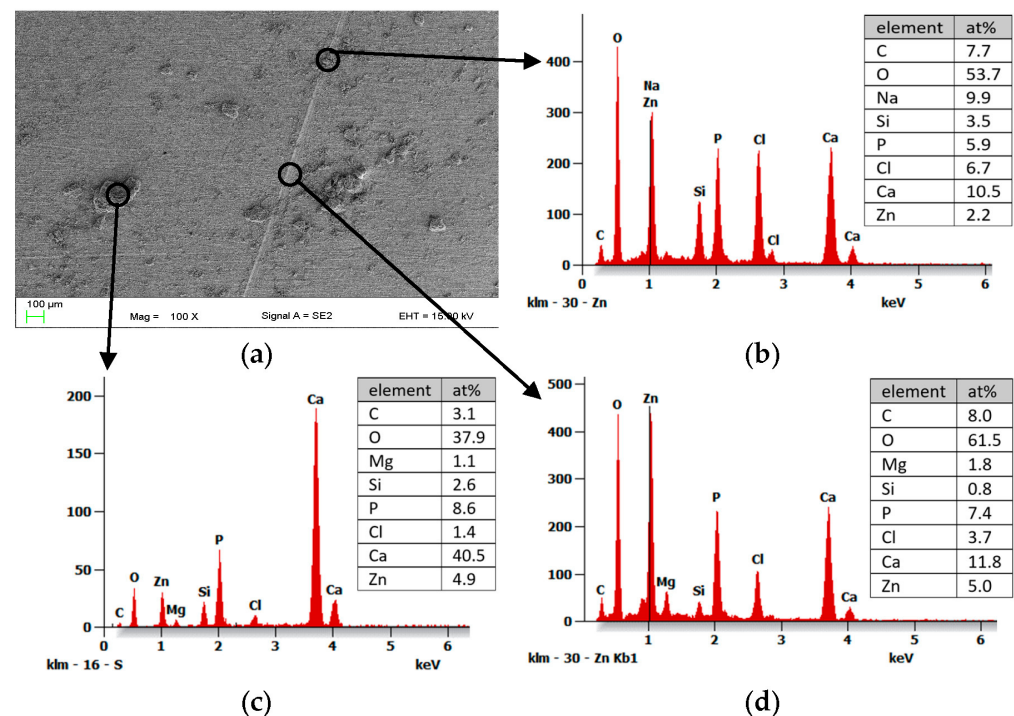
**Figure 9.** Results of EDS chemical composition tests of a sample 2cas1h without sandblasting after an hour of immersion in Ringer's Solution at 37 °C. The analyzed surface area (a) and chemical composition of specific microregions (b–d).

In the location of the scratch, along with visible agglomerates on the edges and in the middle (Figure 9b), P, and Ca, which contains hydroxyapatite in its composition, were detected. In turn, the presence of chlorine most likely comes from the Ringer solution. Silicon is rather an impurity from the dip-coating process or constituent elements. The result of EDS analysis also indicated the presence of a large amount of zinc (Zn), which comes from the substrate and to a large extent may also come from zinc oxide, which is a transformation product of  $\text{Zn}(\text{OH})_2$  produced in chloride environments [10]. The clusters visible in the coating are probably coagulated nanoHAp powder, judging by the high peak from Ca (Figure 9c). The EDS result shown in Figure 9d, in turn, is from the crack area in which there are no such significant coagulations and agglomerates. The presence of analogous elements, as those observed in the EDS data from Figure 9b, was identified. With the exception of one sample, the presence of magnesium (Mg) was detected. Additionally, the zinc (Zn) peak appeared notably higher. This may indicate an uncovered substrate, uncoated or partially coated. Another potential explanation for the presence of magnesium (Mg) in the EDS results could be the existence of a eutectic or another structural phase within this specific area of the substrate.

In order (Figure 9) to examine the qualitative chemical composition of the elements found in the scratch area after an hour of immersion in Ringer's solution, tests were carried out using an EDS analyzer on a sample with a casein coating, but without a sand-blasted substrate.

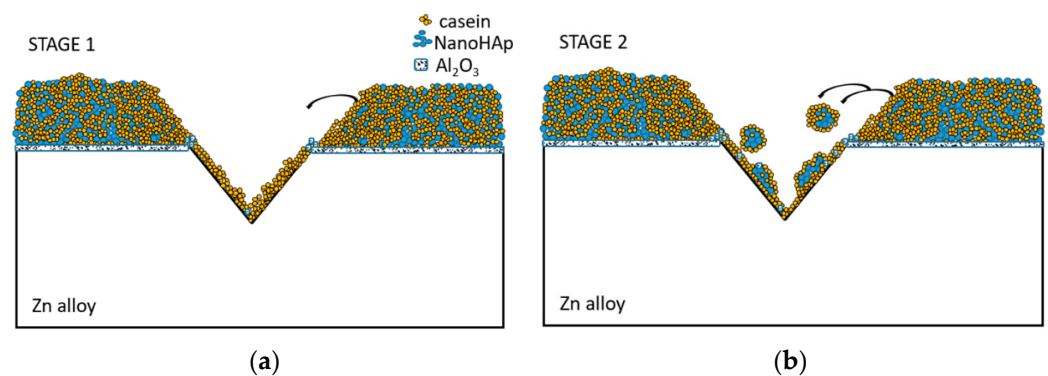
Based on the findings of this study, it can be concluded that there is a self-healing effect observed in the casein-based layers. The mechanism of this phenomenon is presented graphically in Figure 10. This study's results reveal a two-stage self-healing mechanism observed in the casein-based layers investigated. The first stage likely involves the hydrolysis of casein, resulting in its infiltration into the scratch. This is observable as round elements within the scratched area and overhangs along the scratch's edges. Stage 2 involves the migration of nanoHAp particles, bound within the casein, toward the scratched area. This process leads to the formation of "ribs" that connect the edges of the scratch. Both stages probably occur simultaneously, only to a different extent, in different scratch areas. It seems that nanoHAp particles play two roles: as a component of the self-healing layer and as a reservoir of casein as a healing agent. On the other hand, casein also has two roles: as a component of the healing film and as a courier of nanoHAp molecules

as healing ingredients. Therefore, these materials play complementary roles, making the nanoHAp-casein coating self-healing.

**Figure 10.** The proposal of stages of the casein-nanoHAp self-healing effect in the first stage (a) and second stage (b).

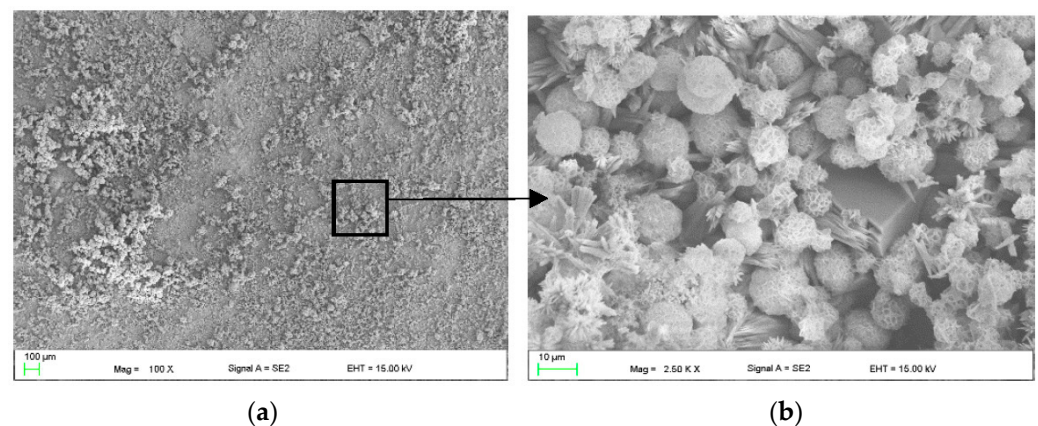
The sample with the 2cas1h coating was immersed for a week in Ringer's Solution at a temperature of 37 °C (Figure 11). Both spherical and irregular elements form a very tight layer of corrosion products. (Figure 11b).

**Figure 11.** SEM images of casein 2cas1h sample after one week immersion in Ringer's solution at 37 °C showing surface covered with corrosion products (a), where spherical and irregular forms compose a very tight layer of corrosion products (b)
