Article

Drinking Water Security Challenges in Rohingya Refugee Camps of Cox's Bazar, Bangladesh

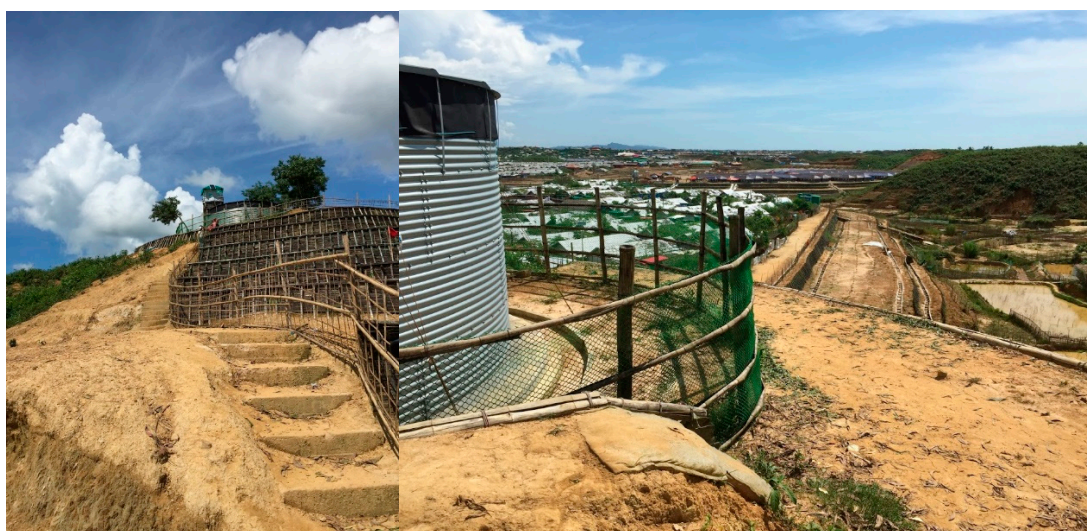
Figure 2. Water supply tank in Camp 4Ext, October 2019, Credit: SMN Uddin.

Camps 2E and Camp 2W have 352 and 299 functional water points respectively, with 65 and 63 people per water point respectively [64]. Camp 4Ext has 47 functional water points, with 126 people using per point [64]. The ratio of people to functional water points abides by the standard level. Overall, the most common source of drinking water was tube wells, as reported by 77% of the households combined. This is the main source in Camp 2, with 97% collecting water from tube wells and only 3% from both tube wells and tap stands. The source in Camp 4Ext is a combination of tube wells (30%), tap stand (46.6%), and both tube wells and tap stand (23.3%). Figure 2 shows a water supply tank in Camp 4Ext.

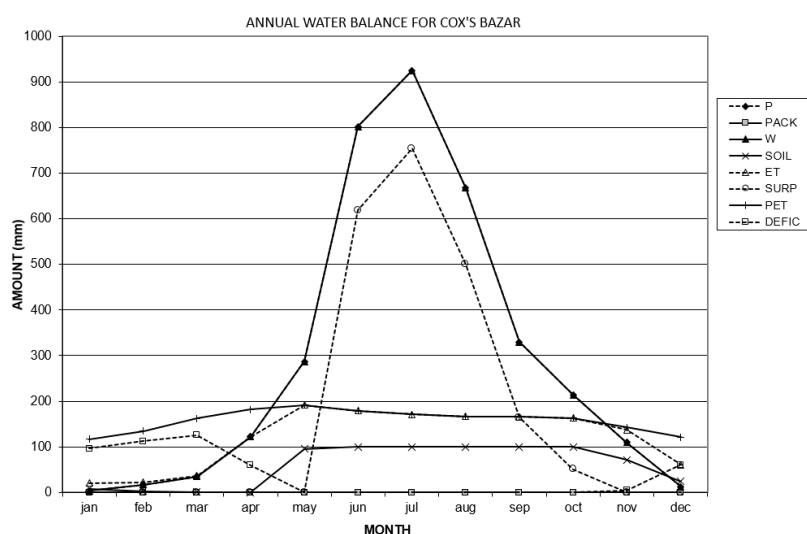
Figure 3. Monthly Water Balance Graph of Cox's Bazar using average monthly temperature and precipitation from 1981–2010, constructed using the Thornthwaite Water Balance Model.

Climate trends heavily influence water source availability in refugee camps. As shown in Figure 3, in Cox's Bazar, the water deficit is lowest from May to November and highest between January and March. Potential evapotranspiration (PET) and evapotranspiration (ET) are highest around May, and total water (W) due to precipitation is highest around July. Soil moisture content (SOIL) is lowest from January to April but it is slightly higher and constant from May to December and is dependent on W. Hence when W is higher than PET and ET, there is a surplus of water, and thus an increased SOIL. The water surplus is highest in July and the lowest from November to April. A high PET/ET and a low W, which usually is the trend during the summer seasons, accounts for the water deficit, which is highest in March. This climate trend explains why 26% of the households felt that water sources were unavailable during the summer. Overall, however, most households (74%) reported source availability round the year.
