Article

Impact of Green Stormwater Infrastructure Age and Type on Water Quality

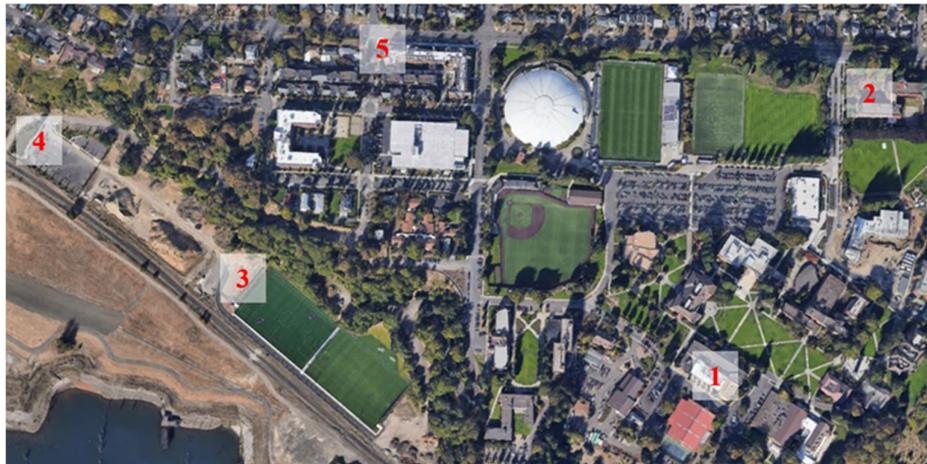
Figure 1. Sampling sites. 1 = Bioswale, 2 = Infiltration Basin, 3 = Bioretention Planter, 4 = Bioretention Basin, 5 = Bioretention Curb Extension (aerial photo source: Google.com).

All GSI systems are located at the University of Portland (Figure 1). Each system has vegetation, mulch, an 18-inch soil layer consisting of 60% sandy loam and 40% compost, and a 12-inch gravel drainage layer. Stormwater infiltrates directly to the native soil below. All systems are maintained by the University of Portland facilities department, which includes annual vegetation pruning. The main differences between each site are the amount of stormwater that is treated, GSI size, and the date of installation. A summary of the site characteristics is shown in Table 1 below.

The results of the ANOVA analysis are shown in Table 3. Numbers correspond to the GSI locations in Figure 1 and are identified in Tables 1 and 2. Significant differences in water quality were observed between the GSI sites.

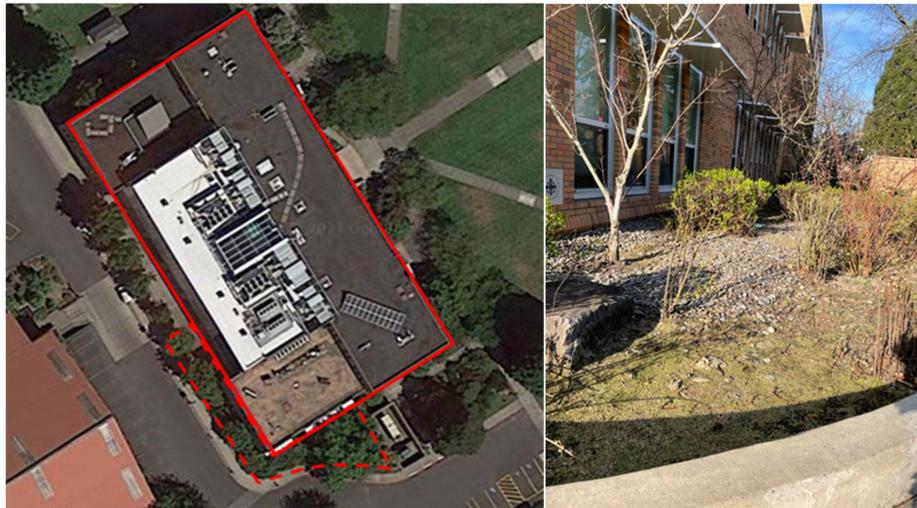
The bioswale wraps around Shiley Hall on the southeast corner of the University of Portland (Figure 2). Runoff from the roof of Shiley Hall drains into the bioswale and infiltrates through the soil or flows into dry well drains located in the bioswale. The roof consists of a 520 m² built-up membrane roof and a 256 m² green roof. The bioswale is designed to treat and convey the water quality design storm (6-month, 24 h storm) for the City of Portland. Vegetation includes *Cornus sericea* (red-twig dogwood), *Acer circinatum* (vine maple), *Rosa nutkana* (nootka rose), and *Buddleja davidii* (butterfly bush).

Figure 2. Bioswale adjacent to Shiley Hall. The solid red line indicates the catchment area, and the dashed line indicates the surface area of the bioswale (aerial photo source: Google.com).

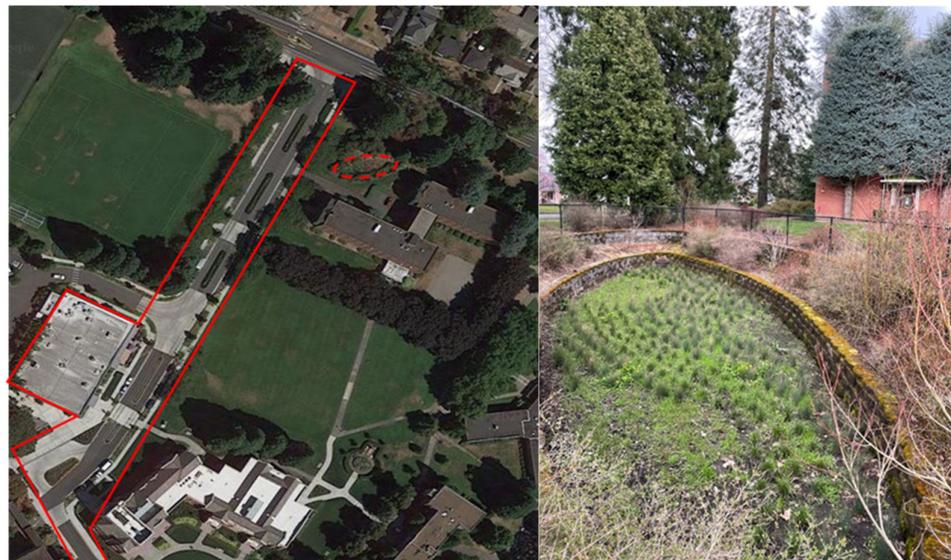
The infiltration basin is adjacent to Shipstad Hall on the northeast corner of the University of Portland (Figure 3). It has a flat bottom with structural walls supporting the basin. Stormwater runoff is collected from the adjacent streets and buildings into a catch basin that drains to the infiltration basin. The infiltration basin is designed to collect and infiltrate the 10-year storm, with an overflow structure for higher flows. Vegetation is primarily *Juncus effuses* (soft rush).

Figure 3. Infiltration Basin. The solid red line indicates the catchment area, and the dashed line indicates the surface area of the bioswale (aerial photo source: Google.com).

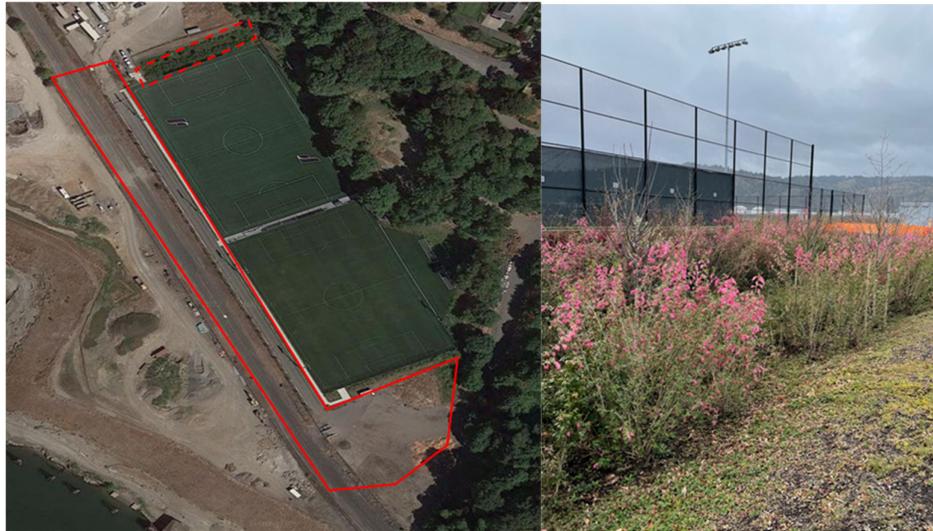
The bioretention planter is adjacent to the soccer fields on the northwest corner of the University of Portland (Figure 4). Stormwater runoff is collected from the adjacent street and parking lot, and it discharges into the planters. The bioretention planters are designed to treat and convey the water quality design storm (6-month, 24 h storm) for the City of Portland, with an overflow structure for larger storms that conveys runoff to the

Figure 4. Bioretention Planter. The solid red line indicates the catchment area, and the dashed line indicates the surface area of the bioswale (aerial photo source: Google.com).

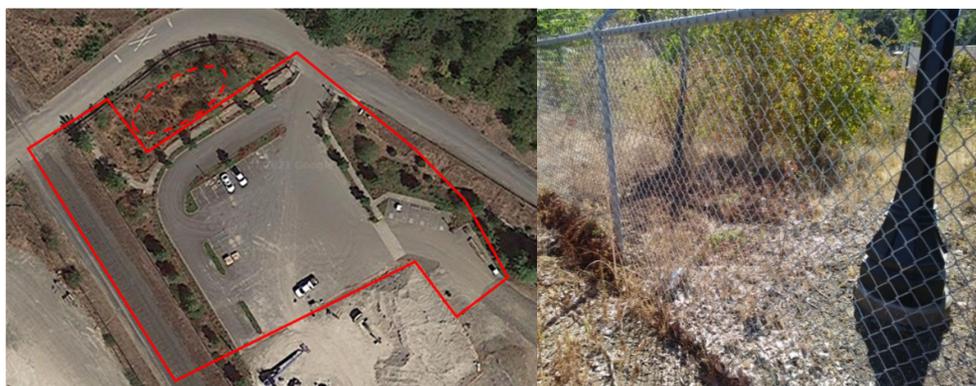
The bioretention basin, adjacent to North Van Houten Place, is located on the north-western corner of the University of Portland (Figure 5). Stormwater runoff is collected from the adjacent parking lot and discharges into the basin. The bioretention basin is designed to treat and convey the water quality design storm (6-month, 24 h storm) for the City of Portland, with an overflow structure for larger storms that conveys runoff to the Willamette River. Vegetation includes *Mahonia aquifolium* (Oregon grape), *Buddleja davidii* (butterfly bush), *Ribes sanguineum* (red flowering currant), *Populus trichocarpa* (black cottonwood), and *Lupinus bicolor* (bicolor lupine).

Figure 5. Bioretention Basin. The solid red line indicates the catchment area, and the dashed line indicates the surface area of the bioswale (aerial photo source: Google.com).

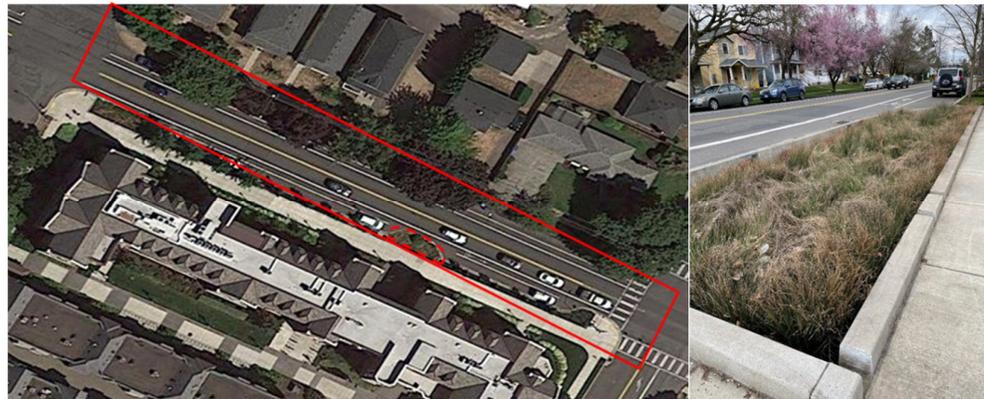
The bioretention curb extension, adjacent to North Willamette Boulevard, is located on the northern corner of the University of Portland (Figure 6). Stormwater runoff is collected from the adjacent street and sidewalk, which discharges into the cell. The bioretention basin is designed to treat and convey the water quality design storm (6-month, 24 h

Figure 6. Bioretention Curb Extension. The solid red line indicates the catchment area, and the dashed line indicates the surface area of the bioswale (aerial photo source: Google.com).

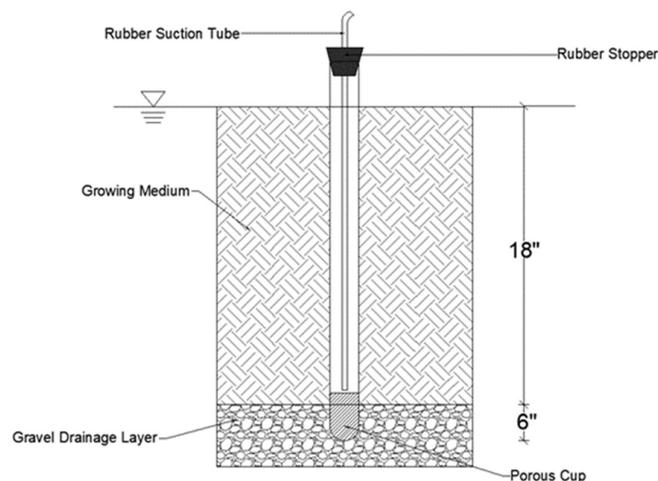
Samples were collected from each site using lysimeters at the bottom of the soil layer. A 1.2 m (4 ft) long agricultural soil auger (AMS) with a 10.2 cm (4 in) diameter mud type core was used to remove soil to install the lysimeter. The lysimeter was placed at approximately 0.6 m (2 ft) or until the AMS reached the gravel layer. The cored soil was used to backfill the voids created and was necessary to ensure the structural stability of the lysimeter. The lysimeter was composed of a 2-inch plastic tube with a porous cup on the end, a suction tube that ran the length of the 2-inch plastic tube, and a rubber stopper on top. Figure 7 shows the general installation of the lysimeter at each site. These samples represent soil water after water has infiltrated through the soil medium. Although not technically effluent, it provides an indication of the runoff water quality that will infiltrate to the native soil.

Figure 7. Soil lysimeter setup.

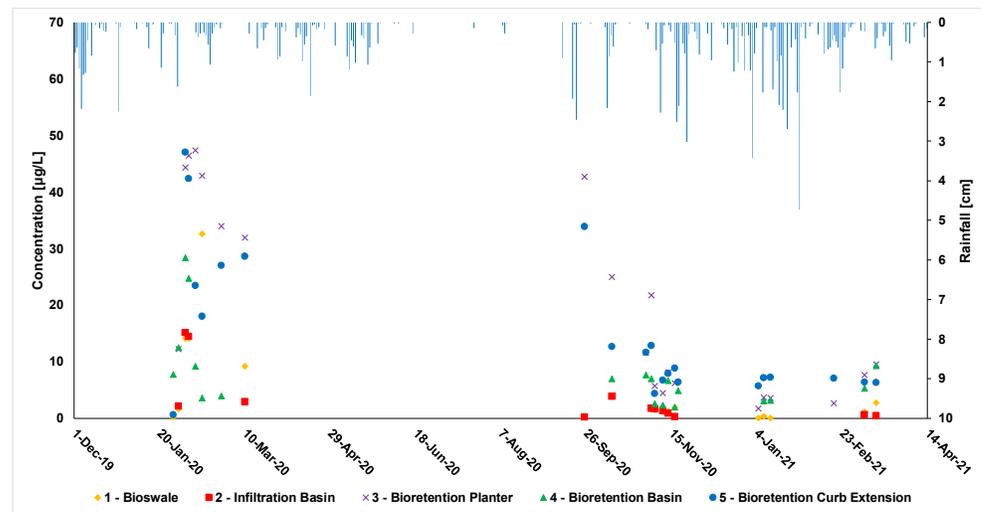
Figure 8 shows Cu concentrations at each GSI site during the sampling period. Copper concentrations in the soil water were significantly higher ($p < 0.01$) in the bioretention planter and bioretention curb extension compared to the other GSI types, and they were significantly higher in the bioretention basin compared to the infiltration basin. Higher Cu concentrations in the soil water may be due to age; the bioretention planter, bioretention curb extension, and bioretention basin were installed 2, 5, and 6 years ago, respectively. In general, Cu concentrations in older systems were lower than the average stormwater concentrations from the NSQD. The highest Cu concentration was observed in the bioretention planter, which is the newest GSI system. However, results do not consistently indicate higher concentrations in newly established GSI systems. Other impacts, such as sources and catchment area/surface area ratios may impact Cu concentrations. The bioretention curb extension receives runoff from a very busy roadway near a traffic light. This may increase the Cu deposition from brake pads. All other systems receive runoff from roofs, parking lots, and roadways with significantly less traffic. In addition, the bioretention curb extension is $\approx 5\times$ smaller than the bioretention basin and bioretention planter and the catchment area/surface area ratio is higher, which may reduce removal efficacy.

Figure 8. Copper concentrations at each GSI site during the sampling period. Rainfall data are from the weather station located at Astor Elementary School (<https://or.water.usgs.gov/precip/astor.rain>, accessed 1 April 2021).

Copper concentrations in the soil water appear to decrease over the sampling period, particularly for the newly established GSI systems (bioretention planter, bioretention basin, and bioretention curb extension). Copper concentrations in soil water from the bioswale and infiltration basin are relatively consistent, except for a brief increase in February 2020. This may be due to additional sources or flushing of Cu, although more investigation would be needed to verify this.

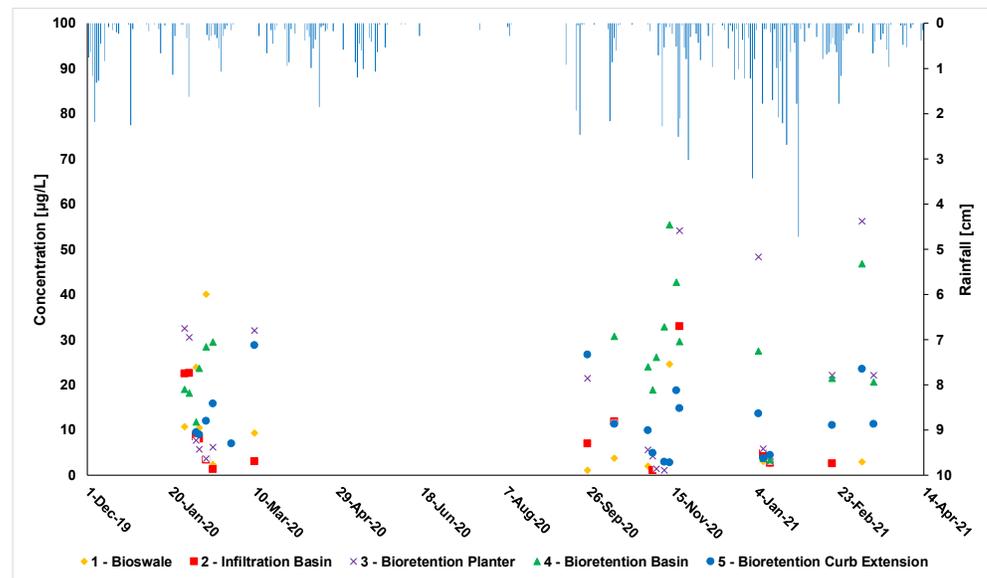
Figure 9 shows Zn concentrations at each GSI site during the sampling period. Zinc concentrations in the soil water were significantly higher ($p < 0.05$) in the bioretention basin and bioretention planter compared to the bioswale and infiltration basin. Zinc concentrations were also significantly higher in the bioretention basin compared to the bioretention curb extension. The bioretention basin and bioretention planters are the newest GSI systems, indicating that age may play a role in zinc removal. Zinc concentrations were statistically the same in the newest GSI sites (bioretention planter and bioretention basin). The bioretention planter was installed 2 years ago, and the bioretention basin was installed 5 years ago. Other impacts such as sources may impact Zn concentrations. High Zn concentrations in the bioretention basin may be due to the steel railroad tracks adjacent to the bioretention basin, which is part of the drainage area. The catchment/surface area ratio does not appear to impact Zn concentrations; the bioswale has the lowest catchment/surface area ratio (8.1) and the infiltration basin has the highest catchment/surface area ratio (46.8). It is likely that the lower concentrations in these GSI types are due to age and sources. The bioswale receives runoff from a green roof and regular roof, and the infiltration basin receives runoff from roofs and campus streets. Zinc concentrations were lower in all GSI types compared to the average stormwater concentrations from the NSQD.

Figure 9. Zinc concentrations at each GSI site during the sampling period. Rainfall data are from the weather station located at Astor Elementary School (<https://or.water.usgs.gov/precip/astor.rain>, accessed 1 April 2021).

Zinc concentrations in the soil water of all GSI types were relatively consistent over the sampling period. There are a few brief increases in Zn concentrations, but no general trend. These brief increases may be due to additional sources or flushing of Zn, although more investigation would be needed to verify this.

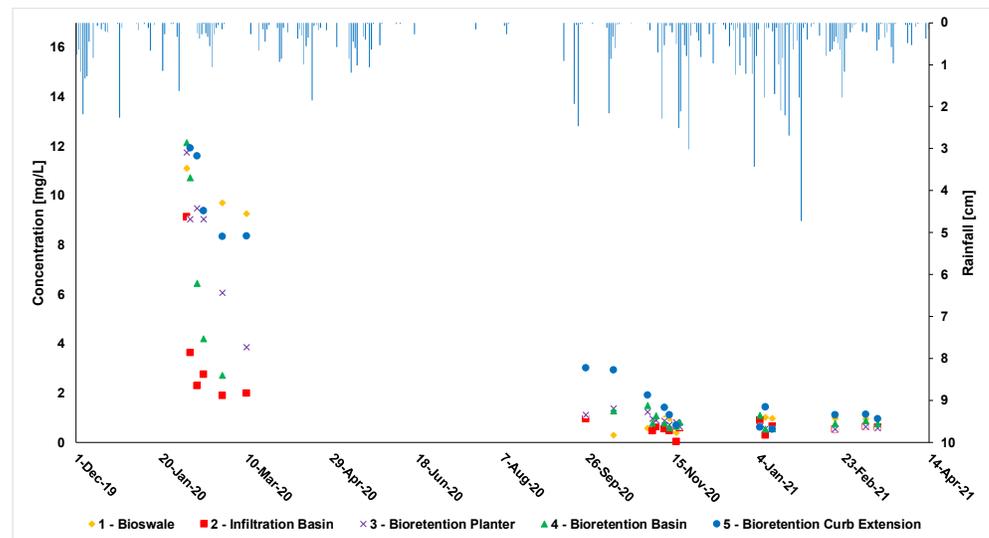
Figure 10 shows PO_4^{3-} concentrations at each GSI site during the sampling period. Phosphate concentrations in the soil water were significantly lower ($p < 0.05$) in the infiltration basin compared to the bioretention curb extension. Phosphate concentrations were statistically the same for all other GSI sites. The trends observed with copper and zinc, where older systems tended to have lower copper and zinc concentrations, were not observed with PO_4^{3-} . Catchment area/surface area ratios also did not appear to impact PO_4^{3-} concentrations. Thus, high PO_4^{3-} concentrations were likely due to sources. The higher PO_4^{3-} concentrations in the bioretention curb extension could be due to domestic animal and bird feces. The bioretention curb extension is located adjacent to a busy pedestrian sidewalk, where many people walk their dogs. Poorly managed pet waste has been found to be a major source of phosphorus pollution in urban waterways [33]. It is also directly under the Lund Hall roof overhang, which may be polluted with bird feces that run off into the bioretention curb extension. All other GSI sites are on campus. The infiltration basin, bioretention basin, and bioretention planter are also separated from busy areas. The bioswale is adjacent to Shiley Hall, so there is some foot traffic. Phosphate concentrations at GSI sites were much higher than stormwater concentrations from the NSQD (on the order of 25–65x higher), indicating there is an export of PO_4^{3-} from these systems. High phosphorus concentrations from GSI systems have been observed in many other studies in the northwest as a result of leaching of phosphorus from the compost in the soil mix [8,18–20,34,35]. Due to the relatively high PO_4^{3-} concentrations in all of the GSI systems, it is likely that the GSI systems on the University of Portland campus are exporting PO_4^{3-} due to the compost in the soil mix.

Figure 10. Phosphate concentrations at each GSI site during the sampling period. Rainfall data are from the weather station located at Astor Elementary School (<https://or.water.usgs.gov/precip/astor.rain>, accessed 1 April 2021).

There were no significant trends observed during the sampling period, although it appears that PO_4^{3-} concentrations are decreasing throughout the sampling period. Phosphate concentrations were generally higher January–March 2020 compared to September–March 2021. There was 14.2 cm and 12.8 cm of precipitation during the January–March 2020 and January–March 2021 sampling periods, respectively. Although there was less total precipitation during January–March 2021, Figure 10 shows that there were less frequent, larger rain storms. These large rain storms may have “flushed” phosphorus out of the GSI systems, resulting in a lower soil water concentration. The higher levels of PO_4^{3-} may also be due to additional sources in January–March 2020. Additional investigation would be needed to determine the causes of the fluctuation in PO_4^{3-} concentrations.

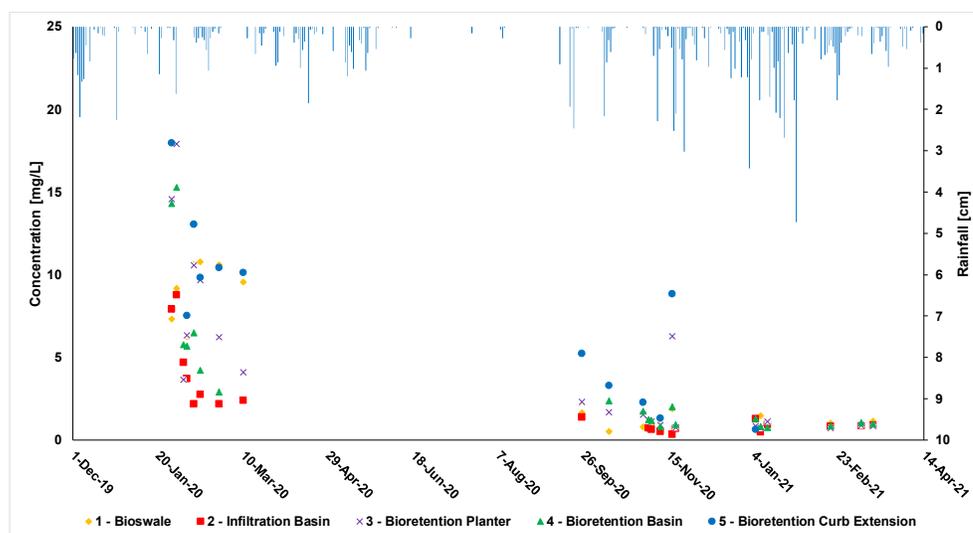
Figure 11 shows TP concentrations at each GSI site during the sampling period. Total phosphorus concentrations in the soil water were significantly lower ($p < 0.05$) in the infiltration basin compared to the bioswale, bioretention planter, and bioretention curb extension. Soil water TP concentrations were also significantly lower ($p < 0.05$) in the bioretention basin compared to the bioretention curb extension. There does not appear to be an impact of bioretention age on TP concentrations. Although the infiltration basin (installed 9 years ago) had lower TP concentrations than the bioretention planter (installed 2 years ago), bioretention basin (installed 5 years ago), and bioretention curb extension (installed 6 years ago), the bioswale (installed 11 years ago) had higher TP concentrations than the infiltration basin. Catchment/surface area ratios also did not appear to impact TP concentrations. The difference in TP concentrations may be due to sources. The bioswale treats runoff from a green roof, which has been shown to have higher TP and PO_4^{3-} concentrations compared to the built-up membrane portion of the roof [36]. The green roof is likely leaching phosphorus from the soil media, which drains to the bioswale. This may be why TP concentrations are higher in the bioswale, despite the age of this GSI site. Similar to PO_4^{3-} , TP concentrations at GSI sites were much higher than stormwater concentrations from the NSQD (on the order of 10–26x higher), indicating there is an export of TP from these systems. These high TP concentrations could be due to the compost in the soil mix, in addition to sources.

Figure 11. Total phosphorus concentrations at each GSI site during the sampling period. Rainfall data are from the weather station located at Astor Elementary School (<https://or.water.usgs.gov/precip/astor.rain>, accessed 1 April 2021).

Similar to PO_4^{3-} , there were no significant trends observed during the sampling period, although it appears that TP concentrations are decreasing throughout the sampling period. Total phosphorus concentrations were generally higher during January–March 2020 compared to September–March 2021. The higher levels of TP may be due to different rainfall patterns or additional sources in January–March 2020. Additional investigation would be needed to determine the causes of fluctuation in TP concentrations.
