# Environmental Impact Assessment of Renovated Multi-Apartment Building Using LCA Approach: Case Study from Lithuania

**Citation:** Chandrasekaran, V.; Dvarioniene, J.; Vitkute, A.; Gecevicius, G. Environmental Impact Assessment of Renovated Multi-Apartment Building Using LCA Approach: Case Study from Lithuania. *Sustainability* **2021**, *13*, 1542. <https://doi.org/10.3390/su13031542>

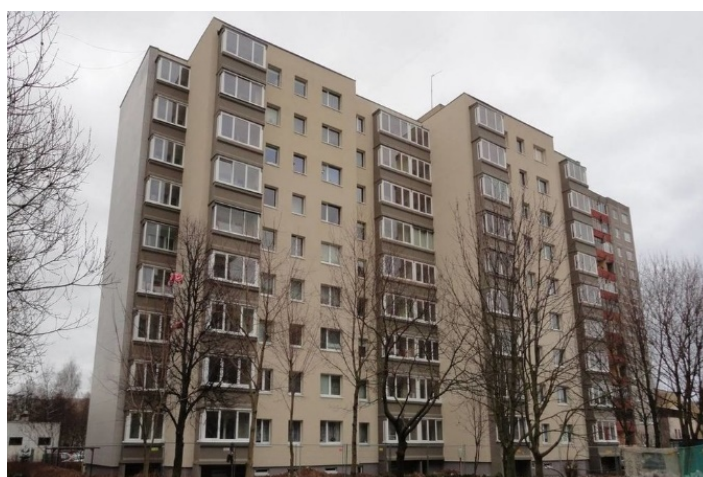
**Figure 1.** Renovated multi-apartment building (Building A).

To understand the two objects clearly, these two apartments will be termed as Building A (Figure 1) and Building B. Building A has been modernized by insulating walls and roofs, replacing new plastic windows. Building B has been renovated identically as Building A, with additional hot water, solar collectors, and heat pump installations (refer to Figure 2).
