Article

Monitoring Retreat of Coastal Sandy Systems Using Geomatics Techniques: Somo Beach (Cantabrian Coast, Spain, 1875–2017)

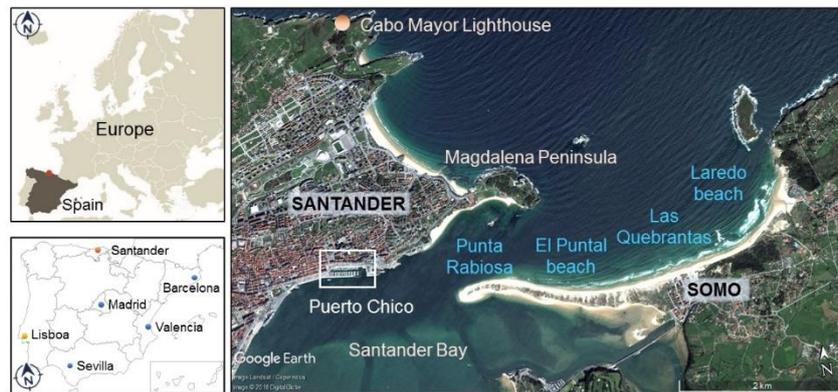
The exterior of the estuary is made up of a continuous beach–dune system within a confining sand barrier associated with a low coastal environment prolonged with a sand strip (Figure 1). There are two large morphosedimentary areas: the barrier strip of El Puntal–Punta Rabiosa, ~3 km in length and protected from the waves of the open sea, and the beach of Somo–Quebrantas–Loredo, ~2 km in length and exposed to the most active swells from the NW [1]. The barrier strip and beaches close the Santander Estuary and are boxed within the estuarine subsystem of the Cubas Estuary [33,34]. Taken as a whole, it makes up one of the most extensive sandbanks of the Cantabrian Sea with a total of 1,047,190 m² (Puntal de Somo: 308,149 m² and Somo–Quebrantas–Loredo dune complex: 739,041 m²) [30] and forms the mouth of the Miera River through the Cubas Estuary.

Figure 1. Geographical location of Somo Beach.

Both systems are the result of the divergence of the NW-dominant swell by diffraction and reflection on the Magdalena Peninsula and in the sandy bar of Las Quebrantas toward Punta Rabiosa, a sheltered area with NE exposure, and toward the beaches of Somo and Loredo, exposed beaches with N and NW exposure, respectively [1,3,10,30,35]. The evolution of the entire sandy system shows a longitudinal tendency toward the west, its apex stretching and turning toward the interior of the bay, and a layout of the whole sand bar toward concavity through its central area [5,10,19,20] (Figure 1).

Subsequent maps were georeferenced, and the 5-m-level curve was digitalized. Figure 4 shows the degree of fit of the georeferencing of the different cartographies, with maximum errors of 40 m. The fit of the georeferenced digitalizations of the different maps in the area of Puerto Chico were checked against the orthophoto in Figure 4, at 1 km northeast of Punta Rabiosa (Figure 1).

To determine the numerical values of the evolution of the shoreline, the beach of Somo was divided into two parts: the sandy strips between Punta Rabiosa and Somo (El Puntal Beach), and the cliffed dune between Somo and Loredo Beach (Las Quebrantas Beach) (Figure 1).

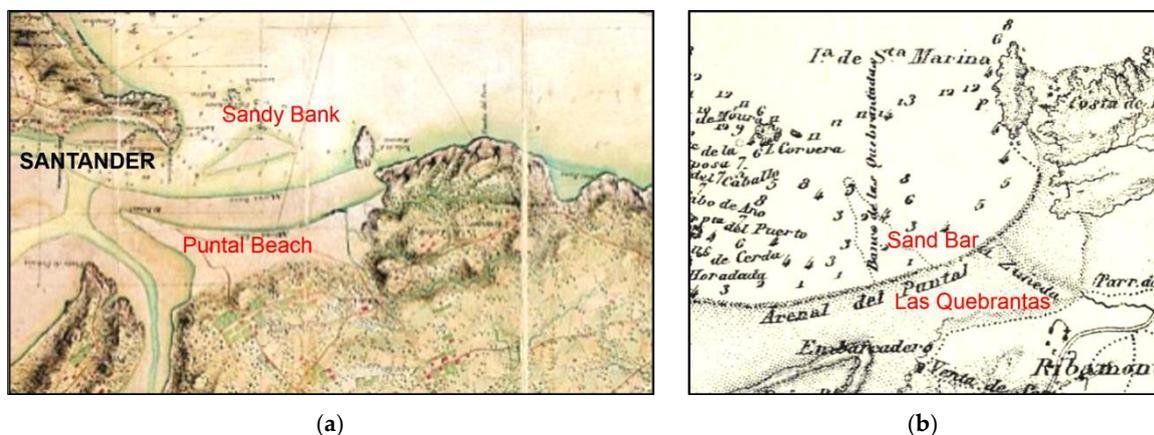
Figure 2. (a) Map of the beach of Somo by Isidro Próspero (1726) with the sandy bank; (b) map by Francisco de Coello (1860) with the sand bar.

For the historical analysis of the dynamic of the El Puntal Beach, the first maps of the city of Santander and its surroundings can be used. These were drawn up by Isidro Próspero Verboom in 1726 (Army Geographical Service). These maps represent the barrier strip that emerges in the neap low tides (Figure 2a). Later, on the 1860 map drawn up by Francisco de Coello (National Geographic Institute), the sandy bar disappeared, and a sand barrier was generated perpendicular to the area of Las Quebrantas (Figure 2b).

The maps of 1726 and 1860 were not used in a cartographical study of the evolution of the beach of El Puntal since it was not possible to georeference them, i.e., transform the map into the geodesic system of official reference in Spain (ETRS 89). As seen in Figure 2, there are no cartographic details in which ground control points can be located (crossings of paths, buildings, field fencing or walling, etc.). Despite not using these maps for the metric analysis of the evolution of Somo Beach, these historical maps give a good idea of how the coastal changes are continuous and are not due to punctual processes. The most influential factor in the retreat of the coastline at Somo Beach may possibly be large storms; thus, a detailed study was made of the last 32 years (1985–2017), since reliable information is available for this period.

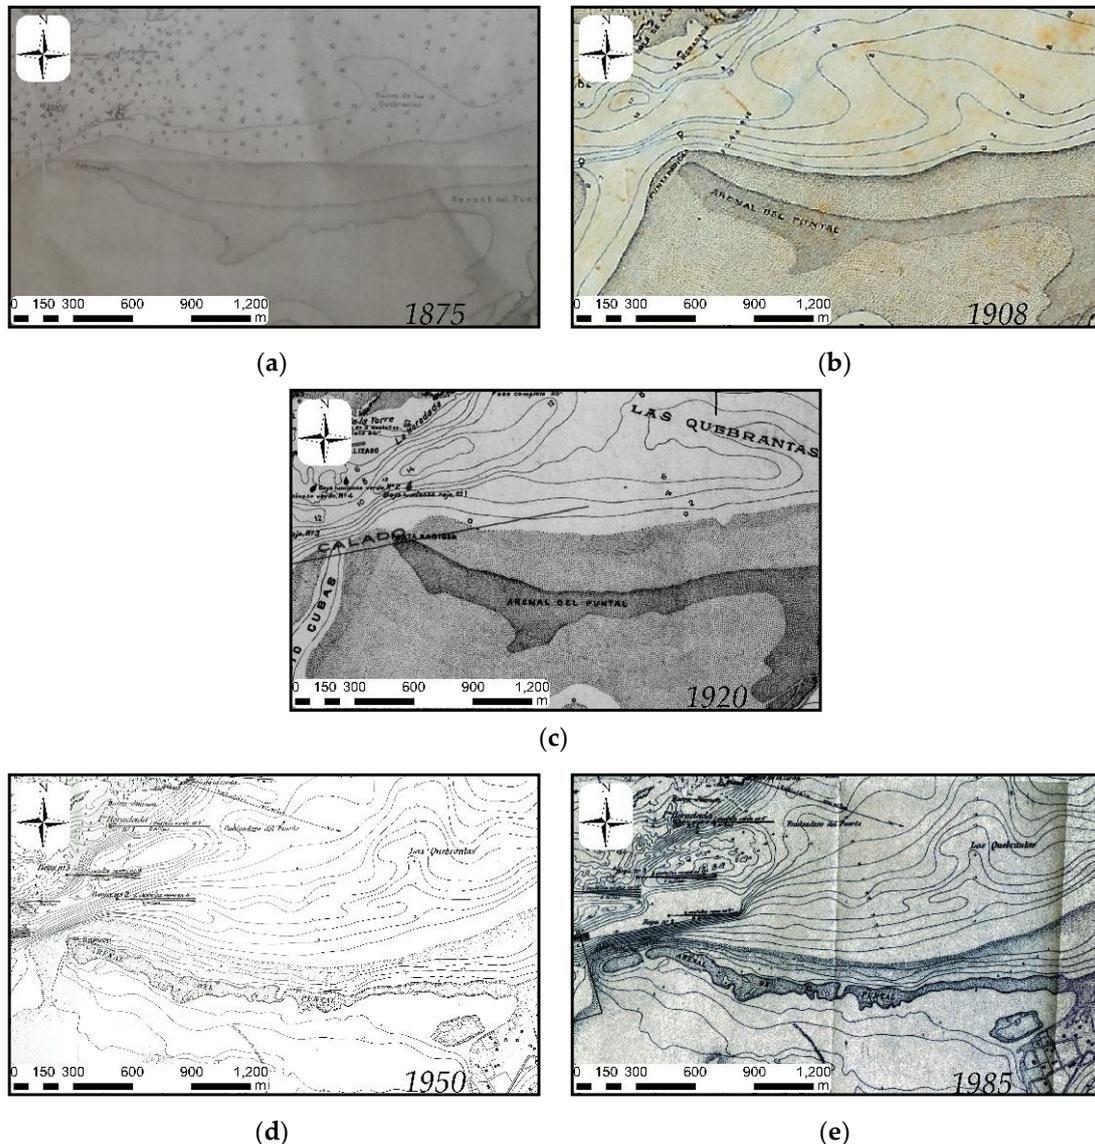
Figure 3. Maps of Somo Beach for the years of (a) 1875, (b) 1908, (c) 1920, (d) 1950, and (e) 1985.

For the cartographical analysis of the evolution of the beach of El Puntal, maps were available from the years of 1875, 1908, 1920, 1950, and 1985 from the Port Authority of Santander (Figure 3).

The different cartographies used (Figure 3) were georeferenced in ETRS 89 so as to collect them all in the same system of coordinates. Only in this way could comparisons be made among maps and other geomatic techniques be used (photogrammetry, topography, and terrestrial laser scanning (TLS)). Using the global navigation satellite system (GNSS), coordinates in ETRS 89 were given to 31 elements present today (houses, churches, walls, etc.) distributed around the bay of Santander, which are represented on several of the historical maps.

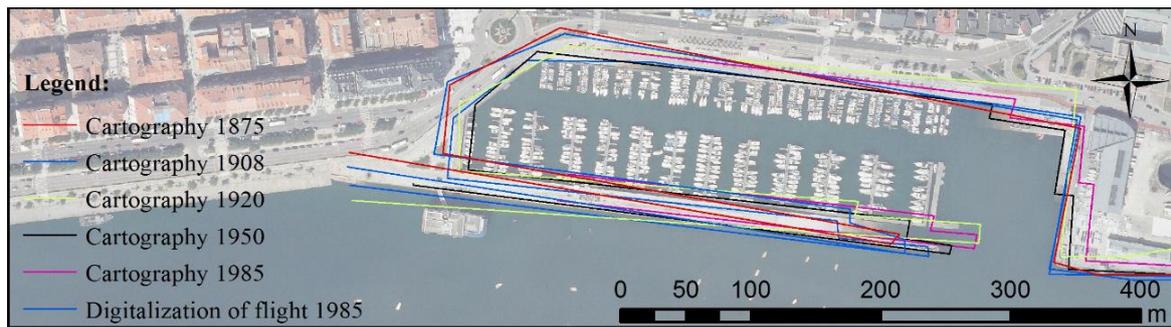
Figure 4. Differences in georeferencing in the digitalizations of the maps of 1875, 1908, 1920, 1950, and 1985. Orthophotography from 2010 (Spatial Data Infrastructure (SDI) Service of the Government of Cantabria, Spain).

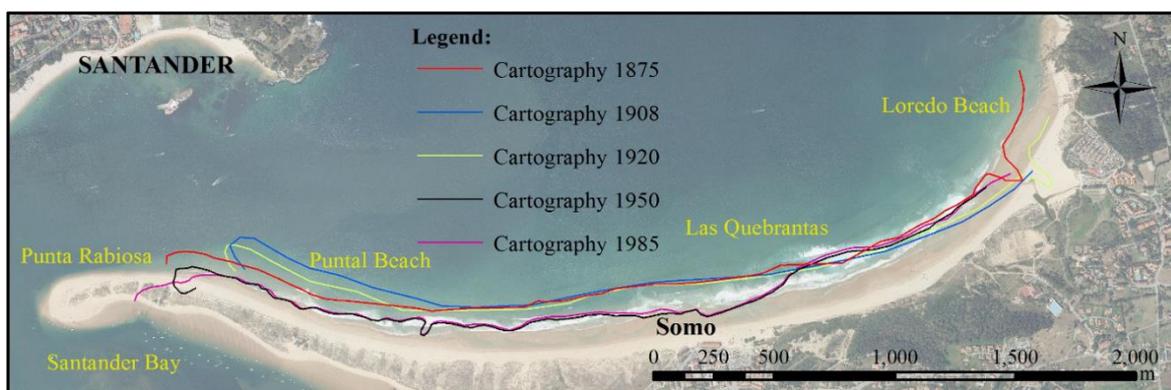
Figure 5. The 5-m-level curve corresponding to the maps of 1875, 1908, 1920, 1950, and 1985. Orthophotography from 2010 (SDI Service of the Government of Cantabria, Spain).

The curve of the 5-m level was then digitalized on each of the georeferenced maps, as this curve was present on all the maps analyzed (Figure 5). It should be pointed out that the 5-m-level curve is normally situated between the upper part of the backshore and the base of the cliffed dune.

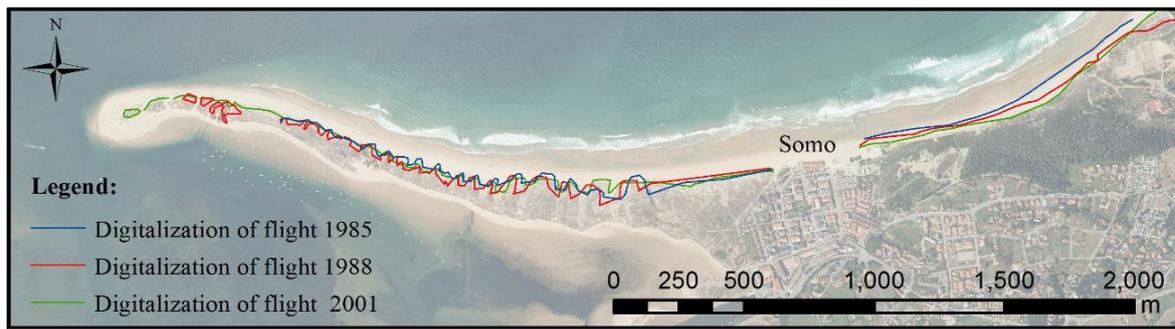
Figure 6. Digitalization of flights (1985, 1988, and 2001) of Somo Beach. Orthophotography from 2010 (SDI Service of the Government of Cantabria, Spain).

The flights in 1985, 1988, and 2001 were rectified using the program ArcMap of ArcGIS. To make the rectification, nearby control points on the shore (level zero) were used, and the upper part of the slope of the sandy front was later digitalized (Figure 6). During this period (1985–2001), a retreat in the shoreline in this area was detected.

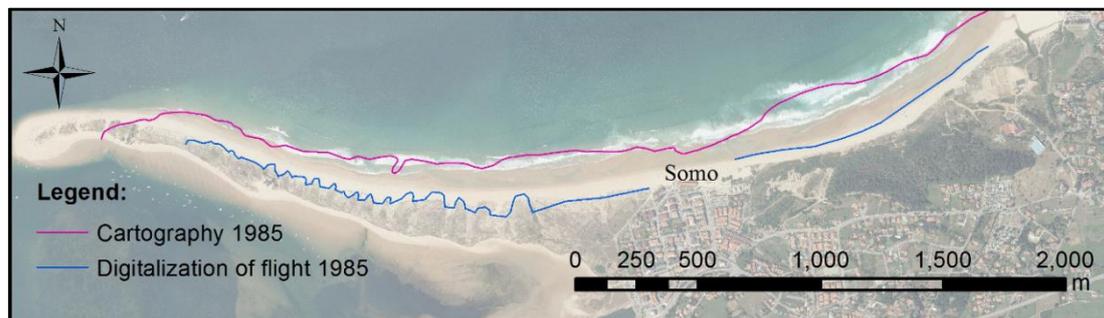
Figure 7. Comparison of digitalizations of the cartography 1985 and of the flight of 1985. Orthophotography from 2010 (SDI Service of the Government of Cantabria, Spain).

The comparison between the digitalizations of maps from 1985 (Figure 5) and the flight of 1985 (Figure 6) show planimetric differences of over 200 m between the 5-m-level curve on the maps and the upper part of the sandy slope from the 1985 flight (Figure 7). Figure 4 shows that it is not a problem of georeferencing, and we can, therefore, interpret that the maps from 1985 fail to reflect the true condition of Somo Beach. The reason for this is that the Port Authority of Santander used the same map from 1950 to 1985 (see the maps of 1950 and 1985 in Figure 3). Both maps represent the mouth of the bay and its bathymetry, information indispensable to navigation for access to the Port of Santander; however, the rest is identical on both maps. Therefore, the map of 1985 was discarded and the digitalization of the aerial photography of the same year was used.

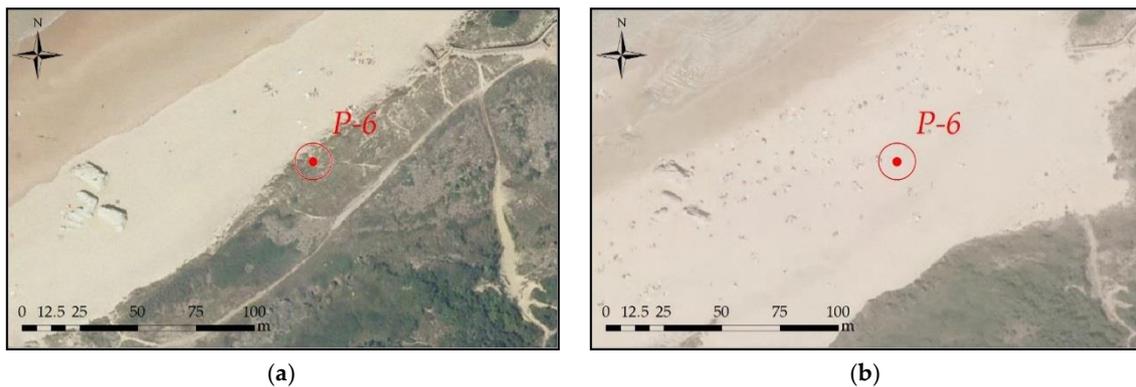
Figure 8. (a) Position of control point 6 in the orthophotographs of 2010; (b) point 6 in the orthophotographs of 2014. SDI Service of the Government of Cantabria, Spain.

Coordinate z in Table 2 indicates the particular situation of point 6 owing to its disappearance following the winter storms in 2013–2014, the origin position (2010) of which is shown in Figure 8a, and the situation in 2014 is shown in Figure 8b. The flight of 2014 was, therefore, given the same planimetric coordinates as the flight of 2010 and its altimetric position (3.318 m) was determined. The loss of level at this point between 2005 and 2014 was 5.431 m. Between 2010 and 2014, loss was 5.109 m, and this value was later taken into account to evaluate the influence of the storms of 2013–2014.

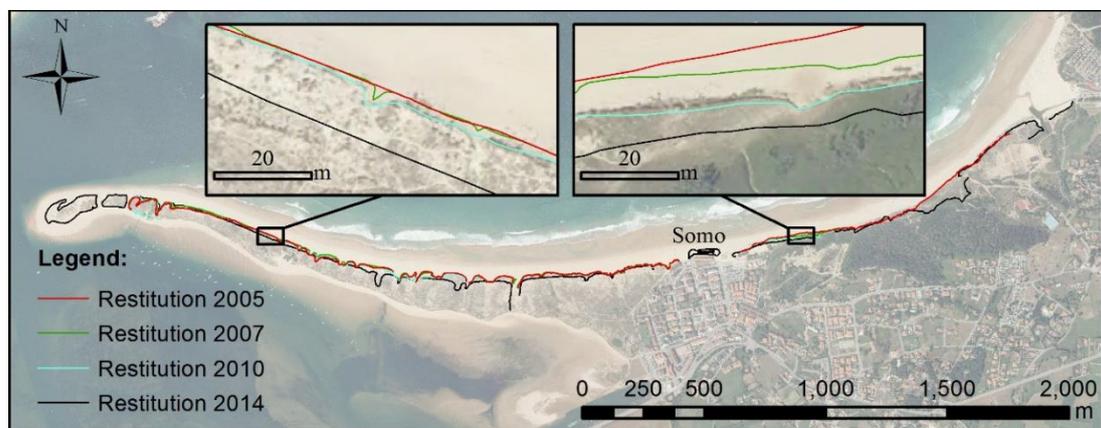
Figure 9. Restitutions of aerial flights (2005, 2007, 2010, and 2014) of Somo Beach, in which only the upper part of the slope of the sandy front is represented. Orthophotography from 2010 (SDI Service of the Government of Cantabria, Spain).

Once the process of photogrammetric orientation was complete, the upper part of the slope of the sandy front was restituted (Figure 9). Both the digitalized cartography and photogrammetric flights prior to 2005 and the photogrammetric restitutions used the ETRS 89 system of coordinates. In order to check the fit of the georeferencing, common elements were used, such as the corners of houses, crossroads, or the corners of fields. The maximum differences between the digitalizations (cartography and photogrammetry) and the photogrammetric restitutions were no greater than 40 m.

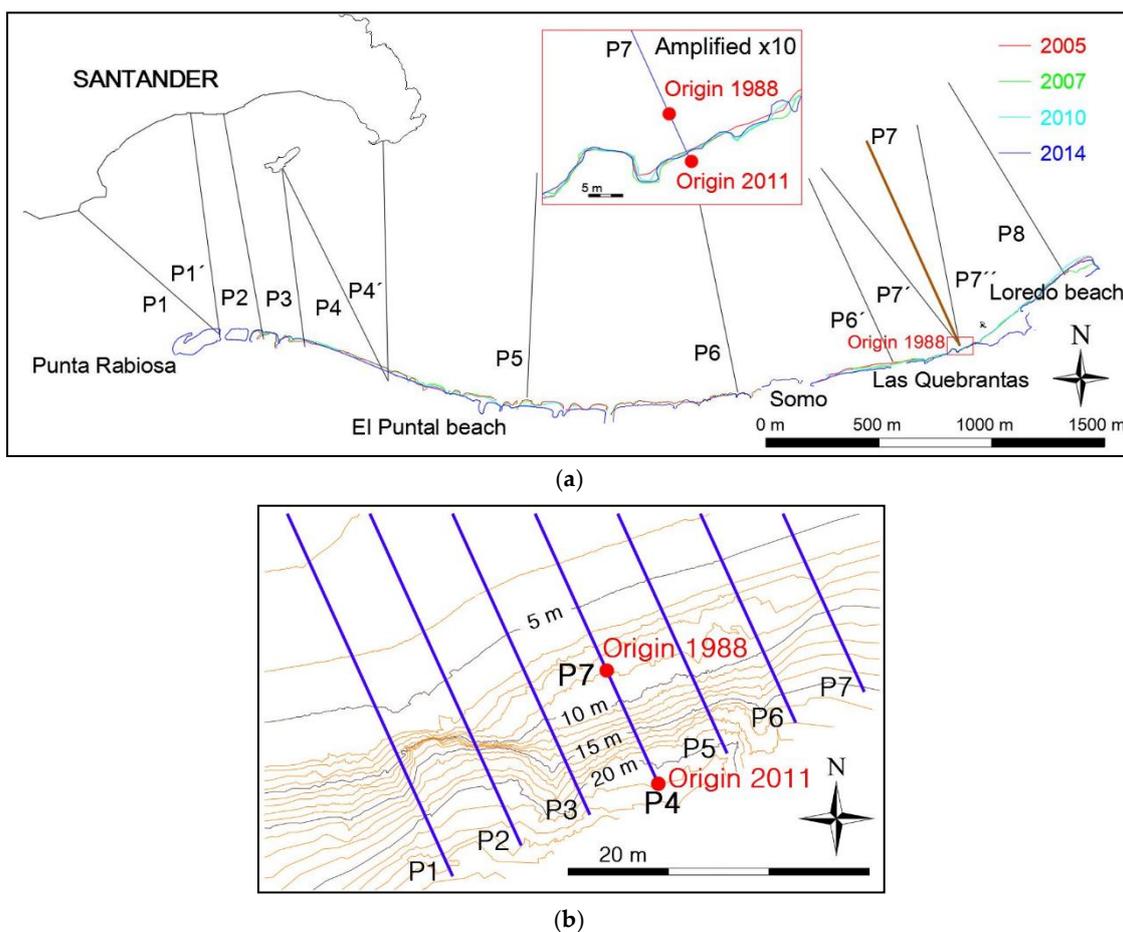
Figure 10. (a) Planimetric representation of the 13 topographic profiles (1988–1993) on the photogrammetric cartography (2005, 2007, 2010, and 2014). The topographic, photogrammetric, and terrestrial laser scanning (TLS) data collection area are also amplified $\times 10$. (b) The seven profiles of measurement using photogrammetry and TLS over the cartography generated by TLS in 2011 are shown. Profile 4 (P4) coincides with the measurement of profile 7 (P7) in the period of 1988–1993. The position of the base in 1988 is also indicated.

For the topographical bathymetric monitoring of the beach of Somo between 1988 and 1993, 13 profiles (P1, P1', P2, P3, ..., P8) were measured monthly (Figure 10a) [10,41]. The bathymetry was observed at high tide and the topographical land measurement at low tide in order to obtain the intertidal overlap between the bathymetric measurements (profile with one sounding on the vessel) and the terrestrial ones (topographical profile on the beach).

The use of TLS in the area of Las Quebrantas provided seven profiles, as shown in Figure 10b. The number of points measured with TLS in each survey was approximately 500 million with a precision at each point of 3 cm including the GNSS error. Two measurements were made per year to evaluate the evolution of the beach during the winter (October–March) and the summer (April–September).

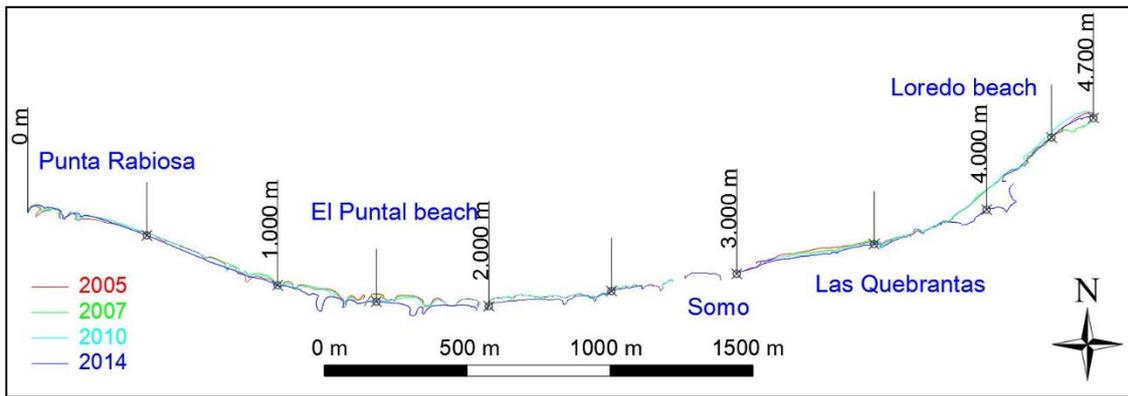
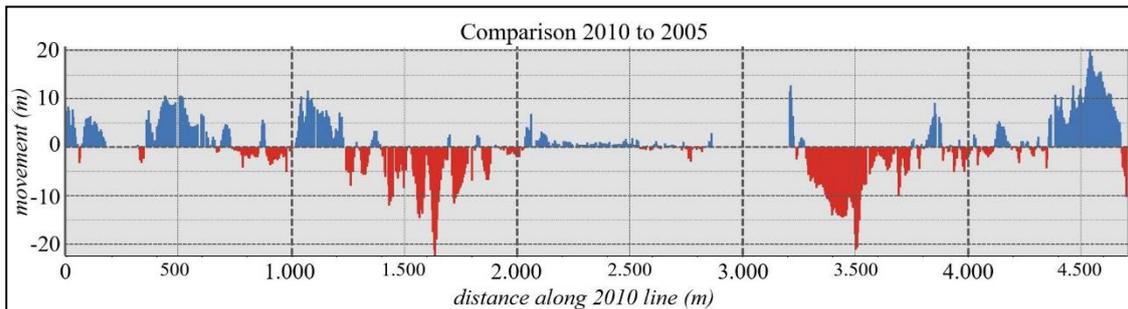
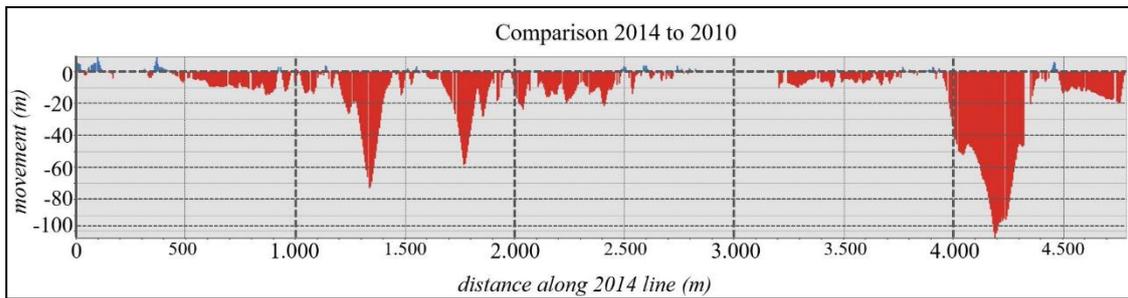
Figure 11. (a) Restitutions of the slope of the sandy front in 2005, 2007, 2010, and 2014. (b) Comparison of the evolution of the shorelines restituted in 2005 and 2010. (c) Comparison of the evolution of the shorelines restituted in 2010 and 2014.

A shoreline of 400 m was selected to make the TLS measurements coincide with those from previous periods. In this way, profile 4 (P4) taken with TLS (2011–2017) is the same as profile 7 (P7), which was measured using topographical techniques (1988–1993), and this same profile 7 (P7) was collected using photogrammetry (2005–2014) (Figures 11 and 12).

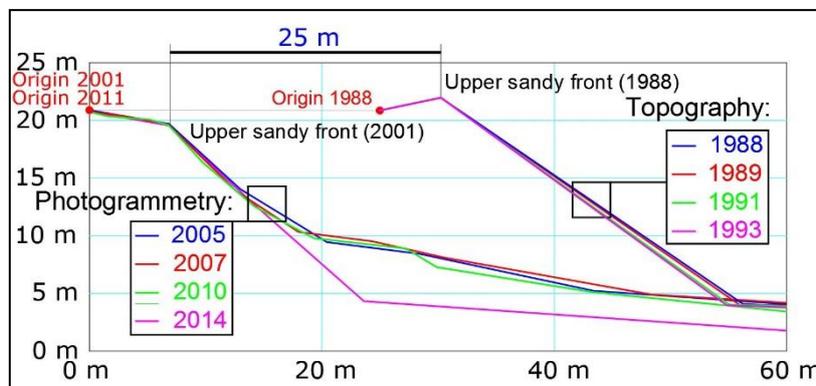
Figure 12. Topographical measurements of profile 4 (Figure 10b) between 1988 and 1993, and photogrammetric evolution of profile 4 between 2005 and 2014.

- Digitalization of the flights in 1985, 1988, and 2001: The retreat of the shoreline during the period was 30 m. Within this period, the analysis of the topographical profile (P4) between 1988 and 1993 showed a retreat of less than 1 m (Figure 12). Between the topographical profile of 1993 and the photogrammetric restitution of 2005, the shoreline retreated by 25 m given that the upper part of the slope of the sandy front between 1988 and 1993 was found to be 25 m farther out to sea with respect to 2005.

Analyzing the results obtained between 1985 and 2017, large retreats of the shoreline are seen between 1993 and 2001 (Figure 12), as well as following the storms between December 2013 and March 2014 (Figure 13). There is a correspondence, therefore, with the data of Table 1, in which we see that the five-year periods of 1995–1999 and 2010–2014 were the most active since the series of swells became available (1985). To be specific, 1999 was outstanding in the series, as there were eight days with storms that year, and more recently, 2014, when there were six days of storms in February and the first week of March, of which four days had tidal range of over 100.

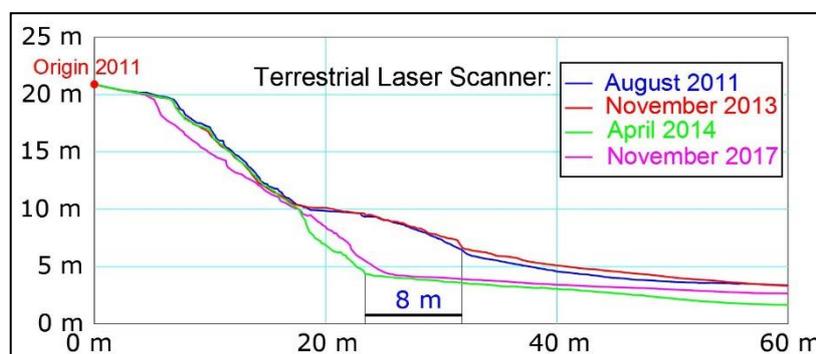
Figure 13. Evolution of profile 4 (Figure 10b) with TLS between August 2011 and November 2017.

- Terrestrial laser scanning (TLS): Measurements taken using TLS in the period from August 2011 to November 2013 show stability with slight variations in the intertidal area. In April 2014, large retreats are seen with respect to the measurements made in November 2013 (Figure 13) and these coincide with the photogrammetric measurements (Figure 12). The retreat of the base of the slope of the sandy front in the position of profile 4 between November 2013 and April 2014 was 8 m. The fall in the level of the entire beach by 3 m was also significant, even as much as 5.431 m in some areas (point 6) (Table 2). From April 2014 to April 2017, the upper part of the slope retreated by 2 m, stabilizing the gradient of the sandy slope (Figure 13).

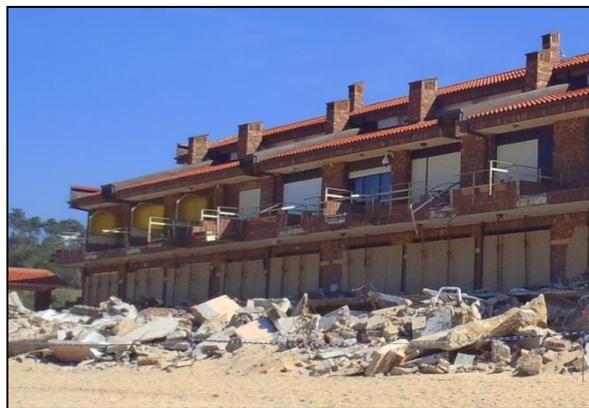
Figure 14. Damaged houses in the urban area of Somo due to the winter storms of 2013–2014.

The village affected by this coastal dynamic is Somo, located between El Puntal Beach and Las Quebrantas Beach. For the period of 1985–2017, the coast retreated by 32 m in this area (Table 5). Somo used to be a village with small individual houses; however, at the beginning of the 1980s, housing estates and attached houses began being built, some of them on the beach front. It is these buildings that this coastal retreat is now affecting, mainly when the swells are higher than 6 m, coinciding with periods of high tidal range of over 100 (Figure 14).

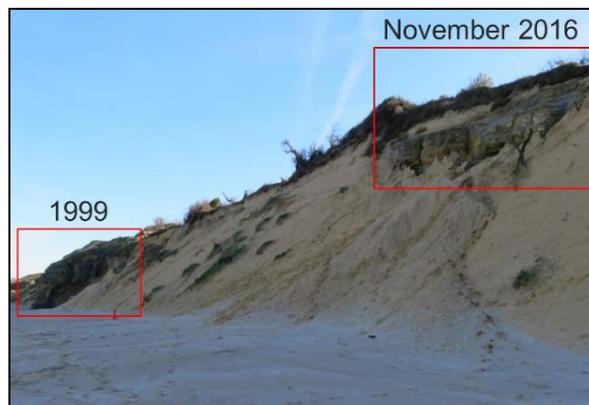
Figure 15. New outcrop of the rock cliff in the year 1999 and in November 2016.

The rock cliff previously covered by the foredune appeared in 1999, and in November 2016, 130 m to the east, a new outcrop rock arose on top of the dune (Figure 15). These dune erosive processes can generate significant changes, producing a continuous cliff without dunes if the erosive processes remain.
