# 3D Data Fusion for Historical Analyses of Heritage Buildings Using Thermal Images: The Palacio de Colomina as a Case Study

**Citation:** Patrucco, G.; Gómez, A.; Adineh, A.; Rahrig, M.; Lerma, J.L. 3D Data Fusion for Historical Analyses of Heritage Buildings Using Thermal Images: The Palacio de Colomina as a Case Study. *Remote Sens.* **2022**, *14*, 5699. <https://doi.org/10.3390/rs14225699>

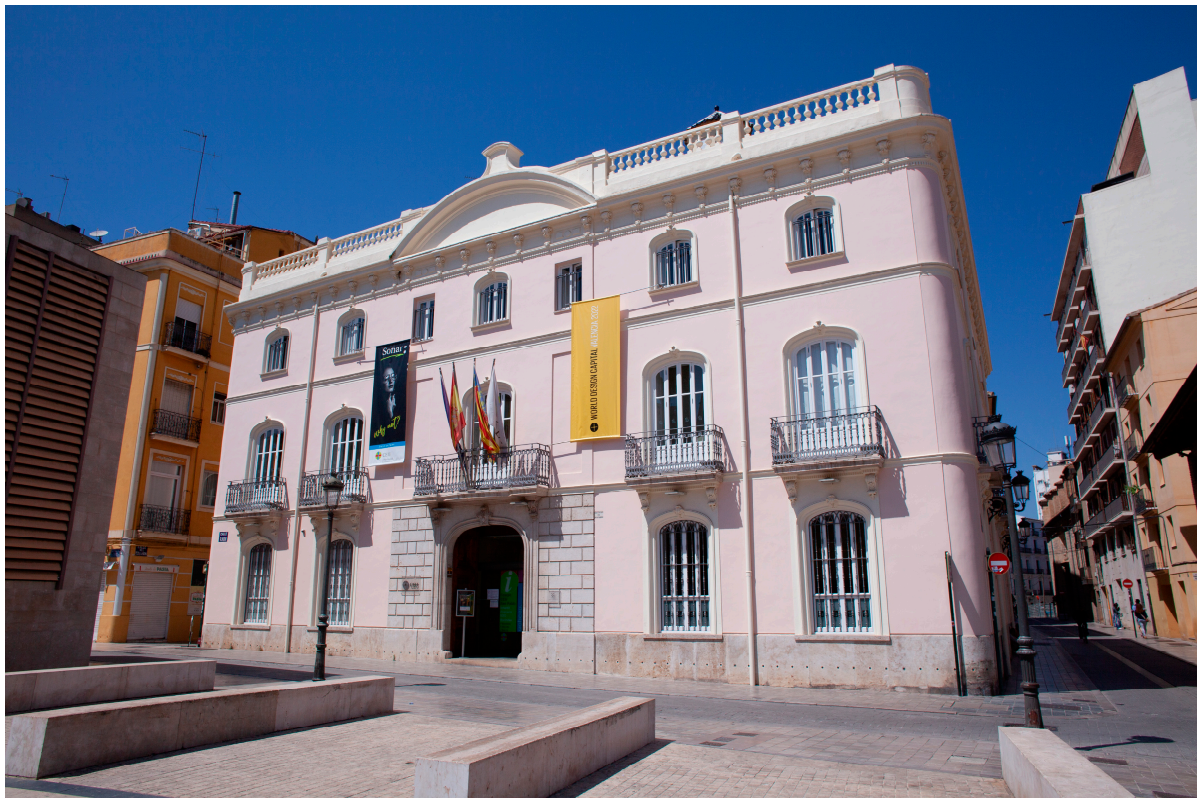
Figure 1. Colomina Palace (southern façade).

The Weight of Flour Street alludes to a presently non-existing endowment. There are neither engravings, photographs of this building, nor publications that describe its appearance, even in the Historical Archive of Valencia, which guards medieval documents. However, it appears on several old maps of the city centre, the 18th-century plan by Tomás Vicente Tosca in 1704, and the *Valentia Edetanorum vulgo del Cid* by J. Fortea in 1738 [27]. In this sense, very few Valencians, seeing the name of the street, imagine that the Weight of Flour building existed, but no one knows what it looked like, and that, under the present eclectic decoration of the Colomina Palace (Figure 1), its original medieval façade remains.

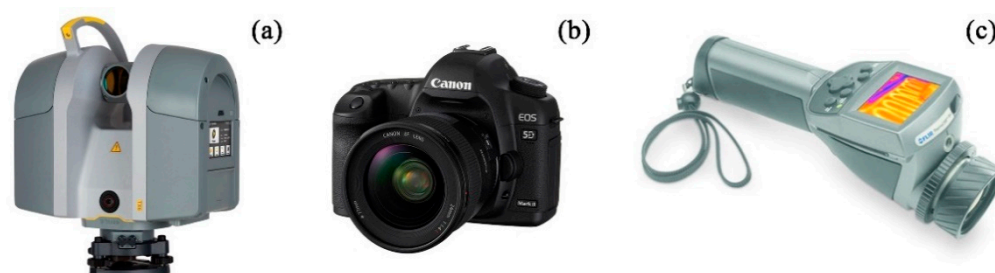
**Figure 3.** (a) Trimble TX6 laser scanner; (b) Canon EOS 5D Mark II; (c) FLIR ThermoCAM<sup>TM</sup> B4.

- 8 LiDAR scans, using a Trimble TX6 laser scanner (Figure 3a) in order to provide high-resolution point clouds to accurately describe the external geometries of the Palacio;
- 455 colour digital images, using a DSLR camera (model: Canon EOS 5D Mark II) (Figure 3b) to document the visible range of the electromagnetic spectrum;
- 308 TIR images, using a terrestrial thermal camera (model: FLIR ThermoCAM™ B4) (Figure 3c) to detect anomalies or phenomena that are not visible to the human eye, but noticeable in long wave infrared (LWIR—8–14.000 nm).

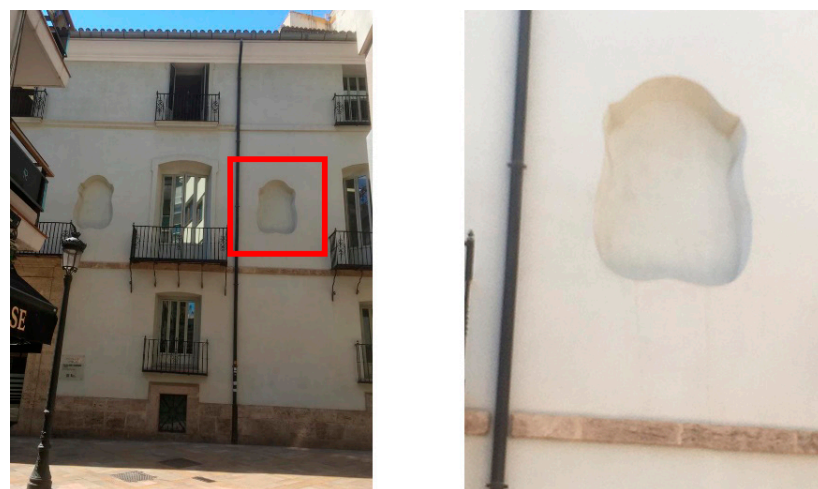
**Figure 18.** Decorative niches on the façade of the Boil de Arenós Palace, Street of Libreros, Valencia.
