Article

Global and Local Aging in Differently Stabilized Polypropylenes Exposed to Hot Chlorinated Water with and without Superimposed Mechanical-Environmental Loads

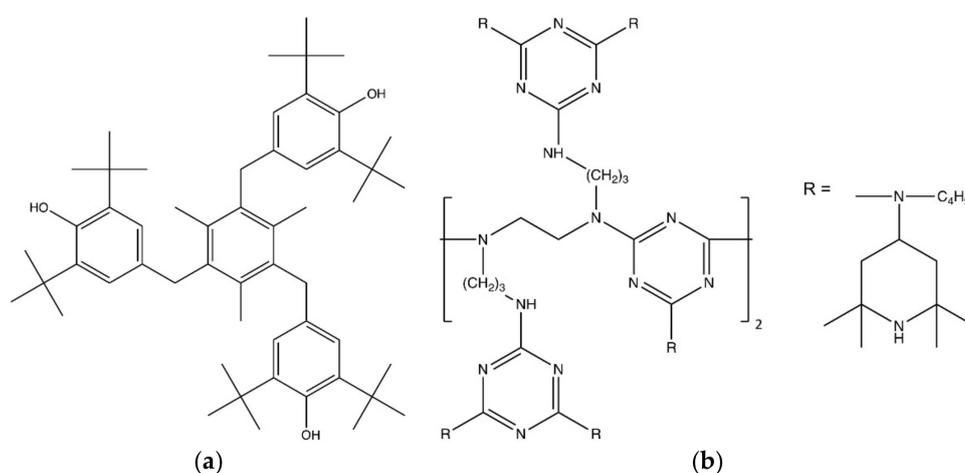
Figure 1. Chemical structure of the stabilizers. (a) Primary phenolic antioxidant (Irganox 1330). (b) Hindered amine stabilizer (Uvasorb HA88).

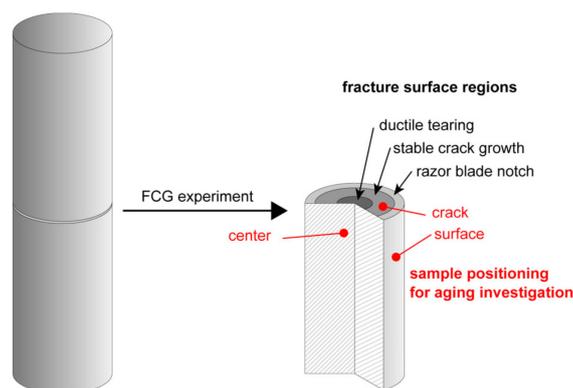
Figure 2. Schematic of the CRB specimen (left) before and (right) after fatigue crack growth (FCG) experiments indicating the three sample positions (i.e., center, surface, and crack) for the investigation of the corresponding local aging states.

the mean molar mass (M_w) and molar mass distribution from three different positions, which are depicted in Figure 2. Two of these positions were remote from the crack tip, with one corresponding to a center volume element of the CRB specimen, which is not direct and, hence, least exposed to the environmental medium (“center” position in Figure 2). The second position corresponds to a volume element at the outer surface of the CRB specimen, which is most exposed to the environmental medium since it is in direct contact with the medium over the entire test duration (“surface” position in Figure 2). The third sample position of specific interest to characterize local crack tip aging is located directly on the fracture surface, and samples were taken from the stable crack growth region of the fracture surfaces of the CRB specimens tested and ultimately fractured (“crack” position in Figure 2).

The local aging states at the three predefined positions of the CRB specimens (center, surface, and crack as indicated in Figure 2) tested under the various conditions of test temperature and liquid environment are depicted in terms of local mean molar masses (M_w) in Figure 6a (non-chlorinated water at 80 °C), Figure 6b (chlorinated water at 80 °C), and Figure 6c (chlorinated water at 95 °C). Starting with the data for non-chlorinated water at 80 °C depicted in Figure 6a, it may be concluded that these environmental conditions do not affect the M_w values to a significant degree at least within the maximum test duration of 41 h. Independent of the sample position, M_w values were found to range in a rather narrow window from 290 kg/mol to 315 kg/mol. Hence, it appears that essentially no molecular degradation takes place under these test conditions.

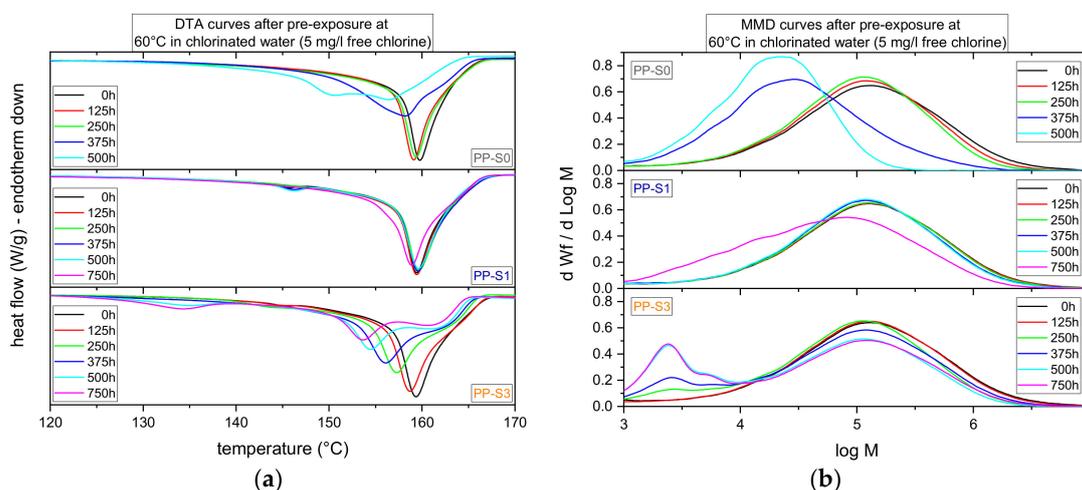
Figure 3. (a) Differential thermal analysis (DTA) curves indicating the melting peaks in the second heating step and (b) molar mass distribution (MMD) curves for various exposure times of micro-sized specimens to chlorinated water (5 mg/L free chlorine) at 60 °C for the three polypropylene (PP) grades.

Results for the morphological and molecular material aging states of micro-sized specimens of the three PP grades exposed to chlorinated water (5 mg/L free chlorine) at 60 °C for up to 750 h are depicted in Figure 3a,b in terms of differential thermal analysis (DTA) curves and molar mass distribution (MMD) curves, respectively. Starting with PP-S0, the PP-grade without long-term stabilization, the main melting peak temperatures from the second heating step, and the number of long chain molecules in the MMD curve continuously decrease with increasing exposure time. While, at up to 250 h of exposure, these changes are quite moderate, more significant changes appear after 375 h and 500 h. For PP-S1, stabilized with a primary antioxidant, up to an exposure time of 500 h, only minor variations in melting peak and molar mass distribution were detected. Significant shifts in melting peak temperature and molar mass distribution are apparent after 750 h of exposure. Therefore, the positive effect of the addition of a primary antioxidant is corroborated. Turning to PP-S3 with a stabilization package of a primary antioxidant and a hindered amine stabilizer, an entirely different evolution of the aging material states was found. In fact, in this material aging seems to take place continuously right from the start of exposure, with a bimodal and, subsequently, multimodal MMD characteristic developing after 250 h of exposure. Simultaneously, a bimodal melting peak appears in the DTA curves, which indicates a morphological inhomogeneity, to some extent. When comparing the three material grades in terms of morphological and molecular global aging kinetics, clearly PP-S1

As to molecular aging indicators, all PP grades were affected by the exposure to hot chlorinated water, which led to continuously decreasing mean weight average molar mass (M_w) values. However, this includes different kinetics depending on the stabilization. The initial M_w values for PP-S0, PP-S1, and PP-S3 with 303 kg/mol, 311 kg/mol, and 317 kg/mol, respectively, were rather similar. With continuous chlorinated water exposure, especially PP-S0 (no long-term stabilization) exhibited a pronounced drop in M_w after 175 h, which indicates significant chemical aging and material degradation after such a short exposure time. Further hot chlorinated water exposure caused additional aging, and, after 500 h, a final M_w value of about 27 kg/mol was found, which represents a value less than 10% of the initial M_w value of PP-S0. Conversely, the M_w values of PP-S1 and PP-S3 after 750 h of exposure dropped to about 163 kg/mol and 185 kg/mol, respectively, which represents an M_w deterioration of approximately 50%. Again, when comparing all three PP grades, PP-S1 over most of the exposure time shows the lowest tendency for molecular degradation, which reaches a rather equivalent state of molecular degradation to PP-S3 after the longest exposure time of 750 h. It should be noted, however, that these equivalences in the mean molar mass between PP-S1 and PP-S3 after 750 h of exposure are a result of entirely different molar mass distributions, which was discussed with reference to Figure 3b.

The dependence of the strain at break (ϵ_b) on the mean weight average molar mass (M_w) is shown in Figure 5 for unexposed and pre-exposed samples of the three PP grades. Referring to a discussion in one of our previous papers [12], in this diagram, the results are plotted in a linear-log scale since this form of data representation allows for a better definition of characteristic mean molar mass values. Below these characteristic mean molar mass values the materials rapidly become brittle as the strain at break values of aged materials approach the yield strains (i.e., characteristic embrittlement mean molar mass, $M_{w,ch}$). Hence, the data in Figure 7 are depicted together with exponential fit functions, from which the $M_{w,ch}$ values may be determined as the vertex of the fit curvature. These $M_{w,ch}$ values are indicated in Figure 7 as dotted lines and range from 180 kg/mol for PP-S0 to 243 kg/mol for PP-S1 to 265 kg/mol for PP-S3. Considering these numbers, two aspects deserve mentioning. First, the $M_{w,ch}$ values determined here for PP homopolymers of different stabilization and ranging from 180 to 265 kg/mol are below the value of about 300 kg/mol reported for PP random copolymers [12,41,51]. Second, the finding of different $M_{w,ch}$ values for the three PP formulations with an identical base polymer investigated in this case, is most likely related to the fact that the stabilizer system used does not only control the degradation kinetics but also has a pronounced influence on the molecular mass distribution (MMD) of the aged polymer. In other words, the stabilizer system used has a pronounced influence on the degree of broadening of the MMD up to the development of bimodal and multimodal MMD in aged polymers. This latter argument, while principally plausible, is consistent with the findings on the MMD evolution for these three materials in Figure 3.

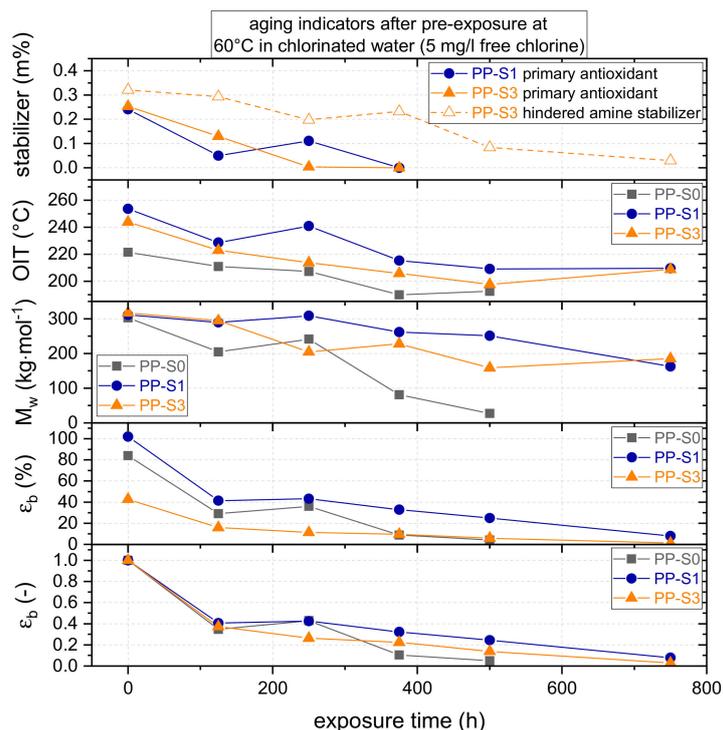
Figure 4. Stabilizer content (primary antioxidants and hindered amine stabilizer), dynamic oxidation induction temperature (OIT), mean weight average molar mass (M_w), strain at break (ϵ_b), and normalized strain at break as a function of exposure time of micro-sized specimens for the three PP grades.

To compare the global aging behavior of the three materials as a function of exposure time, a summary of the various aging indicators, as defined in Section 2.3, is provided in Figure 4. Starting with the progress in stabilizer loss for the two additionally stabilized PP grades PP-S1 and PP-S3, the content of primary antioxidants decreases substantially with increasing exposure time, which results in total antioxidant loss (i.e., 0 m%) after 375 h in both materials. The hindered amine stabilizer in PP-S3 was consumed/extracted continuously over the entire exposure time with the final content of 0.03 m% after 750 h.

Regarding the presence of stabilizers, when comparing the oxidation induction temperatures (dynamic OIT), the effect of the additionally introduced stabilizers is evident from the significantly higher dynamic OIT values for PP-S1 and PP-S3 initially and over the exposure time. With 254 °C and 244 °C, respectively, the initial dynamic OIT values for PP-S1 and PP-S3 are more than 20 °C higher than the value for PP-S0 with 221 °C. However, despite the higher amount of the total stabilizer content in PP-S3, PP-S1 showed a 10 °C higher initial dynamic OIT value, which, again, indicates some antagonistic effect related to the presence of the hindered amine stabilizer. Looking at the aging-dependent evolution of the dynamic OIT data, all PP grades exhibited a decrease over the experimental exposure time with final values of 193 °C after 500 h for PP-S0, and with 210 °C and 209 °C after 750 h, respectively, for PP-S1 and PP-S3. Thus, the drop in dynamic OIT values over the exposure time amounted to some 30 °C to 45 °C depending on the material formulation. Since PP-S0 contained no long-term stabilization, the continuous decrease in dynamic OIT data with exposure time cannot be related to stabilizer loss or consumption during the exposure but may be a result of the polymer degradation process for which evidence was already provided in Figure 3. By comparison, the decrease in dynamic OIT for PP-S1 and PP-S3 is in good agreement with the stabilizer loss data discussed above, which does not exclude some contribution from molecular degradation in these cases. Yet, from an overall perspective, PP-S1, which is the PP grade stabilized with a primary antioxidant, exhibited the highest dynamic OIT values over the entire exposure time.

Moving now to the strain at break (ϵ_b) data as the material performance indicator for global aging, it is apparent from Figure 4 that, under unexposed conditions, PP-S3 with 43% reveals a significantly lower ϵ_b value than PP-S0 and PP-S1 with 84% and 102%, respectively. This is somewhat surprising, considering that, in the unexposed state, all three material grades exhibit quite comparable M_w values and MMD as well as equivalent degrees of crystallinity and melting temperatures. Apparently, the addition of the specific hindered amine stabilizer type used in PP-S3 even acts antagonistic with regard to the material performance in the unexposed material state. According to other investigations, this is due to the primary phenolic antioxidant becoming increasingly acidic, which interacts with the alkaline environment of the hindered amine stabilizer. The resulting antagonistic acid/base mechanism, which involves the consumption of phenol by the activated hindered amine stabilizer, is also discussed

For the dependence of the strain at break (ϵ_b) data on the exposure time, a normalized presentation with strain at break at given exposure times divided by the initial strain at break without exposure is depicted in Figure 4. Considering the initial values for ϵ_b , after 125 h of exposure for all three PP grades, ϵ_b drops to less than a half of the initial values. However, it remains unclear to which extent this is caused by physical aging (post/re-crystallization) vs. chemical aging (molecular degradation). A further drop in strain at break occurs for PP-S0 after 375 h, whereas the ϵ_b values for the other two PP grades show a more continuous decrease with increasing exposure time. Quasi-total embrittlement, with ϵ_b values remaining below overall specimen yielding, is reached for PP-S0, PP-S1, and PP-S3 after 500 h, 750 h, and 750 h, respectively. In terms of the strain at break, PP-S1 containing just the primary antioxidant outperforms PP-S0 (no stabilization) and PP-S3 (primary antioxidant plus a hindered amine stabilizer) over the entire exposure time.

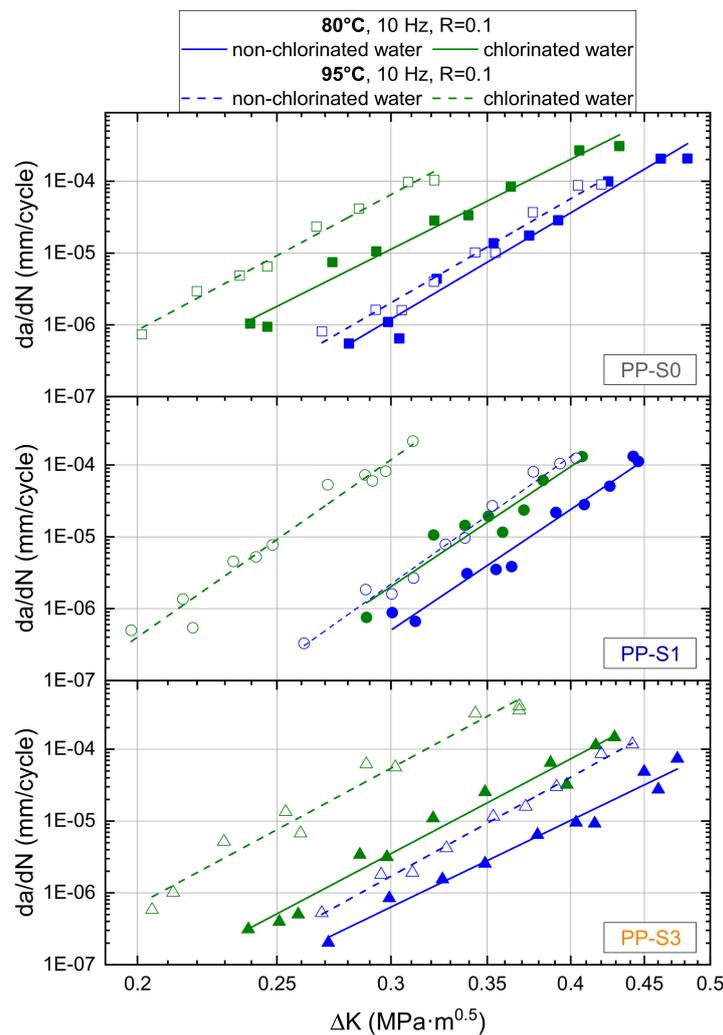
Figure 5. Fatigue crack growth (FCG) curves of PP-S0, PP-S1, and PP-S3 tested at 80 °C and at 95 °C in non-chlorinated water (0 mg/L free chlorine) and in chlorinated water (5 mg/L free chlorine).

To investigate and study local aging effects in chlorinated water via fatigue crack growth (FCG) experiments at predefined temperatures, it is essential to have a reference state for comparison of such FCG curves. These reference states for the test conditions were defined in terms of equivalent test temperatures but non-chlorinated water as the liquid environment. Hence, Figure 5 depicts and compares the FCG curves for the three PP grades tested at 80 °C and 95 °C in non-chlorinated water (0 mg/L free chlorine) and in chlorinated water (5 mg/L free chlorine). From these FCG curves, three essential findings may be deduced. First, enhancing the test temperature from 80 °C to 95 °C in all materials and in both liquids (non-chlorinated water and chlorinated water) leads to a significant increase in FCG rates over the entire stress intensity factor range investigated. Second, and again for all three PP grades, the chlorinated water environment at a given temperature also results in a significant enhancement of FCG rates. In other words, the chlorinated water environment clearly leads to a deterioration of the FCG resistance in these PP materials. Third, when comparing the FCG data generated at 80 °C with those obtained at 95 °C, the deterioration of the FCG resistance by the chlorinated water environment is noticeably magnified at the higher temperature.

Referring back to Figures 5 and 6, the test duration and the investigated crack growth rate regime, have a pronounced effect on local aging. Hence, in Table 2, the deterioration factors determined as the ratio between the environmental-dependent crack growth rates at a given stress intensity factor range ($\Delta K = 0.3 \text{ MPa}\cdot\text{m}^{0.5}$) are depicted for the two test temperatures at 80 °C and 95 °C, comparing non-chlorinated water (reference environment with a deterioration factor of 1) with chlorinated water. With deterioration factors ranging from 4 to 9 for 80 °C and from 32 to 54 for 95 °C, significantly higher values were found at 95 °C, which indicates that the more oxidative environment (chlorinated water) is more aggressive at higher temperatures. Comparing the deterioration factors for chlorinated water at a given temperature, one must be cautious to not over interpret the data, since the reproducibility range for crack growth rates at a given ΔK value is also typically found to be in the order of a factor

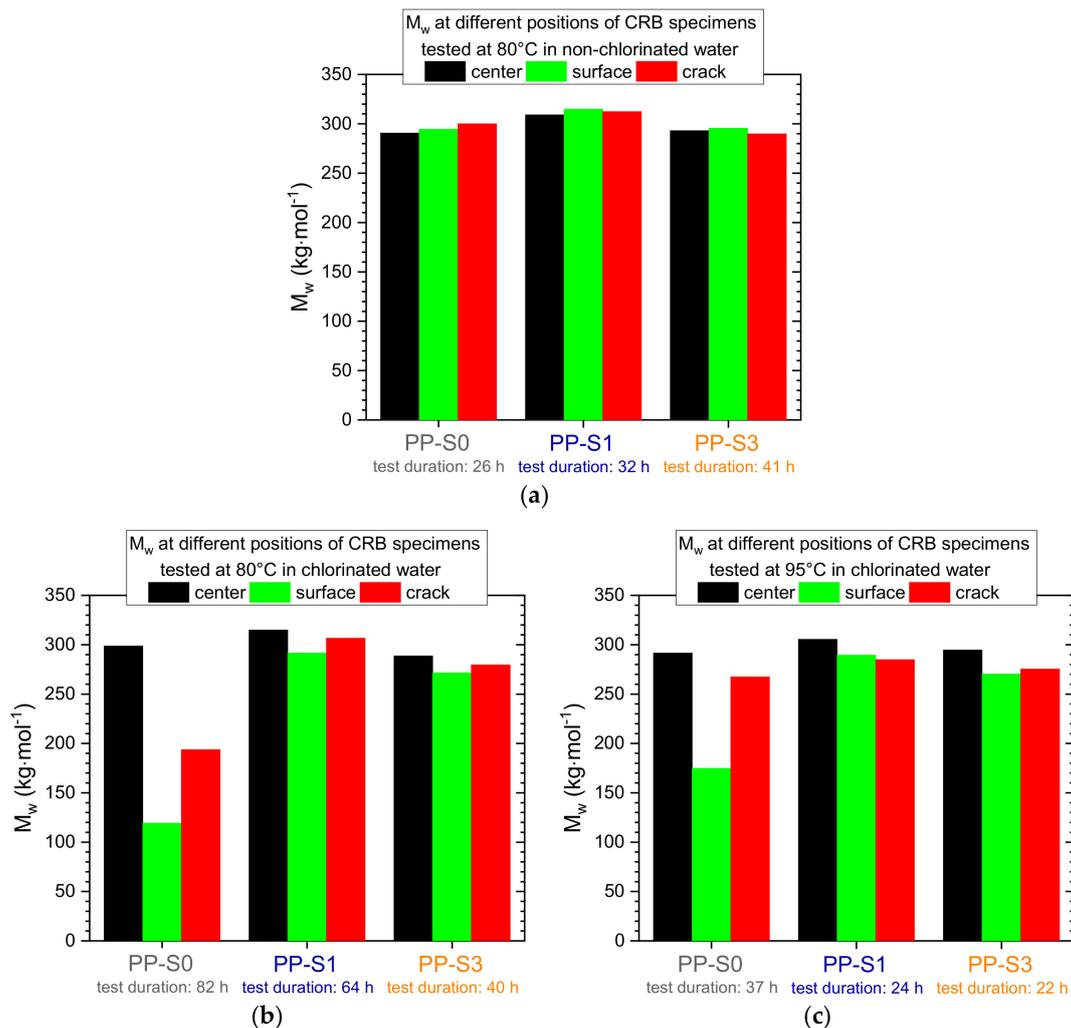
Figure 6. Mean weight average molar masses (M_w) of samples taken from three different positions in CRB specimens of PP-S0, PP-S1, and PP-S3, which were tested under superimposed mechanical-environmental conditions. The fatigue crack growth tests were performed at (a) 80 °C in non-chlorinated water (0 mg/L free chlorine); (b) 80 °C in chlorinated water (5 mg/L free chlorine); and (c) 95 °C in chlorinated water (5 mg/L free chlorine). The total FCG test duration is also indicated.

In sharp contrast, significant molecular degradation was detected for the surface and crack position of PP-S0, containing no long-term stabilization, when tested in chlorinated water at 80 °C (Figure 6b) and at 95 °C (Figure 6c). For example, when tested in chlorinated water at 80 °C, the M_w value at the surface position of a CRB specimen tested for 82 h dropped to 119 kg/mol, whereas the M_w value at the crack position was reduced to 194 kg/mol. Compared to the M_w value of 299 kg/mol for the center position of this CRB specimen, which was not directly exposed to the liquid environment while being tested, this corresponds to an M_w reduction of 60% for the surface position and 35% for the crack position. Analogous reductions, albeit less pronounced, were found for the M_w values of PP-S0 at the surface and crack positions when tested in chlorinated water at 95 °C for 37 h (Figure 6c). In this case, the not directly medium exposed center position exhibited an M_w value of 292 kg/mol,

while the corresponding numbers for the surface and crack position were found to be 175 kg/mol and 267 kg/mol, respectively. In relative terms, these reductions amount to 40% and 8%, respectively. Apparently, the total test duration and, hence, the total direct exposure time of local material regimes to chlorinated water, may be the key parameter determining the degree of local aging, at the specimen surface or at the fracture surface. In other words, the higher reduction in M_w at the surface and crack positions for tests performed at 80 °C versus those at 95 °C are believed to be a result of the twice as long test duration from the start of the test to ultimate failure (82 h at 80 °C vs. 37 h at 95 °C). This also may help explain why the molecular degradation at the surface position is more pronounced than at the crack position. Thus, the surface position is exposed directly to the chlorinated water for the entire duration of the FCG experiment, whereas the crack position is exposed essentially only to the fraction of the total test time once crack growth initiation commences and stable crack growth takes place.

By comparison, the local alterations in the M_w values of samples taken from the surface and crack positions compared to the center position of the long-term stabilized PP grades PP-S1 and PP-S3 are much less pronounced. While this provides clear evidence of the stabilization effectivity in terms of retarding local molecular degradation under chlorinated water conditions at elevated temperatures in these latter two materials, the data do reveal some local molecular degradation even for these long-term stabilized materials. For example, comparing the crack position to the center position of failed CRB specimens of PP-S1 and PP-S3, for both materials, M_w reductions of about 3% and 7% were detected for tests in chlorinated water at 80 °C and at 95 °C, respectively. In this case, it must be kept in mind that the overall test duration to generate FCG curves for PP-S1 and PP-S3 was shorter than the test time for PP-S0. Moreover, when focusing on the ultra-high molar mass fraction of the molecular mass distribution with molar masses above 3000 kg/mol , the analysis of the local aging states of surface and crack samples of tests in chlorinated water at 80 °C and 95 °C, respectively, revealed a reduction of this ultra-high molar mass fraction by about 9% and 25%.

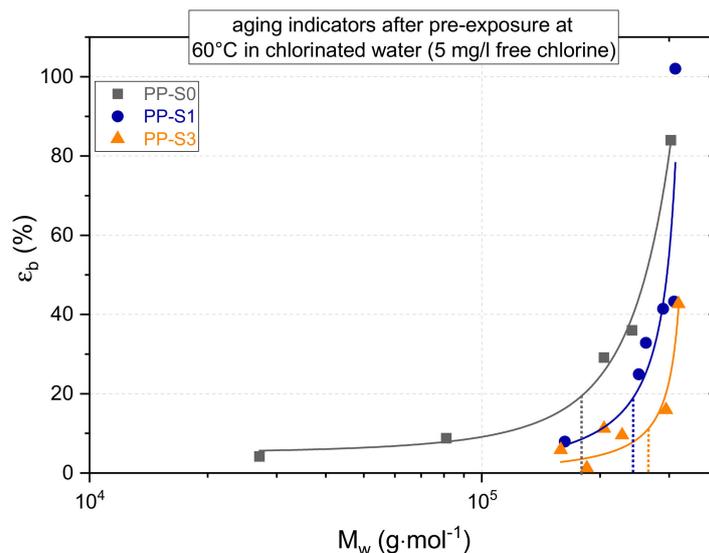
Figure 7. Dependence of strain at break values (ϵ_b) of the three aged PP grades on the mean molar mass (M_w) of these materials in the aged state with indications on the vertex (dotted line) of the fit curvature representing the characteristic embrittlement mean molar mass of the materials (PP-S0: 180 kg/mol), PP-S1: 243 kg/mol, PP-S3: 265 kg/mol).

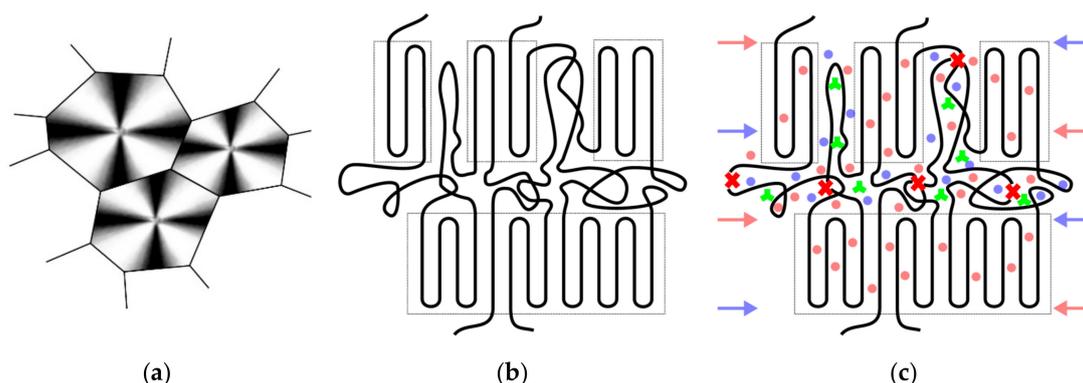
Figure 8. Schematic of key features of the inner material structure of semi-crystalline polymers and the interaction with environmental conditions, (a) spherulite structure, (b) stacked lamellar structure with inter-spherulitic and inter-lamellar amorphous domains with tie molecules and entanglements, and (c) stacked lamellar structure with stabilizers in the amorphous regions (green stars) and interaction with environmental conditions (temperature: red arrows and dots, liquid: blue arrows and dots) leading to aging-induced chain scission (red crosses) in the amorphous regime.

While there may be numerous reasons for different stabilizer systems to cause alterations in the shape of the MMD upon material global aging (i.e., various degrees of MMD broadening and multimodality), an important aspect to consider is that aging in semi-crystalline polymers is believed to occur predominantly in the amorphous regimes between spherulites and crystal lamellae [12,43]. These regimes, however, represent also the areas, where stabilizers are preferentially situated and where environmental liquids such as chlorinated water penetrate into the polymer [12,43]. Taken together, these three aspects also explain why and, to some degree, how the aging kinetics is influenced by the presence of stabilizers and the type and concentration of stabilizer systems used. In terms of chemical polymer aging and molecular degradation, it is especially critical if the inter-spherulitic and inter-lamellar tie molecule and entanglement density is affected. This inter-spherulitic and inter-lamellar molecular degradation mechanism along with some of the micro-structural features and the presence of stabilizers along with the present environmental conditions (temperature and aggressive liquids) is shown in Figure 8.

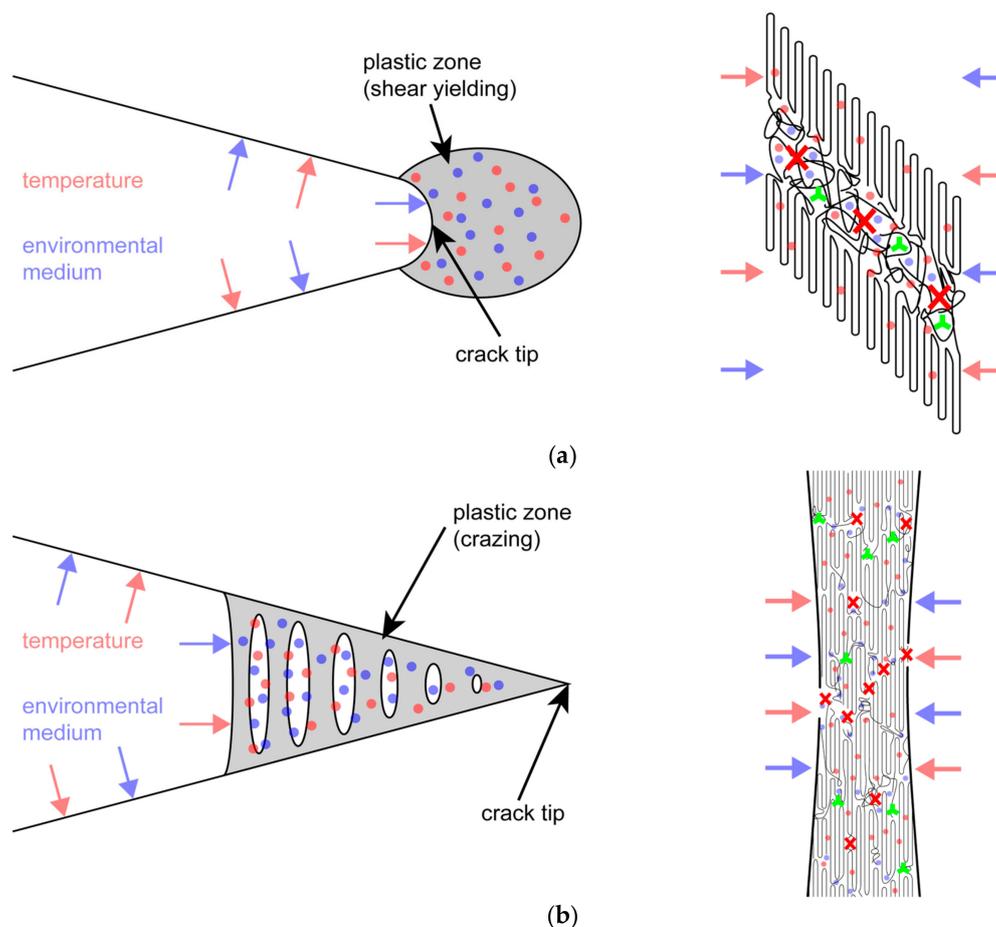
Figure 9. Schematic illustration of the crack tip region under superimposed mechanical-environmental loading (red arrows and dots representing temperature, blue arrows and dots representing environmental liquid, green stars representing stabilizer molecules, red crosses representing molecular chain scission). (a) Plastic deformation by shear yielding with the crack tip shear yield zone (**left**) and irreversible shear deformation of semi-crystalline lamellar structure (**right**). (b) Plastic deformation by crazing indicating the wedge-shaped fibril/void structure of a crack tip craze (**left**) and a highly stretched semi-crystalline craze fibril (**right**).

While the above data provide clear evidence on the deteriorating effects of the chlorinated water environment on local crack tip aging, the micro and molecular mechanisms believed to cause these local crack tip aging effects are not so clear. A schematic illustration of the main mechanisms believed to be involved is provided in Figure 9 for the two primary crack tip plastic zone formation mechanisms of shear yielding (Figure 9a) and crazing (Figure 9b). According to the hypothesis of local crack tip aging [32,33], the superposition of high mechanical stresses and an oxidative environmental medium (e.g., gaseous or liquid) at an elevated temperature may greatly enhance any chemical aging reactions immediately in the crack tip region [12,15,32–36]. For plastic deformation by shear yielding (Figure 9a), a liquid environmental medium may accelerate local aging by the following mechanisms. Facilitated by the enhanced free volume of the mechanically stressed material, the liquid may penetrate and diffuse more easily into the shear yield zone via the amorphous domains. The liquid may then act to leach out some of the stabilizers in the shear yield zone, on the one hand, and simultaneously may cause enhanced stabilizer consumption within the shear yield zone. Both mechanisms will accelerate chemical aging in the crack tip shear yield zone, which leads to faster crack growth rates, particularly when inter-lamellar and inter-spherulitic tie molecules and entanglements are affected by molecular degradation. For crack tip plastic deformation by crazing (Figure 9b), analogous mechanisms are envisaged, which are reinforced by two additional factors. First, the fibril/void network of a craze together with the larger material surface to volume ratio allows for a much better access of the liquid, which accelerates liquid penetration and diffusion and, hence, stabilizer leakage and consumption. Second, the stretch ratio of craze fibrils is typically higher than the one in shear zones [52], which represents a more critical deformation state. This may also enhance the oxidation-enhanced cleavage of inter-lamellar and inter-spherulitic tie molecules and entanglements. While the above failure mechanisms and processes are plausible and may serve as phenomenological explanations of the observed effects under superimposed environmental loading of fatigue crack growth experiments, further research will need to be performed to corroborate these conclusions and to elucidate further details of the stress-environment-material deformation interactions.
