Article

The Effects of Eccentric Web Openings on the Compressive Performance of Pultruded GFRP Boxes Wrapped with GFRP and CFRP Sheets

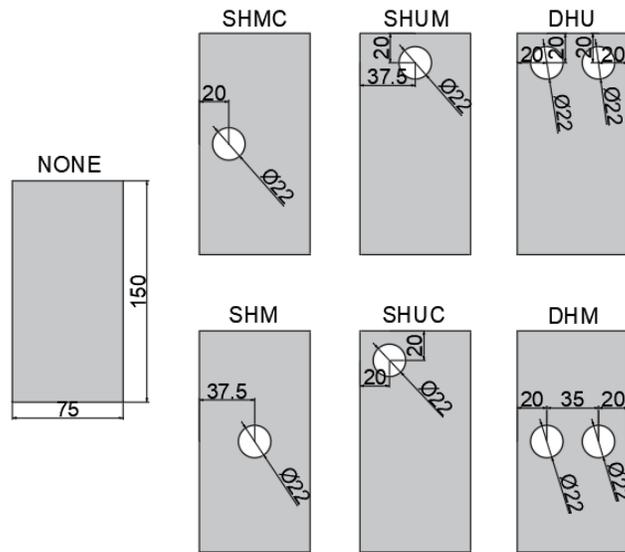
Figure 1. Specimens with same opening size with different location, dimensions are mm.

Hole diameters were kept constant at 22 mm. Reference specimens without holes were also considered. The openings were considered at different locations and two holes were also drilled in some specimens to investigate the effects of the number of holes on the capacity. The specimens were coded as no holes (None); single-hole center (SHC); single-hole middle corner (SHMC); single-hole upper corner (SHUC); single-hole upper middle (SHUM); double-hole middle (DHM); and double-hole upper (DHU). The specimens with openings are shown in Figure 1. Vertical loads were applied to the samples in the direction shown in Figure 1. Furthermore, the specimens were strengthened with two types of composites: single-layer 800 gr/m² 0° CFRP and 1200 gr/m² 0° GFRP. The fiber direction is in the direction of the load. P represents no strengthening, C represents CFRP strengthening, and G represents GFRP strengthening.

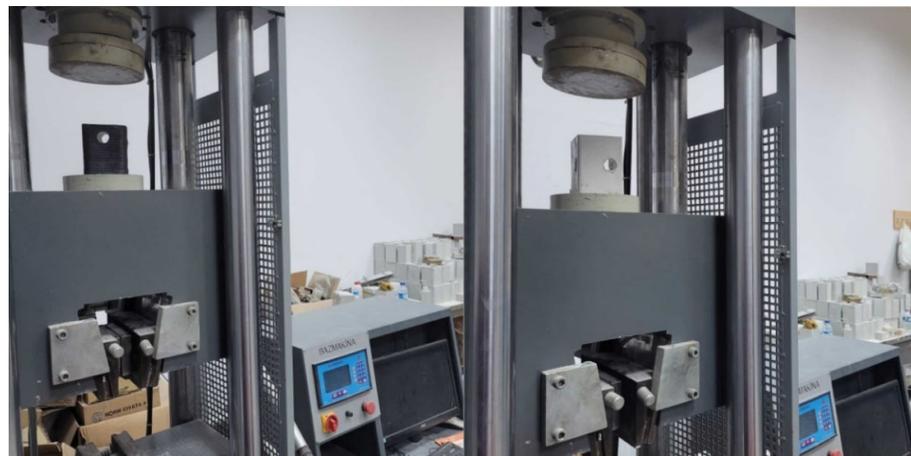
The specimens were tested under compressive loading. The test setup with a capacity of 600 kN shown in Figure 2 was utilized to perform the tests. The test setup has a servo-controlled hydraulic actuator which has a loadcell with a capacity of 600 kN and a displacement sensor. The displacements and loads were automatically recorded during the experiments. The specimens were loaded at a speed of 2 kN/s.

Figure 2. Test setup.

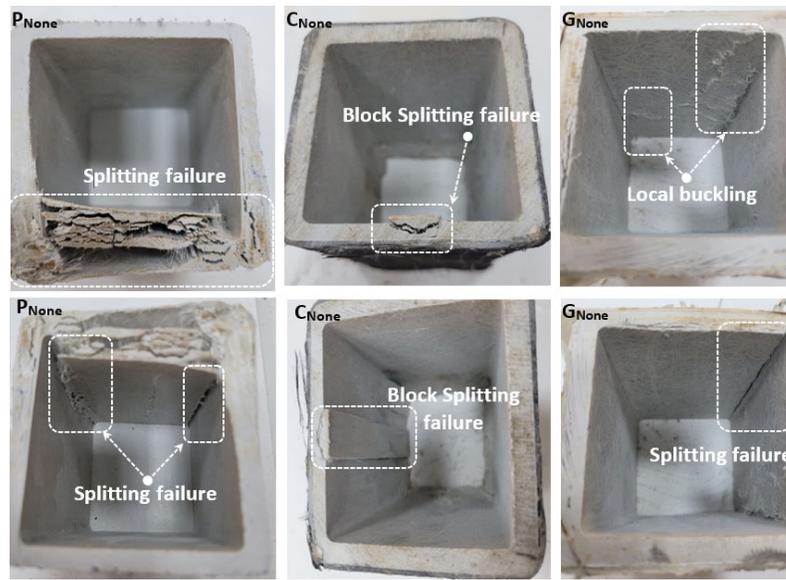
Compared to P_{None} , the load-carrying capacity of the carbon and glass-wrapped C_{None} and G_{None} specimens increased by 3.1% and 1.7%, respectively, when comparing the specimens with no holes drilled first. However, the initial stiffness values increased due to the winding effect. This situation is understood by the increase in the angle made with the horizontal in the load-displacement curve. In addition, comparative damage analyses are shown in Figure 3. When Figure 3 is examined, crushing and splitting failure damage was observed in the profile cross-section due to the pressure effect in the P_{None} specimen. In addition, splitting failure occurred at the corner points along the profile height, and the experiment was terminated. As a result of the reinforcement of the P_{None} specimen with carbon and glass fiber, it was determined that there were significant differences in the damage behavior. First, no splitting damage was observed in the profile cross-section. In addition, as a result of reinforcement with carbon fiber, splitting failure damage at corner points is prevented. However, the damage type caused a block splitting failure in the middle of an edge. Glass fiber reinforcement partially reduced the splitting damage at the corner points. However, local buckling failure has been observed here. As a result of the damage analysis, the applied carbon and glass fiber reinforcements did not show a significant increase in the load-carrying capacity of the unperforated specimen, but changing the final damage type was an indicator of the wrapping efficiency.

Figure 3. Damage analyses of PNone, CNone, GNone.

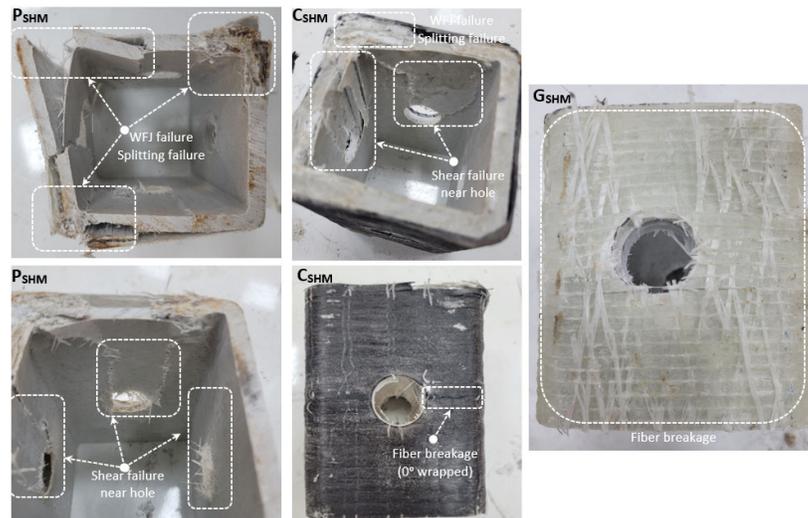
Significant differences occurred in the load-carrying capacity and damage analyses of the specimens called SHM, which opened with a diameter of 22 mm in the middle of the four sides of the PGFRP profile (in Figure 4). According to P_{SHM}, there was an increase of 3.0% and 1.9% in the load carrying capacity of C_{SHM} and G_{SHM}, respectively. Although reinforcement with the carbon fiber provides an increase in the load-carrying capacity compared to glass fiber, the increase rate is at a very low level compared to P_{SHM}. As the load increased in P_{SHM}, shear damages occurred around the hole, crushing in the pressure region and splitting damages occurred in the web flange junction (WFJ) region, and the experiment was terminated. At the end of the experiment, the reinforcements applied with carbon and glass prevented the profile from separating from the corner points. However, in both reinforcement applications, shear damage around the hole and fiber breakage were observed on the profile surface. The fact that the profile remains, as a whole, at the end of the test and no debonding damage is observed indicates that the selected fiber materials have sufficient strength and that the winding is effective.

Figure 4. Damage analyses of P_{SHM}, C_{SHM}, G_{SHM}.

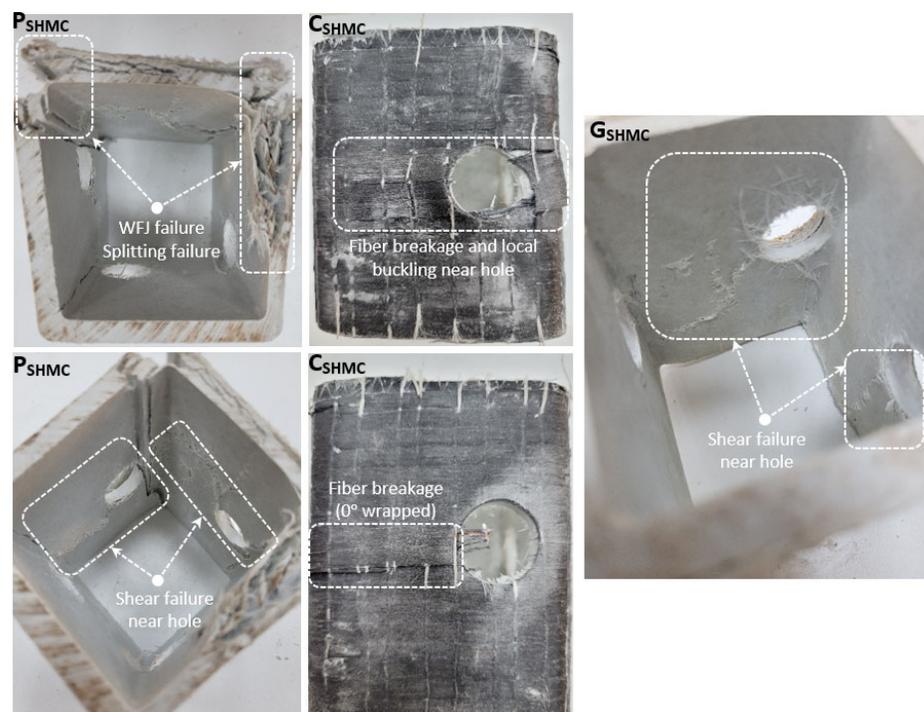
The 22 mm hole diameter drilled into the SHMC sample was drilled in the middle of the height and 20 mm inside from the corner (in Figure 5). In addition, the SHMC sample was reinforced with CFRP and GFRP. Increases of 10.9% and 8.5% were observed in the load-carrying capacity of the reinforced samples (C_{SHMC} and G_{SHMC}) compared to P_{SHMC} , respectively. The load-carrying capacity of P_{SHMC} decreased by 13.9% compared to P_{SHM} , while the reinforced C_{SHMC} and G_{SHMC} decreased by 7.3% and 8.3% compared to C_{SHM} and G_{SHM} , respectively. Strengthening the hole drilled in the S_{HMC} sample with CFRP and GFRP both changed the damage type and limited the decrease in load-carrying capacity. When the specimens whose damage analysis is given in Figure 5 are examined, a splitting failure was observed in the WFJs in P_{SHMC} due to the pressure effect. In addition, shear damage occurred around the hole. Here, the shifting of the hole on the specimen to the edge caused a decrease in the load-carrying capacity and a faster collapse. WFJ damage was not seen in both C_{SHMC} and G_{SHMC} , and WFJ damage, especially in the corner areas, was prevented. Local buckling damage was observed around the hole in C_{SHMC} and G_{SHMC} , while shear damage was observed around the hole. The fact that the drilled hole is close to the edge caused the applied load to be eccentric and the damages to occur, especially in the area close to the hole. This prevented the formation of WFJ damage in the upper parts of the strengthened specimens. Because of fiber breakage, shear failure and local buckling damage around the hole, which is the weakest link, this accelerated the end of the experiment.

Figure 5. Damage analyses of P_{SHMC} , C_{SHMC} , G_{SHMC} .

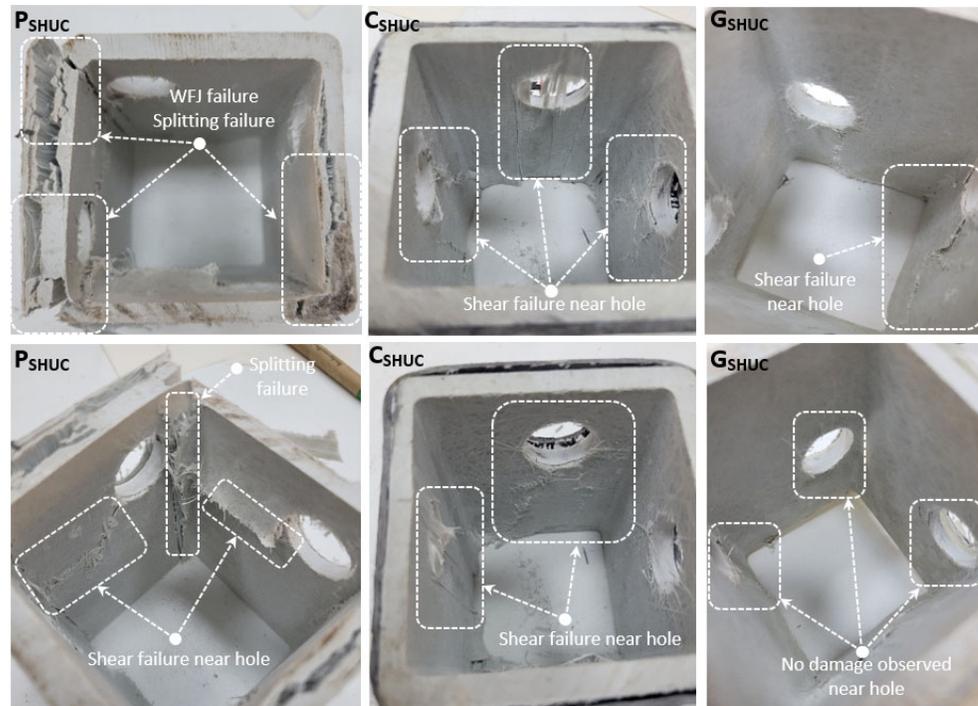
The hole location in the SHUC sample is similar to the SHMC and was created 20 mm from the bottom and edge (in Figure 6). This led to a reduction in load-carrying capacity. According to P_{SHUC} , there was a 10.9% and 7.2% increase in payload capacity at C_{SHUC} and G_{SHUC} , respectively. The load-bearing capacity of P_{SHUC} decreased by 19.1% compared to P_{SHM} , while the fortified C_{SHUC} and G_{SHUC} decreased by 12.8% and 14.9% compared to C_{SHM} and G_{SHM} , respectively. This showed that the web opening eccentrically away from the center reaches less load-carrying capacity. Splitting damages were observed in the WFJ part of the P_{SHUC} , which was considered as a reference (Figure 6). In addition, shear damage around the hole and splitting failure occurred at the corners along the profile height. The fact that the web opening on the specimen was at the bottom and

close to the edge caused a further decrease in the load-carrying capacity and a faster collapse compared to P_{SHM} . WFJ damage was not seen in both reinforced C_{SHUC} and G_{SHUC} , and WFJ damage, especially in the corner areas, was prevented. In addition, the specimens reinforced with carbon had more shear damage around the hole, while the specimens reinforced with GFRP had shear damage around only one hole. The fact that the web opening was at the bottom and close to the edge caused the damage to occur, especially in the area close to the hole. This prevented the formation of WFJ damage in the upper caps of the strengthened specimens. Because the shear failure damage around the hole, which is the weakest link, caused the experiment to be terminated.

Figure 6. Damage analyses of P_{SHUC} , C_{SHUC} , G_{SHUC} .

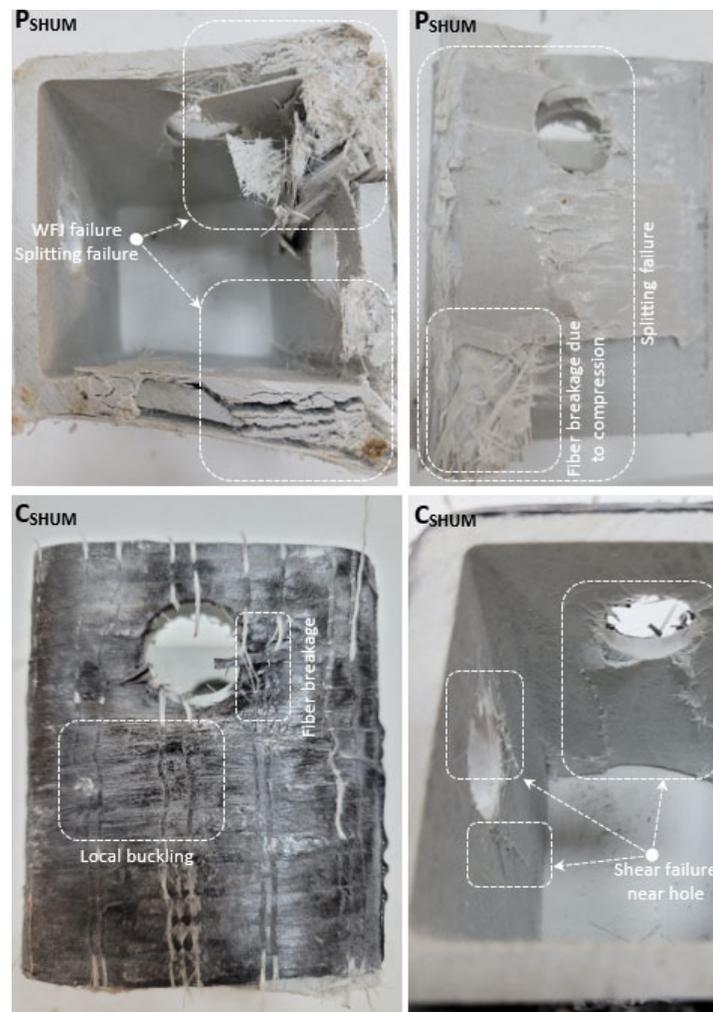
The load-carrying capacity of the unreinforced P_{SHUM} specimen increased by 16.1% and 9.2%, respectively, compared to P_{SHUC} and P_{SHMC} , and decreased by 6% and 13.5%, respectively, compared to P_{SHM} and P_{None} . This shows that the hole diameters opening in the center of the profile contribute more to the load-carrying capacity. Increases of 4.2% and 2.5%, respectively, were observed in the load-carrying capacity of the reinforced specimens (C_{SHUM} and G_{SHUM}) compared to P_{SHUM} . In addition, the rate of increase in specimens with an eccentric web opening diameter is similar. This shows that the increase in load-carrying capacity is limited by strengthening the web opening in the center of the specimens. Therefore, it is understood that reinforcement materials contribute to carrying more load in specimens with eccentric placement. The rate of increase in C_{SHUM} and G_{SHUM} and the rate of increase in C_{SHM} and G_{SHM} (3% and 1.9%, respectively) are approximately similar. The load-carrying capacity of C_{SHUM} and G_{SHUM} decreased by 4.9% and 12.6%, respectively, compared to C_{SHM} and G_{SHM} , while it decreased by 5.4% and 12.8% compared to C_{None} and G_{None} . This shows that the load-carrying capacity is further increased by strengthening the holes in the middle of the specimen's height. In the P_{SHUM} specimen, splitting damage occurred in the WFJ part with the effect of pressure (Figure 7).

Figure 7. Damage analyses of P_{SHUM} , C_{SHUM} , G_{SHUM} .

In addition, splitting failure was observed in the corner part along the profile height. Particularly, shear damage failure occurred around the hole, which is the weakest link, causing a sudden decrease in the load-carrying capacity. However, this damage occurred at a higher load value than P_{SHUC} , depending on the hole position. Both reinforced C_{SHUM} and G_{SHUM} have no WFJ damage, and WFJ damage, especially in corner areas, is blocked by reinforcement materials. In addition, shear damage occurred around the hole of the specimens reinforced with CFRP and GFRP, however, the progression of these damages was limited. As a result, the reinforced specimens had a more stable appearance at the end of the experiment, and the absence of debonding damage showed that the selected fiber materials were suitable for reinforcement.

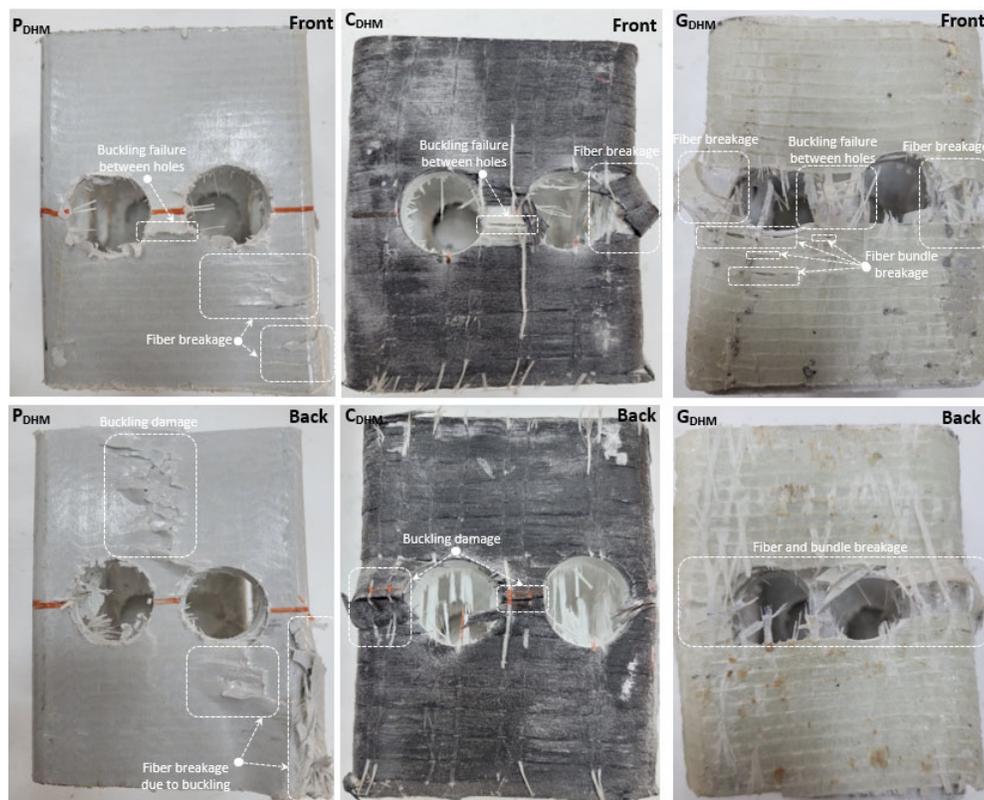
Since the number of web openings in the DHM specimen is two on one side, the load-carrying capacity is significantly less than the specimens with a single hole diameter. While the load-carrying capacity of P_{DHM} decreased by 53.5% compared to P_{None} , the decrease rate of C_{DHM} and G_{DHM} compared to C_{None} and G_{None} specimen was 49.6% and 52.9%, respectively. The increase rate of the strengthened C_{DHM} and G_{DHM} compared to P_{DHM} was 12% and 3.1%, respectively. This shows that the reinforcement made with carbon fiber contributes more to the load-carrying capacity than glass fiber. The load-carrying capacity of the P_{DHM} specimen compared to P_{SHMC} decreased by 41.4%, while the load-carrying capacity of C_{DHM} and G_{DHM} compared to C_{SHMC} and G_{SHMC} decreased by 40.8% and 44.3%,

respectively. In addition, it is understood that the two web openings in the profile considerably reduced the load-carrying capacity and that these specimens cannot be effective even if they are strengthened. As can be seen in Figure 8, a buckling failure occurred between the web openings in P_{DHM} , C_{DHM} , and G_{DHM} specimens. This is due to the small distance between the holes. In addition, fiber breakage damage was observed in the corner region of P_{DHM} with the effect of pressure, while this damage was prevented in the strengthened C_{DHM} and G_{DHM} specimens. Unlike C_{DHM} , fiber bundle breakage damage was also observed in the G_{DHM} specimen. Finally, it was understood from the ruptured fiber materials that the damages were concentrated around the hole, which is the most critical area in the strengthened specimens, and that the fiber materials were forced to prevent this damage.

Figure 8. Damage analyses of P_{DHM} , C_{DHM} , and G_{DHM} .

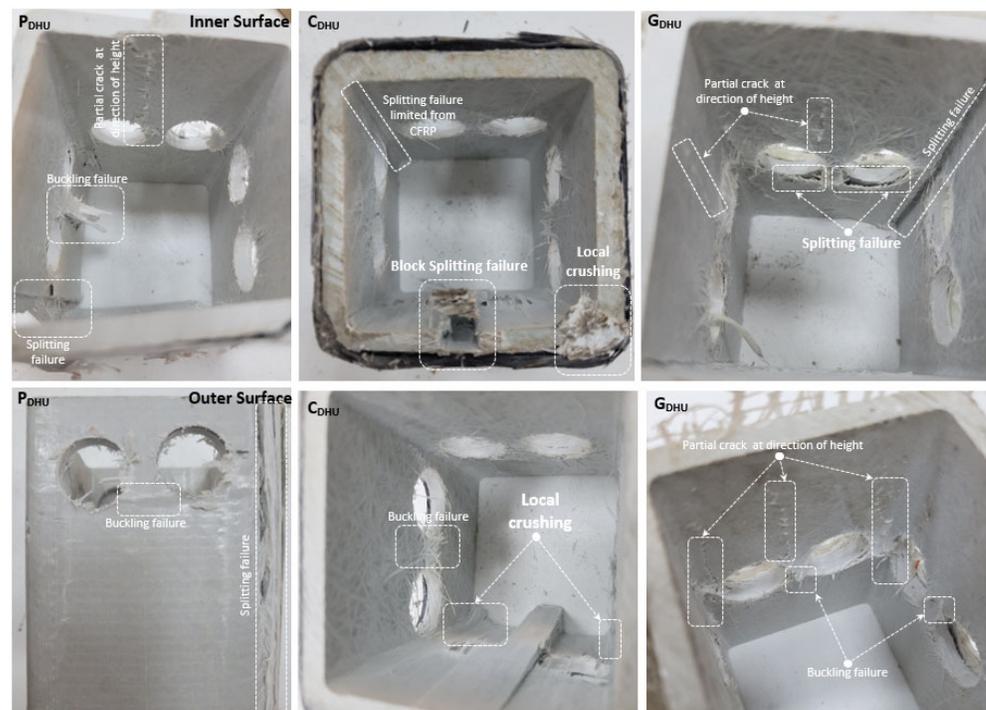
While the load-carrying capacity of the P_{DHU} specimens decreased by 14% compared to P_{DHM} , it decreased by 60.1% compared to P_{None} . The sample with the least load-bearing capacity among the non-reinforced specimens was obtained to be P_{DHU} . This shows that the load-carrying capacity can be significantly reduced according to the number of holes and hole location, and the number and location of the web openings are very important. The load-carrying capacity of the reinforced C_{DHU} and G_{DHU} specimens increased by 20.1% and 10.9% compared to P_{DHU} . In addition, the reduction in load-carrying capacity of C_{DHU} and G_{DHU} compared to the C_{None} and G_{None} specimens was 53.5% and 56.5%, respectively. Although the strengthening applications increase the load-carrying capacity, the fact that the load-carrying capacity is quite low compared to the specimen with no holes also shows that the capacity increase after strengthening will not be sufficient for the specimens with such holes. The load-carrying capacity of the P_{DHU} specimen decreased by 14.01%, 53.8%, 46.4%, 49.6%, and 56.6%, respectively, compared to P_{DHM} , P_{SHUM} , P_{SHUC} , P_{SHMC} , and P_{SHM} . The decentralization of the hole location greatly reduced the load-carrying capacity. Similarly, the load-carrying capacities of the reinforced C_{DHU} and G_{DHU} specimens were

decreased by 7.7–7.4%, 46.8–50.1%, 41.9–44.5%, 45.4–48.5%, and 49.4–52.8% according to CDHM-GDHM, CSHUM-GSHUM, CSHUC-GSHUC, CSHMC-GSHMC, and CSHM-GSHM, respectively. In Figure 9, the damage analyses of P_{DHU} , C_{DHU} , and G_{DHU} are shown. In the P_{DHU} , the damages occurred especially between the two holes. Splitting failure damage was observed in the corner region, as in all other non-reinforced specimens. However, along the specimen height, the cracks starting from the periphery of the hole were elongated and the buckling failure occurred in the region between the two holes. Differences occurred in the damage observed in C_{DHU} and G_{DHU} . In C_{DHU} , splitting damage was significantly inhibited by CFRP at the corner points, whereas in G_{DHU} splitting damage was quite evident. This led to less load bearing of the GFRP reinforced specimen. In addition, since no splitting damage was observed in C_{DHU} , block splitting failure (buckling) occurred in the region between the holes. This situation was not observed in G_{DHU} . Splitting damage around the hole and partial crack propagation along the profile height also occurred in G_{DHU} . Local crushing damages were observed at the points where the load was applied in all three specimens. The damages caused by the web opening in this specimen are especially concentrated around the hole.

Figure 9. Damage analyses of P_{DHU} , C_{DHU} , and G_{DHU} .

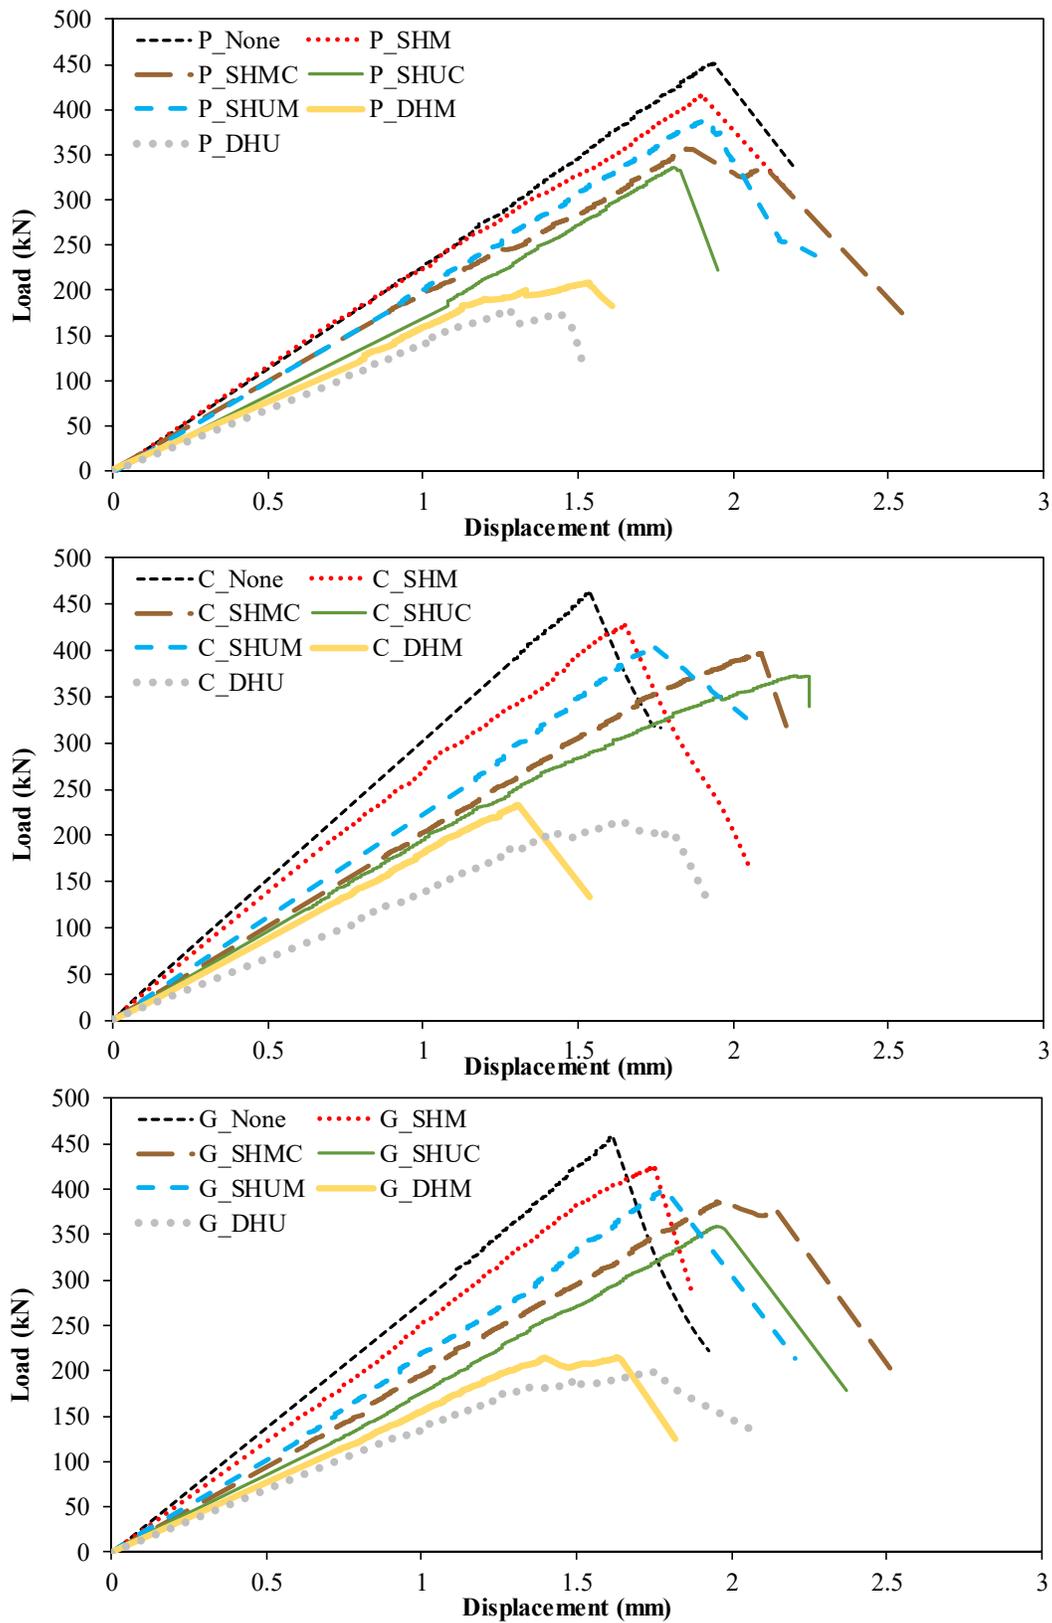
The damage analysis and comparison of each specimen were taken into consideration by considering the load-displacement curves shown in Figures 10 and 11. When the specimens represented with P in Figure 11 were compared, the web opening was close to the top of the profile and there were two holes, as a 60.1% decrease in load carrying capacity occurred compared to P_{None} . In addition, this ensured that the initial stiffness was minimal. However, according to P_{None} , the smallest decrease in load-carrying capacity was observed in the P_{SHM} specimen, where a single hole was opened in the middle at the middle height of the beam, resulting in a 7.9% decrease. This situation occurred similarly in the strengthened specimens.

Figure 10. Load–displacement curves of openings with different locations and numbers.

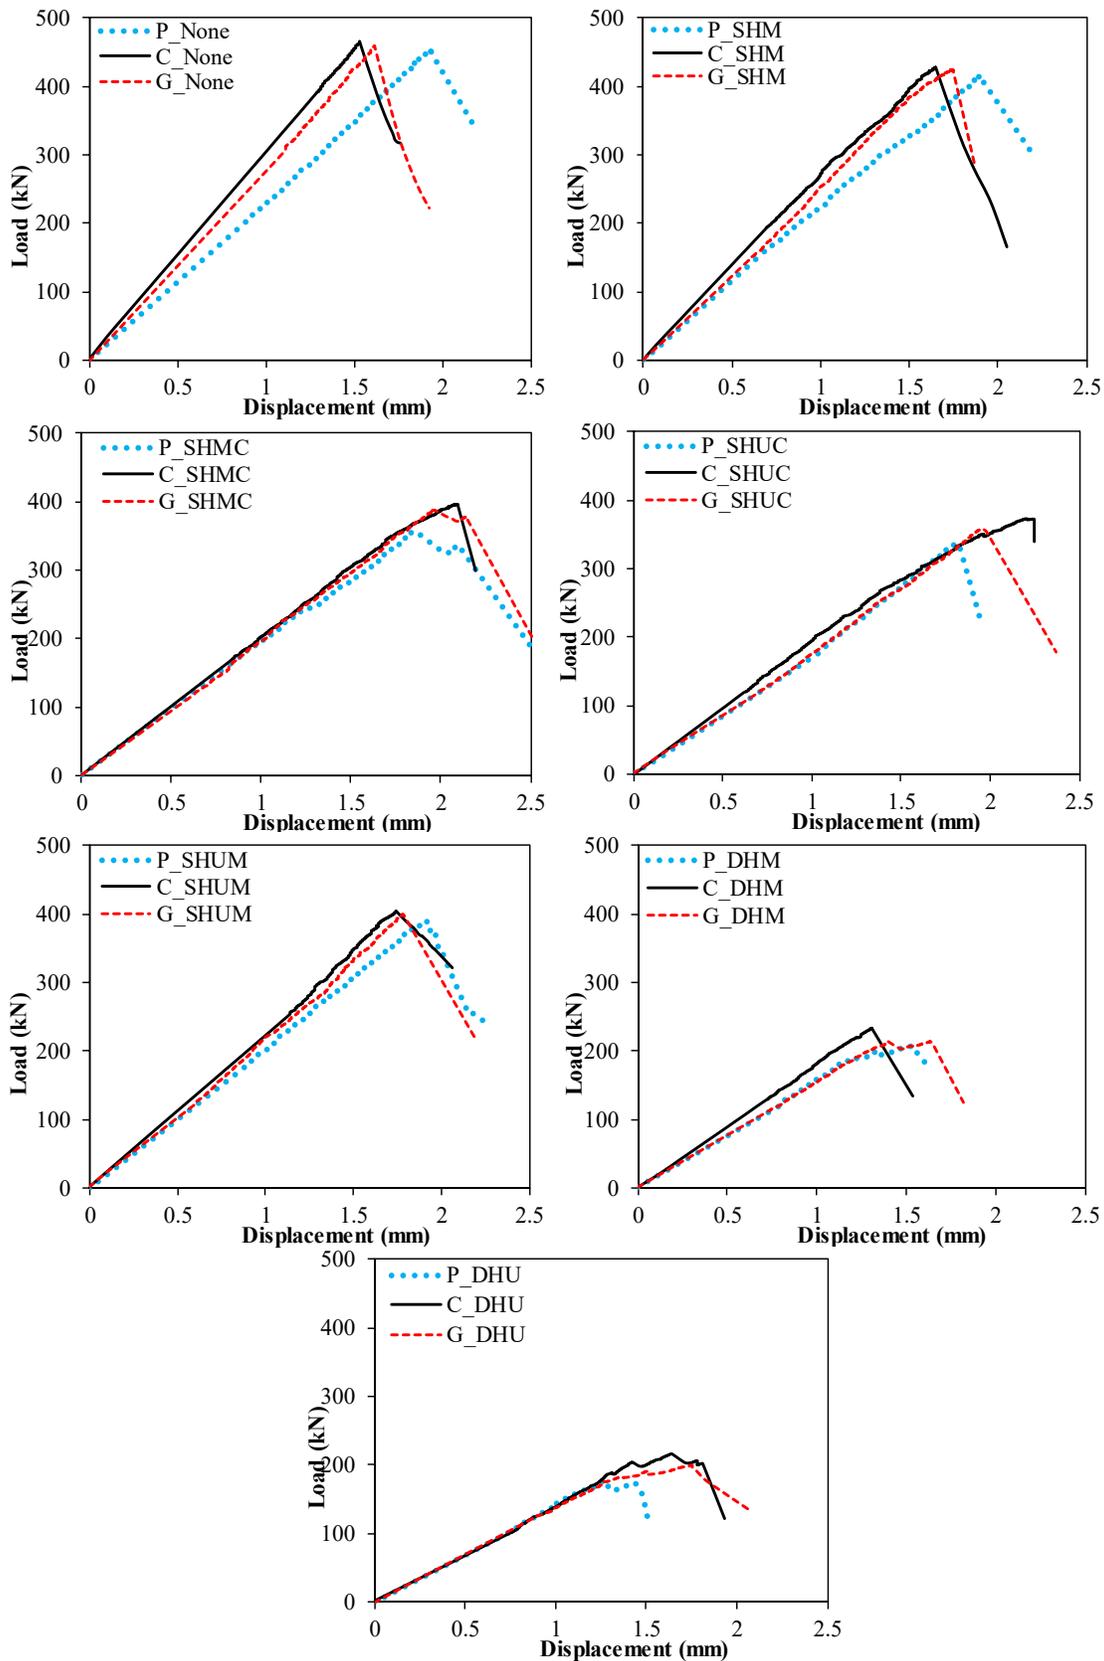
Figure 11. Effects of strengthening on different opening schemes.
