Article

# Glacial Lake Outburst Floods (GLOFs) in the Cordillera Huayhuash, Peru: Historic Events and Current Susceptibility

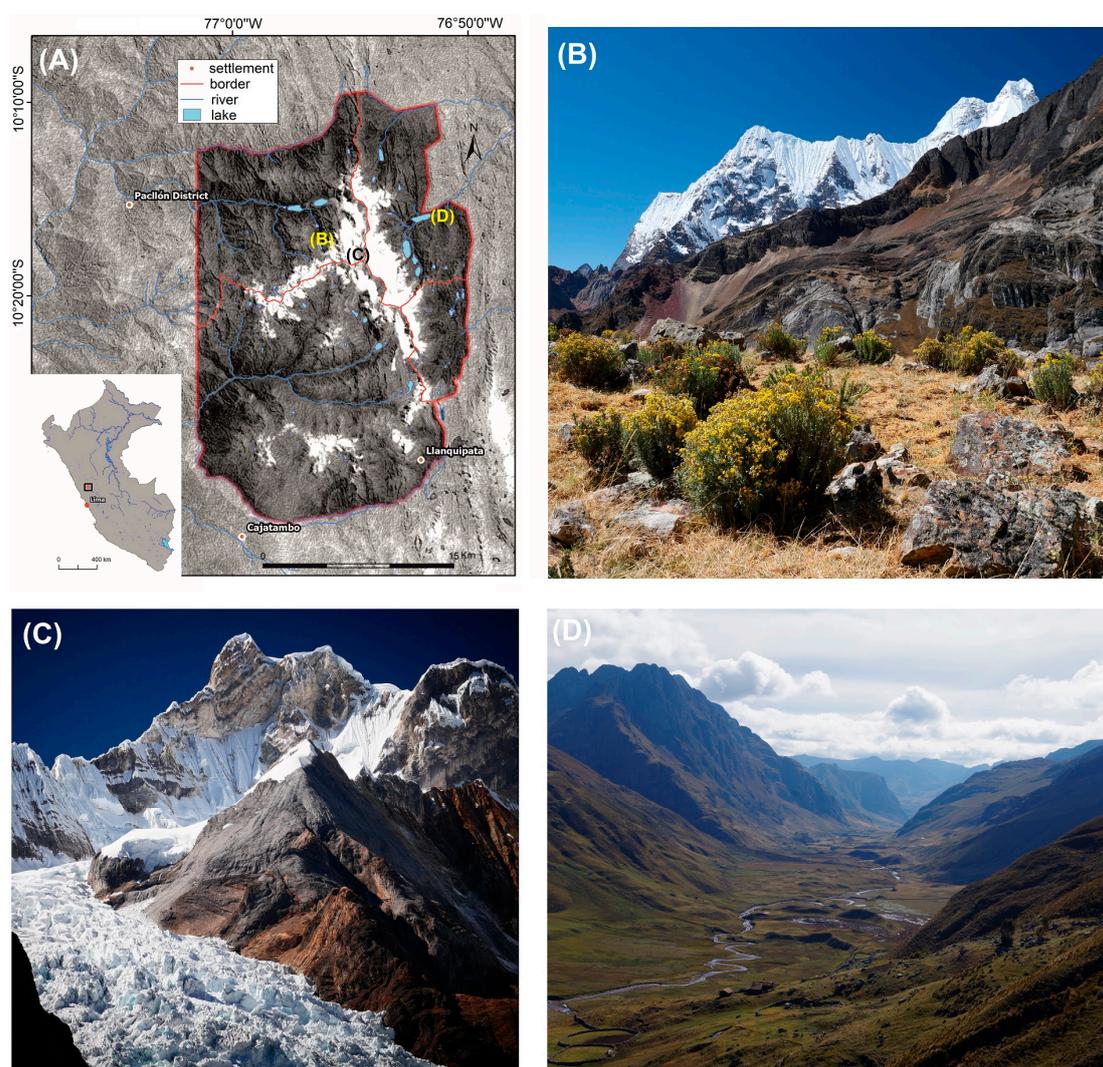
**Figure 1.** Study area. (A) The location of the study area Cordillera Huayhuash in Peru; (B), (C) and (D) diverse environmental conditions in different parts of the study area (for location see (A)). Field images were taken in 2018 and 2019 by AE.

The Cordillera Huayhuash is located about 200 km north of Peru's capital, Lima, and about 50 km south east from the Cordillera Blanca (10.3° S, 76.9° W; Figure 1); indeed, the Cordillera Huayhuash may be interpreted as the southern continuation of the Cordillera Blanca [28]. It is the second highest mountain range in Peru with Nevado Yerupajá reaching 6617 m a.s.l. Its main, largely glacierized spine stretches 25 km in a roughly north-south direction with two lateral ridges, each extending about 10 km to the west. The geological setting of the area is characterized by Cenozoic volcanic rocks (30–15 and 6 Ma) underlain by Cretaceous carbonates and quartzites and the Late Cretaceous Coastal Batholith, with a series of Late Miocene granitic plutons [28]. The Cordillera Huayhuash has been shaped by Quaternary glacial and fluvial erosion forming valleys perpendicular to the main ridge.

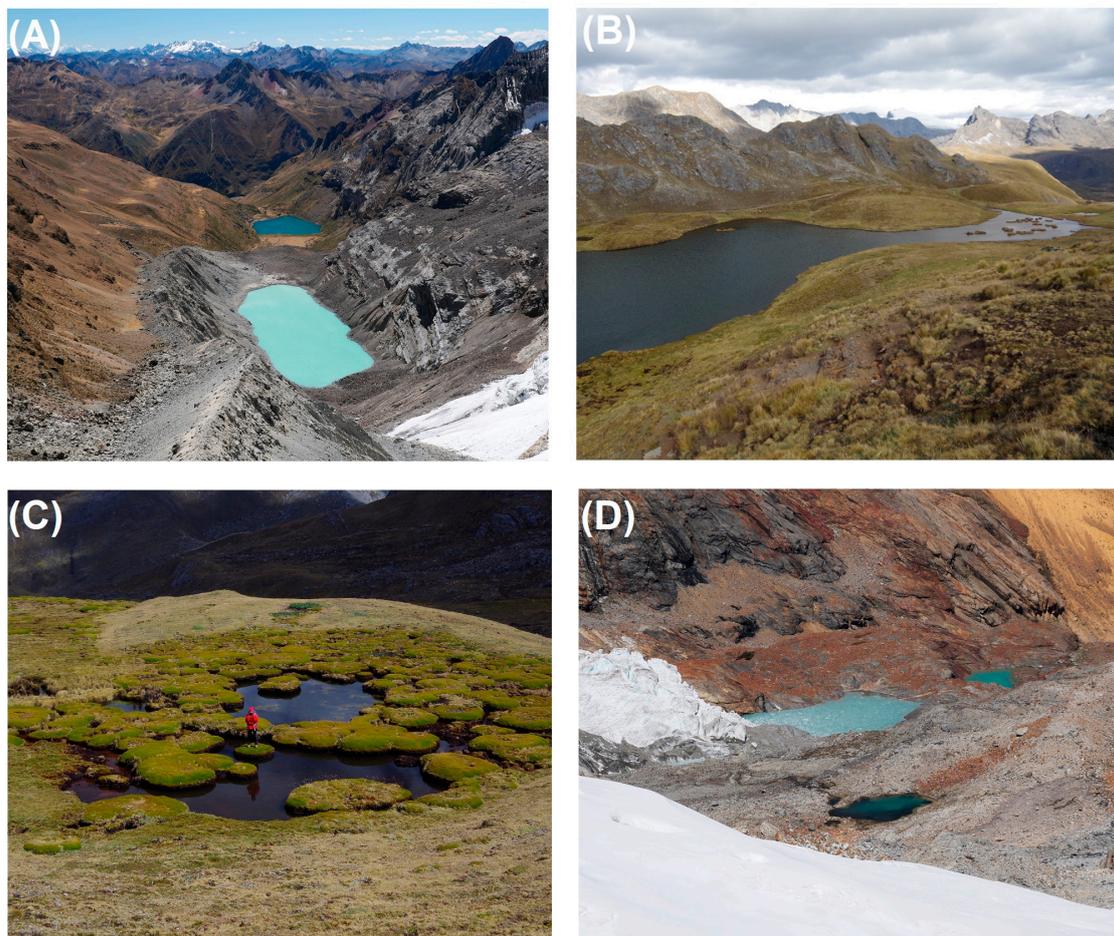
**Figure 2.** Different lake types present in the Cordillera Huayhuash. (A) Moraine-dammed lakes Barrosacocha (upstream, W006) and Rasaqcocha (downstream, W005); (B) large bedrock-dammed Lake Huaracocha (E012); (C) an example of relict ('pampa' type) lake near the Siula Punta; and (D) a small moraine- (in front) and two bedrock-dammed lakes (one of which is proglacial) near the Rasac Punta. All images were taken in 2018 and 2019 by AE.

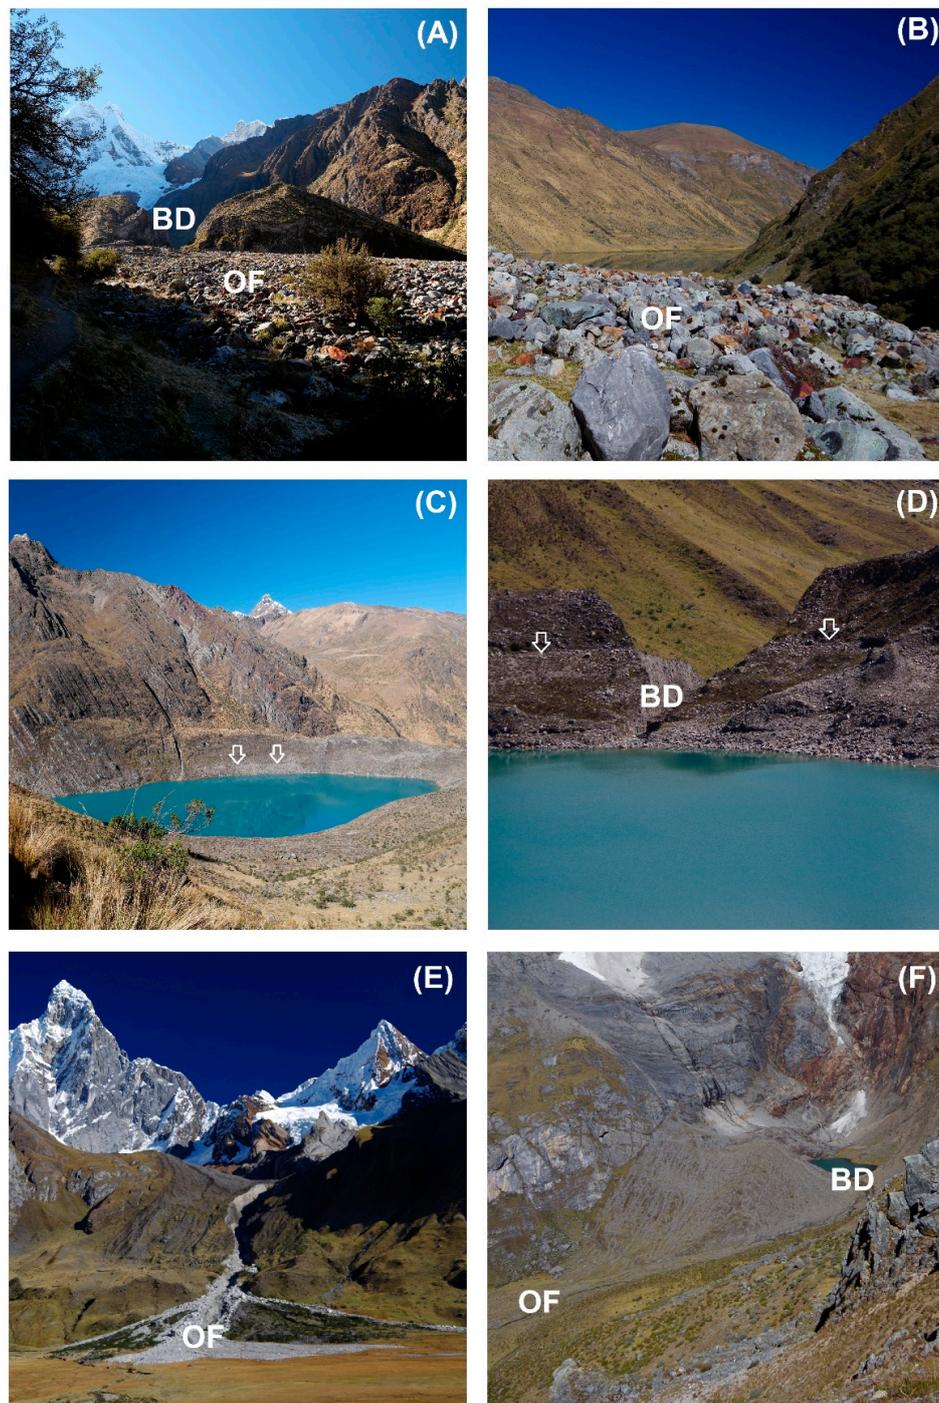
**Figure 3.** Examples of diagnostic features of past glacial lake outburst floods (GLOFs) in the Cordillera Huayhuash. (A) Upstream view on breached moraine dam (BD) of Lake Solteracocha (in centre background) with outwash fan located directly downstream from the dam (OF); (B) downstream view over this outwash fan (OF), the largest boulders are > 2 m in diameter; (C) visible evidence of Solteracocha pre-GLOF lake water level (arrows; GLOF in 1932); (D) downstream view through breached moraine dam (BD) of Lake Gangrajanca and pre-GLOF lake water level (arrows); (E) fresh outwash fan (OF) of recent ambiguous event associated with lake Chaclan; (F) breached moraine dam (BD) and partly vegetation-covered outwash fan (OF) of Unnamed lake (W032). All images were taken in 2018 and 2019 by AE.

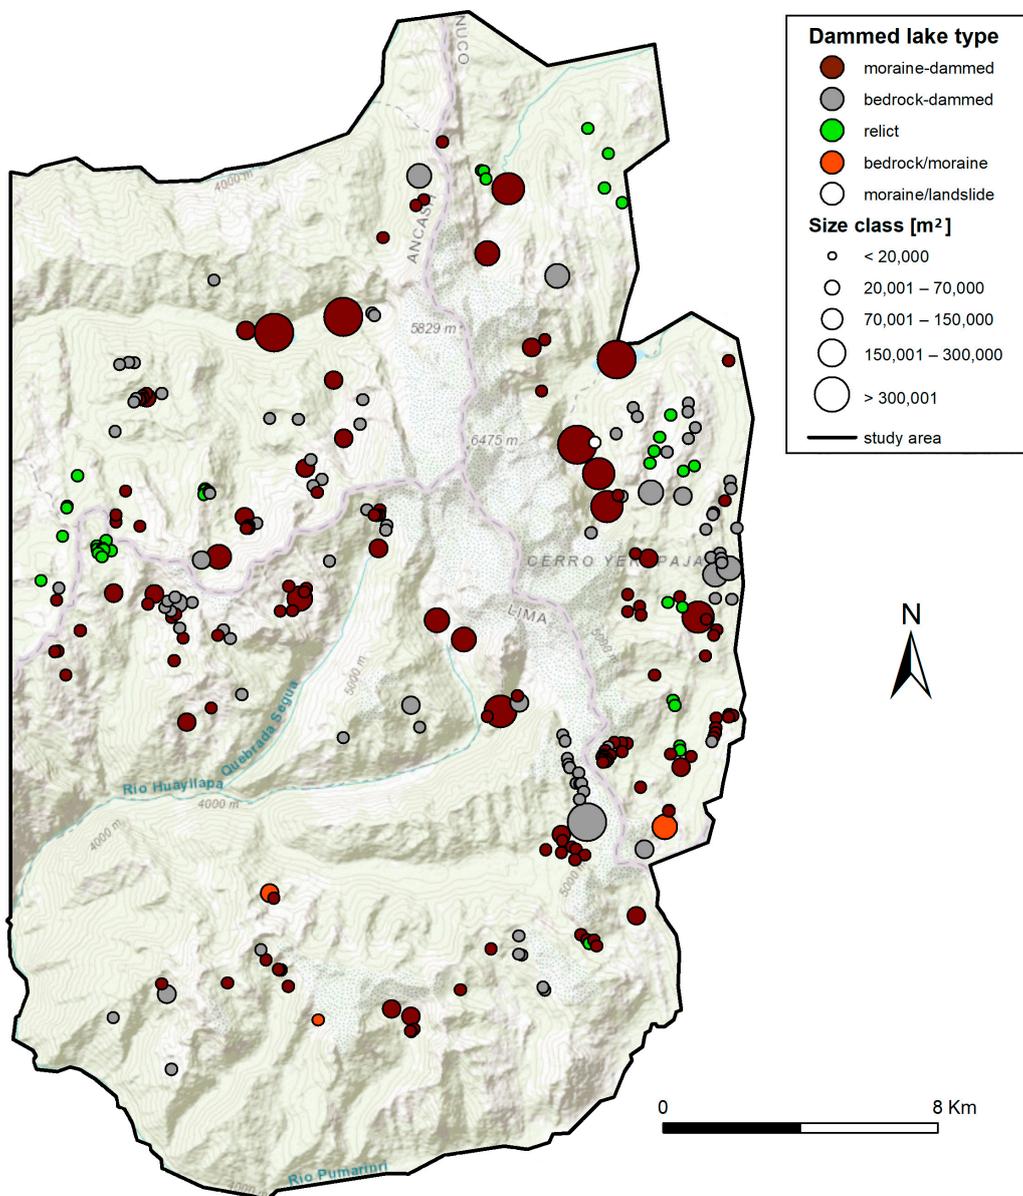
**Figure 4.** Lake inventory of the Cordillera Huayhuash with lake dam types (see Section 2.1 and Figure 2) and lake sizes. Background map: [40].

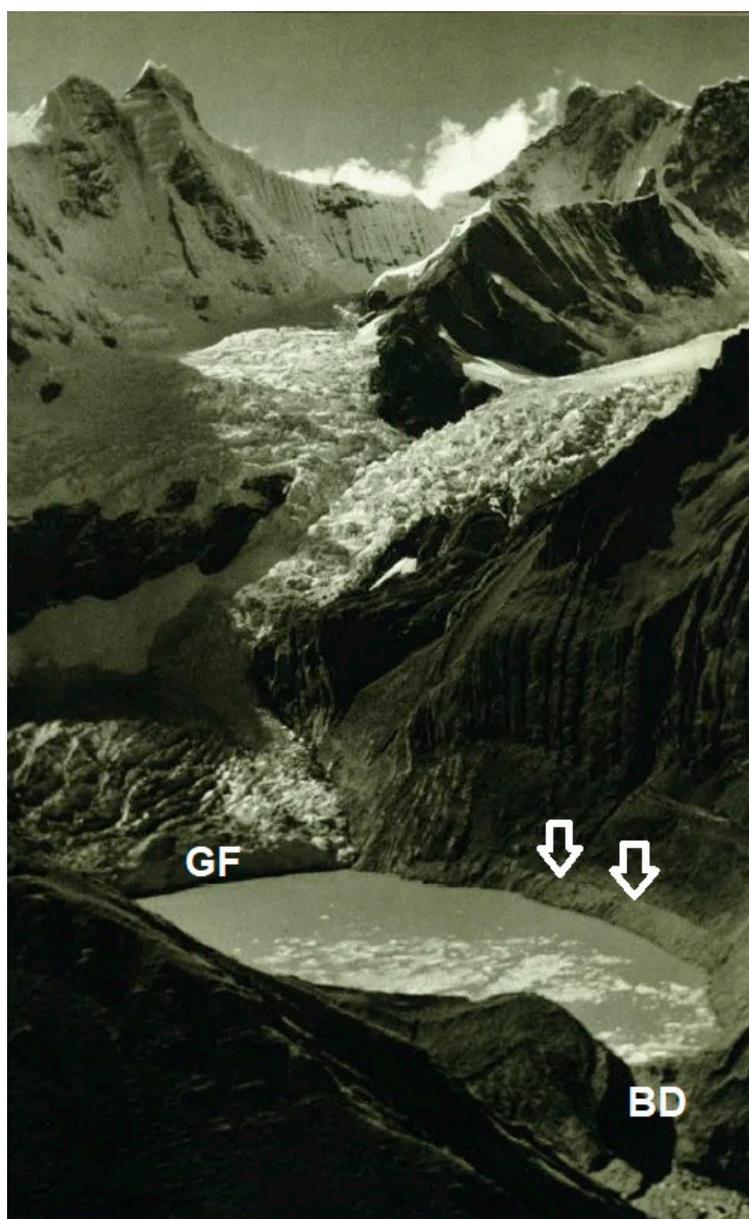
**Figure 5.** Lake Solteracocha in the 1930s (most likely in 1936), shortly after dam failure in 1932. Breached moraine dam (BD) is visible in lower right corner; arrows indicate pre-GLOF lake water level (also visible on Figure 3C). Note that the lake was still proglacial at the time (GF—glacier front). Image modified from [9].

Little is known about the preconditions and triggers of these GLOFs. Historical field images from Austrian–German expeditions carried out in the 1930s, as well as satellite remote sensing imagery, nevertheless reveal some details of these events. Strikingly, most of the current glacier-detached, large moraine-dammed lakes were proglacial at the time of the GLOF (often proglacial in the first post-GLOF image available). For instance, Lake Solteracocha was proglacial several (tens of) years after dam failure (see Figure 5).

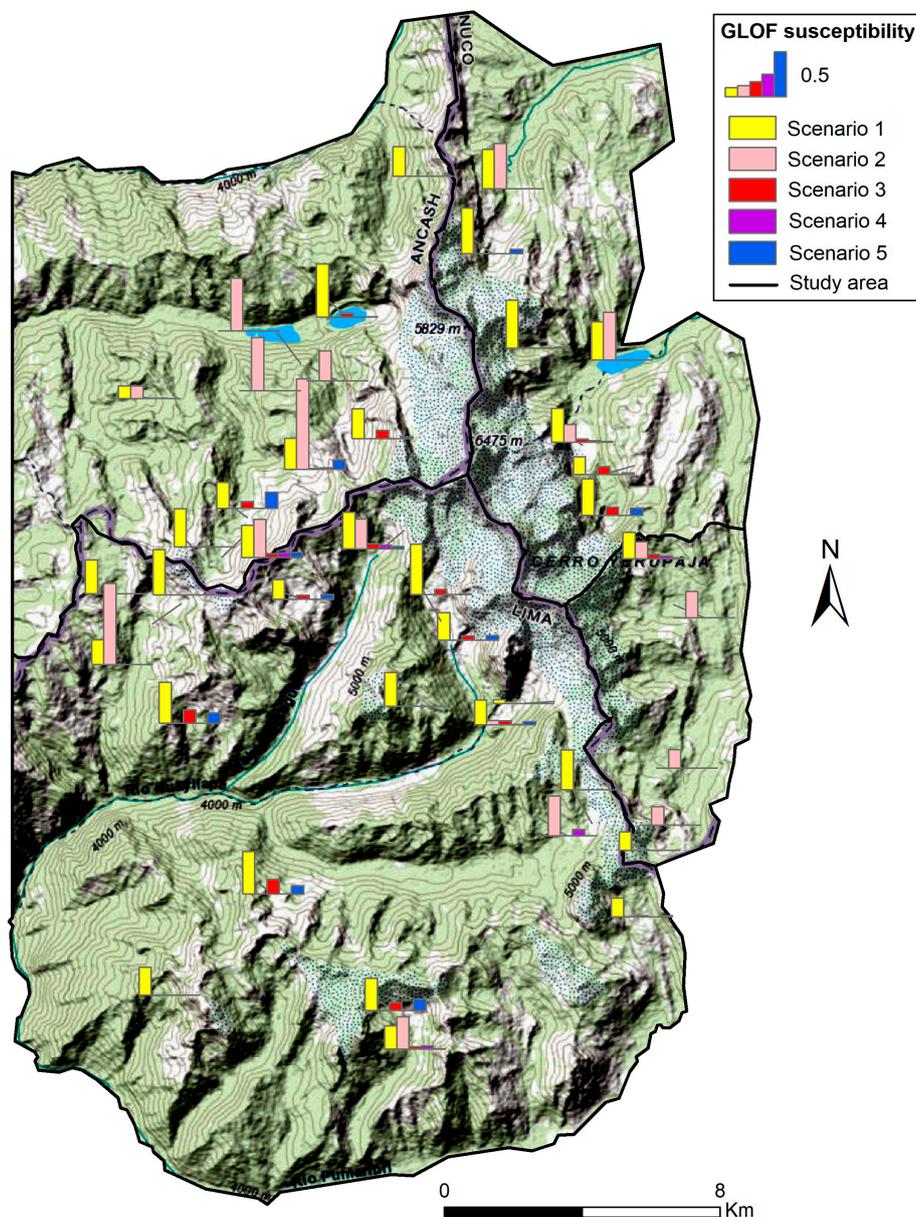
**Figure 6.** Map of the GLOF susceptibility of 46 large lakes (>20,000 m<sup>2</sup>) of the Cordillera Huayhuash. Background map: [40].

The vast majority of lakes of the Cordillera Huayhuash have low susceptibility to generating GLOFs (Figure 6; Table S2). Table S2 further shows that the most frequently expected GLOF scenario in the Cordillera Huayhuash is the dam overtopping due to rapid slope movement into the lake (Scenario 1), followed by the scenario of dam overtopping due to flood wave impact from a lake located upstream (Scenario 2). The susceptibilities of other scenarios rarely exceeded the threshold of negligible values. Out of the 46 evaluated lakes, only two exceeded high susceptibility thresholds, both in Scenario 2. These are Lake Tsacra (W007) and Lake W014. The width of the calving front exceeds the lake width in both cases, which is the main factor increasing susceptibility to GLOF (together with surface outflow, i.e., 0 m dam freeboard). Five lakes were found to have medium GLOF susceptibility for Scenario 1 and four other lakes for Scenario 2. Dam failures (Scenarios 3, 4 and 5) appear unlikely in the Cordillera Huayhuash, considering the fact that the majority of steep-sloped moraine dams that retain large lakes have already failed (see Sections 3.2 and 4.2).
