Article

Forecasting the Failure Time of an Expansive Soil Slope Using Digital Image Correlation under Rainfall Infiltration Conditions

Citation: Wei, X.; Gao, W.; Hu, R.; Gao, W.; Qiu, Y.; Li, Y. Forecasting the Failure Time of an Expansive Soil Slope Using Digital Image Correlation under Rainfall Infiltration Conditions. *Water* **2023**, *15*, 1328. <https://doi.org/10.3390/w15071328>

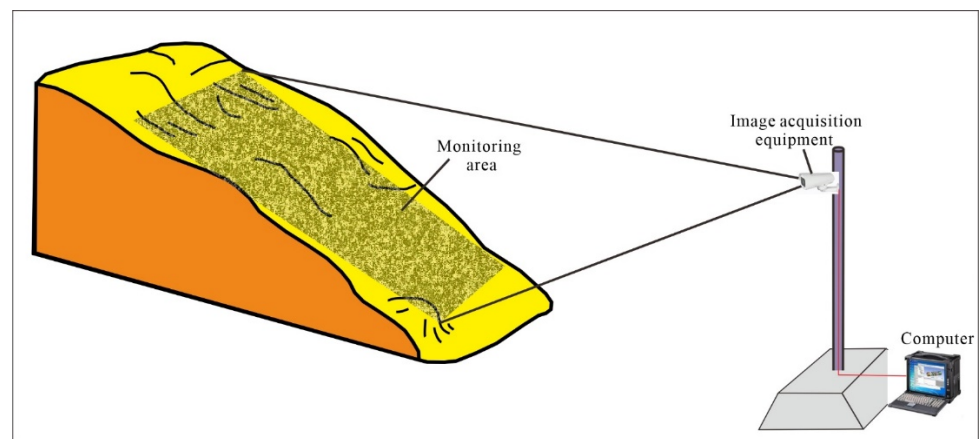
DIC is a new noncontact optical method for obtaining full-field displacement and deformation measurements [33]. Figure 1 shows the field schematic diagram derived using the DIC method with slope deformation measurements. The main processes were as follows: (1) the monitoring points were set according to the landslide scale, and each point was equipped with a camera and other image acquisition equipment. The image acquisition equipment was selected while comprehensively considering the complex climatic conditions at the survey site, the observation distance and the observation angle. (2) The slope was continuously photographed by the image-acquisition equipment to obtain time series images. (3) These images were analysed by digital image processing methods to obtain motion quantities, such as the position, velocity and acceleration, and shape variables, such as displacement and strain [34].

Figure 1. Field diagram of slope deformation measurements derived with the DIC method.

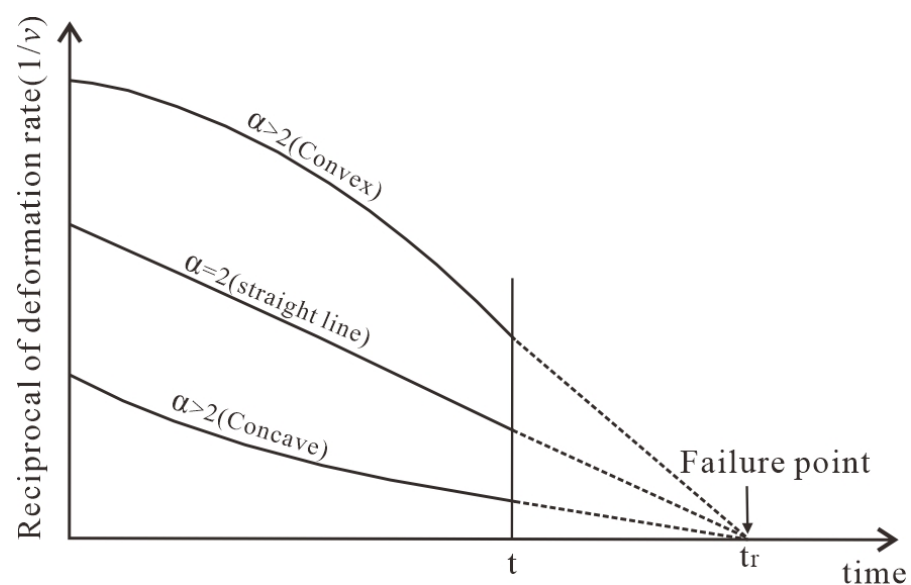
where $\frac{1}{v}$ is the reciprocal of the deformation rate, t is time, t_r is the failure time, and a and α are constants. Therefore, the INV method was proposed. When $\alpha = 2$, the $1/v$ - t relationship curve is linear; when $1 < \alpha < 2$, the curve is concave; and when $\alpha > 2$, the curve is convex. Tests showed that when α varies in the range of 1.5–2.2, the typical model shown in Figure 2 is obtained [24]. When $\alpha = 2$, the intersection of the straight line and the time axis is the forecasted failure time; when $\alpha \neq 2$, the tangent line at any time point or the method provided by [35] can be used to roughly predict the failure time. Because of the simplicity of the linear curve, α is generally assumed to be 2 in actual slope failure predictions.

Figure 2. Plot of the INV model [35].

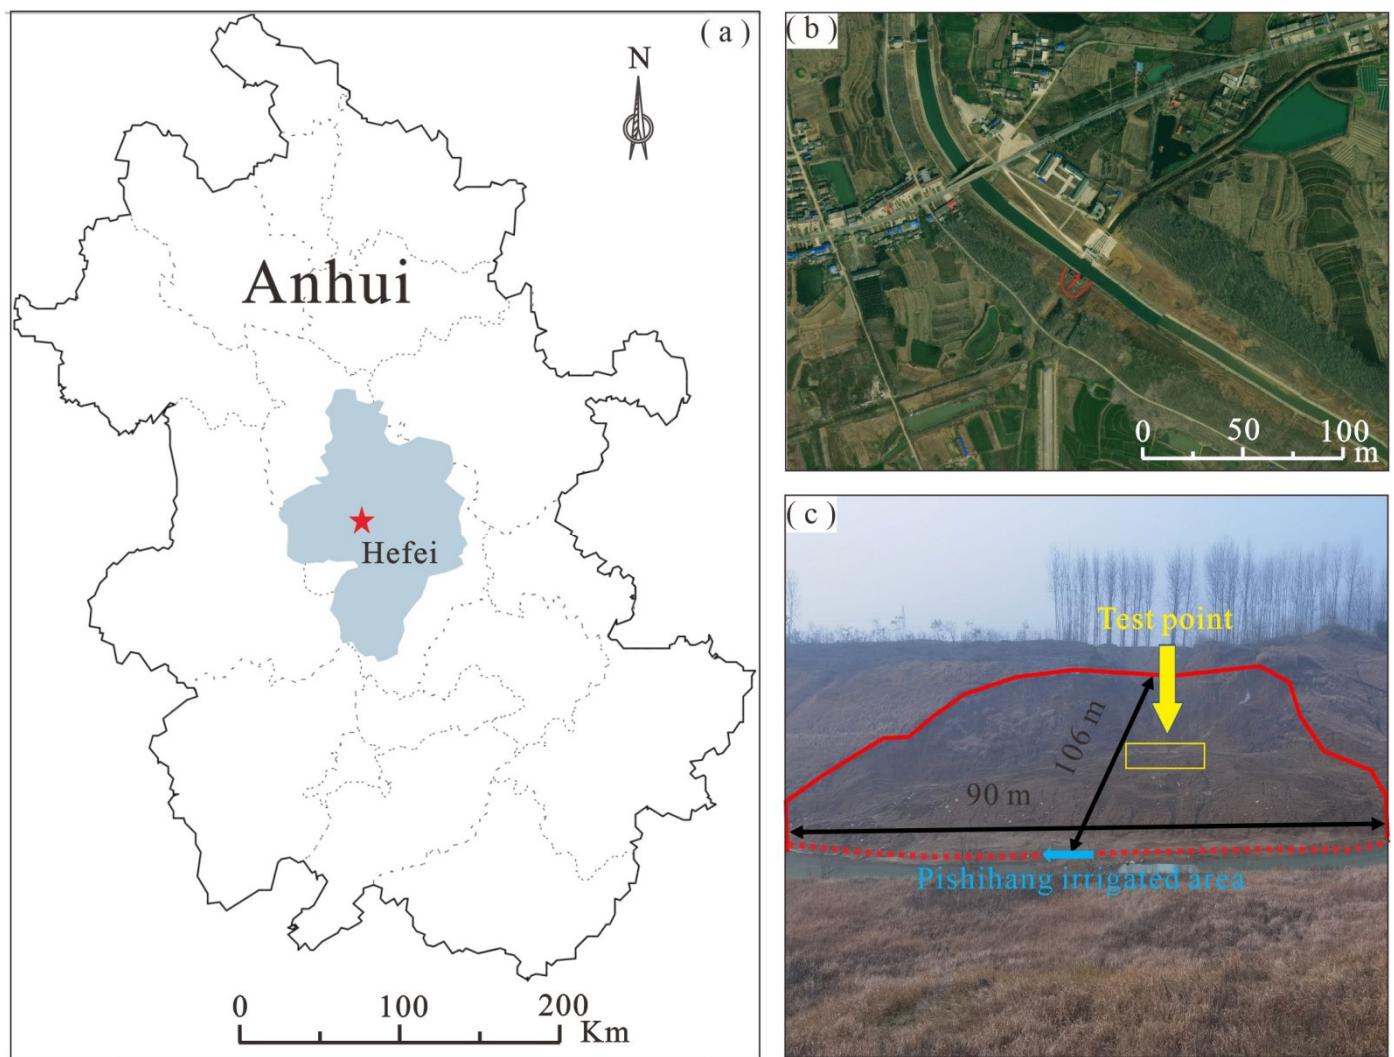
The study area was located on the riverside slope of the Wadong main canal in Pishihang Irrigation District, Hefei city, Anhui Province, at coordinates of 32°3'50" N latitude and 116°54'21" E longitude and 40 m above sea level. This location belongs to Yanliu town, Shouxian County, as shown in Figure 3a, and is situated in the northern Jianghuai watershed, a hilly area with undulating topography. The general terrain trend in this town is high in the southeast and low in the northwest. The study area has a subtropical semimonsoon humid climate with four distinct seasons, moderate rainfall, sufficient sunshine and mild climate conditions. The dominant wind directions throughout the year are east and northeast, the annual average temperature is 15.4 °C, and the annual average sunshine duration is 2523 h, accounting for 51% of the annual sunshine hours. The annual average rainfall is 903.2 mm, the annual maximum rainfall is 1534.1 mm and the daily maximum rainfall is 109 mm. In the study area, rainfall is mainly concentrated from May to September, the flood season.

The soil on the studied slope is mainly yellowish-brown expansive soil, with miscellaneous fill at the top. It belongs to the Quaternary overburden area, the Upper Pleistocene alluvial and diluvial (Q3al-pl) clays. The composition of soil particles is mainly fine powder with the content of 58.44~65.66%, clay content of 33.89~41.13%, and colloid content of 19.18~24.87%, natural water content of 22.1~28.3%, and natural density of 1.9–2.05 g/cm³. The free expansion rate is 35~60%, belonging to the medium and weak expansive soil. Landslides have occurred in this area, with an average thickness of 4 m and a sliding volume of 14,000 m³. These landslides have intruded into the river channel, as shown in Figure 3b,c. At present, the study site has reached a stable state.

Figure 3. Location and geological map of the study area: (a) location of the study area; (b) satellite image of the slope (the base map was produced courtesy of Google Earth); and (c) overall view of the slope.

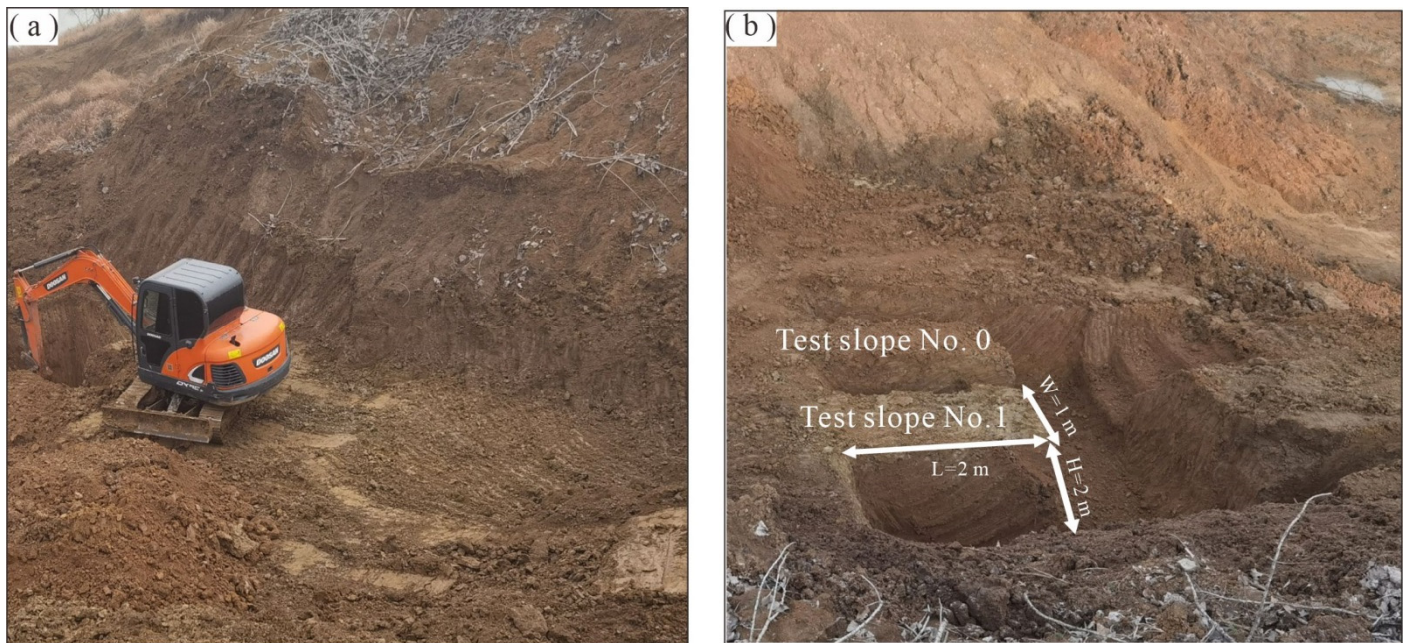
Since the sample site is located on the landslide mass, to eliminate the disturbance impact of landslides and surface human activities on the soil mass, the test machines and tools were excavated downwards to the disturbed expansive soil boundary, as shown in Figure 4a, and then an artificial slope with a planar area of $2\text{ m} \times 1\text{ m}$ and a height of 2 m was excavated. The slope size is shown in Figure 4b. The excavated slope was approximately vertical due to site condition limitations, which conveniently allowed the camera to take crack images. To reasonably set the camera position and accurately set the data acquisition time interval, a calibration slope (Figure 4b: test slope No. 0) of the same size was excavated on the left side of the main test slope (Figure 4b: test slope No. 1) for pretest simulations and to calibrate the data acquisition system.

Figure 4. Test site preparation: (a) soil excavation; and (b) slope layout and size information.

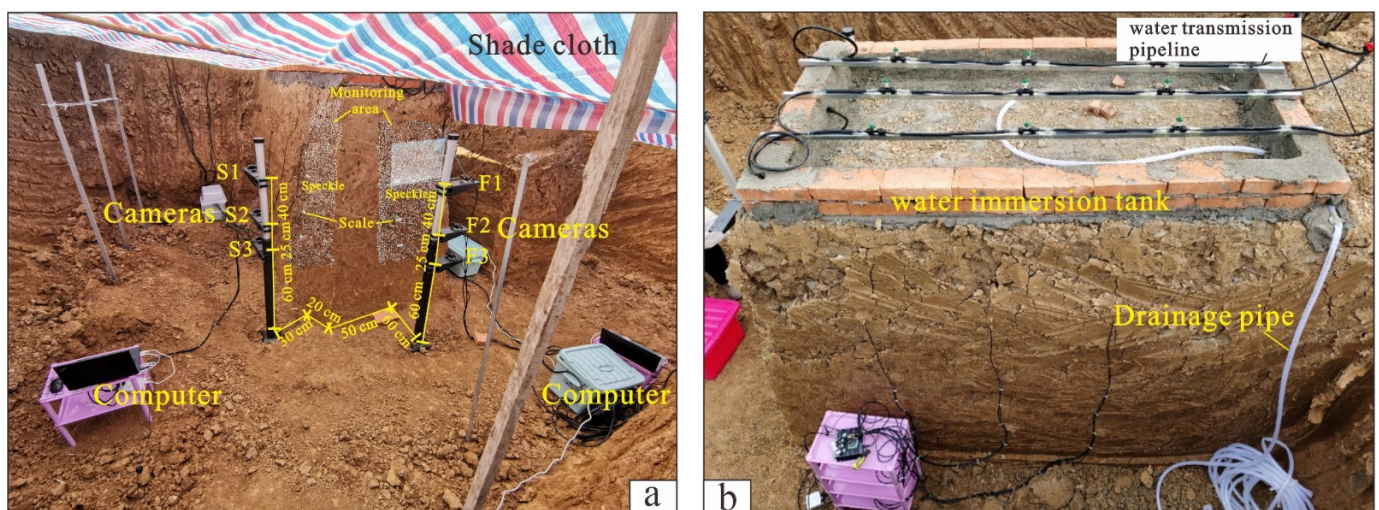
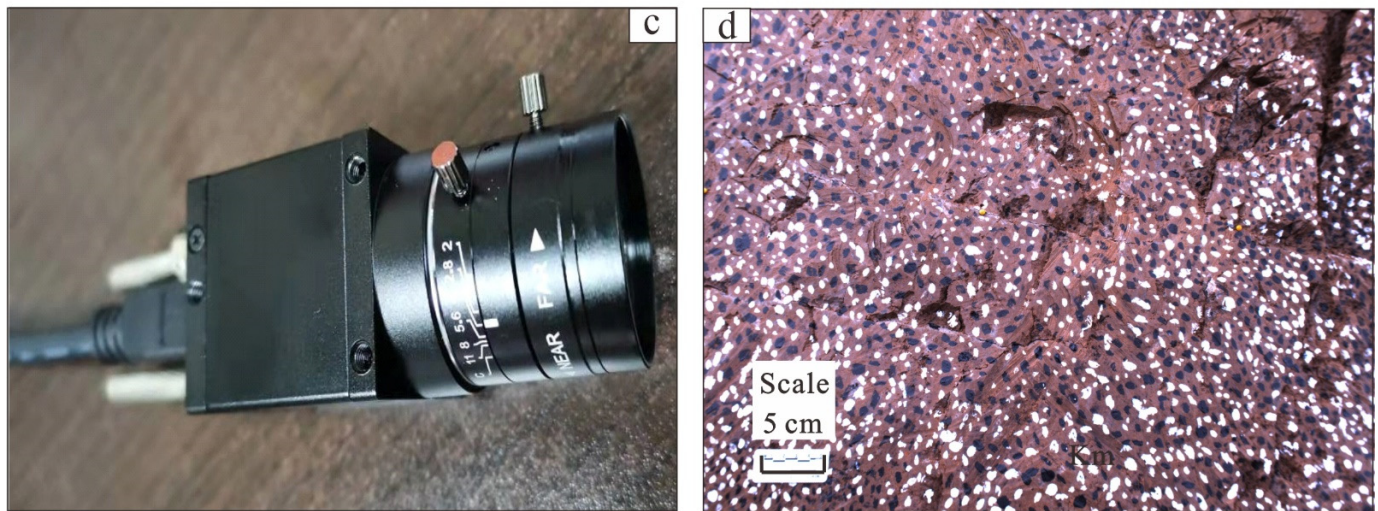
The pre-experiment was carried out on the calibration slope under constant rainfall conditions to obtain the optimal camera shooting position and angle; see Figure 5a for these specific parameters. According to the low-permeability characteristics of expansive soil, to prevent surface rainwater from scouring the slope and ensure the rainfall infiltration effect, a two-layer water immersion tank with a height of 10 cm was built at the top of the test pit, as shown in Figure 6b. Referring to the rainfall intensity classification of the China Meteorological Administration and considering the influence of evaporation, the design adopted the single-dry-wet-cycle mode of artificial rainfall during the day and natural drying at night; to facilitate this, a precipitation nozzle was arranged on the top of the slope to simulate light to moderate rainfall conditions. The 24-h rainfall value was set to 11 mm, and wetting was performed until the slope was completely unstable and damaged.

Figure 5. The layout of the test showing (a) the establishment of the experimental system; (b) the artificial rainfall simulator; (c) the image acquisition equipment; and (d) the image acquisition results (captured by camera F1 in (a)).

The displacement monitoring of the DIC method is based on digital photographs taken at different monitoring time points. Therefore, it can obtain the displacement of only two-dimensional images in each image sequence, and due to the limitations of the camera resolution and image acquisition range, it is impossible to obtain the three-dimensional deformation inside the slope in this test. To ensure that the obtained image can include the areas of possible deformation of the slope as much as possible, three industrial cameras with different heights were arranged at the front and side of the slope (Figure 5a). Huateng

Weishi model HT-SUA1600C-T cameras with resolutions of 16 million pixels were used (Figure 5c). The size of each speckle image was 52 cm \times 40 cm (Figure 5d); cameras F1, F2 and F3 shot the front of the slope from top to bottom, and cameras S1, S2 and S3 shot the sides of the slope from top to bottom. During the test, the lens of each fixed camera was set parallel to the slope surface to ensure that the captured image reflected the real displacement characteristics.

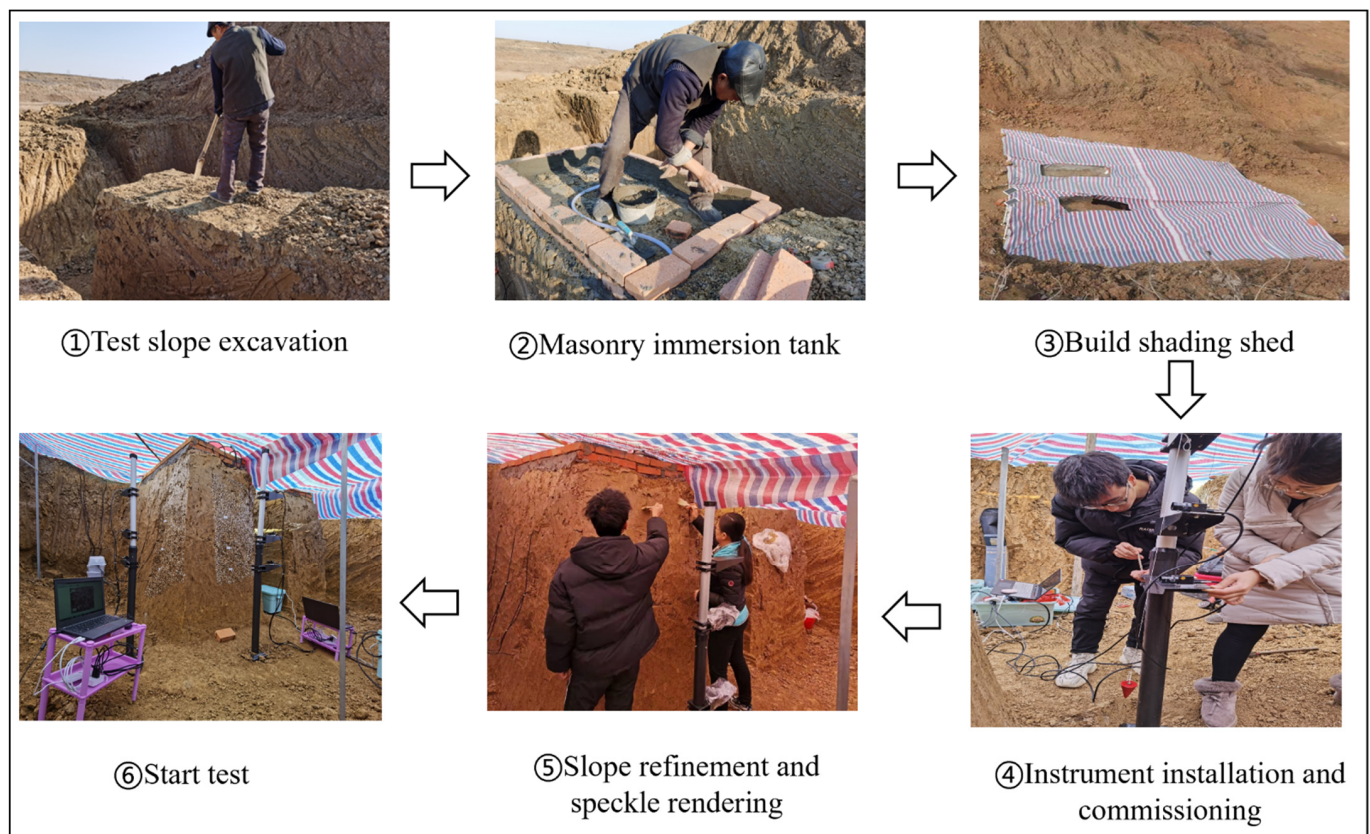
Figure 6. The main steps of the performed tests.

The specific test process was divided into the following steps, as shown in Figure 6. (1) In the test slope excavation, according to the survey data, the site was excavated to the fissured grey–white expansive soil layer below the surface, the site was levelled and measured, and the specific location of the test slope was marked. The slope had an excavation depth of 2 m, a width of 1 m and a height of 2 m. (2) Regarding the masonry of the water immersion tank, the top of the test pit was levelled, and a 2 m \times 1 m area was built at the top of the test pit with two layers of brick walls with a height of 10 cm. A drainage pipe was arranged at the rear of the left side of the test pit. (3) A shading shed was built; a support frame was set up around the test slope, and a shed cloth was used to block the natural light source, in order to reduce the impact of the light difference on the picture image and avoid the soil to dry. Two 40-W stable light sources were set up in the shed to reduce the impact of the light difference. (4) The instrument was installed and commissioned by setting up an industrial camera, adjusting the positions of the camera and the column, correcting the verticality of the cross-arm of the column with a heavy hammer, and assembling and commissioning the camera to ensure that it could record normally without Wi-Fi capabilities and after undergoing power failures and reconnections (to ensure 24-h uninterrupted photography). After commissioning, the camera was treated with moisture and antifreeze. (5) The slope refinement and speckle rendering processes were completed, and the scale was set. (6) The test was started: the slope was allowed to stand still for a given period until all data collectors were functioning stably; then, artificial rainfall commenced according to the specified rainfall scheme.

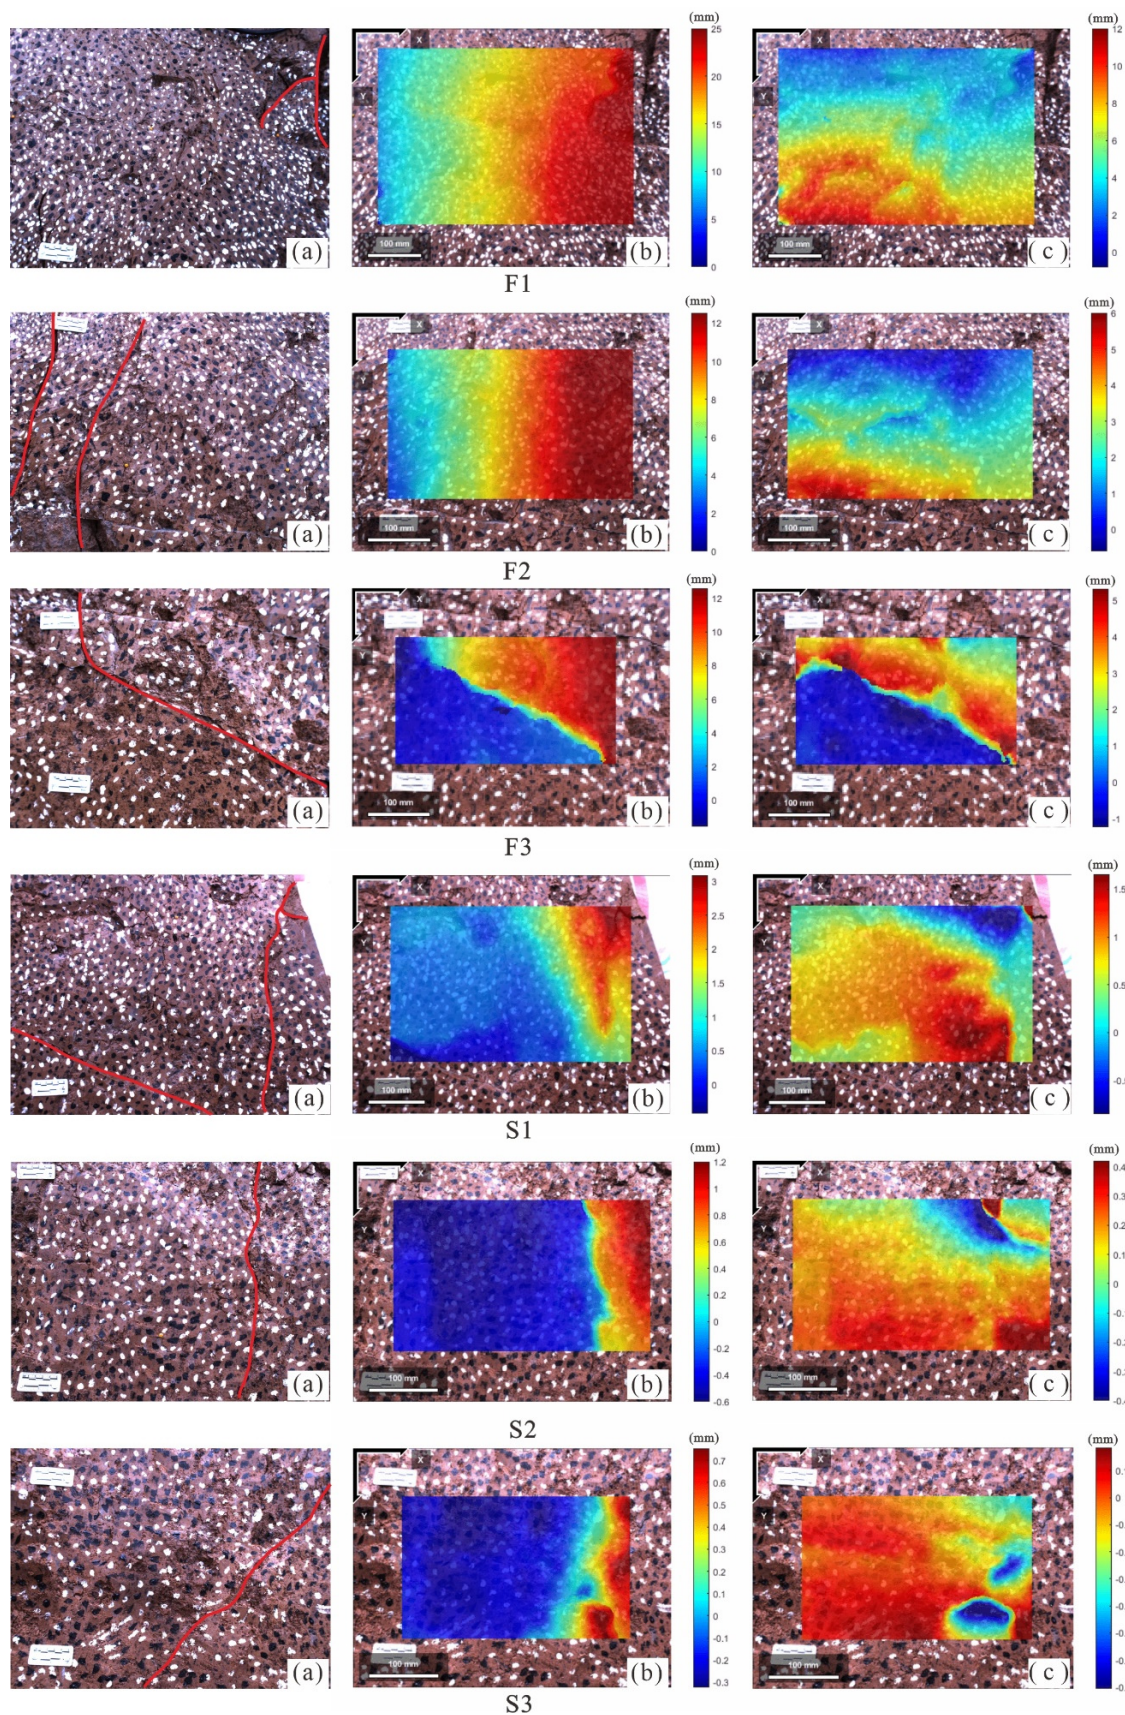
Figure 7. Slope displacement diagram: (a) final state of the slope (the red line indicates cracks that can be observed); (b) horizontal displacement obtained by the DIC method; and (c) vertical displacement obtained by the DIC method.

Figure 7 shows an obvious crack control effect in the deformation process of the expansive soil slope: the slope front (F1, F2 and F3) slid to the right along the horizontal direction, and the displacement was large on the right side. As determined from the vertical displacement results, F1 and F2 exhibited large displacements on the lower side of the slope, and the displacement on the upper right side of the crack in F3 was large, indicating that the soil at the slope front collapsed and slid to the right along the F3 crack. The displacement results of the slope side (S1, S2 and S3) show that the closer the slope was to the free face, the greater the displacement; furthermore, there was an obvious sliding effect along the crack, indicating that such cracks in the expansive soil destroyed the integrity of the soil. Meanwhile, rainwater infiltrated the soil along the cracks to accelerate slope instability and induce landslide disasters.

The change in the position of the speckles on the slope surface can be used to calculate the displacement. The DIC method is a mature method; traditionally, the first image is called the reference image (undeformed image), and the loaded image is called the deformed image. DIC matches the same pixels on the reference image and the deformed image, compares these pixels, and calculates the local horizontal and vertical displacement magnitudes of these points in the X and Y directions by comparing the two images [33]. To eliminate the error caused by distortion during photography, the camera was calibrated with a calibration plate before the test is carried out, the circular spacing of the plates was determined from the figure, and the relationship between the image pixels and real distance was established [36]. After the photographs taken by the camera during the test were processed in MATLAB software, the displacement contour plots of different monitoring areas were derived, as shown in Figure 7, and displacement curves were obtained at different depths, as shown in Figure 8.

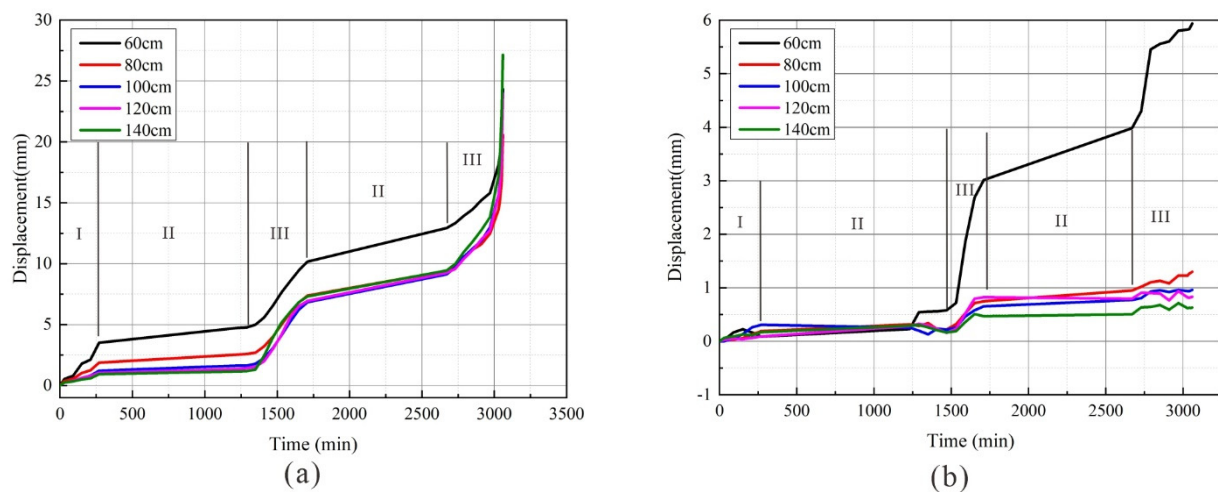
Figure 8. Displacement magnitudes of the slope at different depths (60 cm, 80 cm, 100 cm, 120 cm, 140 cm, corresponding to the vertical distance from the top of the slope): (a) displacement of the slope front; and (b) displacement of the slope side.

The average displacement–time curves derived at different depths (Figure 8) show that the deformation and failure of the expansive soil slope had an obvious “phased change law”, and the displacement–time curve can be divided into three stages. The first stage was the slow deformation stage, the second stage was the stable deformation stage, and the third stage was the accelerated deformation stage. The slope of the deformation curve also increased rapidly until the whole slope was damaged. In addition, the closer to the top of the slope a given position was, the greater its horizontal displacement, while the farther from the top of the slope a given position was, the greater its vertical displacement. Figure 9 shows the average displacement–time curve of the monitored front and side areas of the studied slope. This displacement behaviour also reflected obvious phased characteristics. The slope had an obvious acceleration trend near 1500 min, and the displacement tended to stabilize at 1710 min. Some scholars have divided landslide types into steady-type landslides, exponential-type landslides, step-like landslides, and convergent-type landslides according to their unique displacement monitoring curves [28]. According to this classification, the landslide studied herein can be classified as a step-like landslide. In addition, the monitoring data show that the average displacement of the slope front before failure was greater than the average lateral displacement.

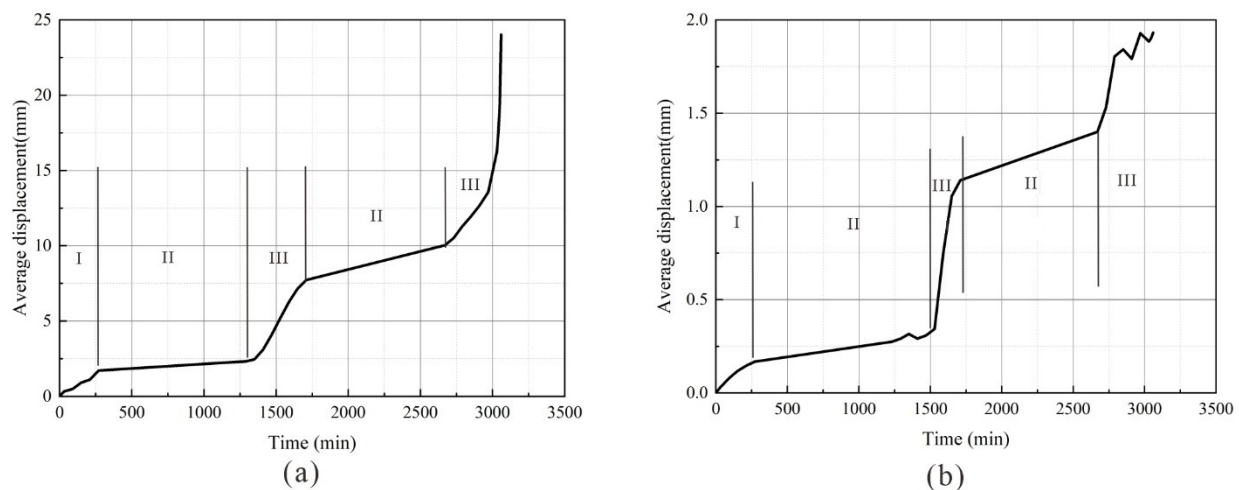
Figure 9. Average displacement magnitudes of the slope: (a) displacement of the slope front; and (b) displacement of the slope side.

The INV method was used to forecast the failure time of the slope. First, the average displacement monitoring data of the surface front and side of the slope were taken (Figure 9), and the average velocity at different monitoring time points was calculated to obtain the reciprocal time series points of the rate of displacement of different monitoring surfaces (Figure 10). The rate dispersion at different monitoring time points was large, and the $1/v-t$ relationship curve is linear, so α was taken as 2. The fitting correlation coefficient of the reciprocal of the deformation rate of the slope R^2 are all less than 0.4, that means the model could not provide good prediction, the specific reasons will be discussed in detail below.

The SLO method was used to forecast the failure time of the slope. First, the average displacement monitoring data of the front and side of the slope surface were determined (Figure 8), and the average velocity was calculated at different monitoring time points to obtain $t(du/dt)-du/dt$ sequence points on different monitoring surfaces. As shown in Figure 11, there was an obvious linear discrete relationship between different monitoring time points, and the $t(du/dt)-du/dt$ sequence points were fitted linearly. The fitting correlation coefficient of the reciprocal of the front deformation rate is $R^2 = 0.999$, and the front deformation monitoring test data are in good agreement with the fitting line. The coincidence degree between the lateral deformation monitoring test data and fitting line was relatively low, with $R^2 = 0.882$. According to these fitting results, the failure time of

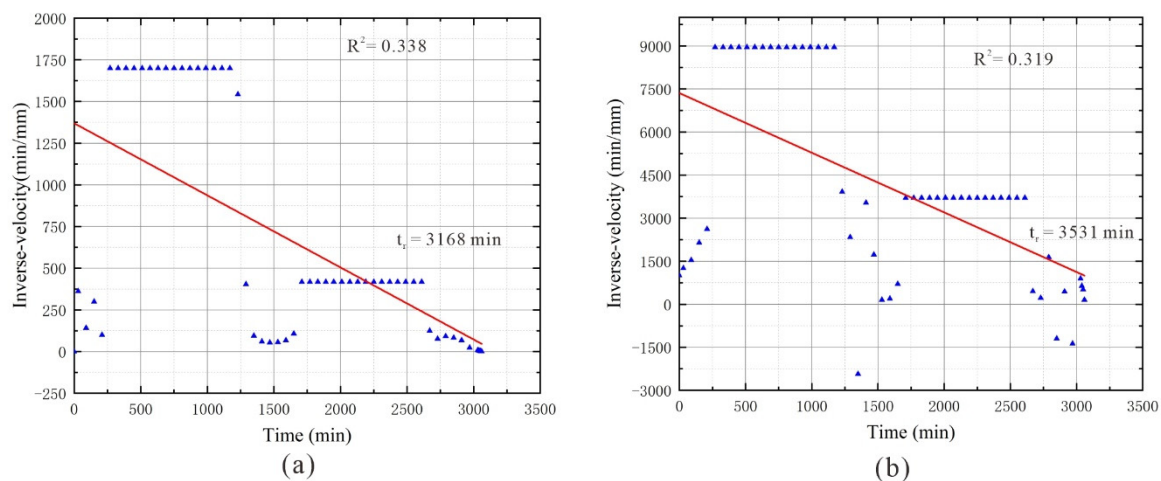
Figure 10. Typical plots used to predict slope failure using the INV method: (a) slope front; and (b) slope side.

The slope failure time recorded at the test site was 3060 min and compared with the prediction results of the INV method and SLO method, the forecast results of the SLO method were basically consistent with the actual failure time of the slope, indicating that the monitoring results of the DIC method can be used for landslide forecasting.

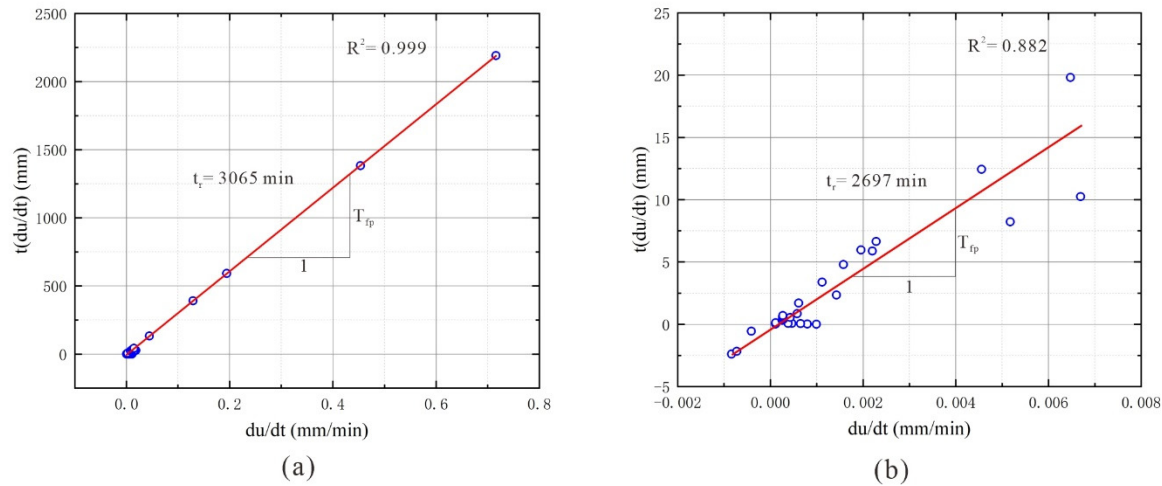
the studied slope forecasted based on the SLO method using deformation data from the front of the slope was 3065 min, and the failure time predicted based on the deformation data from the side of the slope was 2697 min.

Figure 11. Typical plots used to predict slope failure using the SLO method: (a) slope front; and (b) slope side.

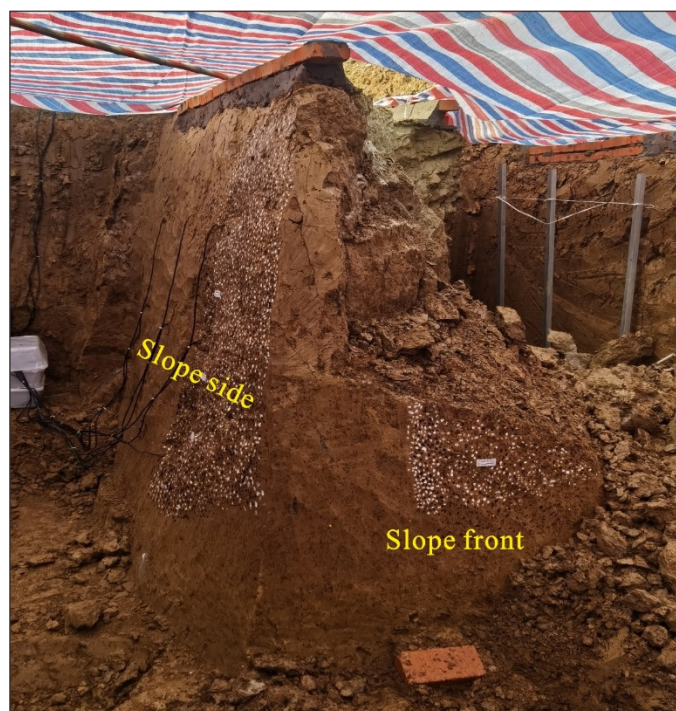
Expansive soil is characterized by strong fissures [38,39], and combined with the slope failure of the image monitoring results (Figure 12), it can be seen that the sliding of the slope results in obvious collapse only on the front and right sides. The failure at the left side of the slope is not obvious, leading to obvious errors in the resulting displacement monitoring curve characterizing the left side of the slope. The forecast results obtained with the INV method were obviously larger, while the prediction results derived through the SLO method were obviously smaller, suggesting that the accuracy of the forecast results was related to the selected monitoring location. The soft structure of the studied slope can control its stability; therefore, the displacement changes of the slope controlled by its structural plane should be the research focus. At the same time, limited by the photography technology itself, the DIC method can only measure the deformation of the shallow surface of the slope and cannot obtain the three-dimensional deformation inside the slope. However, compared with the DIC monitoring results of the deformation and failure of an indoor expansive soil slope model [36], it can be seen that this method has a good application for the acquisition of cracks in the shallow surface of expansive soil and that the field test displacement results of undisturbed soil are more discrete.

Figure 12. Shape of the slope after failure.
