Article

The Long-Term Hydraulic Efficiency of Green Infrastructure under Sea Level: Performance of Raingardens, Swales and Permeable Pavement in New Orleans

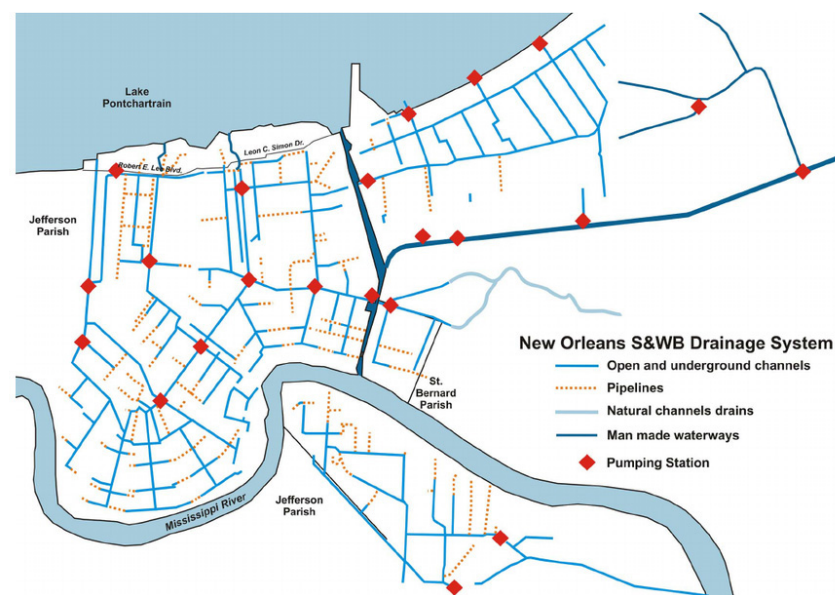
Figure 1. New Orleans pumping stations and drainage system [16].

The New Orleans water management system is equipped with an elaborate network of underground drainage pipes, which are emptied into Lake Pontchartrain by pumping stations (Figure 1). Even though New Orleans' pumping stations belong to the most powerful in the world, ageing infrastructure and heavy subsidence in low-lying neighborhoods have made drainage increasingly difficult [17]. Therefore, the city has been engaged in programs to introduce alternative ways in dealing with stormwater [20,21] and strongly encourage the installation of green infrastructure in new developments through legislation and post-construction runoff controls with local building codes for New Orleans [22]. The 'Dutch Dialogues' workshops in 2008 brought together Dutch and American experts to reimagine New Orleans' flood management and eventually led to the Greater New Orleans Urban Water Plan. This framework plan provides a new paradigm in stormwater management principles and introduces the concept of the water assignment in New Orleans [23]. After Katrina, green infrastructure was implemented (Figure 2) such as raingardens, swales, permeable pavement and bio retention cells.

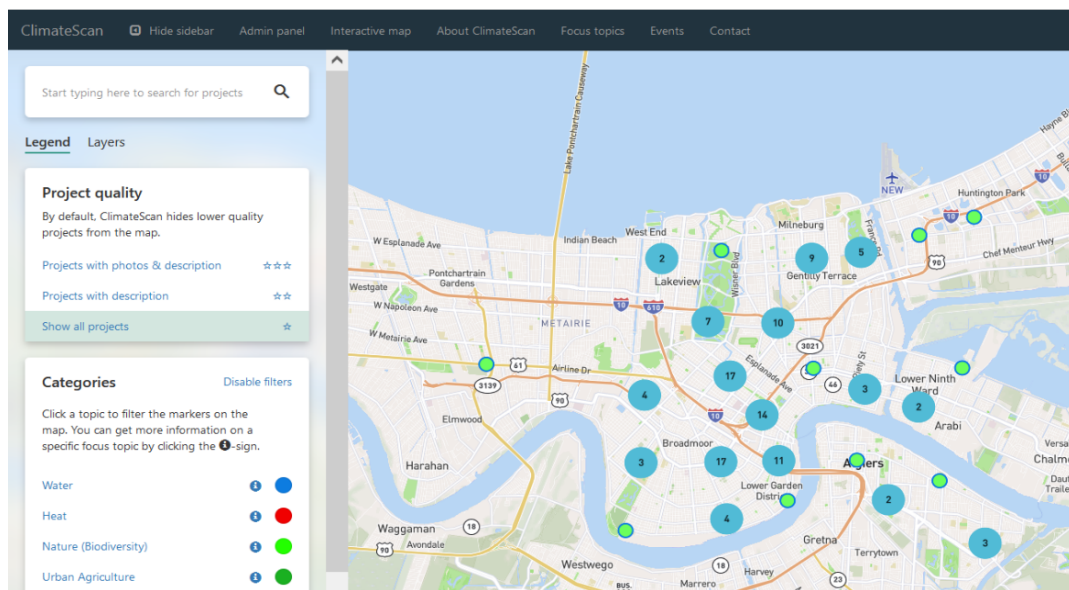
Figure 2. Green infrastructure mapped in New Orleans at public and private properties [source: climatescan.org accessed on 20 December 2022].

The international open source citizen science platform ClimateScan [24] shows over 200 locations where GI is implemented on private and public areas (Figure 2) but little information can be found on the infiltration capacities of this GI.

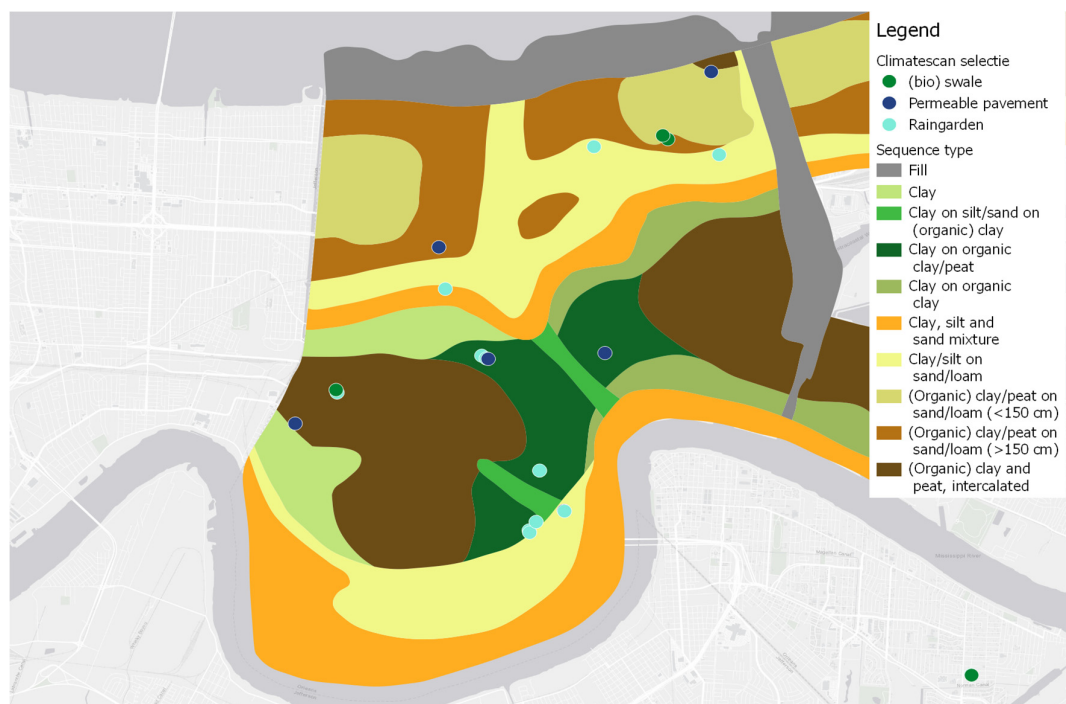
Figure 3. Lithological sequence type map constructed based on borehole information. Source Digital Elevation Model: Deltares (2022).

The infiltration characteristics of green infrastructure largely depends on the permeabilities of the soil and deeper subsurface and the groundwater level before and during rainstorms. The largest area of New Orleans possesses a clay soil (Figure 3) with a low permeability. However, the topsoil area (approx. the zone above the mean lowest groundwater level) green infrastructure is constructed as engineered gardens with high permeable soil and in some cases additional drainage. Figure 3 illustrates the test locations sites with the soil (lithology) characteristics showing that most of the green infrastructure is situated in regions with low permeable soil (clay).

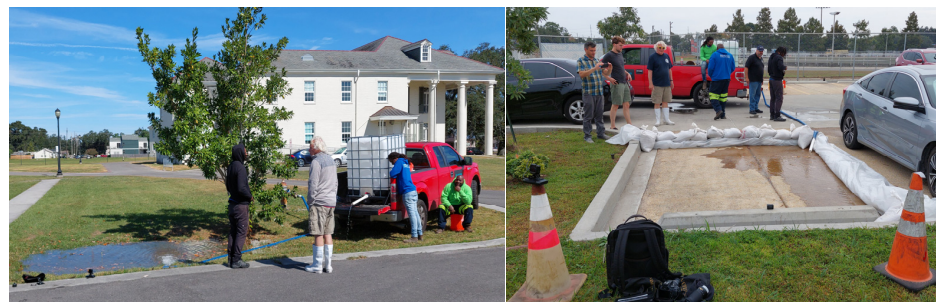
Figure 5. (Left) FSIT at raingarden Milne (test number G14, Table 1). (Right) FSIT at permeable pavement after building a confined space with plastic and sandbags.

Most green infrastructure such as swales and raingardens has a confined storage volume which can be filled without any additional constructions to prevent water leaving the storage volume during the FSIT (Figure 5 left). For the testing of permeable pavement, a confined space was made by making a dike of sandbags (Figure 5, right). For the FSIT in New Orleans, a fire hydrant was used if available or a water basin of 110 L was used.

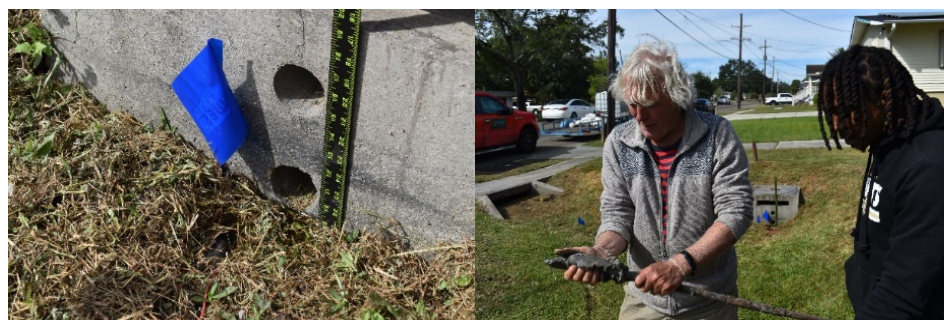
Figure 6. Measurement with loggers and rulers (left) and additional information by drilling the soil (right).

Self-logging, wireless pressure transducer loggers (TD-Diver) were used in the FSIT for measuring and recording the infiltration capacity of green infrastructure. The TD-Diver is a submersible datalogger for real-time water level monitoring using a pressure sensor when submerged at a fixed level under the water surface. The pressure sensor measures the equivalent hydrostatic pressure of the water above the sensor to calculate the total water depth. The logger autonomously measures pressure and temperature and records them in its internal memory. This Diver with a 104 g weight features a stainless steel casing with a 22 mm diameter. The TD-Diver can store a maximum of 72,000 measurements (date/time, pressure and temperature) and measures water height with an accuracy of ± 0.5 cm H_2O and resolution of 0.2 cm H_2O [33]. At the lowest point of the green infrastructure, the loggers are set. The water height loggers log the data in internal memory continuously monitoring the static water pressures at those locations. To verify the water height loggers, additional measurements were used: time-lapse photography and underwater camera (movies available at ClimateScan.org) and hand measurements. At some locations, water quality and soil quality measurements were obtained and continuous loggers were installed for follow-up research. At some locations, drillings of the soil were made to obtain more information on the soil type and groundwater table (Figure 6).

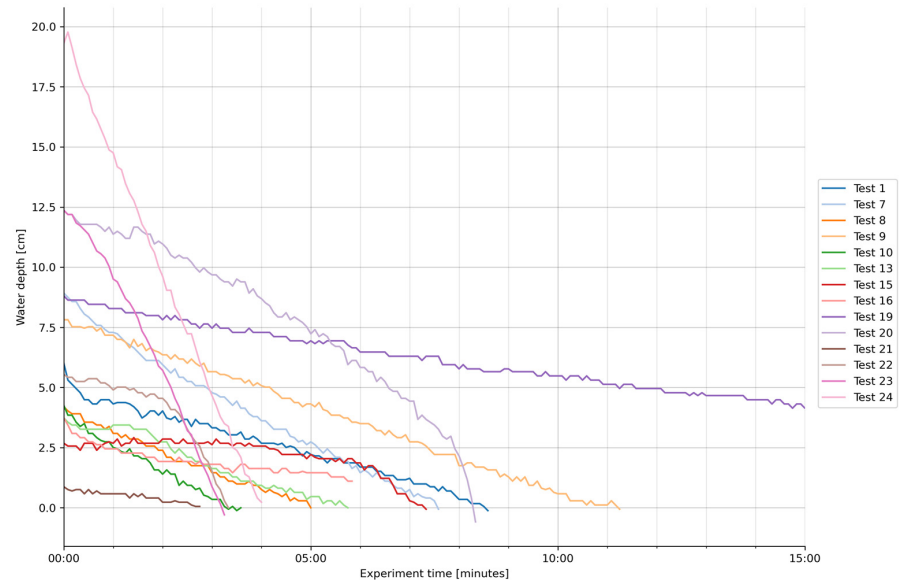
Figure 7. Water pressure green infrastructure curves during full-scale testing (falling head).

The water height curves in time for the tested green infrastructure are given in Figure 7 showing high variation in infiltration capacity.

The average infiltration rate in mm/h for each test site was generated by linear regression analysis with the best fit for the transducer readings from each site. As expected, we observed a high variation. Test number 19, which corresponds with the Aurora raingarden (Table 3), shows infiltration rates of roughly 3 m/day. In contrast, well-drained raingardens near Lafitte Greenway show infiltration rates of over 50 m/day, meaning that the water only had to pass a thin layer of soil before reaching a drain underneath transporting the water without much delay to the stormwater drainage system.

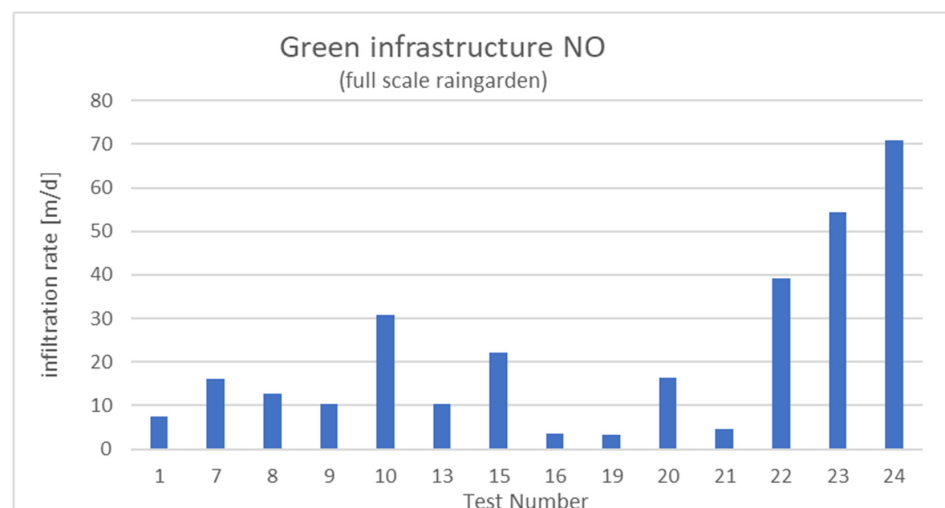
Figure 8. Full-scale test results of green infrastructure in New Orleans.

The FSIT test simulation shows the unsaturated infiltration capacity (Figure 8). Repeating the test led to a reduction in infiltration rates. This was performed at the Aurora raingarden (test 19) with the lowest test result of 3.3 m/day showing a reduction to 2.37 m/d after filling up the storage a second time which is a reduction to 72% of its initial unsaturated infiltration rate. This iteration was also carried out at test 20, 23 and 24 showing percentages in the same order as 54%, 72% and 79%.

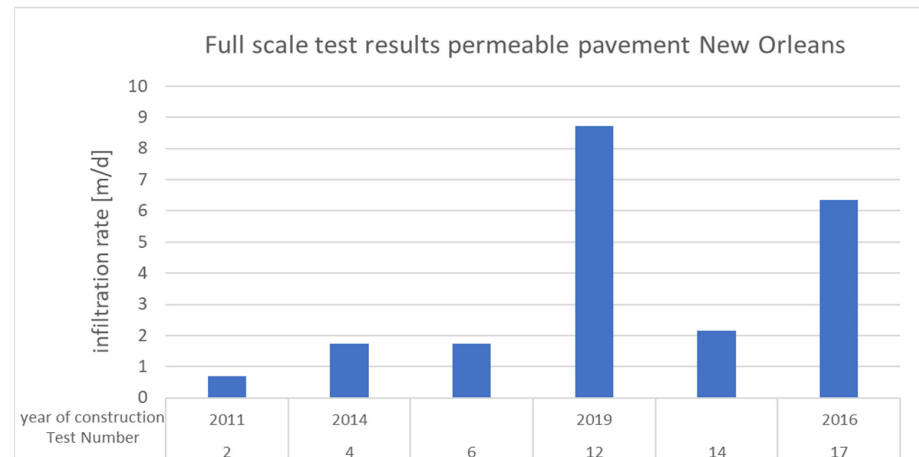
Figure 9. Full-scale test results of permeable pavement in New Orleans.

The difference in infiltration rates for permeable pavement range from 0.7–8.72 m/d measured at the oldest and newest locations constructed in 2011 and 2019 (without any maintenance after construction). Figure 9 shows the test results of permeable pavement where the age (when known) is also noted.

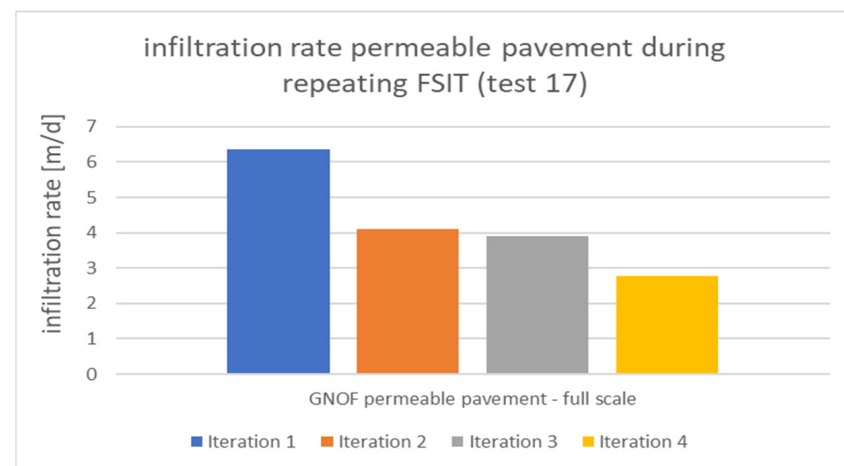
Figure 10. Infiltration rate permeable pavement during repeating FSIT (test 17).

For test 17 (construction year 2016), the initial infiltration rate of 6.35 m/d decreased to 4.11 m/d (test 2), 3.9 m/d (test 3) and 2.79 m/d (test 4). This corresponds with reductions to 65%, 61% and 44% of its initial value (Figure 10).

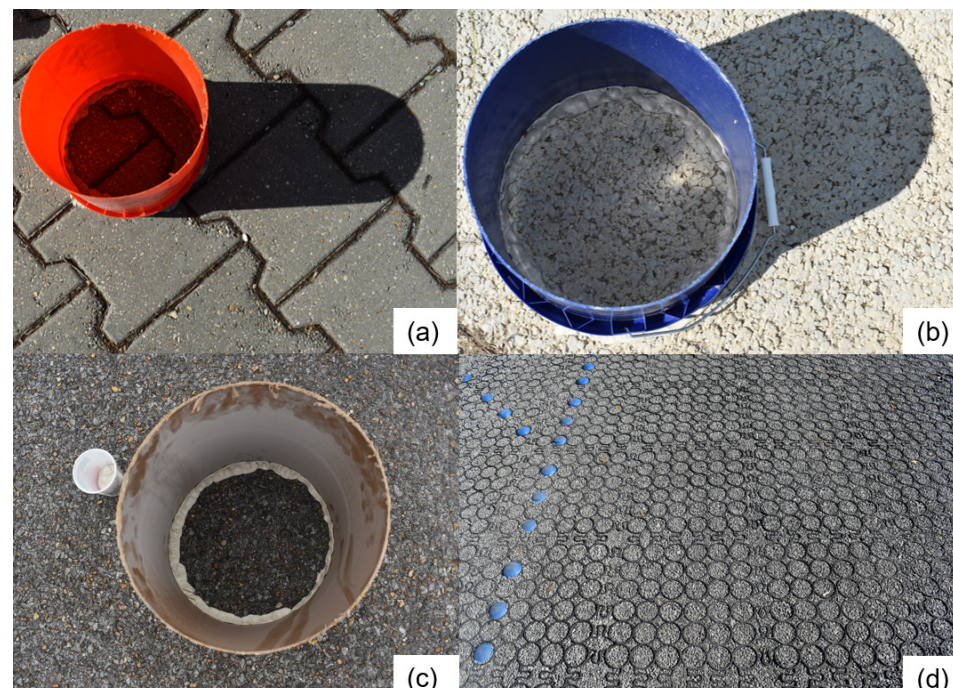
Figure 11. Permeable pavement variants (paver spacing and joint material) in New Orleans during testing. (a) Impermeable concrete interlocking pavers; (b) porous concrete; (c) porous asphalt; (d) plastic grid pavers (not tested in this study).

Some of the types of green infrastructure in this study were of a similar age and construction type but show a large variation in infiltration rates, surprising some of the stakeholders that visited the FSIT during ClimateCafe New Orleans. Potential reasons for the variations in performance of the permeable pavements include differences in pavement laying processes and maintenance (sweeping), different types of bedding aggregates (differences in mix design, compaction) variation of groundwater levels (and moisture content in bedding aggregate), watershed characteristics and surrounding soil type (Figure 3) and the size of the paving joints (Figure 11). These differences have affected infiltration rates through the paving surface. As previously discussed, research found that construction mistakes in green infrastructure may affect surface infiltration rates, and this could also be a reason for the differences [2]. Clogging can be local due to preferential runoff flow routes that drag sediments to particular places or will reduce the infiltration rates of permeable pavements over time [28,29,38,39] and not all of the six pavements tested in this study were of the same age. Differences can be seen in the results of the full-scale test in infiltration rates due to differences in the degree of clogging due to age (Figure 9). A reduced infiltration capacity can also be caused by a decrease in void space through the use of the pavement such as compression from traffic loading and deformation (reduction in air voids) of the asphalt pavement under heavy loads [40].

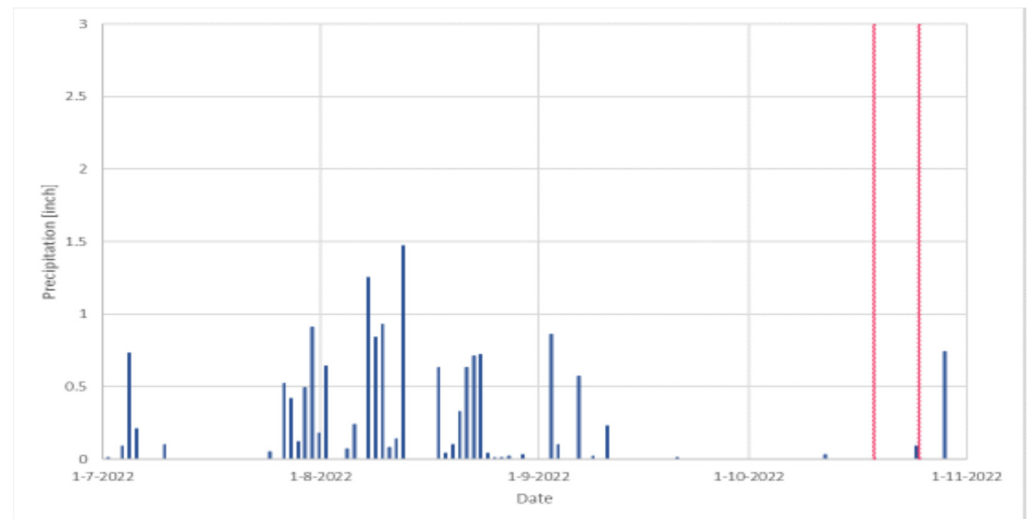
Figure 12. Rainfall prior and before testing, period between red lines is the testing period (source: NOAA-NCEI, Lakefront Airport [41]).

Variation of groundwater levels and moisture content in bedding aggregate can influence the infiltration capacity. There is no data on groundwater levels at the test locations [16], but during the period of testing (17–22 October 2022), the conditions were dry. Prior to the test, during September and early October, New Orleans received a total of 46 mm (1.82 inches) of rainfall. Compared to the average climate during this period, September 2022 was exceptionally dry. A few days before testing, some rainfall occurred, but the pre-conditions of the topsoil before testing showed the topsoil was dry. Over the testing period, no additional rainfall occurred (see Figure 12).
