# Effects of Multi-Pass Friction Stir Processing on Microstructures and Mechanical Properties of the 1060Al/Q235 Composite Plate

**Abstract:** Steel cuttings, holes and cracks always exist at the interfaces in the composite plate. Multi-pass friction stir processing (M-FSP) is proposed in this research to optimize the interface microstructure and the interface connection for the 1060Al/Q235 composite plate. Results show that the microstructures of 1060Al after M-FSP are fine and uniform owing to the strong stirring effect and recrystallization. Micro-defects formed by the welding can be repaired by the M-FSP. However, tunnel defects can also be formed in the matrix of aluminum by M-FSP, especially when the passes are one and two. The melting block and the melting lump in the composite plates are easy to become the source of crack. The shear strengths and the bending properties for the 1060Al/Q235 composite plate after M-FSP are the best when the passes are three, with the tool rotation speed of 1200 rpm and the forward speed of 60 mm/min. The optimized interfaces for the composite plate after M-FSP are mainly by the metallurgical bondings, with a certain thickness and discontinuou

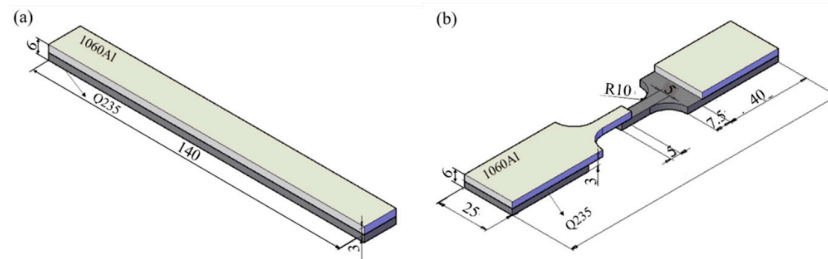
**Figure 1.** Dimensions of mechanical samples: (a) bending specimen and (b) shear specimen (unit: mm).

Based on the GB/T2651-2008 and the GB/T232-2010 standards, the shear specimens and the bending specimens were designed, as shown in Figure 1. Three shear testing samples and two bending testing samples were tested for each group in order to give a better reliability for the testing datum.

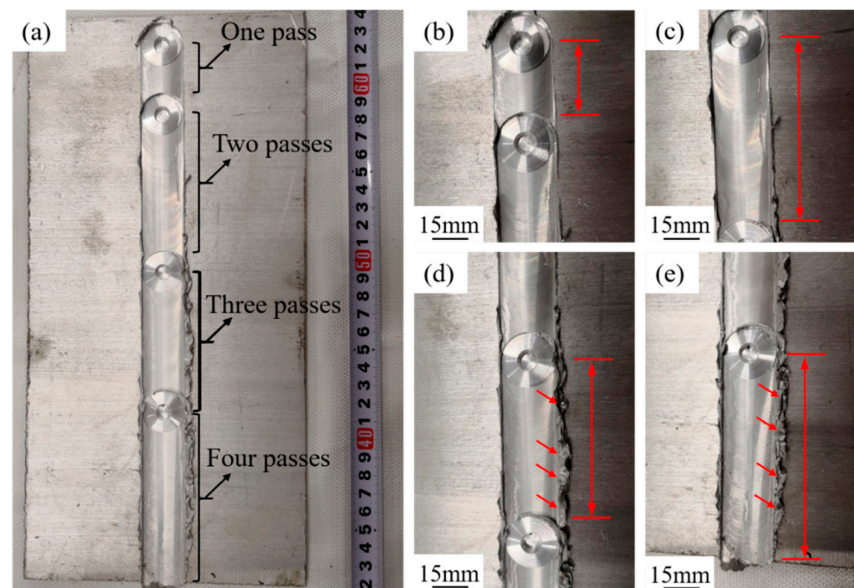
**Figure 2.** 1060Al/Q235 composite plate after multi-pass friction stir processing (M-FSP) with different passes: (a) 1060Al/Q235 composite plate after M-FSP; (b) single pass; (c) two passes; (d) three passes; (e) four passes.

Figure 2 shows the 1060Al/Q235 composite plate after M-FSP with different passes. The repair zone for the 1060Al/Q235 composite plate after M-FSP with different passes are well-formed with no defects in it. However, with the increase of pass, especially for the passes are four, there shows obvious toe flashes after friction stir processing, as shown in Figure 2e with the red arrows. Beside this, according to the continuous axial force resulting in the toe flashes after M-FSP, the thickness of the aluminum plate becomes thinner gradually. Therefore, only four passes friction stir processing have been applied in this study.

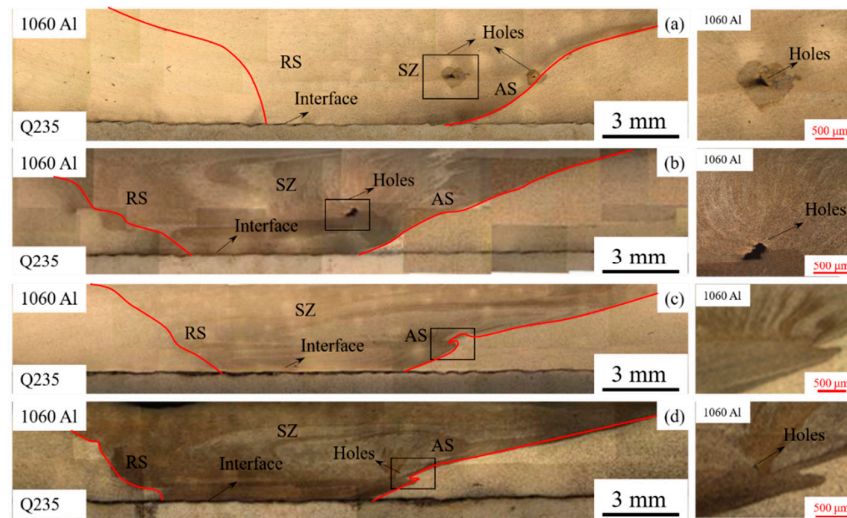
**Figure 3.** Microstructures of the repair zone for 1060Al/Q235 composite plate after M-FSP with different passes: (a) single pass; (b) two passes; (c) three passes; (d) four passes.

Figure 3 shows low-magnification OM images of the repair zone for the composite plate after M-FSP. Holes can be observed in the repair zone. The repair zone appears a shape of basins. The right place of the stirring zone (SZ) is the advancing side (AS) while the left place is the retreating side (RS). The AS presents an abrupt “zigzag line” boundary distinctly and the RS is in a shape of a gradual

change. This is because the temperature and flow fields on the AS are different from those on the RS [30–33].

Meanwhile, holes are clearly seen in Figure 3. For the single-pass FSP (Figure 3a), the area of the large hole is  $9.8 \times 10^3 \mu\text{m}^2$  and the smaller one is  $3.4 \times 10^3 \mu\text{m}^2$ . However, just one single hole is found in Figure 3b with the area of  $12 \times 10^3 \mu\text{m}^2$ . Although the area of the single hole increases, the total areas of the holes decrease. It is confirmed that the numbers and areas of the holes have been repaired by the plastic flow of aluminum after M-FSP. The hole disappears by the influence of repair for the plastic flow in aluminum when the passes of M-FSP are three, as shown in Figure 3c. However, when the passes of M-FSP are four, the hole appears again in the AS area (Figure 3d). Since the distances of these holes from the interface are nearly the same, these holes are the tunnel defects resulted after FSP. The areas of tunnel defects in repair zone with different passes are shown in Table 2. Therefore, with the increase of passes, the tunnel defects decrease. It can be concluded that M-FSP can also repair tunnel defects created by single-pass M-FSP.

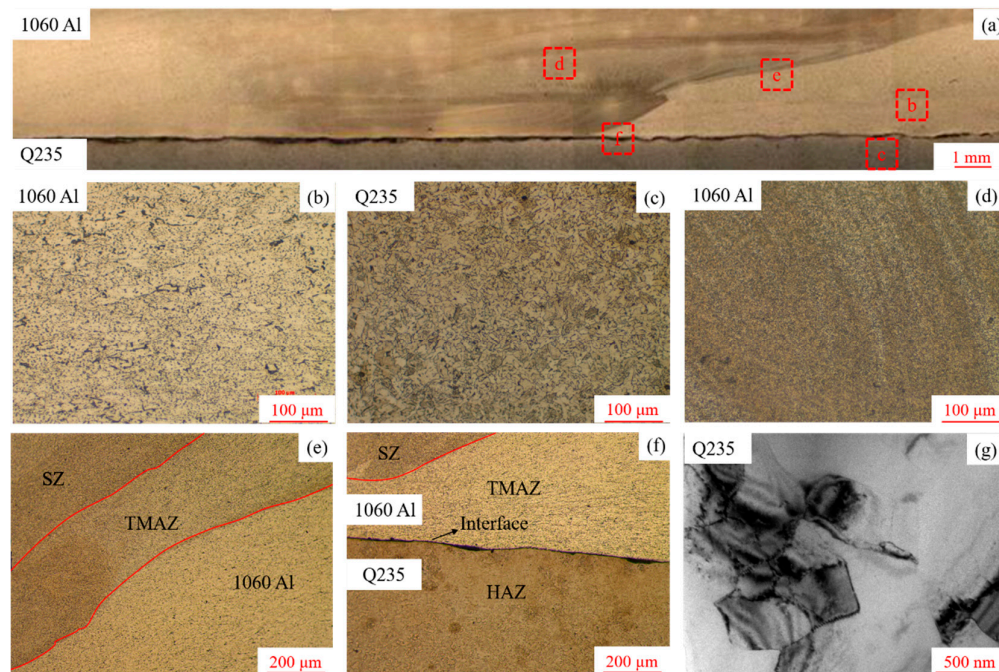
**Figure 4.** Microstructures of composite plate after friction stir processing (FSP) with different passes: (a) repair zone; (b) base metal (BM) of aluminum; (c) BM of steel; (d) stirring zone (SZ); (e) thermo-mechanical affected zone (TMAZ) in the aluminum side; (f) heat affected zone (HAZ) in the steel side and (g) transmission electron microscopy (TEM) image near the interface.

Figure 4 shows microstructures of the 1060Al/Q235 composite plate after FSP with different passes. The microstructures of base metal (BM) for the 1060Al are  $\alpha$ -Al (Figure 4b). The microstructures of BM for Q235 are ferrites and pearlites (Figure 4c). Compared with BM for 1060Al, the grains of repair zone for 1060Al are refined by the stirring effects of M-FSP (Figure 4d). The grain size of 1060Al after M-FSP is about  $3.6 \mu\text{m}$ , much smaller than that before M-FSP ( $22.6 \mu\text{m}$ ). Meanwhile, with the influence of temperature and stir, the microstructures of thermo-mechanical affected zone (TMAZ) are stretched (Figure 4e). Figure 4f shows the interface for the 1060Al/Q235 composite plate after FSP and also exhibits the microstructure of heat affected zone (HAZ) in the Q235 side. Moreover, Figure 4g shows TEM images of interface after M-FSP. The grain size of Q235

is about 600 nm. Even though it only stirs in the aluminum size, the grains for Q235 have been refined by M-FSP, which improves the bonding properties of interface significantly

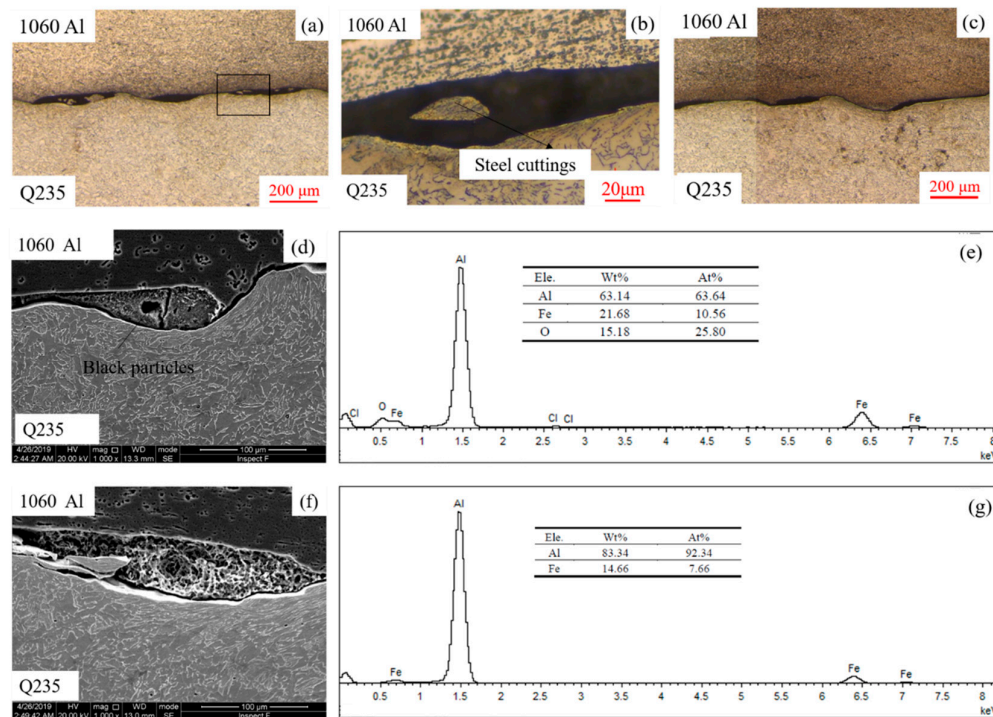
**Figure 5.** Comparisons between the unrepaired interface and the repaired interface: (a) and (b) unrepaired interface; (c) repaired interface; (d) and (e) Scanning Electron Microscope (SEM) and Energy Dispersive Spectroscopy (EDS) analysis of the unrepaired interface; (f) and (g) SEM and EDS analysis of the repaired interface.

Figure 5 shows comparisons between the unrepaired interface and the repaired interface. The steel cuttings are clearly seen at the interface of composite plate without FSP (Figure 5a). The sizes of steel cuttings are about 45  $\mu\text{m}$  (Figure 5b). Such a large steel cutting has a severely disadvantage effect on the strength of the interface. Non-uniform and instantaneous temperatures caused by explosive welding are responsible for these steel cuttings. However, these steel cuttings disappear in the interface with FSP (Figure 5c). Through the temperature and plastic flows of aluminum stirred after FSP, these residual steel cuttings react with aluminum and other materials to form new IMCs at the interface. Figure 5d,e show the SEM and Energy Dispersive Spectroscopy (EDS) analysis of the interface for the BM. The black particles are the oxides of aluminum and iron by melting and reacting with oxygen in the air during explosive welding. They are a kind of brittle and hard phase which will reduce the bonding strength for the composite plate. While in Figure 5f,g, there are no steel cuttings and black particles at the interface. The IMCs at the interface are a kind of Al-rich phase [21]. This is to say that FSP can repair the defects remained by explosive welding and optimize microstructures and properties of composite plate.

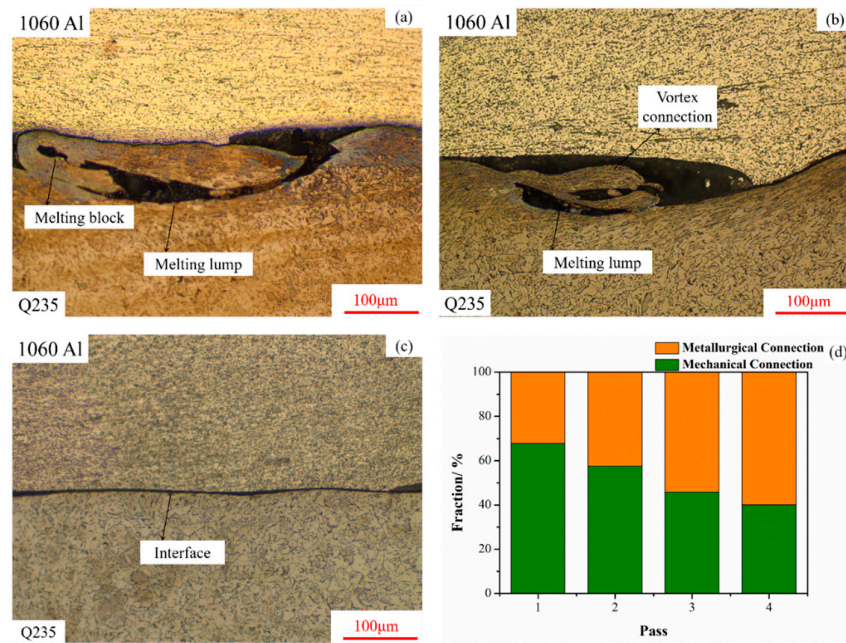
**Figure 6.** Interface connection mechanism of composite plate: (a) hook connections; (b) vortex connections; (c) metallurgical bondings; (d) Fractions for mechanical connections and metallurgical bondings to the interface of composite plate after FSP with different passes.

The interface connections mechanism of composite plate is shown in Figure 6. The mechanical connections consist of hook connections and vortex connections formed by multiple hooks (Figure 6a,b). These mechanical connections are the main connections of interface. Meanwhile, the IMCs formed by reaction of aluminum and steel are the main components of interface during explosive welding. The IMCs on the interface are the basis for the metallurgical bondings, as shown in Figure 6c. Actually, metallurgical bondings are made up of IMCs layers. However, these IMCs separated from the interface are disadvantageous to the properties of composite plate. IMCs show the appearance of melting block if the areas of IMCs are small. Conversely, IMCs show the appearance of melting lump if the areas of IMCs are large. Both the melting block and the melting lump are easy to become originals of crack. The IMCs layer with a certain thickness has a superior effect on the properties of composite plate [22]. Since explosive welding is an instantaneous welding process, the composite plate could not obtain enough thickness IMCs layer. Therefore, M-FSP is used to repair the bonding interface and obtain a proper thickness IMCs layer. With the increase of passes, the proportions of metallurgical bondings increase in the interface (Figure 6d). The increase of passes brings the increase of heat input, which will aggravate the diffusion and metallurgical reaction at the interface. The IMCs layer becomes thicker due to this. Ultimately, the thick IMCs layer leads to the increase of metallurgical bondings.

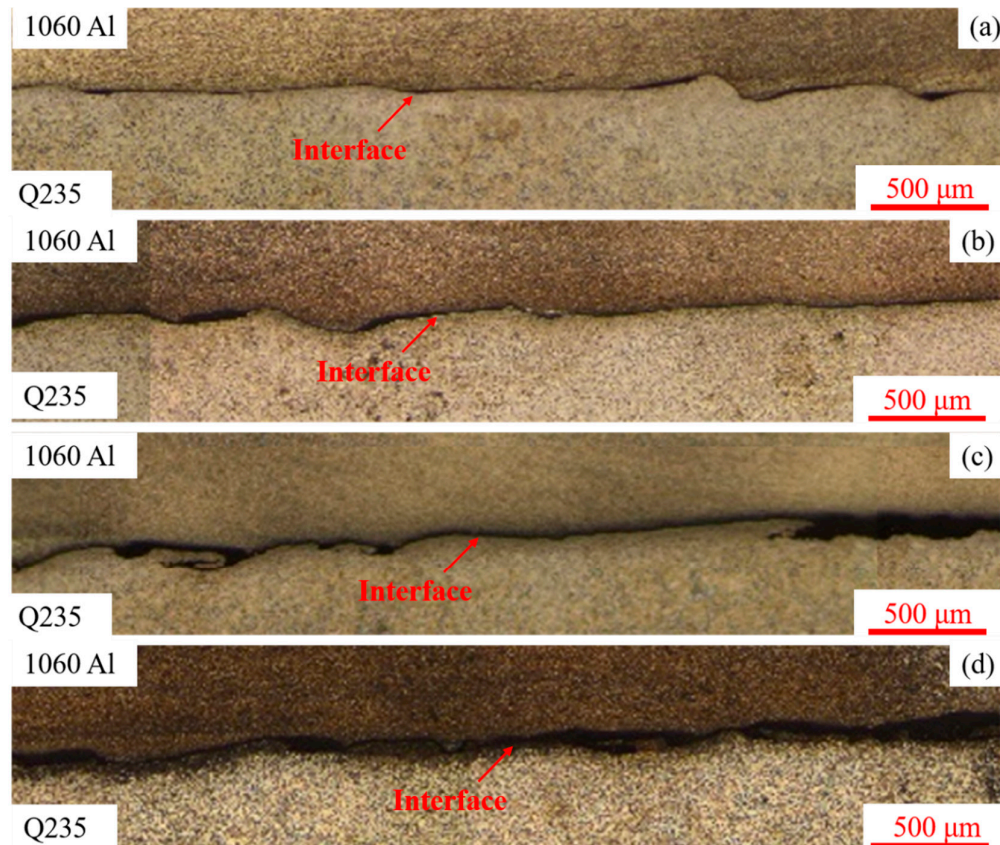
**Figure 7.** Interfaces of composite plate after FSP with different passes: (a) single pass; (b) two passes; (c) three passes; (d) four passes.

Figure 7 shows the interface of composite plate after FSP with different passes. With the increase of passes, the thickness of IMCs layers grows. The interface is flat and straight with just single-pass FSP (Figure 7a). In other words, FSP cannot repair the interface of composite plate with the single-pass FSP effectively. Compared with single-pass FSP, there is a little more thickness of IMCs in the interface with two passes. However, the effect of repair with two passes is still insufficient in contrast to the whole interface. That is to say, the effect of repair is not obvious (Figure 7b). The thickness of IMCs clearly increases with three passes. There is a superior effect of repair with the discontinuous mechanical connections (Figure 7c). The interface is so thick that the bonding strength of the interface is low. Too many passes make the heat input too large, which will make the interface too thick. Due to the existence of too thick interface, the original discontinuous mechanical connections have been connected together. The properties of composite plate must be affected with the too thick interface and continuous connections (Figure 7d). It is clear that too many passes will cause the deterioration of properties for the interface.

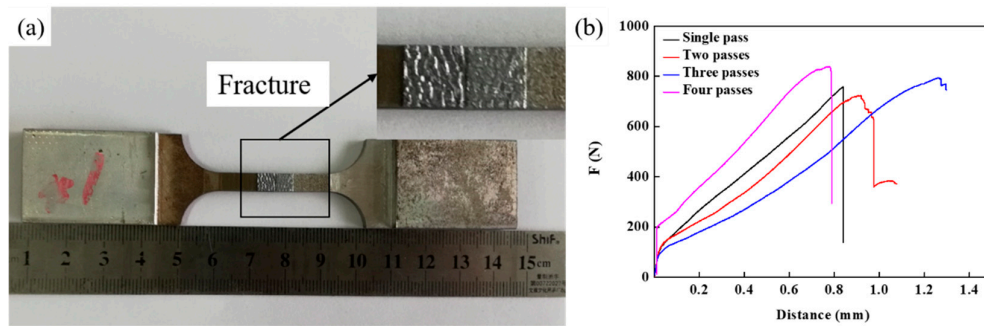
**Figure 8.** Fracture morphologies and strength of shear specimens: (a) fracture morphologies of shear specimens; (b) mechanical property curves of shear specimens.

Figure 8 shows the fracture morphologies and mechanical property curves for the shear specimens and the shear strengths are shown in Table 3. The fracture mode of shear specimens exhibits typical brittle fracture (Figure 8a). The curve of single-pass shows the phenomenon of yielding caused by the tunnel defects under the load. While the curve of two passes and three passes exhibit the brittle fracture more obviously (Figure 8b). Compared with the single-pass FSP, M-FSP has a uniform refinement effect on the aluminum and finally improves the strength of aluminum. When subjected to load, cracks preferentially appear at the interface and the samples break due to the fracture of the IMCs layer. The shear strengths of composite plate after FSP with different passes are shown in Table 3. Due to the yield strength of 1060Al is about 35 MPa and the shear strengths of specimens range from 28.87 MPa to 33.37 MPa, which show that the shear properties of composite plate after FSP are in line with requirements. From the shear strength and curves of different passes, it can be seen that when the passes are three and four, the shear strength is higher than those are one and two. Although the strength increase is not obvious, the shear properties of composite plate are still improved by M-FSP.

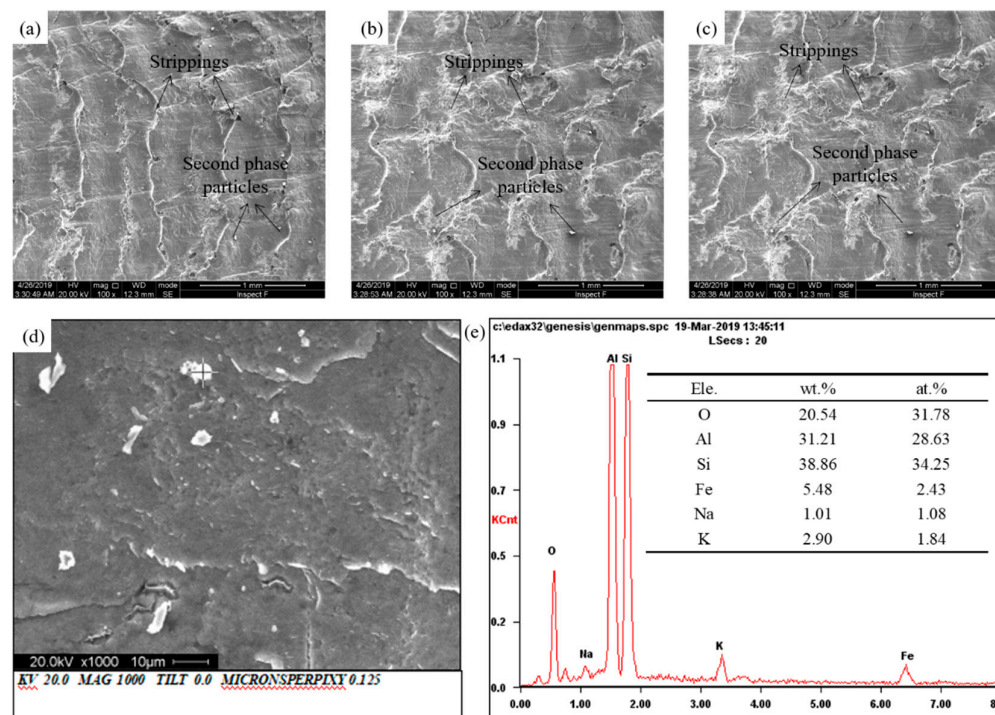
**Figure 9.** Scanning electron microscope (SEM) analysis of shear specimens: (a) single pass; (b) two passes; (c) three passes; (d) and (e) SEM and Energy Dispersive Spectroscopy (EDS) analysis of second phase particles.

The SEM and EDS analysis of shear specimens are shown in Figure 9. Strippings are found in the fracture surfaces, as shown in Figure 9a–c. Analysis shows that these strippings are formed by the failure of the original mechanical connections at the interface under the load. The second phase particles are also obviously seen in the SEM. The EDS result shows that Si element is contained in these particles, which indicates that the second phase particles are Al-Si compounds (Figure 9d). A small amount of dispersed Al-Si compounds can improve mechanical properties of composite plate.

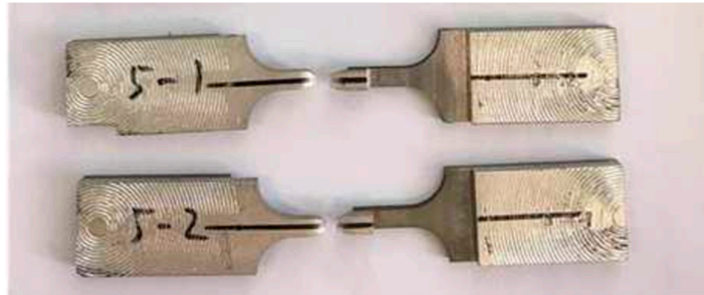
Figure 10. Shear specimens of BM.

The shear mechanical properties of BM are also carried out, as shown in Figure 10. The results show that the phenomenon of yield occurs on the aluminum side of BM. The maximum failure tensile force is 1777 N. However, the failure strength is not the shear strength, while is the tensile strength of 1060Al. The failure strength is 118.47 MPa, which is conformed to 1060Al standard specification. The fracture position of BM without FSP is in the aluminum side rather than at the interface. This is due to the refining effect of FSP in aluminum, which makes the aluminum obtain the grain refining strength after FSP. Therefore, FSP has an obvious repairing effect on the interface of composite plate.

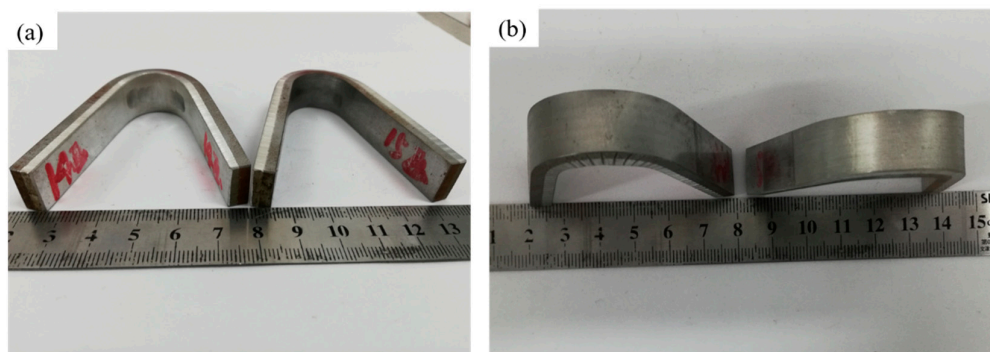
Figure 11. Bending specimens of composite plate after FSP with two passes: (a) compressed face; (b) tensile face

The results of bending test are shown in Table 4. The typical bending specimens are shown in Figure 11. Whether repaired or not, the bending strength is superior. Mainly due to the excellent plasticity of 1060Al, there are almost no cracks during the process of bending. However, cracks can be seen in aluminum after FSP with four passes, as shown in Figure 12. The failure angle of bending is 137°. Excessive axial force of the shoulder leads to the thinning of BM with the cracking phenomenon caused by the reduction of the bearing area in bending. Therefore, it should be well controlled in the M-FSP to ensure the properties of bending.

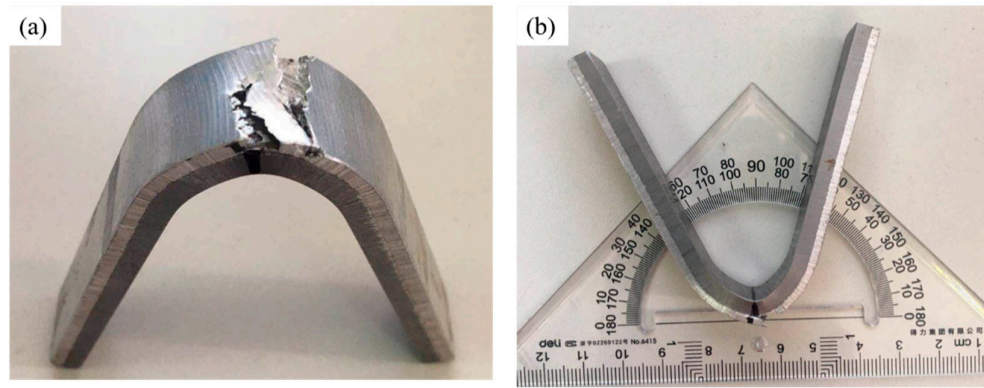
**Figure 12.** Bending specimens of composite plate after FSP with four passes: (a) tensile face; (b) bending diagram of angle measurement.

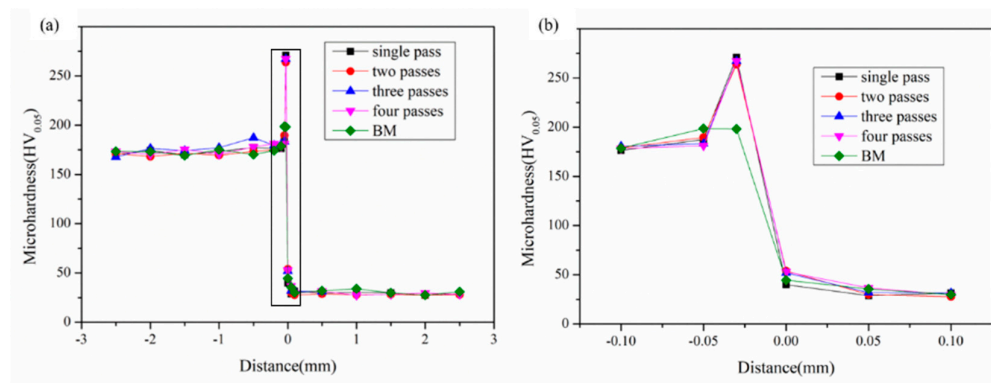
**Figure 13.** Microhardness of composite plate after FSP with different passes: (a) hardness of whole specimens; (b) hardness for the samples near the interface (partial enlargement of Figure 13a).

The microhardness of composite plates after FSP is shown in Figure 13. The microhardness is measured in the positive direction along the aluminum with the interface as the origin. The hardness on the interface near the aluminum side without FSP is  $44.54\text{HV}_{0.05}$ . While the maximum hardness of the interface after FSP can be achieved to  $53.83\text{HV}_{0.05}$ . It is believed that FSP can enhance performances of composite plate and has an obvious repairing effect. Meanwhile, FSP also has an effect of improvement on the properties of metal near the interface. The hardness of Q235 without FSP is  $198.5\text{HV}_{0.05}$  with the distance of  $30\mu\text{m}$  away from the interface, while the hardness can reach to  $270.9\text{HV}_{0.05}$  with the same distance after FSP. Although just repairing in aluminum, FSP can still strengthen steel through the plastic flows of aluminum.

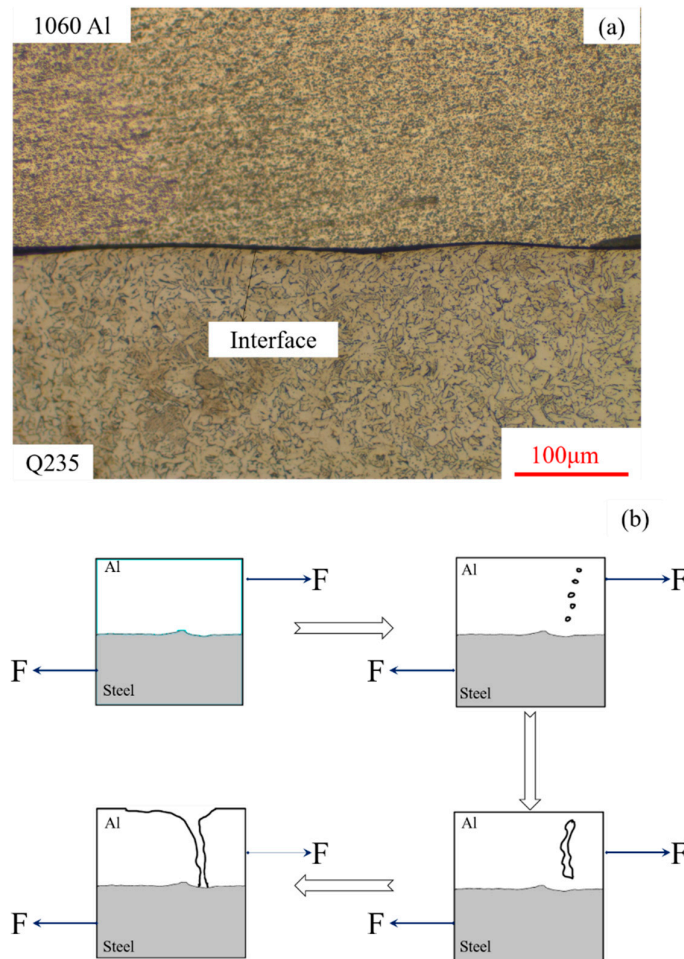
**Figure 14.** Failure mechanism of thin and flat interface: (a) physical diagram; (b) failure diagram of flat interface.

Firstly, when the interface of aluminum/steel composite plate is thin and flat, the crack extension stress of interface is small due to the flat interface. Meanwhile, the aluminum is so soft that it is easy to occur the phenomenon of yield. Several voids will preferentially be formed in the aluminum side. Cracks are formed by the accumulation and growth of voids with the gradually increasing load. Eventually, cracks extend to the aluminum and lead to the failure of composite plate, as shown in Figure 14. This failure mostly occurs in the aluminum/steel composite plate without FSP. It is basically agreed with the yield fracture of BM in the shear test.

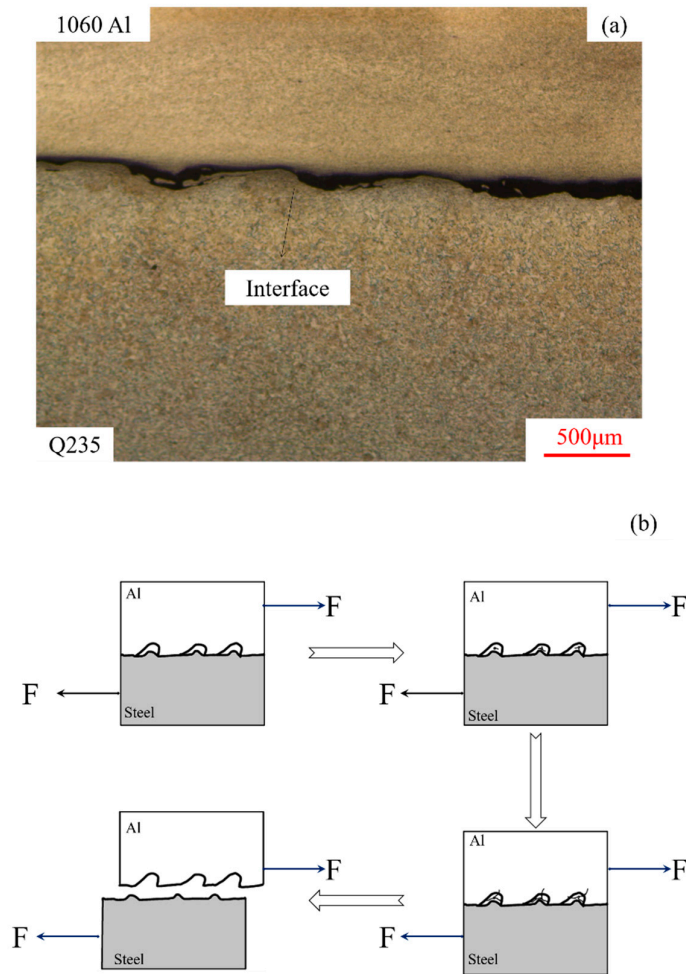
**Figure 15.** Failure mechanism of thick and discontinuous interface. (a) physical diagram; (b) failure diagram of flat interface.

Secondly, when the interface of aluminum/steel composite plate has a certain thickness and discontinuous mechanical connections, the crack extension stress of the interface is large. Several micro-cracks will preferentially be formed at the interface under the load. If the composite plate has been inadequately repaired by less passes, there could be some defects at the interface. The phenomenon of stress concentration caused by defects would accelerate the development of micro-cracks. Therefore, those micro-cracks would coalesce each other rapidly and ultimately lead to the fracture of the whole interface. However, if the composite plate has been adequately repaired by enough passes, the interface would have a certain thickness. The propagation of micro-cracks needs a path. In addition to this, those discontinuous mechanical connections improve the bonding strength of interface, which make the cracks propagate slowly. Thus, a larger load is needed to make the composite plate break. This failure occurs mostly in the aluminum/steel composite plate after repairing by FSP, which is basically consistent with the case of single, two and three passes, as shown in Figure 15.

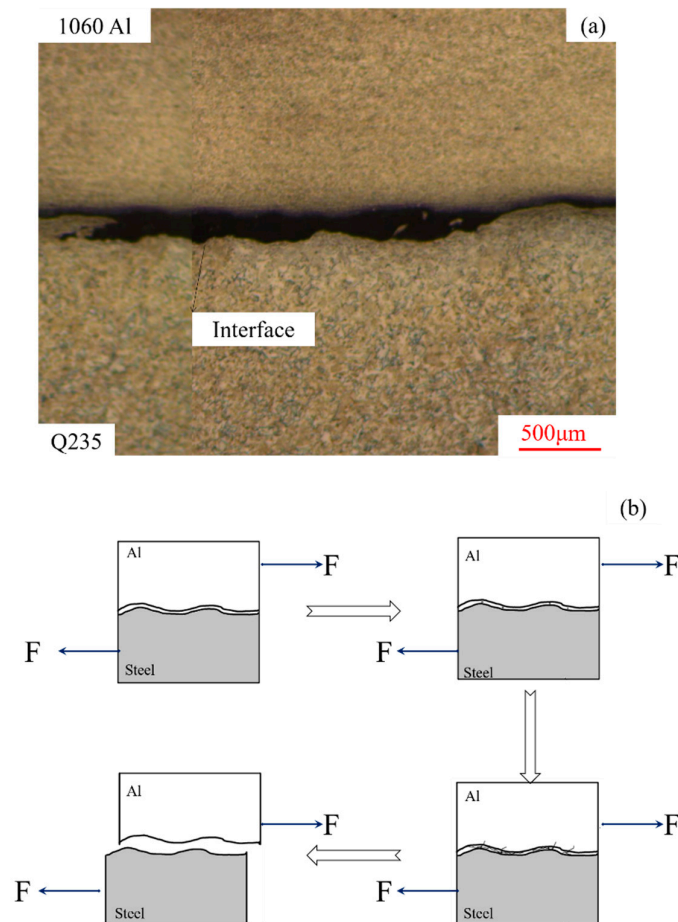
**Figure 16.** Failure mechanism of too thick and continuous interface: (a) physical diagram; (b) failure diagram of flat interface.

Thirdly, when the interface is too thick, although there are discontinuous mechanical connections at the interface, the overly thick interface connects the discontinuous mechanical connections to each other, which results in a bending and continuous interface. The crack extension stress of the interface is also large due to the bending interface. Micro-cracks will preferentially be formed at the interface under the load. Due to the thicker interface, those micro-cracks could easily bypass the mechanical connections. Therefore, the micro-cracks grow rapidly with the increasing load. Finally, the composite plate will break due to the fracture of the interface. This failure occurs more often in the composite plate after FSP with too many passes. The fracture of the aluminum/steel composite plate is basically the same as that of four passes, as shown in Figure 16.
