## Article

# Applicability Study of Pulsed Laser Beam Welding on Ferritic–Martensitic ODS Eurofer Steel

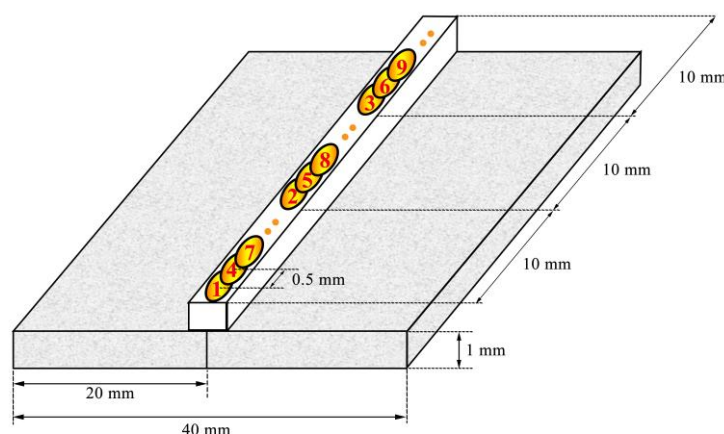
**Figure 1.** Schematic illustration of welding strategies.

A 6 kW Nd/YAG laser (Trumpf HAAS HL3006D, Trumpf, Ditzingen, Germany) was used for the welding experiments. The focusing optic has a focal length of 223 mm and projects a laser spot with a diameter of 0.6 mm on the work piece. A laser power of 2500 W with a pulse duration of 4 ms was applied to realise full penetration. A shielding gas of argon was delivered to the work piece at a flow rate of 8 L/min. In order to compensate the material loss due to metal evaporation during the welding process, an ODS Eurofer square bar with dimensions of  $30 \times 1 \times 1 \text{ mm}^3$  was attached to the surface of the work piece to act as a filler material. The sheets were joined using the pattern indicated in Figure 1. Instead of moving straight in one direction, the laser beam was moved following the sequence number 1, 2, 3, etc., in order to minimise the heat effect of the laser beam on the material and therefore shorten the period of the melt pool. The distance between the centre of the adjacent spots was 0.5 mm to ensure a continuous weld, i.e., an overlap of approximately 8%. The time interval between each spot was 2 min. The pulse shape of the applied laser beam is indicated in Figure 2.

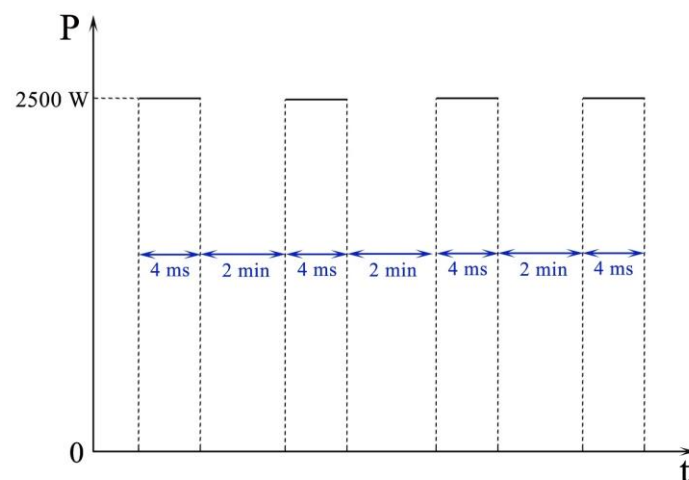
Figure 2. Pulse shape of the applied laser beam.

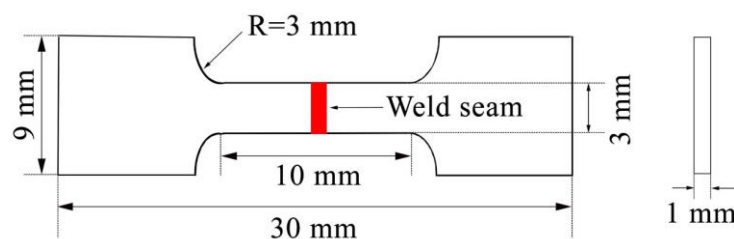
Figure 3. Sketch showing the shape and dimensions of the tensile samples.

The microstructure of the joint was characterised using a JEOL 6500F scanning electron microscope (SEM, JEOL Ltd., Tokyo, Japan) and a JEM-2200FS transmission electron microscope (TEM, JEOL Ltd., Tokyo, Japan) equipped with an energy dispersive spectrometer (EDS) system. To reveal the microstructure for SEM observations, the samples were etched in a mixed solution of 5 g ferric chloride, 50 mL HCl and 100 mL water for 20 s. The TEM specimens were prepared by electropolishing disks with a diameter of 3 mm in a twin-jet electropolisher using 4% perchloric acid and 96% ethanol as the electrolyte. Vickers microhardness across the weld was measured, with a load of 0.3 kg and a step size of 0.1 mm. Flat tensile specimens were cut from the joined sample, with the weld seam located at the centre of the sample and perpendicular to the applied tensile force, as shown in Figure 3. The specimens had a width of 3 mm, thickness of 1 mm and gauge length of 10 mm. The tensile properties were determined using an Instron 5500R machine, with a nominal strain rate of  $2.5 \times 10^{-4} \text{ s}^{-1}$  at room temperature. According to ISO 6892-1:2009(E) [9], the elongation  $A$  is measured from the following equation:

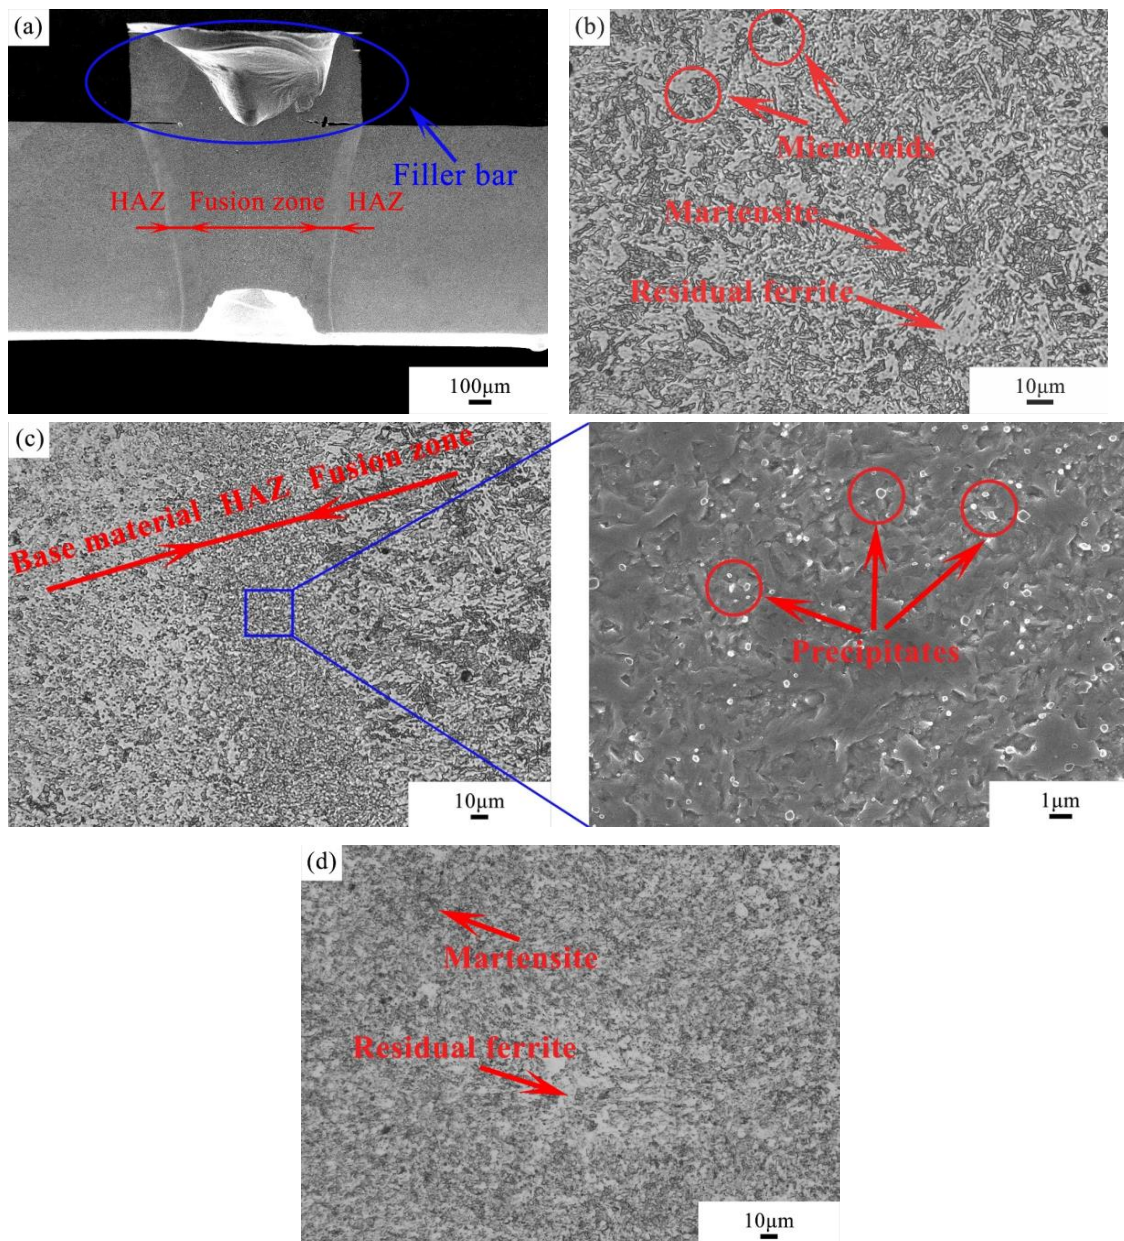
**Figure 4.** SEM morphologies and microhardness of the weld seam with the filler material ( $P = 2500$  W,  $t = 4$  ms): (a) morphology of the weld seam, (b) weld centre, (c) heat-affected zone (HAZ) and (d) base material.

An SEM image of the weld seam is shown in Figure 4a. The laser beam penetrates the plate during the welding process, causing part of the material to evaporate, and therefore a minor material loss from the bottom surface. Severe material losses were observed in the filler bar, in other words, the material loss in the top surface of the specimen is compensated by the filler material. The microstructure of the fusion zone consists of elongated structures with microvoids, as seen in Figure 4b, and contains both martensite grains (dark region) and ferrite grains (bright region). One possible reason for the formation of this microstructure is that since the ferrite–austenite transformation is a diffusion-controlled process, the rapid heating and solidification do not offer sufficient time to complete the phase transformation [10].

As a result, residual ferrite is observed in the fusion zone. The heat-affected zone (HAZ) has a width of around 0.06 mm. The grain size of the HAZ is smaller compared with the base material showing a refinement effect (Figure 4c). Precipitates rich in Fe, Cr and C, determined by EDS analysis, are found to be decorating the grain boundaries in the material. The microstructure of the base material region can be seen in Figure 4d. It is also a dual phase microstructure, consisting of martensite and residual ferrite. The hardness profile of the cross-section of the weld is shown in Figure 5. The average microhardness of the base material is approximately 465 HV. There is a decrease of around 70 HV in the weld centre compared with the base material due to grain growth. In addition, the hardness profile shows a slight increase in the HAZ due to a finer grain size compared with the base material.

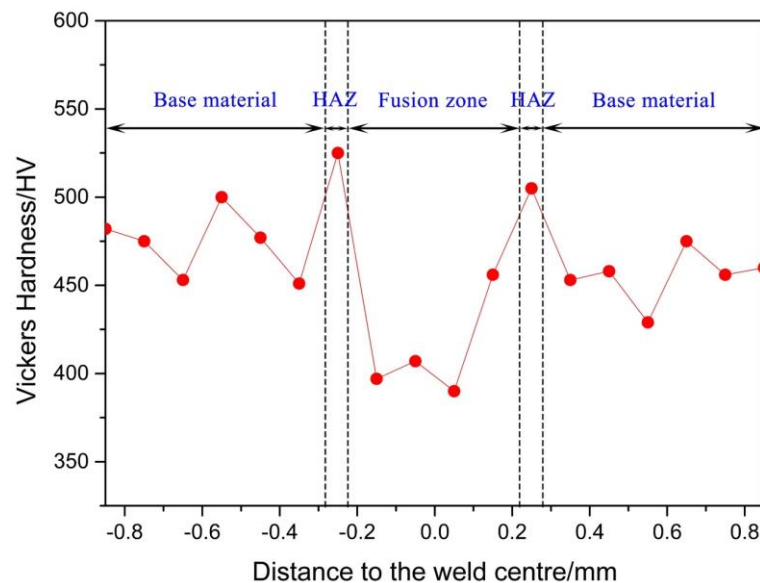
Figure 5. Microhardness profile along the cross-section of the weld.

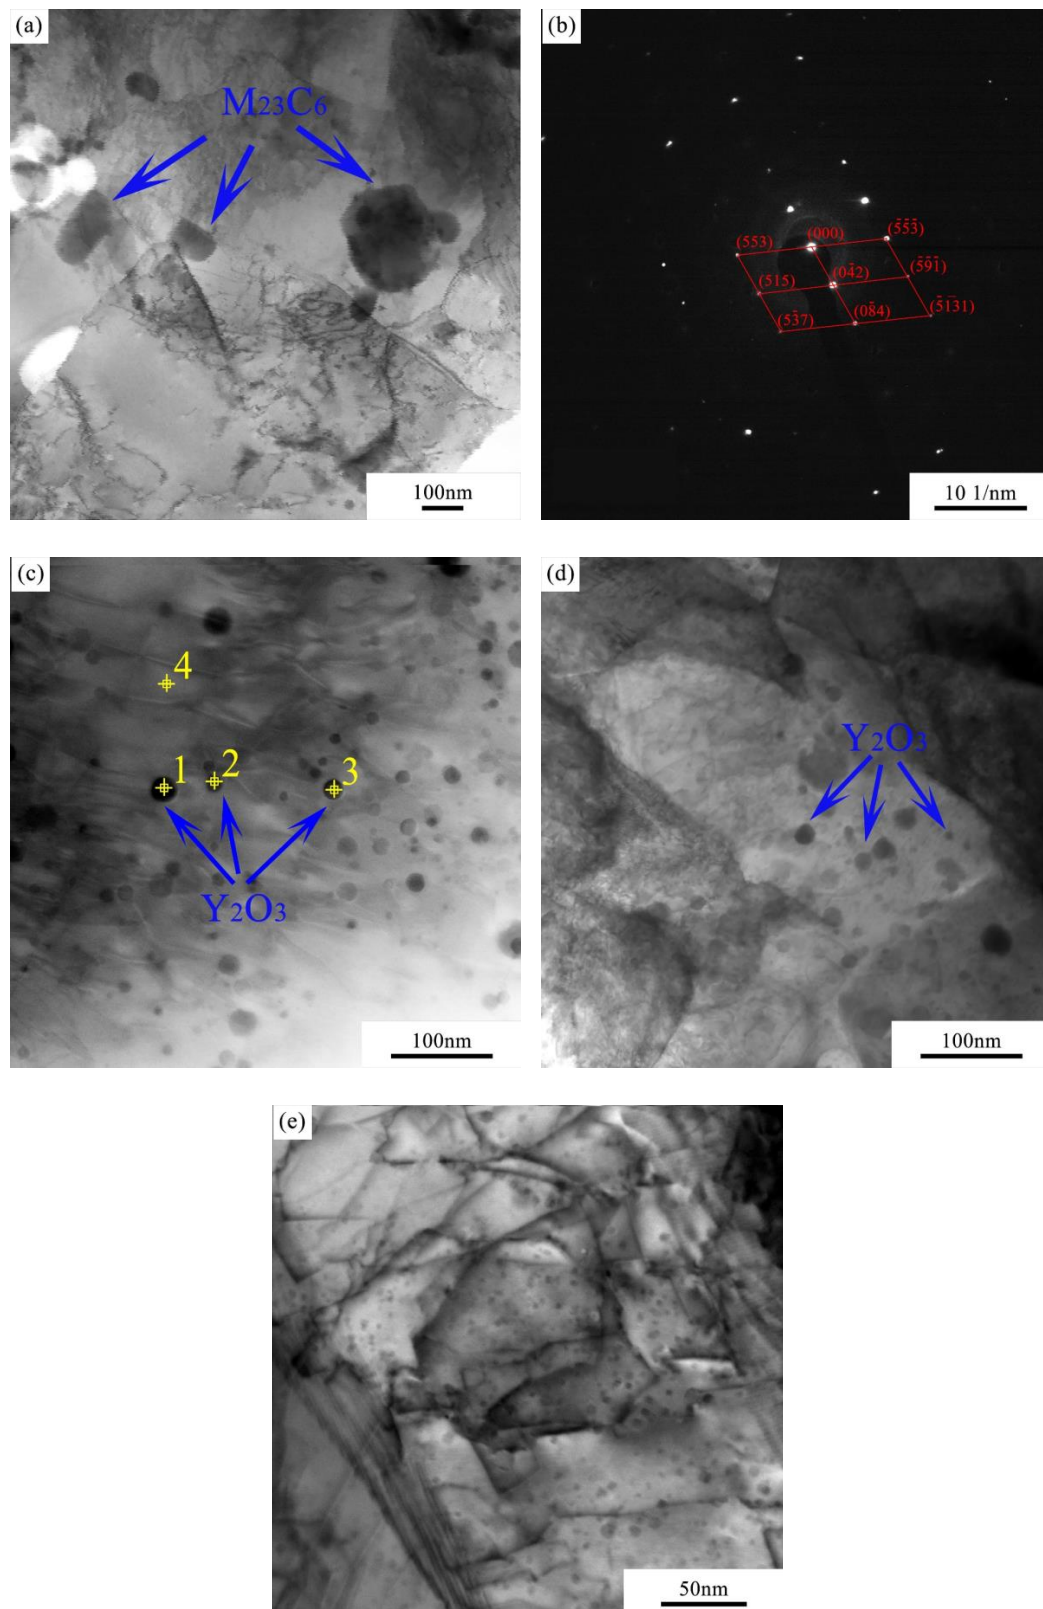
**Figure 6.** TEM images of the microstructural features: (a)  $M_{23}C_6$  carbides in the fusion zone, (b) diffraction pattern of  $M_{23}C_6$  carbides, (c)  $Y_2O_3$  nanoparticles in the fusion zone, (d)  $Y_2O_3$  nanoparticles in the base material and (e) high-density dislocation.

To further investigate the microstructural features in the weld seam, samples taken from the fusion zone and base material were characterised by TEM. As can be seen in Figure 6a, a large number of  $M_{23}C_6$  ( $M = Fe$  and  $Cr$ ) carbides, confirmed by the diffraction pattern shown in Figure 6b, are found to be present in the fusion zone. Meanwhile, finely dispersed  $Y_2O_3$  nanoparticles, confirmed by EDS, are observed in both samples (Figure 6c,d). The chemical composition of the nano-oxides in Figure 6c was determined by EDS, as shown in Table 2. It can be seen that besides  $Y$  and  $O$ , there is an increase of  $V$  in the oxide particles compared with the base material. It is possible that  $V$  combines with  $Y_2O_3$  during the mechanical alloying process. Similar results were obtained by References [11] and [12]. The particle size does not show a significant difference between the fusion zone and base material, which varies within a range of 1–30 nm. In addition, no evident clustering of  $Y_2O_3$  is observed in the microstructure of the fusion zone, which is crucial for the mechanical properties of the joint. A high density of dislocations is evident in the microstructure of the base material (Figure 6e), probably due to the mechanical alloying process. It is also worth noting that  $Y_2O_3$  particles are not homogeneously distributed in the steel matrix. The non-homogeneity of  $Y_2O_3$  particles in the powder metallurgy-prepared ODS steels was reported by several authors [13–15]. Even though high-energy ball milling is known to be efficient to produce powders with nano-scale oxide particles, a perfect solid solution of ODS powders is difficult to achieve.

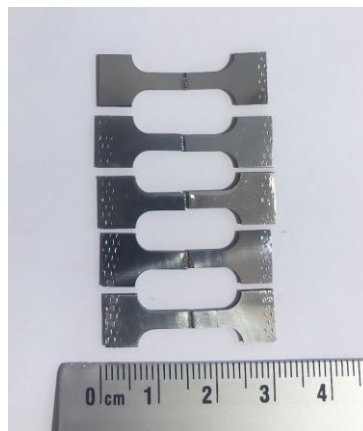
**Figure 7.** Fractured specimens after tensile testing.

The tensile properties of the as-joined specimen are shown in Table 3. The standard deviations of the tensile properties are relatively high. This could be ascribed to the welding defects, which can act as preferential sites for crack initiation. As a result, specimens having a larger number of defects such as microvoids will have a significantly lower strength and ductility. All of the tested specimens fractured in the fusion zone (Figure 7), indicating the weakest point of the joint due to the material loss, microvoids and grain growth. It is worth mentioning that in case the actual cross-sectional area is considered, the strength of the specimen will be increased by approximately 25% compared with the values in the table. The tensile properties of the base material obtained from our previous study are also listed in this table [8]. It can be seen that the strength and elongation of the joined specimen are slightly compromised compared with the base material. This result agrees with the softening weld metal in the fusion zone indicated by the hardness profile.

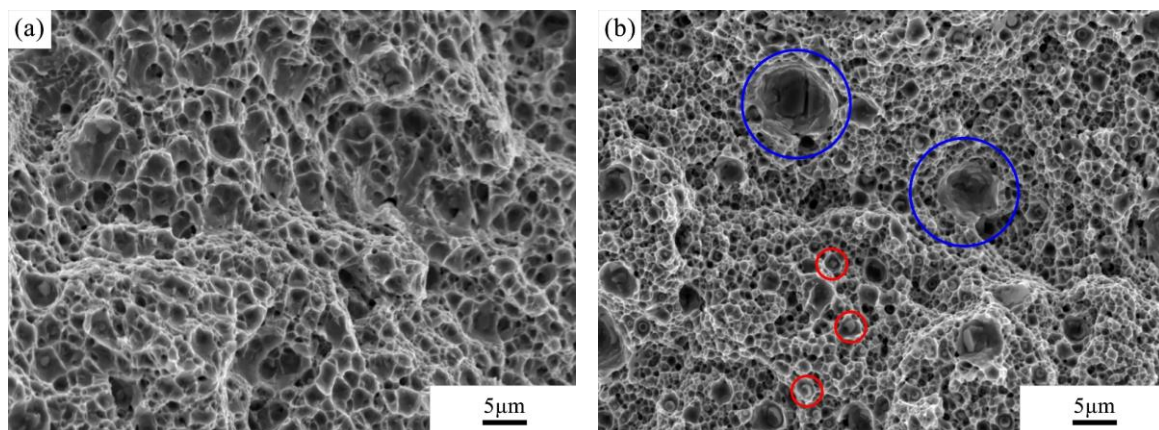
**Figure 8.** SEM micrographs of the fractures for specimens after tensile testing: (a) one specimen with higher tensile strength and elongation and (b) one specimen with lower tensile strength and elongation.

The fractures of two specimens from the tensile testing were analysed by SEM (Figure 8). One specimen (Figure 8a) has higher tensile strength and elongation than the other (Figure 8b). It can be seen that the fracture in Figure 8a shows numerous dimple features, indicating a typical ductile fracture mode. The fracture in Figure 8b also shows a ductile mode but with smaller and shallower dimples, indicating a lower ductility. It is worth noting that large precipitates (red cycles) and microvoids (blue cycles) were observed at the fracture surface. As mentioned above, coarse  $M_{23}C_6$  precipitates and microvoids can act as preferential sites for crack initiation due to the stress concentration [16], leading to decreased strength and ductility.
