Measuring Plasticity with Orientation Contrast Microscopy in Aluminium 6061-T4

Abstract. Orientation contrast microscopy (i.e., electron backscattered diffraction, EBSD) was employed to monitor the plastic strain in loaded tensile samples of aluminium alloy Al6061 in T4 condition. The kernel average misorientation (KAM) is known to be an appropriate parameter in orientation contrast microscopy which has the potential to characterise the plastic strain by monitoring the local misorientations. This technique was applied here to gauge the extent of the plastic zone around a fatigue crack. To establish the magnitude of strain (which can be identified by the KAM parameter), a series of tensile samples were strained in the range of 1% to 25%. KAM maps were compared, and the average misorientations were related to the tensile strain values. The KAM distribution functions for all the strained samples were derived from a large scanned area. In addition, Vickers microhardness tests were conducted for these series of samples. This allowed the comparison of the mesoscopic plastic strain measured by Vickers microhardness with the micro plastic strain locally obtained by KAM. Noise was observed

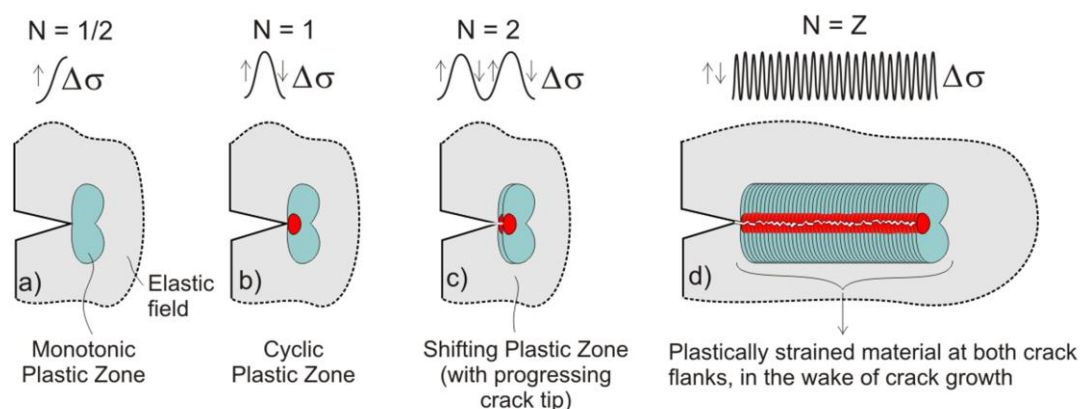
Figure 1. A schematic view of the formation of a plastic zone at the tip of a progressing fatigue crack with (a) Formation of a monotonic plastic zone at the moment of reaching the maximum nominal stress level (for the first time after crack initiation); (b) Formation of the cyclic plastic zone after unloading of step (a); (c) Shifting of the position of the plastic zone, along with the progressing crack tip; (d) Resulting areas of plastic deformation in the wake of crack growth, being the remnants of former plastic zones, in the earlier stage of crack growth.

A schematic view of the formation of a plastic zone at the tip of a progressing fatigue crack showing the formation of the MPZ and CPZ is demonstrated in Figure 1a–d. As the crack grows, the plastic zone forms a wake of plastically strained material along both flanks of the crack (cf. Figure 1d).

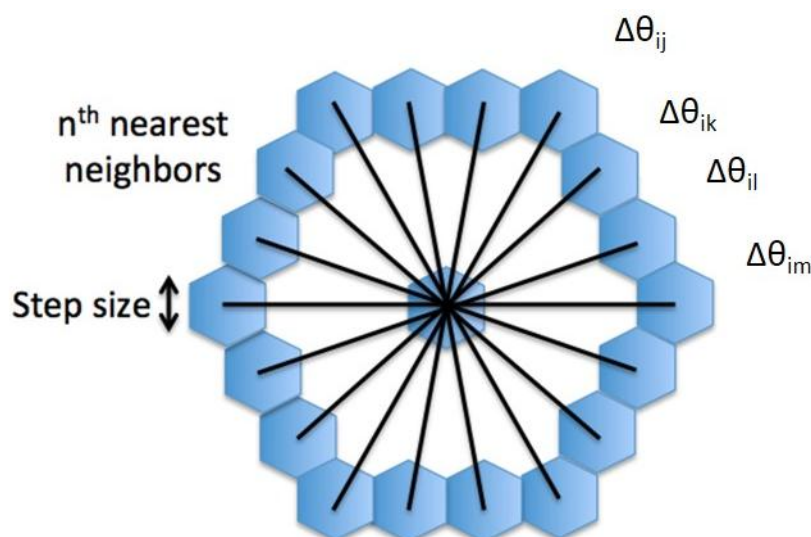
Figure 2. Kernel average misorientation (KAM) parameter used to characterize the accumulated plastic strain by monitoring the local orientation gradients [15].

For metallographic purposes, conventional mechanical polishing up to 0.25 μm was applied with OPS (oxide polishing suspension), followed by electropolishing with A2 Struers[®] electrolyte (Maassluis, The Netherlands, 2011) with a voltage of 39 V and a flow rate of 9 for 15 s. Orientation contrast scans were carried out in a selected region around the crack tip with an EDAX-TSL[®] EBSD tool (EDAX Inc., Draper, UT, USA, 2012) attached to an FEI Quanta 450TM field emission gun (FEG)-SEM. Several grids with step sizes ranging from 0.3 to 2.0 μm were applied. The kernel average misorientation (KAM) parameter was considered as a measure of local orientation gradient. This parameter is calculated by considering for each pixel the average misorientation with the N th neighbouring pixels (neighbouring pixels for which the misorientation exceeds 5° are not included in the average). Only the perimeter points of the kernel are included in the procedure (cf. Figure 2). The misorientation cut-off θ_c was set to 5° , as it is assumed that misorientations of more than 5° originate from grain boundaries, and were not induced by (micro-)plasticity around the crack tip.

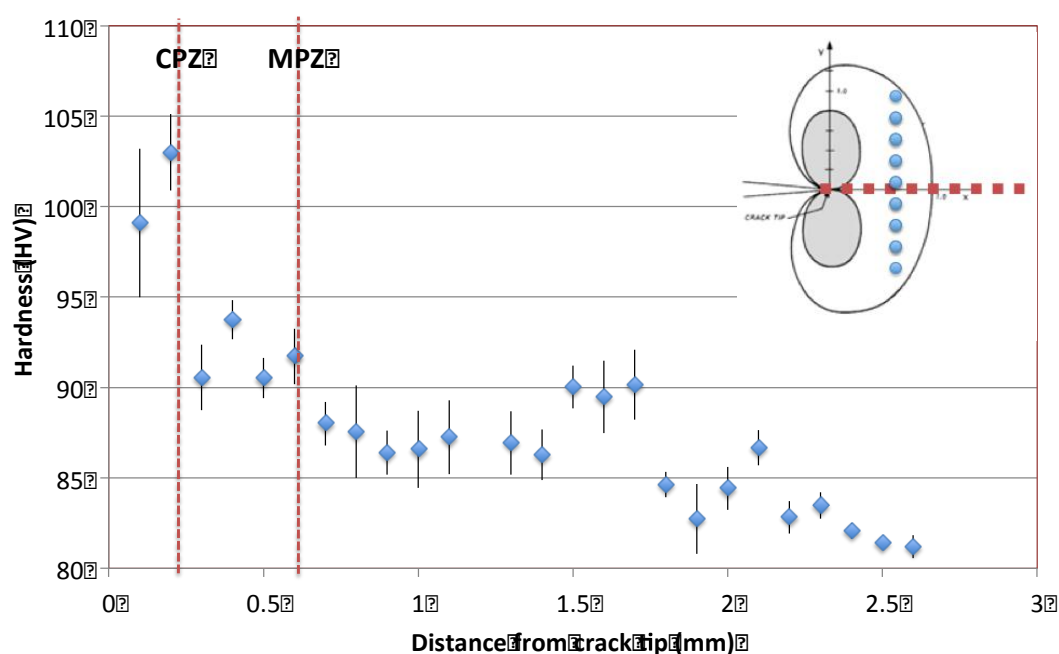
Figure 3. Vickers Hardness (Hv) values along a line in the extension of the crack tip. Each data point is the average of ten data points along a line that is perpendicular to the crack tip (cf. insert). CPZ: cyclic plastic zone; MPZ: monotonic plastic zone.

Figure 3 presents the hardness data along a line that extends along the crack tip. Each data point is the average of 10 data points along a line that is perpendicular to the crack tip (cf. insert in Figure 3). Based on these data, the plastic zone size was determined visually by two drops in Hv values, indicated by the vertical lines in Figure 3. It must be noted that $H_v = 85 \pm 2$ is the hardness of the unstrained or base material. Vickers microhardness measurements indicate an MPZ and CPZ size of ~ 0.6 mm and ~ 0.2 mm, respectively (cf. Figure 3).

Vickers microhardness measurements indicate the MPZ and CPZ size of ~0.6 mm and ~0.2 mm, respectively (cf. Figure 3). These values are in reasonable agreement with the theoretical estimated values of MPZ and CPZ size of 0.53 mm and 0.13 mm, respectively, as derived from Equation (1) with $K_{max} = 5.62 \text{ MPa } \sqrt{m}$ and $C = 1.17$ [3], whereby $CPZ = (1/4) * MPZ$ [4].

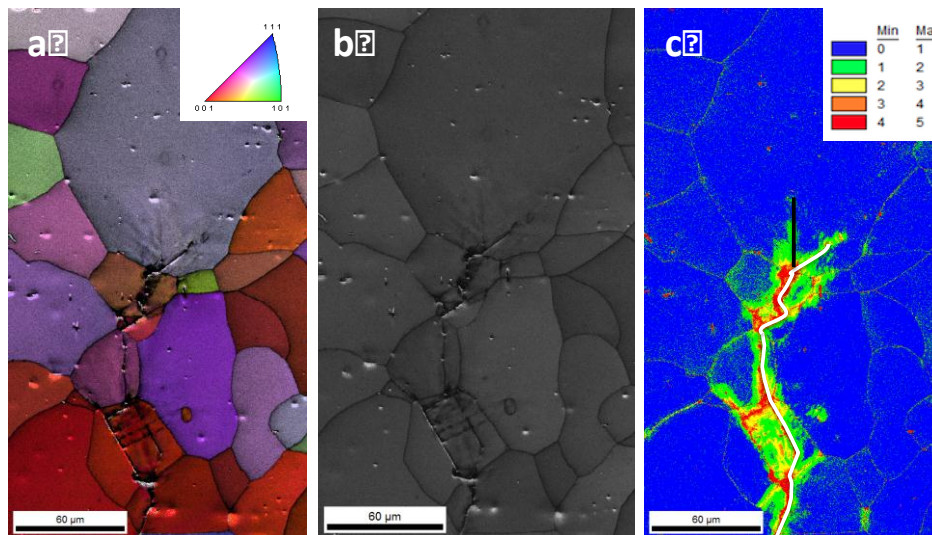
Figure 4. Electron backscattered diffraction (EBSD) scan of the crack tip region: (a) Inverse pole figure map; (b) Image quality map; and (c) KAM map (colour legend in degrees).

Figure 4 shows the orientation contrast scan of the crack tip area. In the inverse pole figure map of Figure 4a, it can be observed that the crack is predominantly of a transgranular nature. The scan

also shows that there are many particles in the microstructure, which is normal for this type of aluminium grade alloyed with Si and Mg. It appears that the crack path morphology is affected by these particles. A similar phenomenon was observed in a previous study of cast iron with the graphite particles embedded in a pearlitic metal matrix during thermo-mechanical fatigue (TMF) testing [16]. Similar to the cast iron case, in the current material under investigation, the crack deviates towards the particles that exhibit a characteristic stress field. The tip of the crack splits in two branches; the one on the right-hand side (marked in white in Figure 4c) is more pronounced, whereas the one on the left-hand side (marked in black in Figure 4c) is less developed but appears to exhibit some deformation lines perpendicular to the crack path (cf. image quality (IQ) map of Figure 4b). However, it seems that this branch of the crack was stopped by a particle in its front.

The misorientation corresponding to the plastic zone at the crack tip—as revealed by the KAM parameter—is shown in Figure 4c. This map suggests a plastic wake size of less than $30\text{ }\mu\text{m}$, which is much smaller than the size obtained from the hardness measurements and theoretical calculations as mentioned above. Therefore, this can suggest that the magnitude of strain in the plastic zone is not high enough to be gauged with EBSD. Hence, the following experiment was performed to determine if the noise dominates the misorientation maps for strain levels below a critical threshold.

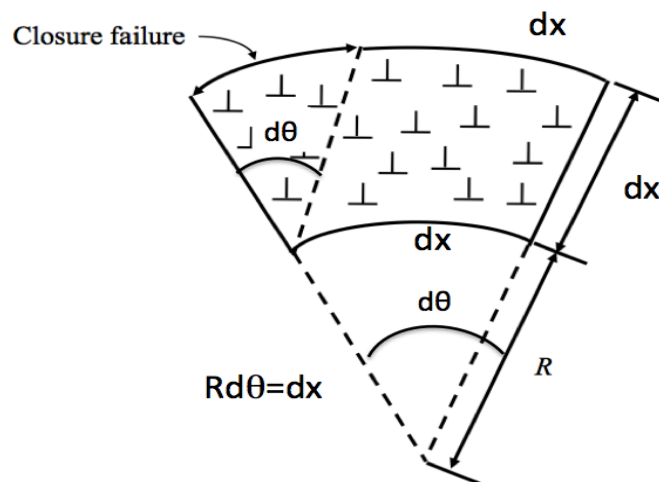
Figure 5. Schematic representation of a one-dimension lattice curvature, inducing a shear strain $d\theta$ [7].

The Nye tensor connects the density of GNDs to the lattice curvature tensor. In a simplified one-dimensional (scalar) representation assuming only parallel edge dislocations of the same sign, this tensor relation can be expressed as (cf. Figure 5) [7]:

whereby κ is the lattice curvature $d\theta/dx$, ρ the density of GNDs, and b the Burgers vector. On the simplified lattice geometry of Figure 5, it can be seen that the curvature $\kappa = 1/R = d\theta/dx$. In a discrete

Figure 5 equally shows that the shear strain $\tan(d\theta) \approx d\theta$ is approximately equal to the local lattice misorientation $d\theta$ in the approximation of very small (shear) strains. If it is assumed that the angular resolution limit of EBSD is approximately equal to 1.0° (0.0174 rad), then this corresponds to a plastic shear detection limit of $\sim 1.7\%$.

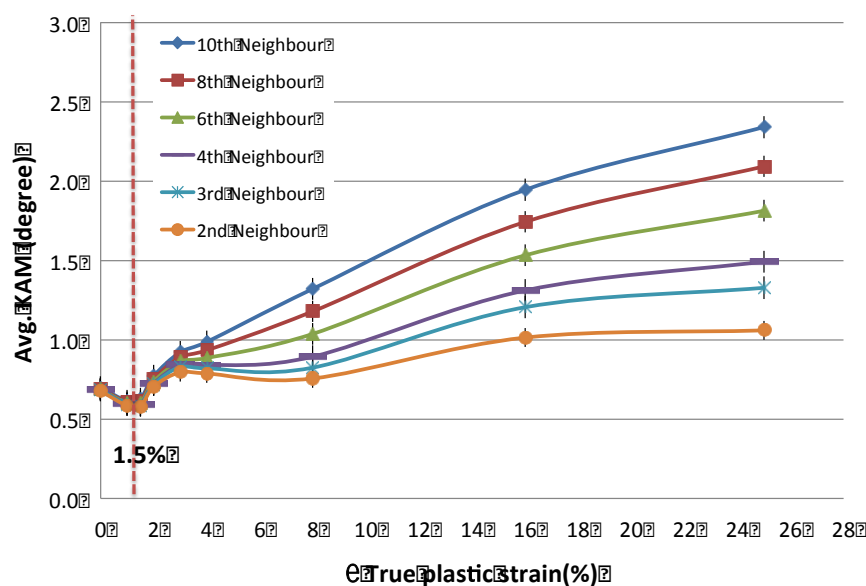
Figure 6. Average KAM parameter vs. true strain observed in tensile experiments. The KAM parameter was evaluated for different values of nearest neighbours.

A plastic strain was applied to a tensile test sample of the same aluminium alloy with tensile strains ranging from 1% to 25% at fracture. Orientation contrast maps were measured with a step size of $0.3\text{ }\mu\text{m}$ on each of the tensile samples in four different locations (scanned area $200 \times 300\text{ }\mu\text{m}^2$), and the scan average KAM value was extracted for each scan; thereafter, the average value and the standard deviation was determined for the set of four scans. The procedure was repeated for different values of nearest neighbours: 2nd, 3rd, 4th, 6th, 8th, and 10th nearest neighbours were considered. The dependence of the KAM value on the tensile plastic strain is shown in Figure 6.

According to the theoretical expectation, it was confirmed that no specific tendency could be observed up to a plastic strain level of $\sim 1.5\%$, indicating that the accumulated plastic strain at the crack tip is less than the detectable limit. For plastic strains exceeding the critical value of $\sim 1.5\%$, noise no longer determines the average KAM value, and there is an ascending correspondence between the KAM value and the plastic strain, which was also observed by Kamaya et al. [13].
