Article

Measuring Plasticity with Orientation Contrast Microscopy in Aluminium 6061-T4

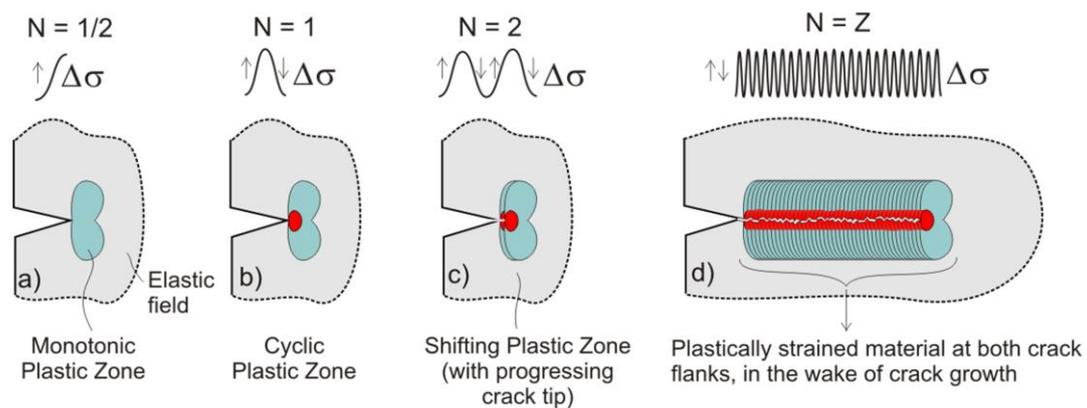
Figure 1. A schematic view of the formation of a plastic zone at the tip of a progressing fatigue crack with (a) Formation of a monotonic plastic zone at the moment of reaching the maximum nominal stress level (for the first time after crack initiation); (b) Formation of the cyclic plastic zone after unloading of step (a); (c) Shifting of the position of the plastic zone, along with the progressing crack tip; (d) Resulting areas of plastic deformation in the wake of crack growth, being the remnants of former plastic zones, in the earlier stage of crack growth.

A schematic view of the formation of a plastic zone at the tip of a progressing fatigue crack showing the formation of the MPZ and CPZ is demonstrated in Figure 1a–d. As the crack grows, the plastic zone forms a wake of plastically strained material along both flanks of the crack (cf. Figure 1d).

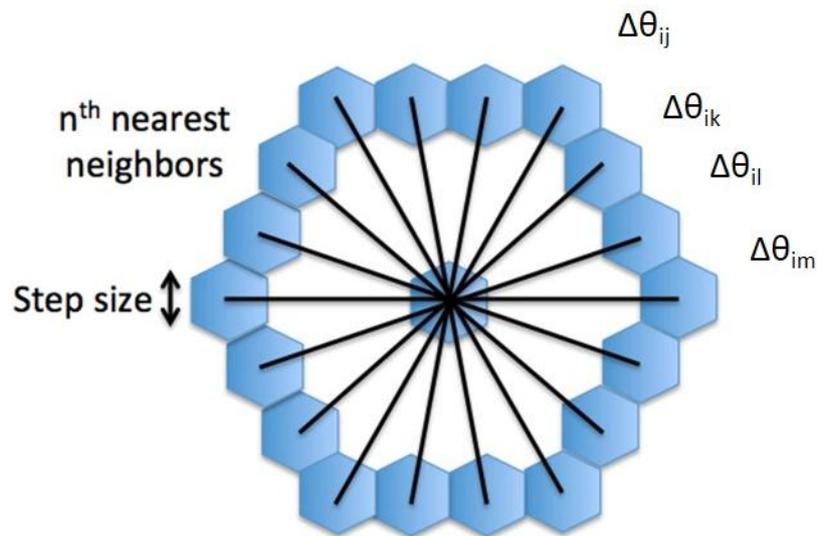
Figure 2. Kernel average misorientation (KAM) parameter used to characterize the accumulated plastic strain by monitoring the local orientation gradients [15].

For metallographic purposes, conventional mechanical polishing up to 0.25 μm was applied with OPS (oxide polishing suspension), followed by electropolishing with A2 Struers[®] electrolyte (Maassluis, The Netherlands, 2011) with a voltage of 39 V and a flow rate of 9 for 15 s. Orientation contrast scans were carried out in a selected region around the crack tip with an EDAX-TSL[®] EBSD tool (EDAX Inc., Draper, UT, USA, 2012) attached to an FEI Quanta 450TM field emission gun (FEG)-SEM. Several grids with step sizes ranging from 0.3 to 2.0 μm were applied. The kernel average misorientation (KAM) parameter was considered as a measure of local orientation gradient. This parameter is calculated by considering for each pixel the average misorientation with the Nth neighbouring pixels (neighbouring pixels for which the misorientation exceeds 5° are not included in the average). Only the perimeter points of the kernel are included in the procedure (cf. Figure 2). The misorientation cut-off θ_c was set to 5° , as it is assumed that misorientations of more than 5° originate from grain boundaries, and were not induced by (micro-)plasticity around the crack tip.

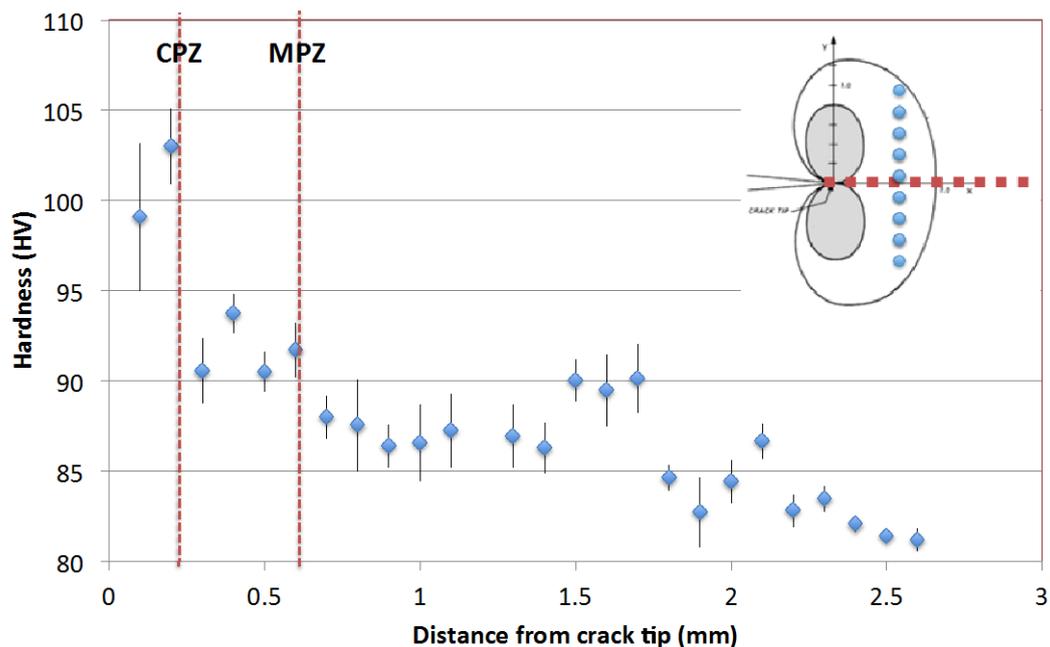
Figure 3. Vickers Hardness (Hv) values along a line in the extension of the crack tip. Each data point is the average of ten data points along a line that is perpendicular to the crack tip (cf. insert). CPZ: cyclic plastic zone; MPZ: monotonic plastic zone.

Figure 3 presents the hardness data along a line that extends along the crack tip. Each data point is the average of 10 data points along a line that is perpendicular to the crack tip (cf. insert in Figure 3). Based on these data, the plastic zone size was determined visually by two drops in Hv values, indicated by the vertical lines in Figure 3. It must be noted that $H_v = 85 \pm 2$ is the hardness of the unstrained or base material. Vickers microhardness measurements indicate an MPZ and CPZ size of ~ 0.6 mm and ~ 0.2 mm, respectively (cf. Figure 3).

Vickers microhardness measurements indicate the MPZ and CPZ size of $\sim 0.6\ \text{mm}$ and $\sim 0.2\ \text{mm}$, respectively (cf. Figure 3). These values are in reasonable agreement with the theoretical estimated values of MPZ and CPZ size of $0.53\ \text{mm}$ and $0.13\ \text{mm}$, respectively, as derived from Equation (1) with $K_{max} = 5.62\ \text{MPa}\ \sqrt{m}$ and $C = 1.17$ [3], whereby $\text{CPZ} = (1/4) * \text{MPZ}$ [4].

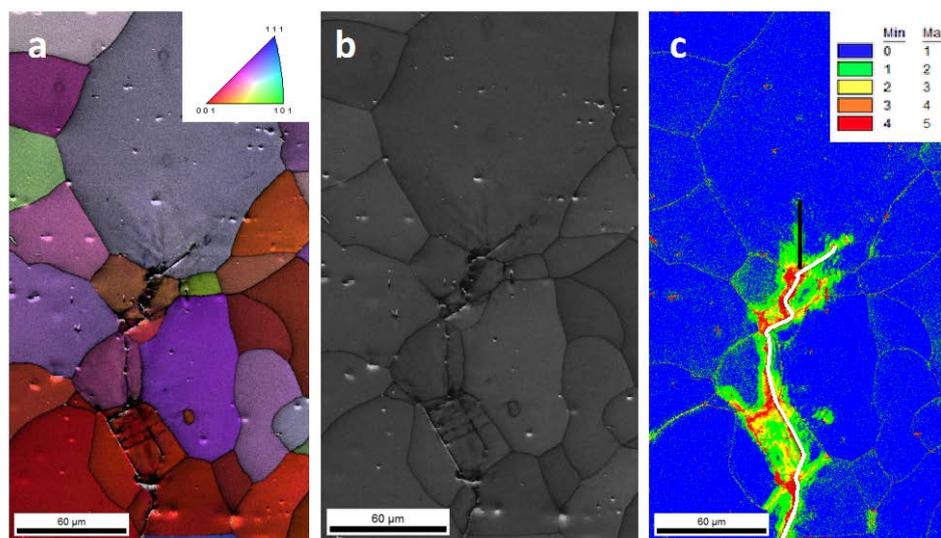
Figure 4. Electron backscattered diffraction (EBSD) scan of the crack tip region: (a) Inverse pole figure map; (b) Image quality map; and (c) KAM map (colour legend in degrees).

Figure 4 shows the orientation contrast scan of the crack tip area. In the inverse pole figure map of Figure 4a, it can be observed that the crack is predominantly of a transgranular nature. The scan also shows that there are many particles in the microstructure, which is normal for this type of aluminium grade alloyed with Si and Mg. It appears that the crack path morphology is affected by these particles. A similar phenomenon was observed in a previous study of cast iron with the graphite particles embedded in a pearlitic metal matrix during thermo-mechanical fatigue (TMF) testing [16]. Similar to the cast iron case, in the current material under investigation, the crack deviates towards the particles that exhibit a characteristic stress field. The tip of the crack splits in two branches; the one on the right-hand side (marked in white in Figure 4c) is more pronounced, whereas the one on the left-hand side (marked in black in Figure 4c) is less developed but appears to exhibit some deformation lines perpendicular to the crack path (cf. image quality (IQ) map of Figure 4b). However, it seems that this branch of the crack was stopped by a particle in its front.

The misorientation corresponding to the plastic zone at the crack tip—as revealed by the KAM parameter—is shown in Figure 4c. This map suggests a plastic wake size of less than $30\ \mu\text{m}$, which is much smaller than the size obtained from the hardness measurements and theoretical calculations as mentioned above. Therefore, this can suggest that the magnitude of strain in the plastic zone is not high enough to be gauged with EBSD. Hence, the following experiment was performed to determine if the noise dominates the misorientation maps for strain levels below a critical threshold.

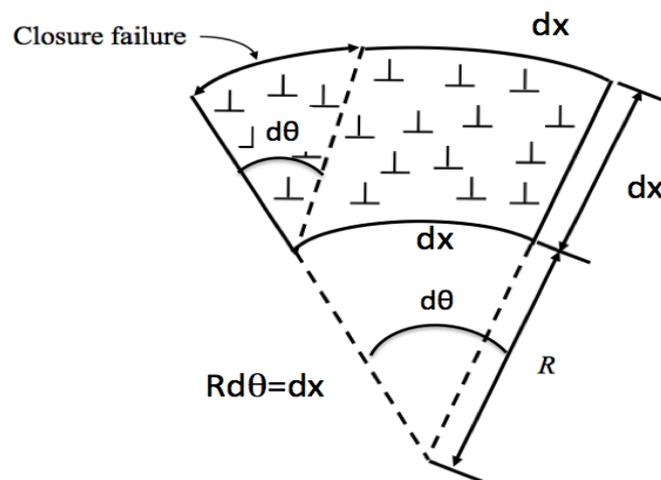
Figure 5. Schematic representation of a one-dimension lattice curvature, inducing a shear strain $d\theta$ [7].

The Nye tensor connects the density of GNDs to the lattice curvature tensor. In a simplified one-dimensional (scalar) representation assuming only parallel edge dislocations of the same sign, this tensor relation can be expressed as (cf. Figure 5) [7]:

whereby κ is the lattice curvature $d\theta/dx$, ρ the density of GNDs, and b the Burgers vector. On the simplified lattice geometry of Figure 5, it can be seen that the curvature $\kappa = 1/R = d\theta/dx$. In a discrete representation, the local $d\theta/dx$ value can be approximated as $\Delta\langle\theta\rangle/\Delta x$, whereby $\Delta\langle\theta\rangle$ is the local average misorientation as quantified by the KAM parameter in an EBSD measurement and Δx is the distance over which the misorientation is evaluated.

Figure 5 equally shows that the shear strain $\tan(d\theta) \approx d\theta$ is approximately equal to the local lattice misorientation $d\theta$ in the approximation of very small (shear) strains. If it is assumed that the angular resolution limit of EBSD is approximately equal to 1.0° (0.0174 rad), then this corresponds to a plastic shear detection limit of $\sim 1.7\%$.

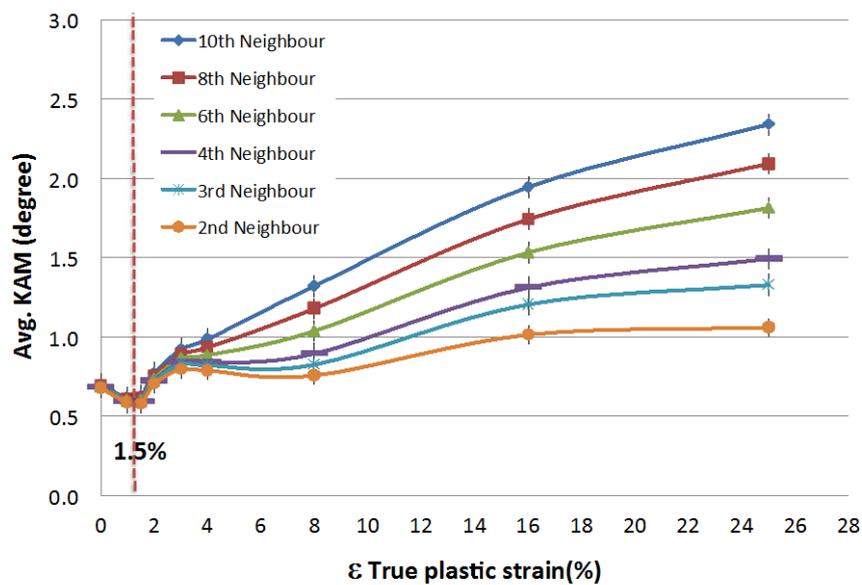
Figure 6. Average KAM parameter vs. true strain observed in tensile experiments. The KAM parameter was evaluated for different values of nearest neighbours.

A plastic strain was applied to a tensile test sample of the same aluminium alloy with tensile strains ranging from 1% to 25% at fracture. Orientation contrast maps were measured with a step size of $0.3\ \mu\text{m}$ on each of the tensile samples in four different locations (scanned area $200 \times 300\ \mu\text{m}^2$), and the scan average KAM value was extracted for each scan; thereafter, the average value and the standard deviation was determined for the set of four scans. The procedure was repeated for different values of nearest neighbours: 2nd, 3rd, 4th, 6th, 8th, and 10th nearest neighbours were considered. The dependence of the KAM value on the tensile plastic strain is shown in Figure 6.

According to the theoretical expectation, it was confirmed that no specific tendency could be observed up to a plastic strain level of $\sim 1.5\%$, indicating that the accumulated plastic strain at the crack tip is less than the detectable limit. For plastic strains exceeding the critical value of $\sim 1.5\%$, noise no longer determines the average KAM value, and there is an ascending correspondence between the KAM value and the plastic strain, which was also observed by Kamaya et al. [13].
