# Material Removal Characteristic of Laser Cladding Cobalt-Based Alloy in the Photochemical Process

Xi Zeng <sup>1,2,\*</sup>, Zhuo Li <sup>1</sup>, Fengfei Xi <sup>1</sup>, Shiming Ji <sup>1</sup>, Lei Qiu <sup>1</sup>, Meng Shi <sup>1</sup>, Qianqian Zheng <sup>1</sup> and Wenbin Qiu <sup>1</sup>

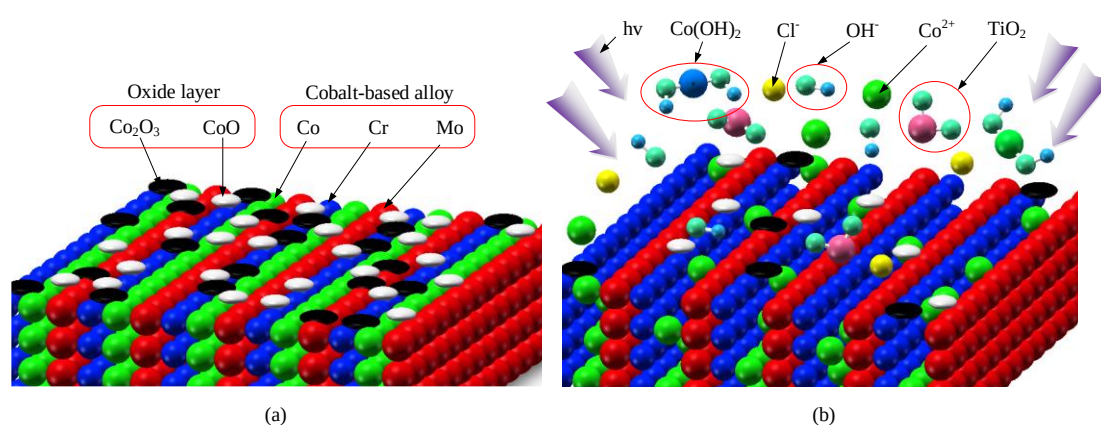
**Figure 1.** Surface model comparison of cobalt-based alloys before (a) and after (b) photochemical pretreatment.

As can be seen in Figure 1,  $h\nu$  stands for the photon energy under ultraviolet light catalysis. The etching solution used was a Basic Yellow 40 solution to which  $\text{TiO}_2$  had been added. The specific implementation method involved the cobalt-based alloy sample being immersed in the etching liquid, with external irradiation performed under ultraviolet light for a suitable time. The main reaction process was as follows:

$\text{CoCl}_2$  is a water-soluble salt, and  $\text{Co}(\text{OH})_2$  is a water-insoluble base. Thus, under the action of Basic Yellow 40 +  $\text{TiO}_2$  corrosion solution and UV photocatalysis, elemental cobalt on the surface of a cobalt-based alloy will eventually be converted into soluble  $\text{CoCl}_2$  and insoluble  $\text{Co}(\text{OH})_2$  precipitate, leading to an alloy with a loose microstructure surface which is easy to remove by machining.

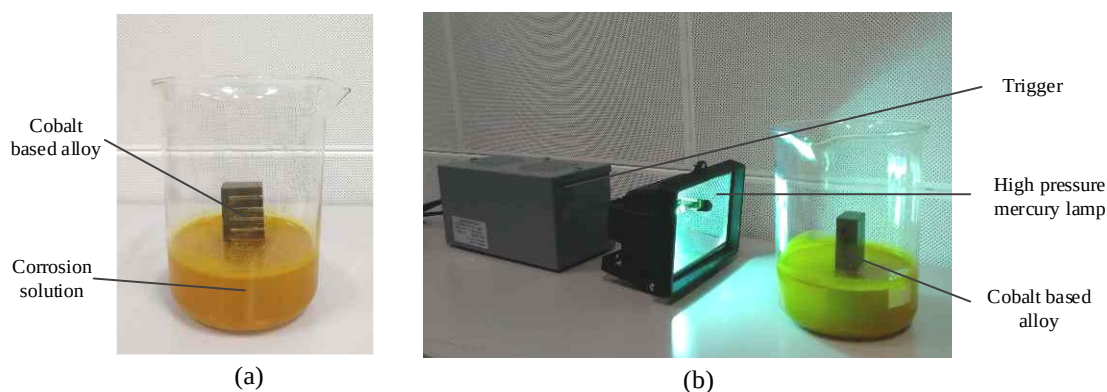
Figure 2 displays the devices used for establishing a corrosion solution configuration test.

**Figure 2.** Test devices of corrosion liquid configuration. (a). Non-photocatalytic test group, (b). Photocatalytic test group.

The material used in the corrosion solution configuration test was Stellite 6B cobalt-based alloy coating on steel No. 45. The wavelength of the UV light was set to 356 nm. Three types of corrosive liquid were prepared, and the amount of each component in the liquids is shown in Table 1.

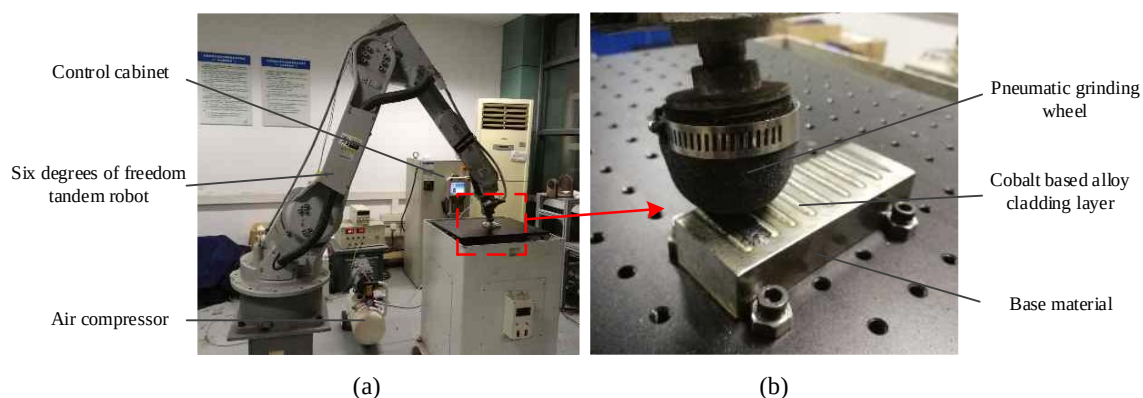
Firstly, a small cobalt-based alloy processing test platform, based on the six-degree-of-freedom industrial robot MOTOMAN-HP20 (Kitakyushu, Japan), was established. An air-pressing machine and a pneumatic wheel were used for the polishing test. Figure 3 displays the test platform used for cobalt-based alloy processing.

**Figure 3.** Test platform of cobalt-based alloy processing. (a). Overall structure, (b). Pneumatic grinding wheel structure.

Using the platform shown in Figure 3, material removal processing tests were performed on the cobalt-based alloys under three different processing conditions. The three condition types were: Pure mechanical processing conditions (Tra), chemical pretreatment + mechanical processing conditions (Tra + Che), and UV photocatalysis + chemical pretreatment + mechanical processing conditions (Tra + Che + UV). Table 2 lists the uniform process parameters under the three processing conditions.

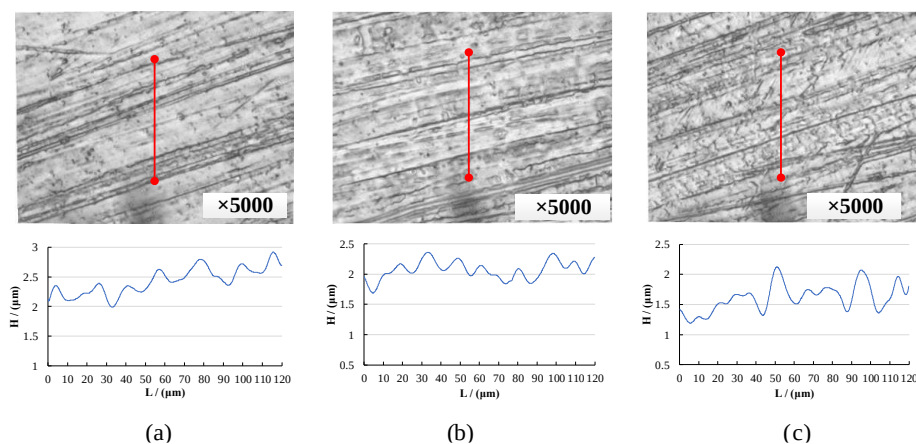
Figure 4 shows the surface topographies of the cobalt-based alloys before and after corrosion, as observed by the dynamic analysis of a three-dimensional display system.

**Figure 4.** Surface topographies and surface profile of cobalt-based alloys before and after corrosion. (a). Original surface, (b). Chemical corrosion, (c). UV light + Chemical corrosion.

As illustrated by Figure 4a,b, elemental cobalt in the surface layer of the cobalt-based alloy was converted into soluble  $\text{CoCl}_2$  and insoluble  $\text{Co}(\text{OH})_2$  after immersion in the  $\text{TiO}_2$  + Basic Yellow 40 solution. Significant corrosion marks appeared on the surface of the sample after cleaning. Compared with the corresponding surface profile figures, it was also found that the surface material was slightly removed, indicating that the surface structure was damaged to some extent. After increasing the UV photocatalytic effect, the corrosion marks were obvious and the surface structure was further destroyed. The surface profile peaks were significantly reduced and the surface structure was obviously destroyed (Figure 4c). Compared with the original surface topography (Figure 4a), the corroded surface of the metal became looser than the previously untreated surface, and the surface metal structure was greatly damaged. At the same time, a large number of pits could be found after corrosion by observing the corrosion morphology (Figure 4b,c). The reason for this was that the cobalt-based alloy was essentially a cobalt-chromium-molybdenum alloy—i.e., the surface was not composed of a single element, as it also contained other elements like chromium and molybdenum. The corrosion solution proposed in this paper was only suitable for elemental cobalt and its compounds in the cobalt-based alloy, rather than other elements on the surface of the alloy. Thus, the corrosion solution caused the surface unevenness observed in Figure 4. In summary, the corrosion process was non-uniform and did not cause significant material removal of the alloy surface, resulting in a desired surface quality. Only with subsequent machining could the ideal machining effect be achieved.

Combined with the results of the XPS analysis in Table 3, it could be determined that a large amount of elemental Co was dissolved under the applied chemical corrosion pretreatment on the surface of the cobalt-based alloys. After adding ultraviolet light irradiation conditions, the corrosion solution had a stronger destructive force to the alloy structure in the same time frame. Consequently, through a pretreatment of UV photocatalysis + chemical etching, we were able to obtain a loose cobalt-based alloy surface structure, which was convenient for subsequent material processing.

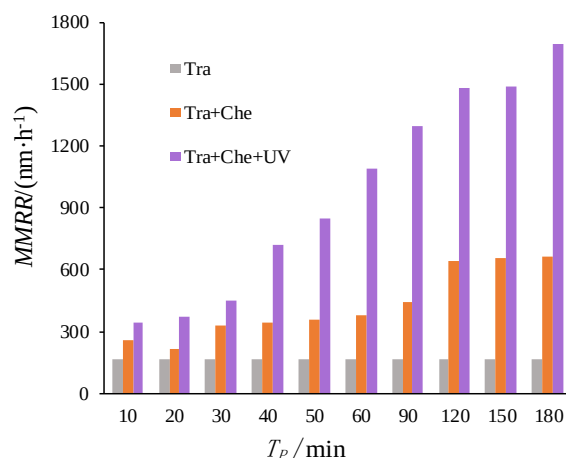
Figure 5 displays the MMRRs under the three different testing conditions outlined in Section 2.3. Note that single mechanical processing without no pretreatment conditions (Tra), which has a fixed MMRR, is provided in Figure 5 to facilitate a comparative analysis.

**Figure 5.** Mechanical material removal rate (MMRR) changes under different processing conditions.

Part of the Co element on the surface of the cobalt-based alloy was oxidized and dissolved into  $\text{CoCl}_2$  or precipitated into  $\text{Co(OH)}_2$  following chemical pretreatment. The surface structure of the alloy was destroyed, and the MMRR was slightly increased. Under the same immersion time, the chemically pretreated alloy structure was sparser following UV photocatalysis, and the MMRR was further improved, which confirmed the high efficiency of the cobalt-based alloy removal method under photocatalytic conditions.

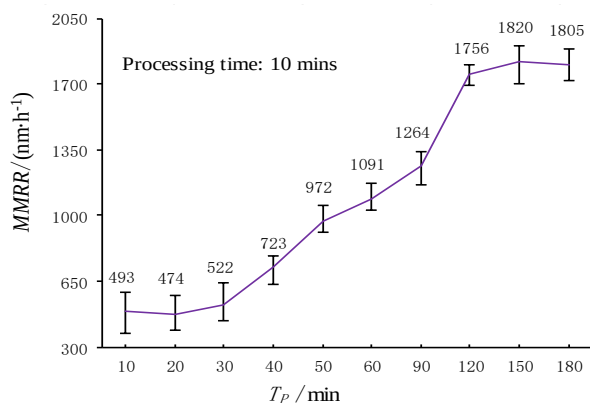
In order to explore the influence of pretreatment time on the cobalt-based alloy MMRR, a series of tests were carried out under the Tra + Che + UV condition. Figure 6 shows the results.

**Figure 6.** Effect of pretreatment time on MMRR of new processing method.

As seen in Figure 6, there was little change among the MMRRs for the ultraviolet photocatalytic + chemical corrosion pretreatment 10 min, 20 min, and 30 min in length. This was due to the presence of an amphoteric  $\text{Co}_2\text{O}_3$  oxide layer in the cobalt-based alloy sample. The  $\text{Co}_2\text{O}_3$  oxide layer limited the contact between Co and both the corrosion solution and ultraviolet light. Thus, it was difficult to dissolve a large amount of the Co element on the surface of the cobalt-based alloy to achieve surface corrosion. Consequently, the surface change was not large and the processing efficiency was not improved. For the pretreatments 40–90 min in length, the  $\text{Co}_2\text{O}_3$  oxide layer was gradually dissolved into the Basic Yellow 40 solution, and therefore more elemental Co was oxidized to  $\text{Co}^{2+}$  and dissolved in the corrosion solution or precipitated as  $\text{Co(OH)}_2$ . The surface structure was damaged significantly

after 90 min of pretreatment, and the MMRR nearly tripled compared to the shorter (10–30 min) pretreatment times. For the pretreatments 90–120 min in length, the  $\text{Co}_2\text{O}_3$  oxide layer was further dissolved, a large amount of Co elements was dissolved into the solution, the surface was extensively destroyed, and the MMRR was further improved by 28%. Although pretreatments of more than 120 min greatly reduced the difficulty of cobalt-based alloy processing, the MMRR was likely to cause excessive reaction and material removal on the surface of the material. Thus, selection of ideal pretreatment times should also consider the impact of machining quality.

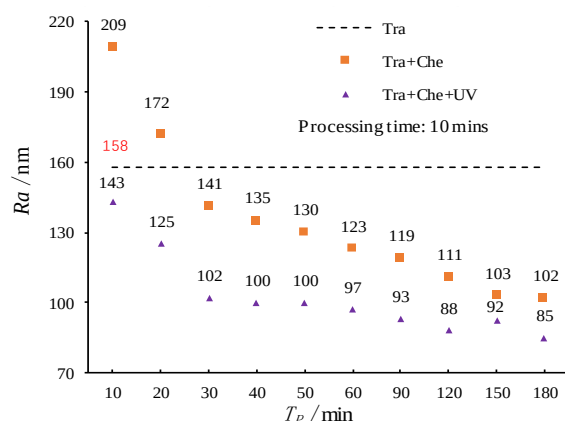
In order to analyze the impact of the photocatalytic conditions on the resulting machining quality, the surface roughness,  $R_a$ , was firstly measured using an NT9800 white light interferometer. We selected a group of cobalt-based alloys with an  $R_a$  between 230 nm and 250 nm for these experiments. Figure 7 shows the change of  $R_a$  under the three different testing conditions mentioned above and outlined in Section 2.3.

Figure 7. Surface roughness changes under different conditions.

As seen in Figure 7, the cobalt-based alloy was a kind of high wear-resistant and high hardness material, and the original surface structure seriously affected the removal efficiency of the material so that  $R_a$  was only reduced from 242 nm to 158 nm. After chemical corrosion pretreatment, with the help of dissolution of the Co and  $\text{Co}_2\text{O}_3$  oxide layers, the  $R_a$  of the sample was reduced to 102 nm after pneumatic wheel processing. When the ultraviolet light catalysis condition was added in the pretreatment stage, the surface structure of the cobalt-based alloy material became sparser, and the machining difficulty was further reduced. As exhibited in Figure 7, after a pretreatment of 30–50 min, the pressure roller process could reduce the  $R_a$  to 100 nm, or even further to 85 nm.

Additionally, according to further analysis of the UV photocatalytic + chemical pretreatment + mechanical processing test group data in Figure 7, we also found that in the first 30 min of pretreatment, the machining difficulty was reduced and the surface quality was improved significantly. After processing by the pneumatic wheel, the  $R_a$  of the sample surface had been reduced to 100 nm. Following pretreatment of 30 min to 180 min, the improvement in machining quality by the pneumatic wheel was not significant, despite the surface metal being further dissolved and the processing difficulty being further reduced. Consequently, in the case of removal of cobalt-based alloy material by the pneumatic wheel, the processing difficulty of the modified surface was significantly reduced following 30 min of UV photocatalytic + chemical pretreatment.

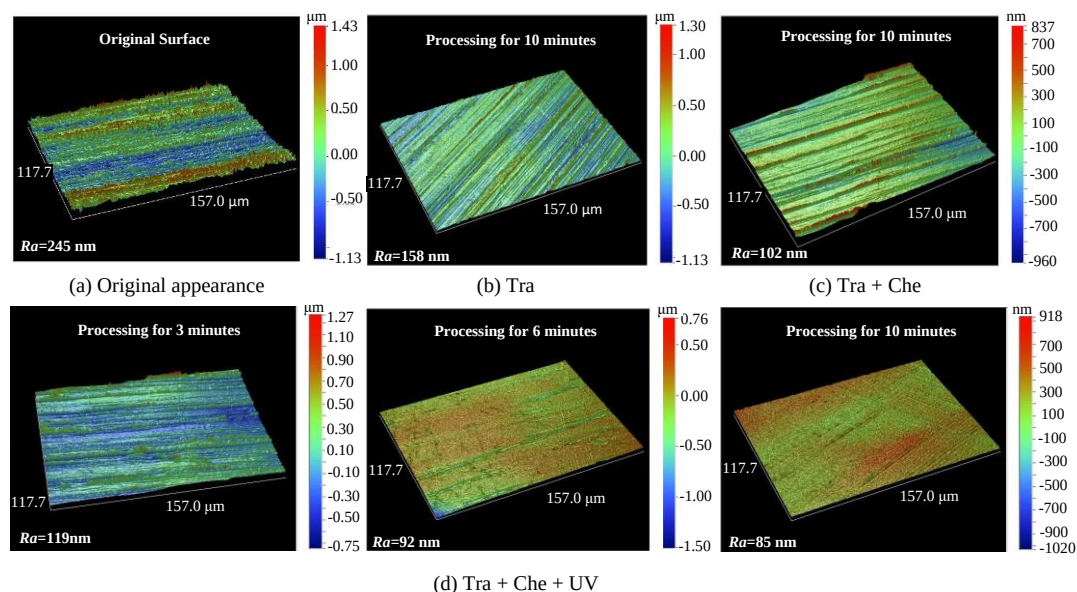
The surface topography of the samples was also observed using the NT9800 white-light interferometer. Figure 8 shows topographical views of the machined surfaces under the three different testing conditions.

**Figure 8.** Surface topographies under three different processing conditions. (a). The original workpiece, (b). Mechanical processing conditions (Tra), (c). Chemical pretreatment + mechanical processing conditions (Che + Tra), (d). UV photocatalysis + chemical pretreatment + mechanical processing conditions.

As seen in Figure 8, only a small amount of material could be removed by the mechanical processing method without pretreatment, and the surface scratches were obvious after processing (Figure 8b). After chemical corrosion pretreatment, although the workpiece's processing difficulty was reduced, the effect on scratch removal was not good (Figure 8c). Machining for 3 min could approach the surface quality of a single chemical corrosion pretreatment with machining. After 6 min of machining, the  $R_a$  was significantly reduced, and the surface scratches disappeared, indicating a significant improvement in surface quality. After machining for 10 min, the surface quality was basically level with the effects of 6 min of processing (Figure 8d). This suggests that cobalt-based alloy coating pretreated by UV photocatalytic + chemical corrosion should be processed for 6 min to obtain an ideal processed surface, and that the processing efficiency can be improved by more than 40% compared to the other two processing methods.
