Article

Influence of the Alkaline Reserve of Chloride-Contaminated Mortars on the 6-Year Corrosion Behavior of Corrugated UNS S32304 and S32001 Stainless Steels

Asunción Bautista *, Francisco Velasco and Manuel Torres-Carrasco

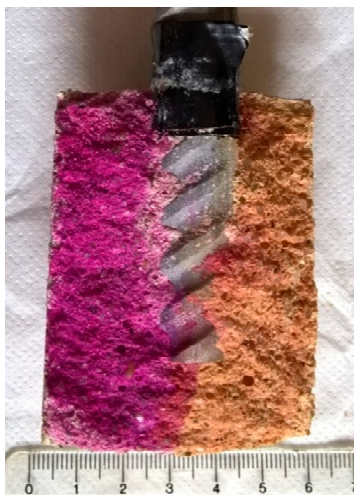
Figure 2 shows an example of the results obtained after the use of phenolphthalein (on the left part of the broken mortar) and yellow alizarin (on the right part). The use of both indicators indicates that the mortar samples which were previously exposed inside the carbonation chamber had a pore solution pH similar to that given by the carbonate/bicarbonate buffer (around 10.2) or higher, as the surface wetted with phenolphthalein became violet (i.e., $\text{pH} > 10$) and the surface wetted with yellow alizarine was yellow and slightly reddish (i.e., $\text{pH} < 12$). So, the samples had a reduced alkaline reserve and their pHs can be initially considered as between 10 and 12.

Figure 2. Image of a broken reinforced sample previously exposed to CO_2 , after the use of phenolphthalein (left) and yellow alizarin (right) indicators to check pH.

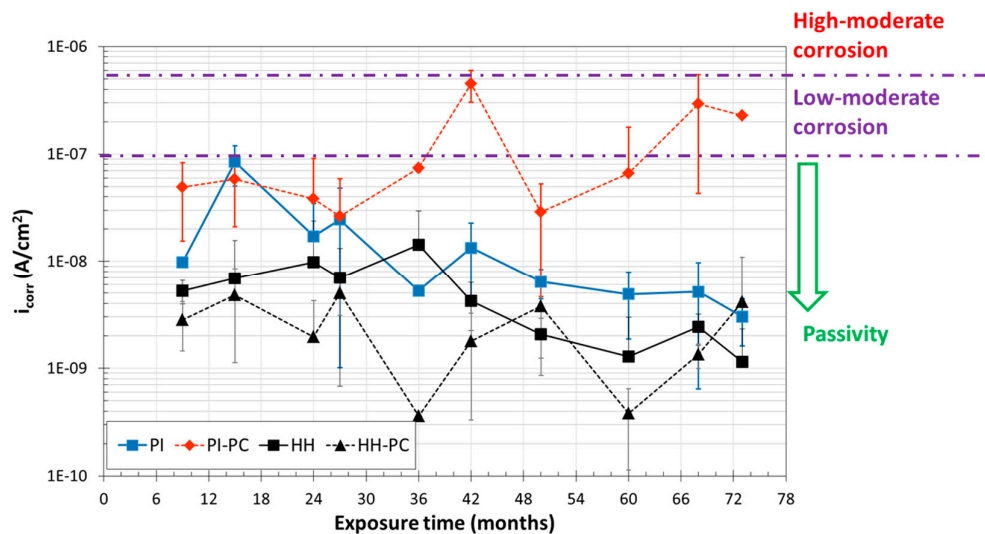
The results regarding the i_{corr} measured for S32001 reinforcements can be seen in Figure 8. The PI-PC condition was confirmed to be especially dangerous for the cheapest grade under study. Meaningful i_{corr} values were occasionally measured for this low-alloyed duplex stainless steel in this condition (after 42 months and at the end of exposure for the three tested rebars, and also after 68

months for two of them). The S32001 steel in PI condition had a single i_{corr} value slightly higher than $0.1 \mu\text{A}/\text{cm}^2$, and this point corresponds to an E_{corr} in the range of uncertain corrosion activity, although there were other E_{corr} values for S32001 in PI treatment in the range of uncertain corrosion activity whose i_{corr} clearly corresponded to passive reinforcements. Previous results in fully carbonated solutions have already suggested that S32001 grade steel could suffer chloride-induced corrosion in this media [18]. However, the values obtained for S32001 reinforcements in PI suggest that the higher chloride content in the mortar than in the HH-PC could more strongly affect the i_{corr} than the decrease in the alkaline reserve performed in this study before the exposures. Pitting corrosion has already been reported for S32001 when the bars were embedded in extremely porous chloride-contaminated mortar [19].

Figure 8. Corrosion rate (i_{corr}) values calculated from EIS experiments for S32001 steel under different testing conditions.

The polarization studies of the S32001 (Figure 10) confirmed the lower stability of its passivity, as already suggested by the results in Figure 8. After exposure in PI-PC, the bars showed i_{corr} values characteristic of active corrosion at E_{corr} , and the current densities increased at a moderate rate under increasing anodic polarizations. An intense pitting activity began under moderately high anodic overpotentials (+285 mV vs. SCE in the curve plotted in the figure). If the S32001 bars were embedded in PI mortar, they only pitted at very high anodic overpotentials (between +460 and +500 mV vs. SCE). The curves corresponding to S32001 embedded in mortars with lower chloride concentrations (HH and HH-PC) suggest that no corrosion-related phenomena occurred during the anodic polarization of the bars. After the polarization tests, the mortar cover of the samples was broken and the bars were cleaned to allow a study of the location and morphology of the pits. Besides some mortar adherences and small surface damages caused by the mechanical cleaning process, only visible pits were found in the bars that showed high anodic currents when they were anodically polarized (S32304 after PI-PC and S32001 after PI-PC and PI). The pits (Figure 11) appeared mainly in the lower part of the immersed area of the bars, suggesting that there is no special danger associated to partial immersion conditions, in contrast to what occurs with carbon steel reinforced samples, where macrocell corrosion cannot be considered negligible [44]. This difference could be related to the different corrosion mechanisms taking place in stainless steels and in carbon steel. Moreover, the location of the pits was not related to ribs or more strained regions of the bars. The fact that the studied bars were manufactured by hot working could influence the pit location, as it has already been proved that the working method (i.e., hot or cold) determines the corrosion behavior of stainless-steel reinforcements [45]. Besides these macroscopic pits, the presence of other microscopic pits cannot be discarded.
