Damage Assessment of Reinforced Concrete Elements Due to Corrosion Effect Using Dynamic Parameters: A Review

Citation: Duvnjak, I.; Klepo, I.; Serdar, M.; Damjanović, D. Damage Assessment of Reinforced Concrete Elements Due to Corrosion Effect Using Dynamic Parameters: A Review. *Buildings* **2021**, *11*, 425. <https://doi.org/10.3390/buildings11100425>

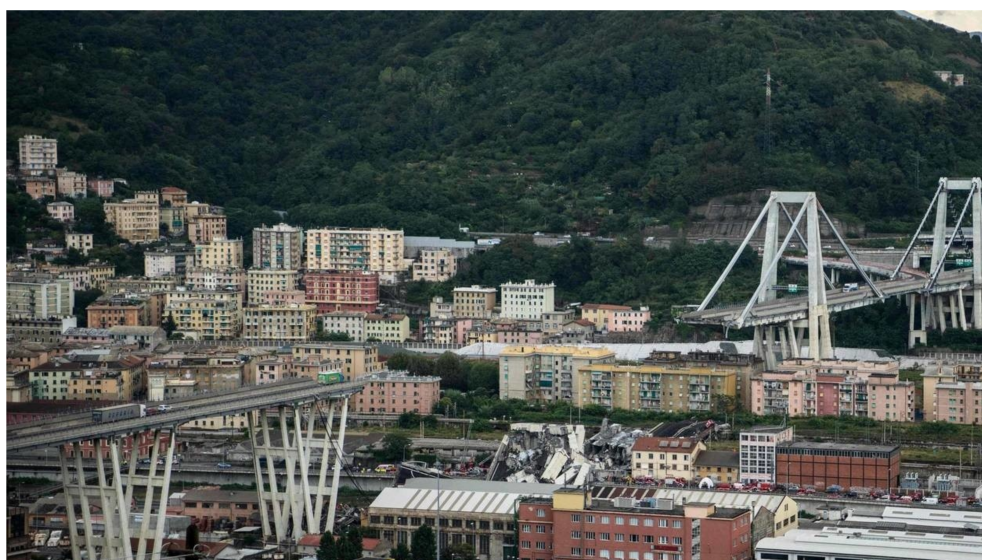
Figure 1. View of the collapsed part of the Polcever viaduct in Genoa, August 2018. (AP Photo, Antonio Calanni, 2018).

As a result of the collapse of part of the Polcever viaduct, built in 1967 according to a project by Riccardo Morandi, forty-three people were killed that day. The viaduct is 2.4 km away from the sea, so it was directly exposed to the aggressive action of seawater salt throughout its use. Analysis concluded that the failure of the hanger, made of prestressed concrete, was due to a combination of fatigue of the material and damage caused by corrosion, whose progressiveness was high due to the proximity of the sea and the industrial zone [5]. In order to minimize such catastrophic events in the future, it is necessary to emphasize detailed assessments of the condition of existing bridge structures and apply appropriate modern maintenance measures, or consider the removal of those that are not worth repairing [6].

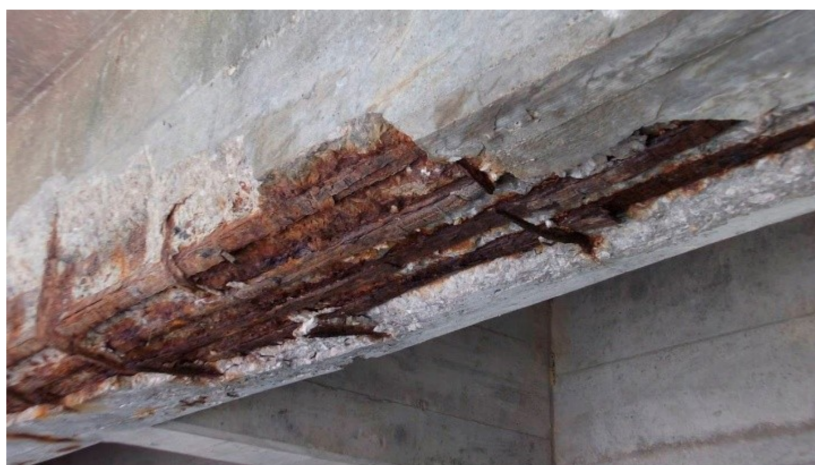
Figure 2. Display of reinforcement corrosion effects in reinforced concrete beam.

The impact of reinforcement corrosion is one of the most significant problems related to the durability of concrete structures [7]. Corrosion of reinforced concrete elements is always a coupling phenomenon between steel cross section reduction and loss of bond strength [8]. Either uniform or local corrosion can have important effects on the mechanical behavior of the steel reinforcement bars [9] and has previously led to a decrease in the strength and stiffness of reinforced concrete structures [10]. The consequent action of corrosion causes initial cracks in the concrete and separation of the protective layer (Figure 2).

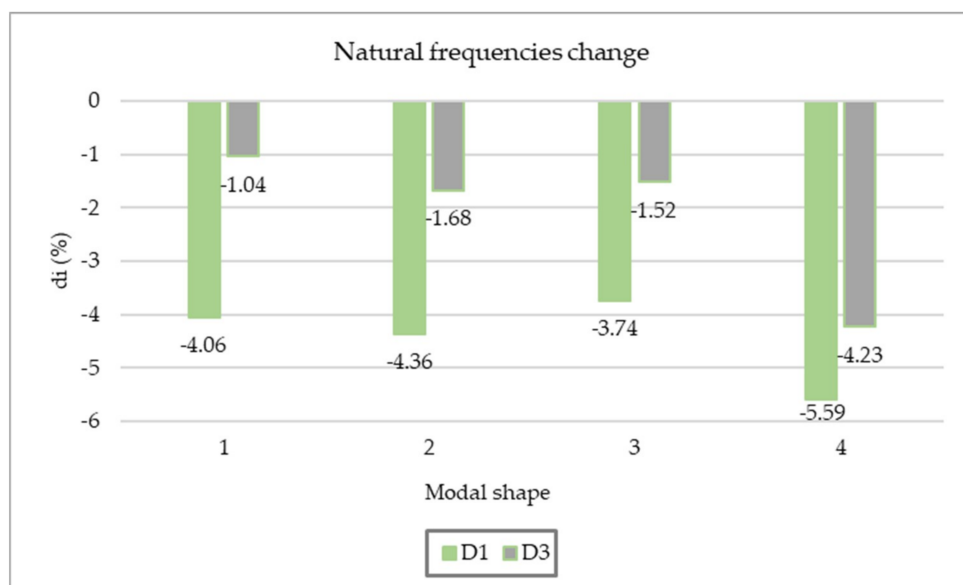
Figure 6. Representation of the change in the values of natural frequencies on beams D1 (steel surface loss 7.77%, maximum crack width 5.0 mm) and D3 (steel surface loss 7.65%, maximum crack width 1.0 mm) (author's processing based on [53]).

H.A. Razak and F.C. Choi [53] concluded that, due to corrosion damage, the D1 beam had a decrease in natural frequencies in the range of 4% to 11%, while the D3 beam had a decrease between 1% and 4% (Figure 6). Also, with the beam D1, a larger decrease in bending stiffness was observed, as well as a smaller bearing capacity than with the beam D3. From the damping coefficients determined for the first three modal forms, their increase was observed in the second and third modal forms, while in the first modal form there was a

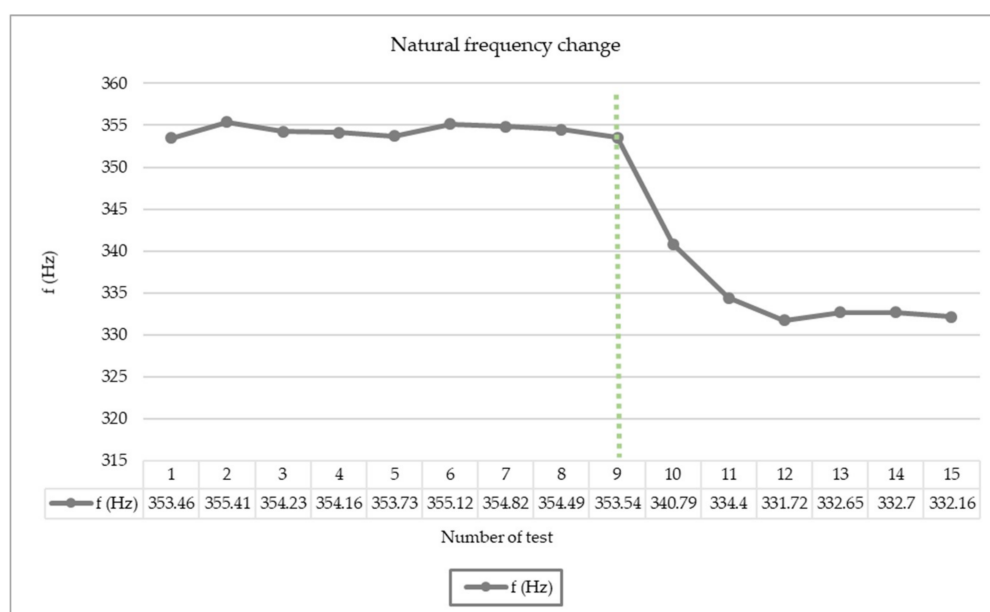
Figure 8. Change in the natural frequency values after a single test (author’s processing based on [56]).

By examining the Tr-2 and Tr-3 samples in article [56], the change in the values of the natural frequency and damping coefficients at different degrees of local corrosion was monitored. As part of the Tr-2 sample test, dynamic tests were performed at three different degrees of corrosion (L-1, L-2, and L-3). In the third stage (L-3) there was a decrease in the value of natural frequencies in the amount of 33.17% compared with the undamaged state, while the value of the attenuation coefficient was 7.68 times higher. In the Tr-3 sample, dynamic tests were performed after each of the fifteen accelerated corrosion tests and changes in the values of the natural frequency and damping coefficients were monitored during each test, as was the achieved degree of corrosion. The degree of corrosion in this case is shown as the product of the current strength expressed in milliamperes (mA) and the duration of each corrosion process expressed in seconds (s). The test results show that a significant decrease in the value of the natural frequency, i.e., an increase in the value

of the damping coefficient, occurred after the tenth accelerated corrosion procedure (at a corrosion rate of $9720 \text{ A} \times \text{s}$), which is explained by the appearance of a crack at the bottom of the sample just before the tenth procedure (Figure 8). Dynamic tests after the last series of fifteen procedures showed a decrease in the value of the natural frequency in the amount of 5.8%, and an increase in the value of the damping coefficient in the amount of 117%, demonstrating that changes in the damping value are more sensitive to damage caused by corrosion [56].
