Danish Dwellings with Cold Attics—Ventilation Rates and Air Exchange between Attic and Dwelling

Tessa Kvist Hansen

Department of the Built Environment, Aalborg University, 2450 Copenhagen, Denmark; tessa@build.aau.dk

Citation: Kvist Hansen, T. Danish Dwellings with Cold Attics—Ventilation Rates and Air Exchange between Attic and Dwelling. *Buildings* **2021**, *11*, 64. <https://doi.org/10.3390/buildings11020064>

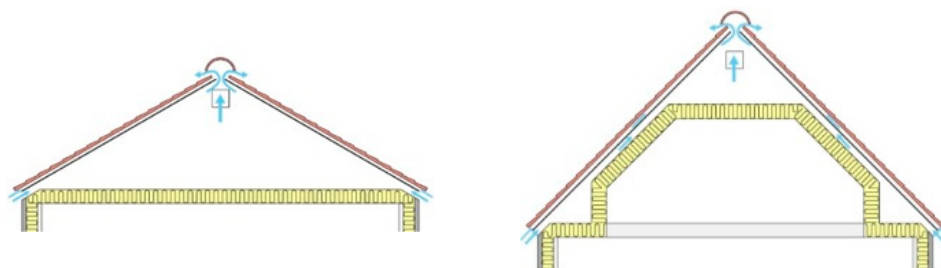
Figure 1. Illustration of ventilation principles at eaves and ridge in two types of cold attics [11]. In these examples the ventilation is further supplemented with openings in the gables (valid for short buildings < 16 m).

Natural ventilation occurs through openings at the eaves and the ridge, as well as openings in the gables or roof windows in some cases [11]. The ventilation is driven by air and wind pressure, as well as by thermal conditions, utilizing the stack effect and airflow through the ridge openings, Figure 1.

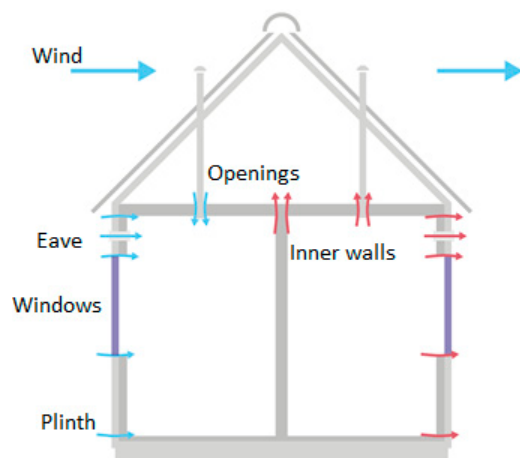
Figure 2. Air movements through a building with wind load. Blue arrows: cold air, Red arrows: warm air.

Wind on the building and the roof creates typically an overpressure on the windward side, and underpressure on leeward, and due to these pressure differences, air and moisture both infiltrates and exfiltrates the building, through ventilation gaps and other openings. Due to thermal buoyancy, there is often an underpressure created in the lower sections of the building, especially in colder seasons, and infiltration occurs. At the same time, an overpressure is created towards the top of the building, and exfiltration occurs. The exfiltration and infiltration in the building, as well as the air exchange through the ceiling, primarily occurs by convection through leakages, cracks and penetrations. Thus, the ventilation in these attics is primarily driven by the two factors; pressure differences (wind) and thermal differences (chimney effect), and these factors are dominated by the outdoor conditions (wind velocity and direction, temperature), and therefore the variation in air change rate can be significant. In Figure 2 it is seen that cold air enters the building on the

windward side, which can cause draught. Furthermore, the overpressure created in the attic can drive air and possible impurities down to the dwelling. The warm air is driven out through the façade and ceiling, which causes both heat loss, and risks of moisture damage, as the moist, warm air is driven towards colder construction parts. Especially the roof underlay can become very cold in connection with sky radiation, and if the temperature falls below the dewpoint, condensation can occur, increasing the risks of mould and decay.

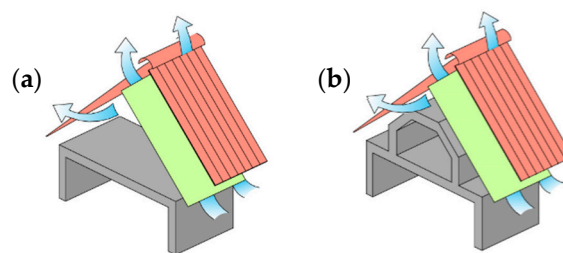
Figure 3. Roof and attic construction types included in the study [27]; (a) is a cold, open attic space, while some of the attic space is utilized (warm) in (b), and less space is left for the cold attic.

Criteria for selection of houses to be included in the investigation were first and foremost the attic and roof construction. Types as presented in Figure 3 were included in the study. Furthermore, the attic had to be accessible, so the inclination of the roof had to be $>15^\circ$.

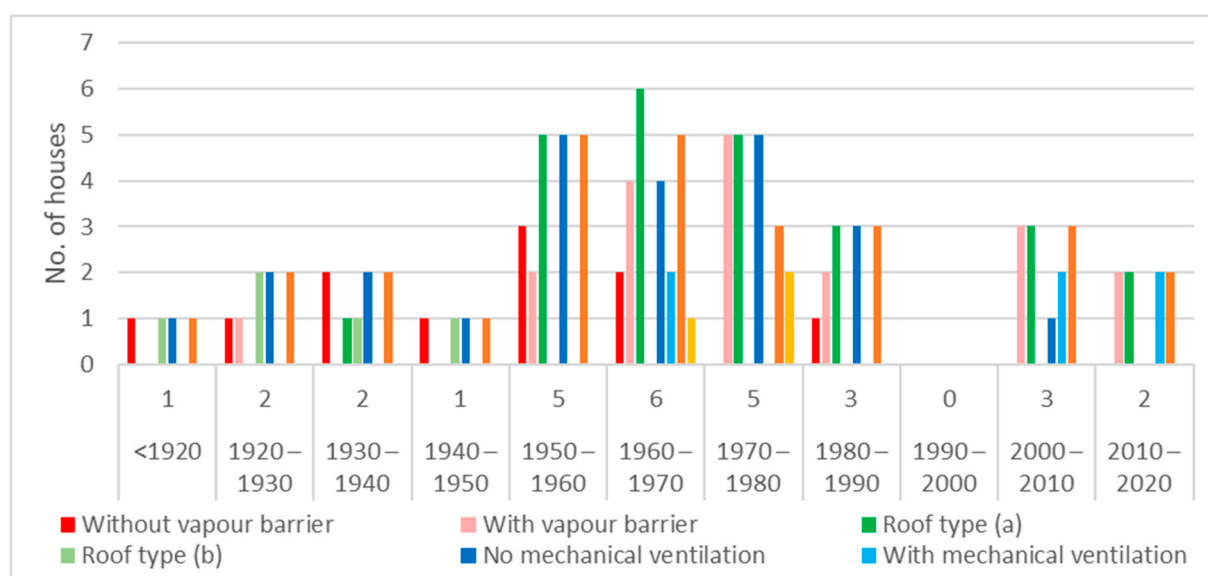
**Figure 5.** Distribution of house types included in the study, including year of construction, with/without a vapour barrier in the ceiling, roof type according to Figure 3, ventilation systems and insulation material.

Furthermore, an equal distribution of houses with and without vapour barriers was targeted, as well as an equal distribution of houses with mineral wool and cellulose-based insulation materials due to the differences in moisture buffering properties. However, the equal distribution was not achieved, as it proved to be a complicated task to find 30 suitable houses to volunteer for measurements. Alas, the distribution of with/without a vapour barrier was 19/11, and mineral wool/cellulose-based insulation was 27/3. In the three cases with cellulose-based insulation, this had been applied on top of an existing layer of mineral wool. Of the houses reported to have vapour barriers, the condition of these were largely unknown—especially in the older houses. Most of the houses without vapour barriers, were from prior to 1970. All the included buildings were equipped with air extraction in kitchen and bathrooms, and further six houses were equipped with mechanical ventilation systems. The houses were primarily constructed between 1928 and 2016, and a single house is from 1719. The 30 houses are elaborated in Table 1, and a graphical distribution of houses on year of construction, with/without a vapour barrier, roof type, ventilation and insulation is seen in Figure 5.

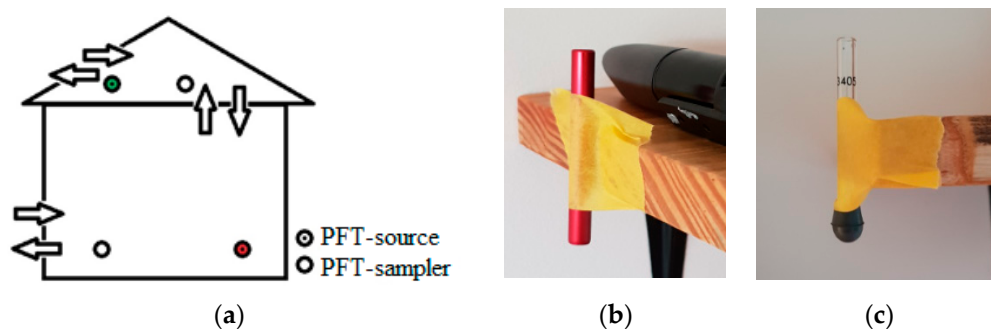
Figure 6. (a) Illustration of the two-zone model for perfluorocarbon tracer (PFT) measurements. (b) PMCH (perfluoromethylcyclohexane) tracer gas source and T/RH logger. (c) Sampling tube.

For the measurements, the following equipment was used: passive tracer gas sources, passive sampling tubes, and temperature measurements for determination of average emission rate. Thermal desorption and ECD (electron capture detector) were used for analysis of the sampling tubes after measurements. The passive tracer gas sources are small metal tubes with compressed gas, sealed with silicone the gas can diffuse through (Figure 6b). The sampling tubes are small glass tubes with an adsorption material (Ambersorb type 347) (Figure 6c).

In this project, the two-zone principle was used, and two types of tracer gases in all 30 houses. The principle is simple and illustrated in Figure 6a. One gas type, PMCH (perfluoromethylcyclohexane) was placed in the dwelling-zone, and another, PMCP (perfluoromethylcyclopentane) was placed in the attic-zone. By estimation of the emission rate of each gas source by average temperature and the empirically estimated sampling rates (dependent on the tube dimensions and the gas types), the infiltration and exfiltration can be determined. Divided by the volumes of each zone, the air change rate is also determined. The volume of dwelling and attic space was determined from floor plans when possible, and the height of both dwelling and attic were determined with a handheld laser distance measurer. The laser distance measurer was also used in cases that could not provide drawings drawn to scale.

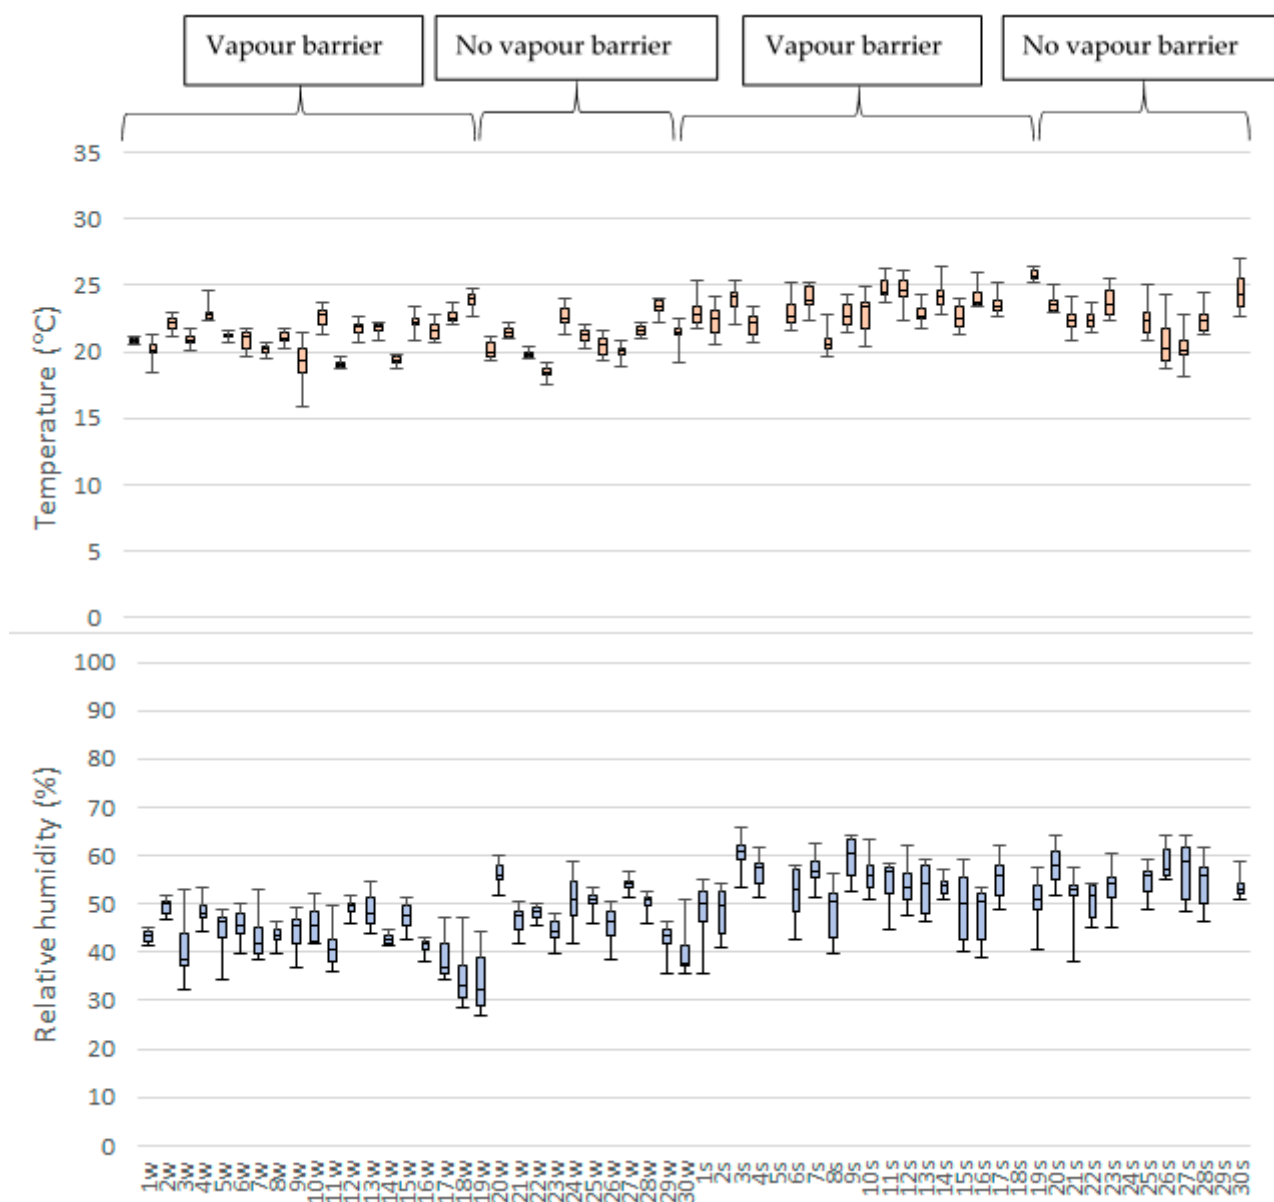
Figure 7. Box plot with temperature and relative humidity measured in the dwellings. Houses 1–19 have vapour barriers, and houses 20–30 do not have a vapour barrier. The notation “w” represents winter measurements, and “s” represents summer measurement.

The measured values of temperature and relative humidity for dwellings and attics are presented in Figures 7 and 8 as daily averages. From Figure 7 it can be seen, that the dwelling temperatures are fairly stable around 20 °C, and a little warmer in summer. The relative humidity in dwellings fluctuates between 30–60%, and is also slightly higher in summer.

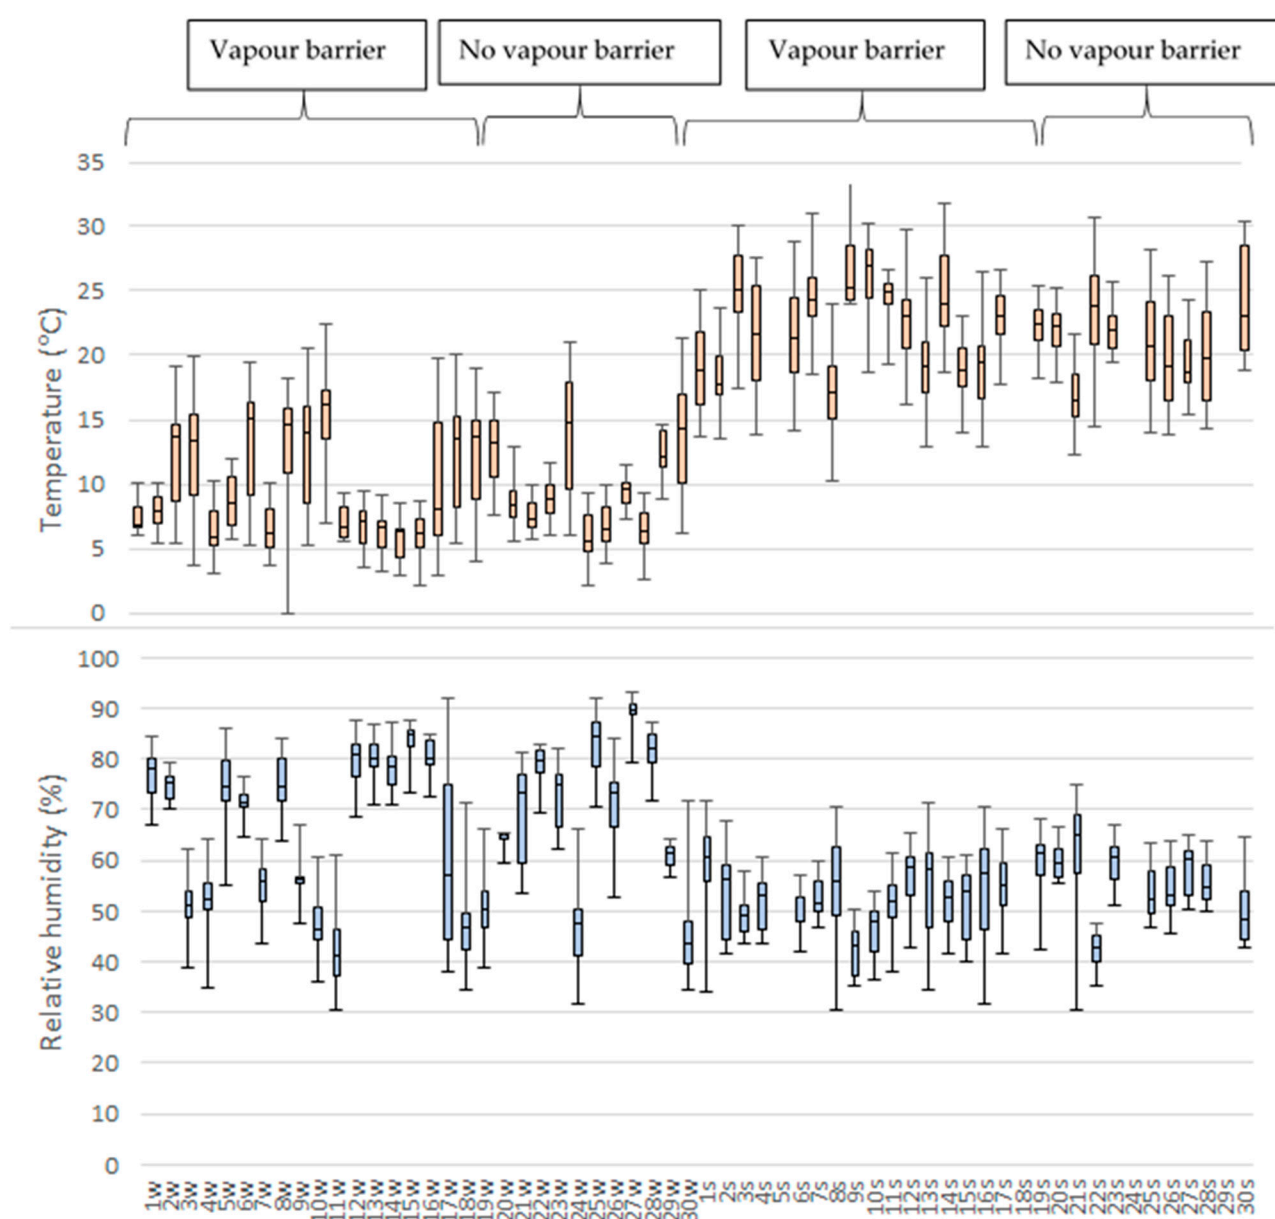
Figure 8. Daily average of temperature and relative humidity measured in the attics. Houses 1–19 have vapour barriers, and houses 20–30 do not have a vapour barrier. The notation “w” represents winter measurements, and “s” represents summer measurement.

The temperature and relative humidity measured in the attics, Figure 8, show a large daily and seasonal variation. The attic spaces become very cold in winter, down to 0 °C, while the relative humidity is high, above 80%. As the temperature increases, the relative humidity decreases, but peaks above 80% still occur. The attic conditions are very similar to the exterior conditions.

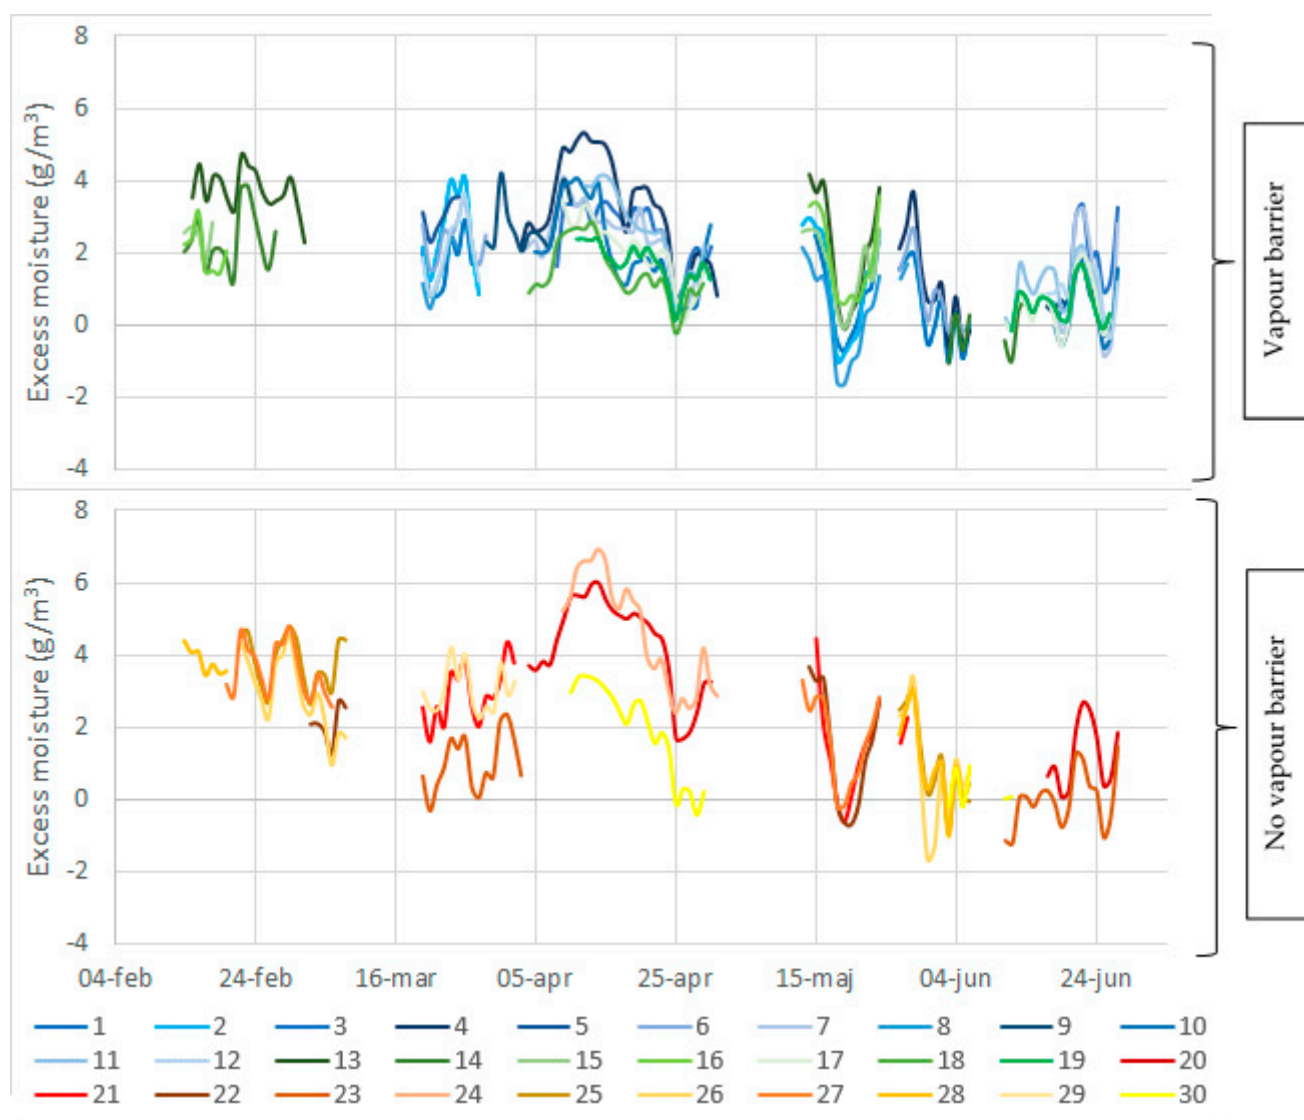
Figure 9. Daily average of excess moisture in the dwellings. Top: houses with vapour barriers (1–19), bottom: houses without vapour barriers (20–30).

To study the course of excess moisture in dwellings and attics, respectively, relatively to the outdoor air, the excess moisture was determined as a difference between absolute humidity in a zone and outdoors. Absolute humidity is generated from temperature and relative humidity measurements. These are portrayed in Figures 9 and 10. The figures show that there clearly is excess moisture in the dwellings compared to the outdoor conditions in cold seasons, up to 5–6 g/m³, while the conditions in the dwellings are more similar to outdoor conditions in warmer periods, most likely due to the increased ventilation rates in the dwellings. In the cold attics, there also exists excess moisture in the cold time of year, but less than in dwellings, while the conditions in summer are similar to outdoor air—and dwellings.

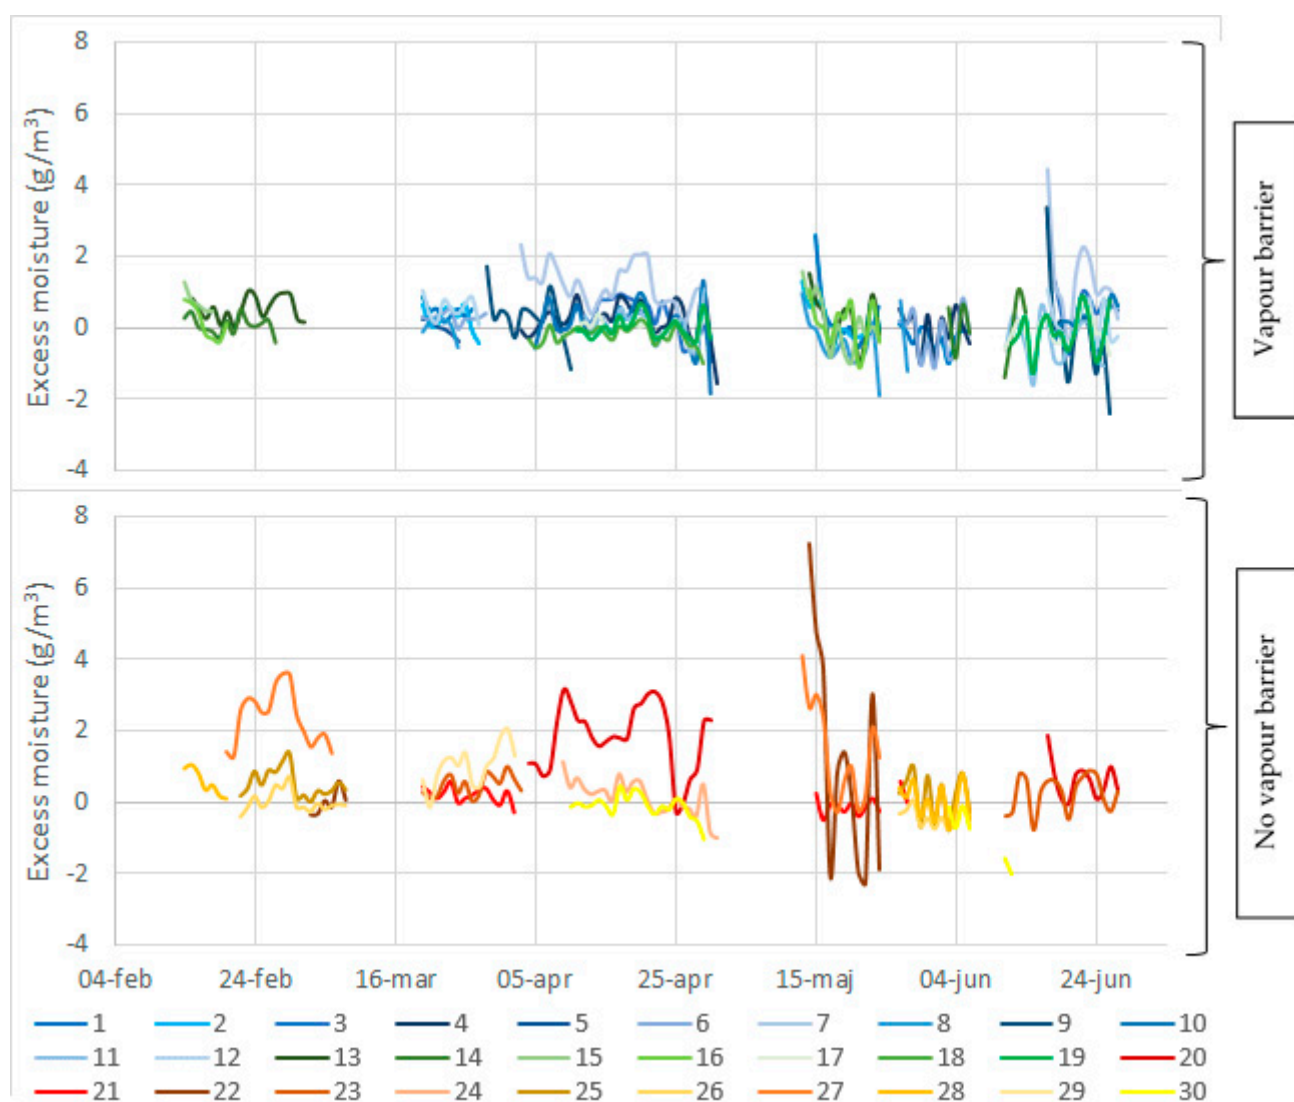
Figure 10. Daily average of excess moisture in the attics. Note that some measurements from house 22 exhibit excess moisture up to 16 g/m³ in single measurements. Top: houses with vapour barriers (1–19), bottom: houses without vapour barriers (20–30).

Nearly all the attics exhibit daily variation that ranges from positive to negative excess moisture values in relation to outdoor conditions with few exceptions. Attics 20 and 27 exhibit higher absolute humidity than outdoor conditions for nearly the complete winter measurement periods. House 20 is an old rectory, and the residents pointed out problems with moisture and rising damp. House 27 was under renovation, and the resident pointed out missing covings, and expected a leaky ceiling. It is apparent that there is excess moisture from dwellings to attics, as the attics exhibit excess moisture (with fluctuations however) when compared to outdoors—and this is most pronounced in winter.

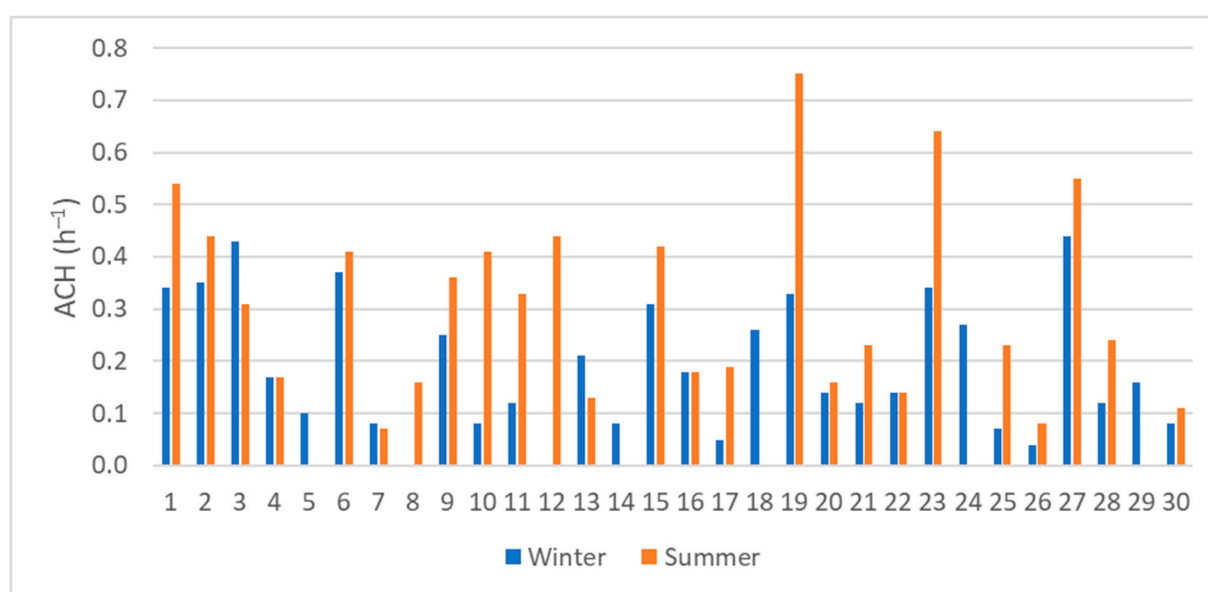
Figure 11. Air change rates measured in the 30 dwellings.

The measured air change rates for all 30 dwellings and attics, for summer and winter, are presented in Figures 11 and 12. The general tendency of air change rates in the dwellings are higher in summer when compared to winter. This is a natural phenomenon, as

inhabitants have tendencies for more open doors and windows in warm seasons. The average air changes rate for all the houses is 0.20 h^{-1} for winter, and 0.31 h^{-1} for summer. Three houses (4, 16, 22) have the same air change rate for both seasons, and two houses (3, 13) have a higher air change in the dwelling in the winter. From Figure 11 it can be seen, that the majority of dwellings do not achieve the recommended air change rate of 0.5 h^{-1} by the Danish building regulations [31]. Only four houses (1, 19, 23, 27) reached the recommended level of air change rate, and only in summer measurements. In 2012, Dimitroulopoulou gathered a review of measurements of ACH (air changes per hour) in dwellings from various European studies [32]. A general tendency is seen, that despite a requirement of 0.5 h^{-1} , a significant number of dwellings exhibit lower air change rates in Denmark. Similar results have been found in other northern countries despite similar regulations, e.g., Finland, Norway, Sweden and U.K. [32].

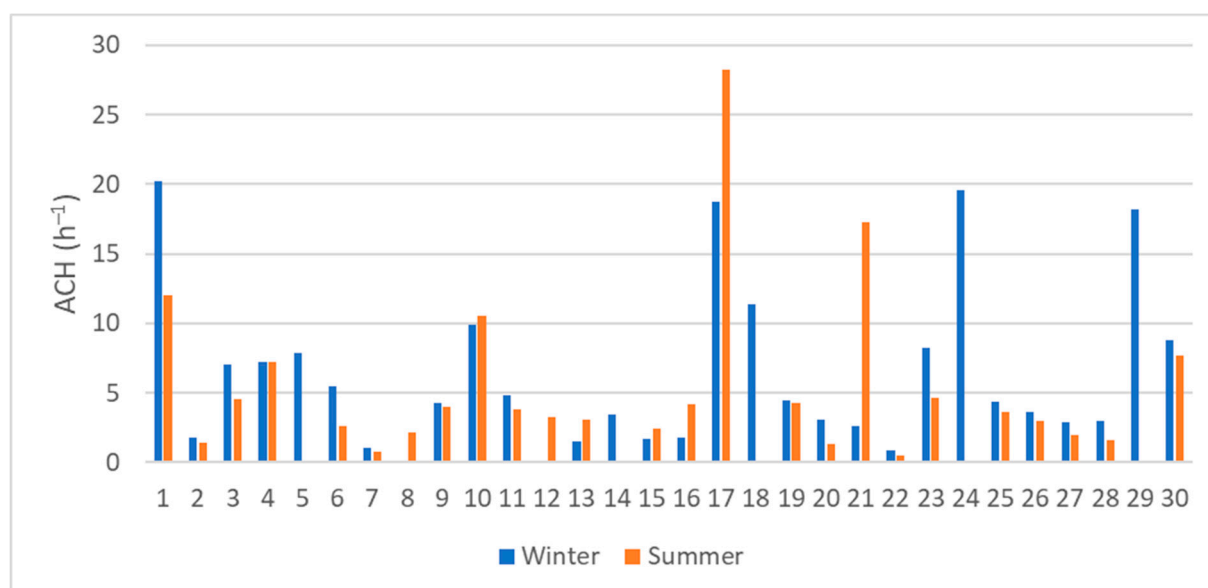
Figure 12. Air change rates measured in the 30 attics.

The air change rates measured in the cold attics vary significantly between the cases, and measurement periods, as seen in Figure 12. The air change rate in the attic is highly dependent on the outdoor conditions, including wind velocity and orientation. A similar study of air change rates in cold attics also showed a large variety—up to factor 10 in the same attic, depending on the measurement time [33]. The average air change rates in the attics was found to be 6.7 h^{-1} in cold periods, and 5.5 h^{-1} in warmer periods, but with large deviations. The lowest air change rates were found to be 0.9 h^{-1} in winter, and 0.5 h^{-1} in the summer, whereas the highest air change rates were 20.2 h^{-1} in winter, and 28.2 h^{-1} in summer. The largest variation within one case was found in house 21, with a variety of factor 6.5.

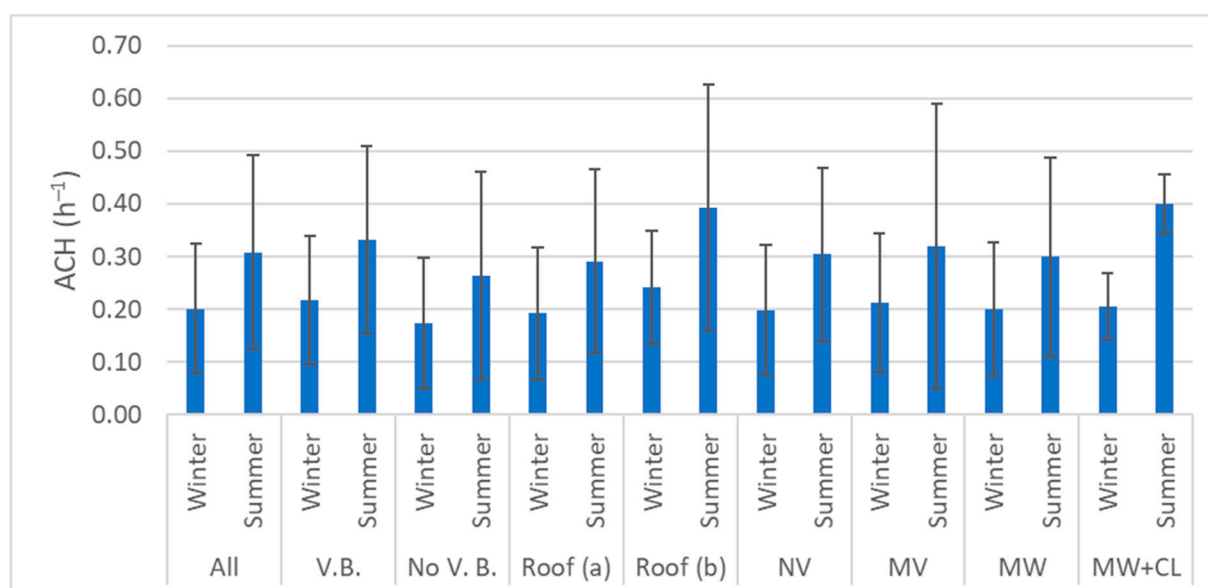
Figure 13. Average air change rate in dwellings and standard deviation distributed by types; all investigated houses (all), houses with (V.B) and without (no V.B.) a vapour barrier, roof type (a) according to Figure 3 (Roof (a)), roof type (b) according to Figure 3 (Roof (b)), houses with only natural ventilation (NV), houses with mechanical ventilation (MV), insulation material mineral wool (MW) or mineral wool and cellulose-based insulation (MW+CL).

In order to evaluate the effect of the various variables; vapour barrier, roof type, natural/mechanical ventilation and insulation material, average values for each category has been calculated and are depicted in Figures 13 and 14. From the average values in the different construction categories in Figure 13, it can be seen that dwellings with vapour barriers have slightly higher air change rates. This can be due to the fact that these houses are newer, and ventilation conditions were considered in the design process. In cases where vapour barriers were installed in older houses during renovations, the focus may also have been on maintaining sufficient ventilation conditions. Furthermore, it can be seen that roof type (b) exhibits higher ventilation rates, which may be associated with the fact that these buildings are primarily from before the 1950s, and the general airtightness in these buildings is assumed to be lower when compared to new buildings, which is why the dwelling ventilation may be higher.

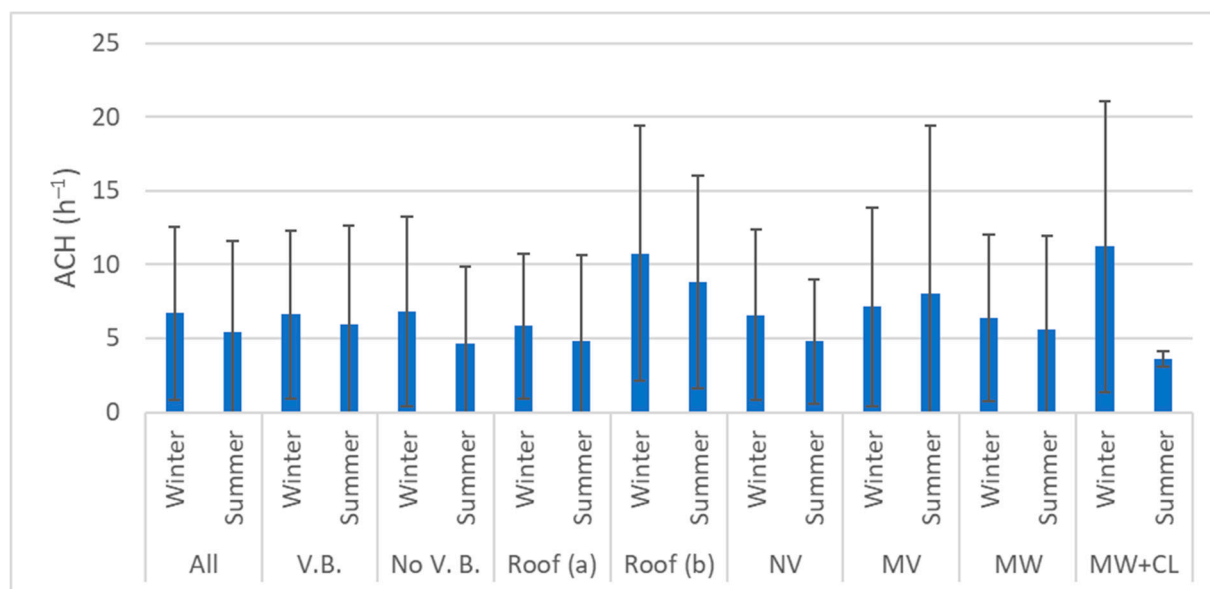
Figure 14. Average air change rate in attics and standard deviation distributed by types; all investigated houses (all), houses with (V.B) and without (no V.B.) a vapour barrier, roof type (a) according to Figure 3 (Roof (a)), roof type (b) according to Figure 3 (Roof (b)), houses with only natural ventilation (NV), houses with mechanical ventilation (MV), mineral wool insulation material (MW) or mineral wool and cellulose-based insulation (MW+CL).

The average values for the different construction types show, that roof type (b) has higher air change rates when compared to roof type (a). In all cases of roof type (b), the roof is of roof types without underlay. Furthermore, some cases with roof type (b) also had open roof windows, contributing to higher ventilation rates. There are no recommendations as to ventilation rates in these cold attics, but it should be sufficient enough to remove excess moisture.

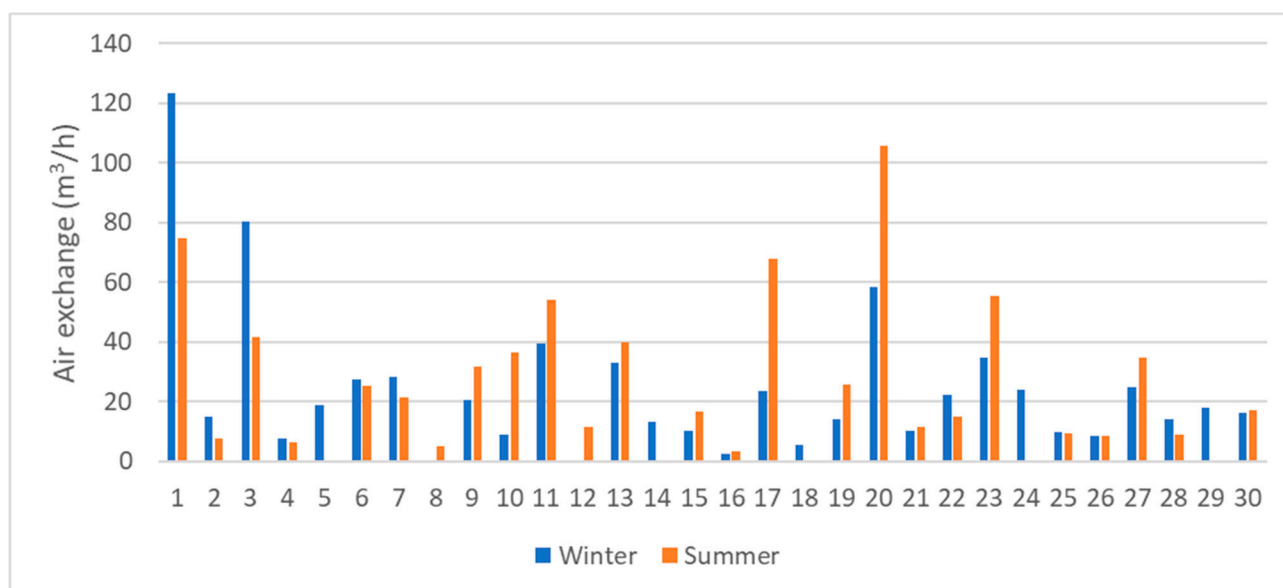
Figure 15. Upward air exchange from dwelling to attic.

In Figures 15 and 16 the average upward and downward air exchange respectively for both measurement periods for all the included houses are presented. Figure 15 illustrates the upward air exchange from dwelling to attic, whilst Figure 16 presents the downward air exchange from attic to dwelling. The figures clearly indicate, that air exchange to a greater or lesser extent occurs in both directions, and in both seasons for all the houses. Therefore, it can be stated that air exchange between dwelling and attic occurs in both houses with and without a vapour barrier, and there are no clear indications or reduced air exchange in houses with a vapour barrier in the ceiling. This can partly be attributed the fact that the condition of these vapour barriers is mostly unknown. By considering newer houses erected after 2000, namely houses 15–19, all with vapour barriers with conditions assumed to be tight due to the low age, relatively low air exchange is observed, however not significantly lower than older buildings, or buildings without vapour barriers. Average values for the air exchange suggest higher upward air exchange in winter periods. The average values also suggest higher downward air exchange in summer. However, considering the individual houses, those observations appear invalid; For winter periods, measurements show that the upward air exchange dominates in 14 of 28 valid measurements (nine with a vapour barrier, five without a vapour barrier), while the remaining 14 houses (eight with a vapour barrier, six without a vapour barrier) predominantly show higher downward air exchange in winter. For the summer period, with 25 valid measurements, the upward air exchange dominated in 17 houses (12 with a vapour barrier, five without a vapour barrier). Thus, a seasonal dependence of the direction of air exchange cannot be established based on the obtained results.

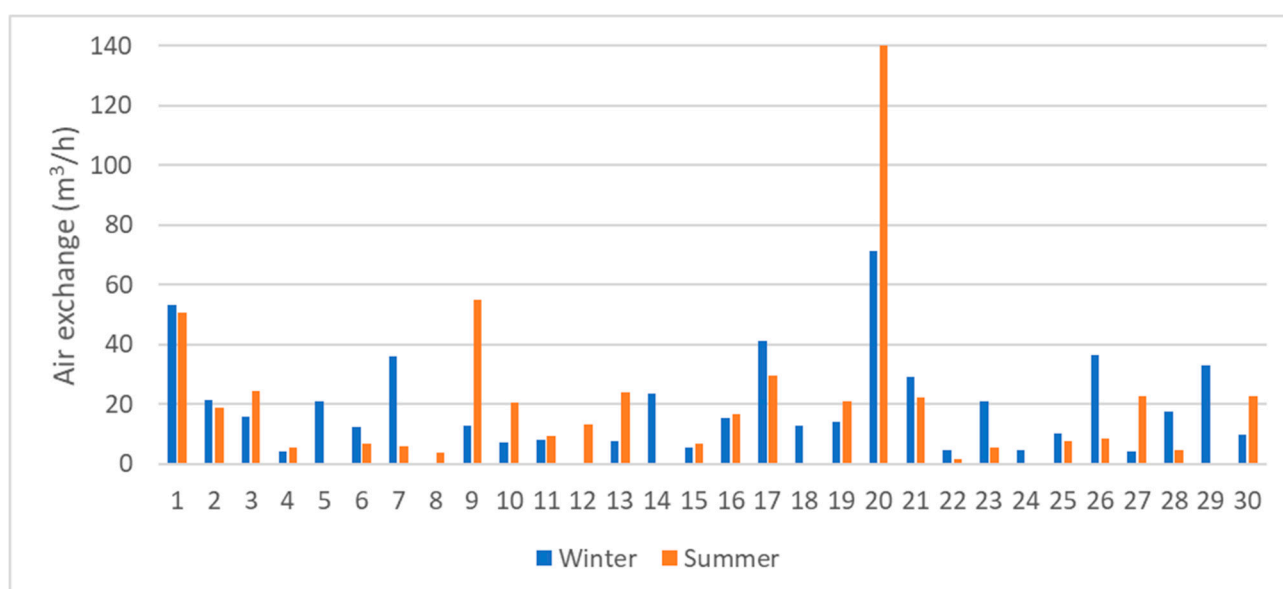
Figure 16. Downward air exchange from attic to dwelling. In the summer, house 20 obtains a downward air exchange of 225 m³/h.

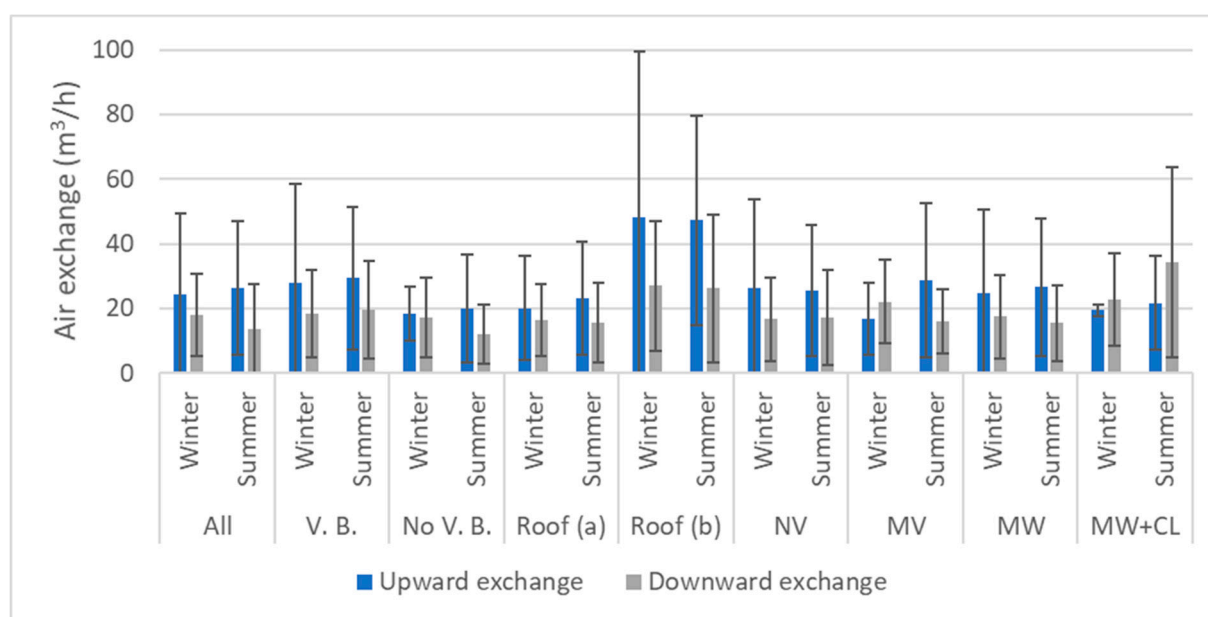
Figure 17. Average air exchange between dwelling and attic in both directions, summer and winter, distributed on construction types; all investigated houses (all), houses with (V.B.) and without (no V.B.) a vapour barrier, roof type (a) according to Figure 3 (Roof (a)), roof type (b) according to Figure 3 (Roof (b)), houses with only natural ventilation (NV), houses with mechanical ventilation (MV), mineral wool insulation material (MW) or mineral wool and cellulose-based insulation (MW+CL).

The average air exchange between dwelling and attic distributed on construction types, can be seen in Figure 17 for summer and winter. Due to extreme measurements of air exchange from house 20, this has been removed from further analysis. In the figure, it can be seen, that for almost all cases, the upward air exchange is higher both winter and summer. The exceptions to this, are the few houses with mechanical ventilation, and the few houses with additional cellulose insulation. The reason for the exceptions may be that there has been focus on the airtightness of the ceiling in connection with postinsulation, or installation of mechanical ventilation. Furthermore, the results show that roof type (b) has significantly larger upward air exchange when compared to roof type (a) as well as the other categories. In this study, this roof type is represented by older houses, constructed in 1943 or before. Prior to the 1950s, vapour barriers were not common in Danish ceiling constructions [9], and only one of the five cases with roof type (b) includes a vapour barrier. At the same time, there is no significant difference in the air exchange between cases with and without vapour barriers.

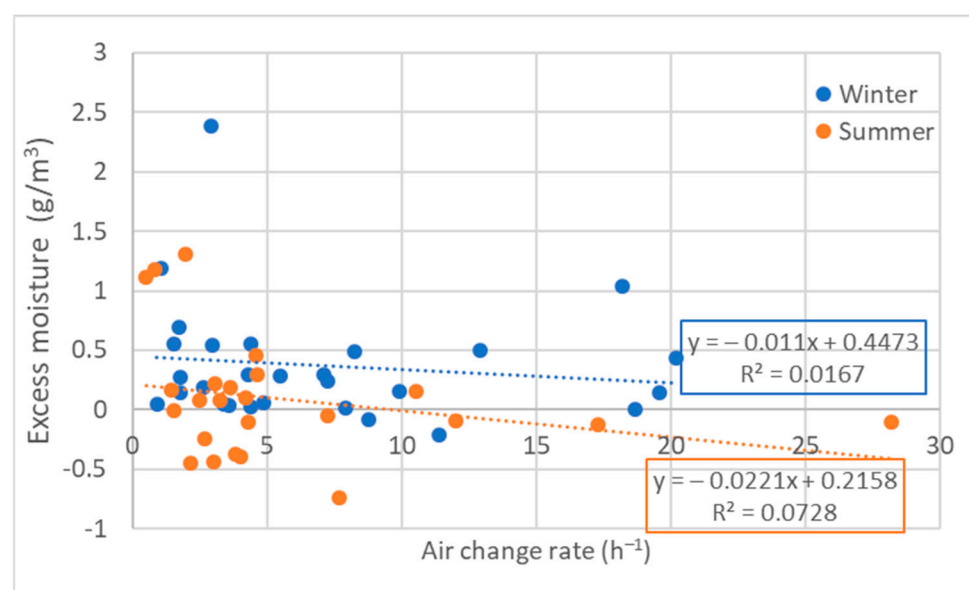
Figure 18. Average excess moisture in attics plotted against the average air change rate in attics for measurement periods in summer and winter, with linear trendlines.

In order to assess the effect if the air change rate in the attic with regards to excess moisture, the average air change rates in attics are plotted against the average excess moisture for the attic in relation to outdoors, found in the same period in Figure 18. It can be seen, that for both seasons, there is a tendency of reduced excess moisture with larger air change rates, which could be expected; however, the results are a bit scattered.

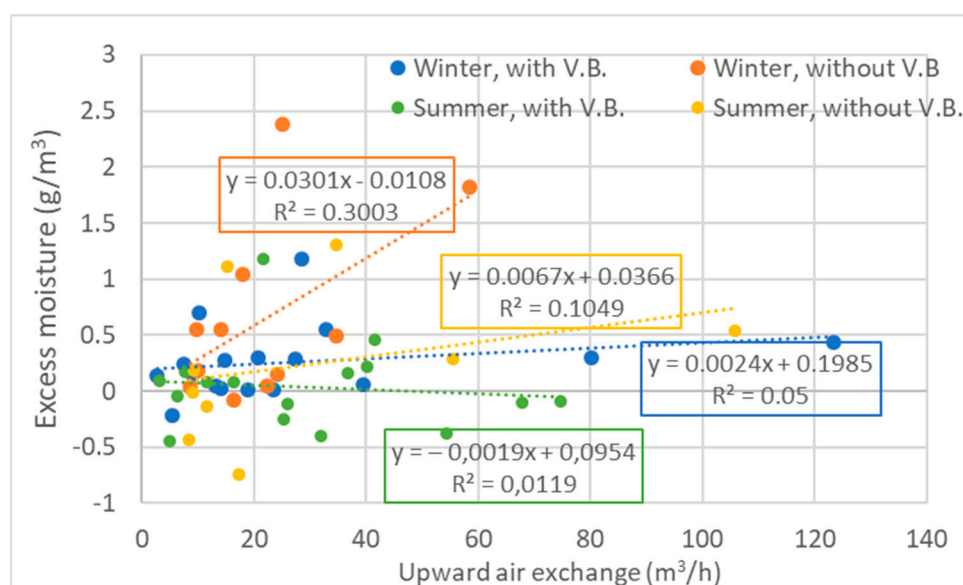
Figure 19. Moisture excess in attics in relation to outdoors as a function of average upward air exchange for the 30 houses included in the study, for both summer and winter, and linear trendlines. Houses with a vapour barrier are presented with blue/green, and houses without a vapour barrier are presented in orange/yellow.

In order to assess to what extent upward air exchange affects the average excess moisture in the attics, for houses both with and without a vapour barrier, the upward air exchange is plotted against the excess moisture in the attic in relation to outdoors, and presented with trendlines in Figure 19. The trendlines indicate a correlation between the excess moisture and upward air exchange; The excess moisture increases with increasing upward air exchange, with the exception of summer periods in cases with a vapour barrier. The tendency is significantly larger in winter, and in cases without a vapour barrier. For cases with a vapour barrier, there is less influence of the upward air exchange on the excess moisture in the attic. It should be noted however, that the number of measurements was limited, why the tendencies should be regarded as indicative.

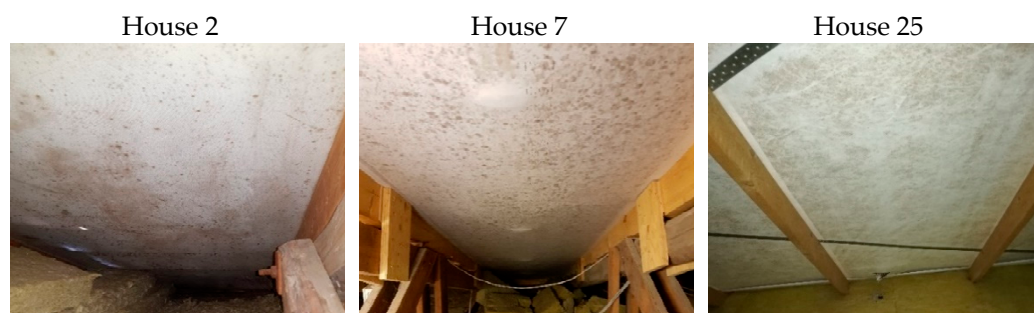
Figure 20. Mould growth in the attics of three test houses, namely houses 2, 7 and 25.

In connection with the measurements, three of the cases buildings exhibited significant visible mould growth on the roof underlay as seen in Figure 20. In these attics, relatively low air change rates were measured, namely 1.76 h^{-1} , 1.04 h^{-1} and 4.4 h^{-1} (winter) and 1.44 h^{-1} , 0.80 h^{-1} , 3.64 h^{-1} (summer), respectively. However, other houses exhibit equally low air exchange rates in the attics, without visible mould growth.
