Case Report

# Procedure for Safety Assessment and BIM Modelling of an Historical Complex Structure through a Macroelement Approach: The Building “Molino-Pastificio Soresi” of Partinico (Italy)

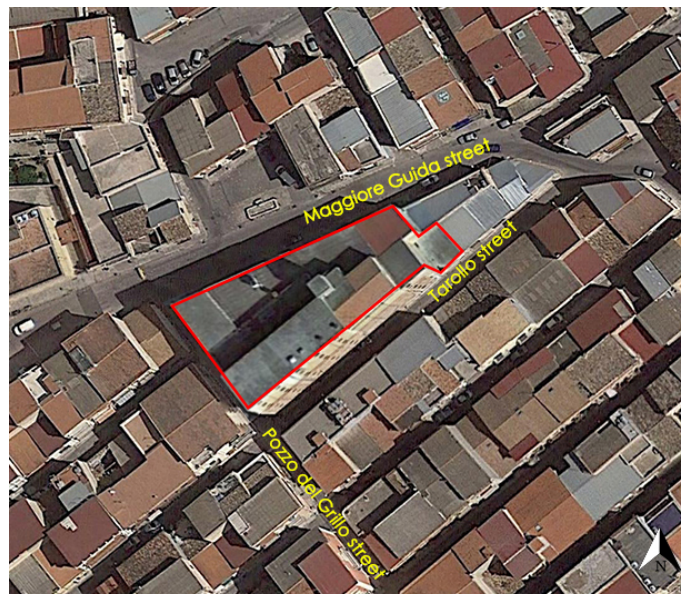
The owner transformed a first stock of buildings, with an oil mill inside, received in inheritance, located at the corner between the Maggiore Guida street and the Pozzo del Grillo street (Figure 1).

Figure 1. Site plan of Molino-Pastificio Soresi (today).

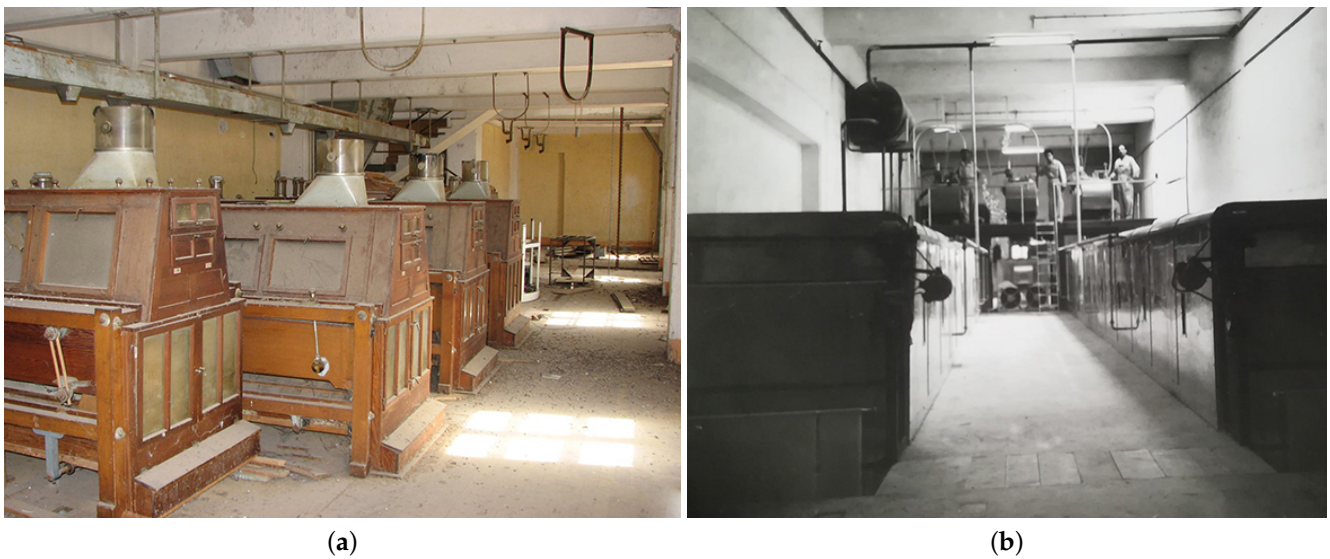
Around the 1960s, the company faced a great development with the installation of new and heavy machines and introduced new production processes (Figure 3).

**Figure 3.** Historical photos of Molino-Pastificio Soresi. (a) Semolator machines; (b) Machines for the production of short pasta.

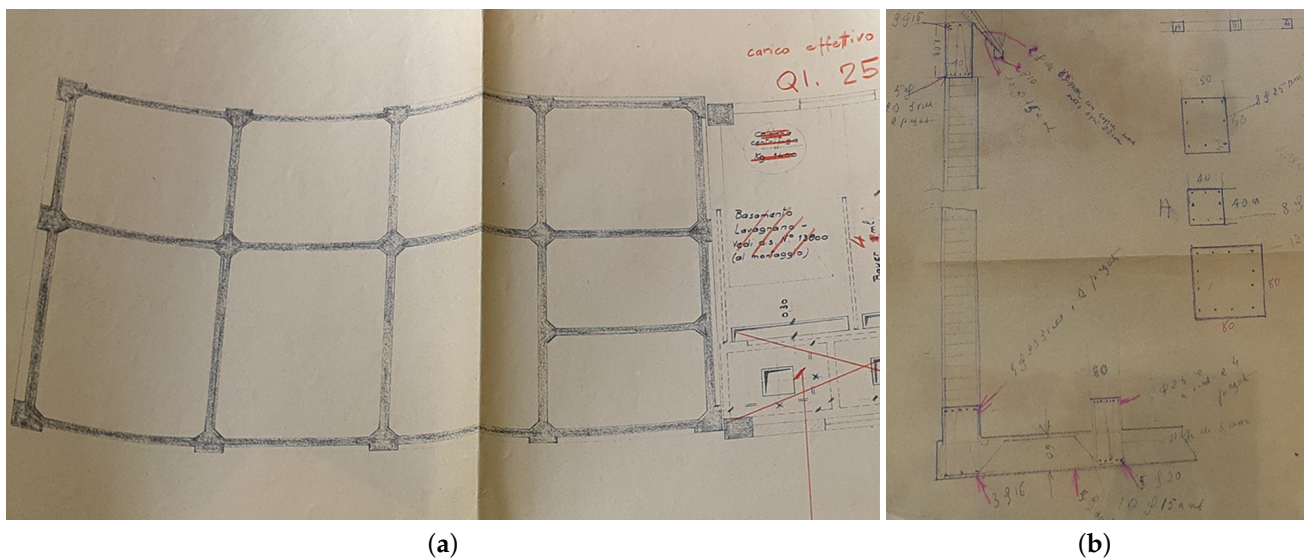
Eight internal RC silos 14.50 m tall were installed inside the main building with separation joints and used for the storage of grain. Original design drawings (Figure 4) indicates the date of the construction (1950). The silos are supported from RC columns with square cross-section with side length equal to 70 cm and placed at the crossing points of the walls. The structure was made using the RC “Hennebique system” [5], widespread in those years. Square openings were also installed at each storey for inspecting the silos inside.

**Figure 4.** Project of the silos in RC of the late '50s. (a) Original design drawings: plan; (b) Original design drawings: section.

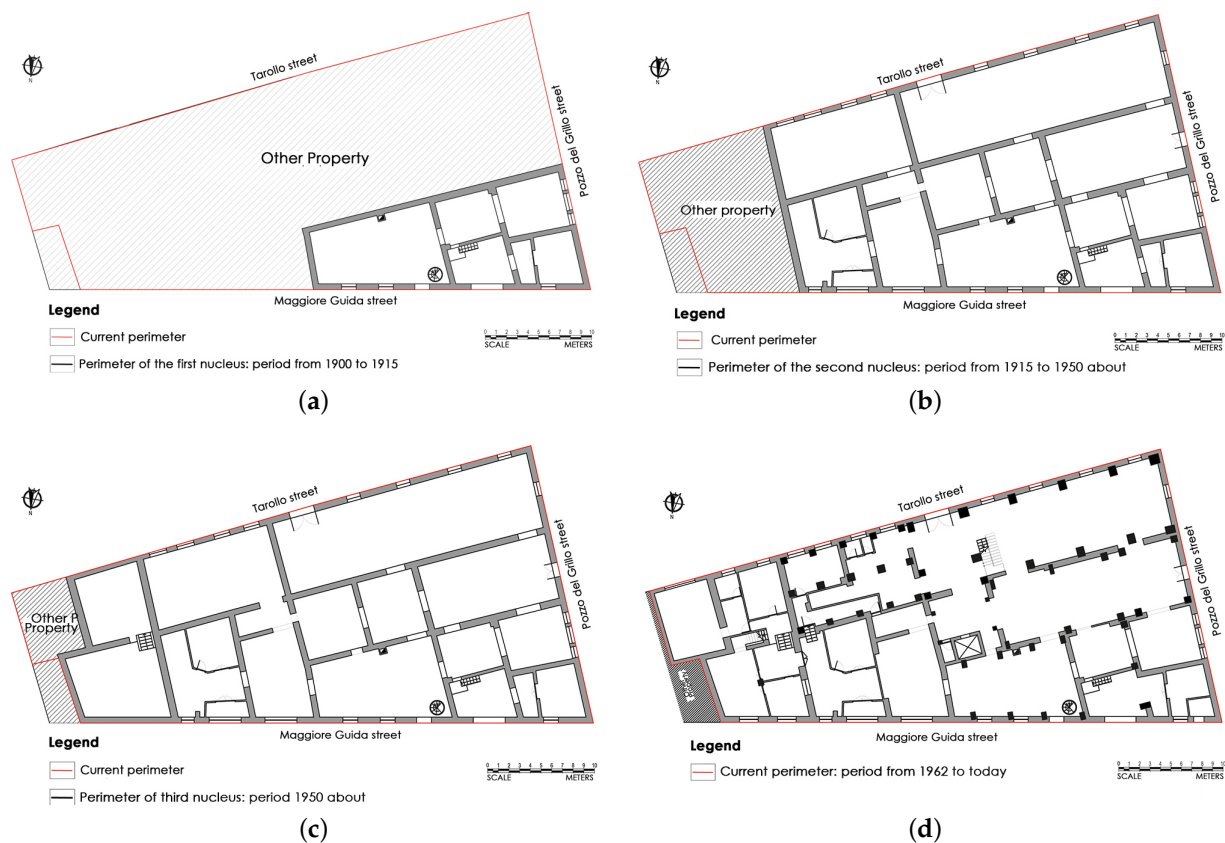
Figure 5 shows the evolution of the plan since the early 1900 (Figure 5a) to about the '60s (Figure 5d), highlighting the introduction of new parts of the building and the construction of the framed structure. The "Molino-Pastificio Soresi" company worked for almost ninety years, also under commission of relevant companies marketing pasta worldwide, and it ended its activity in 1990. The building was then closed and abandoned still today.

**Figure 5.** Constructive evolution: from 1900 about to 1960 about. (a) 1900 about; (b) 1915 about; (c) 1950 about; (d) 1960 about.

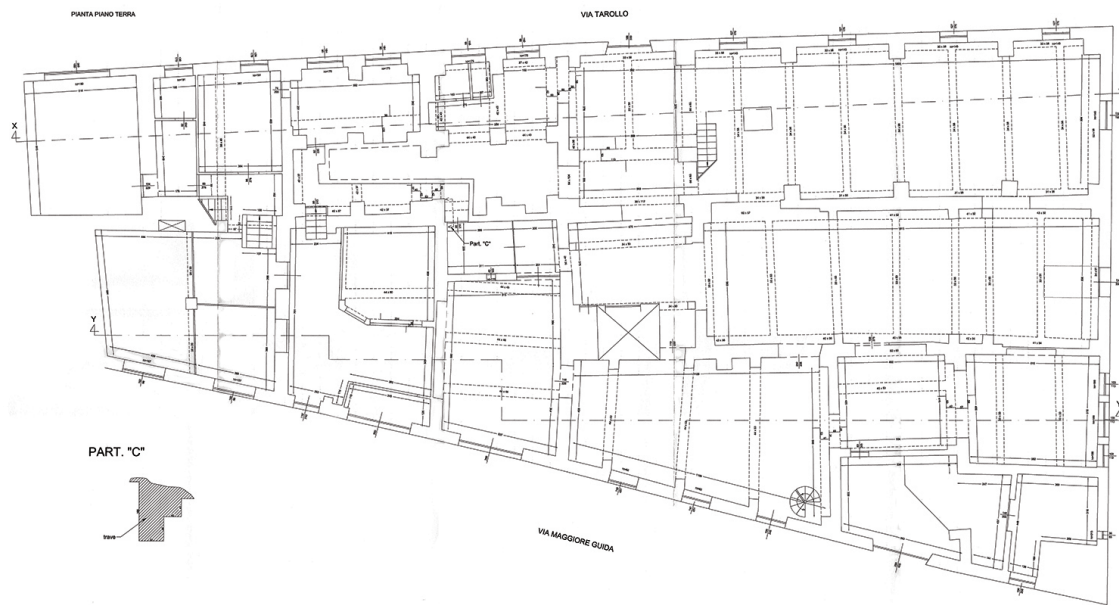
The complete architectural survey of the first floor is reported in Figure 6, while Figure 7a shows the main front on Maggiore Guida street and Figure 7b the rear front along Tarollo street.

Figure 6. Geometric survey of the first floor.

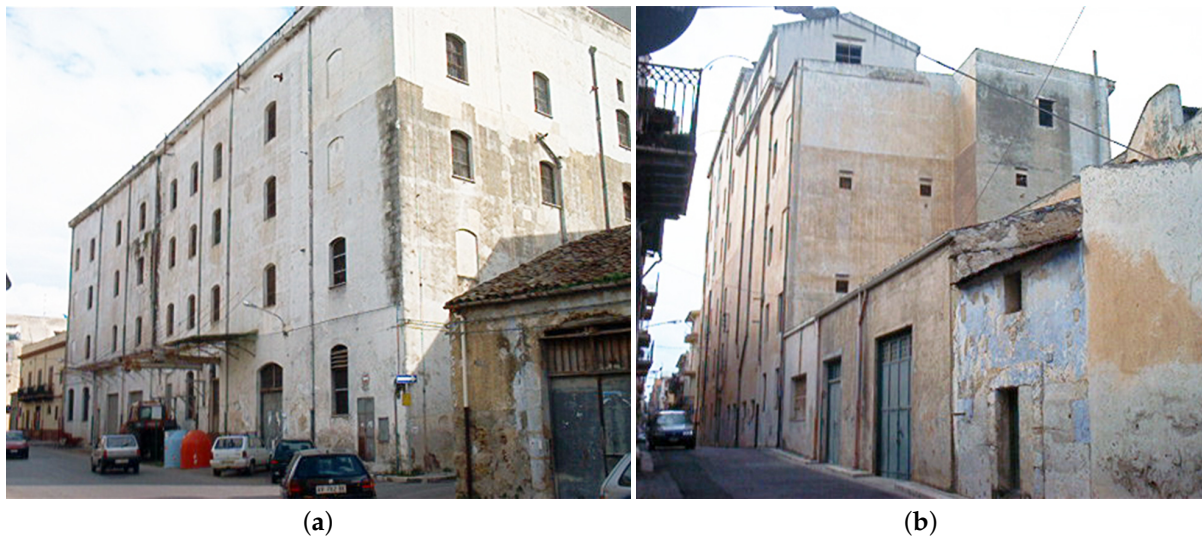
Figure 7. Building exterior views. (a) Main front; (b) Secondary front.

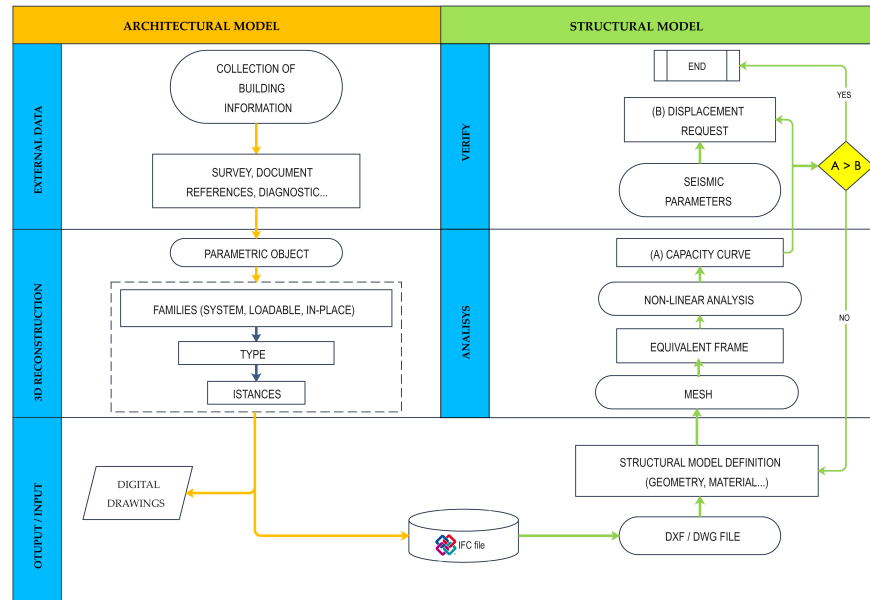
The procedure followed for the BIM implementation and analysis is summarized in the flowchart of Figure 8. This last is staged in different stages. The initial stages aims to create a digital architectural model of the building by taking advantage of parametric objects, to be implemented into the software, such as “families”. These can be of system, loadable or realizable in-place, all fully customizable with parametric dimensions which allows to adapt a single modeled element to more usages. The output of this model is an International Foundation Class (.IFC) file, which is platform neutral and can be read and edited by any BIM software and it represents the base input file for the structural modelling. The final stage of the work consists in the passage from the architectural model to the structural model. This passage is allowed by the package BIM2CAD, included in Tremuri [7], which converts the BIM format in a classic CAD model and exporting plane views for each storey. These plane representations allow the straightforward structural modelling, converting objects in finite elements, such as beam, slabs or walls.

**Figure 8.** Flow process for HBIM modeling and seismic safety assessment.

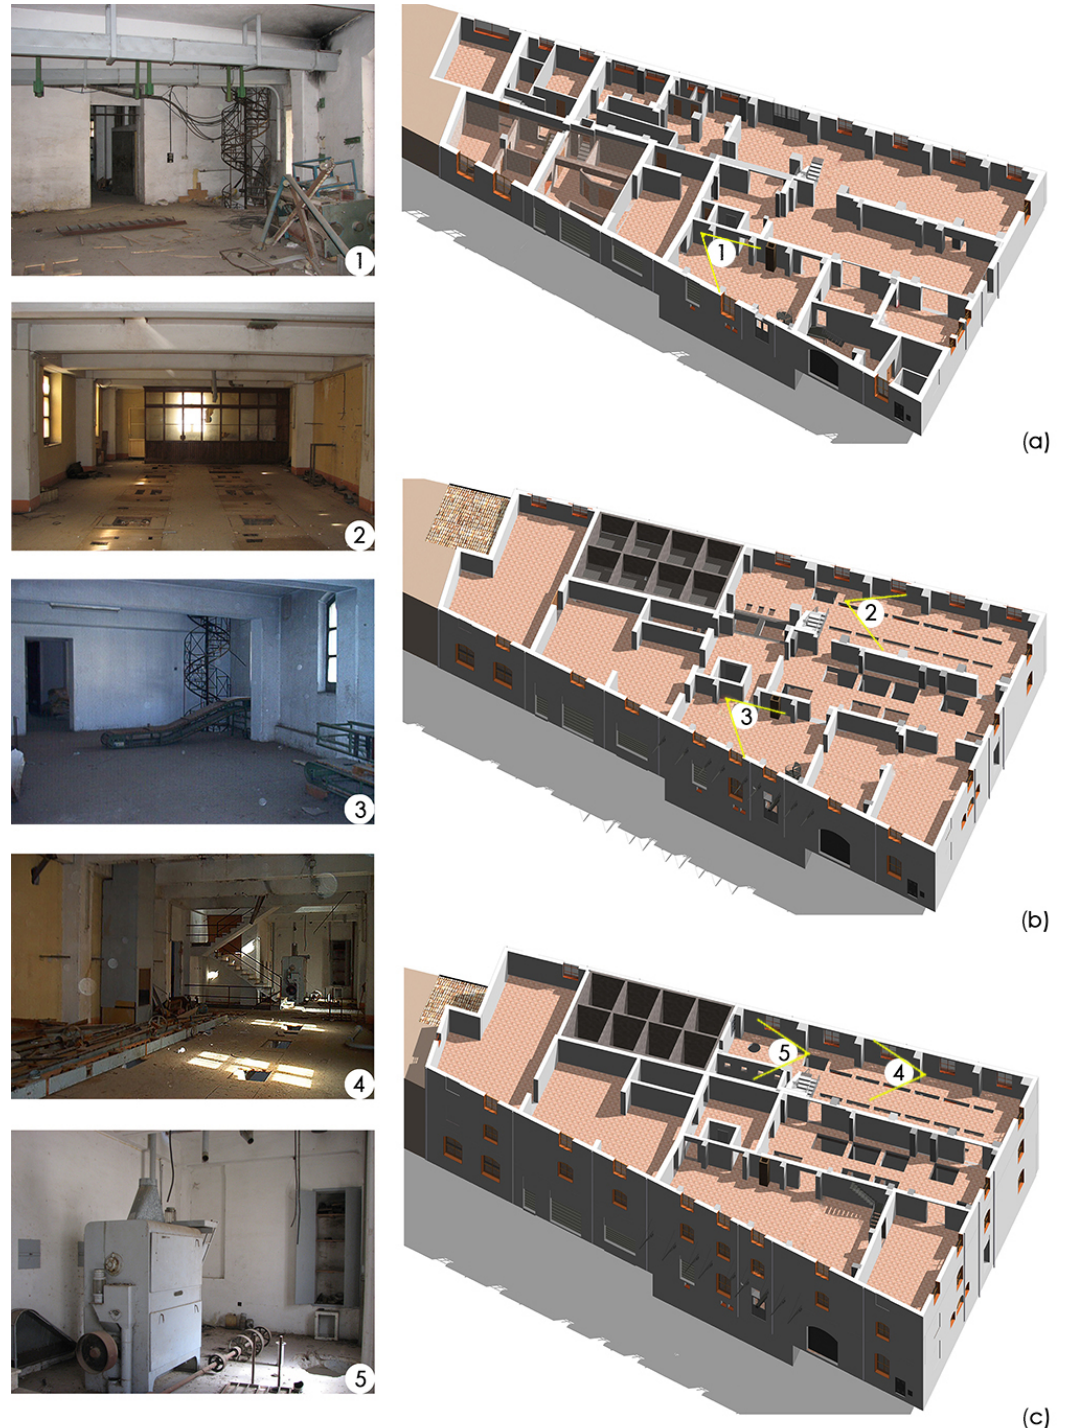
Figure 9a shows the axonometric view of the first floor of the building with a surface of about 800 square meters and characterized by two floors of footfall placed at different altitudes; in fact the two levels at Maggiore Guida street and Tarollo street differs in height of about 1 m. The lower part of the building adjacent to the Tarollo street was then selected for procuring and storing water due to the presence of a water well. A basement level with a surface area of about 65 square meters and originally used as a technical room can be identified. It is accessed from the first floor by means of a steel spiral staircase. Bearing walls are made with a regular masonry of calcarenite stone units. The stone was

of sedimentary clastic origin and units were produced in the quarry of Mazara del Vallo, about 40 km far from Partinico. This kind of stone is almost common in much of the island of Sicily. Masonry walls have a thickness of 60 cm at the base storey and it decreases down to 40 cm at the fourth storey on the Maggiore Guida street front.

**Figure 9.** (a) First floor; (b) Second floor; (c) Third floor.

The axonometric cross-section in Figure 9b shows the second floor of the building with a surface of about 800 square meters and characterized by the presence of RC silos and holes in the floors. In addition, an intermediate “mezzanine” floor on the ground floor with an area of about 100 square meters can be identified, which was originally used as an archive.

An internal lift made by masonry walls for moving heavy weights can be identified inside. Slabs are built with reinforced bricks and concrete, namely “SAP” typology (self-supporting slab), widely adopted in Italy during the '50s and '60s. Similar typologies of this kind of slab can be found all across Europe [8]. These slabs are made by small beams made with concrete, in-place assembled and cast into brick grooves, reinforced with plain bars and finally finished with mortar. Finally, the slab is finished with a continuous layer of concrete. All the slabs in the buildings have openings with various shapes and dimensions for allowing the movement of the different industrial machines and goods inside the building.

Figures 9c and 10a show respectively the third and fourth floor of the building, both with a surface area of about 800 square meters. Also in this case, RC silos and holes in the floors can be seen. RC frames are visible with the Hennebique system, which provides the connection between beams and columns through link beams and the presence of main and secondary beams along the two directions of the slab.

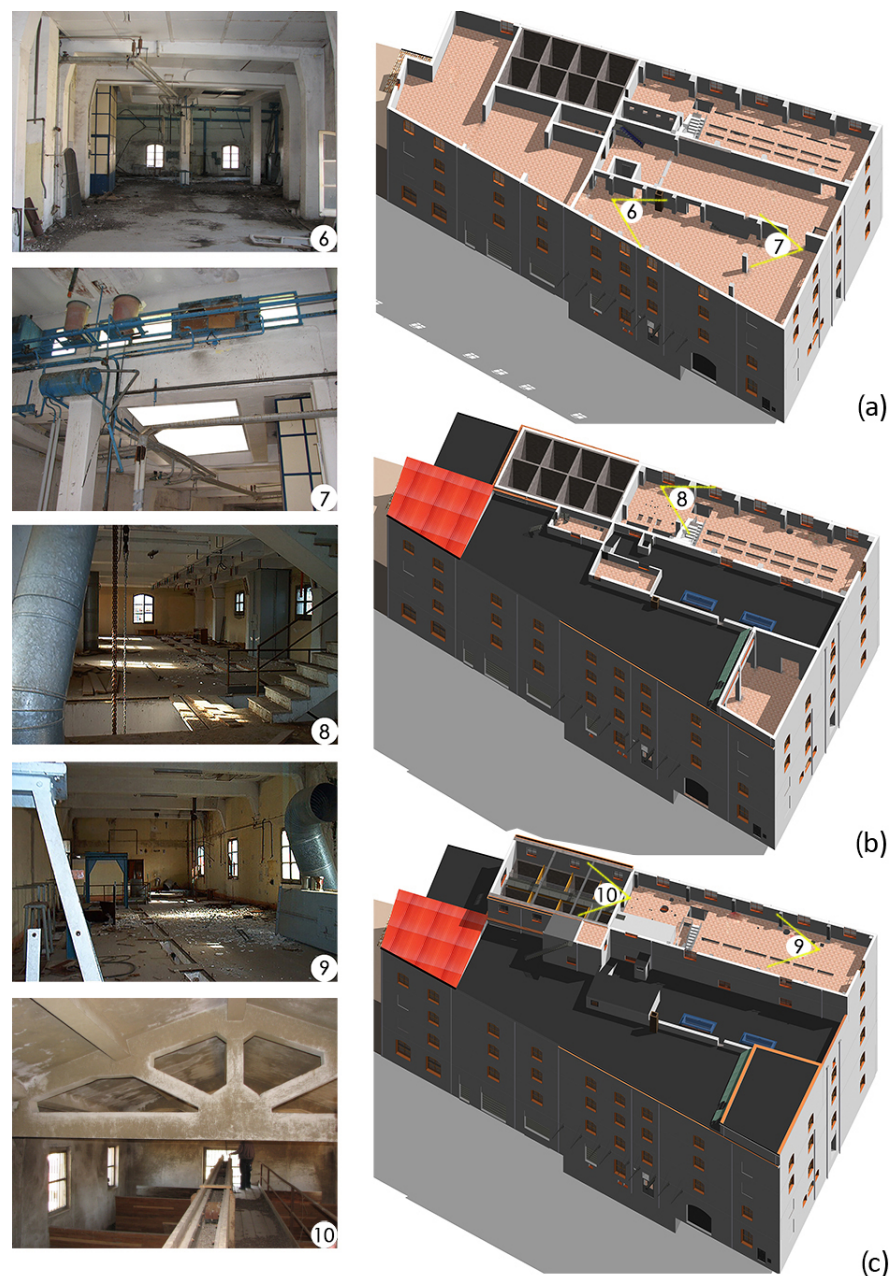
**Figure 10.** (a) Fourth floor; (b) Fifth floor; (c) Sixth floor.

The axonometric cross-sections in Figure 10b,c present the fifth and sixth floors of the building, respectively, with a surface area of about 300 square meters. Note on the sixth floor the presence of two cast-in-place RC trusses approximately 7.50 m long, and a flat cover with an area of about 500 square meters and accessible for maintenance only. Silos develop up to the fourth floor, with a final inclined roof made with the already described SAP slab supported by the RC trusses. The top part of the silos is open, forming wide tanks for the movement of the grains through the use of industrial machines. The tanks are accessible on the top part through a wood footbridge. Two glass skylights are also present at the fourth level with dimensions equal to 3.00 by 1.60 m.

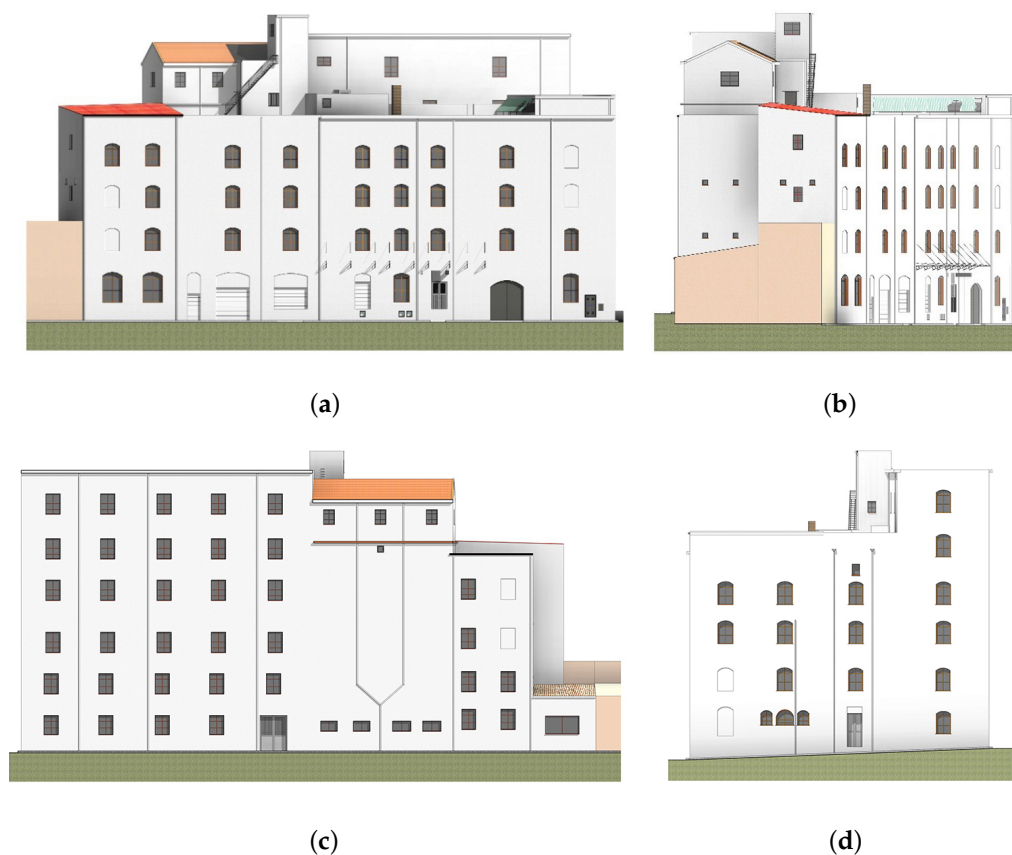
Figure 11 reports the main elevations, from which it is possible to note clearly the regular distribution of the openings in the masonry panels. The different internal sections of the building are shown in Figure 12, from which it is possible to observe the internal RC staircase connecting the floors from the first storey up to the sixth, and the steel spiral staircase connecting from the underground basement up to the third floor. The above presented digital drawings were obtained through an automated procedure from the BIM model built by the software Autodesk Revit® [6].

**Figure 11.** Digital drawings: main elevations. (a) North Elevation on the Maggiore Guida street; (b) East Elevation on the other property; (c) South Elevation on the Tarollo street; (d) West Elevation on the Pozzo del Grillo street.

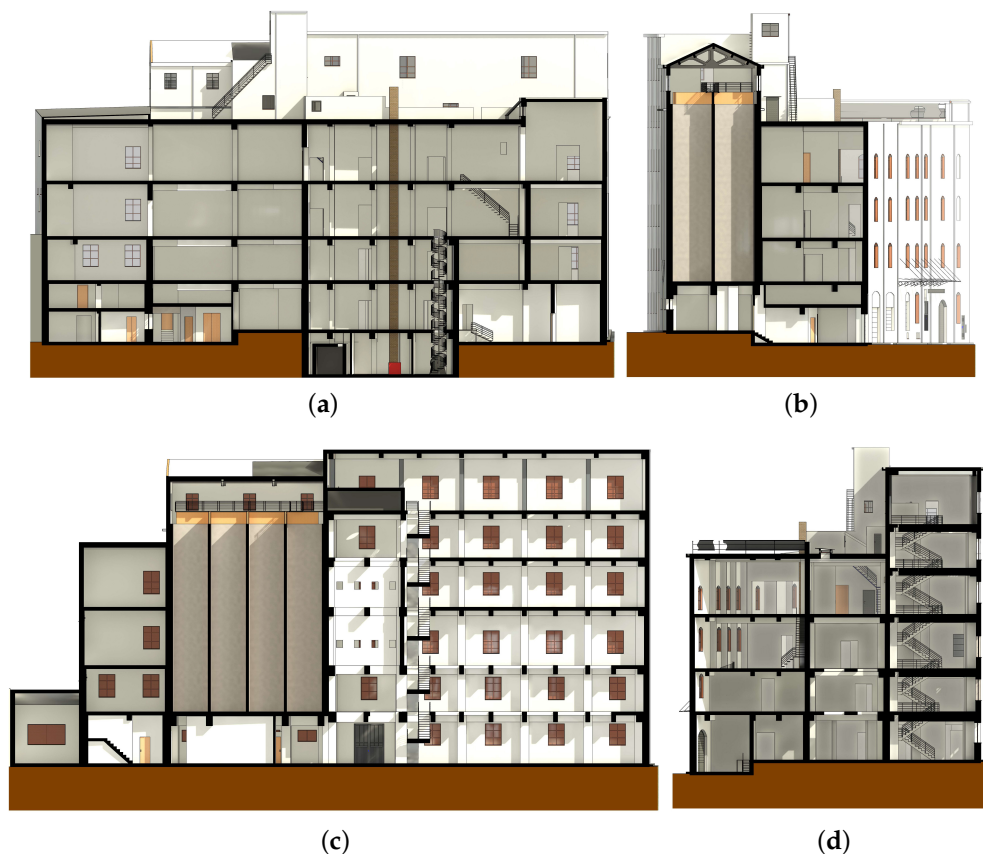
Figure 12. Digital drawings: Building internal sections.

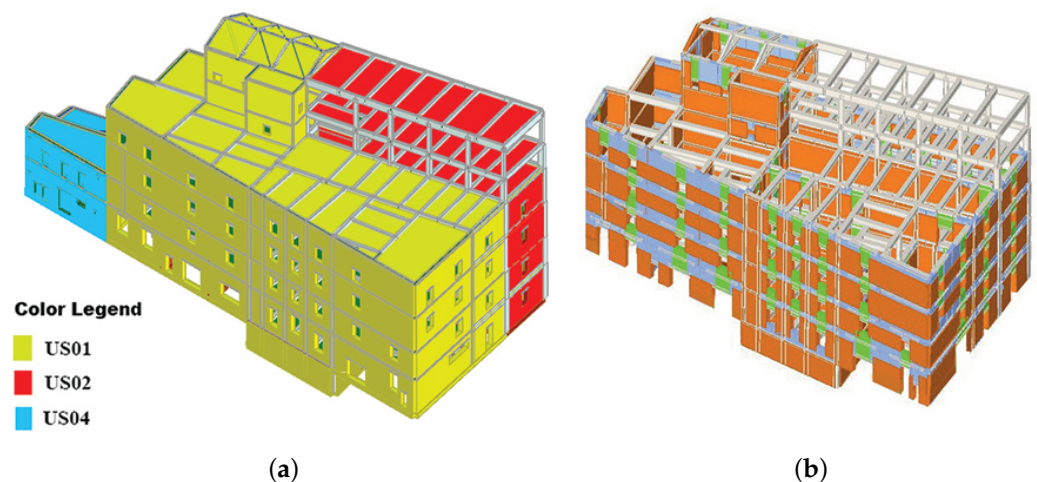
In the following, the results achieved on the US01 and US02 that make up the “Molino-Pastificio Soresi” are discussed from a global point of view, taking into account the dynamic interaction of the US04 of other property, but excluded from the calculation results from the structural model (Figure 14).

**Figure 14.** Structural model performed using the “macro-elements” modeling approach.

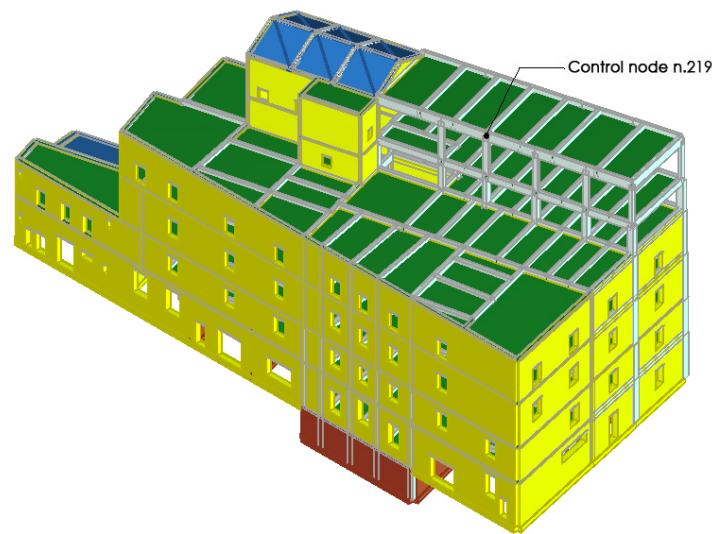
The control node was chosen into account the elements that come to collapse and their elevation position that affected the most significant levels of the building (Figure 15).

Figure 15. Choice of control node.

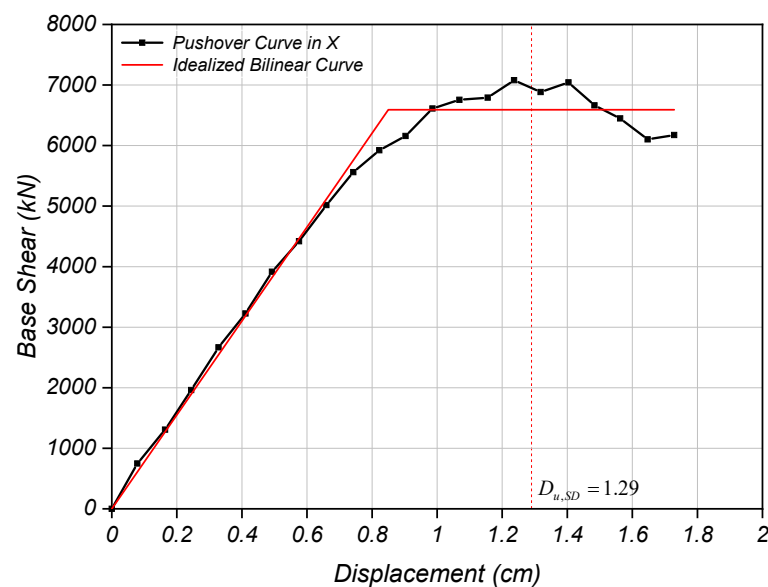
Figure 16 shows the capacity curve of the structure for the first load combination, being X the main load direction, and the corresponding bilinear curve of the SDOF system, while Figure 17 shows the color plot of failure modes in the structural members at the last step of the analysis. It is highlighted as the vulnerability of the structure is mainly related to the large openings at the first floor, which limit the shear capacity of the shear walls. The framed RC structure inside the building keeps almost undamaged, with the exception of a bending damage at the beam ends and a few of shear failures, while the overall capacity is affected from the achievement of the shear capacity for almost all the masonry walls at the first floor, as highlighted from Figure 18. This latter shows the main front along X direction, and it stresses that the limited stiffness of the structure at the base storey and the relatively low shear strength give to the structure an ultimate “soft-storey” mechanism, limiting the displacement capacity.

**Figure 16.** Pushover curve of seismic analysis n.1, direction X (Uniform).

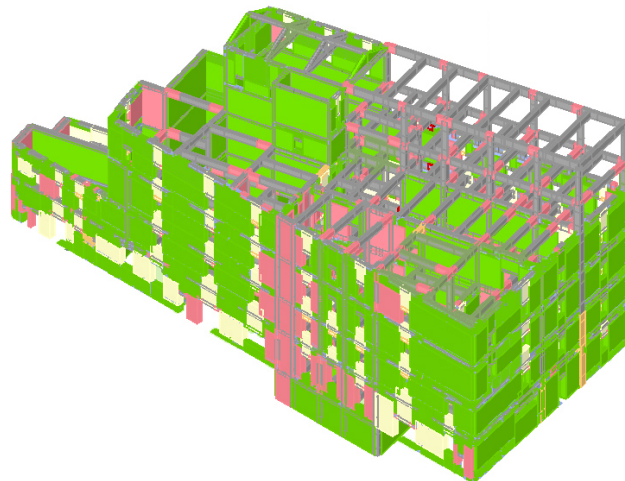
Figure 17. Structural damage at the last step of seismic analysis n.1, direction X (Uniform).

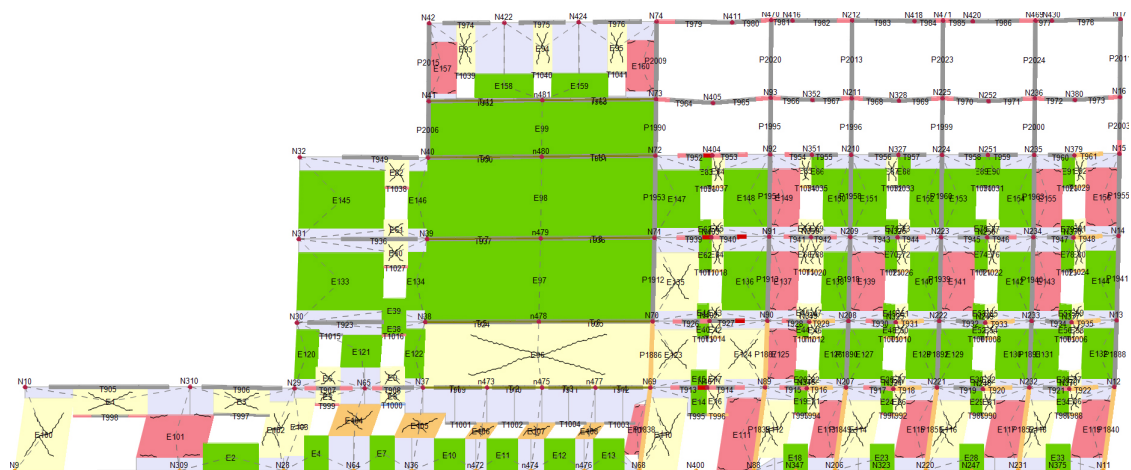
Figure 18. Structural damage wall n.1 at the last step of seismic analysis n.1, direction X (Modal forces).

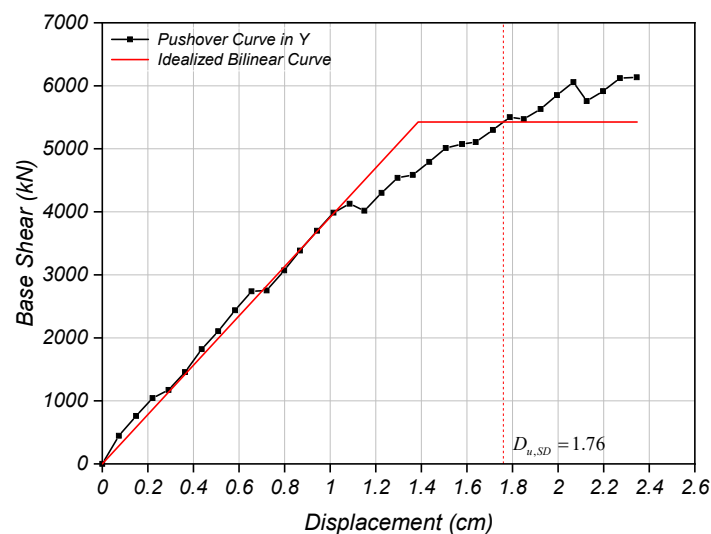
Similarly, Figure 19 shows the capacity curve of the structure for analysis n.21, i.e., uniform distribution of loads and Y main direction of the forces.

Figure 19. Pushover curve of seismic analysis n.21, direction Y (Uniform).

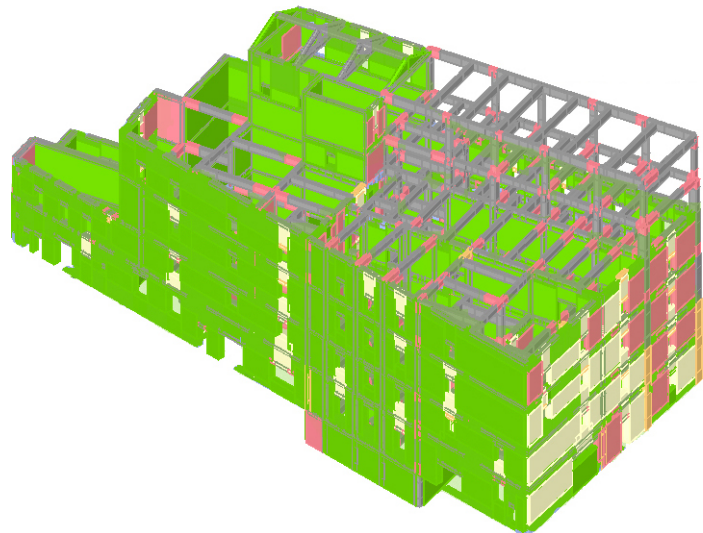
Similarly, Figure 20 shows the failure mode of the structure for analysis case n.21 (Y direction and uniform distribution). It is highlighted that the structure has a slightly lower lateral capacity and a greater ultimate displacement, meaning that the structure is more flexible along the Y direction, as confirmed by the presence of a lower number of walls in this direction. In this case, the seismic force is mainly sustained by the RC framed structure and by the front walls, as highlighted by Figure 20. In this last case, the attainment of the Limit State is due to the shear failure of the walls in Y direction and reaching of the ultimate rotational capacity of the beam elements in the RC structure.

Figure 20. Structural damage at the last step of seismic analysis n.21, direction Y (Uniform).

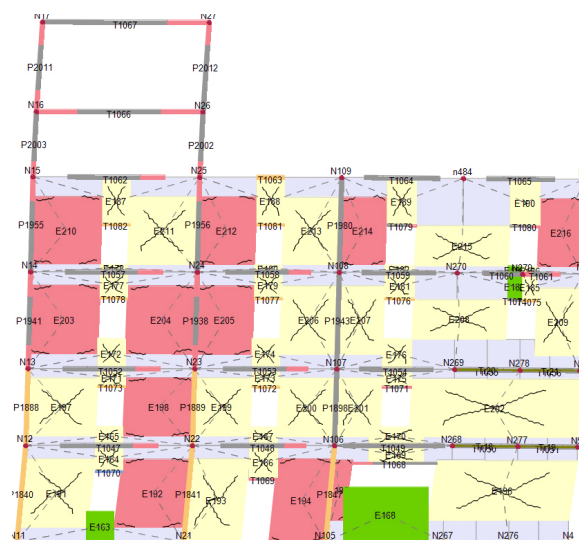
Figure 21 shows the detail of the front wall at the last step of the analysis, confirming the predominance of shear mechanisms in the masonry structure.

Figure 21. Structural damage wall n.3 at the last step of seismic analysis n.21, direction Y (Uniform).
