Perspective

Degradation of Insulating Glass Units: Thermal Performance, Measurements and Energy Impacts

Citation: Likins-White, M.; Tenent, R.C.; Zhai, Z. Degradation of Insulating Glass Units: Thermal Performance, Measurements and Energy Impacts. *Buildings* **2023**, *13*, 551. <https://doi.org/10.3390/buildings13020551>

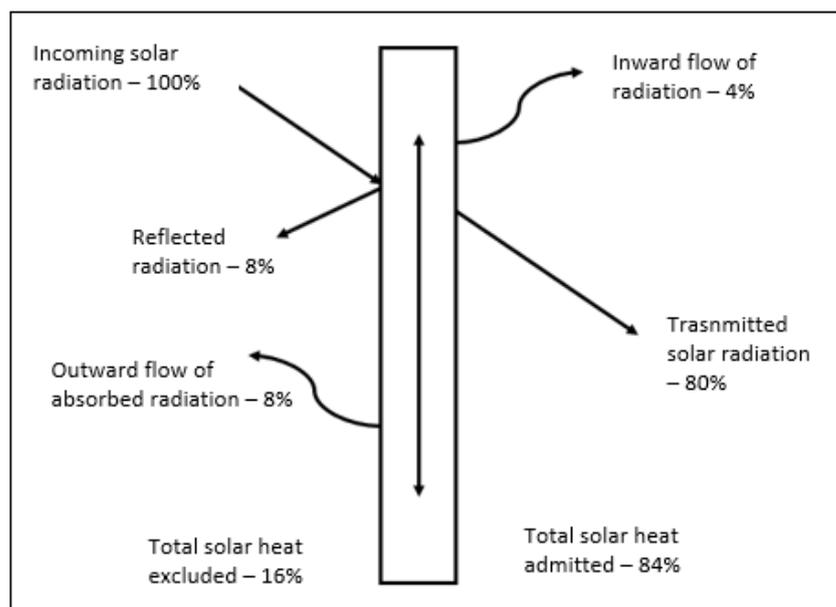
Figure 2. Solar Radiation on a Window; regenerated [8].

The solar radiation and thermal conductivity lead to increased heat gains in the summer which increase cooling loads. In the winter, only the conductivity contributes to the increase in heating required. The conductivity associated with extreme temperature differences and the solar radiation striking windows also drive degradation [9]. Windows are typically broken down into two physical components: the insulating glass unit (IGU) and the frame. The IGU consists of at least two glass lites that are separated by a spacer system, typically containing a desiccant material with the edges of the units sealed using various polymeric materials. The interior of the sealed unit is typically filled with an inert, low thermal conductivity gas, and the glass lites may have low emissivity (Low-e) coatings for mitigating solar heat gains. Degradation of IGUs is most often associated with edge seal failure, inter-pane gas loss, and breakdown of the low-e coating. These modes of failure occur within the IGU of a window system and can typically be decoupled from thermal bridging and other frame effects. Commercial windows have a life span of 20–30 years compared to the overall 50–60 year life span of a commercial building [10]. Their shorter lifespan, multiple modes of degradation, and large contribution to energy

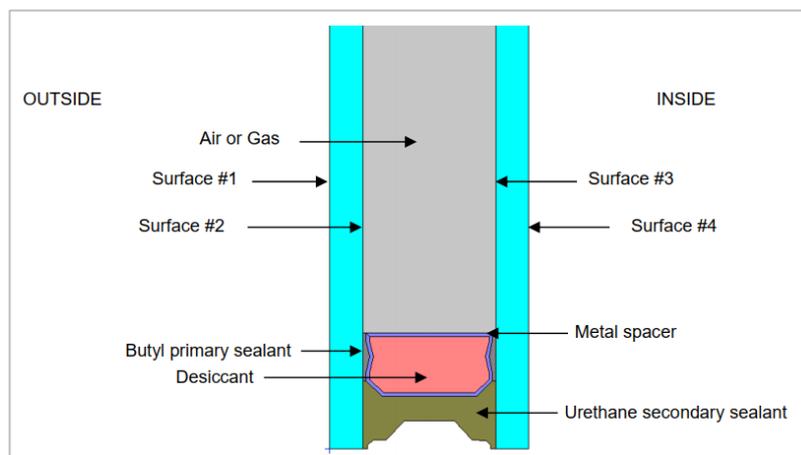
Figure 3. NFRC diagram.

Figure 3 shows an IGU with a dual edge seal system, which became popular in the 1990s due to the demand for longer service life [9]. A dual seal system consists of a “primary” sealant, typically polyisobutylene (PIB), which provides gas retention properties, and a secondary seal of varied polymeric materials that provides structural integrity for the unit. Commonly used secondary sealants include polyurethane, polysulphides, and polysilicones. The spacer, which holds the two glass lites apart, is filled with a desiccant material that is intended to absorb any moisture that enters the edge seal and prevent ingress to the inter-lite gas gap. The dual seal system of an IGU is of great importance to product durability as it has a notable influence on the gas leakage rate and vapor permeability, which both can reduce the thermal performance of a window [13]. In addition

The durability of a window is its ability to remain functional and perform as designed. Window durability is dependent on the frame and sash, insulating glass seals, and weatherstripping, though there is no simple rating of durability [12]. Figure 3, from NFRC 100, shows the arrangement of a dual-paned IGU.

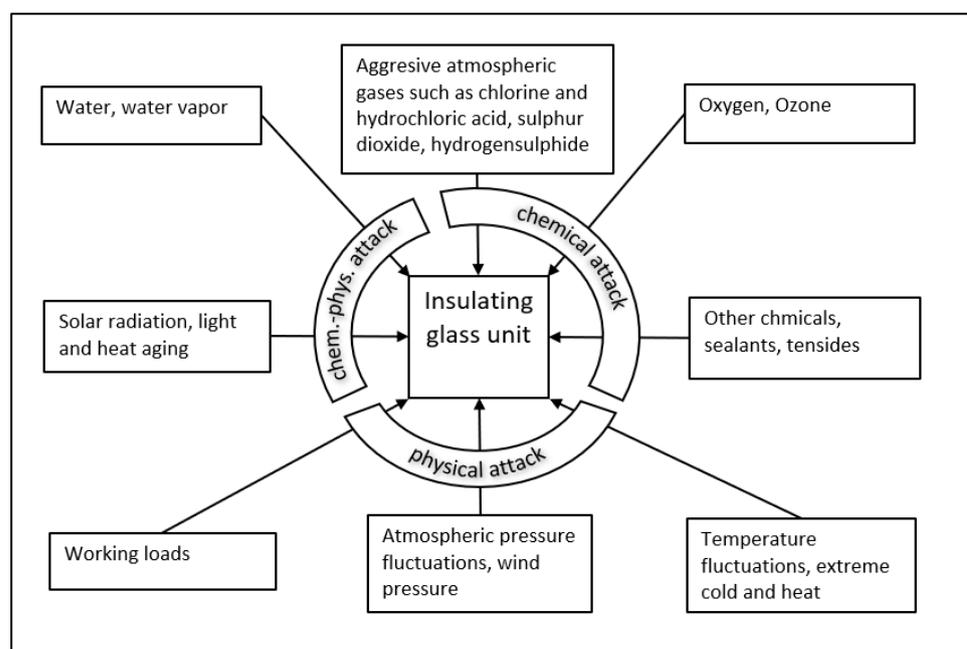
Figure 4. Environmental Influences on Aging Process of Insulating Glass [13].

In the 1990s, Wolf and Waters found that the secondary seal of IGUs played the most important role in IGU life expectancy and durability [14]. The main environmental aging and weathering effects on an IGU and seal are temperature, pressure, sunlight, and oxygen/ozone, as shown in Figure 4 [13].

Both temperature and pressure fluctuations lead to mechanical stress on the edge seal which can affect elasticity and accelerate physical deterioration. Oxygen/ozone exposure can result in the oxidation of the glass sealants and make them more brittle. Sunlight is regarded as the most important aging factor on IGUs due to its thermal and photochemical effects on the edge seal. These aging factors work in tandem during the entire lifecycle of IGUs and can result in seal and glass material degradation. Additionally, low elastic recovery of the secondary seal at high temperatures shortens the service life of IGUs. Wolf and Waters evaluated the effects of temperature on vapor diffusion of 15 insulating glass sealants following DIN 53122. They assessed the permeability at 20 °C, 40 °C, 60 °C, and 80 °C, and found that the sealants exhibit six to eight times more permeability at 60 °C than 20 °C. This indicates that the sealant will degrade more rapidly in summer months than winter months, even when exposed to high temperatures for a shorter duration. Wolf and Waters also observed that silicone sealant permeability varies less as a function of temperature than those with a polysulphide base, as shown by Figures 5 and 6, indicating that polysilicones may extend the lifespan of sealants and prevent moisture penetration. Note that for Figure 5, sealants labeled with b had no meaningful data obtained.

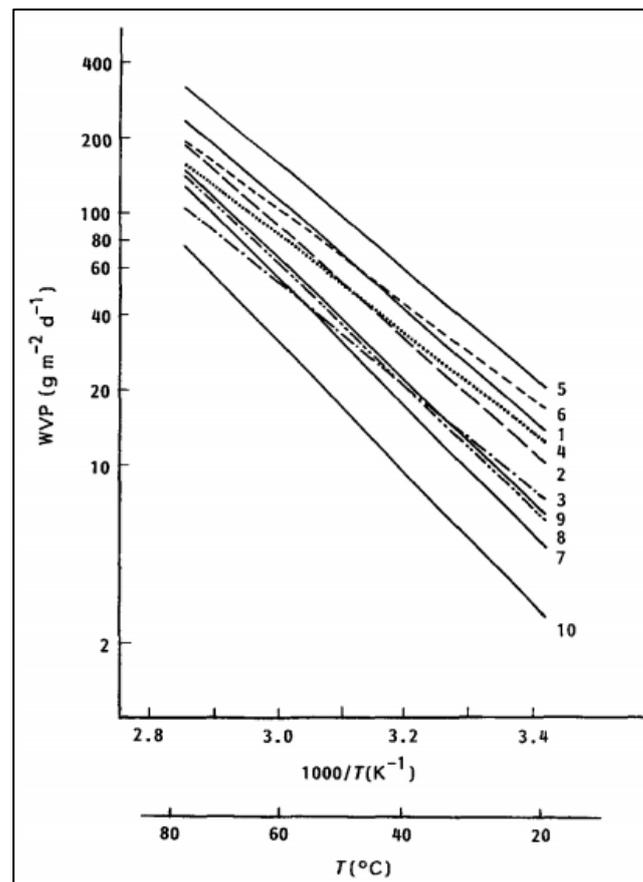
Figure 6. Arrhenius Plot for the Water-vapor Permeabilities of Insulating Glass Sealants [14].

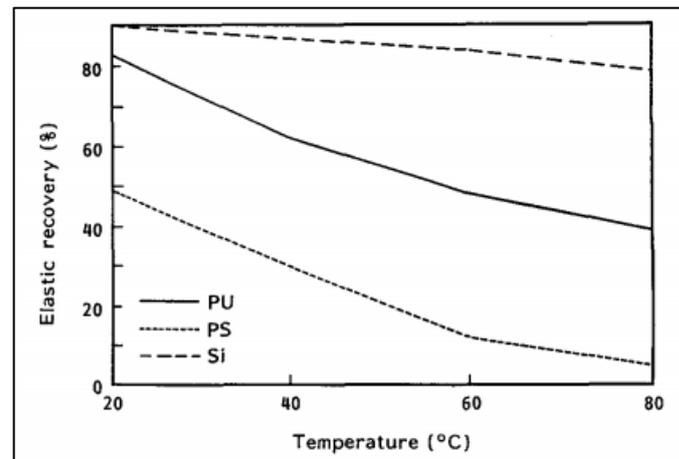
Figure 7. Influence of Elastic Recovery of the Secondary Sealant [14].

Wolf and Waters also analyzed eight sealants on premature failure due to adhesion loss following ASTM G-53. All sealants were allowed to cure for six weeks under standard climate conditions before being subjected to accelerated weathering. The accelerated weathering of the sealants consisted of UV light exposure over 1000, 2000, 5000, 10,000, and 20,000 h followed by a weathering cycle of four of UV exposure at 65 °C, then by four hours of condensation at 50 °C. Finally, specimens were elongated by 25% for 24 h and considered “failed” if they lost more than 10% of adhesion. Results of this test revealed that polysulphide sealants exhibited the poorest resistance to UV exposure and lowest elastic recovery, as shown in Figure 7.

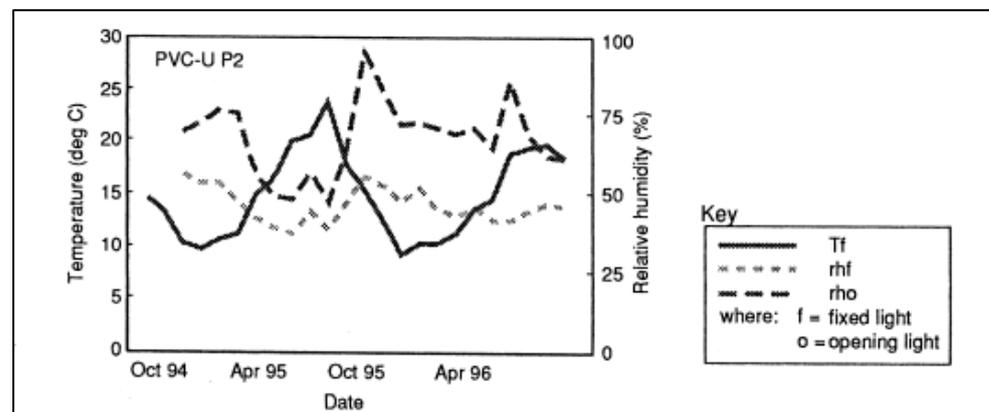
Figure 8. Mean Temperature and Relative Humidity for PVC-U P2 Type Window [15].

Unlike most durability literature that is typically completed in a lab, Garvin and Wilson used in-field measurements to acquire quantitative data on durability parameters [15]. The main goal of this research was to analyze the potential service life of windows under real conditions given the lack of long-term durability studies. The experiment was set up in a test home in Scotland and took place over two years. Windows of various orientations and constructions were monitored every 30 min on relative humidity of the cavity, temperature of the cavity, and liquid moisture in the edge seal. The interior room temperature was controlled via heaters while the exterior was exposed to ambient conditions. Humidity results showed that the mean relative humidity in the cavities was highest during winter months and for timber frames, likely due to direct penetration of rain. Temperature readings revealed that the cavity temperatures were a direct reflection of external conditions. Liquid moisture in the edge seal was found to be higher in fully bedded windows than the drained and ventilated frames. A sample of the results for a PVC-U frame is shown in Figure 8.

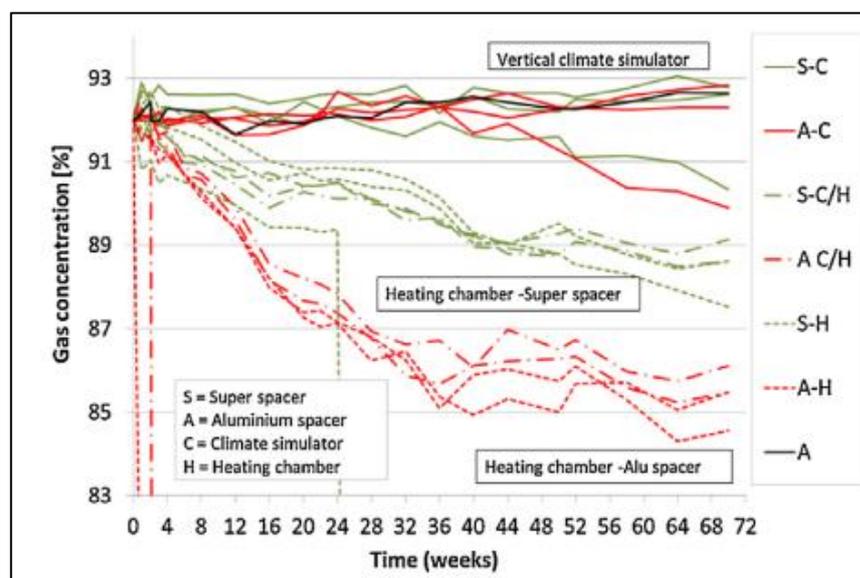
Figure 9. Gas Concentration Versus Time of the Windowpanes Subjected to Accelerated Aging [5].

Asphaug et al. found that aging and degradation of windowpanes can lead to a loss of noble gas concentration within the inter-pane space [5]. Like Wolf and Waters, Asphaug et al. found that the durability of IGUs is primarily characterized by spacer type. Seal failure leads to the loss of insulating gas, such as argon, krypton, xenon, and air, which can increase the U-factor of an IGU up to 32%. Their experiment included 18 IGUs filled with argon gas, nine with super spacers and nine with aluminum spacers. The IGUs were split into three groups with various weathering methods including a climate simulator, a heating chamber, and a combination of the two. The gas concentration of each IGU was measured regularly over a span of 70 weeks and plotted versus time. Results indicated more gas leakage for aluminum spacers and significantly more leakage for all IGUs put in the heating chamber, as shown in Figure 9.

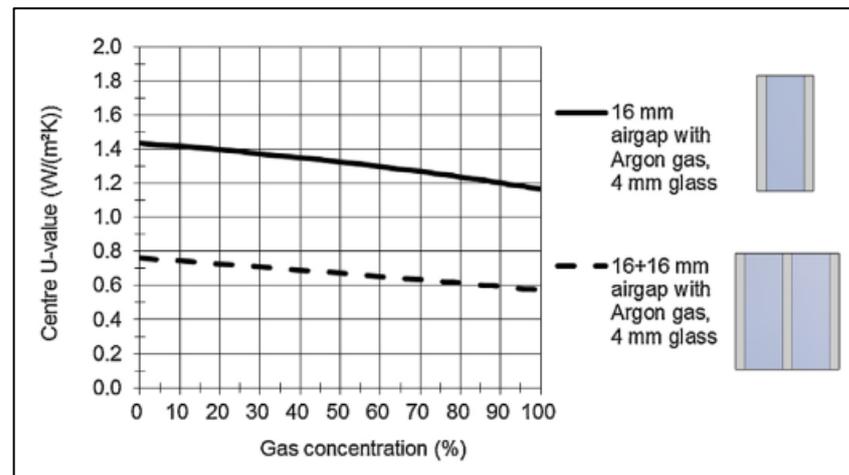
Figure 10. Increasing Center U-value with Decreasing Gas Concentration [5].

Results also indicated a decrease in U-factor as a function of gas leakage, as provided in Figure 10, but little information is given on how U-factor is evaluated in this study.

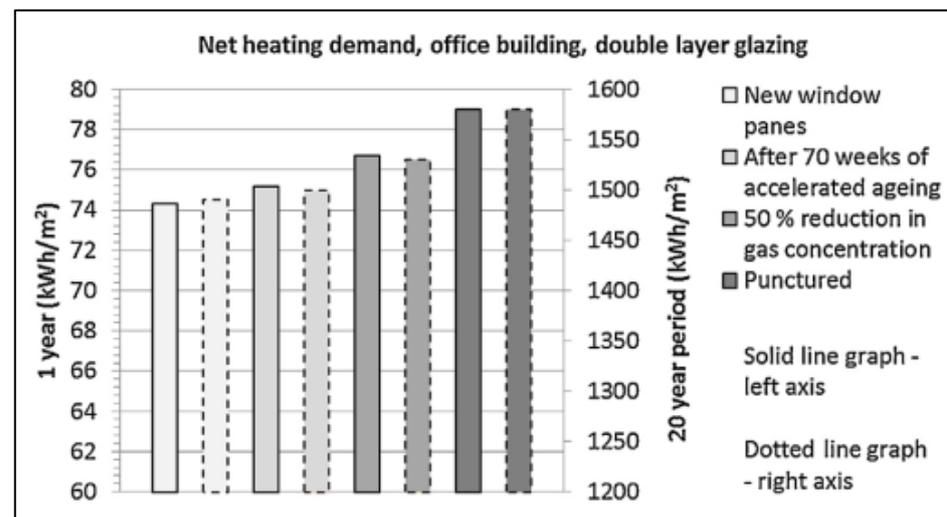
Figure 11. Net Heating Demand, Office Building, Double Layer Glazing [5].

Similar to the gas concentration, little information is given on the overall U-factor of the windows used in each of the simulations. Results of the simulation showed that an increase in heating demand over 20 years due to gas concentration loss would be up to 65 MWh for a typical office building and up to 1.3 MWh for a single-family home. A sample of the results is provided in Figure 11.

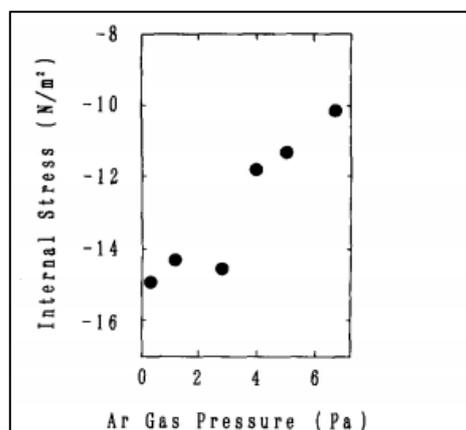
Figure 13. Dependence of the Internal Stresses in ZnO Layers on the Sputtering Gas Pressure [26].

Miyazaki and Ando [26] discuss improving the durability of silver-based low-e coatings. In their study, they investigated the degradation of a silver layer sandwiched between two layers of zinc oxide. The degradation process was comprised of a humidity test at $50\text{ }^{\circ}\text{C}$, 95% relative humidity for 144 h. After this test, Miyazaki and Ando used electron microscopy, energy dispersive X-ray spectroscopy, and X-ray diffraction to compare to the new sample. They found that the zinc films had a large internal stress under higher gas pressure that was reduced by adding aluminum, as shown in Figure 13.

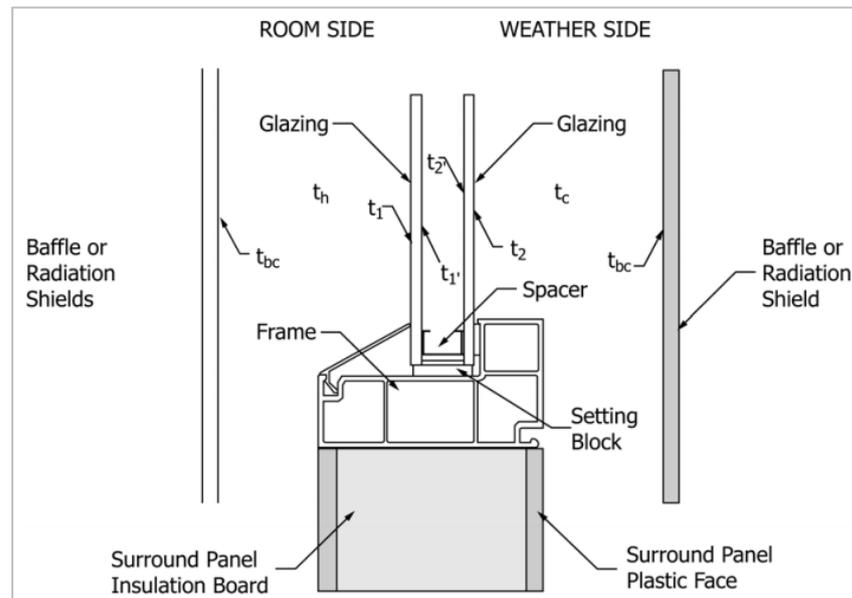
Figure 14. ASTM C1199 testing setup.

durability of windows in the field. Because of these drawbacks, the standard itself states that “results obtained do not reflect performances that are expected from field installations,” leading users to question the practicality of the results obtained from the standard.

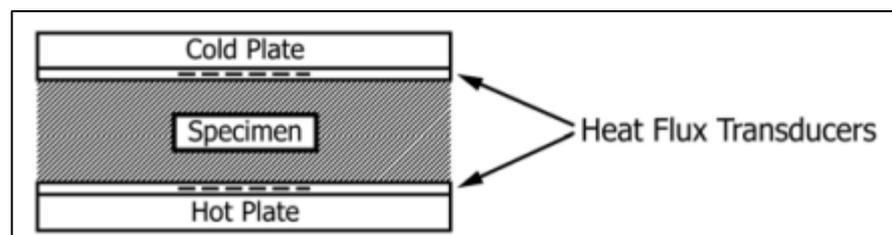
Figure 15. Apparatus with Two Heat Flux Transducers and One Specimen.

ASTM C518-21 is a standard test method for steady-state thermal transmission through flat slab specimens using a heat flow meter apparatus. This standard can be applied to any material, including glass samples. Steady-state one-dimensional heat flux through a specimen is generated through two parallel plates. Fourier’s law of heat conduction is used to calculate thermal conductivity based on the heat flux and plate temperature measurements. This method offers a quick and easy way to measure thermal properties of window samples using a heat flow meter; however, the testing apparatus is typically large and cannot be used in the field. Figure 15 shows a typical assembly using two heat flux transducers and one specimen.

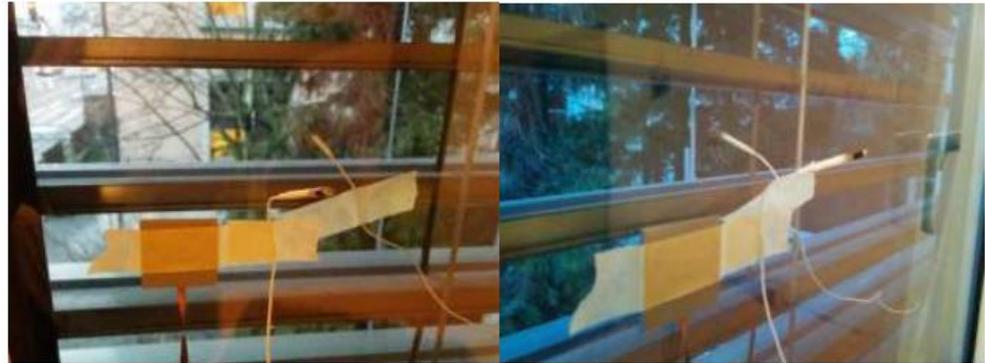
Figure 16. gSKIN Measurement Setup [31].

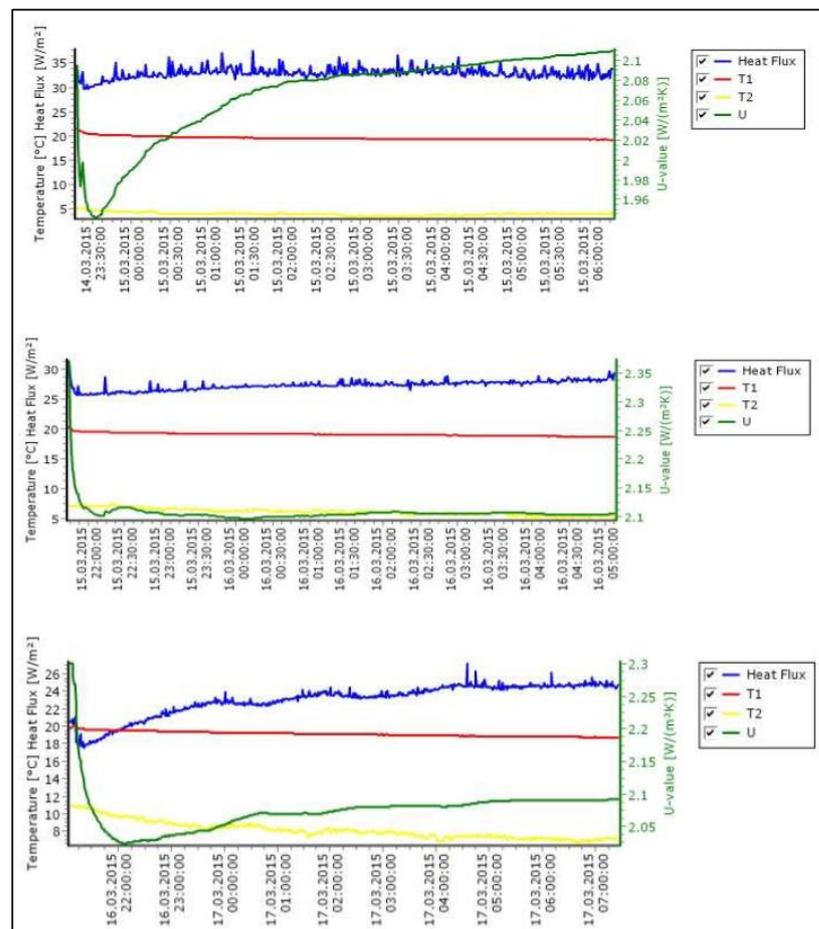
Figure 17. Results of Three Nighttime Measurements [31].

Three night-time measurements were taken over several hours with stable weather conditions to negate the effects of wind and solar radiation and evaluated using greenTEG software. Graphs of these measurements are provided in Figure 17.

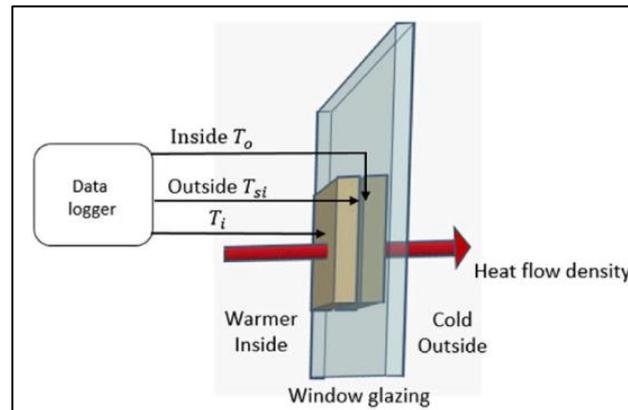
Figure 18. Typical Measurement Setup [32].

used two 3D-printed objects made of acrylonitrile butadiene styrene with known thermal properties, three temperature sensors, and a data logger as their measurement setup, as shown in Figure 18.

The thermocouples in Figure 18 measure inside air temperature, outside air temperature, and inside surface temperature. They assumed steady-state so that the heat flux through the 3D-printed object and window could be equal, and the equations simplified. By doing so, they were able to estimate the center-of-glass U-factor of the window based on three temperatures and the R-value of the 3D object. The three temperatures were processed every second by a micro-controller and plotted versus time over several hours in the evening to avoid solar radiation effects. Three measurements with various outdoor conditions were taken on a double-pane window with a manufacturer U-factor rating of $2.97 \text{ W/m}^2\text{K}$. The first measurement took place with an indoor temperature of $24.1 \text{ }^\circ\text{C}$ and outdoor temperature of $6.3 \text{ }^\circ\text{C}$. It took 35 min to reach steady-state and the measured U-factor was $3.15 \text{ W/m}^2\text{K}$, a 6.1% error compared to the known value. The second measurement took place with an indoor temperature of $23.7 \text{ }^\circ\text{C}$ and outdoor temperature of $8.4 \text{ }^\circ\text{C}$. It took 35 min to reach steady-state and the measured U-factor was $3.26 \text{ W/m}^2\text{K}$, a 9.8% error compared to the known value. The third measurement took place with an indoor temperature of $23.8 \text{ }^\circ\text{C}$ and outdoor temperature of $18.2 \text{ }^\circ\text{C}$. It took 40 min to reach steady-state and the measured U-factor was $2.32 \text{ W/m}^2\text{K}$, a 21.6% error compared to the known value. Figures 19–21 show the results from each measurement.

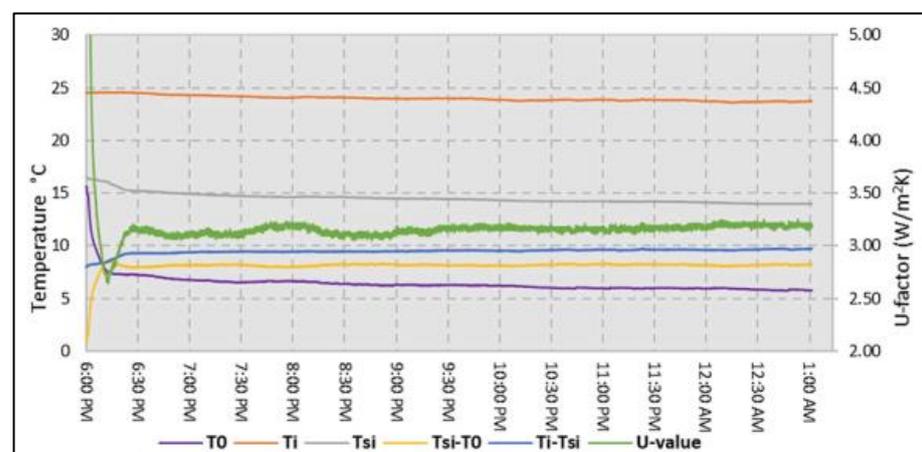
Figure 19. First Measurement [32].

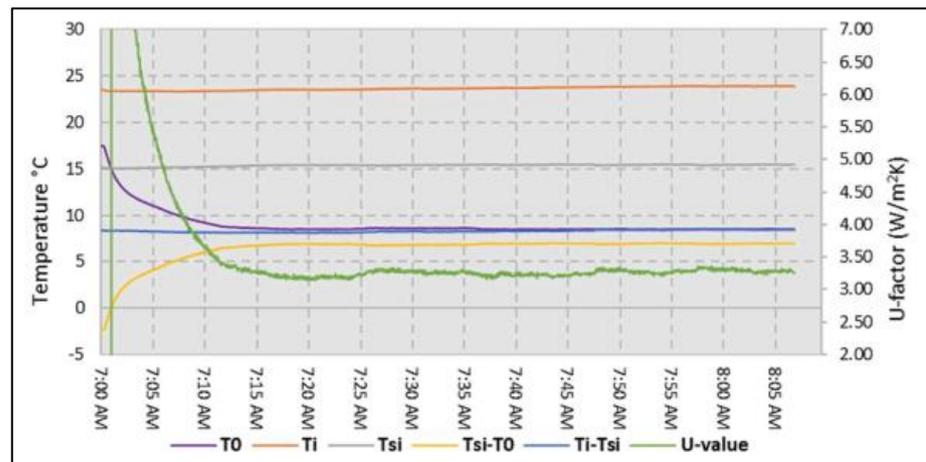
Figure 20. Second Measurement [32].

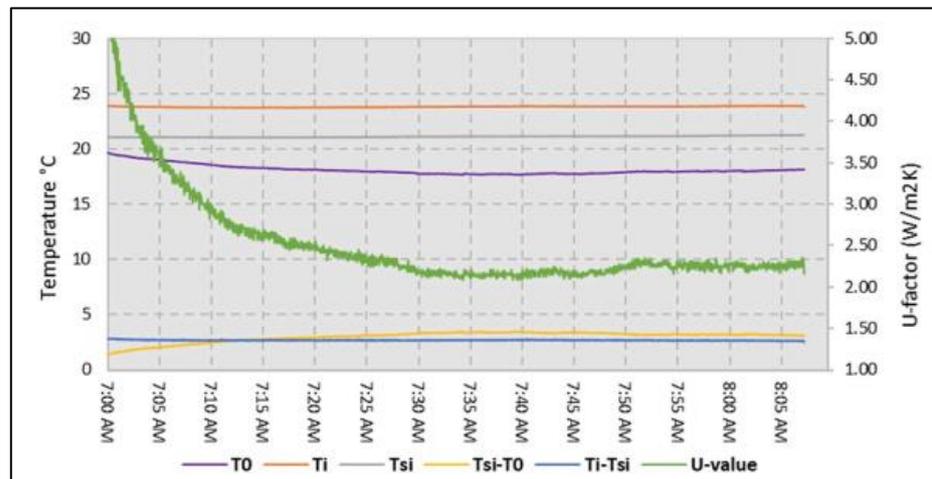
Figure 21. Third Measurement [32].

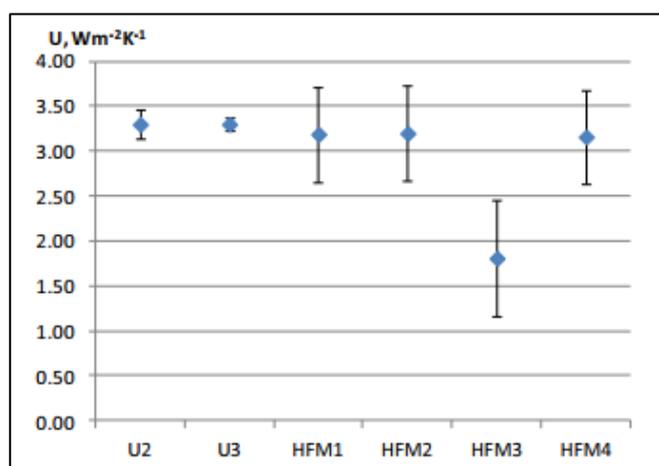
Figure 22. Comparison between in situ U-values [33].

The authors found method one to be unreliable and thus scrapped it from their results. Their results for the window sample show a range of accuracy for each test and each heat flux meter. They averaged the results for each sample duration and found the U-factors to be 3.19 W/m²K, 3.2 W/m²K, 1.81 W/m²K, and 3.16 W/m²K for four different HFM measurement techniques. These are compared to the known U-factor of 3.3 W/m²K. A box-and-whisker plot of these in situ values, along with U2 and U3 values measured in-lab and their uncertainties, is provided in Figure 22.

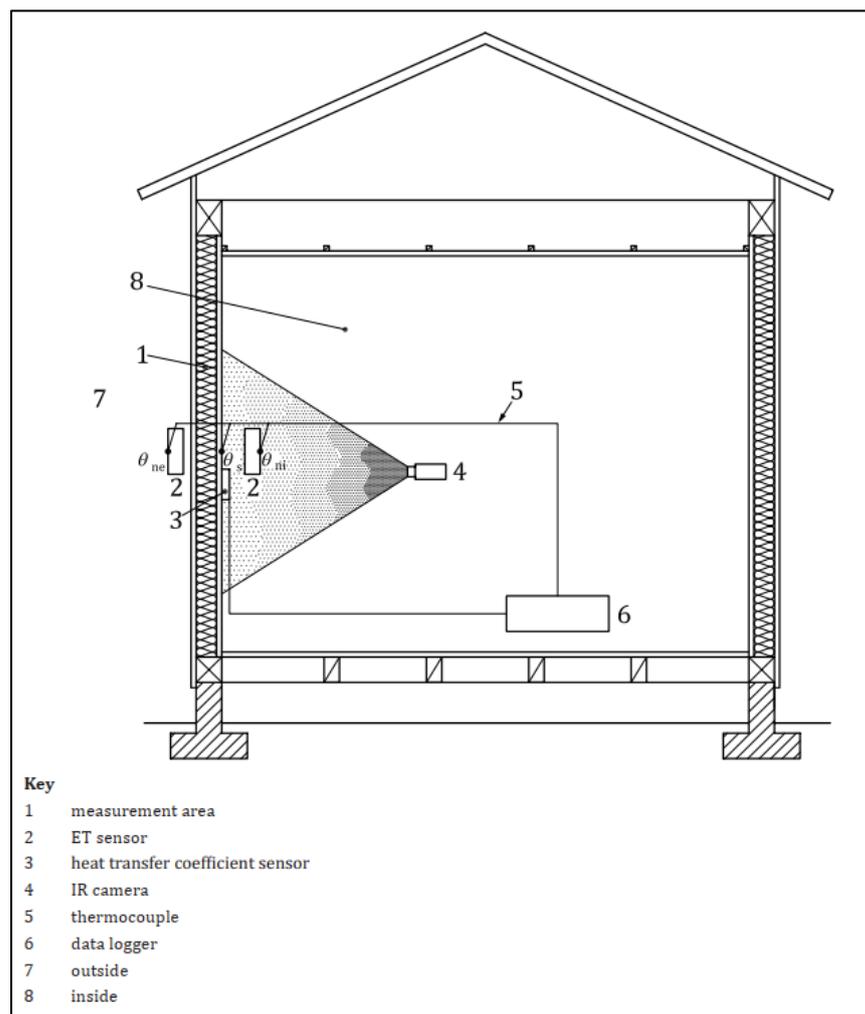
Figure 23. IRT Measurement Setup.

Another promising method for measuring window U-factor in situ is the infrared method. The apparatus consists of an infrared camera, heat transfer coefficient sensor, ET sensor, and thermocouples. This method measures the amount of irradiance of regions in contact with outside air from the surface temperature, total heat transfer coefficient, and ambient temperatures. Compared to the heat flow method, infrared offers shorter testing time, more flexibility of measurement area/location, and less interference with building constructions. The infrared method is outlined in ISO 9869-2 for opaque envelope constructions and results on accuracy for transparent constructions is mixed. An example of the testing apparatus is provided in Figure 23. ET sensors are used to measure environmental temperature of the regions of the object to be measured, and the heat transfer coefficient sensor is used to estimate the total heat transfer coefficient of the surface to be measured. Thermocouples are arranged to measure inside air temperature, outside air temperature, and at least one surface temperature. The main component of the setup is the infrared camera which captures a thermal image of the surface.

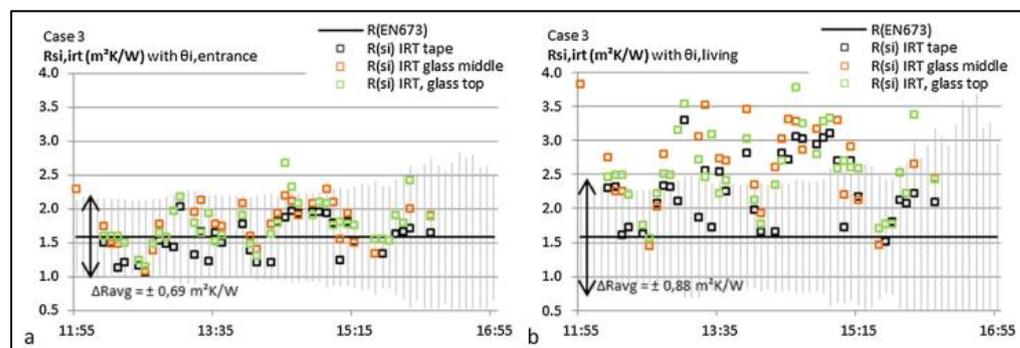
Figure 24. (a) Resistance Calculation for location 1 and (b) Resistance Calculation for location 2 for Case 3 Sample [34].

indicate high sensitivity to the internal and external heat transfer coefficients and outdoor air temperatures. Figure 24 shows the results of resistance values for Case 3 (triple glazing with argon). This figure shows the high variation of measured R-values (shown as black, orange, and green squares) compared to a known value (black line).

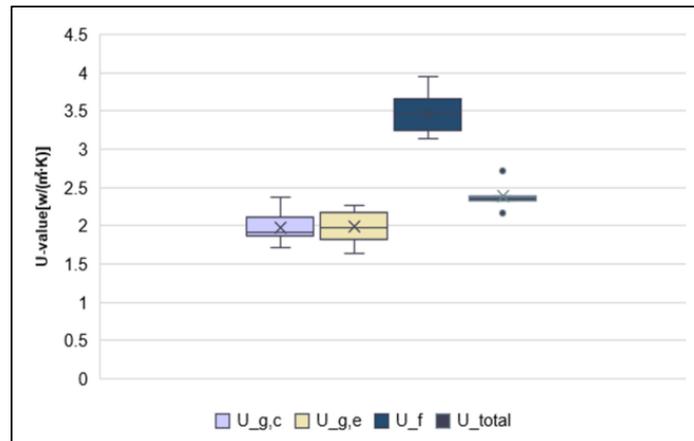
Figure 25. Boxplot of U-value Results Using HFM Method [36].

flux and temperature after the sample reached steady-state. For the IR method, a black body was created to correct for emissivity and reflectance, then the surface temperature of the actual window sample was taken. The U-factor was evaluated based on the measured surface temperature and surface coefficient using either case one or case two mentioned above. Results showed that the relative errors for the HFM, IR case one, and IR case two are 5.9%, 3.05%, and 11.81%, respectively. Boxplots of these results are given in Figures 25–27.

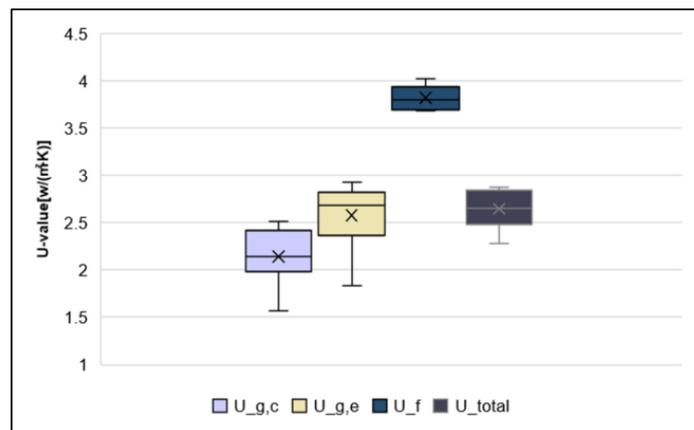
Figure 26. Boxplot of U-value Results Using IR Case 1 [36].

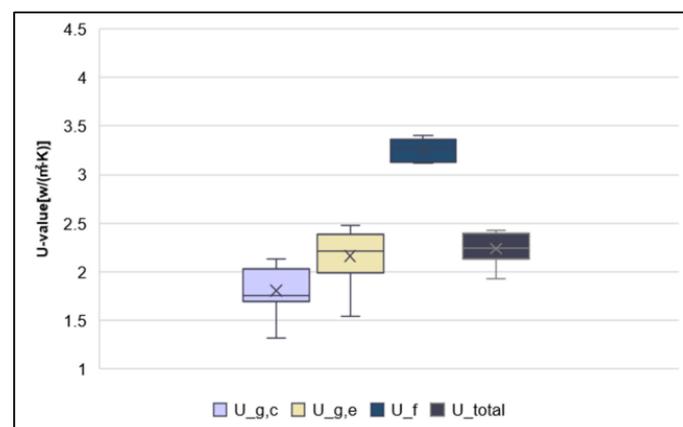
Figure 27. Boxplot of U-value Results Using IR Case 2 [36].

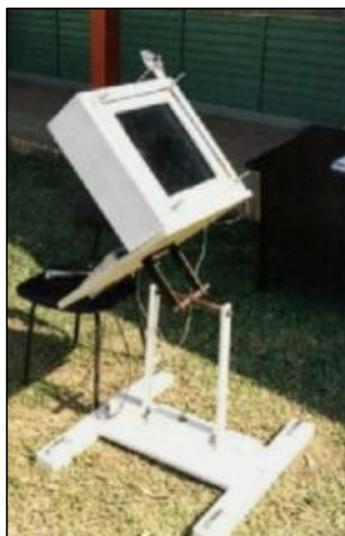
Figure 28. Front View of Fenestration Radiometer Prototype [38].

Marinoski et al. [38] presented a study on an improved system for measuring the solar heat gain through fenestrations. Their test setup consisted of clear glass measuring 21 cm by 21 cm within a fenestration radiometer prototype consisting of cooling fans, heat flux meters, and a support system as shown. A photo of the actual setup is shown in Figure 28.

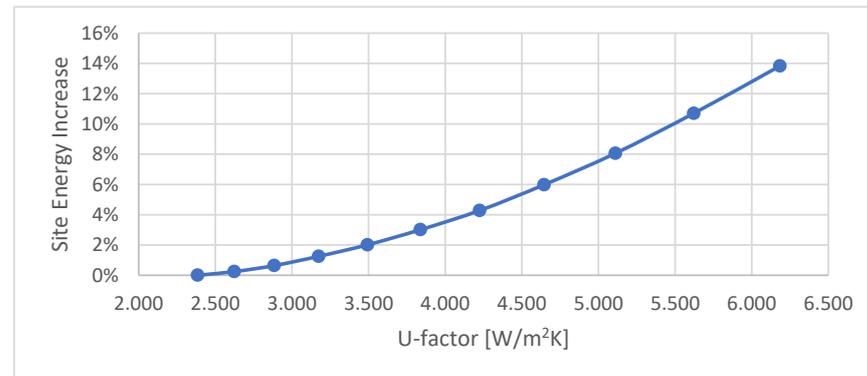
Figure 29. Site Energy Increase as a Function of Window U-factor.

Ratings and simulations do not account for window durability or aging effects, leading to an underestimation of annual building energy consumption of up to 14% per building based on a black-box model of a typical office building located in Denver, as shown in Figure 29.

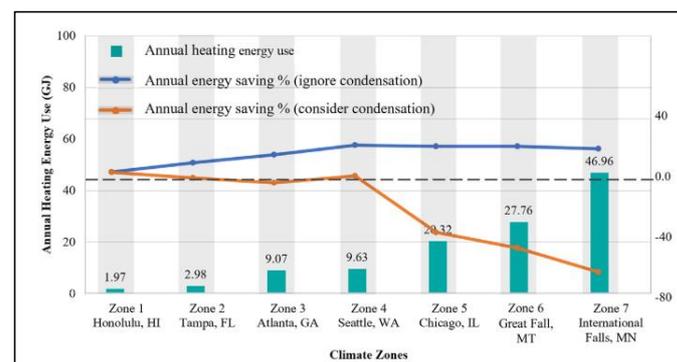
Figure 30. Annual Heating Energy Use and Associated Energy Savings Trends [39].

Duan et al. [39] consider the effects of condensation in low-e windows on overall building energy use. Duan et al. point out that inner glazing surfaces with added low-e coatings are colder than those without and may increase the risk of condensation. Condensation within the panes of an IGU leads to reduced energy performance and cascades down to all equipment in the building. The authors of this paper chose to focus on condensation because no prior study considered whole-building impacts. The authors extended the Nusselt film-wise condensation model to validate their own analytic model. They then created a series of building energy use comparisons within EnergyPlus. The authors found that low-e films on single pane windows are not suitable for colder climates due to condensation effects. Figure 30 shows the difference in annual heating energy savings with and without considering condensation effects applied to retrofitted windows. It reveals that there can be a loss of savings in climate zones 5–7 when condensation is considered.
