# The American Schools of Oriental Research Cultural Heritage Initiatives: Monitoring Cultural Heritage in Syria and Northern Iraq by Geospatial Imagery

**Abstract:** The American Schools of Oriental Research Cultural Heritage Initiatives (ASOR CHI) continues to address the cultural heritage crisis in Syria and Northern Iraq by: (1) monitoring, reporting, and fact-finding; (2) promoting global awareness; and (3) conducting emergency response projects and developing post-conflict rehabilitation plans. As part of this mission, ASOR CHI, through a public–government collaboration with the United States of America (US) Department of State, has been provided with access to hundreds of thousands of satellite images, some within 24 h of the image being taken, in order to assess reports of damage to cultural heritage sites, to discover unreported damage, and to evaluate the impacts of such incidents. This work is being done across an inventory of over 13,000 cultural heritage sites in the affected regions. The available dataset of satellite imagery is significantly larger than the scales that geospatial specialists within archaeology have dealt with in the past. This has necessitated a ret

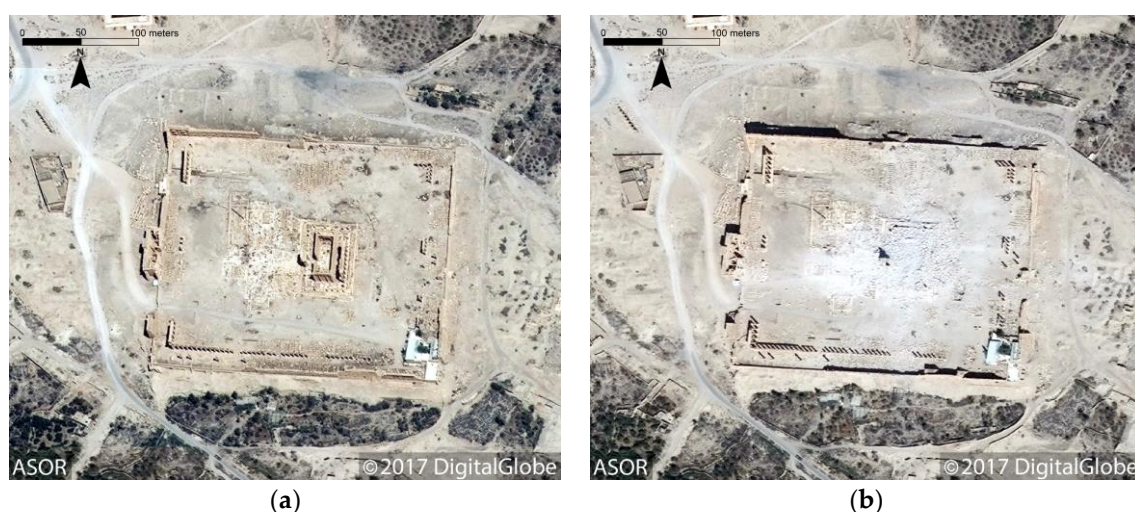
**Figure 6.** DigitalGlobe satellite imagery of the Temple of Bel: (a) prior to intentional destruction (DigitalGlobe NextView License; 26 June 2015); (b) post-destruction with the cella of the temple destroyed (DigitalGlobe NextView License; 2 September 2015).

The destruction of Palmyra's famous Temple of Baalshamin and Temple of Bel formed the middle stages in this campaign of performative destruction [46,47]. Soon after ISIS took over the site in May 2015, reports began to emerge that ISIS militants had planted explosive devices within the archaeological site, which was confirmed by 23 June 2015 through CHI sources, who reported that locals had seen members of ISIS place "large mines/bombs in the ruins of many buildings in Palmyra", and told Tadmor's residents of their intent to destroy the ruins—using loudspeakers in Tadmor—to gain media coverage and possibly as a deterrent to counterattacks. During this time, ISIS leaders also allegedly lived at the site, to protect themselves from airstrikes, and munitions were stored on-site. ISIS has regularly repurposed heritage sites and cultural and educational buildings for military and political use, throughout the conflict zone. On 23 August 2015, reports began to emerge that ISIS had destroyed the Baalshamin Temple (largely of the 2nd century CE). Soon after, ISIS released photographs showing the temple walls lined with barrels of explosives and the subsequent explosion. DigitalGlobe satellite imagery taken on 27 August 2015 acquired by CHI confirmed this destruction. A few days later, on 30 August 2015, the pattern repeated at the Temple of Bel, which dated to the 1st century CE, with reports of its destruction using explosives. This was confirmed via satellite imagery a few days later (Figure 6a,b). ISIS later published images of the destruction in its online magazine.

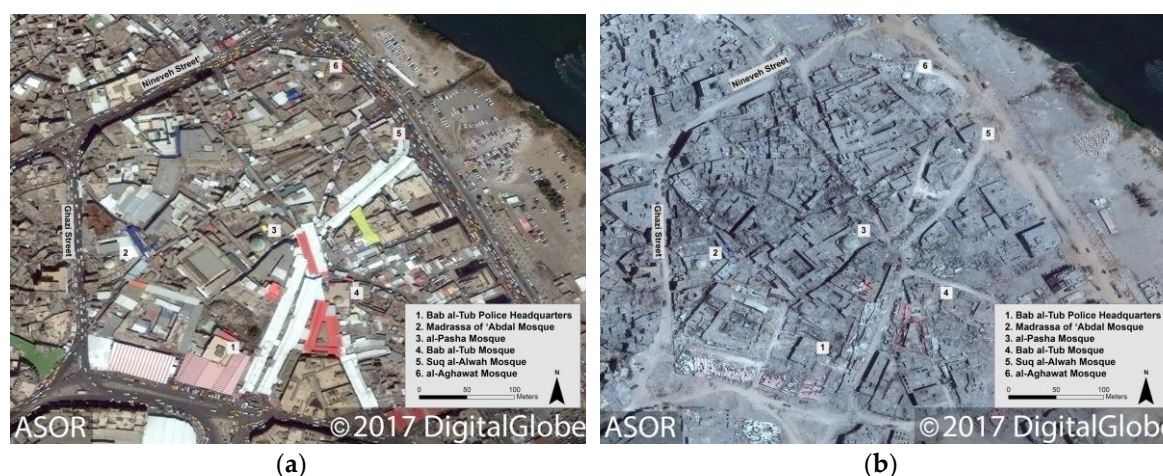
**Figure 10.** DigitalGlobe satellite imagery of the souq area within the Old City of Mosul: (a) prior to the offensive to retake the Old City (DigitalGlobe NextView License; 9 May 2016); (b) after recapture by Iraqi forces (DigitalGlobe NextView License; 12 July 2017).

The ongoing bombardment and street warfare continues to leave its mark on the historically and culturally significant locations within the city, none more so than the area of the souqs. Much of this damage has occurred within the last year, beginning in March 2017, as visible in DigitalGlobe satellite imagery. Since May 2016, the streets and courtyards of this area have been systematically covered with metal roofs, including in the final phase over Nineveh Street and Ghazi Street, as a way to provide cover from airstrikes. In March, severe aerial bombardment damaged much of the area, including Bab al-Tub Police Headquarters, Souq al-Alwah Mosque, and Bab al-Tub Mosque. The damage was so severe that pieces of the metal roofing were visible in satellite imagery floating in the Tigris River. As of 22 May 2017, the ongoing conflict has further damaged these sites as well as the al-Aghawat Mosque, al-Pasha Mosque, and the former site of the Madrasa of the Abdal Mosque, which had been previously razed to

the ground in an intentional destruction by ISIS and a new construction built on top of it. By the end of the offensive in the Old City, of the eight heritage sites identified in this area, three were destroyed, four were severely damaged, and one showed some damage (Figure 10).
