Application of Sonic Tests and Modal Identification in the Characterization of Masonry Walls

Abstract: This work contemplates the application of non-destructive techniques, sonic and environmental vibration tests, on a set of soil-cement compressed earth blocks reinforced masonry walls, which were built in laboratory, under the project SHS-Multirisk. The present work constitutes a comparative study that aimed at verifying the reliability of the sonic test method in masonry characterization and in testing a methodology of combined tests for structural assessment. For that purpose, a numerical model of the walls was developed and calibrated with the mechanical properties that were calculated from the sonic tests data. The results of the simulation of the numerical model were compared with the results of the environmental vibration tests, which enabled to reach a correlation between the frequencies, as well as enabling the indirect sonic tests, which were performed in the vertical direction, to result in an accurate prediction of the Young modulus to be used in the numerical models.

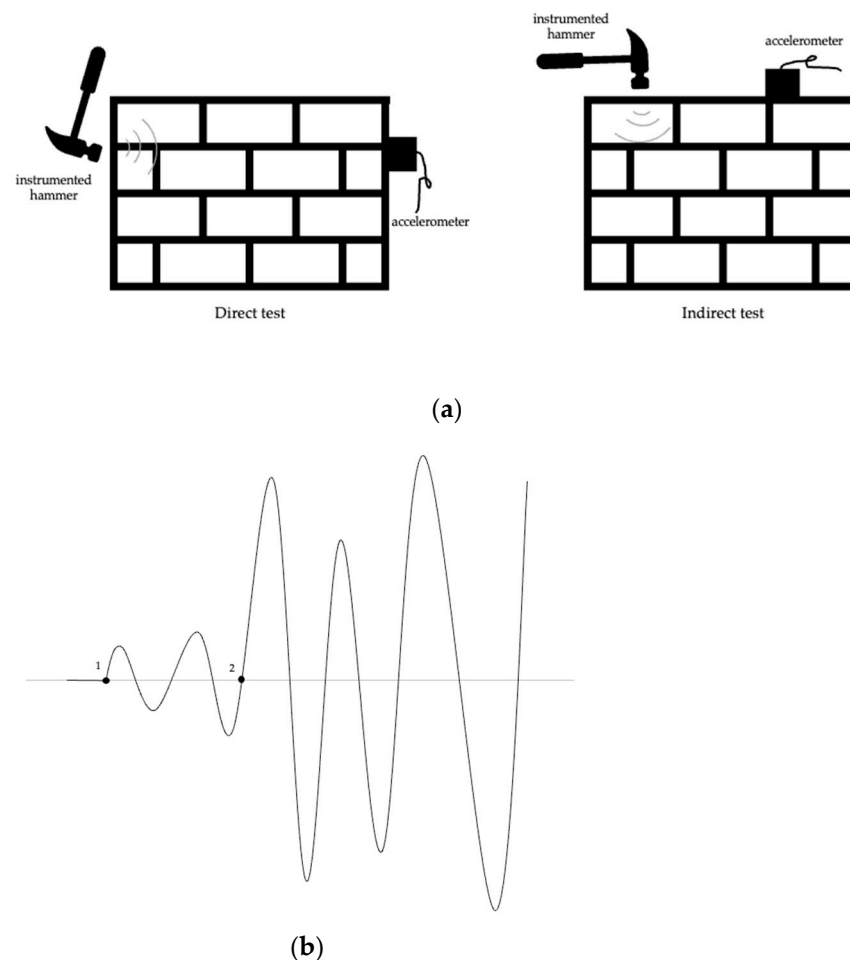
Figure 1. (a) Sonic tests configuration and (b) wave identification scheme.

Depending on the configuration adopted in the test (the relative position of the emitter and receiver), it is possible to identify different types of waves (Figure 1a). Direct tests aim to measure the velocity (VP) of primary waves (P-waves) by placing the hammer and accelerometer in line at opposite sides of the wall. Indirect tests can measure both the velocity of P- and R-waves (VR) [8].

Considering a particle at the surface, it is known that it will first experience the arrival of P-waves, followed by S-waves, after a period of quietness. Subsequently, the particle experiences the arrival of R-waves, which are characterized by oscillations of a much higher amplitude that corresponds to a higher percentage of energy, and that attenuate much more slowly than the P- and S-waves. This theory, applied to the wave identification of the indirect tests, is illustrated in the scheme of Figure 1b, where it is possible to identify the P-waves as those that arrive first (1), followed by the arrival of the R-waves (2), signaled by an increase in the percentage of energy.

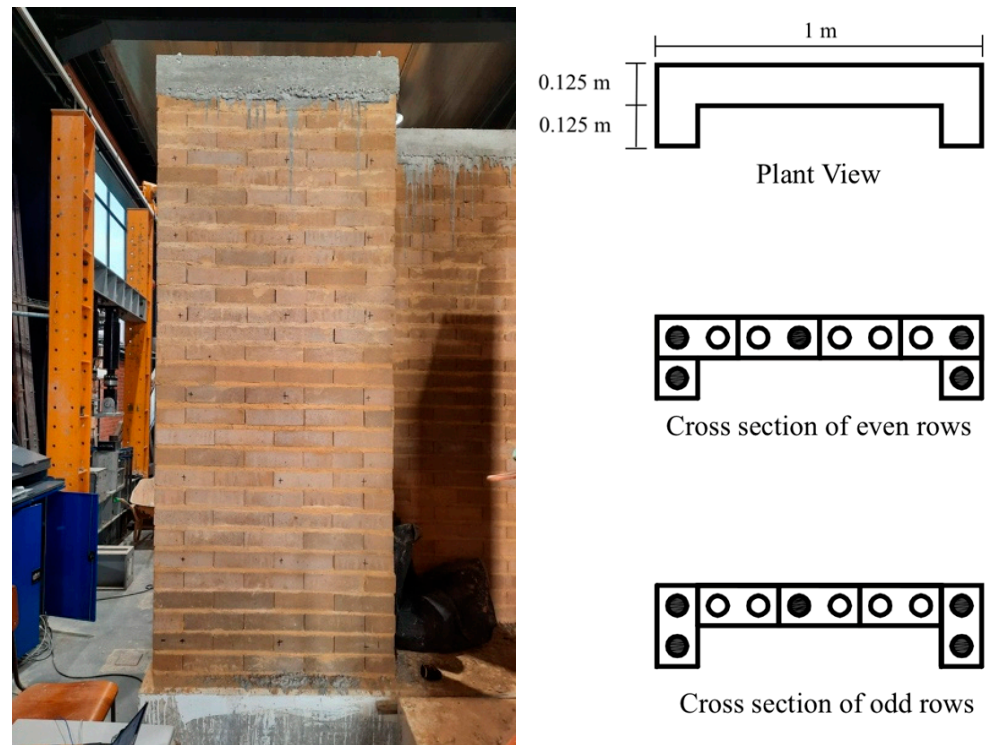
Figure 2. Masonry wall layout.

The present experimental SHS campaign was performed at UA, which involved a set of six reinforced masonry soil-cement compressed earth blocks walls, with 1 m width, a height of 2.3 m and a thickness of 0.125 m. The walls have a U section and are constituted by soil-cement blocks (with two holes) in the proportion 8:1, vertical 10 mm diameter A400 steel bars (in five filled holes), horizontal 6 mm diameter A400 steel bars (in four 55 cm spaced levels, starting from the top) and soil-cement mortar in the proportion 5:1 (See Figure 2). All the specimens were built on a 60 cm height reinforced concrete base and designed with the same layout and materials, W1, W2, and W3 without plaster and W4, W5, and W6 with 3 cm of soil-cement plastering in one side of the wall.

Each row has five whole blocks or four whole blocks and two half-blocks, laid on a layer of mortar about 1 cm thick, without mortar in the vertical joints, which are alternated between the thirty rows. Holes with vertical reinforcements are filled with the same mortar used as the blocks, with manual compaction. The vertical reinforcements have an overlapping splice at mid-height, and the lower bar was anchored with a chemical anchor in the reinforced concrete footing. The horizontal reinforcements are embedded in the mortar joints. At the top of each specimen, a crown was built in reinforced concrete, approximately 10 cm high. All production of blocks and construction of masonry walls were carried out strictly by hand, without the use of electricity. This guideline was adopted to approximate as much as possible the conditions of laboratory production to those situations of project application when there is not always electricity available.

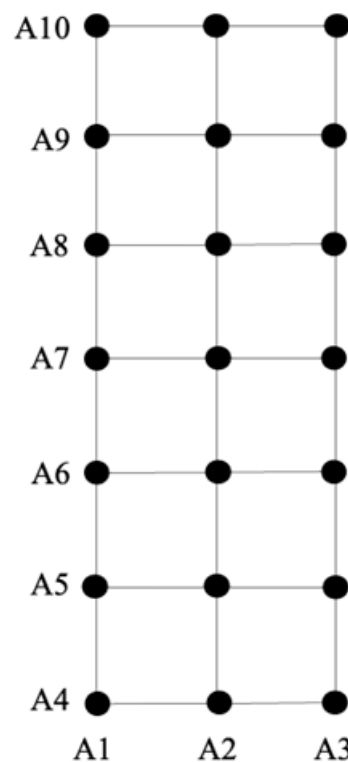
Figure 3. Indirect tests grid configuration.

In this experimental campaign, two test configurations were performed: direct and indirect (vertical and horizontal analysis). For the direct tests, the set used constituted nine rows, spaced by 20 cm in the vertical slope, and by 1 m in the horizontal slope. The instrumented hammer (emitter) and accelerometer (receiver) were placed on opposite sides of the specimen faces. Waves were generated by the impact of the instrumented hammer in each row and recorded by the data acquisition system. To perform the indirect tests, a grid of points was marked on each wall with a 7×3 configuration, spaced by 30 cm, both in vertical and horizontal slopes (see Figure 3). To collect data corresponding to the horizontal slope, the accelerometer was fixed at position A1, and the instrumented hammer was struck at points A2 and A3, along the points of the vertical slope. In turn, to collect data corresponding to the vertical slope, the accelerometer was fixed in position A4, and the instrumented hammer was struck at points A5, A6, A7, A8, A9, and A10, along the points of the horizontal slope.

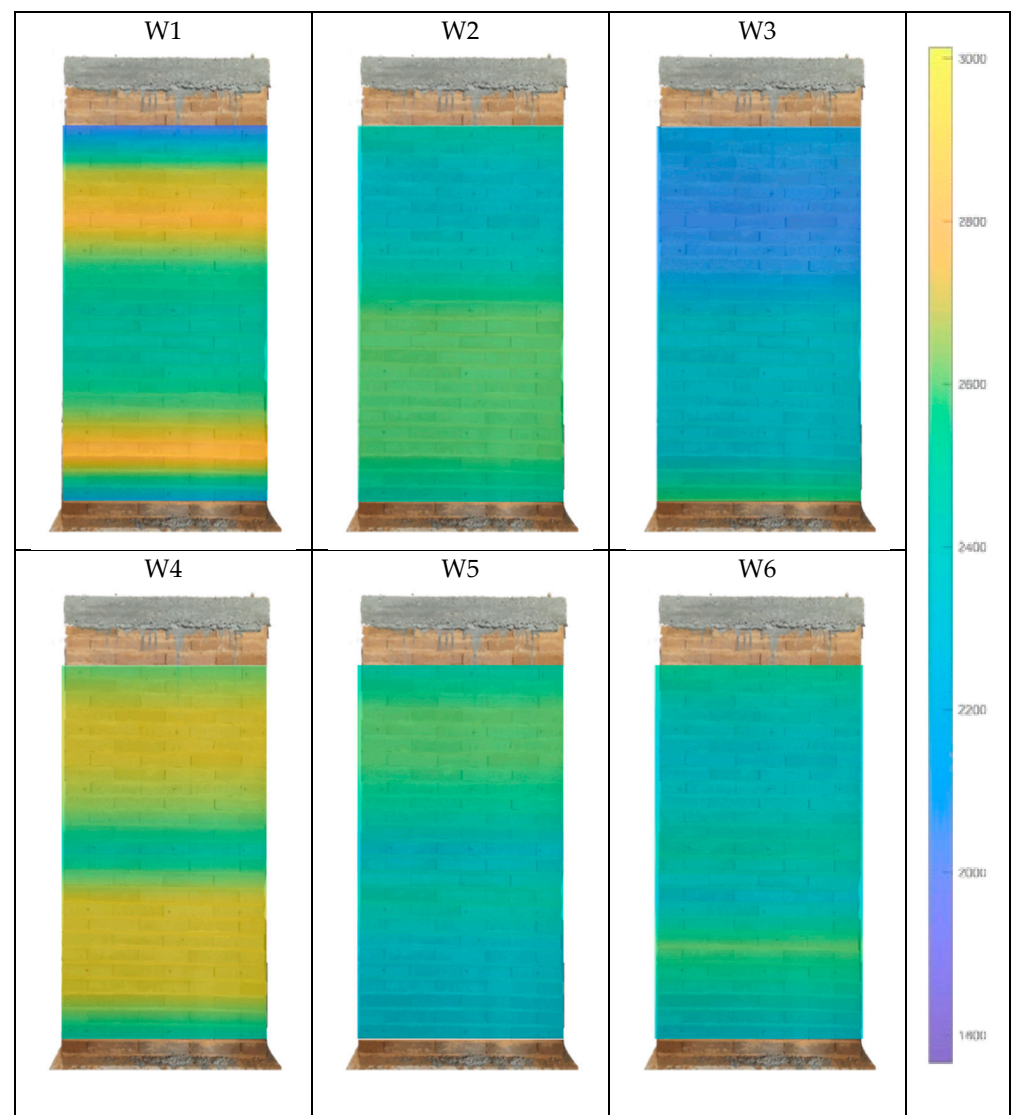
**Figure 4.** Surface of the direct tests' velocity data (m/s).

Table 1 presents the summary of the results obtained for the velocities of P-wave propagation for each wall, in each test. Figures 4–6 represent the velocities of propagation by a surface graphic in the tested area.

From the surface analysis, it is possible to observe that, in most of the area tested, the walls present low variability (<15%), which reflects their material uniformity. Moreover, it is visible that the values obtained in the horizontal direction tests present higher values of velocities compared to the values obtained in the vertical tests, which indicates that there are less voids in the horizontal slope of the walls.

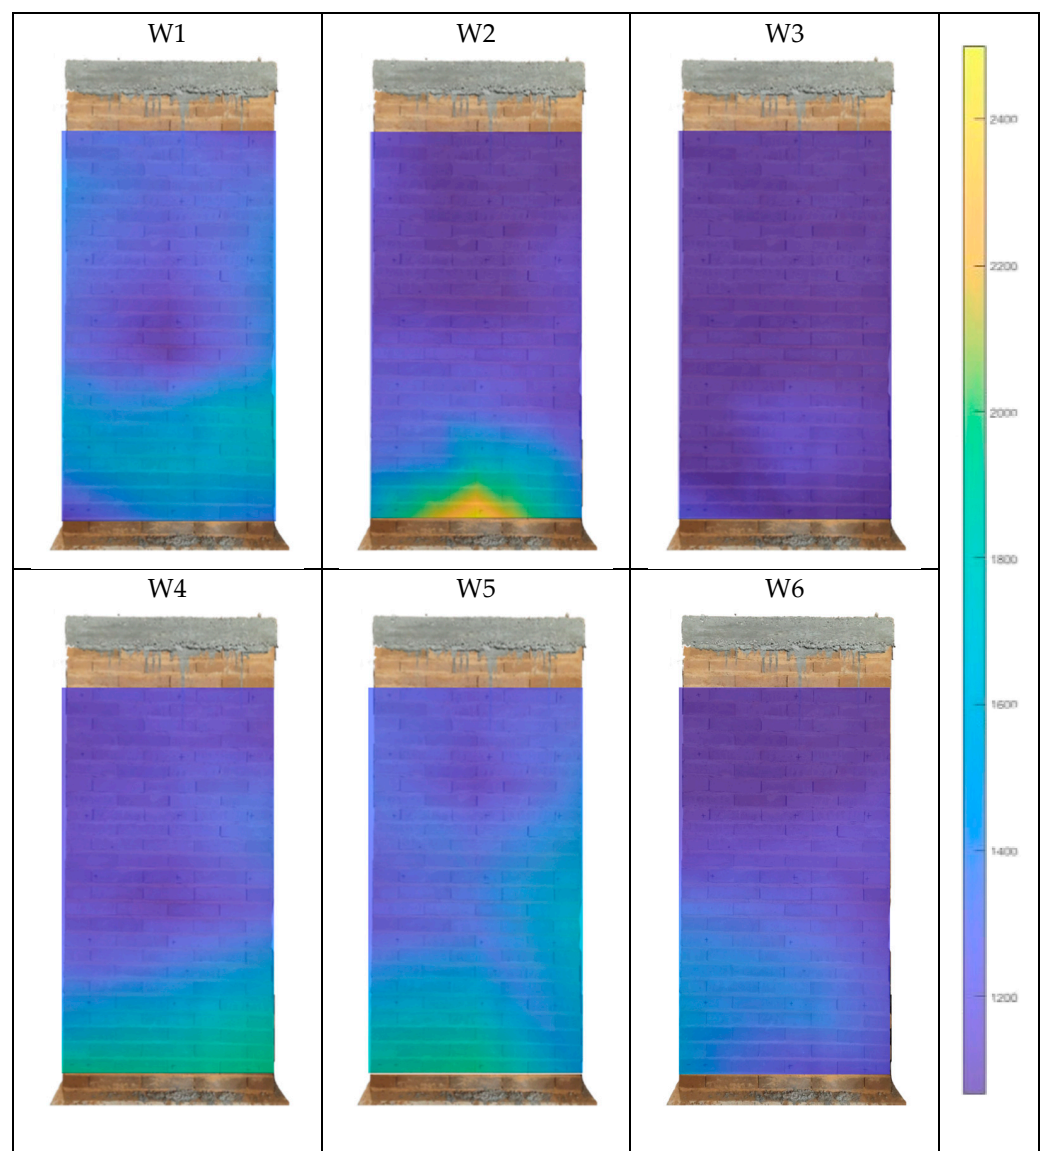
Figure 5. Surface of the indirect tests (vertical slope) velocity data (m/s).

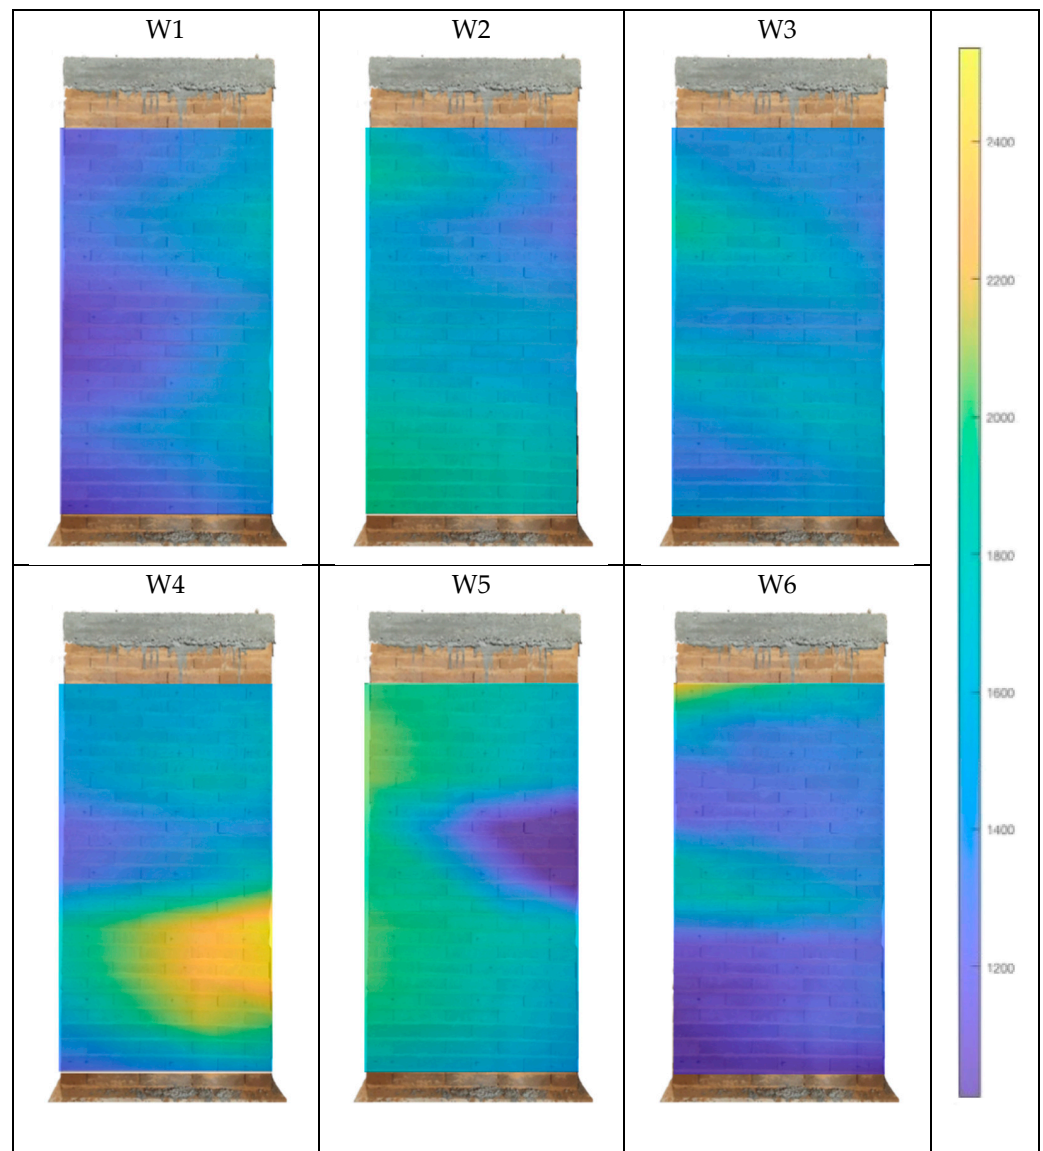
Figure 6. Surface of the indirect tests (horizontal slope) velocity data (m/s).

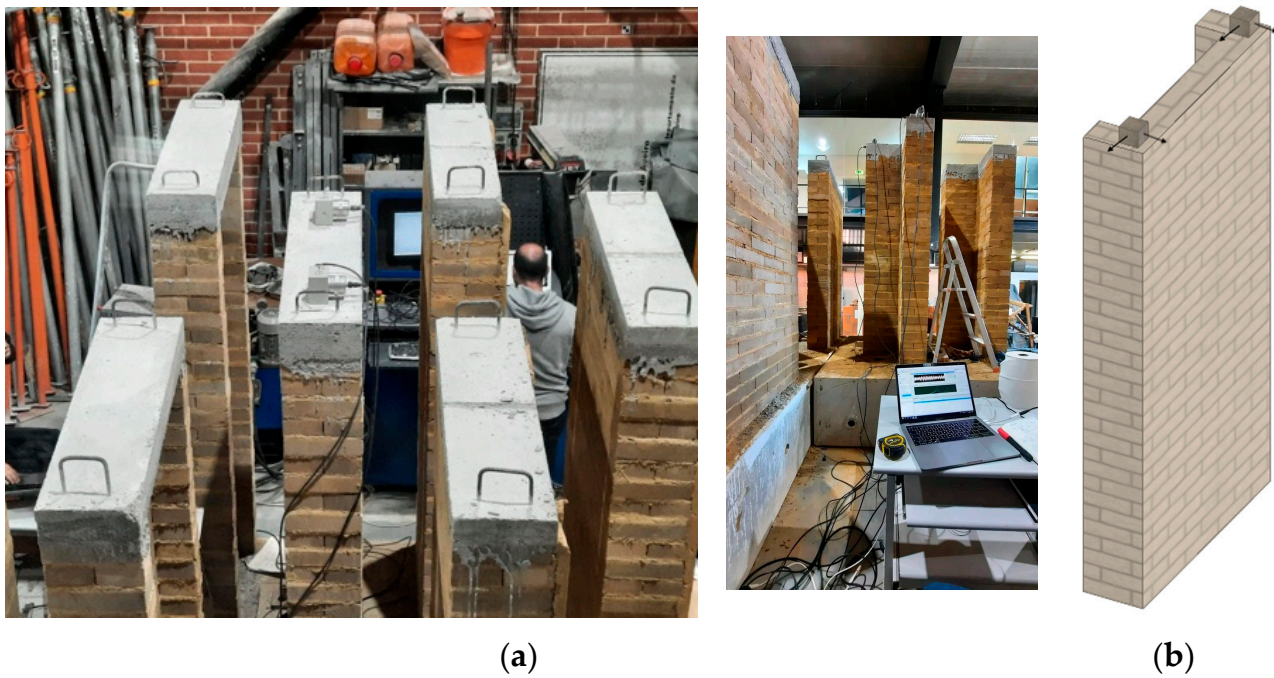
Figure 7. Dynamic identification test: (a) sensors placed during one setup and (b) axonometric scheme of the location of the sensors.

The dynamic characterization tests were performed to obtain the modal shapes and natural frequencies of the walls. The tests were done using four uniaxial accelerometers and the records were taken with one setup, acquiring 600 s with 1500 samples/s. Figure 7a shows one setup at the time of the test, while the sensors layout is shown in Figure 7b. Accelerations were measured in both directions at some locations in order to detect both possible in-plane and out-of-plane mode shapes.

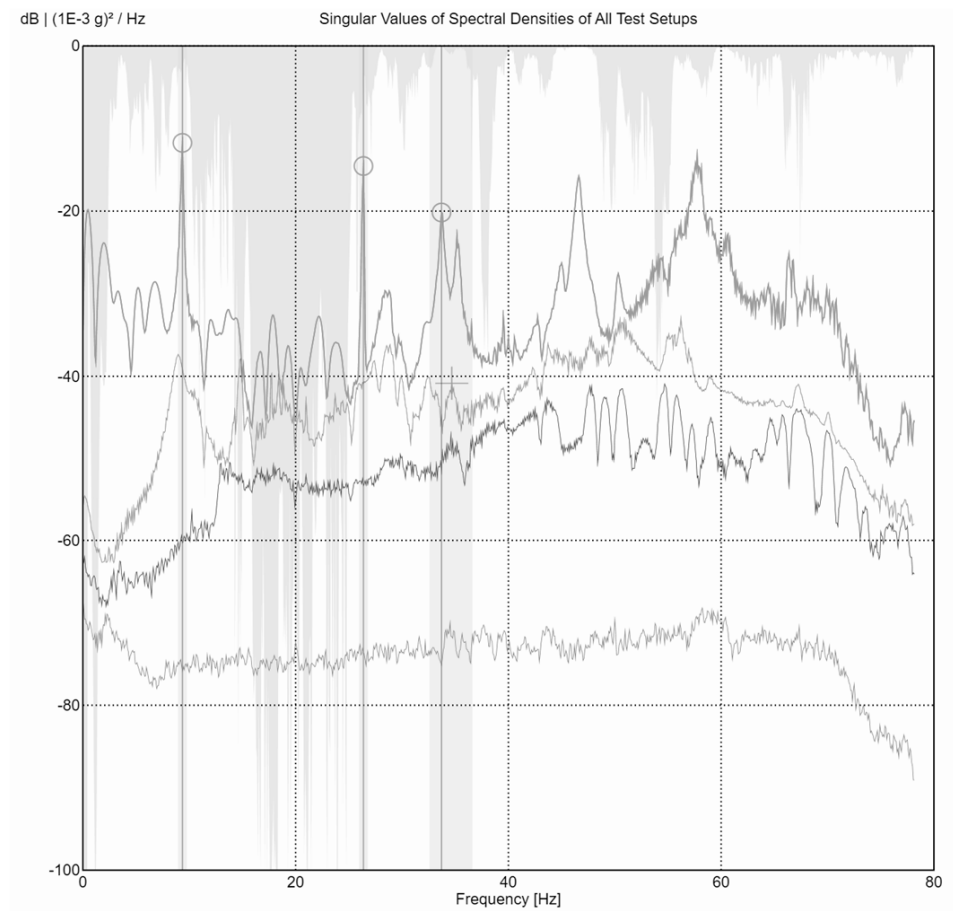
Figure 8. Singular value plots from the FDD analysis.

The modal estimation was carried out using ARTeMIS software, which allows analyzing the results from all test setups simultaneously, and the representative singular value plots provided by (traditional) FDD are shown in Figure 8 with all picked modes. The peak values of frequency were selected using FDD analysis, to later compare the results and determine the natural frequencies of the wall obtained with the numerical model. Figure 9 shows the first three identified modes of the walls in terms of mode shape and natural frequency. This first mode consists in the expected out-of-plane vibration of the façade and presents a slight difference in the walls, as seen in Table 3. The second mode is a torsional mode, and the third mode is in the plane of the wall. The differences observed are most likely related to the construction issues; however, the third mode associated with the in-plane response of the wall was the one where most differences were observed; however, no apparent cause was identified.

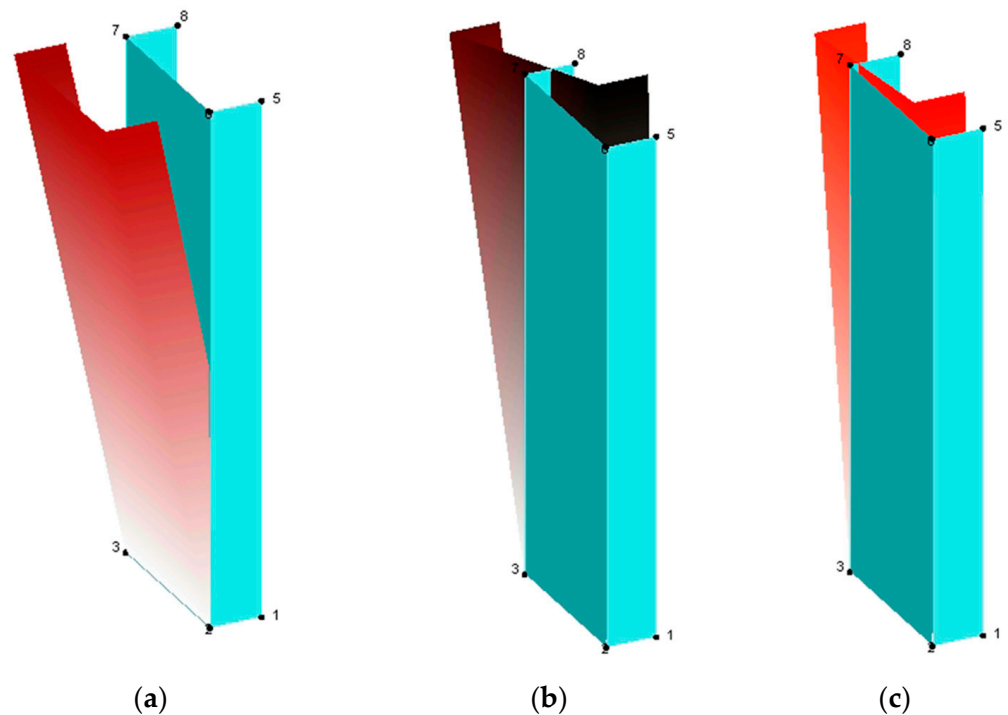
Figure 9. Example of the mode shapes for wall W1: (a) $f_1 = 9.34$ Hz; (b) $f_2 = 26.37$ Hz; and (c) $f_3 = 33.72$ Hz.

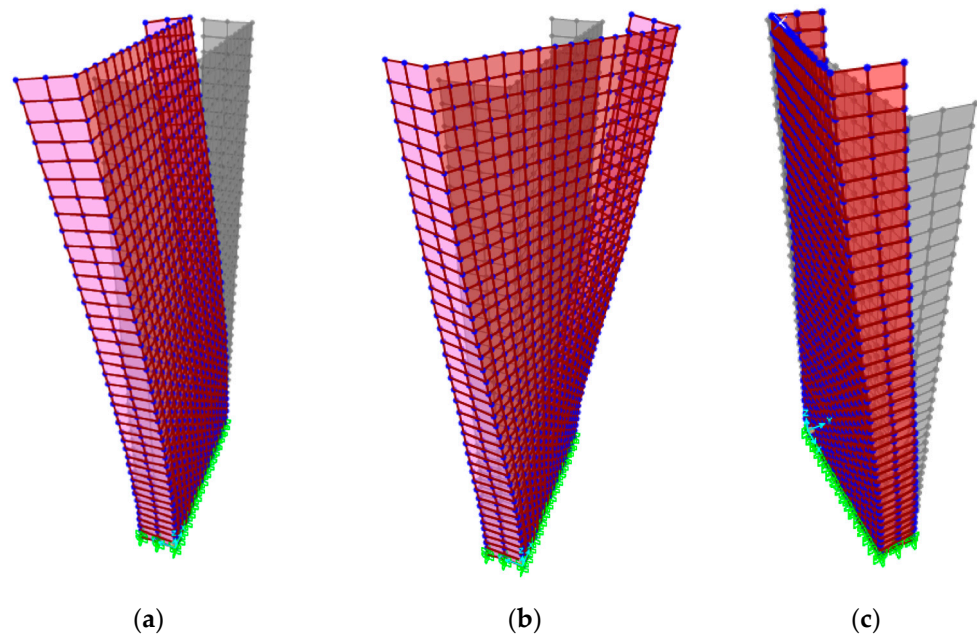
Figure 10. Numerical model shapes of the walls obtained experimentally: (a) first mode; (b) second mode; and (c) third mode.

In the numerical model, a Poisson coefficient of 0.25 was considered, and a density of 1937 kg/m^3 was considered in the sonic tests. A global agreement between the experimental (Exp) and numerical frequencies (Num) was found. The comparison between the natural frequencies from dynamic identification and those from numerical modeling is reported in Table 4. It is also clear that the main differences observed are related with the third mode. When not considering the third mode, the errors (D_f) would be lower than 1% in all the walls (with exception of wall 3). The value presented in Table 4 for the Young modulus was the value used in the numerical analysis. Table 4 also presents the values of the average Young modulus obtained with the sonic tests in the vertical and horizontal directions for each wall. It can be seen that there exists an agreement between the Young modulus considered in the numerical analysis and the Young modulus obtained with the sonic tests in the vertical direction.

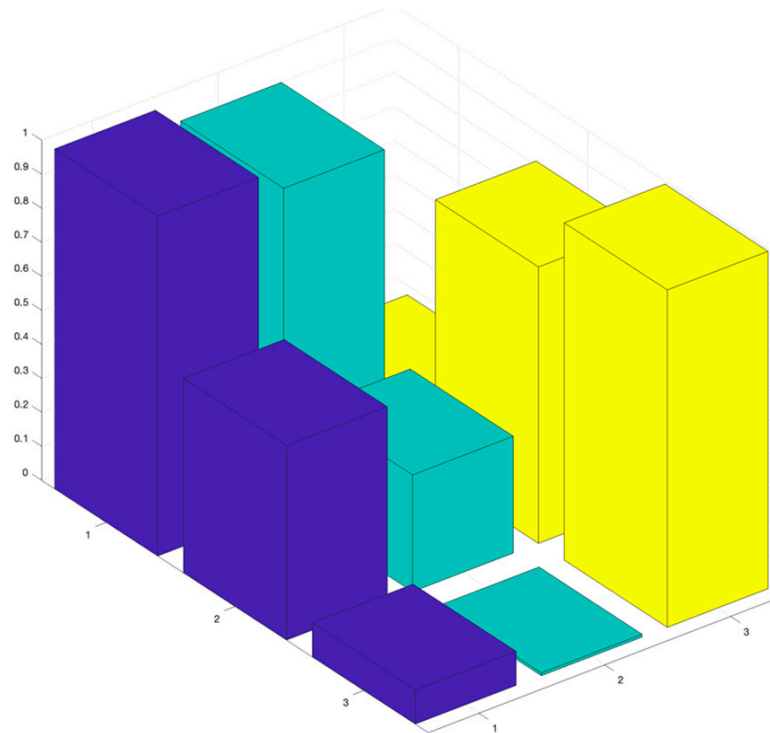
**Figure 11.** MAC correlation matrix.

The agreement between the numerical and the experimental modal shapes was estimated through the Modal Assurance Criterion (MAC) [29]. The numerical simulation better approximates the experimental measurements as the MAC approaches to 1. Figure 11 shows the MAC correlation matrix between the experimental and numerical modes. The results reveal that the MAC coefficient is greater than 0.8 for modes 1 and 3, and lower than 0.4 in mode 2, showing a poor correlation in the torsional mode.
