Article

Evaluation of the Corrosion Depth of Double Bottom Longitudinal Girder on Aging Bulk Carriers

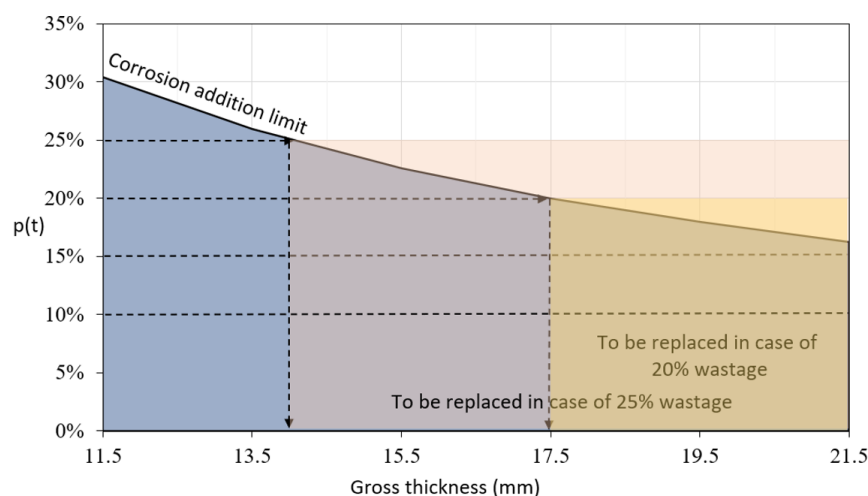
According to Table 2, the design values of corrosion addition and corresponding gross thicknesses are illustrated in Figure 1, considering the most common criteria for plating replacement (shaded areas)—10%, 15%, 20%, and 25% of corrosive wear, labeled here as $p(t)$ and expressed in %. Assuming that the strict criteria of 10% or 15% of corrosive wear are reached, thinner plates would have a larger margin before they reach the corrosion addition limit and net thickness. On the other hand, plating whose thickness is 21.5 mm would have a margin of only 2% (in case of 15% wear).

Figure 1. Gross thickness and corrosion addition percentage plotted against the corrosion wear percentage of gross thickness with corresponding criteria for the LG of bulk carriers.

Considering less strict criteria, such as 25% of wear, all the plates whose thickness exceeds 14 mm of gross thickness would have to be replaced, whereas, in the case of 20%

of allowable wear, only the plates that are more than 17.5 mm thick would have to be removed.

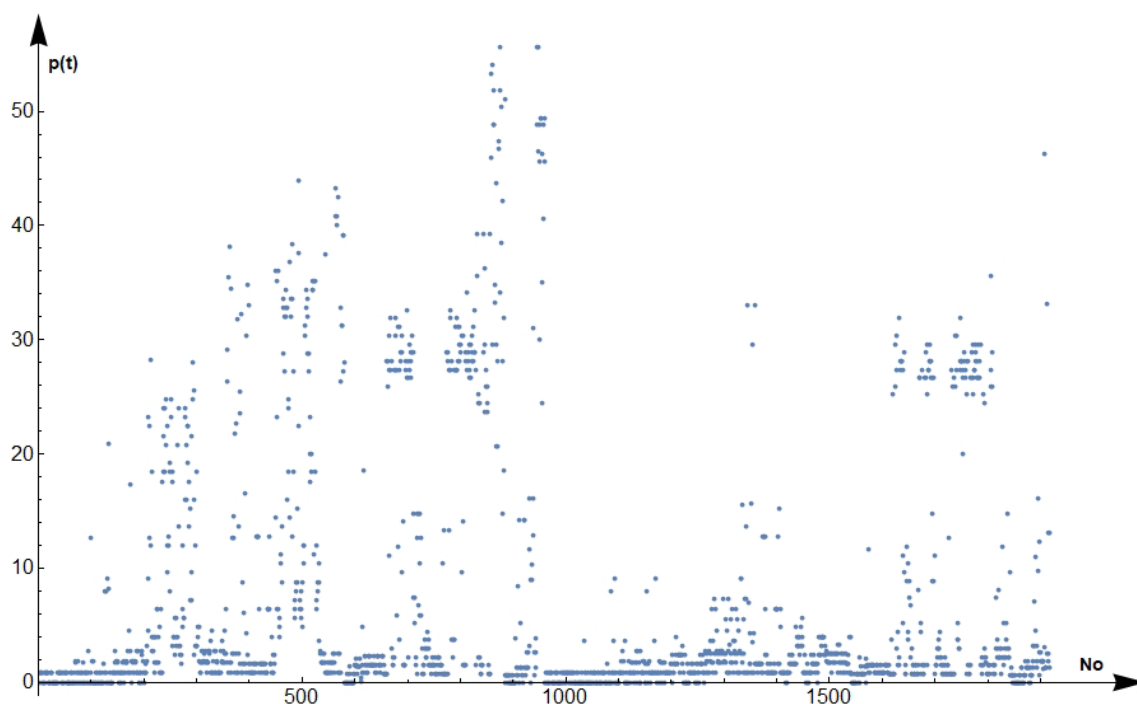
Figure 2 shows 1918 elements of the empirical database. The ordinal numbers of the measurements are shown on the x-axis, while the values of the wear percentage of the LG section are shown on the y-axis. Each element of the input database is associated with one point on the graph shown in Figure 2. This empirical database was used in the statistical analysis that was conducted to establish a linear relationship between the wear percentage of metal structures and the operating time of the ships. The statistical analysis enables the prediction of the time in the operation cycle when LG structures reach the critical values of the corrosive wear percentage.

Figure 2. Input corrosion depth database for the LG structural elements.

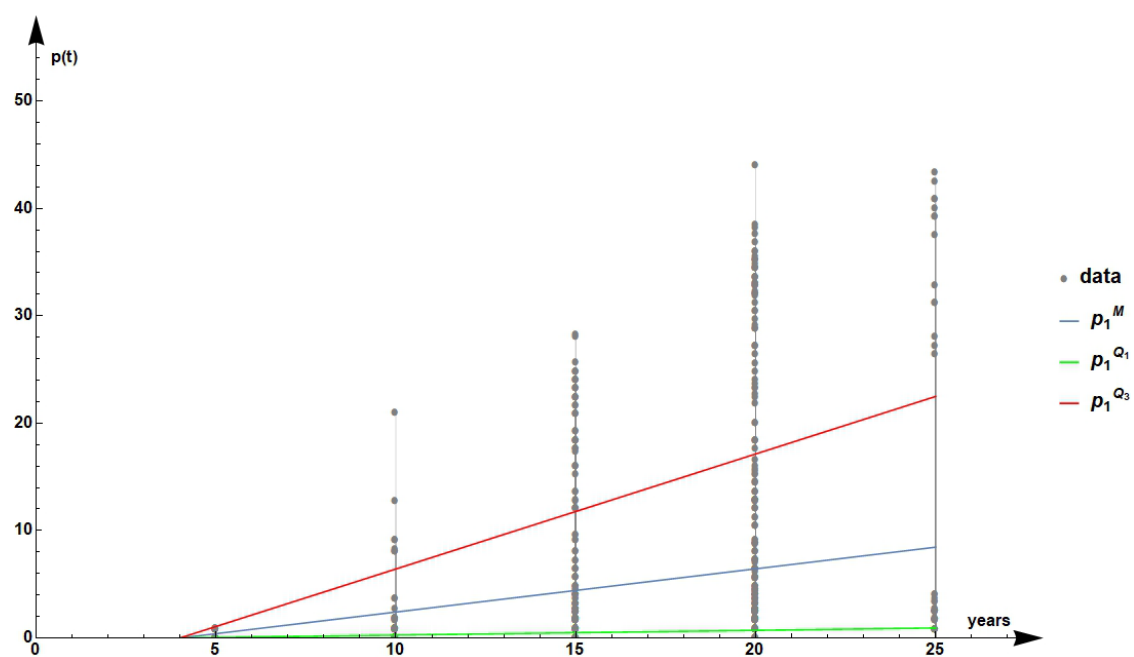
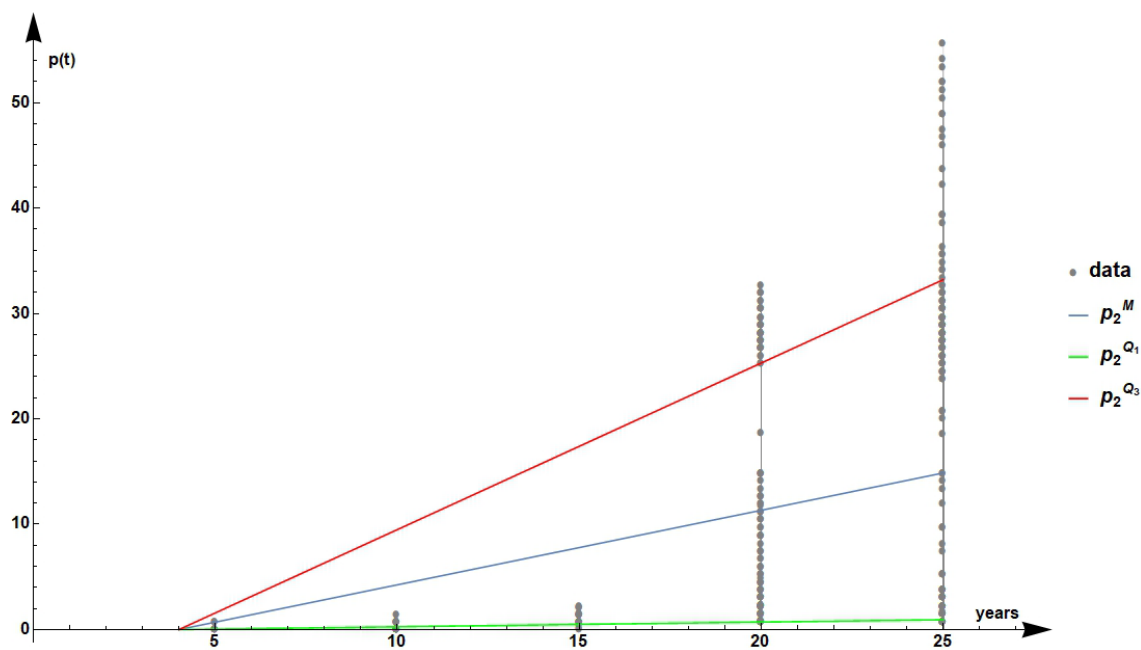
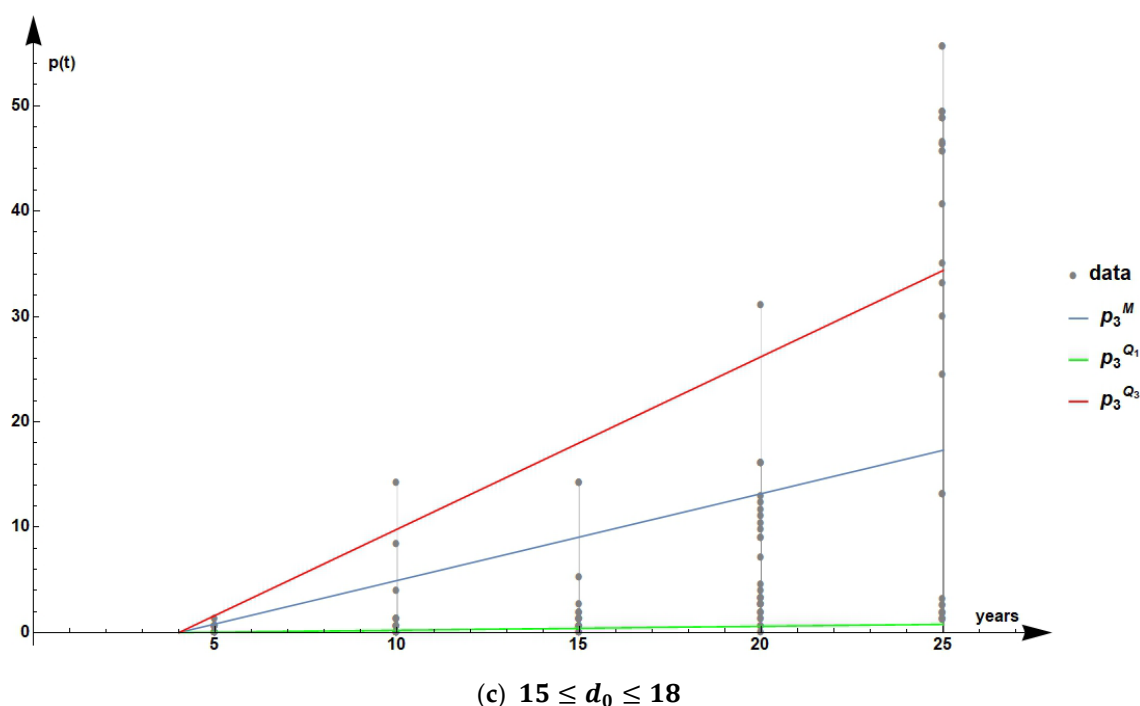
Figure 3 graphically presents the linear dependence of the corrosive wear percentage (Equations (6)–(14)) in the LG section on the elapsed time of ship operation. In addition, these figures show the empirical data on the wear percentage of the LG section that were grouped in terms of the length of ship operation. According to the figures, the lowest percentage of corrosive wear was recorded for the original steel thickness in 13 mm–15 mm intervals on the ships that were in operation for less than 15 years. The ships aged between 20 and 25 years exhibited significantly different characteristics. In the case of the older ships, the highest percentage of corrosive damage was noted at higher original thickness values of the metal plates, while the thinnest metal plates showed stable corrosive behavior without drastic and abrupt changes.

(a) $11 \leq d_0 < 13$

(b) $13 \leq d_0 < 15$

Figure 3. Linear models for the minimum (a), mean (b), and maximum (c) corrosion wear percentage of the LG ship structures.

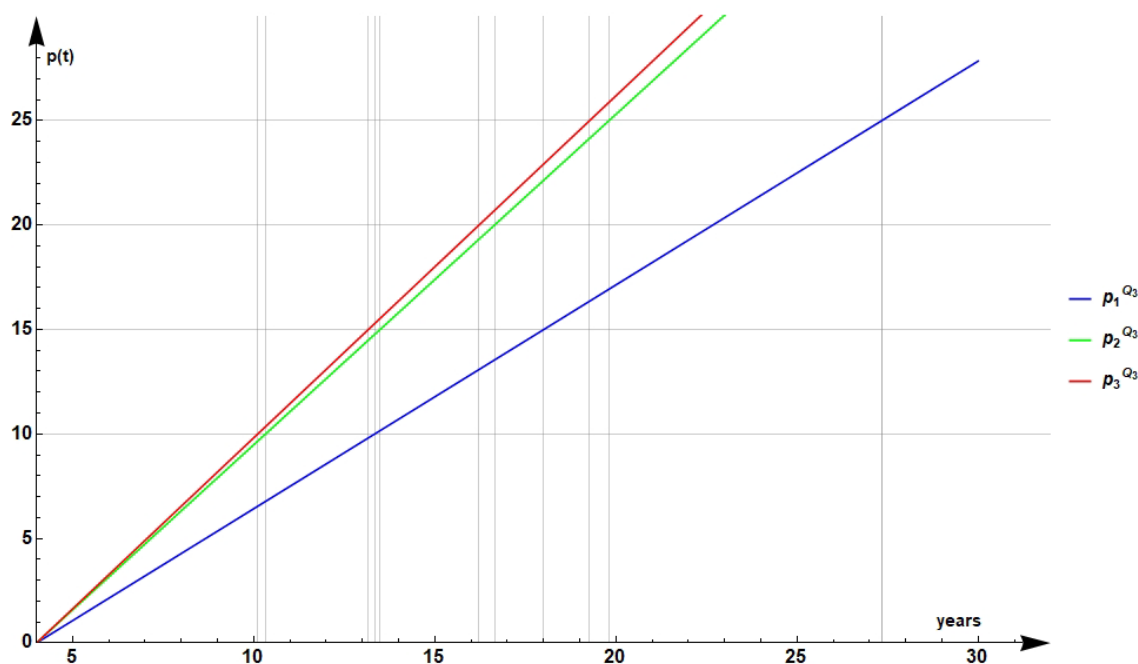
Figure 4 additionally illustrates the critical wear of 10%, 15%, 20%, and 25%, as well as the time when these values were reached by the three observed intervals of the original thickness of metal structures. In the case of the 11 mm–13 mm interval of the original steel thickness, the prescribed wear limit of 10% was reached after 13.3 years. On the other

hand, in the case of the maximum thickness (15 mm–18 mm interval), the wear of 10% was reached after 10.1 years of operation.

Figure 4. The critical values of the maximum wear percentage—of LG.

According to Figure 4, corrosive processes on LG are highly intensive. Therefore, considering the total wear of 10% of the longitudinal girder area, the entire area should be replaced after 10 to 13 years of usage. The projected ship lifespan of 25 years is, thus, unreachable. Furthermore, corrosion intensity exceeds the projected corrosion margins, and better optimization and the increase in corrosion margin are necessary for the design phase.

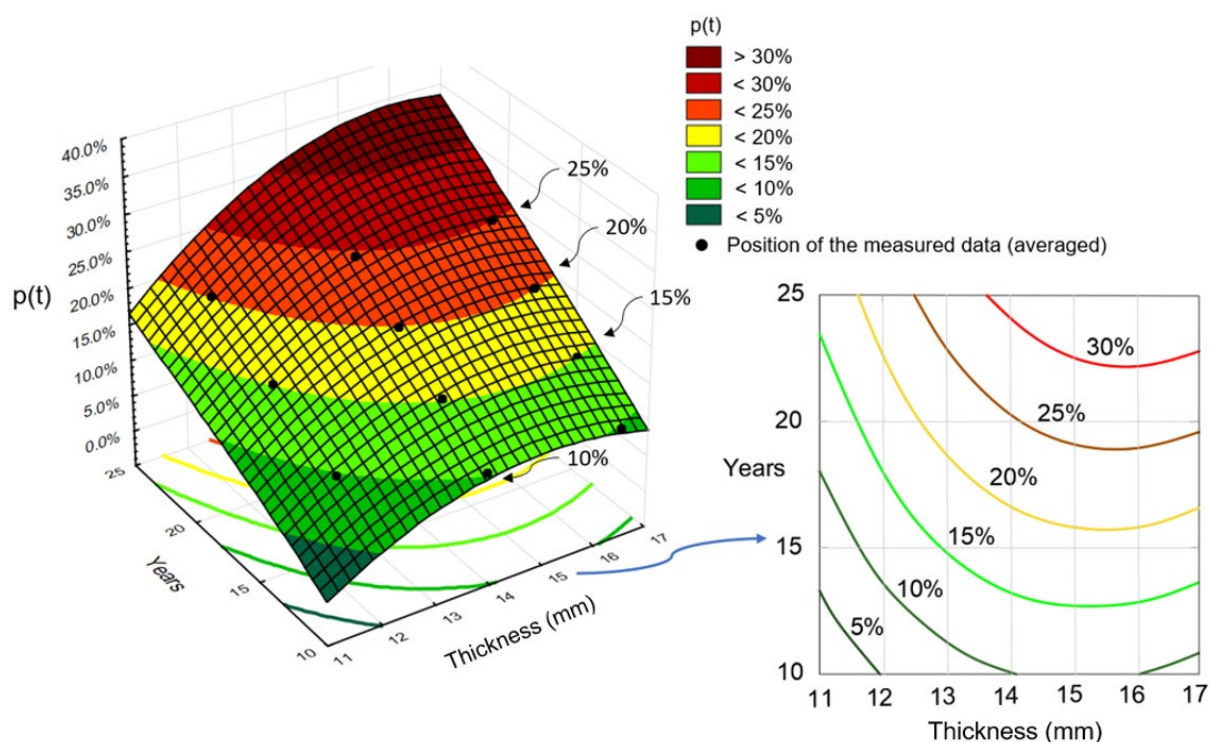
Figure 5 shows the percentage of corrosion depth on LG, which is plotted against the operating time and built-in thickness. The plotted surface is created based on the empirical data on ageing bulk carriers using the cubic spline function. Black spots represent the position of the average values of the measured data that were previously examined (11–13 mm, 13–15 mm, 15–18 mm). Different ranges of the wear percentage of metal plates are highlighted in Figure 5 in different colors, as shown in the corresponding legend. Moreover, the graph shows the position of plating replacement criteria (10%, 15%, 20%, and 25%) that are following the relevant requirements of classification societies. These sections are further projected on the year/thickness plane and illustrated by the figure on the right that depicts the relationship between age and thicknesses of LG.

Figure 5. Corrosion depth percentage plotted against the operating time and built-in thicknesses of the LG of the bulk carriers examined.

The data above show that thicker longitudinal girders reach the replacement criteria faster. For example, an LG whose thickness is 12 mm will reach a 20% of corrosion depth percentage in around 22.5 years. The limit of 25% will not be reached at all and replacement would not be necessary. However, an LG that is 15–16 mm thick will reach the limit of 20% in about 16 years and the limit of 25% in approximately 19 years. Figure 5 (right 2D plot) shows a range of thickness values (see 14–16 mm) whose corrosion depth is increasing faster than for thin plates since the requirements minima are gravitating towards such a range. These findings correspond to the conclusions from Section 3, which indicate that thinner plates from the same range exhibit a higher margin considering the designed corrosion addition (Figures 1 and 6). Furthermore, the range between 16 mm and 17 mm (Figure 5) offers a glimpse of corrosion depth margin that has an opposite trend in comparison with the margin relevant for the thickness interval between 14 mm and 16 mm.

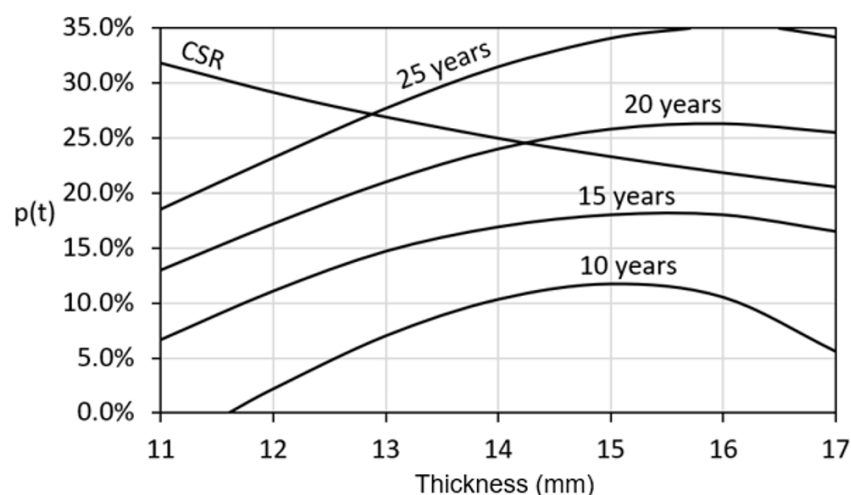
Figure 6. Corrosion depth percentage plotted against the thicknesses of LG: measured data vs. CSR corrosion addition limit.

Additionally, Figure 6 is obtained by the projection of a surface (Figure 5) to the thickness/percentage (i.e., vertical) plane based on operating time. Moreover, the CSR data (corrosion addition limit) from Table 2, see IACS [6], overlap with the curves allowing the comparison between measured and designed values.

The CSR corrosion addition and 25-year curve intersect approximately at 12.8 mm and have different trends. Below the limit of 12.8 mm, the CSR corrosion addition is providing a larger margin than 25 years of full operating life. However, for the thickness above 12.8 mm, the designed margin of 3.5 mm (see Section 3) of the LG does not sustain the entire operating cycle.

Therefore, this study proposes an estimation curve for the designed corrosion addition of LG (located between FOT and WBT) and emphasizes the dependence on the thickness of plating (Figure 6, 25-year curve) that varies between 11 mm and 17 mm for the LG. The CSR curve for the thickness below 12.8 mm and the 25-year curve for the thickness above 12.8 mm could be used for more precise estimation. In that way, corrosion addition would not depend only on the original thickness of structural elements. Moreover, corrosion addition would be expressed as a depth percentage of the original thickness, rather than an absolute value.
