Effect of Hot-Wet Storage Aging on Mechanical Response of a Woven Thermoplastic Composite

Abstract: The effect of hot-wet storage aging on the mechanical response of a carbon fiber polyether ether ketone (PEEK)-matrix woven composite has been studied. A wide range of static loads and selected cyclic load tests on the interlaminar fatigue strength were performed. Static tests were conducted in batch mode, including on- and off-axis tension, compression, flexure, interlaminar shear strength (ILSS) and fracture tests in Modes I, II and I/II. Respective mechanical properties have been determined, indicating a degrading effect of aging on strength-related properties. The measured response in general, as well as the variance quantified by batch-mode test execution, indicated the appropriateness of the applied standards on the material under consideration, especially in the case of fracture tests. The material properties presented in the current work may provide a useful basis towards preliminary design with PEEK-based woven thermoplastic composites during service in aerospace applications.

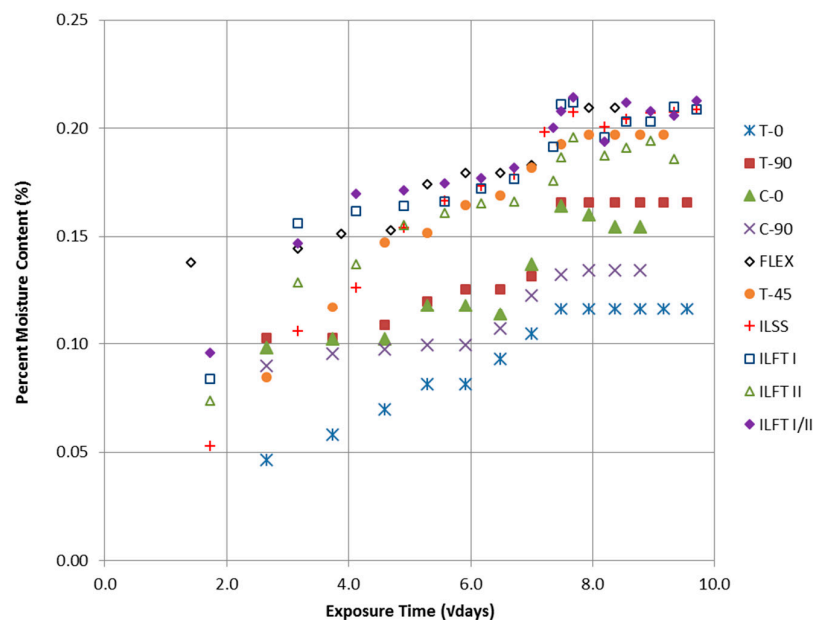
**Figure 1.** Conditioning curves for test types considered; the exposure time is expressed in square root of days.**Table 2.** Moisture uptake parameters extracted from conditioning curves.

For each test type, the respective moisture absorption curve, measured from corresponding traveler specimens (in-plane dimensions 25 × 25 mm), is reported. Figure 1 provides an overview of the conditioning process. On the basis of these curves, the moisture content uptake rate and water content at saturation during conditioning have been extracted in Table 2. For the determination of the slope, a measurement at saturation and the initial measurement have been used.

In order to comment on the trends observed in the conditioning process, the thickness of the relevant traveler specimen should be taken into account, since in-plane dimensions have been identical for all traveler specimens. It may be concluded that thicker traveler specimens, such as those considered for in-plane and interlaminar shear tests (including fracture toughness) yield generally higher moisture uptake rates and maximum values. This trend is attributed to the fact that moisture penetrates more easily across the sides of the specimens along thickness, which are uncoated compared to the upper and lower faces. Moreover, it is highly related to the effect of aging on the response in each test, as will be explained in the following sections.

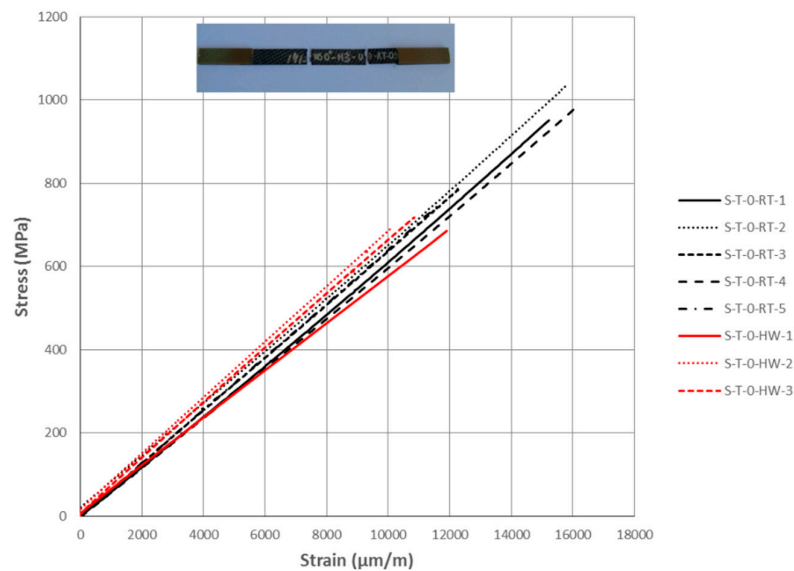
Figure 2. Static tension of warp-directional laminate: stress vs strain data and characteristic failure mode at RT. The description of tests follows a custom naming convention: S—static, T—tension, 0—warp direction, RT—room temperature test, HW—hot wet test, last digit—specimen number.

The head velocity was 2 mm/min, as dictated by the standard. Strains were measured by strain gages: biaxial rosettes have been attached on each specimen, whereas an additional longitudinal strain gage has been attached on the opposite side of one specimen to ensure that bending remained below 10% throughout the test. Data for stress vs. longitudinal strain for RT and HW specimens are presented in Figure 2. It should be noted that the maximum load may differ from the value shown, as strain gages occasionally got detached at a lower load level. Moreover, in the legend of Figure 2 the custom naming convention pattern followed in all subsequent data figures is provided.

It may be observed that the elastic modulus is insensitive to aging (2% difference), whereas strength is strongly affected in a negative sense (21% reduction). This trend agrees well with results obtained by Solvay for PEEK thermoplastic polymer prepregs [32], and may be at least partially explained by the fact that the modulus is evaluated in the linear strain range (1000–3000 $\mu\text{m/m}$), while strength involves larger strains. It is reasonable to assume that in such a high demanding situation in terms of strain, the load-bearing capacity of the material appears to be sensitive to aging. As far as the Poisson ratio is concerned, it also seems to be affected, however, its measure is small and thus not expected to be of major importance as a design variable.

A typical failure mode is also illustrated in Figure 2. Lateral failure modes at multiple areas and various locations (LMV according to ASTM D3039) have been primarily observed. This trend has been expected, since the woven pattern of the fabric in the laminate prevents the occurrence of exploding modes. Similar failure patterns have been observed in RT and HW specimens, indicating that failure mode is rather insensitive to aging. Most failure patterns (8 out of 10) included failure near the tabs, indicating the redistribution of stresses along the specimen near/at failure load. The subsequent failure mode is related, partially at least, to inertia forces following the first failure, to a 3-D stress state involving local stress fields near the tabs, and to free-edge effects. The present approach focuses on the determination of the effect of hot-wet storage aging on the global mechanical properties of the woven thermoplastic material, while a detailed study of the failure mechanisms involved [11] would require special equipment, which has not been available in the context of this work.

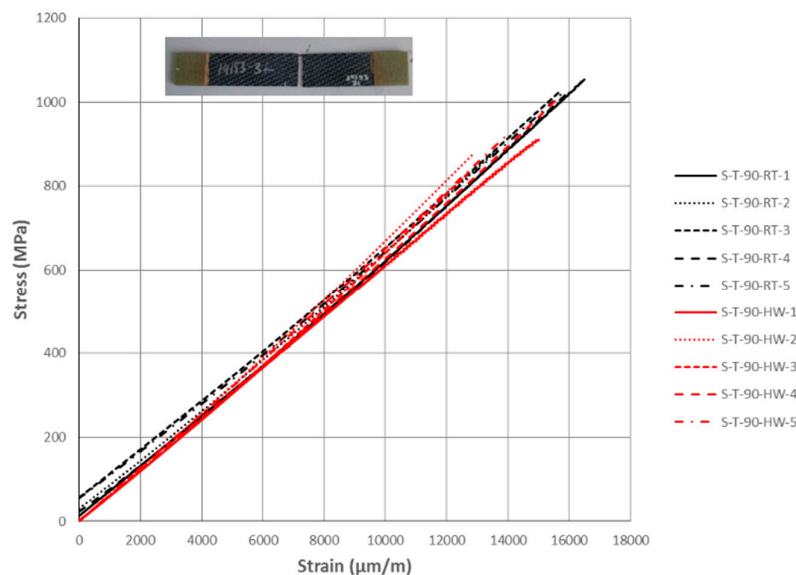
Figure 3. Static tension for weft-directional laminate: stress–strain data and characteristic failure mode.

Stress vs. longitudinal strain data for RT and HW specimens are presented in Figure 3.

Concerning the effect of aging, a similar trend is observed, as in the case of the warp-directional specimens. The elastic modulus appears to be slightly (9%) increased due to aging, while strength is slightly (7%) reduced. Such a trend for the modulus has been expected, as both laminations are similar, whereas the reduction in strength is less than expected.

A typical failure mode of an RT specimen is also illustrated in Figure 3. Lateral failure modes have been observed in all specimens, being less distributed along the specimen compared to the case of warp-directional laminates. Most specimens (7/10) failed in the vicinity of the tabs. These failures are attributed to pre-stress, due to excessive pressure on the tabs at the grips of the machine in order to avoid slippage during loading.

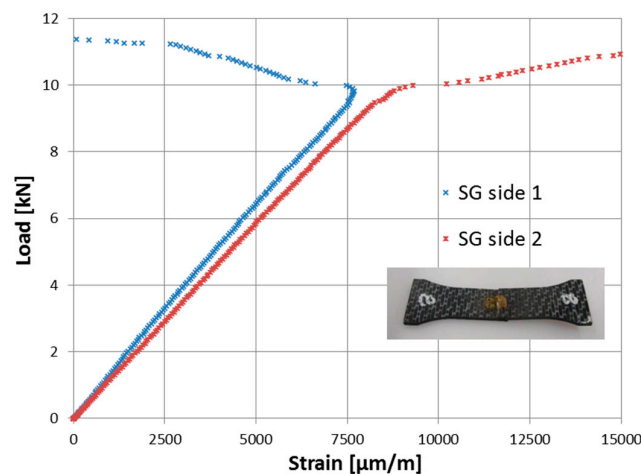
Figure 4. Compression test for warp-directional laminate: typical measured load vs longitudinal strain data and typical failure mode (SG: strain gauge).

A typical load vs. longitudinal strain measurement is presented in Figure 4. A typical failure mode is also shown. All specimens failed under intralaminar shear.

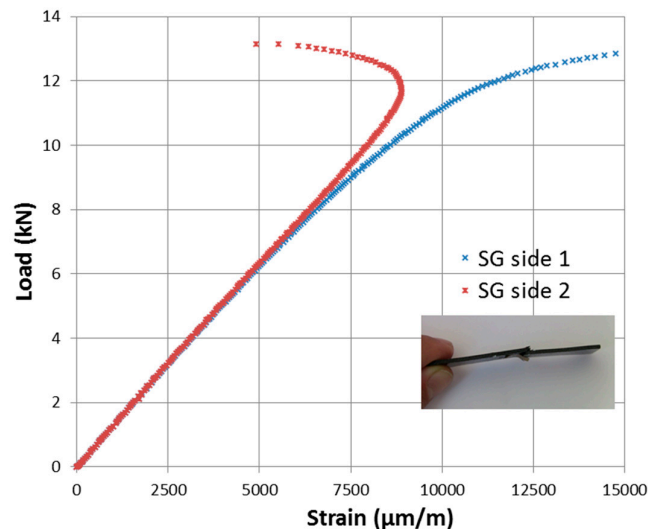
**Figure 5.** Compression test for weft-directional laminate: typical measured load vs. longitudinal strain data and typical failure mode.

Two batches in total, each consisting of 5 RT and 4 HW specimens, were tested. The head velocity was the same as in the warp-directional case and strains were also measured accordingly. A typical load vs. longitudinal strain data curve is presented in Figure 5 along with a typical failure mode. All specimens failed under intralaminar shear.

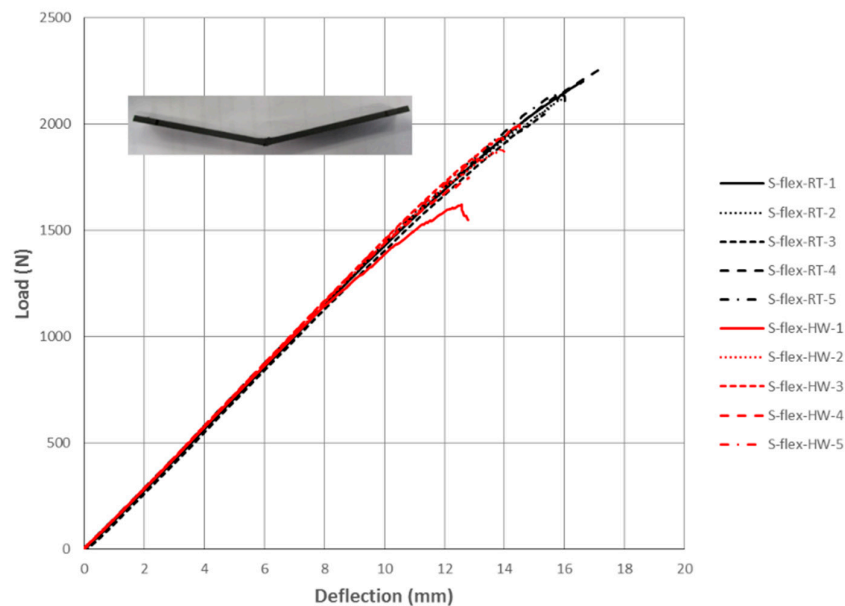
Figure 6. Static flexure: load-deflection data and typical failure mode.

The load vs. mid-span deflection for RT and HW specimens is presented in Figure 6, along with a characteristic failure mode.

As far as failure modes of the specimens are concerned, all specimens failed under tension at the bottom surface, either at (5/10, failure description TAB according to ASTM D7264) or between loading noses (5/10, failure description TBB). According to the standard, these failure modes indicate valid flexural strength. This point is further supported by the acceptable variance in experimentally determined values for strength.

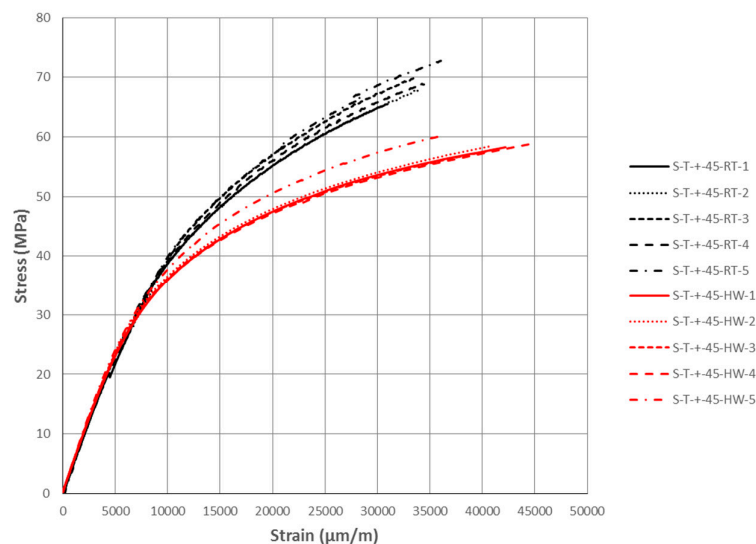
Figure 7. Effect of aging on stress–strain curves of in-plane shear strength (IPSS) test.

The stress vs. shear strain data for RT and HW specimens are presented in Figure 7, respectively. Each strain gage failed at approximately $15,000 \mu\epsilon$. The achieved range allowed for the evaluation of the 0.2% offset (yield) strength. Nevertheless, the load continued to rise after the failure of the strain gages and eventually reached a plateau at about 23 kN. Thus, the ultimate strength has been evaluated from the maximum load. At that stage, the plastic deformation of the specimens was visible with the naked eye, albeit no rupture of the specimen has occurred. That trend indicates a ductile response of the material, similar to that of metals, excluding failure in terms of breakage.

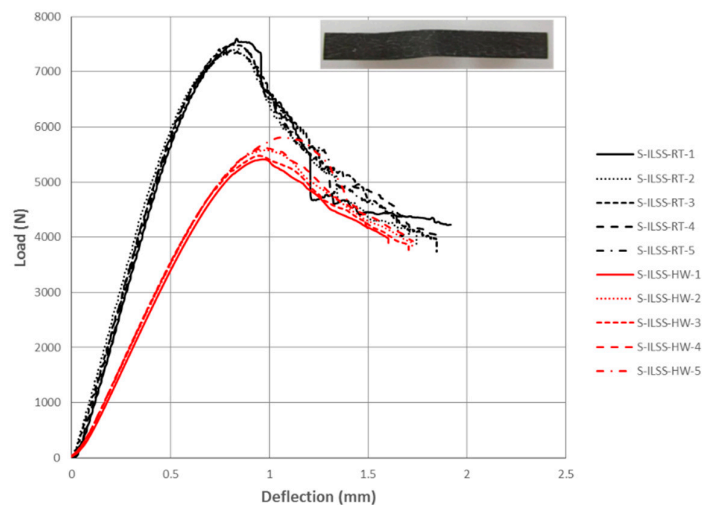
Figure 8. Effect of aging on load-deflection curves measured in ILSS test.

The load vs. mid-span deflection for RT and HW specimens is presented in Figure 8. A typical failure mode is also shown.

As far as the failure mode is concerned, the specimens failed under inelastic deformation and interlaminar shear. Each of these failure modes are considered acceptable in the standard, however, in the current case the failure appeared to include both modes as a result of the ductility of the matrix compared to thermoset composites.

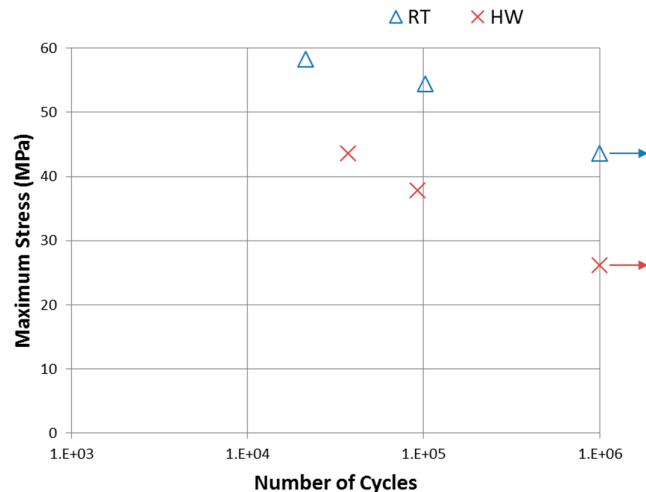
Figure 9. Effect of aging on fatigue interlaminar shear strength. Arrows to the right indicate that no failure has occurred.

The effect of aging on interlaminar shear fatigue strength is presented in Figure 9. Aging has a clear degrading effect on the fatigue strength of the thermoplastic material, which is obvious in low-, medium- and high-cycle regimes. This trend is in-line with the experimental results of corresponding static tests and supports the argumentation based on the effectiveness of the thickness to width ratio on the enhanced sensitivity of ILSS specimens to hot-wet storage aging. It should be noted that all failures in fatigue have been attributed to a reduction in slope in the load-displacement loop beyond 10%. It should be also indicated that, as these tests are limited in quantity, statistical means cannot be drawn.

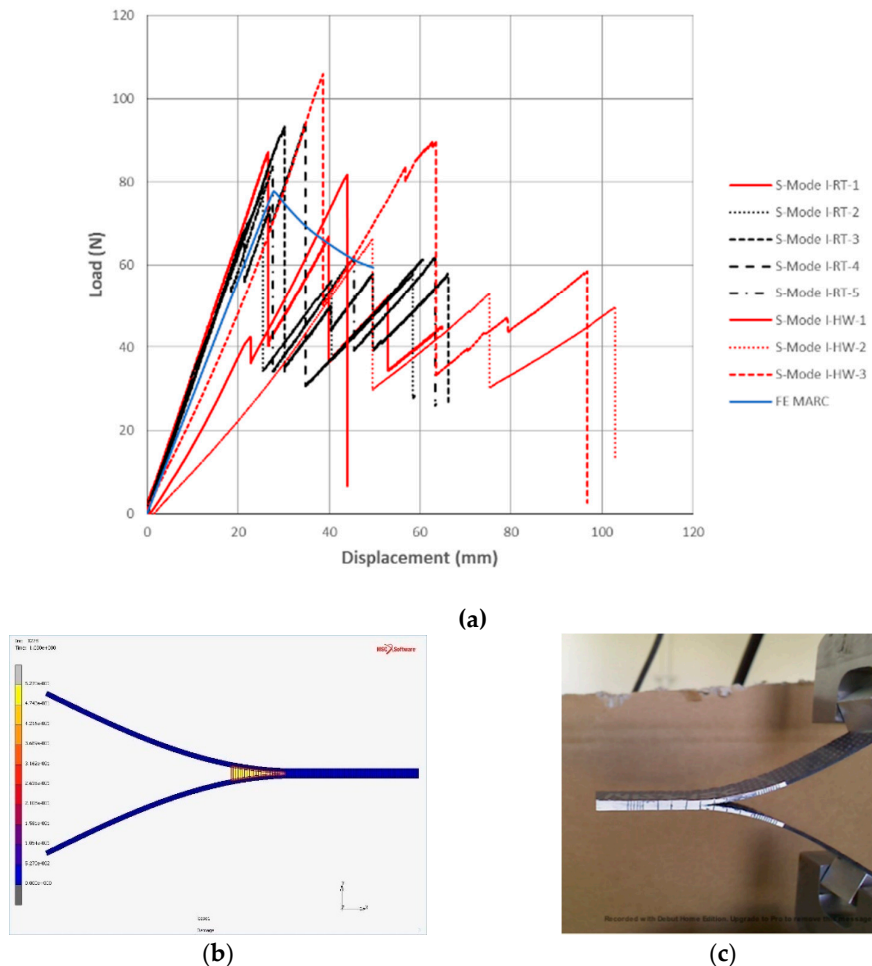
Figure 10. Mode I fracture test: (a) measured and predicted load vs. opening displacement data; (b) instance of crack propagation prediction; (c) typical deformed shape during test.

According to the standard, an initial delamination of 60 mm has been built in by the intervention of a release film at the middle of the stacking sequence in the fabrication process. A head velocity of 1 mm/min has been applied. An initial loading has been considered for creating a crack propagation of 3–5 mm to eliminate fiber bridging effects, followed by a reloading stage for further crack propagation. In Figure 10a, measured load vs. opening displacement data for RT and HW specimens at the reloading stage are presented. A predicted instance of crack propagation is shown in Figure 10b. An interesting observation during the test was the “stick-slip” response during

crack propagation, which resulted in the usability of few data points for the evaluation of fracture toughness. While in the case of unidirectional (UD) thermoset materials, a stable propagation has been measured [28], it being common practice and, as such, considered in the related standards, in the case of the woven thermoplastic material propagation occurred in maximum of four steps. As shown in Figure 10c, both the upper and lower face have been excessively deformed at each propagation step. Thus, strain energy was stored in the face up to a sudden release. At that point, the crack propagated to an arbitrary distance, indicating a highly non-linear response and leading to a relatively large variance in fracture toughness. This stick-slip response has not been observed in similar tests on PEI matrix-based woven thermoplastics reported in the open literature [13], whereas the values obtained for fracture toughness are in a similar range. Thus, the stick-slip response could be attributed to the type of matrix, adhesion between fibers and matrix and weave type.

The FE model, which is based on LEFM, succeeds at predicting the slope of the load-displacement curves, whereas deviation is observed for maximum load. The deviation observed indicates that detailed unit-cell models and the application of appropriate failure criteria for woven thermoplastic materials should be applied in order to improve this prediction.

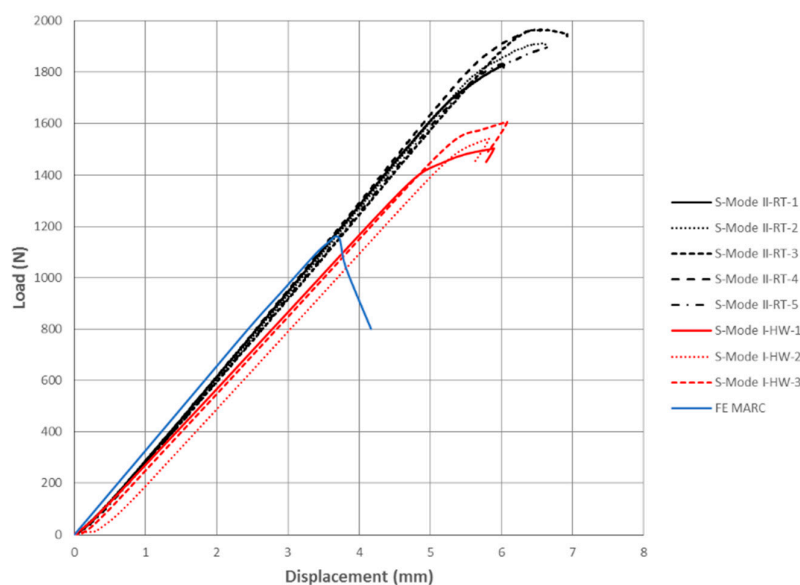
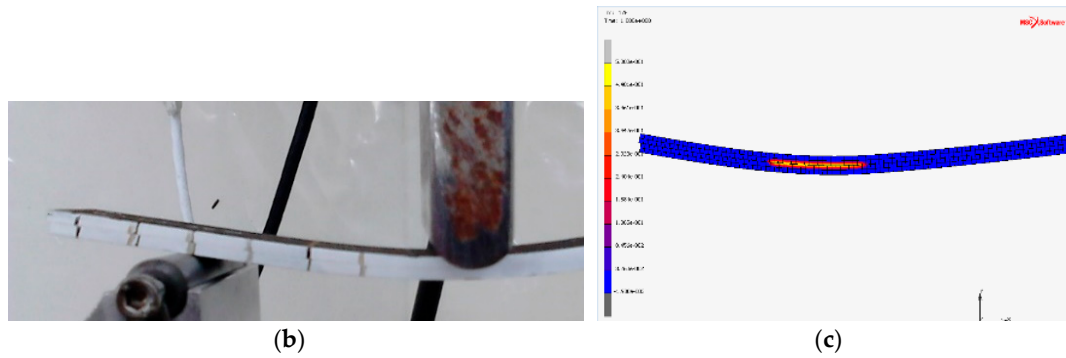
Figure 11. Mode II fracture test: (a) measured and predicted load vs. transverse displacement data; (b) typical deformed shape during test; (c) instance of crack propagation prediction.

According to the standard, an initial delamination of 45 mm has been considered by applying a 0.012 mm release film at the middle of the lamination. A head velocity of 0.5 mm/min was applied. A non-precrack (NPC) and a subsequent precrack (PC) loading stage have been applied, each consisting of two tests for compliance calibration and an additional one for crack propagation. In Figure 11, measured load vs. transverse displacement data for RT and HW specimens in the crack propagation test of the reloading stage are presented, whereas measured and predicted instances of crack propagation are also shown. In contrast to the observations made in the DCB test, the woven thermoplastic material exhibits a stable response, similar to the one observed in the case of thermoset UD materials [28]. The FE model succeeds in accurately predicting the slope of the measured curve, whilst it fails to adequately estimate the measured maximum load for crack propagation. This shortcoming of the numerical model is largely attributed to the lack of implementation of appropriate failure criteria for woven thermoplastic materials encompassing interlaminar shear effects.

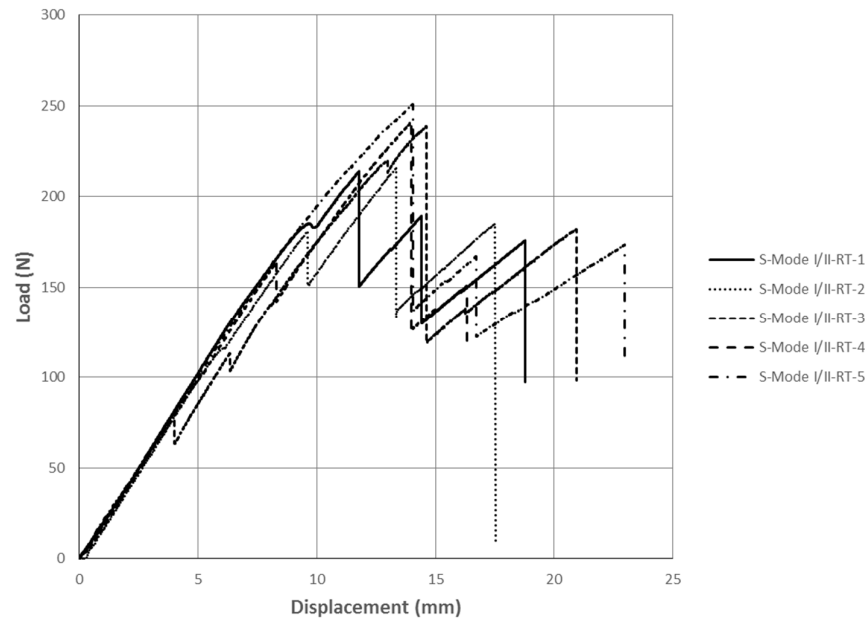
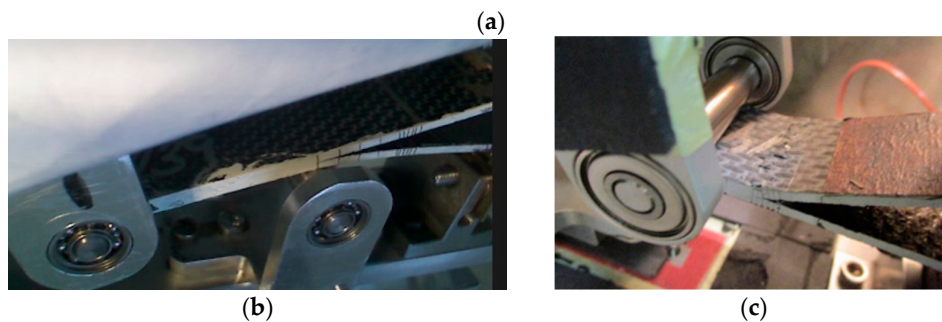
Figure 12. Mode II fracture test: (a) measured and predicted load vs opening displacement data RT specimens; (b) typical deformed shape during RT test; (c) failure mode at root of upper face during HW test.

A mode mixture of $R = G_{II}/(G_I + G_{II}) = 0.2$ has been selected for the RT specimens and a corresponding lever length of $c = 93$ mm. An initial delamination of 45 mm has been considered by applying a 0.012 mm release film at the middle of the lamination. A head velocity of 0.5 mm/min was applied. In Figure 12, measured load vs. opening displacement data for RT specimens are presented, along with instances of measured crack propagation. The “stick-slip” response during crack propagation has been also observed in this case, leading to relatively few data points and large variances. In the case of HW tests, the specimen failed at the root of the upper face at a maximum opening displacement between 3 and 10 mm. Thus, various mode mixtures ($R = 0.25, 0.3$ and 0.5) have been considered, albeit without success in eliminating that trend.

The large variance observed indicates the highly non-linear nature of this test on woven thermoplastic PEEK materials. The aged specimens exhibited significantly lower fracture toughness than the RT ones. However, premature failure of the upper face, as well as the fact that the crack evolves in limited steps, did not allow for a proper estimation of fracture toughness in the case of the HW specimens. The latter two points might indicate that the standard should be further elaborated in order to prescribe a stable and uniform crack growth in woven thermoplastic laminates, especially under hot-wet aged conditions.
