# Sensitivity Assessment of the Seismic Response of a Masonry Palace via Non-Linear Static Analysis: A Case Study in L'Aquila (Italy)

Ilaria Capanna, Angelo Aloisio \*D, Franco Di Fabio D and Massimo Fragiacomo

Citation: Capanna, I.; Aloisio, A.; Di Fabio, F.; Fragiacomo, M. Sensitivity Assessment of the Seismic Response of a Masonry Palace via Non-Linear Static Analysis: A Case Study in L'Aquila (Italy). *Infrastructures* 2021, 6, 8. https://doi.org/10.3390/ infrastructures6010008

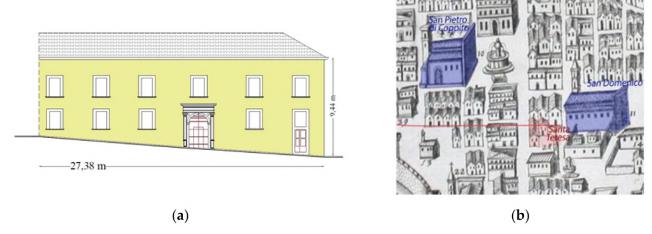
Figure 3. (a) Prospect of the St. Teresa convent; (b) historical map with the indication of the position of the St. Teresa convent [26].

In some cases, the refurbishments after the earthquakes caused significant alterations of the urban layout. For example, during the reconstruction after the earthquakes occurred in 1315 and 1350, a tower of the city wall became the St. Silvestro church's chapel, a masterpiece of the local monumental heritage [25]. After the restoration carried out in the 16th century, a monastery, called "St. Teresa", see Figure 3a, arose from the fusion of several dwelling units. The repair works incorporated a neighboring church wall, called St. Domenico, in the St. Teresa building's body. A historical map, depicted in Figure 3b [26], confirms that the two buildings were isolated before the 16th century.

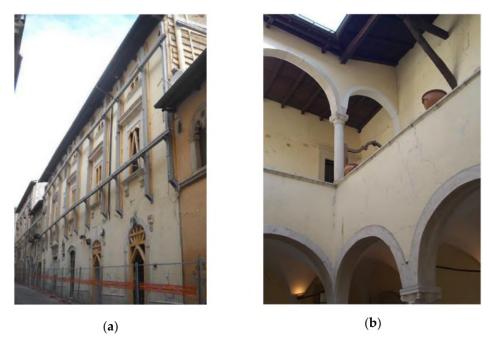
**Figure 5.** (a) Photo of the façade of Burri Gatti palace after the 2009 earthquake; (b) photo of the palace entrance hall.

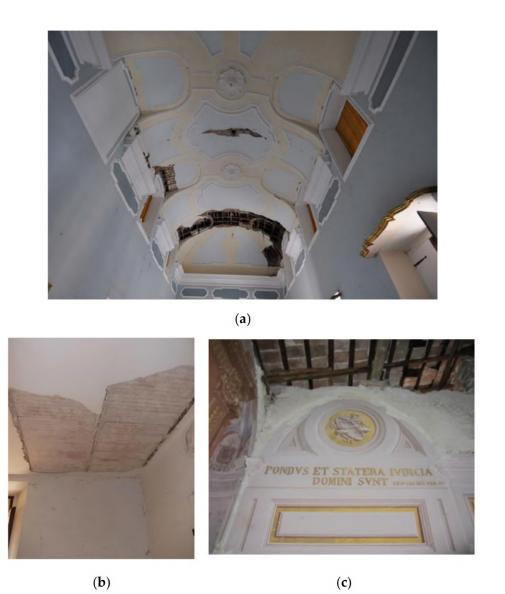
**Figure 9.** Views of some floor typologies detected in L'Aquila: (a) HS3; (b) HS4; (c) HS1. HS, Horizontal Structure.

Six values were selected for the stiffness of floors: (HS1) wooden floors, in Figure 9c, with joists and flooring made of one layer of timber planks, with a shear modulus G of 10 MPa; (HS2) wooden floors with joists and flooring made of two layers of perpendicular timber planks, with a shear modulus G of 1000 MPa; (HS3) brick vaults on the ground floor with G equal to 100 MPa, and deformable (wood or steel) floors on the upper floors, in Figure 9a, with G equal to 10 MPa (HS4) floors made of steel joists and brick vaults, with G equal to 8700 MPa; (HS5) floors made of steel joists and brick tiles, see Figure 9b, with G equal to 10,000 MPa; (HS6) RC monolithic floors, with G equal to 14,500 MPa.
