# Influence of Tool Length and Profile Errors on the Inaccuracy of Cubic-Machining Test Results

**Abstract:** A cubic-machining test has been proposed to evaluate the geometric errors of rotary axes in five-axis machine tools using a  $3 \times 3$  zone area in the same plane with different tool postures. However, as only the height deviation among the machining zones is detected by evaluating the test results, the machining test results are expected to be affected by some error parameters of tool sides, such as tool length and profile errors, and there is no research investigation on how the tool side error influences the cubic-machining test accuracy. In this study, machining inaccuracies caused by tool length and tool profile errors were investigated. The machining error caused by tool length error was formulated, and an intentional tool length error was introduced in the simulations and actual machining tests. As a result, the formulated and simulated influence of tool length error agreed with the actual machining results. Moreover, it was confirmed that the difference between the simulation result and the actual machining result can be explained by the influence of the tool p

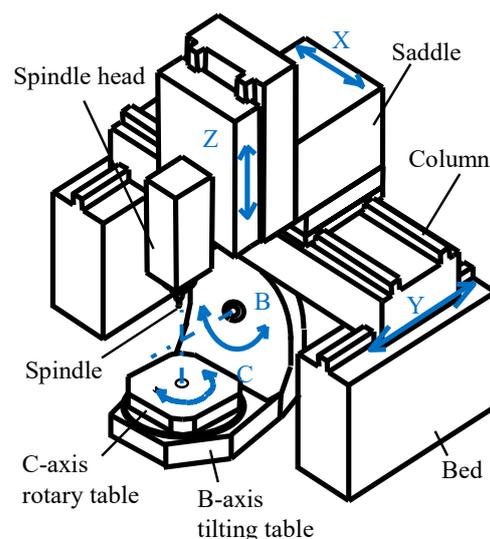
**Figure 1.** Structural configuration of a five-axis machining center.

A vertical-type five-axis machining center with tilting and rotary axes on the table side (NMV 1500 DCG, DMG Mori) was used in this study, in which a tilting rotary table was controlled around the B-axis and C-axis motions, as shown in Figure 1. In a previous study, the authors conducted a simulation and experiment focusing on the geometric error influences of the cubic-machining test [16].

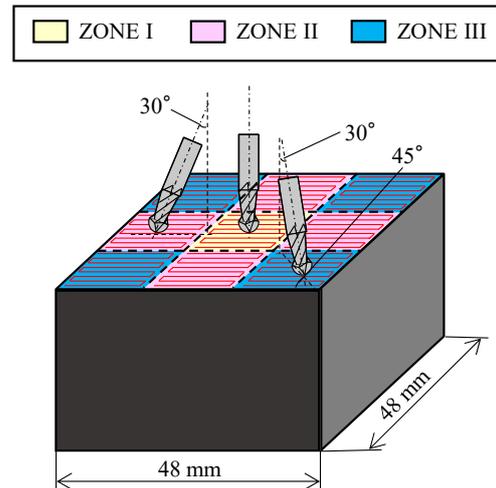
**Figure 2.** Cubic-machining test.

To avoid the influence induced by other error sources, the workpiece design and machining tool path were assumed to be the same as those in [16]. Hence, as shown in Figure 2, the size of the machining test specimen was  $48 \times 48$  mm, and the tool path of each machining zone was in the zigzag direction, and the scanning path interval was set to

0.1 mm. In addition, the machining zones can be classified into three types as shown in Figure 2: the center of the square area is ZONE I, where the tool is always vertical to the machining surface; the four squares adjacent to the center zone compose ZONE II, where the tool is tilted  $30^\circ$  to the normal line of the workpiece surface, toward the center of the square area; and the four squares diagonal to the center zone are ZONE III, where the tool is tilted by  $30^\circ$  and rotated by  $45^\circ$  toward the center of the square.

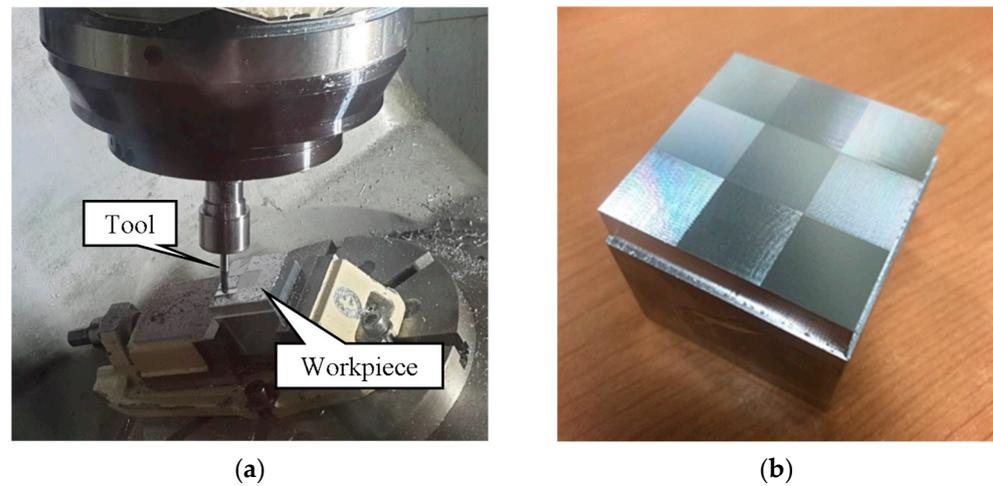
Figure 3. Actual cubic-machining test: (a) workpiece setting and machining method; (b) example of a machined workpiece.

Figure 3a shows the actual machining experiment, and Figure 3b shows the cubic-machining workpiece after finishing cutting. Surface measurements were performed using a contact-type shape measurement system (DSF900, Kosaka Laboratory Ltd.), as shown in Figure 4a, and a  $40 \times 40 \text{ mm}^2$  square area of the machined surface was measured to evaluate the height deviation among the machining zones, as shown in Figure 4b.

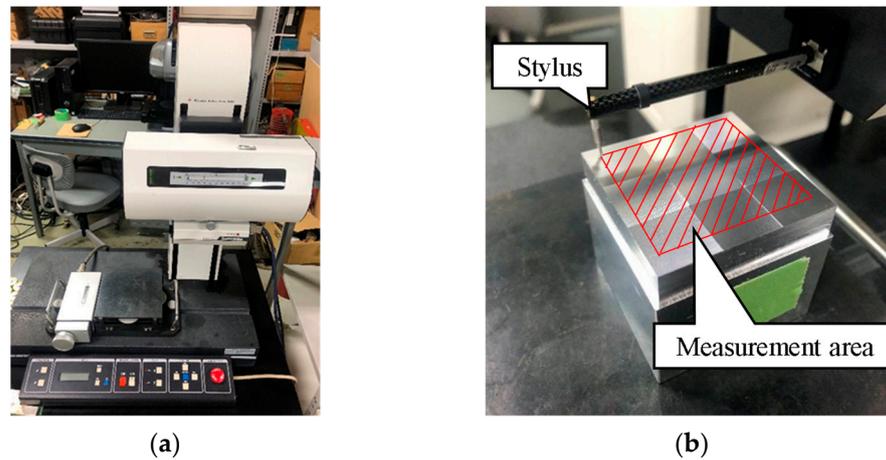
Figure 4. Measurement of machined workpiece accuracy: (a) measurement system; (b) measurement area.

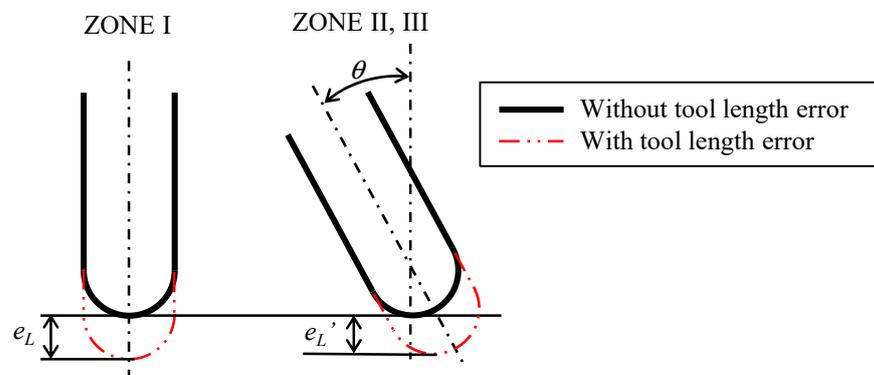
Figure 5. Illustration of tool length error influence.

Tool length error during the machining test can easily occur because of tool length measurement error, repeatability of tool change, and thermal expansion of the spindle. In this section, the influence of the tool length error on the machined accuracy is formulated to suggest the expected results. Figure 5 illustrates the height deviation caused by the tool length error between ZONE I and ZONES II and III. According to the definition of the cubic-machining test, the height deviation between ZONE I and other machining zones is assumed to be zero in an ideal situation. However, if the actual tool length is longer than the measured tool length and the deviation amount is  $e_L$ , the cutting depth should be larger than the ideal cutting depth. In the case of ZONE I, the tool is perpendicular to the machined surface, and the deviation in the cutting depth is also assumed to be  $e_L$ . In the case of ZONES II and III, as the tool has a relative angle  $\theta$  to the machined surface, the deviation in the cutting depth,  $e'_L$ , is not supposed to be equal to  $e_L$ , as shown in Figure 5. The relationship between  $e_L$  and  $e'_L$  is calculated using Equation (1).

$$e'_L = e_L \cos \theta \tag{1}$$

Hence, the height deviation  $\Delta h$  among ZONE I and other machining zones caused by the tool length error can be formulated as Equation (2).

$$\Delta h = e_L - e'_L = e_L(1 - \cos \theta) \tag{2}$$

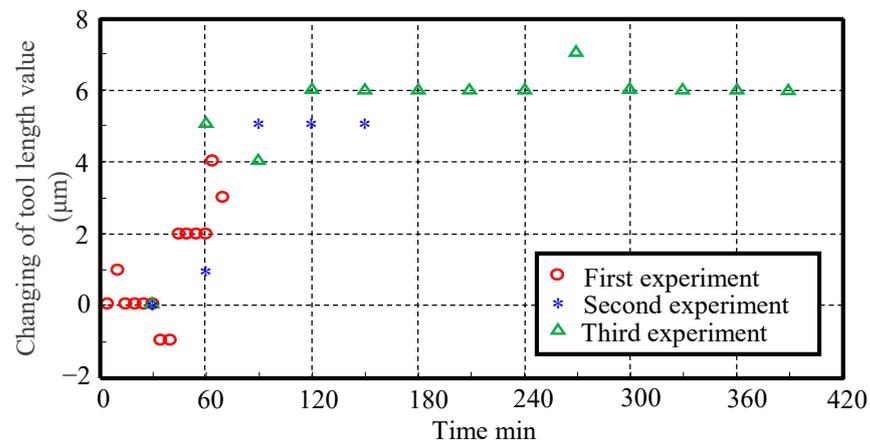
Figure 6. Measured thermal expansion characteristics on the tool length changes.

Figure 6 shows the measured results of the tool length for all three sets of experiments. During the experimental process, the tool and tool holder were kept fixed to the spindle, such that the error due to the tool changing accuracy could be assumed to be 0. The experimental value shown in Figure 6 is the change in the tool length from the value measured at the initial time of each experiment. According to Figure 6, after approximately 120 min of spindle running, the deviation in the tool length became stable. Thus, as the thermal deformation of the spindle stabilizes after 120 min, the tool length measurement and machining tests should be implemented after 120 min of spindle rotation.

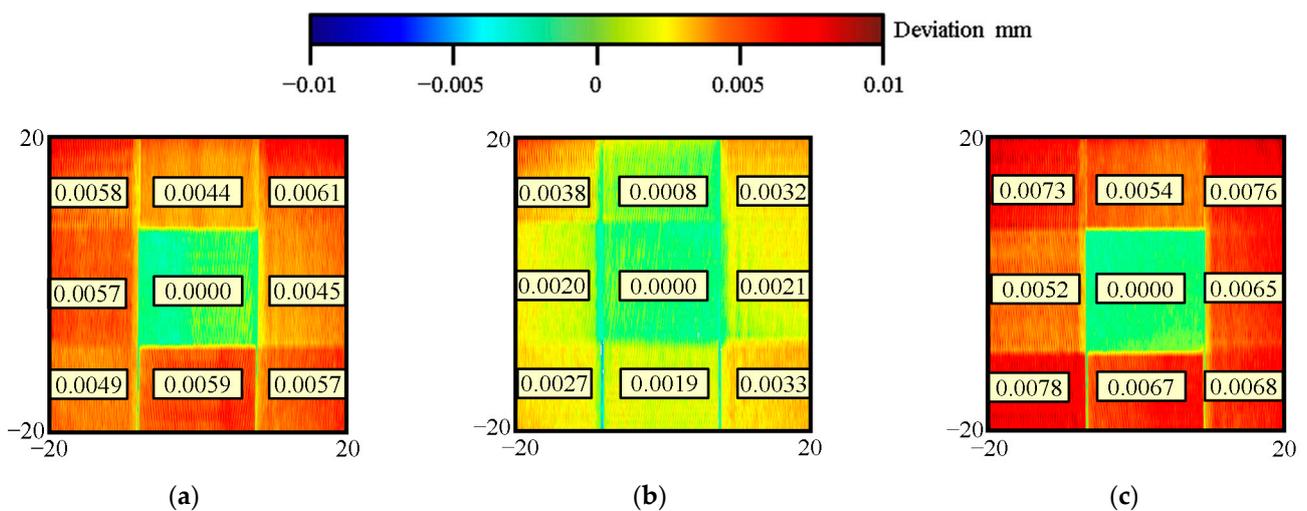
Figure 7. Measured relative height deviation of the test surfaces: (a) without tool length error; (b) with positive tool length error; (c) with negative tool length error.

Figure 7 shows the measured machined surface of the cubic machining with different values of tool length error  $e_L$ , where the values (unit: mm) attached to each machining zone are the average relative height deviation from the standard machining zone (ZONE I), and the deviation appearing on the machining without tool length error ( $e_L = 0$ ) was considered to be caused by geometric errors of the machine tool. According to Figure 7, it can be seen that the average height of the surfaces became higher when the negative tool length error existed.

Comparing the measured surfaces shown in Figure 7 and the simulated ones shown in Figure 11, the average height of the simulated surfaces was lower than that of the measured ones around 5 μm. To clarify the reason, the tool profile accuracy of the ball-end mill should be considered.

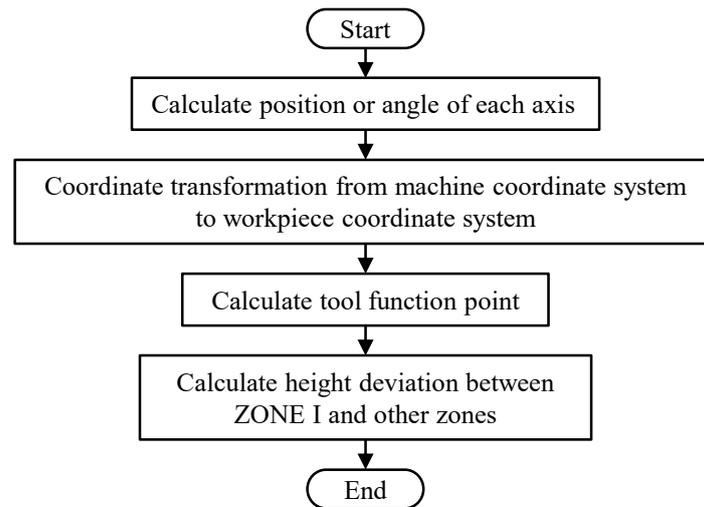
Figure 8. Simulation process.

The simulation process used is shown in Figure 8. The positions of the X-, Y-, and Z-axes represent the translational feed motion of the spindle, and those of the B- and C-axes indicate the orientation of the work table. According to [14], the coordinate transformation from the machine coordinate system to the workpiece coordinate transformation was implemented using Equations (3) and (4), respectively:

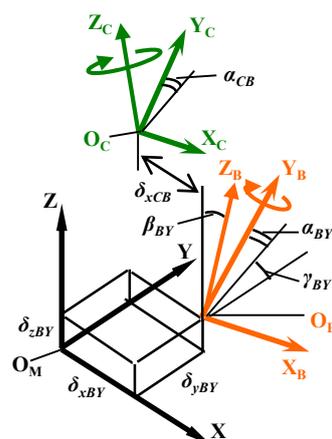
Figure 9. Illustration of geometric errors listed in Table 4.

In addition,  $M_{\gamma_{BY}}$ ,  $M_{\beta_{BY}}$ ,  $M_{\alpha_{BY}}$ ,  $M_{\delta_{zBY}}$ ,  $M_{\delta_{yBY}}$ , and  $M_{\delta_{xBY}}$  are the impact matrices of geometric errors between the B-axis and machine bed, and  $M_{\alpha_{CB}}$  and  $M_{\delta_{xCB}}$  are the impact matrices of geometric errors between the B- and C-axis, respectively. The definitions of each geometric error are presented in Table 4 and illustrated in Figure 9.

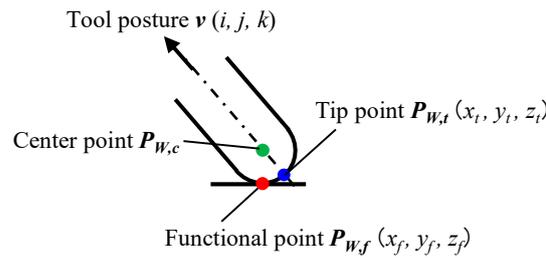
Figure 10. Relationship between tool center point, tool tip point, and tool functional point.

The tool tip position, considering the geometric and tool length errors, can be calculated as mentioned above. To simulate the machined accuracy, the position of the functional point is required. The relationship between the tool tip point and tool functional point in the cubic-machining test is illustrated in Figure 10. Therefore, the tool functional point can be calculated using Equation (12), where the tool posture  $v$  is calculated using Equation (13), where  $r$  is the radius of the ball-end mill, and  $P_{W,f}$  and  $P_{W,t}$  are the coordinates of the tool functional point and tool tip point in Figure 10.

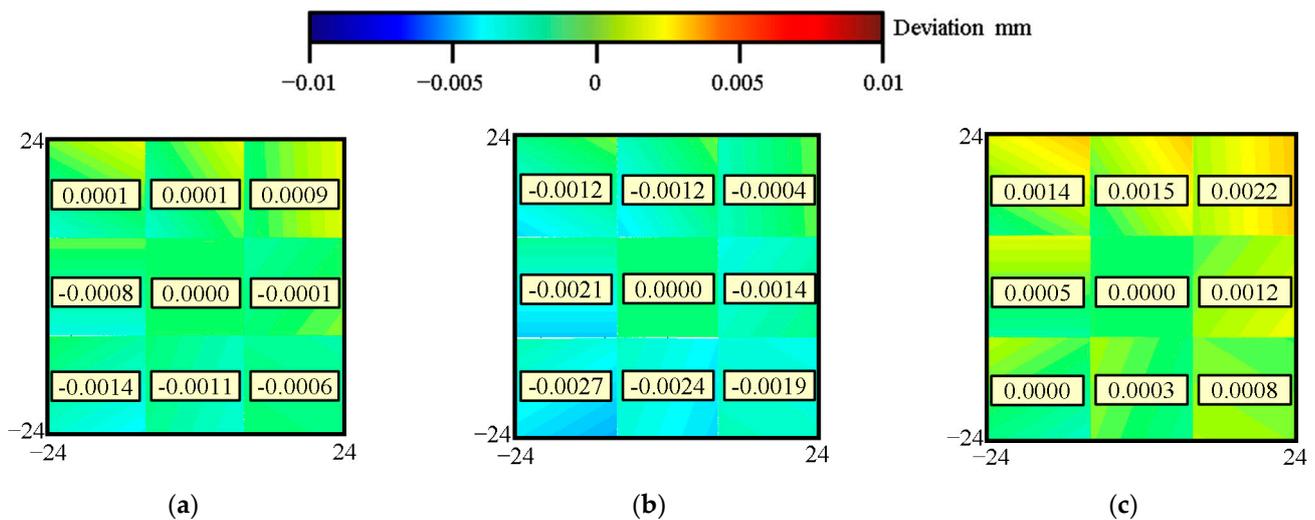
Figure 11. Simulated relative height deviation of the test surfaces: (a) without tool length error; (b) with positive tool length error; (c) with negative tool length error.

Figure 11 shows the simulated results of cases with a different tool length error  $e_L$ , and the value (unit: mm) attached to the machining zones suggests the height deviation from ZONE I. According to Figure 11, the average height of the surfaces increased when a negative tool length error existed, similar to the real machined results. Table 6 shows the influences caused by tool length errors compared with the results without tool length error. According to Table 6, it can be indicated that the simulation results agree with the formulated value for each machining zone.

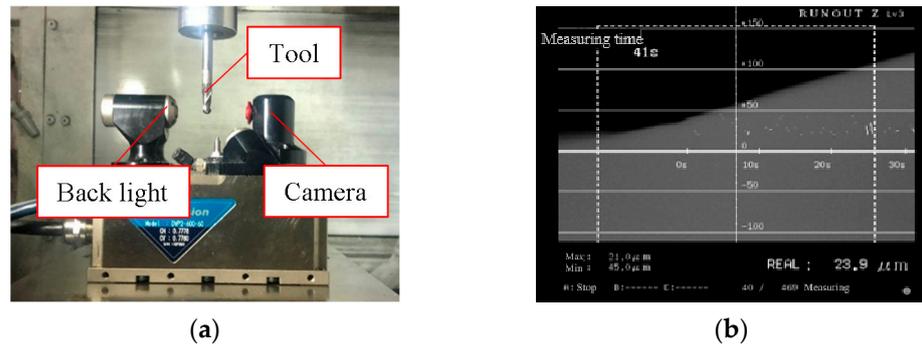
Figure 12. Tool profile measurement method: (a) measurement setup; (b) example of a graphical vision for the measurement.

In this study, the tool profile measurement was implemented using a Dyna vision system (produced by Big Daishowa Group). Figure 12a,b shows the measurement setup and measured vision, respectively. A processor was installed inside the Dyna vision system to calculate the deviation from the profile to the standard scale. The angular interval of the measurement process was selected to be 1°, and the profile was measured until 45° from the tool tip point.

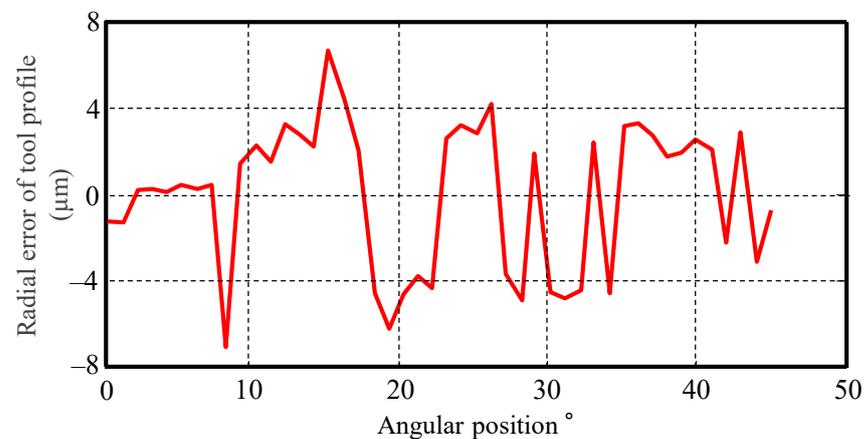
Figure 13. Measured tool profile accuracy of the ball-end mill used in this study.

Figure 13 shows the measured result of the tool profile accuracy, where the vertical axis represents the radial error of the tool profile, calculated as the deviation between the measured and nominal tool radii. A negative deviation indicates that the tool diameter is smaller than the designed one. In the actual cubic-machining test, ZONE I was machined by an area of approximately 0°, and the others were machined by an area of approximately 30°. According to Figure 13, there was a 4 μm deviation between the 0° and 30° areas, which is in agreement with the difference between the simulation and machining results discussed in Section 4. This suggests that the tool profile error directly affects the accuracy of the cubic-machining test. It can be said from the result that the tool profile should be carefully considered in the evaluation of the cubic-machining test accuracy. More tests will be conducted in the future with different tool accuracies to clarify the influence of tool profile errors.
