Case Report

Implementation of an Electrosurgical Checklist in a Podiatry Unit in Relation to a Case of Inadvertent Burns during Hallux Valgus Surgery

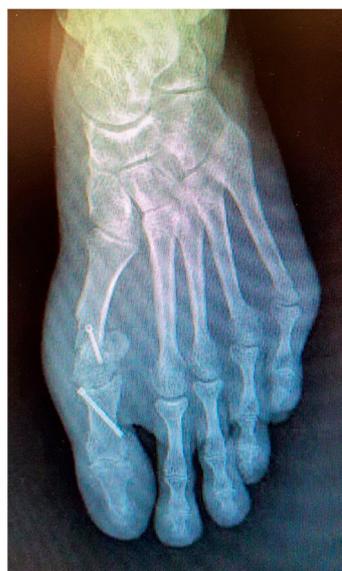
Figure 1. Postoperative radiological aspect of foot after the first procedure.

In May 2021, he underwent an operation to correct the hallux valgus deformity using chevron capital osteotomy and a proximal Akin procedure (Figure 1). The patient reported that a year later he had to be operated on again due to pain at the level of the first MPJ to remove the osteosynthesis material. The second surgery was performed outpatiently with epidural anaesthesia through a medial incision at the MPJ level (Figure 2).

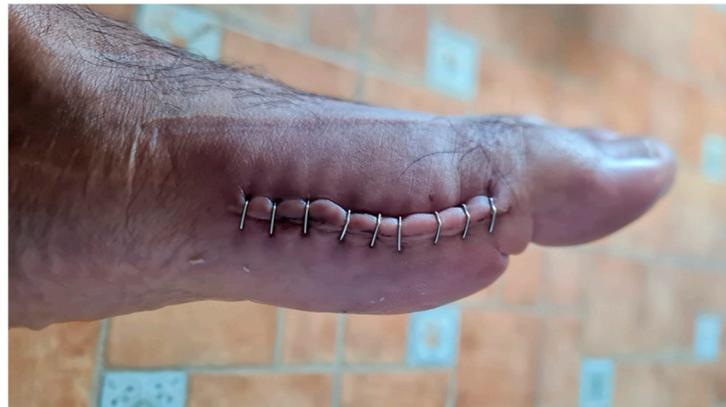
Figure 2. Postoperative appearance of the medial incision prior to staple removal.

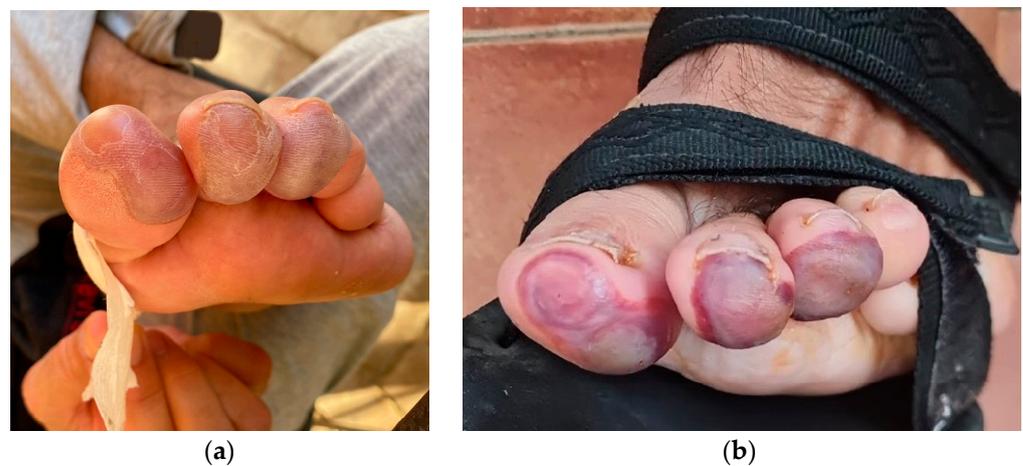
The patient was reviewed to perform the first dressing change and surgical control a week after surgery, and the responsible nurse noticed blisters fade under pressure with pain in the ball of the first, second, and third toes compatible with partial-thickness burns (Figure 3a). The patient reported having suffered severe pain at the level of the toes in the operated foot and difficulty walking during the first three days after surgery. He reported that the pain did not subside with the prescribed medication (acetaminophen 650 mg every 8 h per os). After consulting with the surgeon, he was unaware of the circumstances that caused the injuries, and the nursing staff was urged to take care of the wounds for both the surgical incision and the burns. The injuries were initially treated by the patient at home with applications of povidone iodine antiseptic solution. After two weeks, the skin staples were removed from the medial incision, and adequate closure of the surgical incision could be verified. On the injured toes, the redness of the blisters was observed to fade under pressure (Figure 3b). At three weeks, rupture and desiccation of the blisters with epidermal necrosis areas were observed in the burns and surgical excision was performed. The local application of silver sulfadiazine was carried out every 48 hours until complete healing that was achieved at 7 weeks (Figure 4a,b).

Figure 3. Appearance of the foot at seven days (a), and two weeks postoperatively (b).

Adverse events caused by direct coupling have been widely described in the literature as a complication associated with laparoscopic surgery [4,7]. In orthopaedic surgery, most of the reported cases occurred during arthroscopic surgery procedures. Reported cases in open surgery are rarer [12–14]. In the present case, it is likely that the injuries were caused by direct coupling when the active electrode inadvertently encountered a non-insulated metallic instrument such as an orthopaedic retractor. The current could have been carried through the surgical instrument, causing burns to the tissue which was in contact with the retractor. Injuries could also have occurred if the metal retractor encountered a haemostat that was energised to coagulate a bleeding vessel.

The literature review shows that in 82% of the cases injuries from energy-based surgical devices were identified intraoperatively, in 9% postoperatively in inpatients, and in 9% after discharge [1]. In laparoscopic surgery, approximately two-thirds of the injuries may not be detected during the procedure [3,4]. As in the present case, the injuries were undetected and not recognised until the following five days when partial-thickness burns were observed on the skin between one or three inches away from the medial incision (MPJ), appearing far away from the region where the electrosurgery had been performed. These burn sites could be an area where the retractor rested on the skin.

To avoid accidents due to direct coupling, as reported in this case, the exact location of the active electrode must always be controlled when it is being energised. Special care should be taken whenever the active electrode is energised near another metal object, especially retractors. Given that the surgical approach was made through a medial incision, it is likely that the plantar location retractor was the one that repeatedly encountered the active electrode, causing burns in the plantar area of the toes.

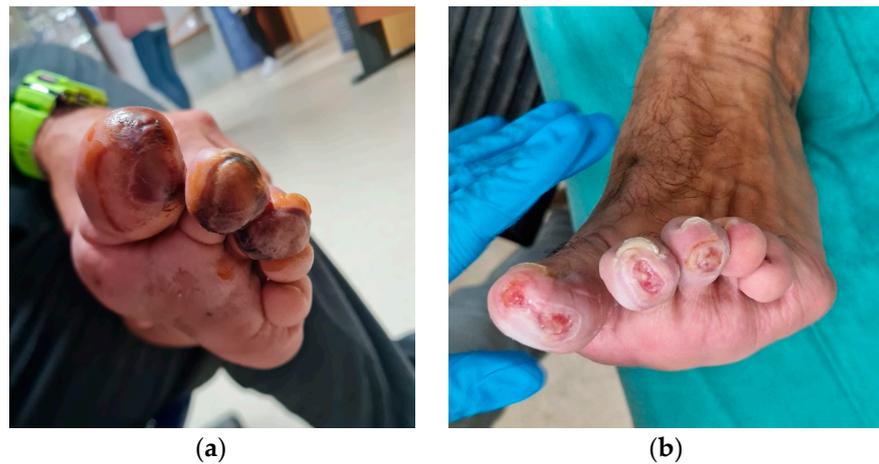
Figure 4. Rupture and desiccation of the blisters with areas of epidermal necrosis can be observed after three weeks (a). Aspect after surgical excision of epidermal necrosis areas (b).

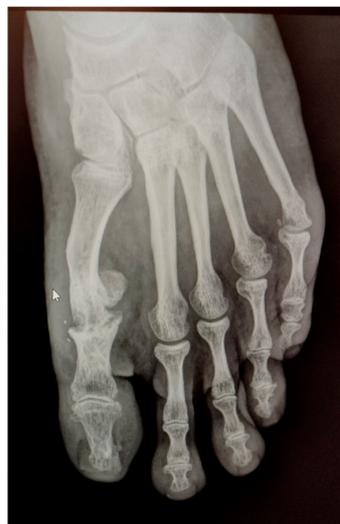
Radiographic examination after one year following the second surgery showed signs of severe joint destruction compatible with MPJ resection arthroplasty with significant shortening of the first toe (Figure 5). The patient was treated conservatively with orthopaedic insoles.

Figure 5. Postoperative radiography one year after the second procedure. Signs of severe joint destruction compatible with resection arthroplasty can be observed.
