Preventing Glass Misting in Indoor Showcases with Burial Remains at Al Ain, UAE

Abstract: The historic house of Sheikh Mohammed Bin Khalifa, Al Ain (Abu Dhabi, UAE) belongs to the World Heritage Cultural Sites. The courtyard and two rooms include mudbrick archaeological remains that are preserved in showcases for public display. The building lies in a hot desert climate and needs air conditioning to be comfortable. This paper is concerned with indoor showcases and their compatibility with the indoor climate. Sometimes, misting for condensation is generated on the glass panes for the temperature and humidity contrast between the room climate and the showcases that are embedded in the floor. When misting occurs, the remains cannot be viewed. This paper investigates indoor glass misting, the exchanges of heat and moisture between archaeological remains, showcases and rooms, and the results after a year of environmental monitoring. An aim is to assess the potential risks for the preservation of the remains, recognizing the frequency and severity of the conditions for condensation. Another aim is to discuss mitigation methodologies to avoid glass misting, e.g., (i) reducing the room co

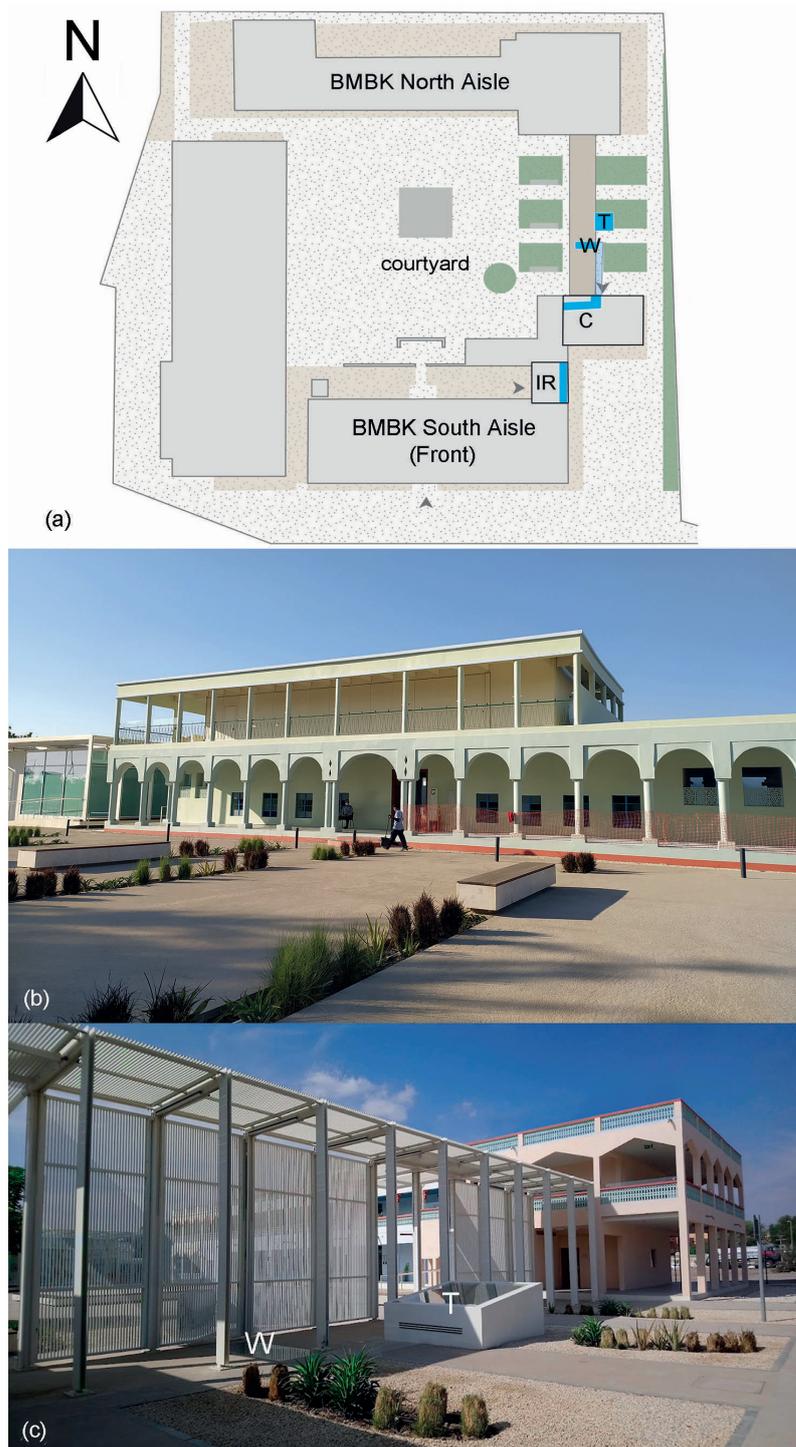
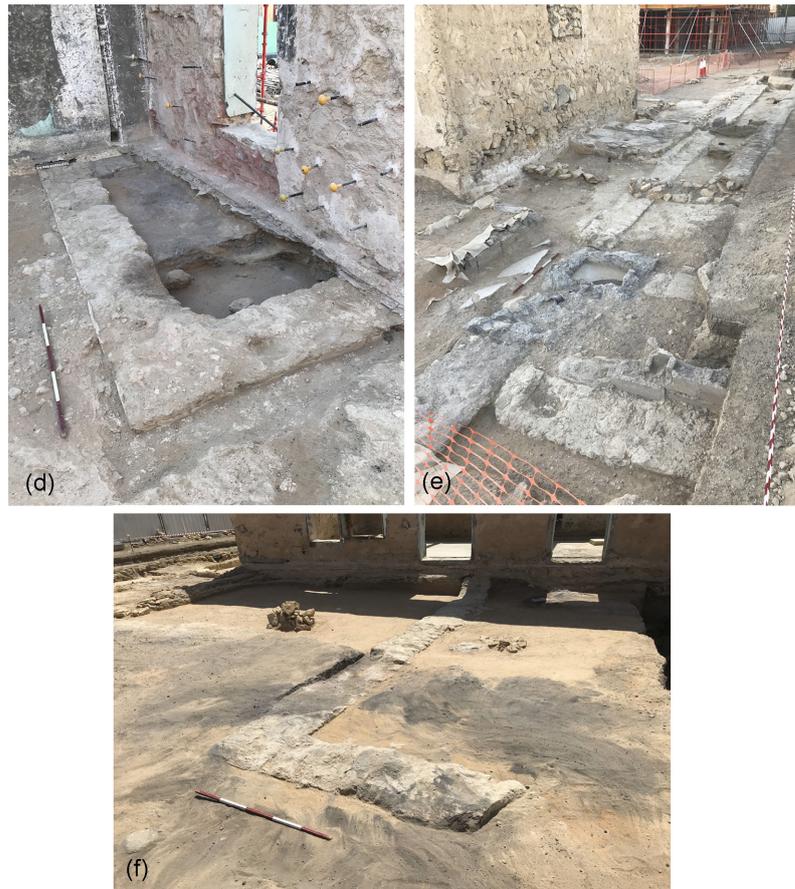
Figure 1. Cont.

Figure 1. (a) Map of the BMBK complex, built around the courtyard. The BMBK building considered in this study includes the Classroom (C) and the Interpretation Room (IR) with their showcases (cyan). In the courtyard, the Tanoor (T) and Walkway (W) showcases are also cyan. Garden plants are located in the green areas. (b) The southern aisle of the BMBK complex, built in 1958 and restored 2017–2021, which includes the indoor showcases. (c) The northern aisle with the two outdoor showcases (W, T) studied in [14]. (d) View inside Classroom (C) during the project showing the remains of a mudbrick wall predating the construction of the present BMBK. (e) View showing a number of truncated mudbrick, stone and concrete block walls revealed to the north and east of block where Classroom (C) is located. (f) Drone view during the project works showing the mudbrick walls to the north and east of Classroom (C) and the ashy deposits created by the later use of this area for cooking.

In the Classroom, the remains of an earthen foundation are exhibited in the showcase, while in the interpretation room the showcases lie underground and consist of protective walls built around the remains. The top is made of glass panes at room floor level. A linear light is placed on both sides of the remains. Inside the Interpretation Room, a linear showcase shows the stone foundation of an earlier structure of boundary wall, upon which a modern wall was erected. This ancient wall is on one side directly connected to the outdoors. In the two rooms, the showcases are similar between them. Both rooms lie around 80 cm above the external ground level; therefore, the remains lie 80 cm below the room floor.

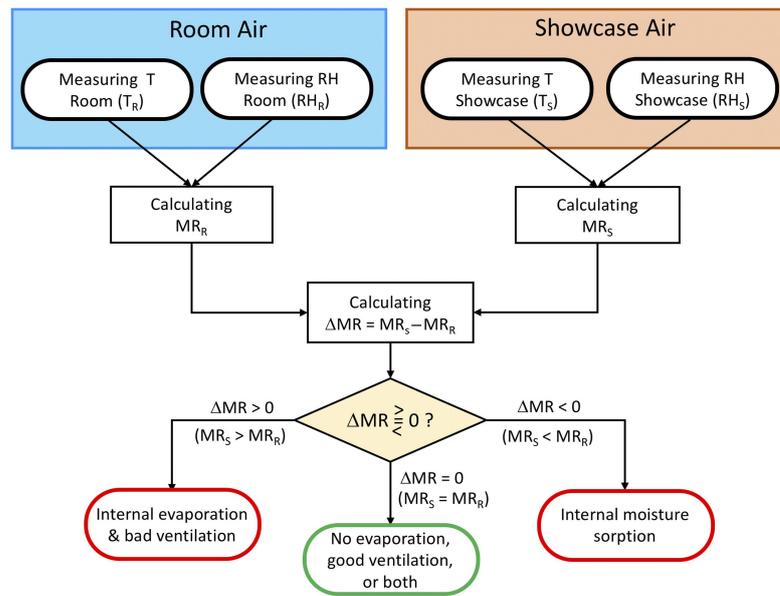
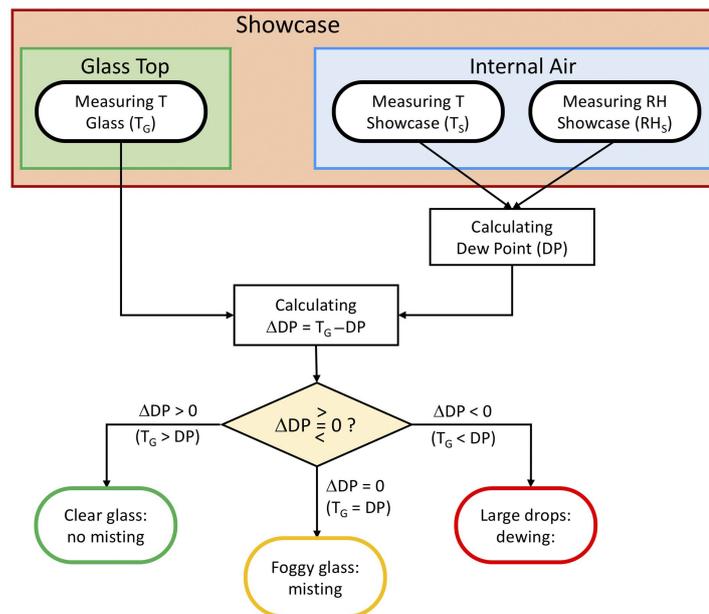
(a) Investigating air exchanges between room and showcase, and evaporation, or sorption, from remains

(b) Seeing through glass: clear, misting or dewing

Figure 2. Flow diagrams to illustrate the methodology to investigate: (a) the combined effect between the evaporation from the archaeological remains and the air exchanges between the showcase and the exterior; (b) the glass misting and dewing.

From the recorded temperature and relative humidity data, other parameters useful for environmental diagnostic purposes have been obtained by calculation [6,20] as illustrated in Figure 2.

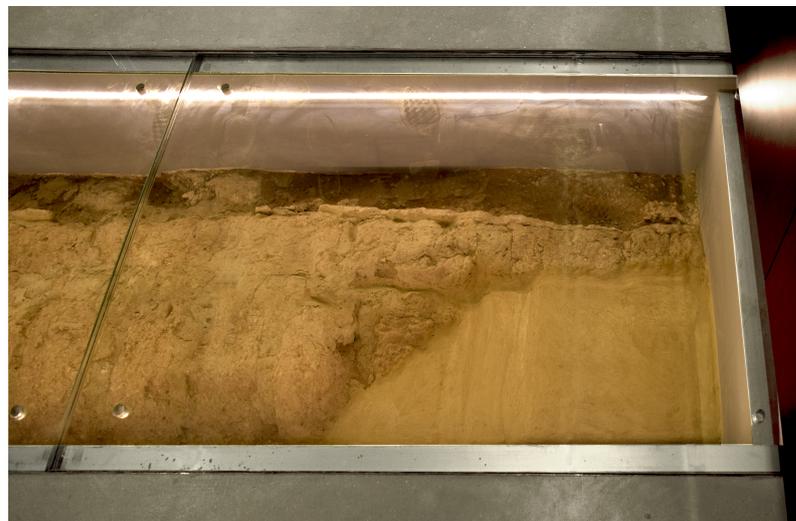
Figure 3. Detail of an earthen remain. The uneven shape makes it difficult to assess deterioration by visual inspection.

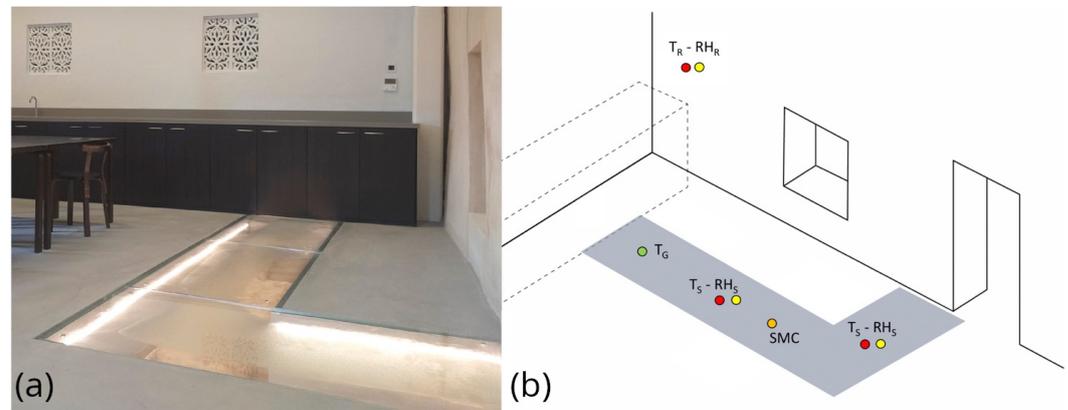
Figure 4. (a) The Classroom with the L shaped showcase. Some glass misting is visible. (b) Location of sensors. T_R , T_G , T_S : temperature of the room, glass and showcase, respectively; RH_R , RH_S : relative humidity of the room and showcase; SMC : soil moisture content.

depth of 44 cm. The location of sensors is shown in Figure 4. A pair of combined ($T_R|RH_R$) sensors was installed on the wall to monitor the room climate. The sensor of the glass pane temperature (T_G) was fixed on the lower side of the pane, where condensation occurs. Two ($T_S|RH_S$) pairs were positioned inside the showcase. The sensor of soil moisture content (SMC) was inserted into the ground close to the archaeological remains.

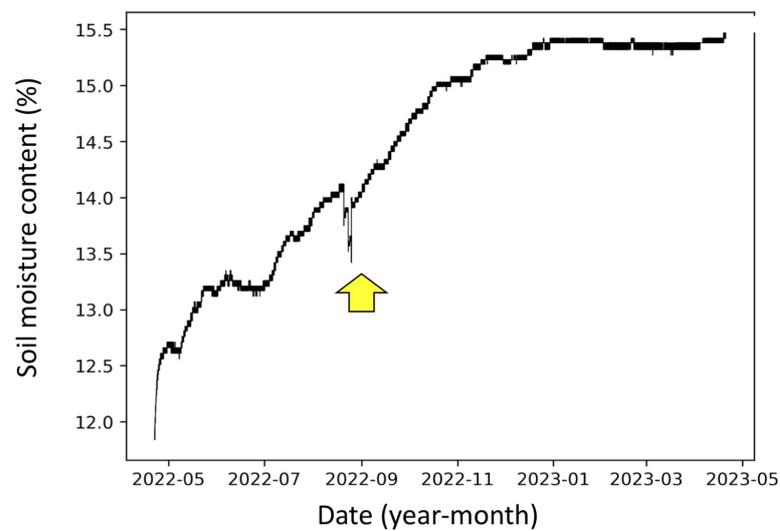
Figure 5. The soil moisture content of the showcase in the Classroom. Arrow: a sharp drop for some works that have required the removal of the glass panes.

In the Classroom, the glass misting is frequent, and a possible explanation that had to be verified is whether the external plant watering causes an underground percolation of water that reaches the open bottom of the showcase and then evaporates from the remains, causing the condensation on the glass pane. This hypothesis is justified because some flowerbeds with small plants and a tree are located near the building, and when they are watered, some water may reach the archaeological remains. Therefore, a simple soil moisture sensor can provide an answer: if the cause is underground water percolation, this should be recognizable from the record, where moisture peaks should be related to the glass misting and the plant watering, although with some delay for the distance. However, the plot of the soil moisture content (Figure 5) shows no peaks, but an increasing trend over 2022; it stabilized in 2023. On the 20–25 August, a sharp drop is visible (arrow) for some works that have required the removal of the glass panes. This homogeneous trend excludes the hypothesis that the glass misting in this room is directly related to single episodes of infiltration and percolation of external water. The general increase followed by a plateau may suggest that the plant watering has caused an average (small) increase in the moisture content in the surrounding area in 2022 when the green areas were created.

The comparison between the two relative humidities in the room and the showcase is reported in Figure 8a. The relative humidity in the room (RH_R) has a median of around 55% but is not strictly controlled because it is affected by large imbalances. It generally lies between 40% and 70%. However, at times, the RH_R drops to very dry values, i.e., 20% to 30%. The relative humidity in the showcase (RH_S) is very high, lying between 80% and 100%. In the occasion of maintenance interventions, when the topping glass panes were removed (yellow arrow in Figure 5), the RH_S level reached dry conditions.

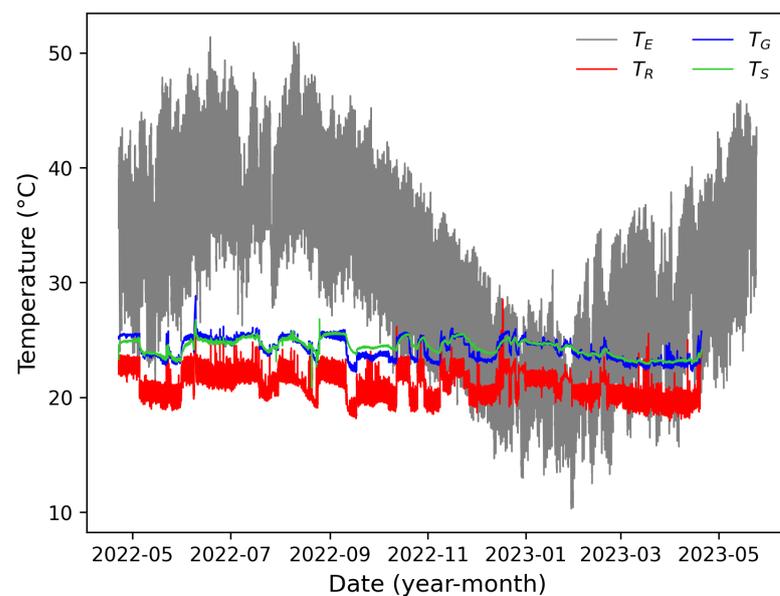
Figure 6. The temperatures concerning the Classroom, i.e., T_E : external temperature; T_R : room temperature; T_G : glass pane temperature; T_S : showcase temperature.

During this campaign, the temperatures directly or indirectly related to the Classroom are reported in Figure 6.

The external temperature followed an annual cycle that, on average, lies between 22 °C and 40 °C, with the mode around 35 °C. The annual extremes reach 10 °C and 50 °C. The amplitude of daily cycles (i.e., T_E maximum – T_E minimum) is from 10° to 15 °C.

The room temperature generally lies between 18° and 24 °C, with levels established by the setting points of the HVAC. Some short peaks should be attributed to use, for example, temporary air exchanges due to the opening of doors or windows, or interruptions of the HVAC.

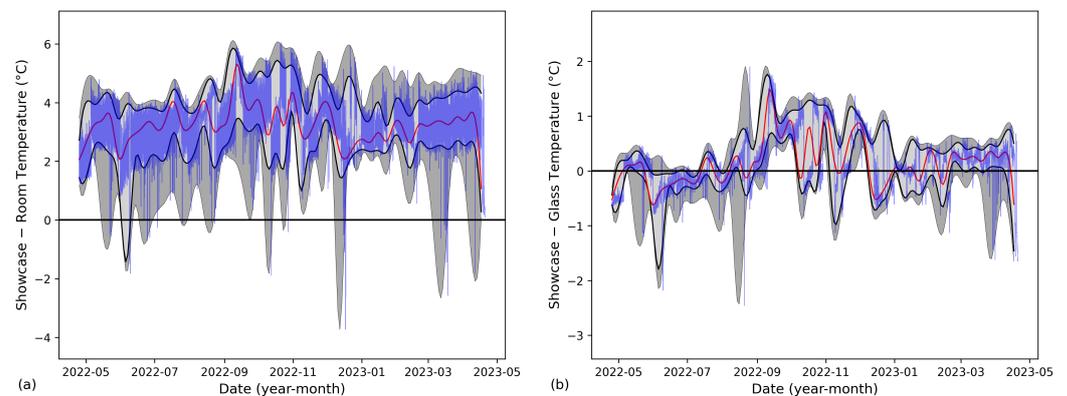
Figure 7. (a) Difference in temperature between the showcase and the room; blue line: recorded data; red line: median, i.e., 50-ile on a weekly basis; light gray areas: band from 8 to 92-ile; dark gray area: bands of the most extreme events, i.e., 0 to 7-ile and 93 to 100-ile. (b) The difference in temperature between the showcase and the glass.

The difference between the showcase and the room temperature (Figure 7a) shows that for the HVAC, the Classroom is permanently colder (mainly $T_S - T_R = 2^\circ$ to 5° C) than the

showcase. Negative values occur when the HVAC stops operating (e.g., during the night) and the room returns to the naturally warmer climate determined by the building envelope.

The difference between the showcase and the glass temperature ($T_S - T_G$) (Figure 7b) shows that the glass panes closely follow the air temperature of the showcase; the variability is within 1 °C, with peaks reaching 2 °C. Negative values are explained as in the previous difference.

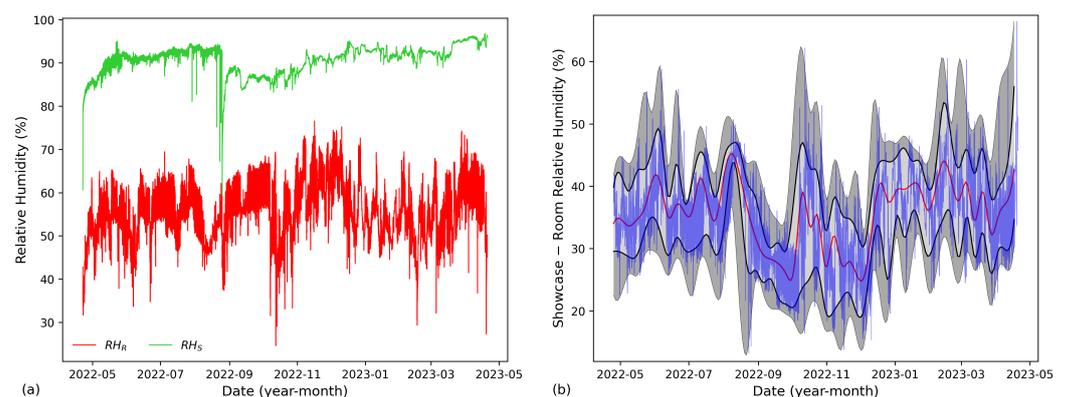
Figure 8. (a) Relative humidities in the Classroom and the showcase; (b) Difference between the relative humidities in the room and the showcase; color code as in Figure 7.

The difference in relative humidity between the room and the showcase ($RH_R - RH_S$) (Figure 8b) shows that, for the climate control operated by the HVAC system, the humidity level in the Classroom is permanently lower than in the showcase, i.e., $RH_R < RH_S$. The difference $RH_S - RH_R$ is highly variable, from around 20% to 50%.

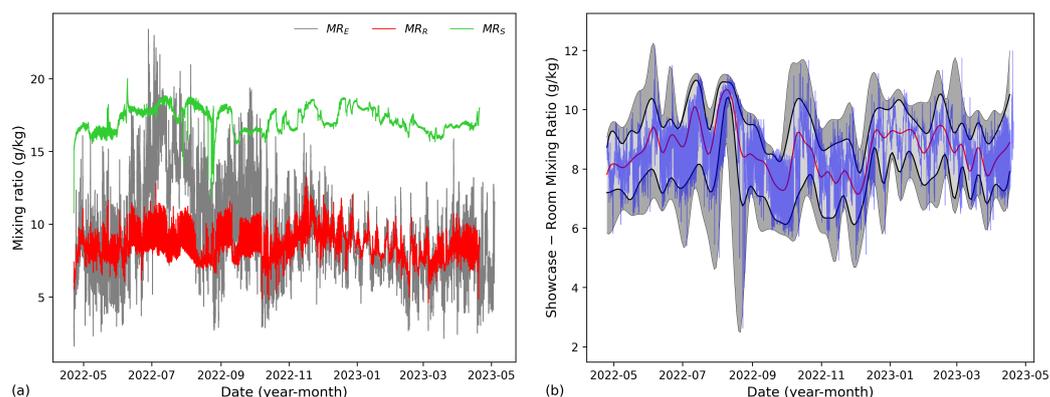
Figure 9. (a) The mixing ratios measured outdoors (MR_E), in the room (MR_R), and in the showcase (MR_S). (b) Difference between the mixing ratios in the showcase and in the room; color code as in Figure 7.

The three mixing ratios related to this showcase, i.e., external, room and showcase, are reported in Figure 9a.

The mixing ratio measured outdoors lies between 2 and 20 g/kg, with a mode of around 8 g/kg. Similar to air temperature, the annual cycle of the MR_E reaches its highest levels in summer and its lowest in winter. The mixing ratio in the Classroom generally lies between 6 and 12 g/kg. The mixing ratio in the showcase generally lies between 15 and 19 g/kg.

The difference between the two mixing ratios, in the showcase and the room (Figure 9b) shows that the mixing ratio is permanently higher in the showcase than in the Classroom, i.e., $MR_S - MR_R > 0$. This means that the showcase includes a source of moisture, and the only possibility is from the bottom, i.e., the archaeological remains and the surrounding ground. This confirms that the remains are fed by moisture seeping underground.

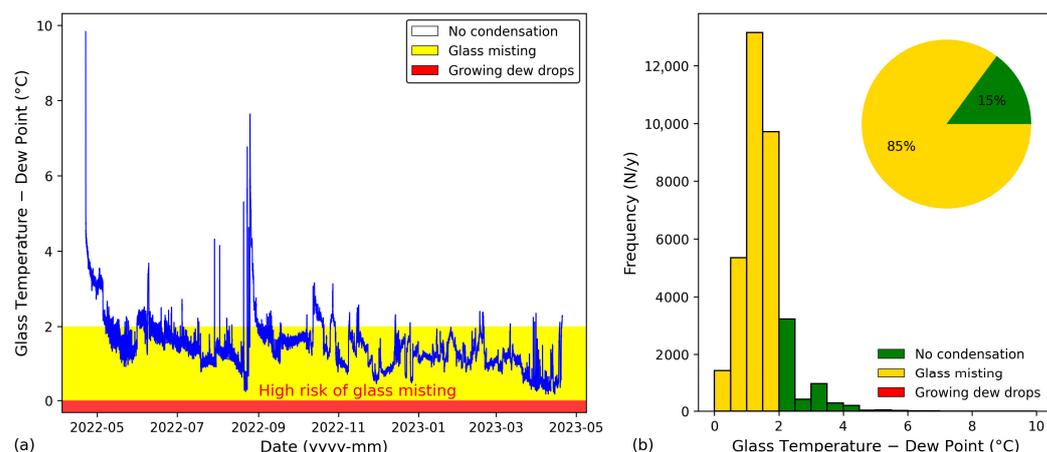
Figure 10. (a) Difference between the glass temperature and the dew point. (b) Frequency of glass misting in the Classroom.

The difference between the glass temperature T_G and the dew point DP observed during the monitoring period is reported in Figure 10a. It must be specified that the dew point is determined exactly by optical dew point meters, and only approximately by traditional temperature and RH sensors, due to the uncertainty that affects RH sensors as they approach saturation [6,20]. RH sensors are intended for use in dry conditions, i.e., excluding the presence of liquid water. The declared accuracy of the sensors decreases when the 90% RH is exceeded, and the uncertainty increases with the humidity level. When saturation is reached and the capacitive film is damp, the sensor is faulty and three solutions are possible, depending on the manufacturer: (i) the sensor, by default, indicates 100%, and this is the most common use; (ii) the sensor continues to operate, giving levels above 100%; (iii) the output is stopped because it is unreliable [6,25,26].

The information about the frequencies of no misting (green), misting (yellow), or condensation (red), is reported in the histogram (Figure 10b). The frequency represents how many times during the monitoring period the difference $T_G - DP$ was found within each temperature bin in the abscissa. The pie represents the percentage of time in which the three classes (no condensation; misting; dewing) have occurred in a year.

The frequency histogram shows that in the Classroom the conditions for misting have been largely dominant over the whole monitored period. The pie diagram shows that the glass was foggy for 85% of the time.

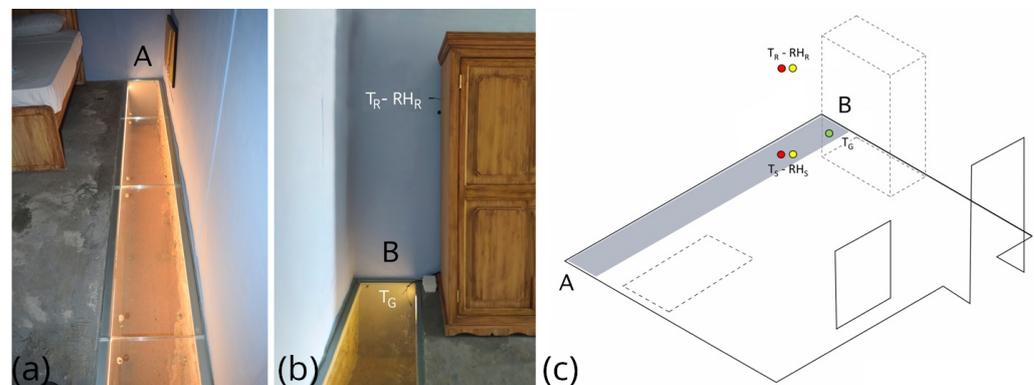
Figure 11. (a,b) Two views of the Interpretation Room showing the two ends A, B of the linear showcase. (c) Location of the sensors. T_R , T_G , T_S : temperature of the room, glass and showcase, respectively; RH_R , RH_S : relative humidity of the room and showcase.

In the Interpretation Room, a linear showcase was dug on the floor to display the wall foundation (Figure 11a,b). The dimensions are: length 443 cm, width 48 cm, depth 76 cm. The location of sensors is shown in Figure 11c. A pair of combined ($T_R|RH_R$) sensors was installed on the wall to monitor the room climate. The sensor of the glass pane temperature (T_G) was fixed on the lower side of the pane. A pair of temperature and relative humidity sensors ($T_S|RH_S$) was positioned inside the showcase.

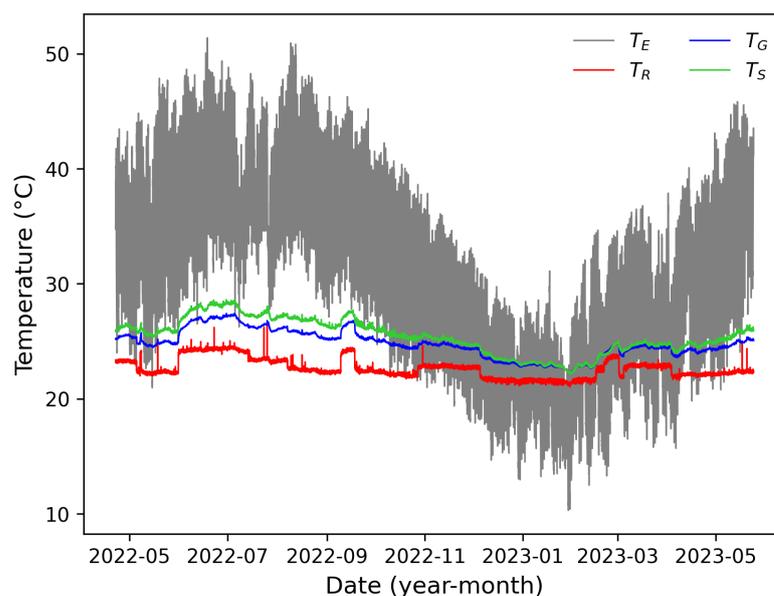
Figure 12. Temperatures considered in this survey. T_E : external temperature; T_G : glass temperature; T_R : room temperature; T_S : showcase temperature.

The temperature of the Interpretation Room (Figure 12) has been kept between 21 °C and 24.5 °C, with levels established by the setting points of the HVAC. The plot shows some minor irregularities due to use, e.g., HVAC turned off, and temporary air exchanges through doors or windows. The showcase and the glass pane have similar temperature levels and are at an intermediate level between the external values and the room temperature, which appear to be the main drivers. The glass pane temperature lies between 22 °C and 27.5 °C, and the room cooling is a bit lower than the showcase temperature which lies between 22 °C and 28.5 °C.

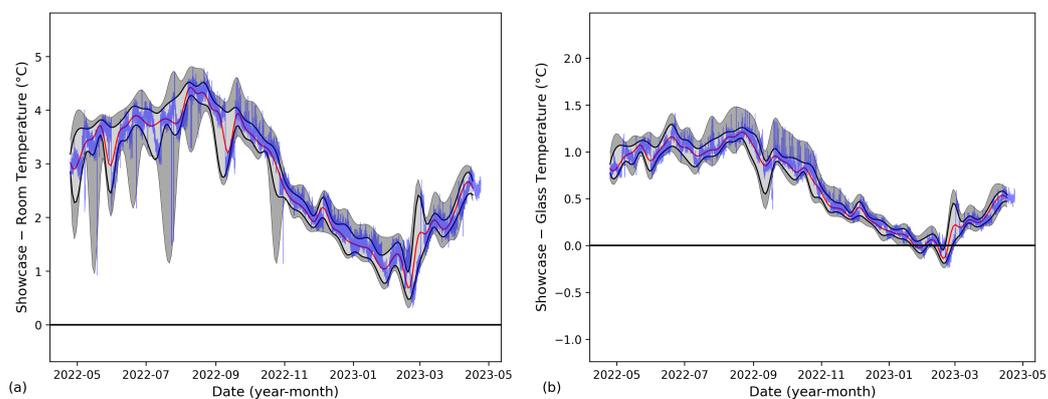
Figure 13. (a) Difference between the showcase and the room temperature; color code as in Figure 7. (b) Difference between the showcase and the glass temperature.

The small differences in temperature between the showcase and the room, and between the showcase and the glass pane, are highlighted in Figure 13. The showcase temperature is permanently higher than the room temperature (mainly 2 °C to 5 °C), for the cooling operated by the HVAC. Only rarely does the difference change sign, e.g., when the HVAC is turned off.

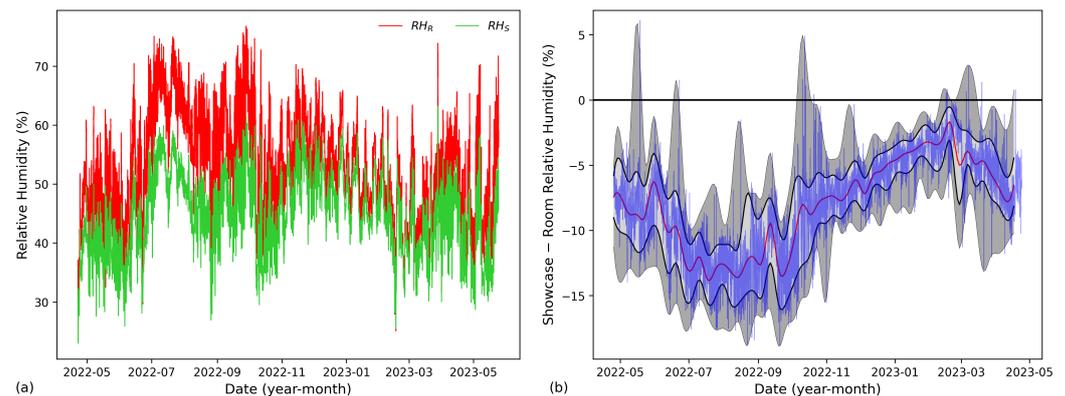
Figure 14. (a) Relative humidities in the Interpretation Room and the showcase; (b) difference between the relative humidities in the showcase and in the room; color code as in Figure 7.

In the room, the relative humidity has a median of around 50%, but is poorly controlled and generally swings between 30% and 75%, sometimes reaching more extreme values (Figure 14a). In the showcase, the relative humidity has a median of around 45% and generally lies between 30% and 60%.

The difference between the two relative humidities, i.e., $RH_S - RH_R$, shows that the humidity in the Interpretation Room is permanently higher than in the showcase (Figure 14b). The difference is variable, from around -2% to -15% RH with the largest departure in summer (when the air conditioning is more powerful). The relative humidity is determined by the combination of air temperature and mixing ratio. In the showcase, the lower relative humidity level is explained because the HVAC cooling keeps the room temperature lower, while the mixing ratio is the same (next section).

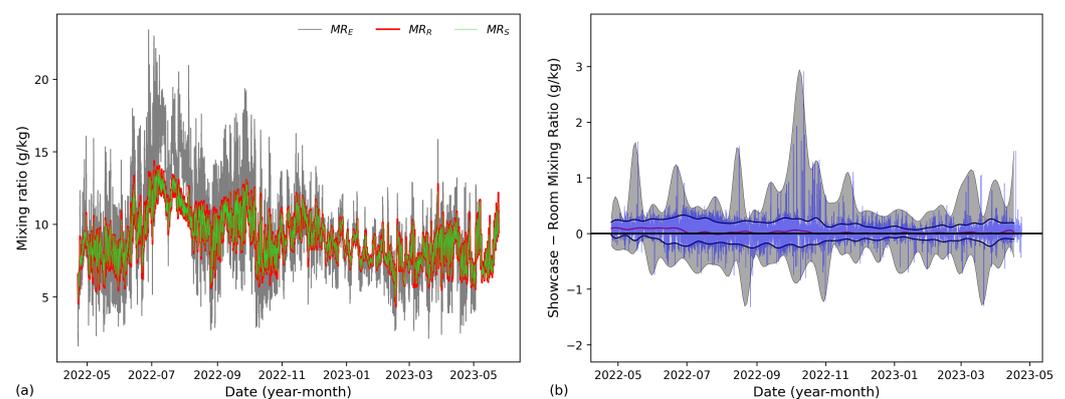
Figure 15. (a) The mixing ratios measured outdoors (MR_E), in the Interpretation Room (MR_R), and in the showcase (MR_S). (b) Difference between the mixing ratios in the showcase and in the room; color code as in Figure 7.

In the Interpretation Room, the mixing ratio generally lies between 5 and 14 g/kg and is mainly controlled by the HVAC. The mixing ratio in the showcase generally lies between 5 and 14 g/kg, i.e., the same values as the room. The difference between the two mixing ratios in the showcase and in the room (Figure 15b) is always small, around the zero level, with temporary imbalances likely related to the variability in the room for its use. This suggests that there is a balance between the two environments and that there is no evaporation from the ground in the showcase, i.e., the showcase behaves like a box with all sides closed, including the bottom, without exchanges with the underground moisture.

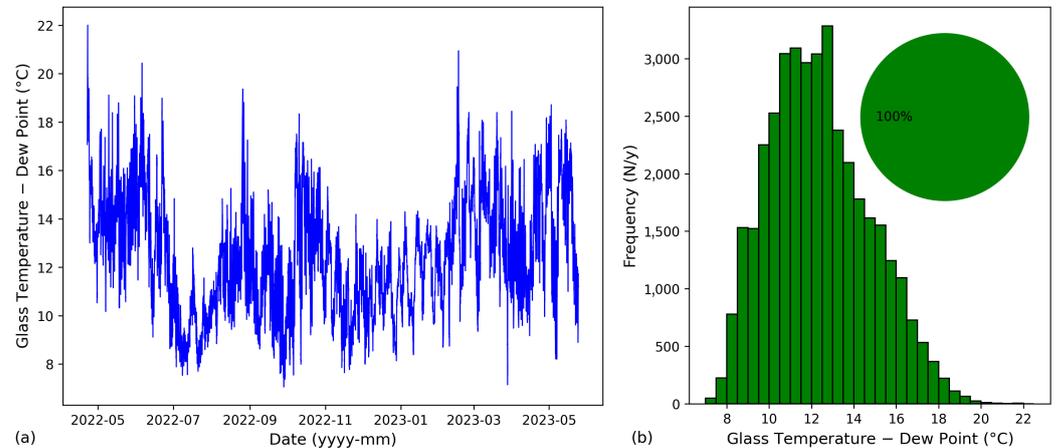
Figure 16. (a) Difference between glass temperature and the dew point; (b) Frequency of glass misting.

In the Interpretation Room, the difference between the glass pane temperature and the dew point of the air inside the showcase is always positive (Figure 16a). The frequency histogram (Figure 16b) shows that during the reporting period, the Interpretation Room has been mostly from 7.5 °C to 20 °C above the misting threshold, with a 12 °C modal value. The pie diagram shows that the percentage of time far from the misting conditions has been 100%.

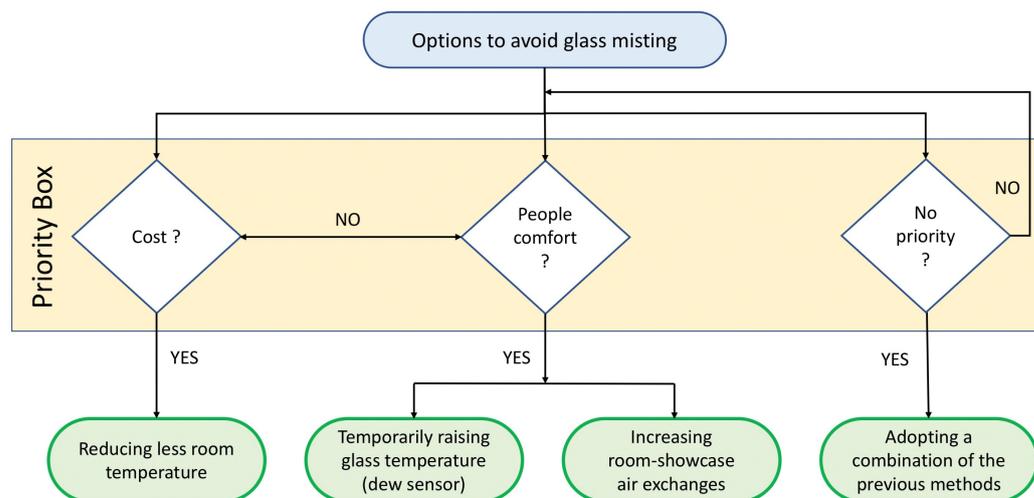
Figure 17. The four options to avoid glass misting.

3. To increase the natural air exchanges between the showcase and the room. This is another easy option because it is sufficient to open some natural ventilation slots between the glass panes and the floor. This option, however, is advisable only in case of modest evaporation, otherwise, ventilation risks increasing the evaporation rate and the accumulation of soluble salts on the archaeological remains.

4. Reducing plant watering can help to reduce the problem, but does not solve it because it is not the only cause.
5. To adopt a combination of the previous options. For instance, increasing the natural ventilation of option 3, which lowers the dew point, and consequently reduces the room temperature increase required in option 1. Alternatively, increasing the ventilation in option 3 as before, but reducing the need, duration and intensity of glass warming in option 2.

These options provide a variety of solutions, that every user may select and apply, depending on personal choices or room use. In this case study, all choices are more or less equivalent; however, in other situations, the choice must be determined by the results of the investigation, and in particular, by the temperature difference that should be compensated, or the difference in mixing ratio, and the cost that each option will entail.
