# Developing a Qualification and Testing Framework for Cold Spray Repairs in Aerospace Applications <sup>†</sup>

Cold spray is a solid-state deposition technology with great potential for coating and repair applications. This study examines the compliance of the cold spray repair process with a qualification and testing framework based on the requirements set by the European Union Aviation Safety Agency (EASA). As part of this effort, the case study of a repair of a Main Landing Gear (MLG) aluminium component is investigated to demonstrate the applicability of the proposed framework. This framework integrates mechanical and microstructural evaluations, including bond strength, hardness profiling and microstructural characterisation according to relevant ASTM and ISO standards. Experimental results from post-repair testing indicated promising performance, while ongoing testing is aligning reasonably with expected benchmarks and showing compliance with the EASA requirements.

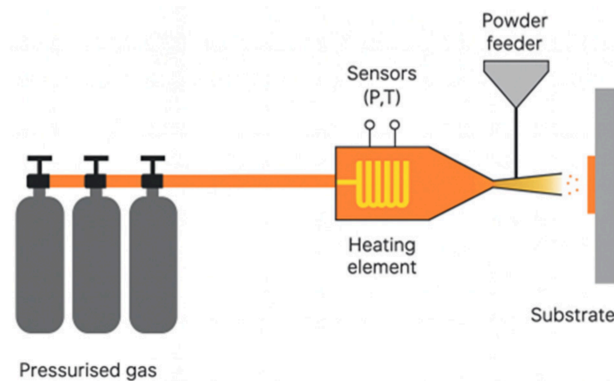
**Figure 1.** Illustration of the cold spray deposition process.

Cold spray (CS) is a solid-state deposition process which has drawn significant attention for a wide range of applications. Due to the solid-state nature of the process, which prevents thermal damage to the substrate often associated with conventional thermal spray or welding processes, the CS technology proves to have great potential as an additive repair method [1]. The working principle of cold spray is that a supersonic gas stream is used to accelerate powder particles to velocities ranging from 300 to 1500 m/s and propel them towards a substrate [2,3] as illustrated in Figure 1. Upon impact, these particles undergo plastic deformation and bond with the substrate through a combination of mechanical interlocking and metallurgical bonding mechanisms [4]. Cold spray can be applied to a wide range of materials, including aluminium, titanium, nickel, and stainless steel, making it suitable for repairing a variety of components, including worn-out turbine blades and machine parts in industries such as aerospace, automotive, and marine [1,5–8].

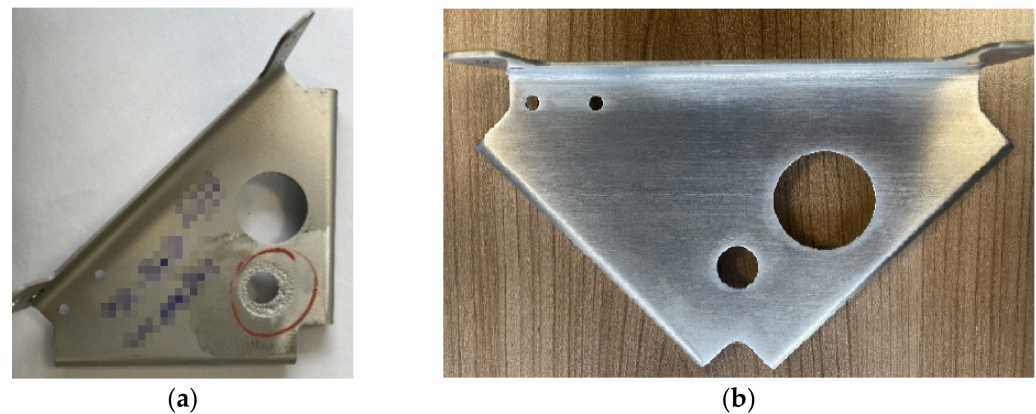
**Figure 2.** Images of the aircraft MLG bracket (AA 6013-T6), which has been employed as a use case: (a) bracket damaged by pitting corrosion around the indicated hole; (b) bracket repaired with CS.

This section identifies specific requirements and compliance methods as a qualification framework for cold spray repair applications in the aviation MRO industry based on the relevant EASA regulations. In particular, the investigated use case concerns the CS repair of a typical aircraft component which is an aluminium alloy wire bundle support bracket, located in the MLG area, damaged by pitting corrosion (Figure 2).

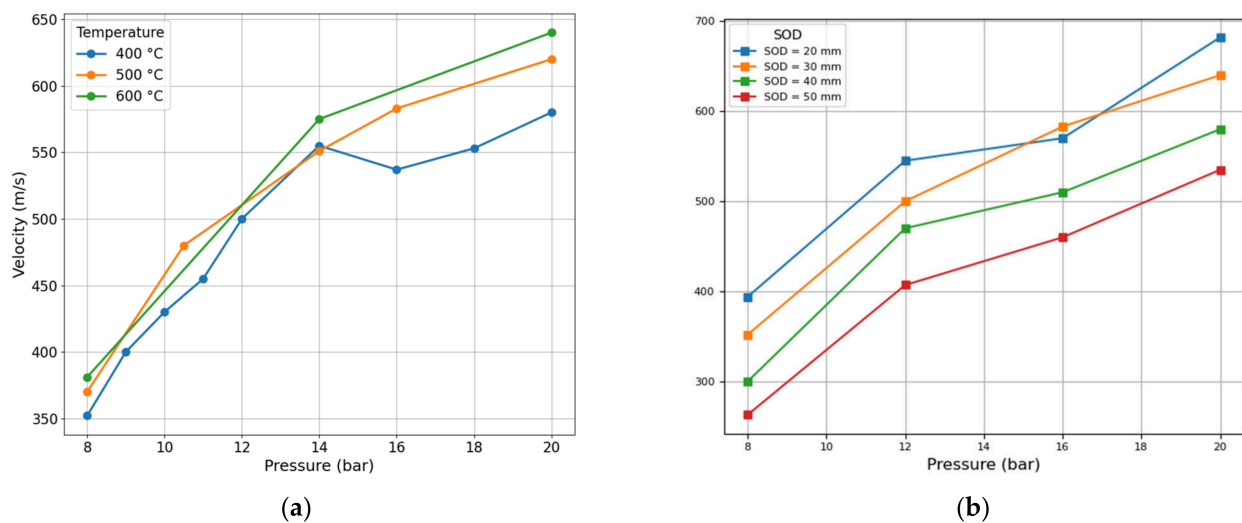
**Figure 3.** Particle velocity response of the system for (a) varying pressure and temperature (SOD at 30 mm) and (b) varying SOD, pressure and constant temperature (400 °C).

Gas temperature, pressure and stand-off distance (SOD) are among the most important parameters that determine the particle velocity at impact and, consequently, the CS repair performance and quality. A sensitivity analysis using conducted measurements with a particle image velocimetry technique indicated how the particular CS system responds to a variation in pressure, temperature and SOD, as illustrated in Figure 3. These results were used to optimise the experimental effort in terms of a reduced testing matrix. For the present testing campaign, 3 pressure levels (10, 14, 20 bar) and 2 temperature levels (400 °C, 600 °C) were chosen, resulting in a total of 6 experimental conditions. All experiments were performed with an SOD of 20 mm.

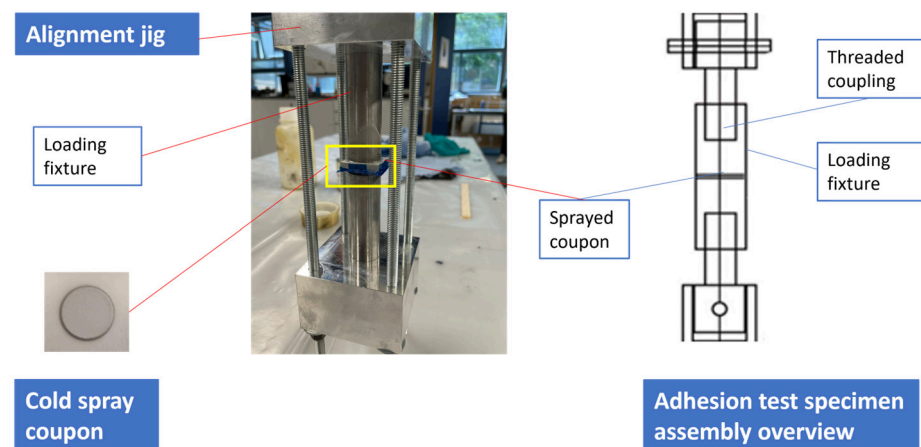
**Figure 4.** CS repair test specimen preparation according to ASTM C633.

The bond strength was evaluated through the adhesion strength pull-test method according to ASTM C633. Standard circular deposits with a 25 mm diameter were prepared with the use of spraying masks on the brackets. The test specimens were manufactured by cutting a square section around the sprayed area out of the bracket and then glueing the

coupons to two identical cylindrical loading fixtures with the use of the epoxy HTKUltra Bond 100 (Hamburg, Germany). An in-house developed jig was used to ensure alignment during the bonding, as illustrated in Figure 4.

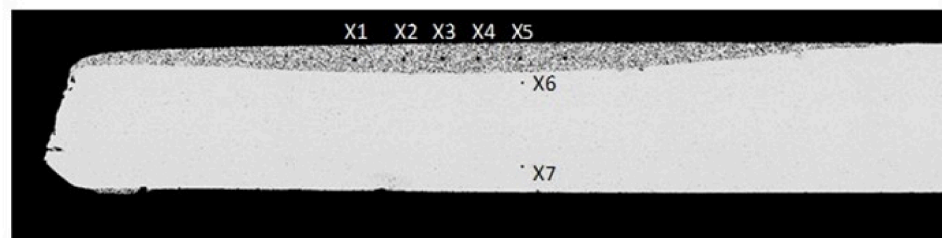
**Figure 5.** Locations of microhardness testing on cross-section 3-1 of bracket #3 (locations X1–X5 in coating side, locations X6–X7 in substrate).

Microhardness measurements were performed after the microscopic imaging. The measurement of hardness was carried out in accordance with EN ISO 6507. A loading time of 10 to 15 s was applied. The locations of the 7 hardness measurements per cross-section and the sequence of numbering from the coating side (locations X1–X5) to the substrate (locations X6–X7) are shown in Figure 5.

Preliminary results indicate that the CS deposit hardness is approximately 70–80 kg/mm<sup>2</sup> (HV0.1) according to EN ISO 6507. The detailed results from hardness measurements on cross-section 3-1 are denoted in Table 1, and the corresponding indentations are shown in Figure 5. The CS deposit microhardness results are reasonably comparable to observed data for relevant Al/Al<sub>2</sub>O<sub>3</sub> CS coatings on various substrates [28,31,32].

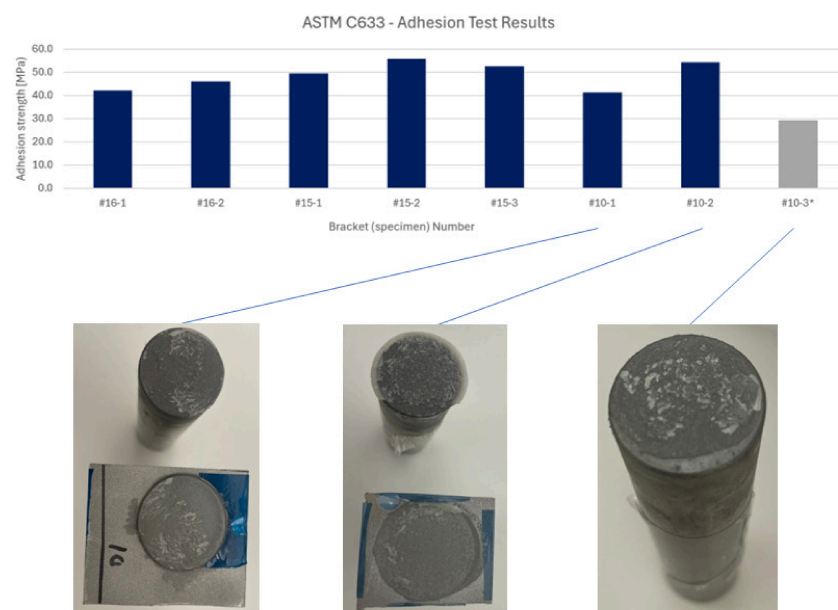
**Figure 6.** Results of bond strength test according to ASTM C633. Coupon #10-3\* failed at a lower load due to poor application of the adhesive epoxy.

The bond strength test yielded stresses at failure, varying from 34 to 54 MPa, averaging 47 MPa, which is above the average value reported in the literature [27,28]. The failure surfaces from adhesion tests were examined to determine the failure mode. It was found that all the test specimens (with the exception of specimen #10-3, which failed due to a manufacturing defect during the application of the adhesive epoxy) consistently failed adhesively at the epoxy layer (see some examples in Figure 6). The latter implies that the adhesion strength of the CS layer is higher than the stresses recorded at failure and validates the CS bond strength as sufficient for the investigated repair.

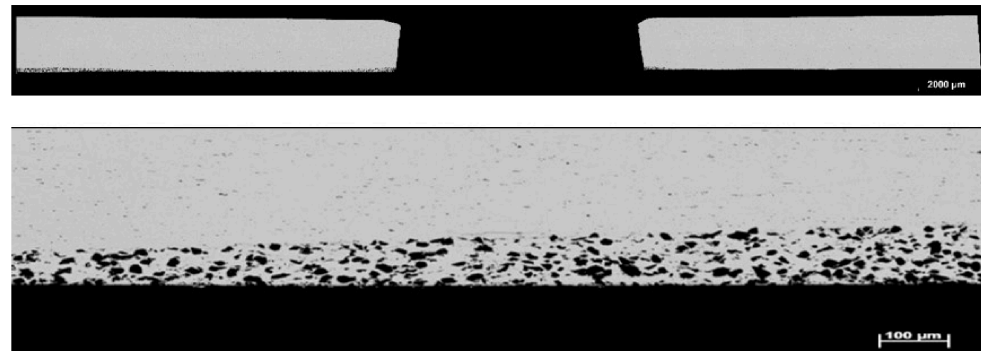
**Figure 7.** Microscopic analysis general observations and CS bond line quality.

All the inspections performed on the cross-sections indicate that a CS coating was successfully deposited at the areas to be repaired. The CS coatings follow the contours of the substrate material and no significant coating defects such as cracks, delamination, or inclusions were found. Figure 7 shows cross-section 13-1 in which a flat surface and thickness restoration were obtained. For this cross section only 0.6% of the total linear CS bond line length was affected by a single minor crack (probably due to poor removal of the pitted area of the previous step and not induced by the CS), i.e., 99.4% of the bond line was free of defects.

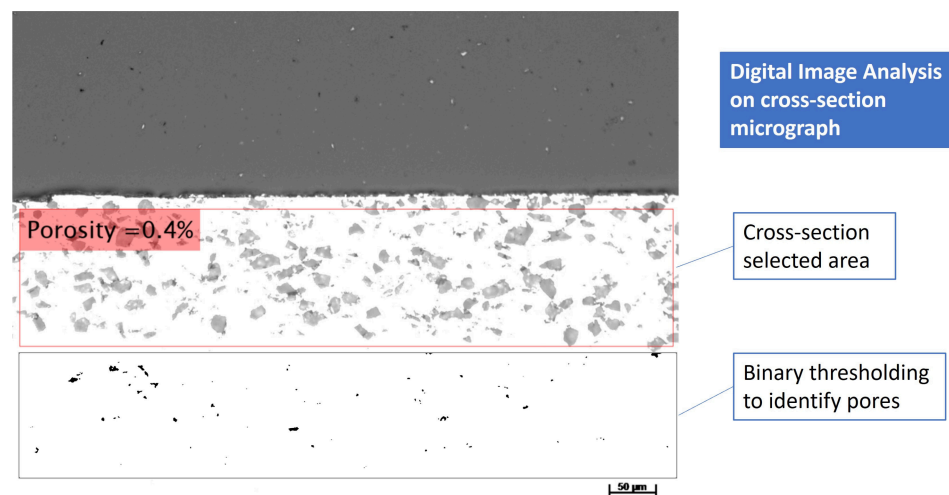
**Figure 8.** Porosity rating results according to ASTM E3/ASTM E2109.

Moreover, preliminary results from cross-sections cut from two different brackets yielded a porosity rating up to 0.4% (as illustrated in Figure 8), which is lower or comparable to porosity ratings for relevant Al/Al<sub>2</sub>O<sub>3</sub> CS coatings on various substrates [28–30].
